RE: CONFIRMATION THAT THE HERITAGE SPECIALIST ASSESSMENT OF THE SPRINGHAAS GRID CONNECTION PROJECT HAS MET THE REQUIREMENTS OF THE STANDARD FOR THE DEVELOPMENT AND EXPANSION OF POWER LINES AND SUBSTATIONS WITHIN IDENTIFIED GEOGRAPHICAL AREAS, 2022

HERITAGE IMPACT ASSESSMENT: PROPOSED POWERLINES FROM SPRINGHAAS SOLAR FACILITY 4 TO COLLECTOR SUBSTATION A WITHIN THE PROPOSED SPRINGHAAS GRID CONNECTION CORRIDOR NEAR DEALESVILLE IN THE FREE STATE PROVINCE (J. Orton, June 2022)

Springhaas Grid Connection: Overhead powerlines up to 275kV in capacity from the Springhaas Solar Facility 4 to Collector Substation A, near Dealesville, Bloemfontein, Free State (Line 3)

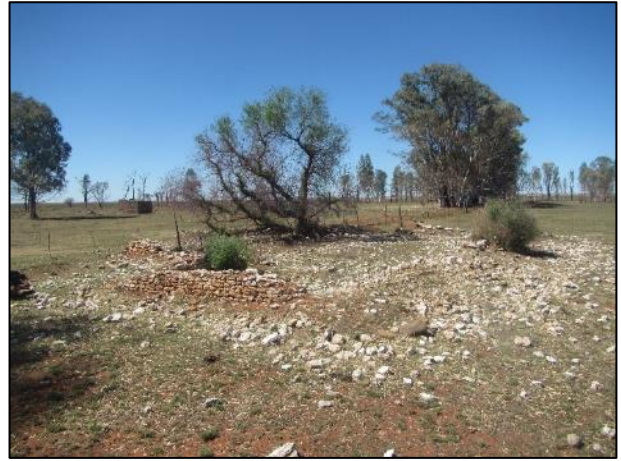
Another small gabled stone cottage with a loft under a tin roof was better preserved, although an addition to its west face was partially collapsed (waypoint 294 just outside the corridor; Figure 18). There are again patterns in the walling. The lowermost 1 m is almost all of calcrete, while above this there is a mix of calcrete, dolerite and shale. Shale blocks have been used for the windowsill and display some wear (Figure 19). Alongside this cottage was a brick ruin with at least half its walls collapsed and its roof missing (waypoint 295 on the edge of the corridor; Figures 20 to 22). This was undoubtedly the main house of this farm complex. The bricks, being softer than stone, have dissolved in the rain with the result that this ruin is far more poorly preserved than the stone ruins. Nearby is another outbuilding built of calcrete. Its function is indeterminate as it is too poorly preserved but it may have been a kraal (waypoint 298 just outside the corridor; Figure 23).

Figure 23: The remains of a calcrete-walled structure at waypoint 298.

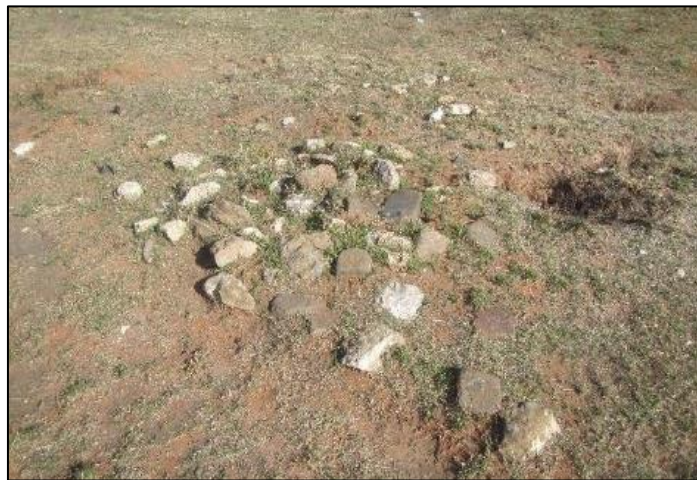
Graves were seen in four locations in the broader study area, with another marked as a possible grave. Only the latter is relevant here as it lies very close to, but just outside of, the grid connection corridor and well away from the proposed development. This was a loose pile of stones with no apparent function (waypoint 384; Figure 24) but, being located very close to a ruined structure, it seems unlikely to be a grave but, for precautionary reasons, it has been treated as one.

Figure 24: Possible grave at waypoint 384.
