HERITAGE IMPACT ASSESSMENT: PROPOSED POWERLINES FROM SPRINGHAAS SOLAR FACILITY 5 TO COLLECTOR SUBSTATION A WITHIN THE PROPOSED SPRINGHAAS GRID CONNECTION CORRIDOR NEAR DEALESVILLE IN THE FREE STATE PROVINCE (J. Orton, June 2022)

Springhaas Grid Connection: Overhead powerlines up to 275kV in capacity from the Springhaas Solar Facility 5 to Collector Substation A, near Dealesville, Bloemfontein, Free State (Line 4)

1. INTRODUCTION

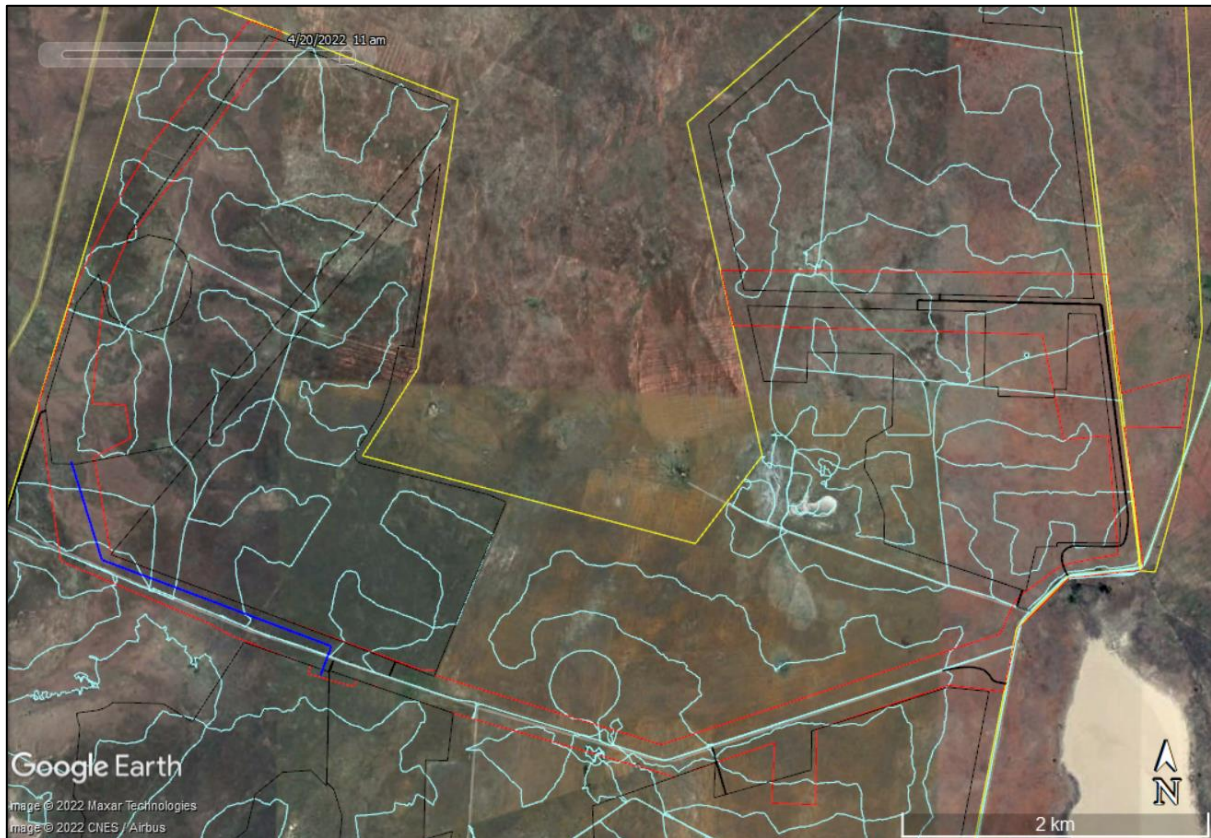
Figure 4: Aerial view of the study area (key as per Figure 3) showing the survey tracks (light blue lines).

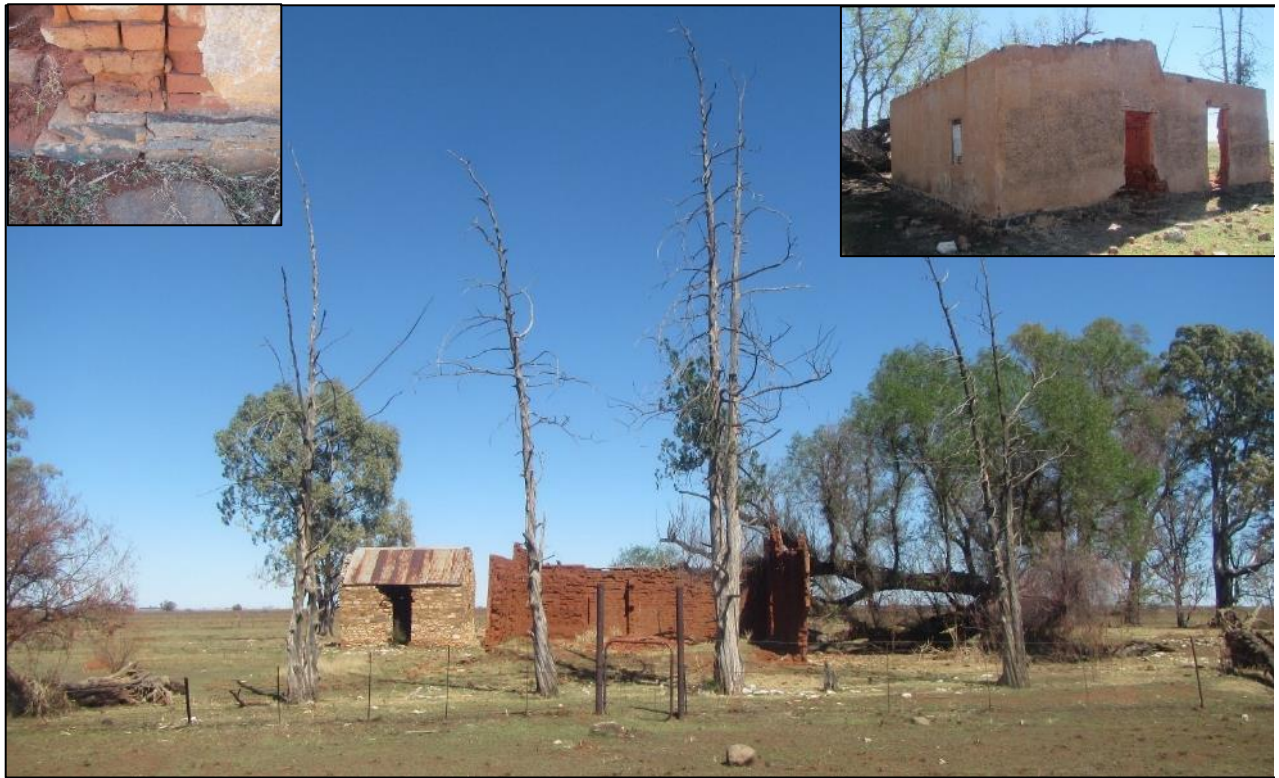
Figure 20: View of the farm complex with associated trees at waypoint 294 (roofed ruin) and 295 (red brick ruin). A line of cypress trees stands in the foreground, just behind the fence. Left inset: Brick wall on stone plinth. Right inset: southwest corner of house.

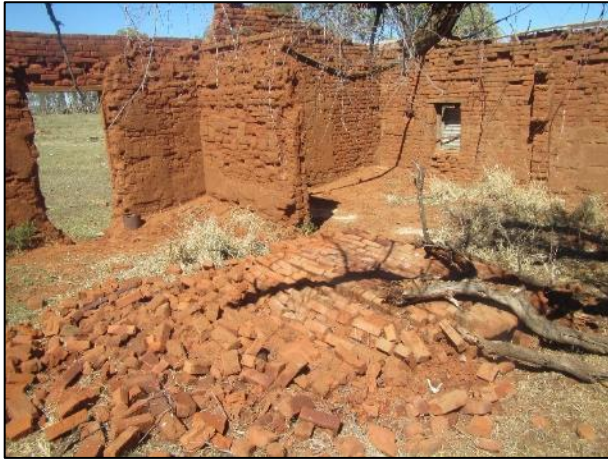
Figure 22: Interior of the brick house at waypoint 295.

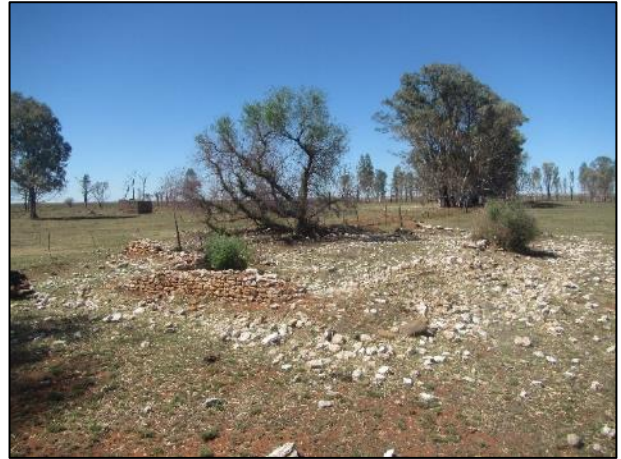
Figure 23: The remains of a calcrete-walled structure at waypoint 298.

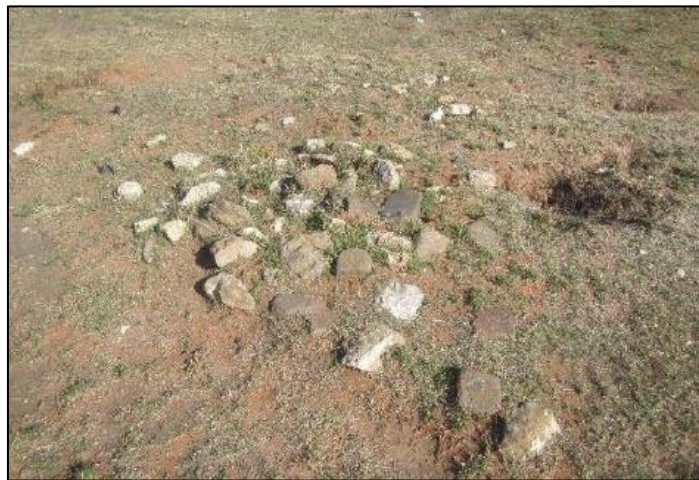
Graves were seen in four locations in the broader study area, with another marked as a possible grave. Only the latter is relevant here as it lies very close to, but just outside of, the grid connection corridor and well away from the proposed development. This was a loose pile of stones with no apparent function (waypoint 384; Figure 24) but, being located very close to a ruined structure, it seems unlikely to be a grave but, for precautionary reasons, it has been treated as one.

Figure 24: Possible grave at waypoint 384.

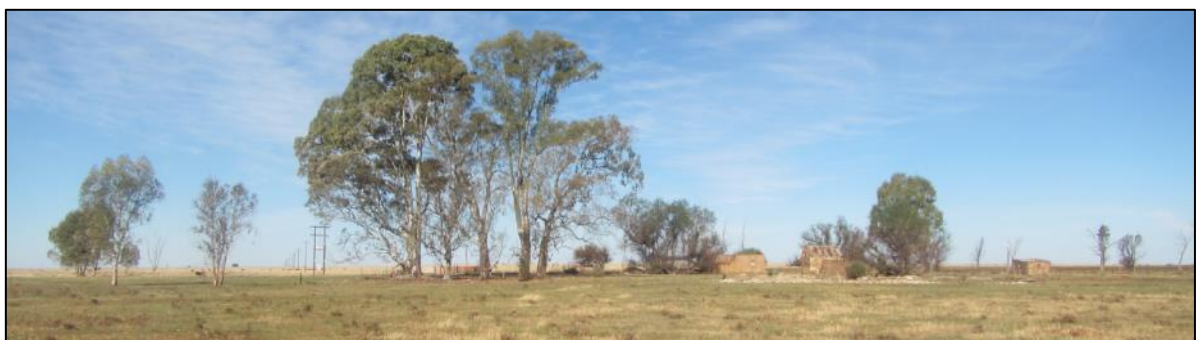
As described above, the landscape is strongly rural in nature. Occasional arable lands occur, including a centre pivot field just north of the southern section of the corridor, but the vast majority is grassland used for grazing. Aerial imagery indicates that many areas were ploughed in the recent past and have probably been left to recover naturally due to drought conditions over the last several years. No evidence of this ploughing was seen on the ground though, with the only arable land in the broader study area being the centre pivot. The cultural landscape features scattered homesteads – either occupied, unoccupied and derelict, or completely ruined archaeological sites – in a sea of grass. These homesteads are often, but not always, marked by groves of trees. Figure 25 shows a view of the farm complex located along the southern edge of the corridor.

Figure 25: View of the farm complex at waypoints 291-298 showing the mature trees which mark the existence of the complex.

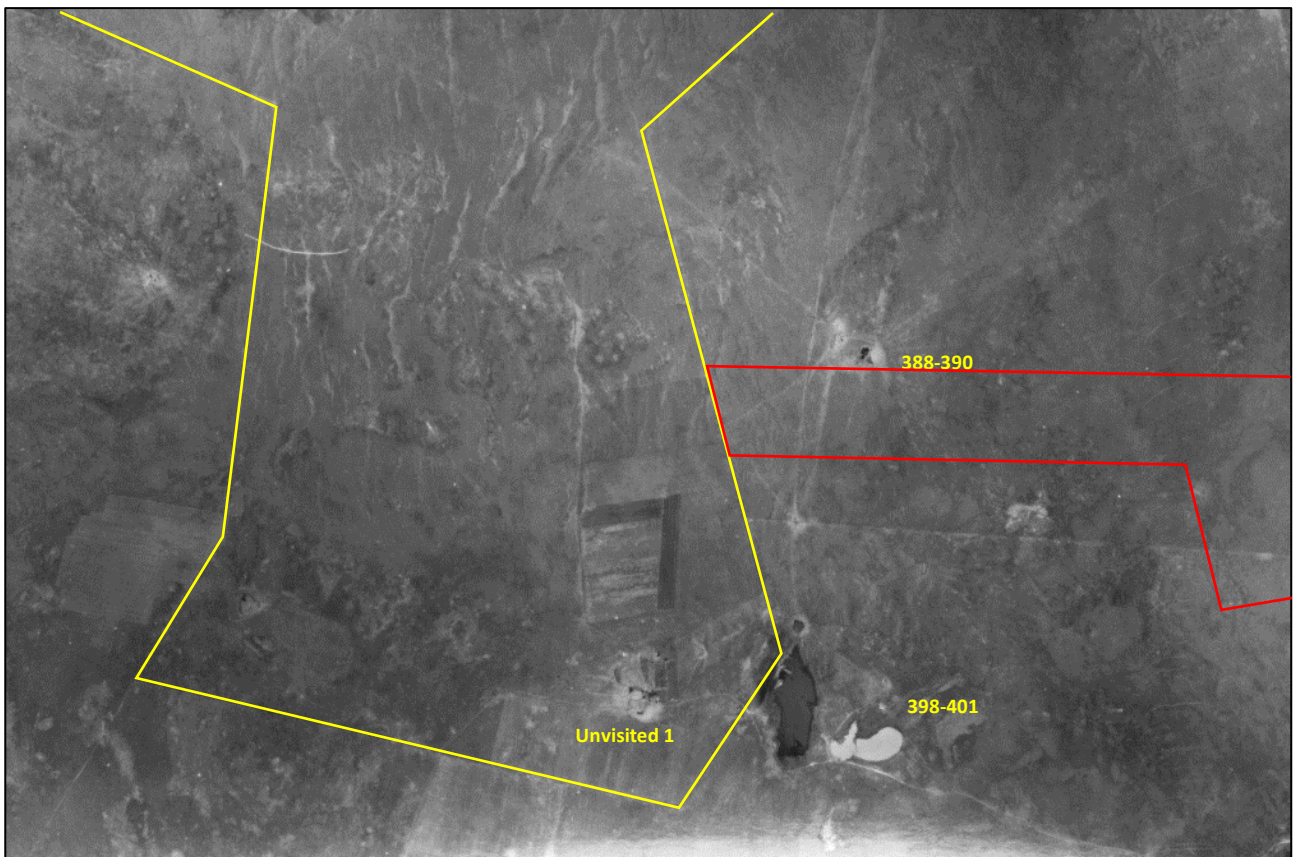
Figures 26 and 27 show aerial views of the broader study area from 1956. Some change is evident over the last 65 years. The ruin at waypoint 388 (just outside the corridor) was still in use and the adjacent modern house and shed were not yet built. The waypoint 398-401 complex (outside

corridor) was already disused (as indicated by the lack of desire lines in the grass) and had probably already been in ruin for some time. The same applies to the one at waypoints 315-324 (outside corridor), although its dam was still intact. The complexes at waypoints 368-377 (just outside corridor), 299-307 (outside corridor) and 291-298 (along southern edge of corridor) appear to have been still fully functional. All three of these are now completely ruined. The latter is shown as having had a single labourer's cottage to the west with another to the north and a third to the east. While a ruin marks the location of the eastern one, the other two have both been completely removed. It is evident from these images that structures built without cement can deteriorate very quickly once their roofs are removed. It is likely that joinery and rocks were frequently removed for reuse elsewhere which greatly exacerbates the degradation.

Figure 26: Aerial photograph from 1956 (377_002_05062) showing three farmsteads in the north-eastern part of the broader study area outside the grid connection corridor and proposed development footprint (waypoint numbers indicated).

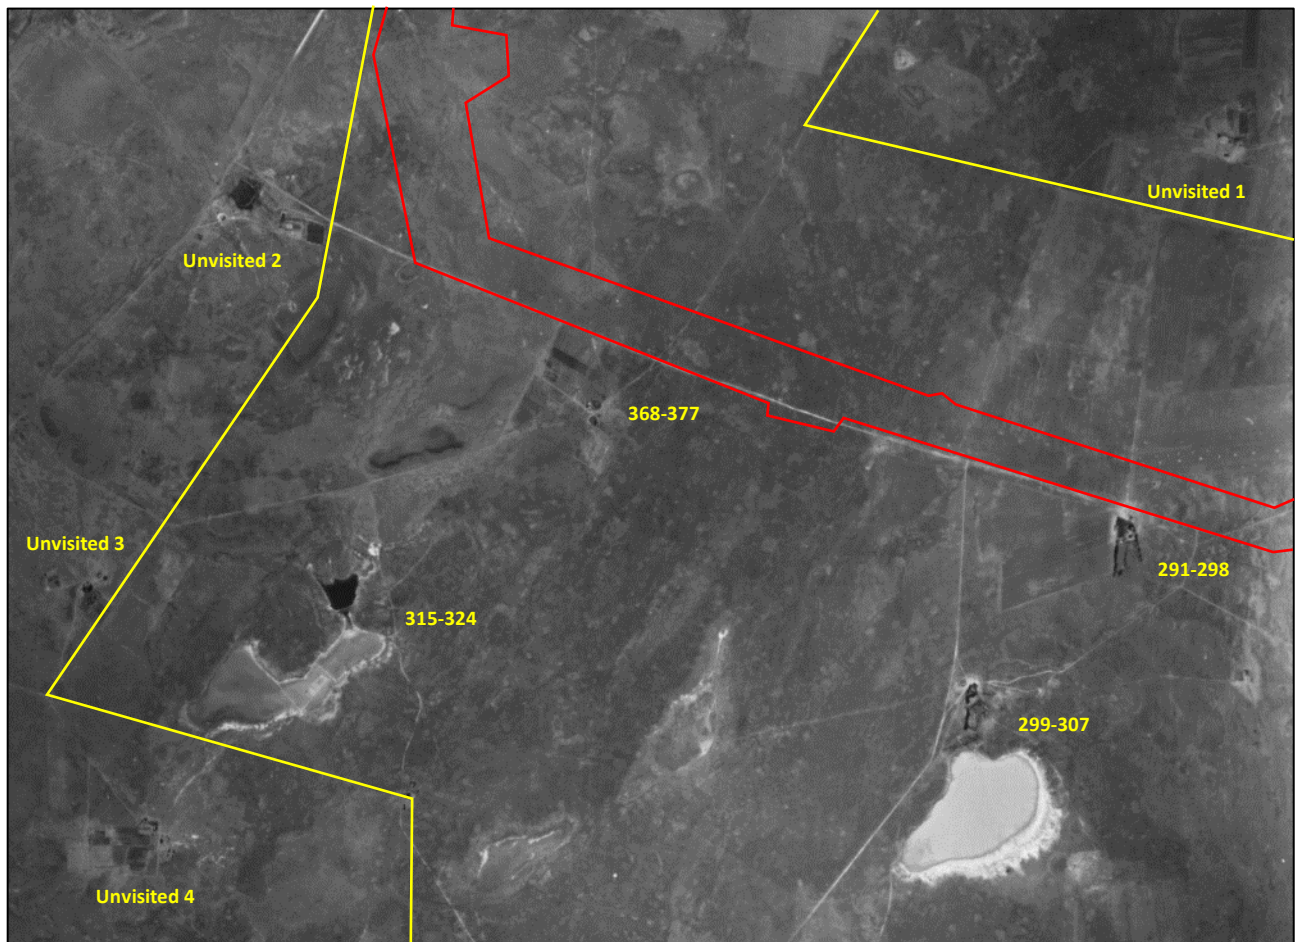
Figure 27: Aerial photograph from 1956 (377_003_05103) showing four farmsteads in the southern part of the broader study area (waypoint numbers indicated).
