**RE: CONFIRMATION THAT THE HERITAGE SPECIALIST ASSESSMENT OF THE SPRINGHAAS GRID CONNECTION PROJECT HAS MET THE REQUIREMENTS OF THE STANDARD FOR THE DEVELOPMENT AND EXPANSION OF POWER LINES AND SUBSTATIONS WITHIN IDENTIFIED GEOGRAPHICAL AREAS, 2022**

*HERITAGE IMPACT ASSESSMENT: PROPOSED POWERLINES FROM SPRINGHAAS SOLAR FACILITY 6 TO COLLECTOR SUBSTATION B WITHIN THE PROPOSED SPRINGHAAS GRID CONNECTION CORRIDOR NEAR DEALESVILLE IN THE FREE STATE PROVINCE (J. Orton, June 2022)*

*Springhaas Grid Connection: Overhead powerlines up to 275kV in capacity from the Springhaas Solar Facility 6 to Collector Substation B, near Dealesville, Bloemfontein, Free State (Line 5)*

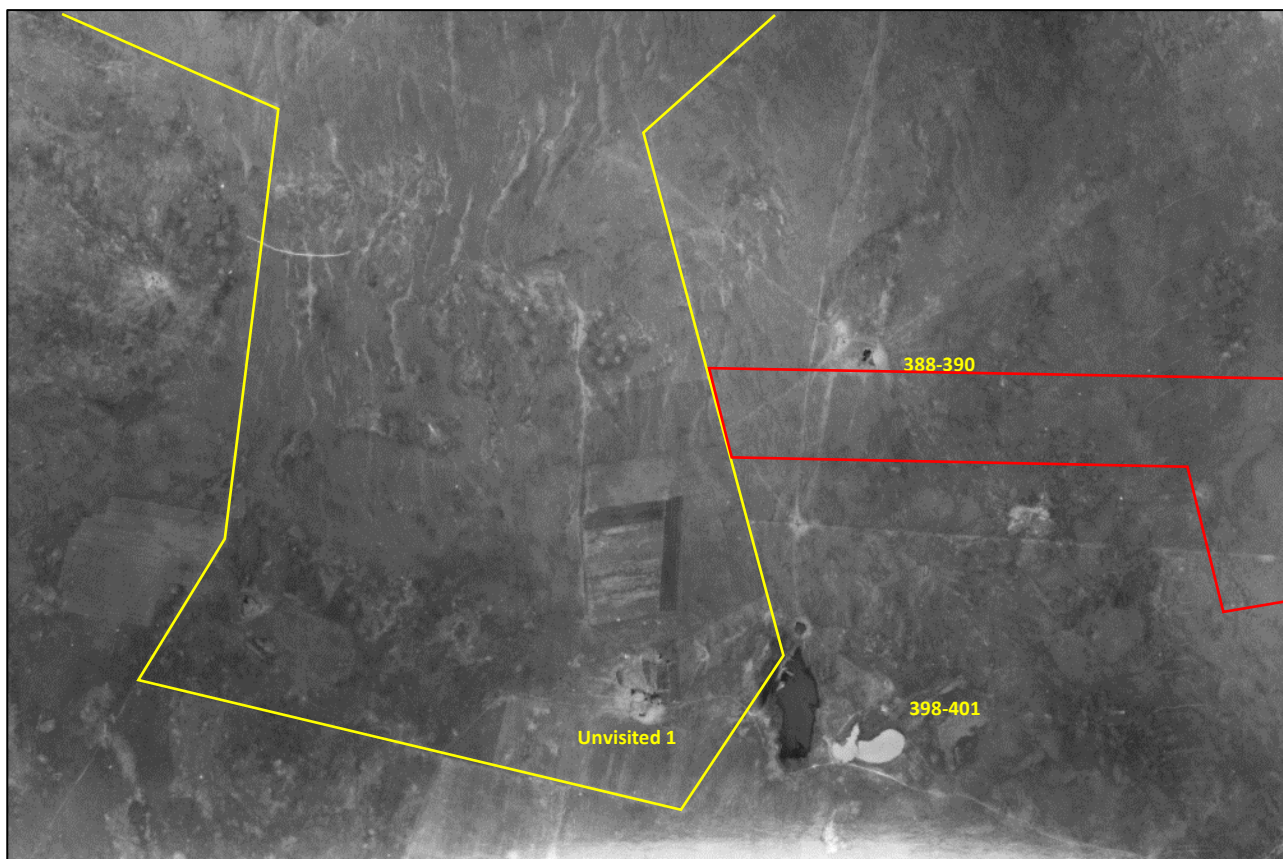
Figures 26 and 27 show aerial views of the broader study area from 1956. Some change is evident over the last 65 years. The ruin at waypoint 388 (just outside the corridor) was still in use and the adjacent modern house and shed were not yet built. The waypoint 398-401 complex (outside

corridor) was already disused (as indicated by the lack of desire lines in the grass) and had probably already been in ruin for some time. The same applies to the one at waypoints 315-324 (outside corridor), although its dam was still intact. The complexes at waypoints 368-377 (just outside corridor), 299-307 (outside corridor) and 291-298 (along southern edge of corridor) appear to have been still fully functional. All three of these are now completely ruined. The latter is shown as having had a single labourer's cottage to the west with another to the north and a third to the east. While a ruin marks the location of the eastern one, the other two have both been completely removed. It is evident from these images that structures built without cement can deteriorate very quickly once their roofs are removed. It is likely that joinery and rocks were frequently removed for reuse elsewhere which greatly exacerbates the degradation.

**Figure 26:** Aerial photograph from 1956 (377\_002\_05062) showing three farmsteads in the north-eastern part of the broader study area outside the grid connection corridor and proposed development footprint (waypoint numbers indicated).
