**RE: CONFIRMATION THAT THE HERITAGE SPECIALIST ASSESSMENT OF THE SPRINGHAAS GRID CONNECTION PROJECT HAS MET THE REQUIREMENTS OF THE STANDARD FOR THE DEVELOPMENT AND EXPANSION OF POWER LINES AND SUBSTATIONS WITHIN IDENTIFIED GEOGRAPHICAL AREAS, 2022**

*HERITAGE IMPACT ASSESSMENT: PROPOSED POWERLINES FROM SPRINGHAAS SOLAR FACILITY 8 TO COLLECTOR SUBSTATION A WITHIN THE PROPOSED SPRINGHAAS GRID CONNECTION CORRIDOR NEAR DEALESVILLE IN THE FREE STATE PROVINCE (J. Orton, June 2022)*

*Springhaas Grid Connection: Overhead powerlines up to 275kV in capacity from the Springhaas Solar Facility 8 to Collector Substation A, near Dealesville, Bloemfontein, Free State (Line 6)*

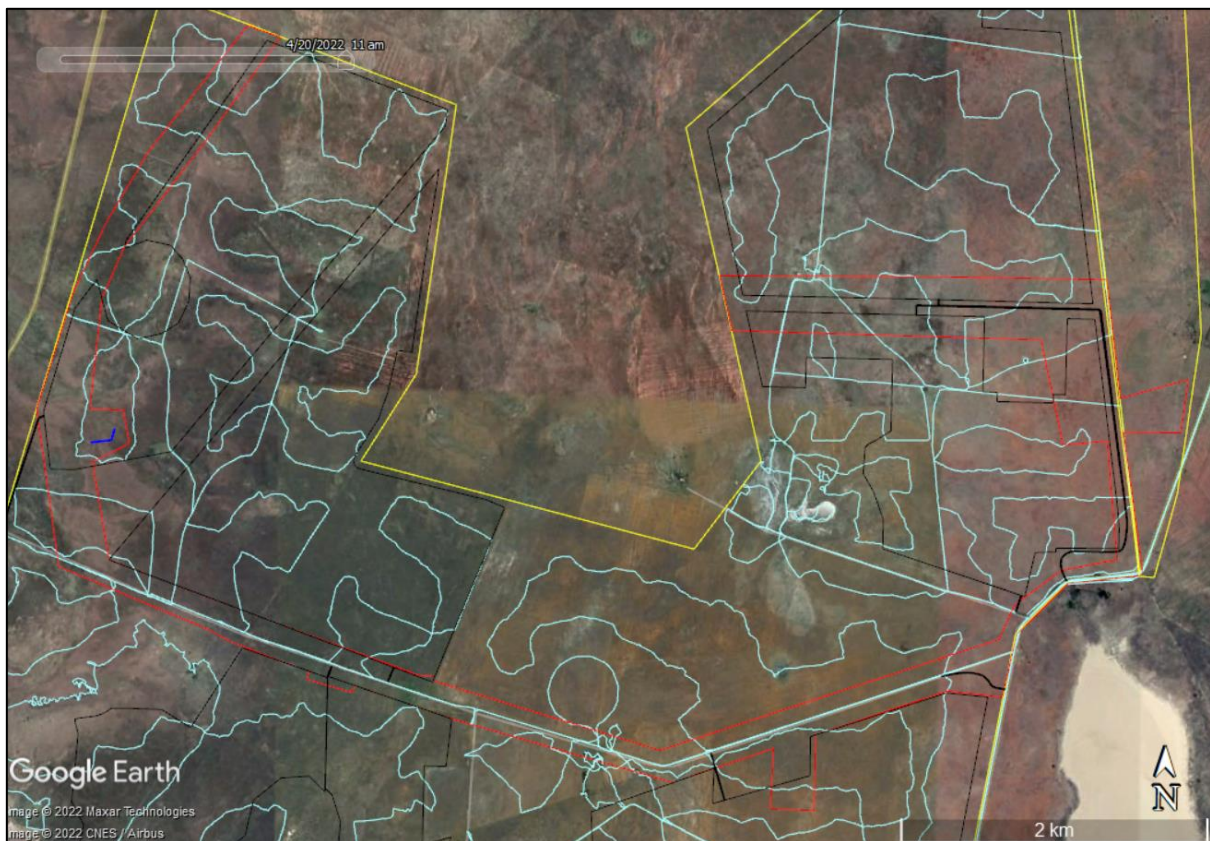
**Figure 4:** Aerial view of the study area (key as per Figure 3) showing the survey tracks (light blue lines).
