### **3.3.4 Built environment**

## **PART 2: FOSSIL SITE ENCLOSURE**

### **3.4 Research Environment**

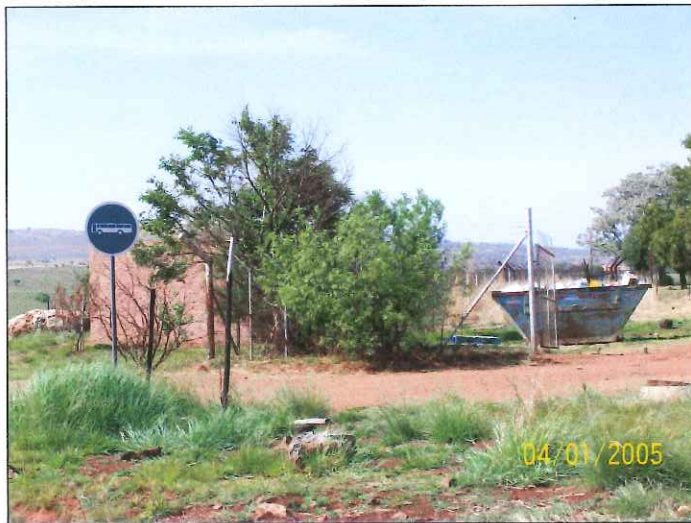
*Fig 23; In winter, bus drivers create small seats for themselves and make fires to keep warm (see middle foreground) because there are no shelter facilities for them. Uncontrolled fires can easily start on site in this way*

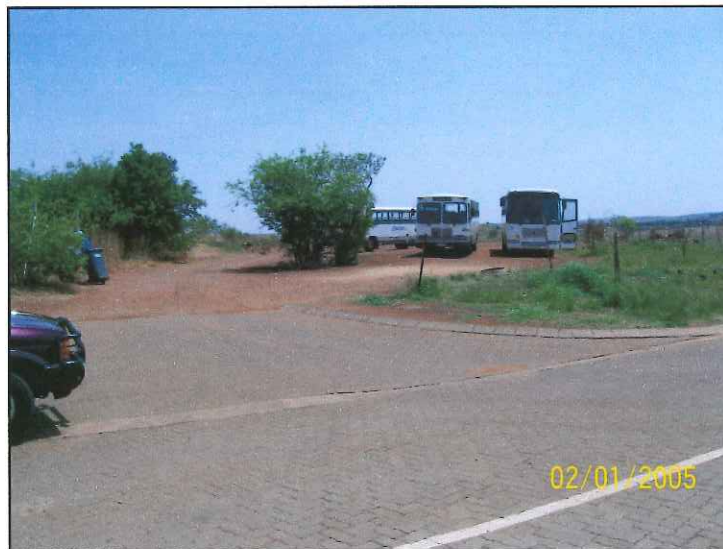
*Fig 24: The traffic throughflow, service vehicle routes and turning facilities for buses have not been well thought through. Buses waiting for tours to finish often pile up one behind the other causing traffic congestion*

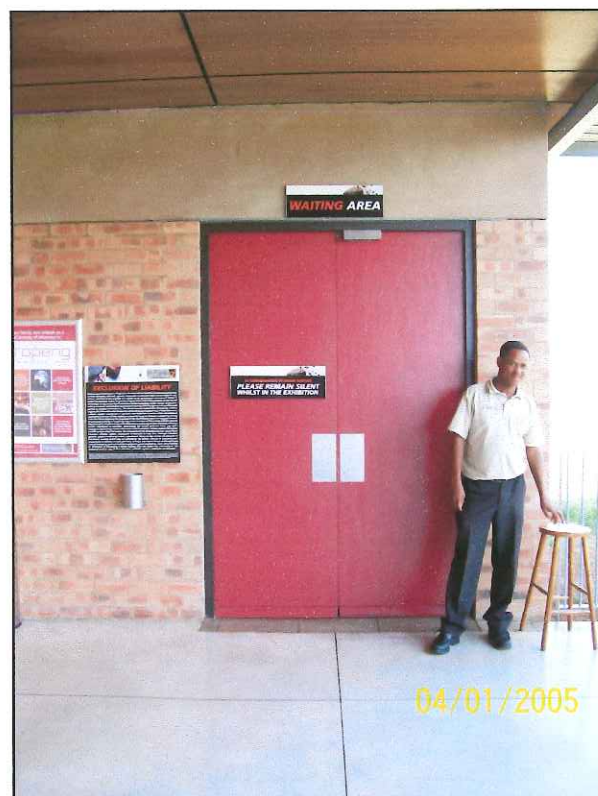
*Fig 25: Inappropriate label over Museum door reads 'Waiting Area' – many visitors have departed unaware that there was a museum. Waiting area is being interpreted as an organizing venue for large groups of schoolchildren*

- There is directional signage on site, but the museum is labeled 'Waiting Area' and many visitors miss it (Fig 25)
- There are behavioural modifiers (e.g. no eating in the caves, no littering)

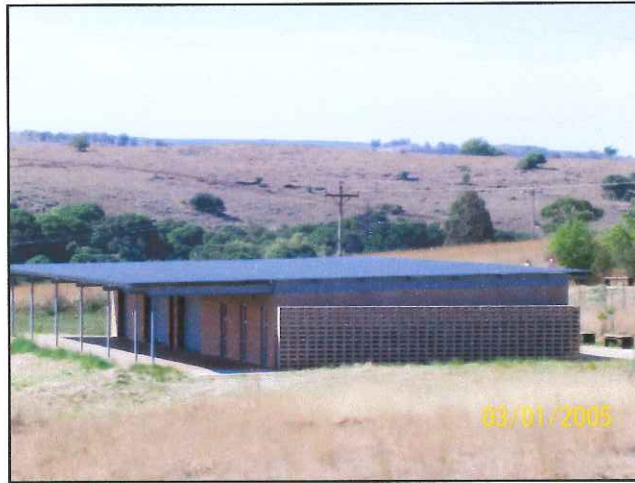
*Fig 26. The laboratory and fossil store built for the scientists has many inherent flaws in its design. It is utilized by the swartkrans excavation team from across the valley and by the Sterkfontein technicians for casting. Future planning should address ways in which amendments to inappropriate design could be rectified to make the structure fulfill the purposes for which it was built, or fit it for alternative purposes if this is not possible*

- There is a new store room and laboratory for the use of the permitted scientists busy on site, with storage room, work room and offices (Fig 26). Unfortunately the design of this building has many flaws and it does not suit the activities it was originally planned for. Details have been included in the Site Inspection Report for Sterkfontein, October 2006.
- There are toilets, ablution facilities and a wash basin
- The laboratory is air-conditioned but not dust-proof.

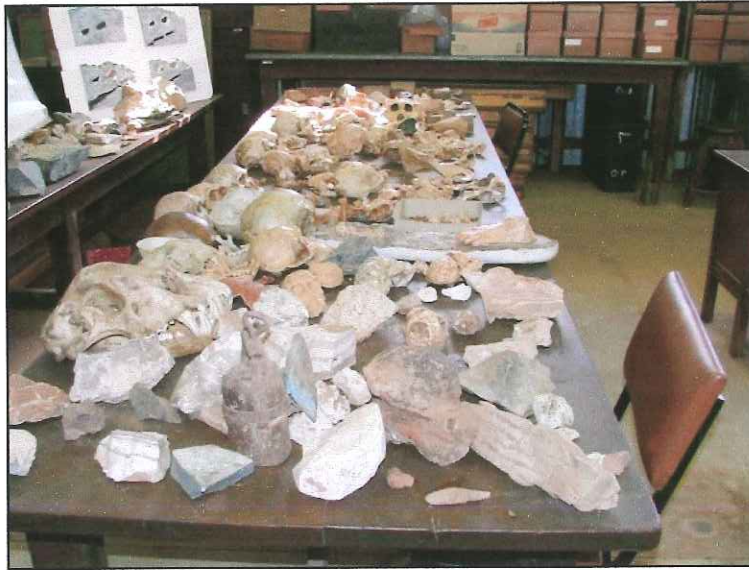
*Fig 27: The metal shed within the fossil site enclosure is used as a store and as a delightful informal site interpretation facility for students and scientific visitors. It is not open to the public, but serves an important function. Preparators can work indoors in inclement weather, increasing productivity (Note: date not correct)*

- There is a metal shed which was erected in the early 1970s, using the surface of a flattened dump as a foundation. It is used to store excavation equipment, prepared fossils awaiting transportation to the University, and the casts and demonstration material needed for site interpretation for professional and international academic visitors (Fig 27)

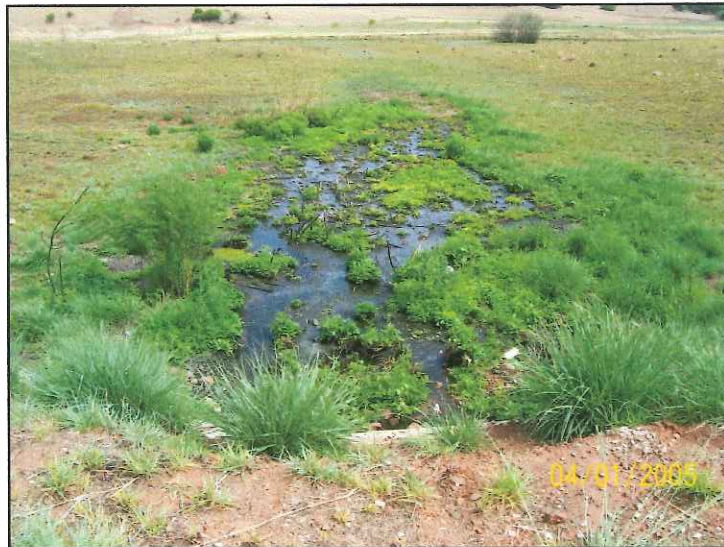
*Fig 28: Effluent from the multiple septic tank system at Sterkfontein caves spills over into the Blaauwbank River, an already heavily polluted drainage system. The throughput at Sterkfontein exceeds design specifications and an upgrade is planned. The overflow seen here is on its way to the Blaauwbank at the valley bottom seen in the distance*

- There are flush toilets at the Visitor centre which discharge into a septic tank system. This situation is far from ideal in a dolomitic area with a known void beneath the site because of risk of water contamination- the authorities are aware of this.
- The system needs to be re-engineered to accommodate unexpectedly high volumes of through-put.
- The overflow flows through a series of reed beds which assist in filtering process (Fig 16)
- The final effluent is discharged under the Sterkfontein tar road and seeps down into the Blaauwbank drainage system, an already heavily polluted conduit (Fig 28).
- The toilets in the scientists' laboratory also drains into the septic tank
- The toilet facilities in the excavation enclosure have their own septic tank
- The ideal situation would be a closed sewage system with a holding tank which could be emptied periodically

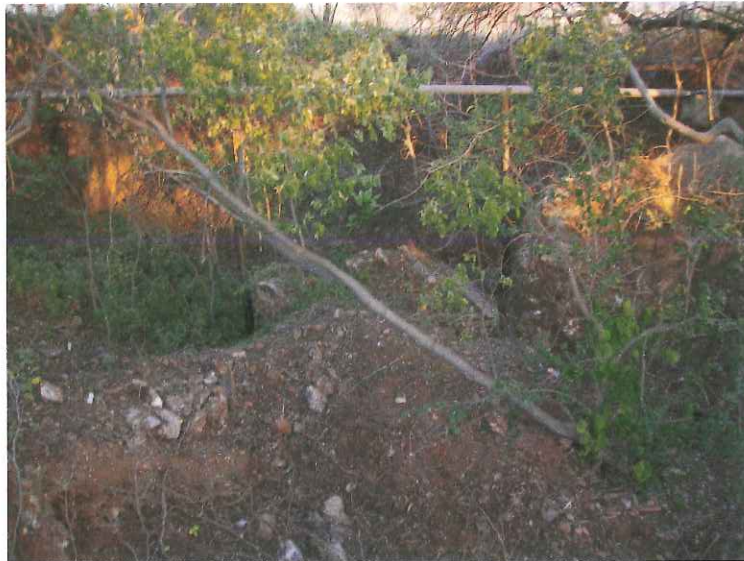
*Fig 29: redundant infrastructure such as telephone lines that once served the former Cave Inn Restaurant and the pipeline water supply need to be removed to reduce visual impact.*

- The site has good telecommunications and a good cellular phone signal
- There are redundant telephone lines and poles which need to be removed in order to improve visual aesthetics (Fig 29)

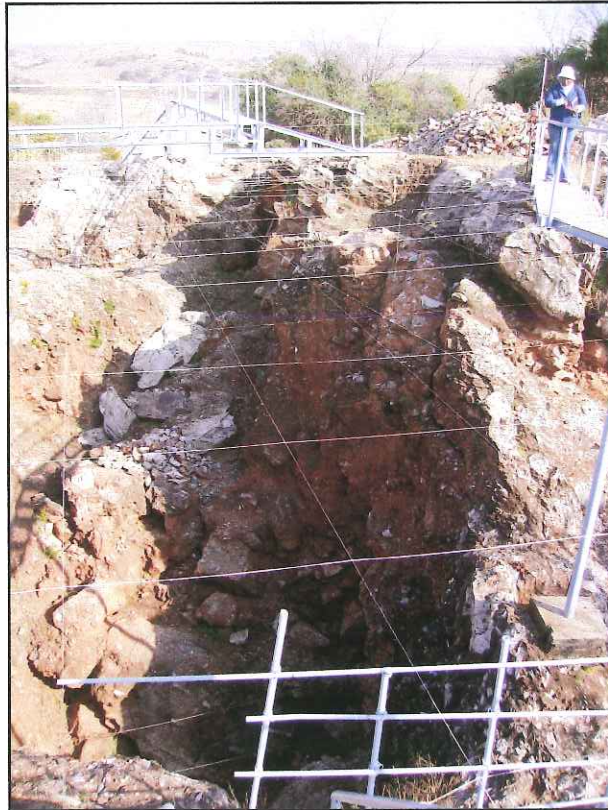
- Excavation walls have reached dangerously impressive heights at Sterkfontein. The excavations have not been benched but have mostly proceeded straight down (Fig 30). This has created dangerous overhangs and vertical faces, particularly where patches of decalcified breccias underlie solid deposit. Some of the overhanging material has had to be blasted down before excavation could continue.

- Another consequence is the problem of access to the base of the excavation when it is 5 or 6 metres down.
- The creation of a huge sump in which rainwater can collect, or drain off into the underground cave, taking sediment with it, is a further problem. Water in the underground cave causes its own problems. At the time of the discovery of Little Foot, the walls of the Silberberg Grotto were wet and muddy with water draining into the cavern from above.

- Collapse of friable wall material
- Loose boulders may collapse, together with wall material
- Safety aspects of steep drops
- Ponding of water destabilizes footwall and washes sediment into underlying caves

*Fig 30: Excavations into the breccias at Sterkfontein have reached a considerable and dangerous depth. The report of a professional site safety officer is awaited. Cracks, overhangs and unstable breccia make the site unsafe for excavators and other site users (Image from May to July folder)*

- The situation is one which should be watched closely. Each case needs to be assessed on its own merits, but as yet there are no agreed guidelines as to how deep, (apart from the safety factor), excavations should go without benching out, and without preserving sections of deposit which demonstrate contacts and field relationships between different sedimentary strata. Such situations need to be discussed in the proposed scientific advisory committee (see generic issues document)

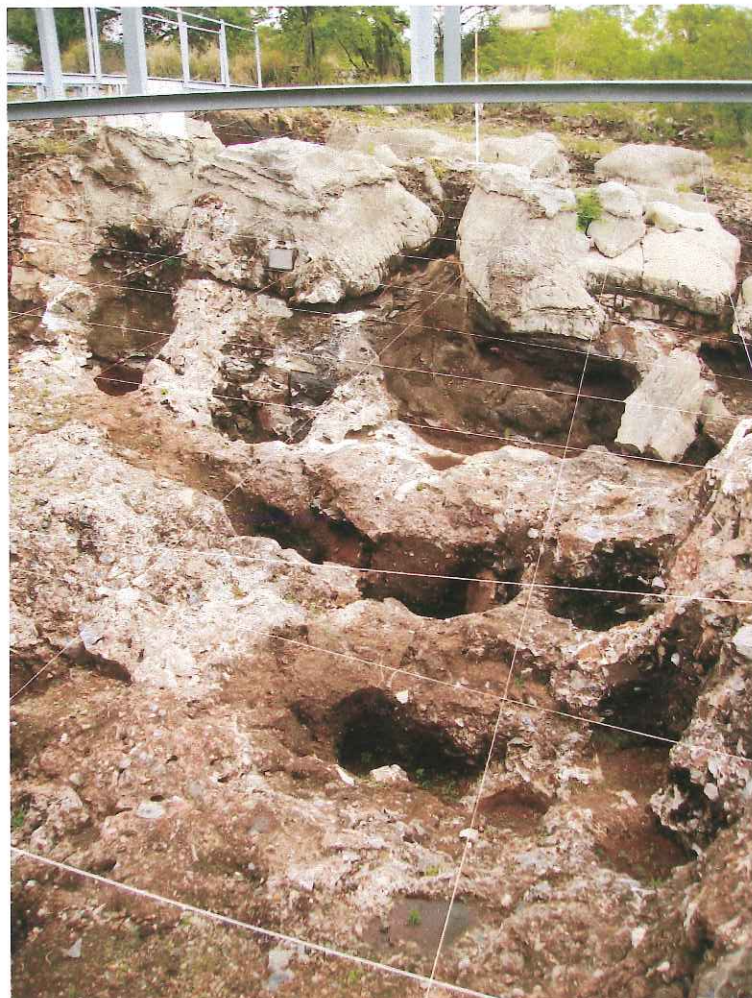
- A witness section demonstrating members 4,5 and 6 plus post-6 has been identified in squares U,T,S and R, and R66. This area of the deposit demonstrates contacts between these members (Fig 31)
- Witness section at the 'Historic face' at the original 'Mrs Ples' discovery site (Fig 32)
- Witness section in south wall at M4 near STW 53 find site and contact between Member 4 and Member 5

*Fig 31: Witness section along south-western extremity of the de-roofed Sterkfontein deposit showing interdigitation of Member 4 (chocolate brown) and Member xx (beige, and with considerable more embedded clasts). Last remaining roof blocks of dolomite can be seen just below the walkway, with breccia fill underneath*
