Heritage Impact Assessment

Heritage Impact Assessment for the Proposed Mixed-Use Development on the Remaining Portion of Portion 79 (a portion of Portion 70) of the Farm Sterkspruit 33 JT, in Lydenburg, Thaba Chweu Local Municipality in the Mpumalanga Province.

16 January 2015

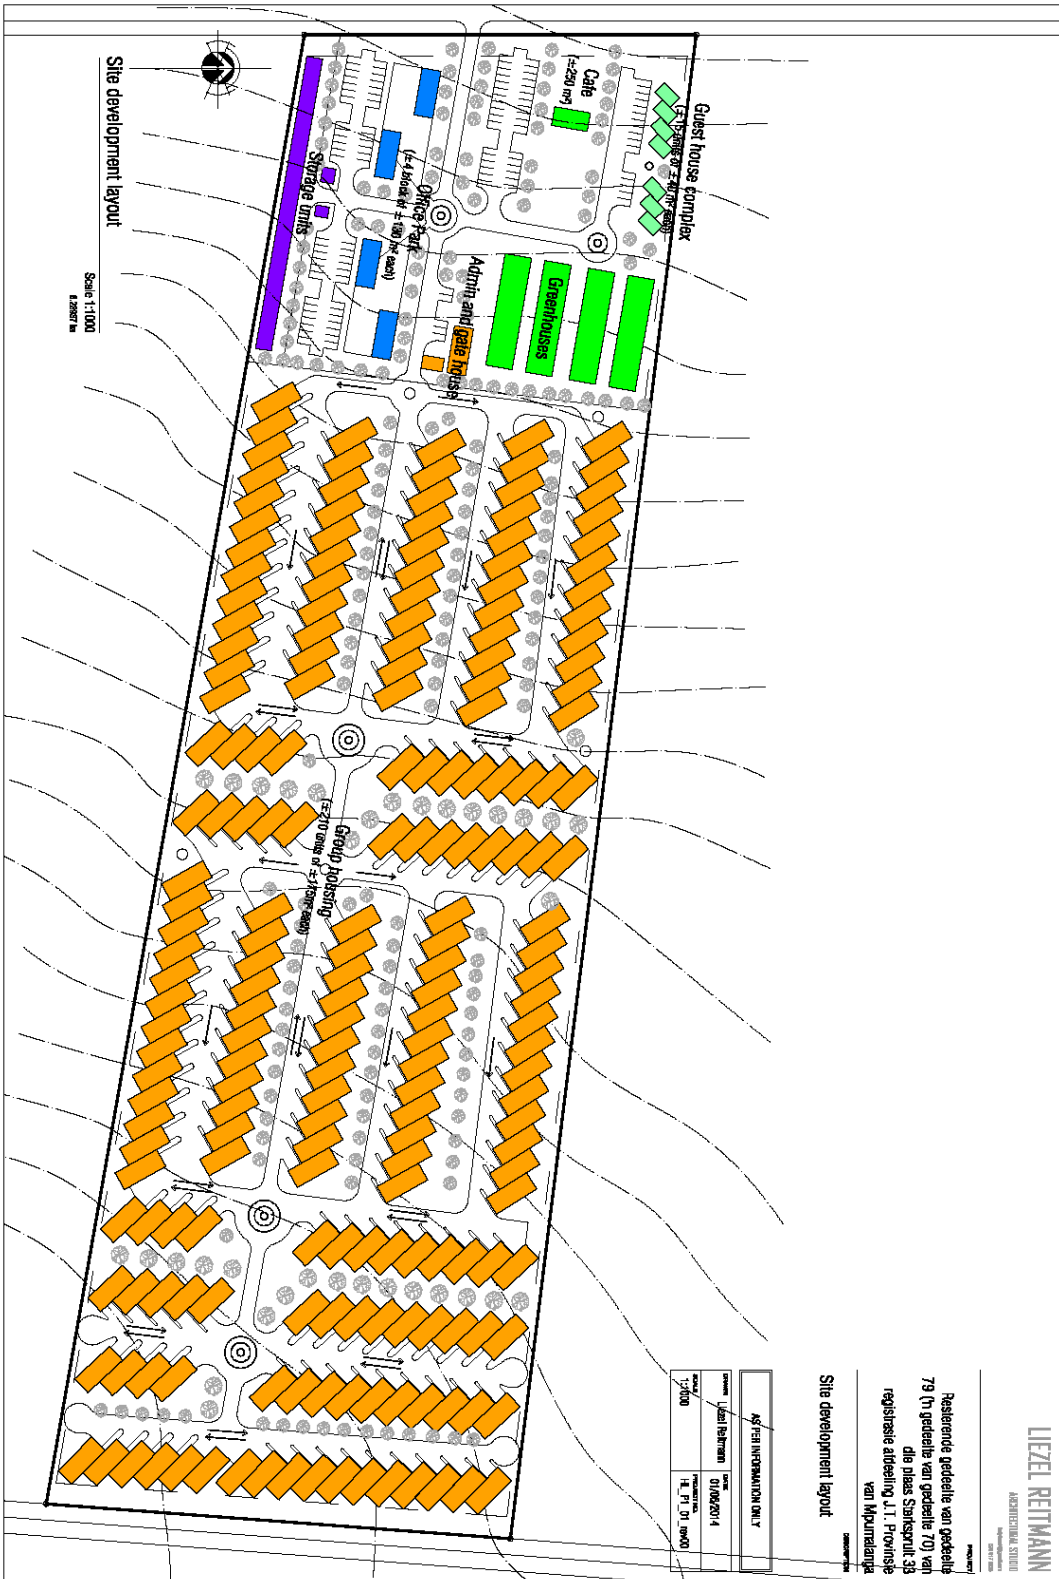
A proposed site development layout plan (figure 8) was provided to show the proposed land use options.

Figure 8: Proposed development layout plan (as supplied by Interdesign Landscape Architects).

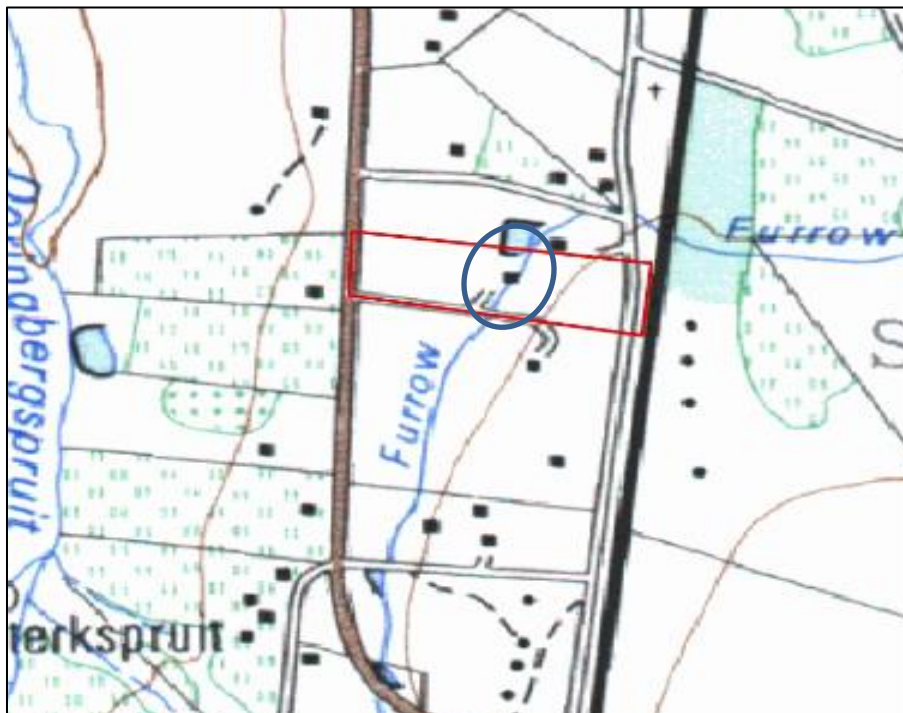
A furrow is indicated on the 1:50 000 topographic map. This furrow crosses the central parts of the property from the south to the north. It is indicated to pass on the eastern side of the homestead. No other references regarding this furrow were found during the literature study. The origin and age of the furrow is unknown.

Figure 10: Location of the furrow across the property.

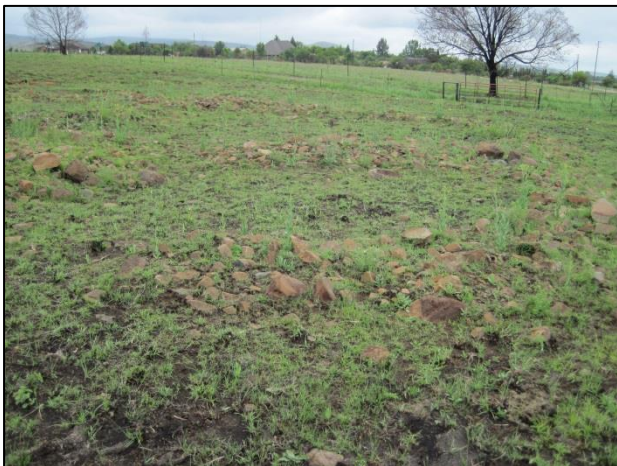
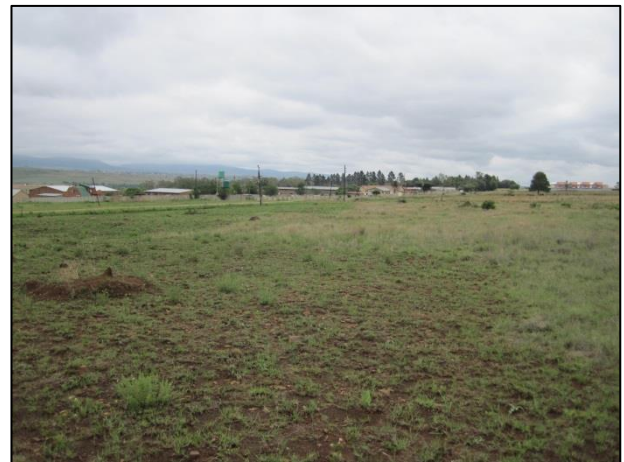
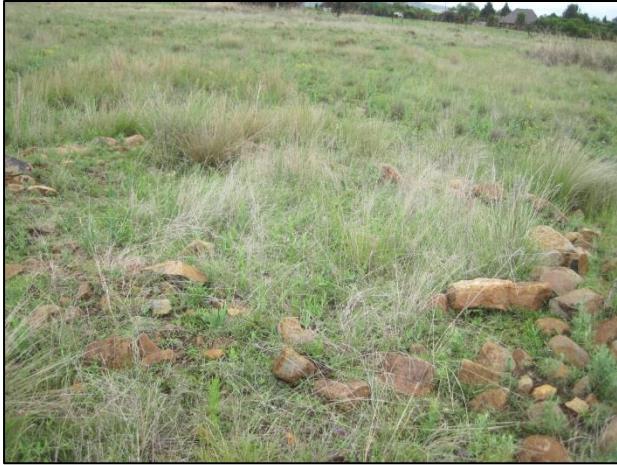
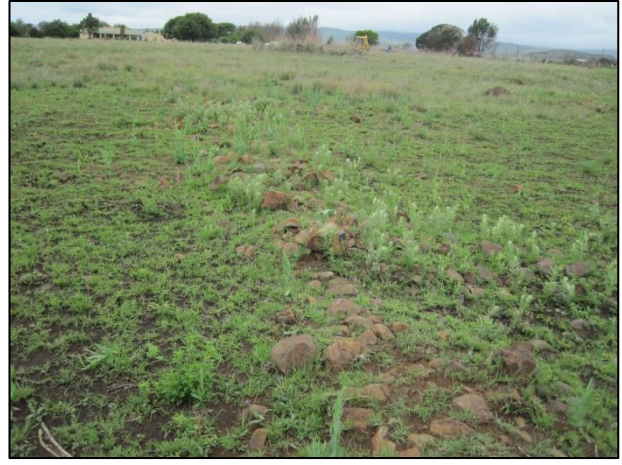
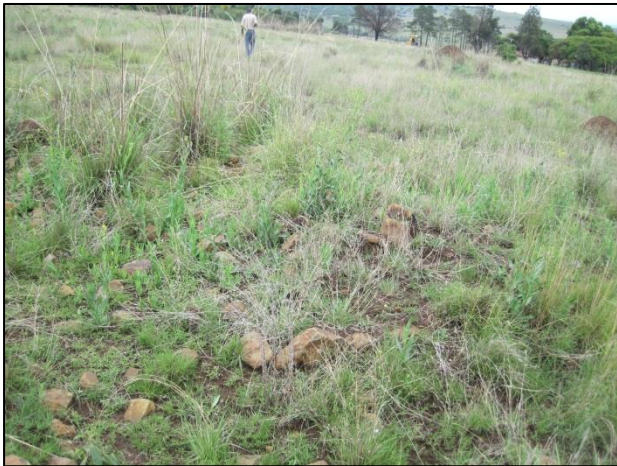
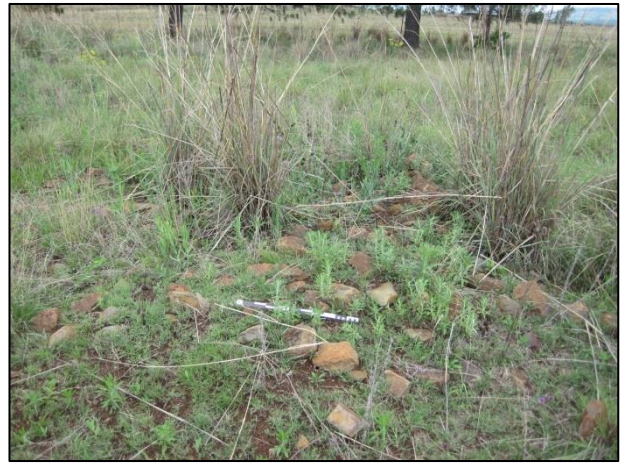
An extended stone walled complex was identified at this location (figure 14). The stone walled complex is situated on the western extreme of the property and study area (figure 15). It covers approximately 1.5 hectares on that side of the property. The identified site consists of several stone walled enclosures (figure 16), terraces (figure 17) and possible cattle tracks. Some of the enclosures are connected and together they form an extended, continuous site. The walls are in a dilapidated state and are low and are covered with grass and other vegetation (figure 18), which makes them difficult to identify. The walls were also damaged to an extent as previous ploughing activities (fields) were also identified nearby the walls. The walls look like low mounds of discarded rocks (figure 19), but they are continuous and do form patterns and shapes (enclosures, terraces and perimeter walls). No artefacts or any other finds were found in association with the stone walls.

Figure 14: View of some of the identified low stone walls.

Figure 15: General view of the western extent of the study area with the stone walls.

Figure 16: View of one of the smaller stone walled enclosures.

Figure 17: View of some of the terrace stone walls.

Figure 18: View of the stone walls covered with grass and other vegetation.

Figure 19: Another view of some of the low stone walls.

Field Rating:	Generally Protected B. Grade 4B
Heritage Significance:	Medium
Impact:	Moderate
Certainty:	Definite
Duration:	Demolished
Mitigation:	B – Mapping of the site and controlled sampling required

The identified site was most probably a part of a settlement of one of these Late Iron Age Communities who settled in the region between 1600AD to 1800AD. A lot of research was done on similar sites in the region and the sites were classified into groups regarding the complexity of the stone walling. The following is recommended:

- A Phase II investigation implies that the site be cleared from vegetation, documented and mapped. The documentation and mapping of the site will contribute to our understanding and knowledge of the regional distribution and settlement of these Late Iron Age Communities. A surface collection of any material is also recommended. Archaeological material retrieved from the site must be donated to a museum and a report on the findings of the Phase II investigations must be prepared for the South African Heritage Resources Authority (SAHRA).

- Archaeological test excavations are however, not recommended. Similar sites have recently been excavated and documented on the neighbouring Farm Rooidraai. Archaeological excavations will most probably not contribute very much to the existing knowledge and understanding of these sites and their inhabitants.

- A watching brief performed by a qualified Heritage Practitioner, is also recommended during the construction phases of the proposed development. The Heritage Practitioner

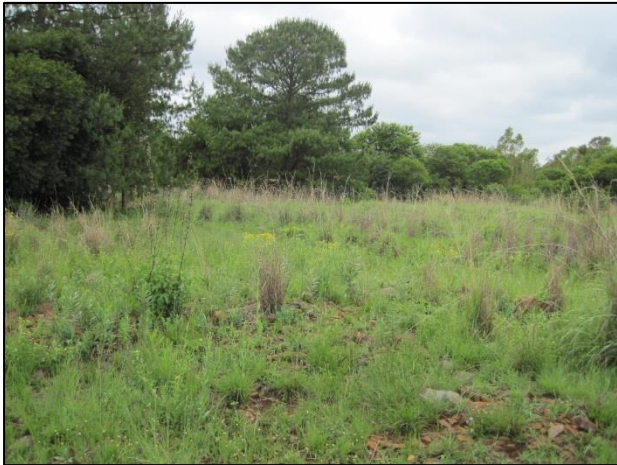
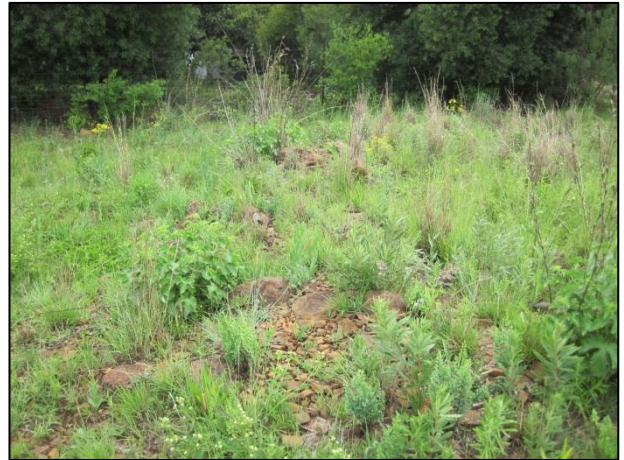
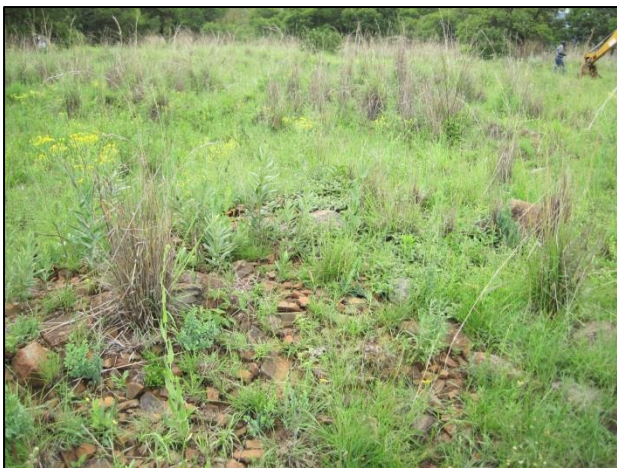
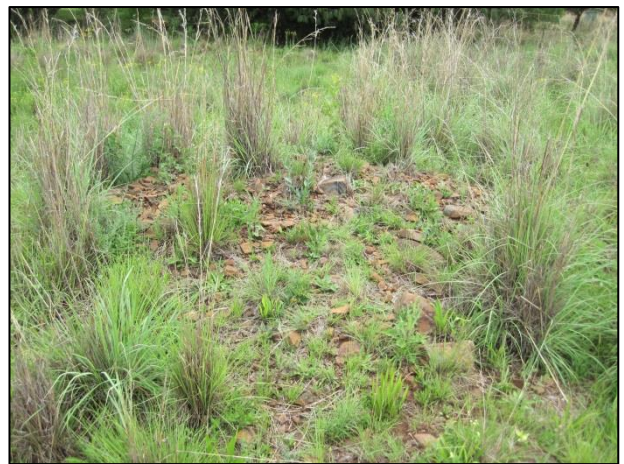
Another stone walled complex was identified at this location (figure 20). This stone walled complex is situated on the northern edge of the property in between the green houses and the railway line. The site measures approximately 50m in diameter and consists of a few enclosures (figure 21) which are connected to each other. The walls are in a dilapidated state and are low and are covered with grass and other vegetation (figure 22), which makes them difficult to identify. The walls were also damaged to an extent as previous ploughing activities (fields) were also identified nearby the walls. The walls look like low mounds of discarded rocks (figure 23), but they do form inter-connecting enclosures. No artefacts or any other finds were found in association with the stone walls.

Figure 20: General view of the identified stone walled site.

Figure 21: View of one of the identified stone walled enclosures.

Figure 22: View of one of the stone walled enclosures covered with grass and vegetation.

Figure 23: Another view of some of the identified low stone walls.

Field Rating:	Generally Protected B. Grade 4B
Heritage Significance:	Medium
Impact:	Moderate
Certainty:	Definite
Duration:	Demolished
Mitigation:	B – Mapping of the site and controlled sampling required

Again, the identified site was also most probably a part of a settlement of one of these Late Iron Age Communities who settled in the region between 1600–1800 AD. A lot of research was done on similar sites in the region and the sites were classified into groups regarding the complexity of the stone walling. The following is recommended:

- A Phase II investigation implies that the site be cleared from vegetation, documented and mapped. The documentation and mapping of the site will contribute to our understanding and knowledge of the regional distribution and settlement of these Late Iron Age Communities. A surface collection of any material is also recommended. Archaeological material retrieved from the site must be donated to a museum and a report on the findings of the Phase II investigations must be prepared for the South African Heritage Resources Authority (SAHRA).

- Archaeological test excavations are however, not recommended. Similar sites have recently been excavated and documented on the neighbouring Farm Rooidraai. Archaeological excavations will most probably not contribute very much to the existing knowledge and understanding of these sites and their inhabitants.

- A watching brief performed by a qualified Heritage Practitioner, is also recommended during the construction phases of the proposed development. The Heritage Practitioner can advise and guide the developer regarding unforeseen archaeological discoveries (such as graves) during the development process.

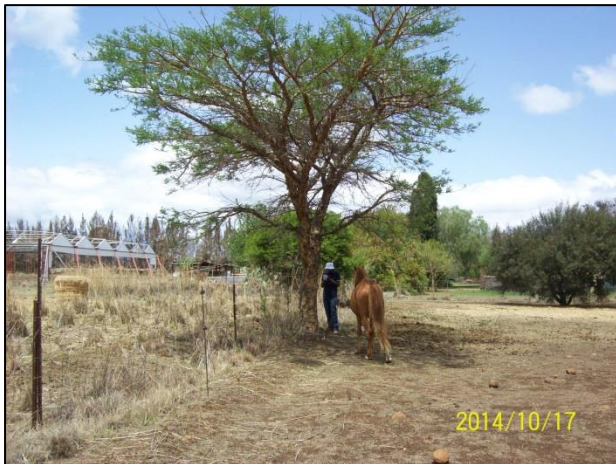
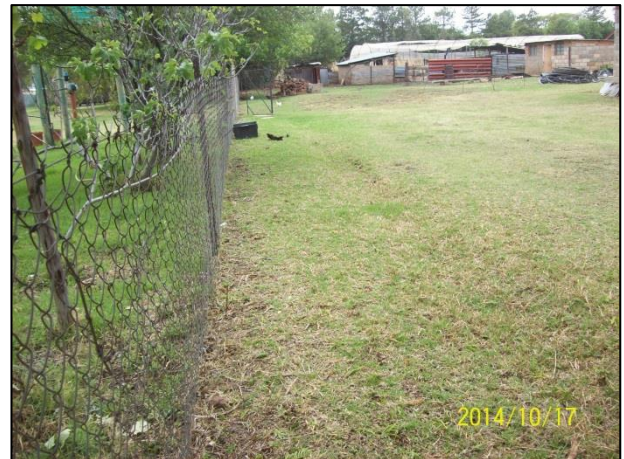
A furrow is indicated on the 1:50 000 topographic map. This furrow crosses the central parts of the property from the south to the north. It is indicated to pass on the eastern side of the homestead. Possible indications of this furrow were identified next to the fence of the yard of the homestead (figure 24 & 25). Most of the furrow is filled up and its exact location and course are not clear. The furrow as such is not functioning anymore and has very little heritage value or significance. No other features or any other finds were found in association with the furrow. No other references regarding this furrow were found during the literature study. The origin and age of the furrow is unknown.

Figure 24: View of the possible location of the identified furrow.

Figure 25: Another view of the possible location of the identified furrow.

Field Rating:	Generally Protected C. Grade 4C
Heritage Significance:	Low
Impact:	Low
Certainty:	Definite
Duration:	Demolished
Mitigation:	A – No further action necessary

The furrow was identified during the desk top study from the 1:50 000 topographical map. Most of the furrow is filled up and its exact location and course are not clear. The furrow as such is not functioning anymore and has very little heritage value or significance. The following is recommended:

- The furrow has very little heritage value or significance as it was degraded during several developments on the property. The construction of the homestead and the development of the garden mostly contributed to the filling up of the furrow.
- No further heritage mitigation measures or is required.
