**STERKSPRUIT TRUNK SEWER PROJECT (WARD 4),
HAMMARSDALE, KWAZULU-NATAL**

Phase 1 Heritage Impact Assessment

December 2018

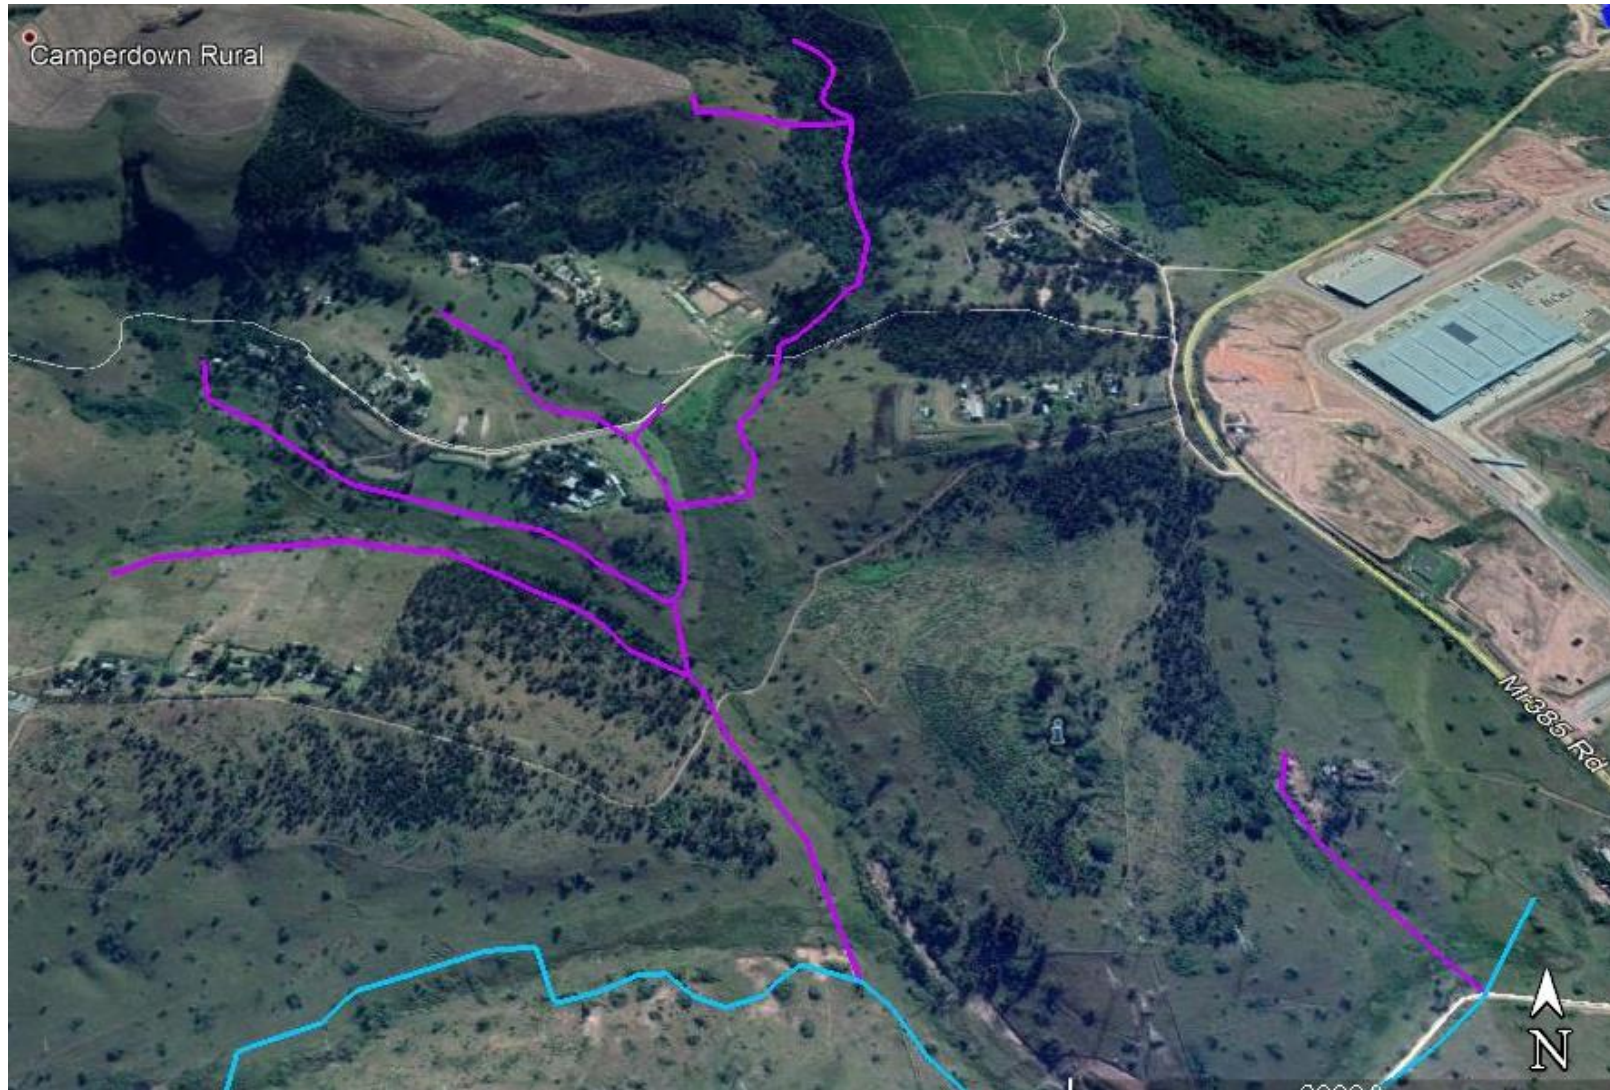
Figure 3: View of Phase 2 indicated in cerise

The Phase 2 component of the trunk sewer project is located north of the Phase 1 component. The southernmost route crosses through a plantation of trees with thick undergrowth which made visibility and access difficult at times.

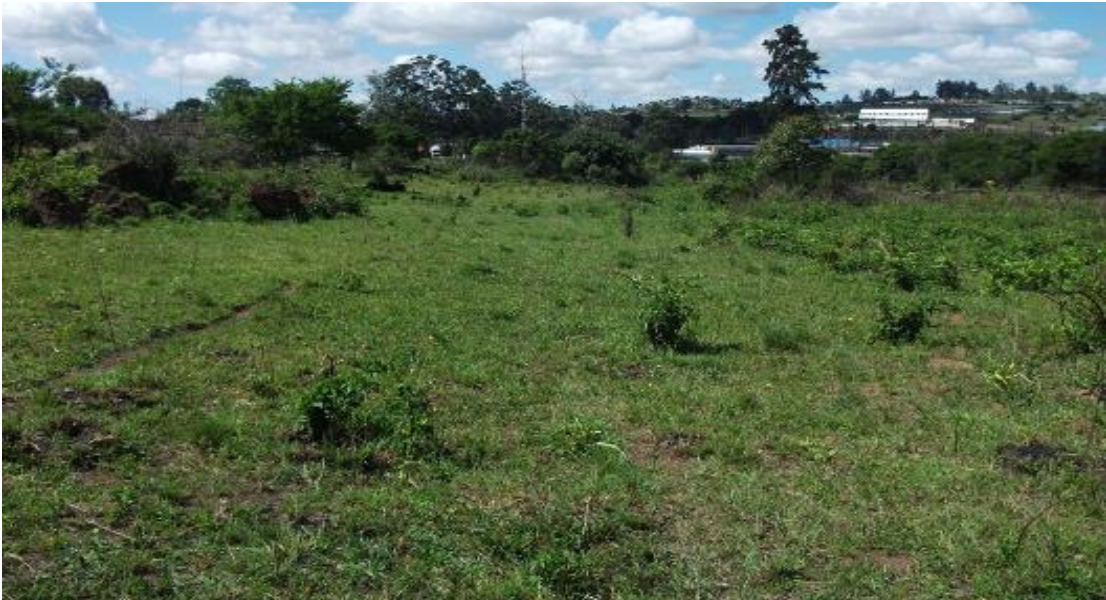
Figure 4: Pipeline route looking southwards towards Hammarsdale

Phase 1 of the project starts close to Hammarsdale and moves northwards along a tributary of the Sterkspruit. The area is initially open grassland with a few eucalyptus (gum) trees; as the pipeline heads further north it crosses through an eucalyptus plantation. The adjacent tributary is heavily overgrown with vegetation. No heritage resources were noted during the inspection.

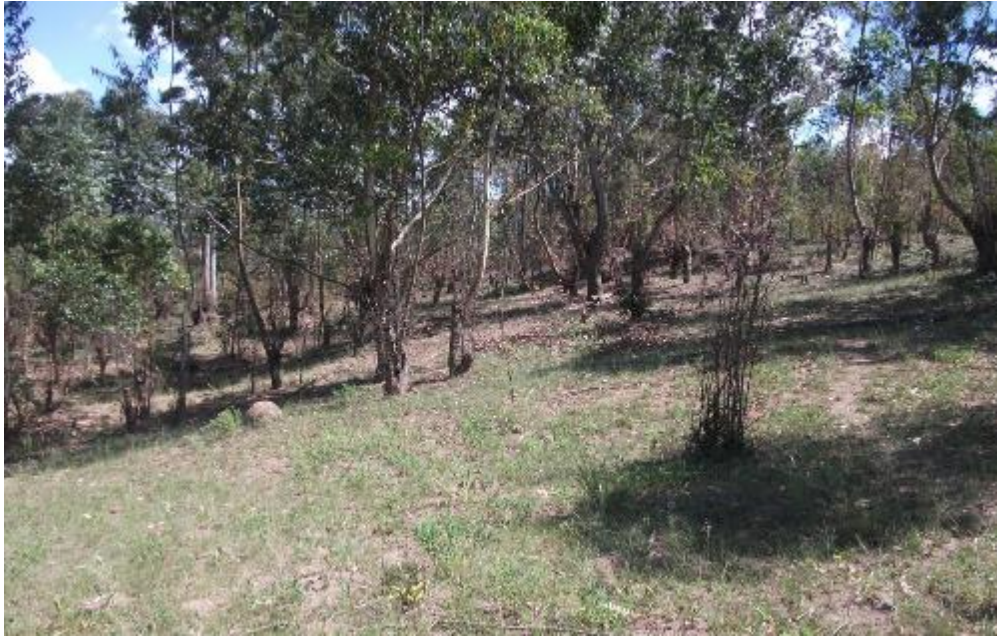
Figure 5: Eucalyptus plantation

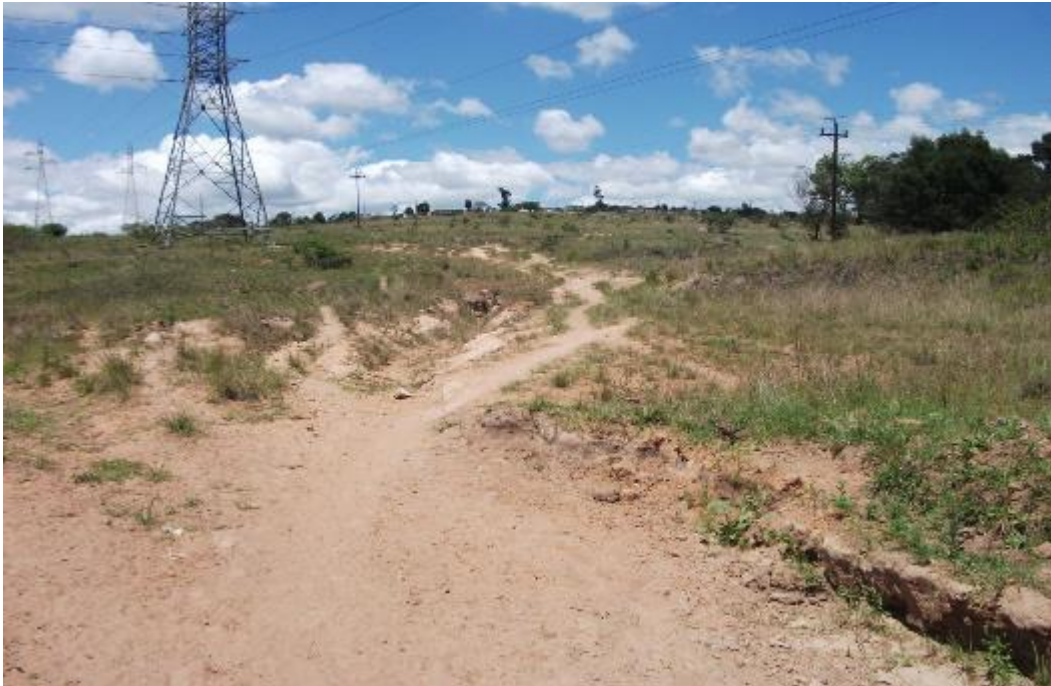
Figure 6: Eroded area with power lines

The pipeline route that goes to the west and north of the township of Mpumalanga is disturbed by some erosion and by informal roads, pathways, power lines and illegal sand mining. A search for archaeological scatter within the eroded areas revealed no material.

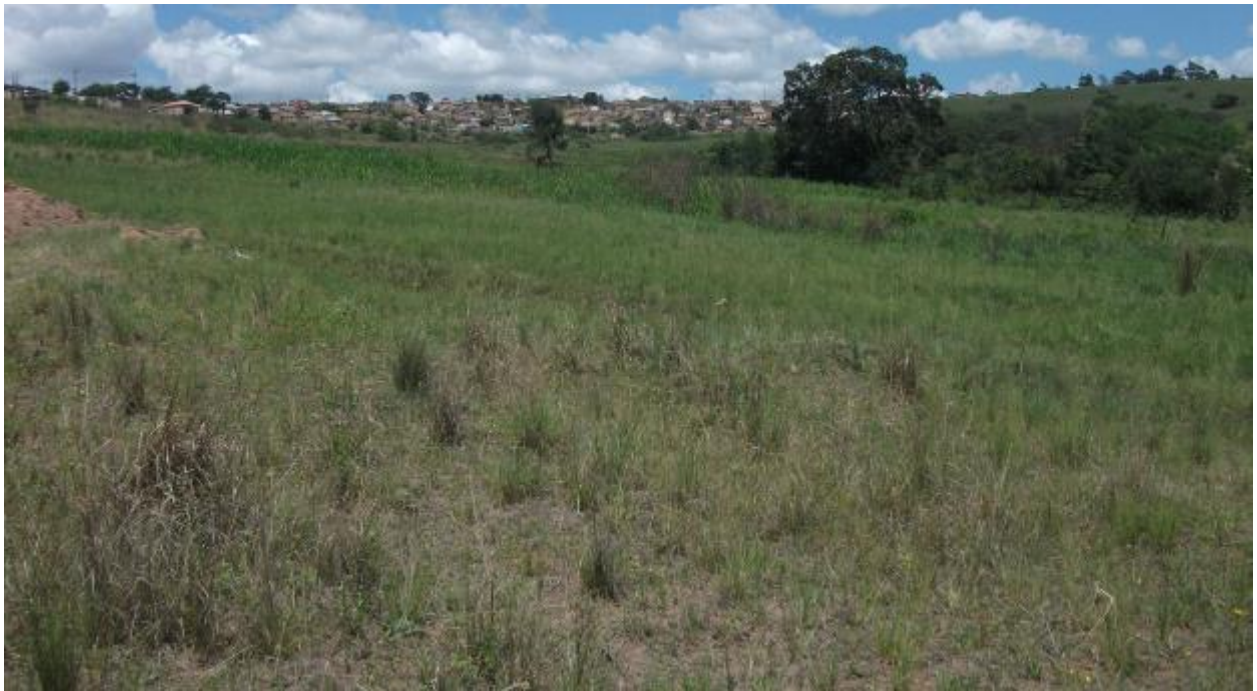
Figure 7: Towards end of pipeline with township in background

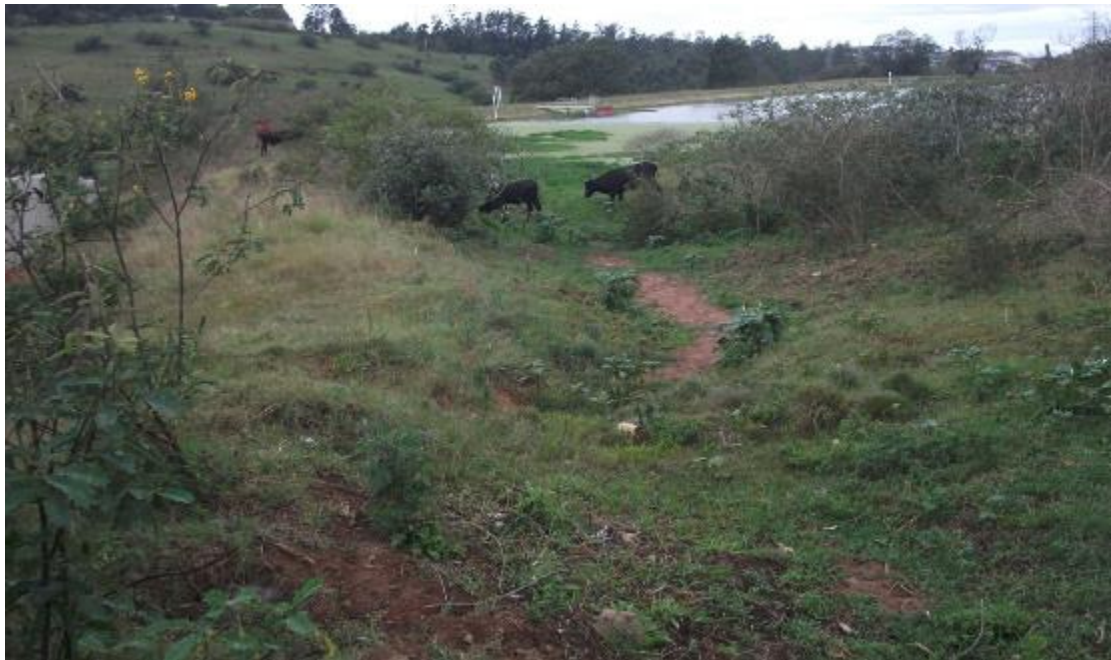
Figure 8: Dam with fencing in left hand corner

The pipeline route that runs adjacent to the route situated north of the township of Mpumalanga runs in a north-westerly direction through a fenced off area of what appears to be a recycling operation and a dam. The area is disturbed through by the recycling operation and the dam and no heritage sites were found during the inspection.

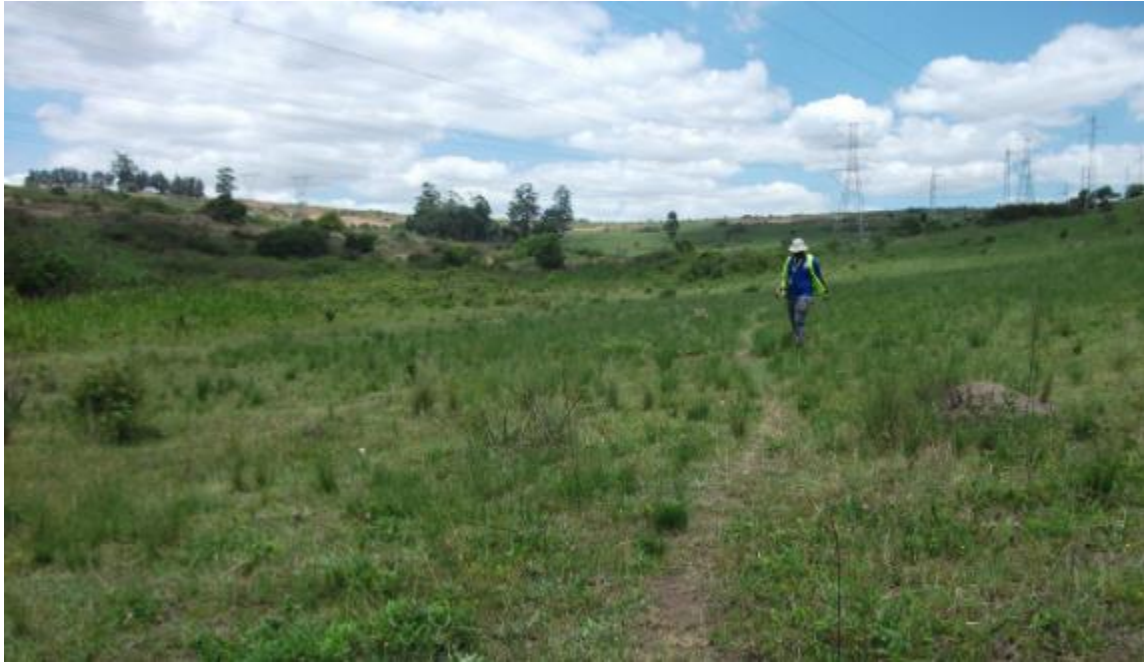
The route then turns westward to run initially on the southern side of the wetland, before crossing to the northern side before crossing again just below the man-made dam. This area forms part of a power line servitude with open grassland and some eroded areas.

Figure 9: Pipeline route looking towards the west

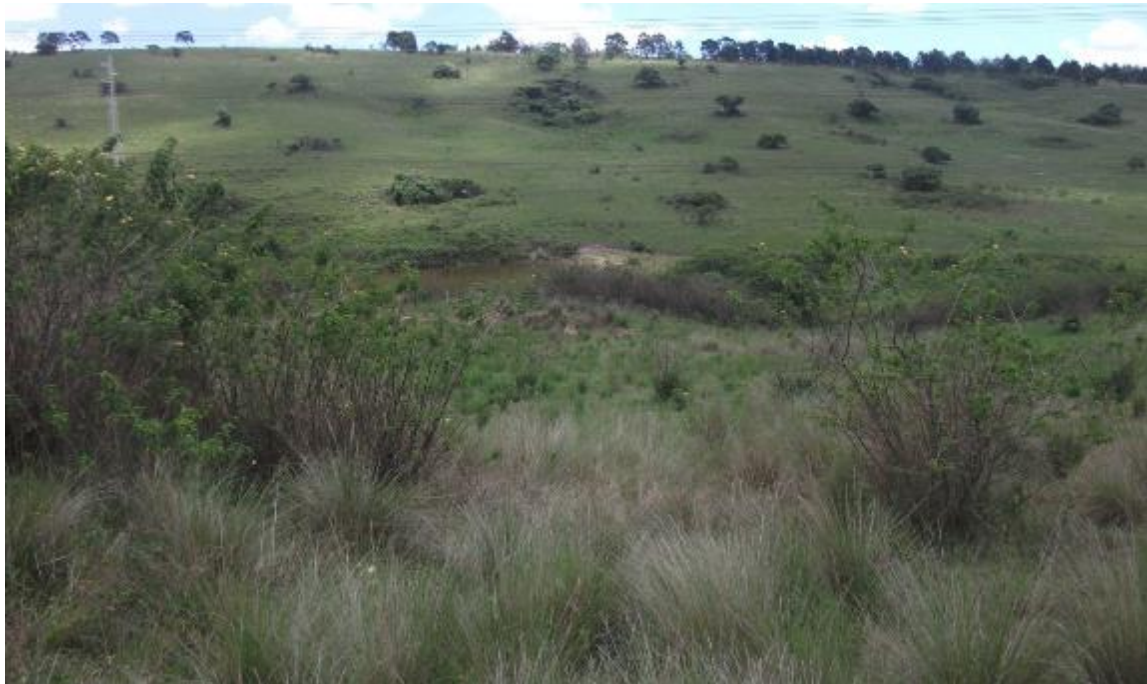
Towards the end of the route, the pipeline passes very close to a dwelling and associated structures which are located at 29°46'57.21"S 30°38'16.20"E. The dwelling and structures are fenced so they could not be inspected. It is recommended that the pipeline is moved 15m to the east of the dwelling to avoid any impact on the structures and the owners (see **Figure 16** below).

Figure 10: Pipeline route with dam and power lines in background

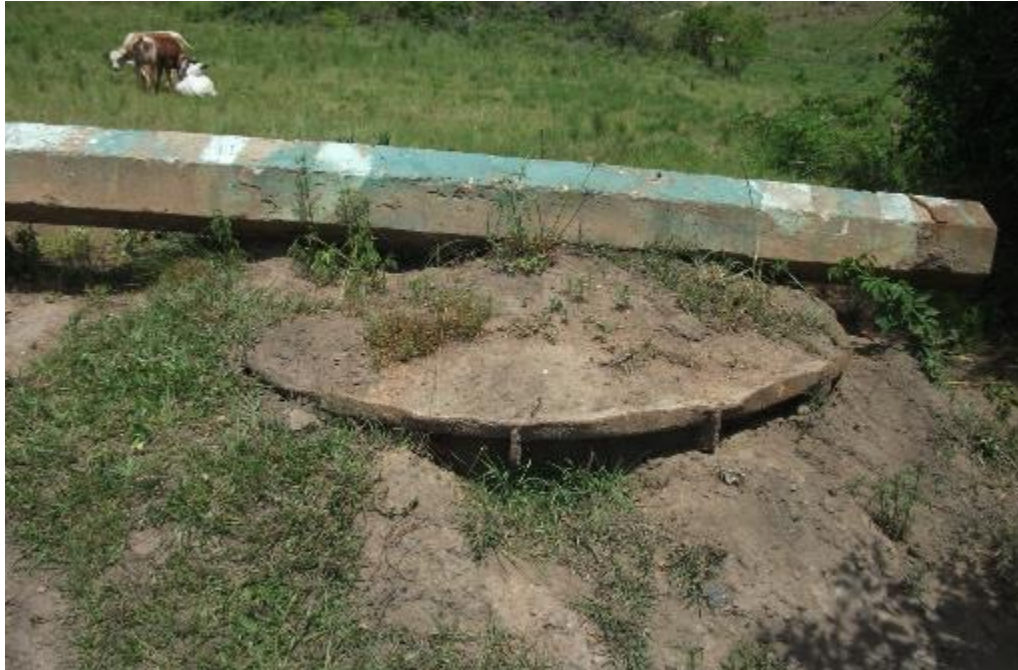
Figure 11: Possible stormwater infrastructure

The remainder of the Phase 1 sewerage reticulation runs along the D816 gravel road before ending below a scrapyard and close to what appears to be existing stormwater infrastructure located at 29°46'41.2"S 30°39'16.4"E.

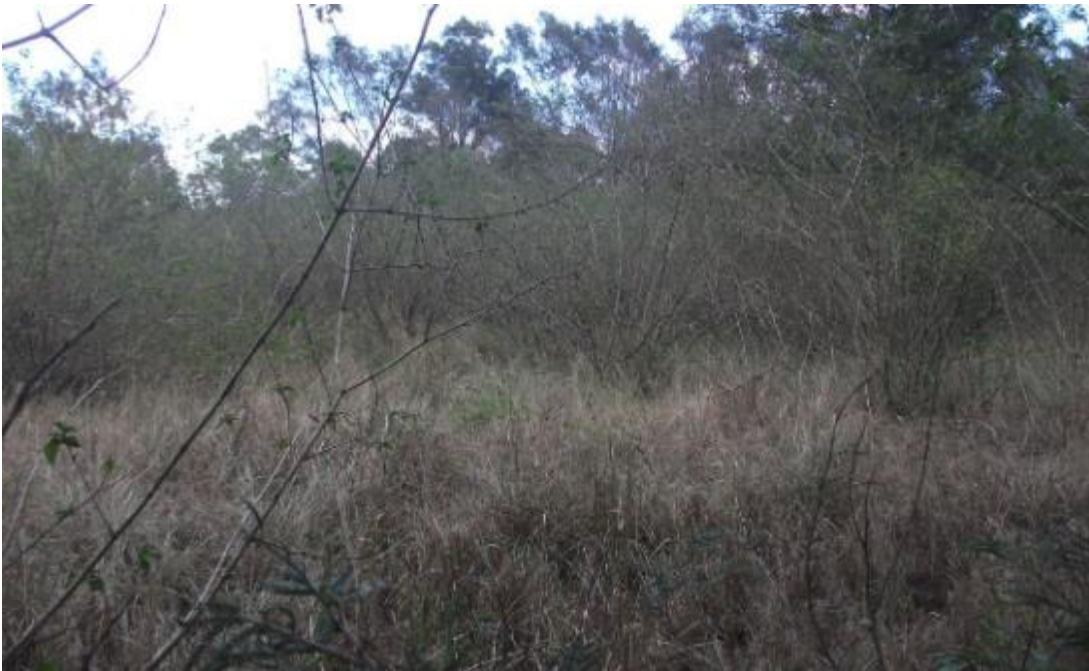
Figure 12: Dense undergrowth

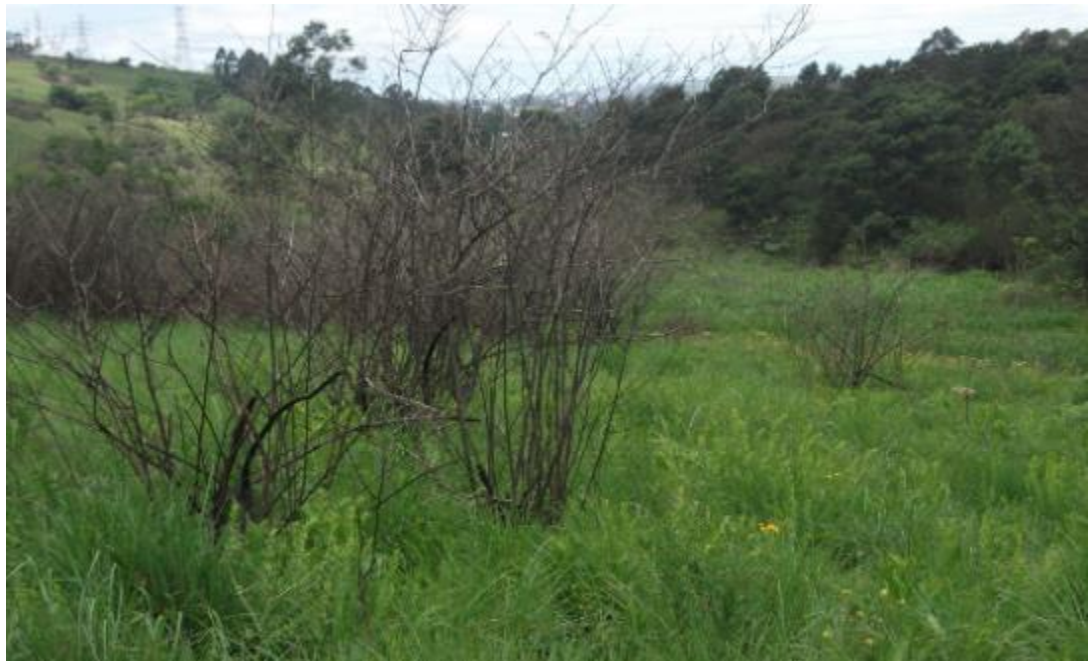
Much of the pipeline route that is located immediately north the pipeline discussed above could not be inspected as it crosses privately owned land and is also situated very close to the wetland which was densely overgrown and impossible to access.

Figure 13: Dense vegetation close to wetland

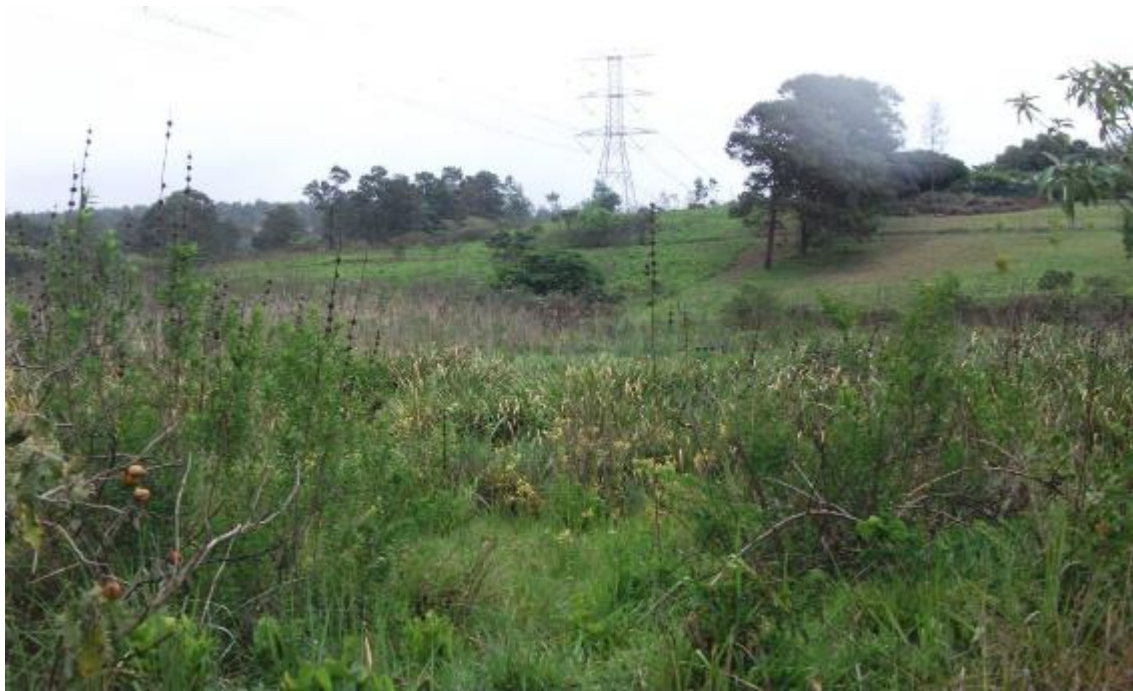
Figure 14: Part of pipeline route crossing wetland

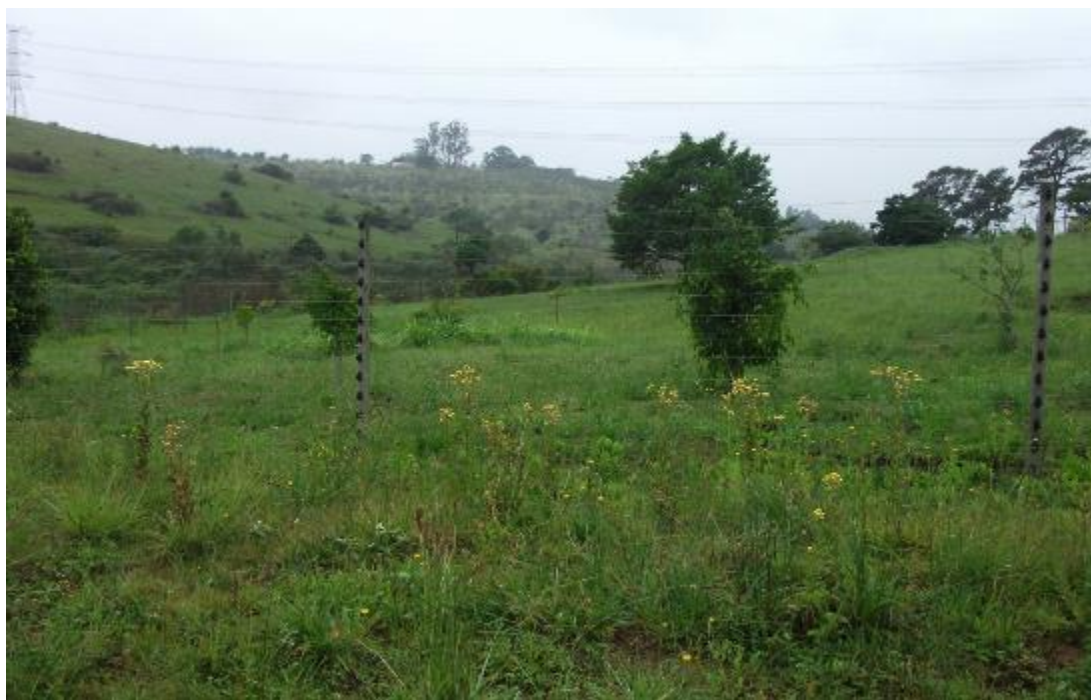
Sections of the remaining pipeline were inspected apart from those on privately owned land. This included those sections of the pipeline route that run through a well-established eucalyptus forest where access was possible. No heritage sites were discovered during the inspection.

Figure 15: Section of pipeline situated on privately owned land
