MARITIME ARCHAEOLOGICAL DIVING SURVEY FOR THE CAPE TOWN EMERGENCY WATER RESILIENCE PROJECT, STRANDFONTEIN AND MONWABISI, FALSE BAY, SOUTH AFRICA

Report #: 2018/WC/001
Status: Interim
Revision #: 0
Date: 15 January 2018

Prepared for: WorleyParsons RSA (Pty) Ltd t/a Advisian
Representative: Michelle Herbert
Tel: 010 593 3944 / 082 308 8535
Address: 31 Allen Drive, Loevenstein, Bellville, Cape Town, 7535
E-mail: michelle.herbert@advisian.com

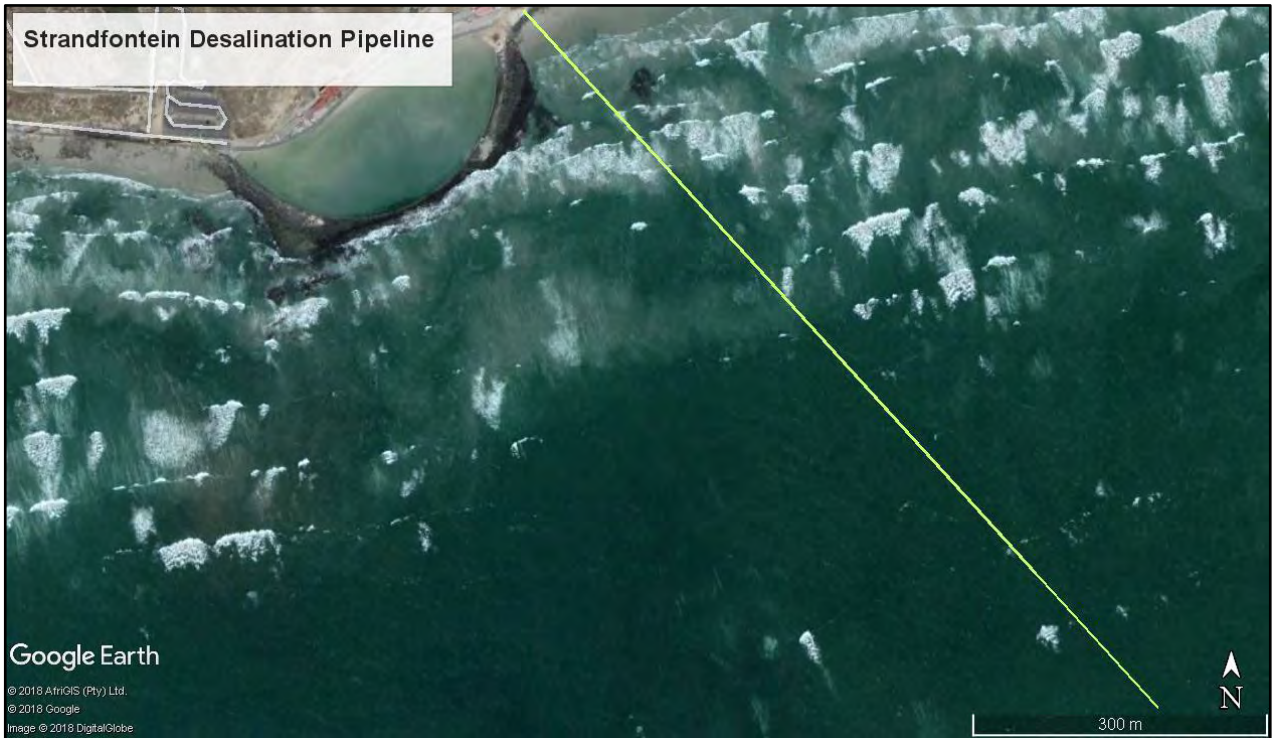
Figure 2: Strandfontein Desalination Pipeline Route (Google Earth 2018; WorleyParsons 2017)

This site is located off the Strandfontein Pavilion Resort, False Bay, Cape Town (Figure 2). The beginning of the subsea pipeline is at 34° 5.291'S 18° 33.429'E and the end of the subsea pipeline is at 34° 5.636'S 18° 33.810'E. The length is approximately 865 m with a bearing of 137.8°.

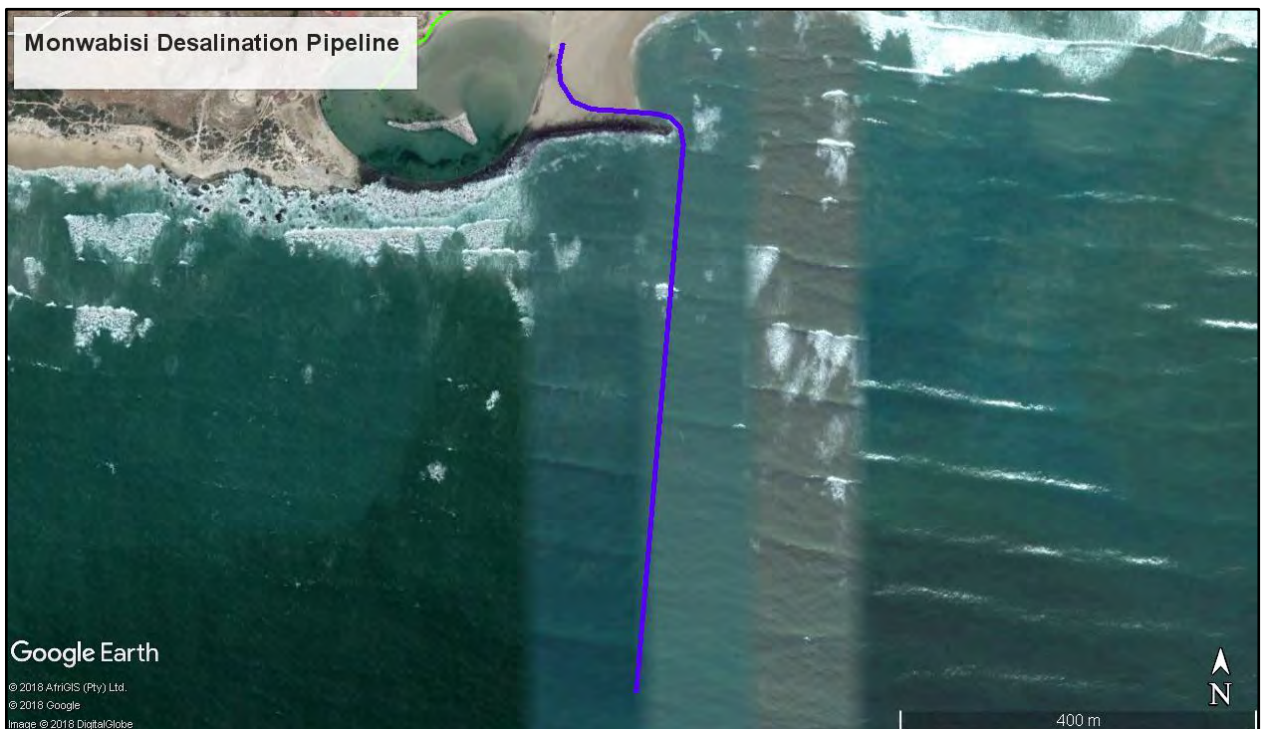
Figure 3: Monwabisi Desalination Pipeline Route (Google Earth 2018; WorleyParsons 2017)

This site is located off the Monwabisi Tidal Pool, False Bay, Cape Town (Figure 3). The beginning of the subsea pipeline is at 34° 4.449'S 18° 18' 41.428'E and the end of the subsea pipeline is at 34° 4.791'S 18° 41.397'E. The length is approximately 625 m with a bearing of 184.4°.

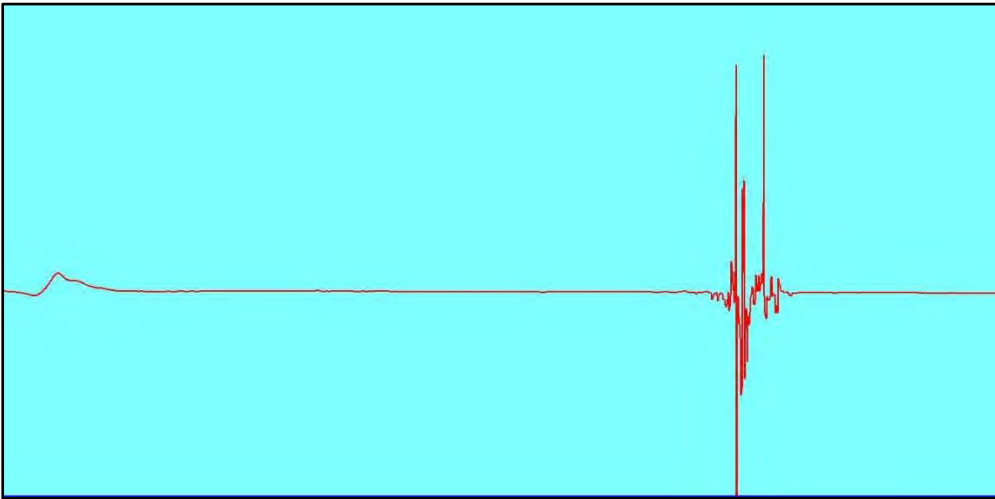
The magnetometer data collected by MagLog software was analysed twice. The first or field analysis is performed as the magnetometer is towed (Figure 7). This analysis observes real time spikes within the magnetic field. Possible sites are tabulated and analysed according to the environmental conditions in the field. These conditions include:

Figure 7: A magnetic anomaly reading from the magnetometer

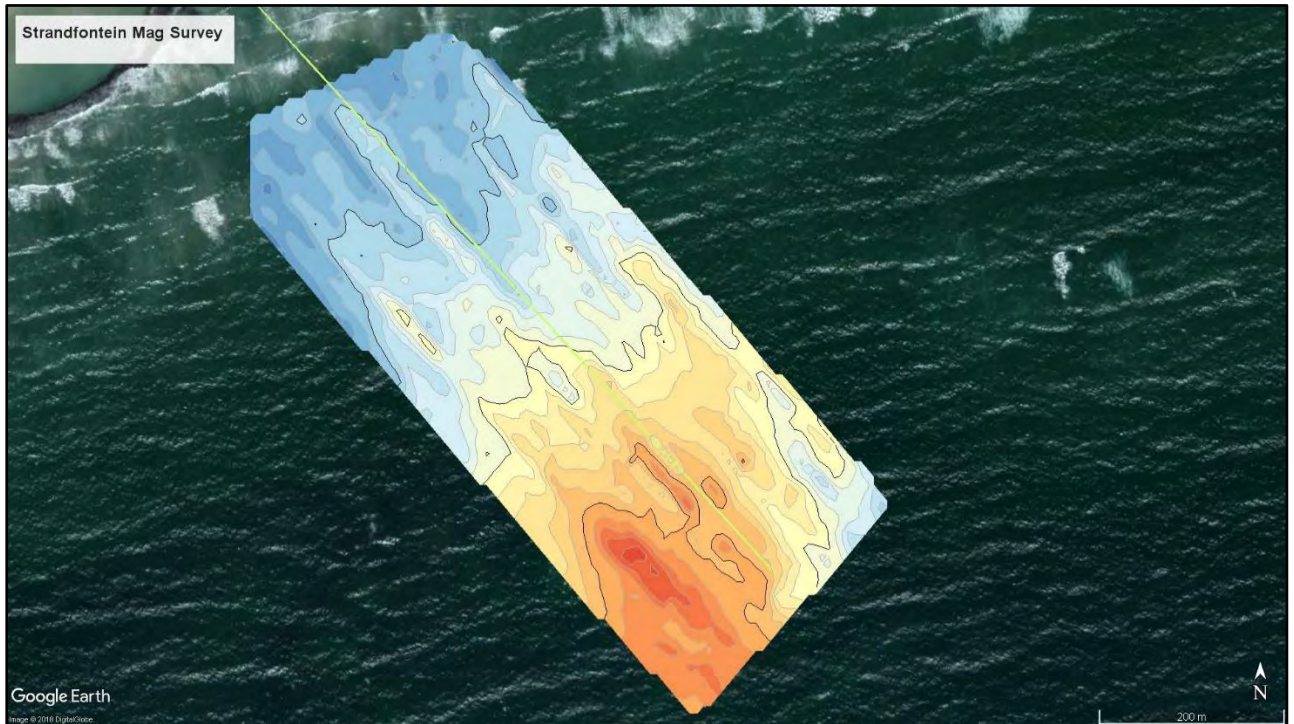
The post-field analysis was interpreted with Surfer geophysical software, ignoring the environmental conditions. A second analysis was performed while looking at the data stream and taking cognizance of the environmental conditions at the time of the survey (Figures 8-11).

Figure 8: Strandfontein Magnetometer Survey Map (Google Earth 2018)

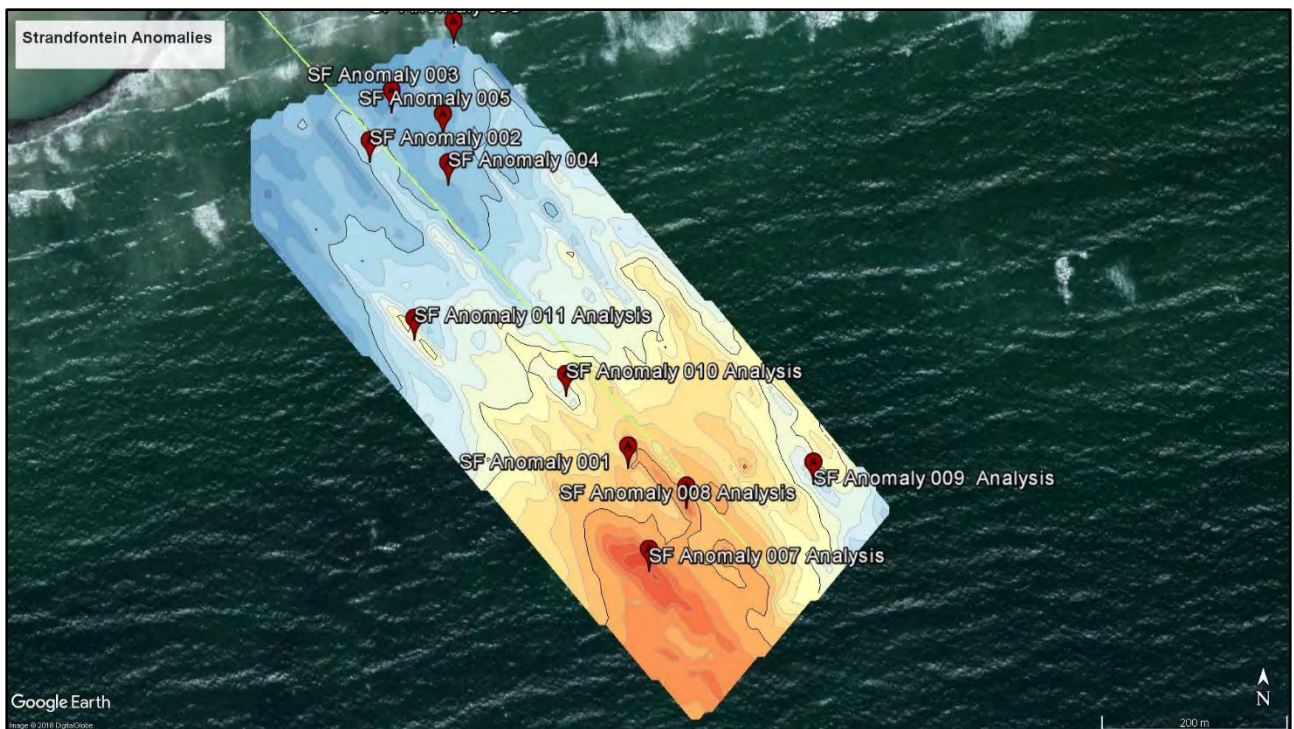
Figure 9: Strandfontein survey with anomalies (Google Earth 2018)

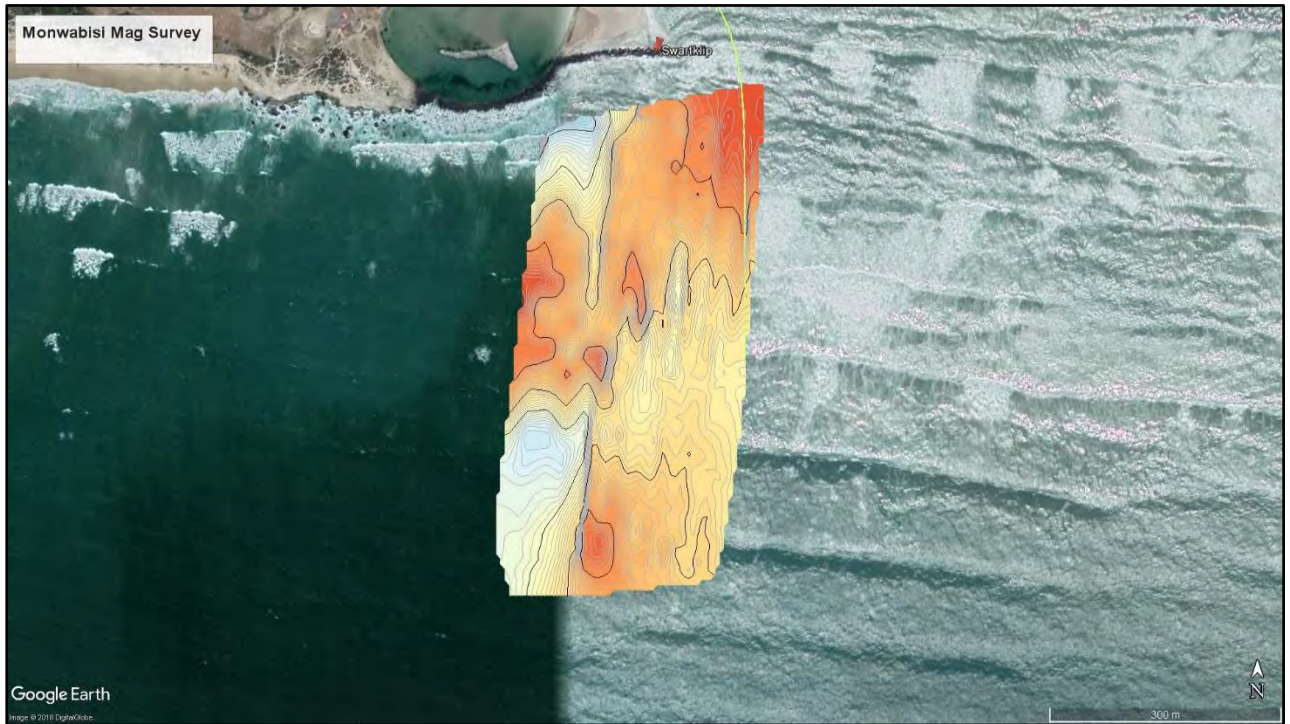
Figure 10: Monwabisi Magnetometer Survey Map (Google Earth 2018)

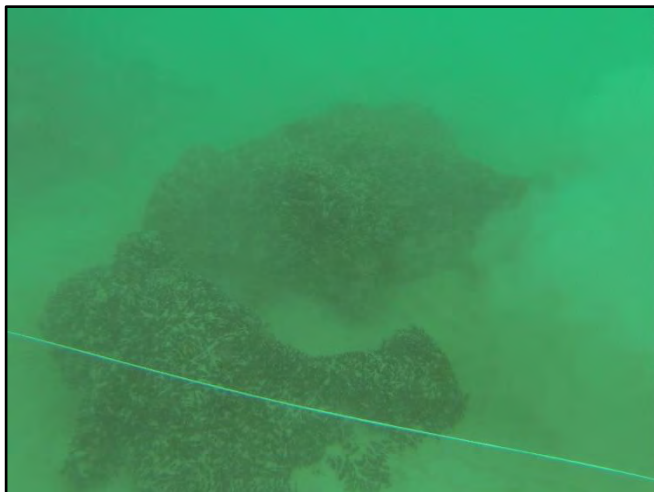
Anomaly	Divers	Date	Time In	Time Out	Description
SF01	V. Maitland A. Maitland	07-01	7:36	8:10	No visible MUCH; sand and reef (Figure 12)
SF02	V. Maitland A. Maitland	07-01	08:18	08:45	Sand and reef; piece of metal (Figure 13)
SF03	V. Maitland A. Maitland	07-01	09:25	09:45	No visible MUCH; sand and reef
SF04	V. Maitland A. Maitland	07-01	10:14	10:33	No visible MUCH; sand and reef
SF05	V. Maitland A. Maitland	06-01	08:18	08:56	No visible MUCH; sand and reef
SF06	V. Maitland A. Maitland	06-01	11:25	11:50	No visible MUCH; sand and reef
SF07	V. Maitland A. Maitland	06-01	10:26	10:47	No visible MUCH; sand and reef
SF08	V. Maitland A. Maitland	06-01	09:32	09:59	No visible MUCH; sandy
SF09	V. Maitland A. Maitland	07-01	11:35	11:45	No visible MUCH; sandy
SF10	V. Maitland A. Maitland	07-01	10:45	11:10	No visible MUCH; sandy
SF11	V. Maitland A. Maitland	07-01	11:15	11:25	No visible MUCH; sandy

Figure 12: Typical mussel covered reef at Strandfontein (Maitland 2018)

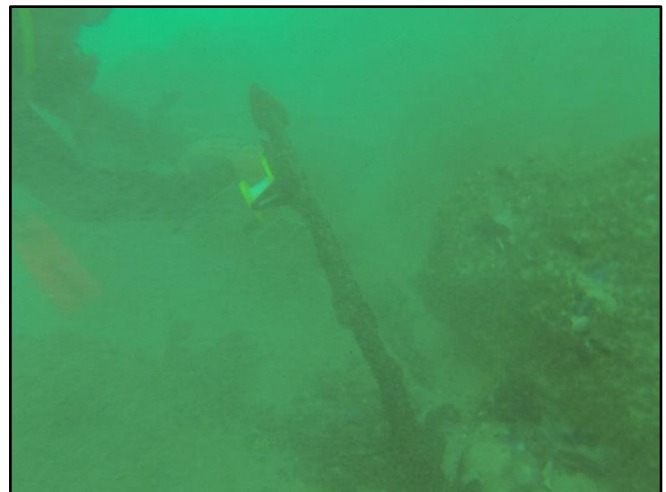
Figure 13: Anomaly SF02 (Maitland 2018)

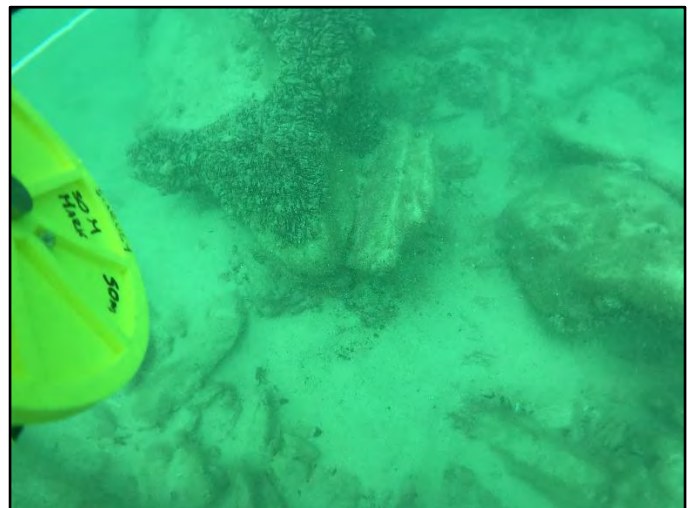
Figure 15: MWA08 Typical dune rock reef
