FIRST PHASE DESKTOP HERITAGE IMPACT ASSESSMENT OF THE PROPOSED CONSTRUCTION OF THE SUMITOMO, RUBBER PLANT, EMNAMBITHI LOCAL MUNICIPALITY, KWAZULU-NATAL.

# For: SIVEST

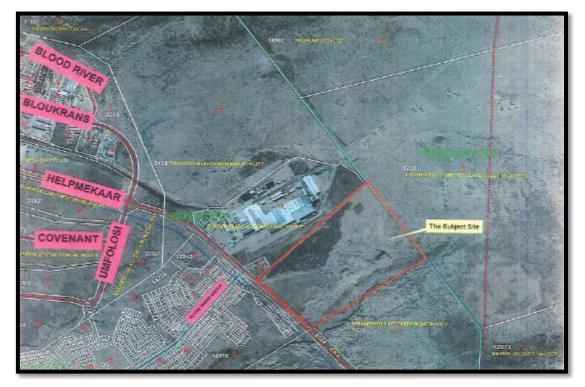
Figure 1. Aerial Photograph showing the location of the footprint (red polygon).

The proposed area for expansion is highlighted in red on the aerial photograph below

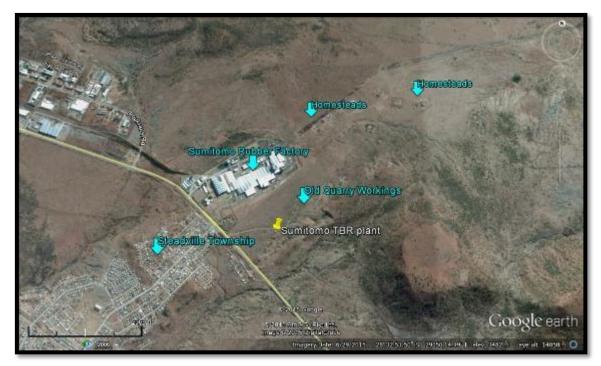
Figure 2. Showing the Surrounds of the Proposed Footprint

The proposed footprint is located within light industrial area in Ladysmith town. 229m to the north northwest lies the Sumitomo Rubber factory. Immediately to the north-east and south-east are old quarry workings, which may be historical, and of some heritage significance. A Second Phase Heritage Survey will determine how significant these diggings are from a Heritage perspective. Further to the north-east are extended periurban homesteads which will not be impacted by the proposed development. To the west and south-west lies the expansive Steadville Township (Fig 2).

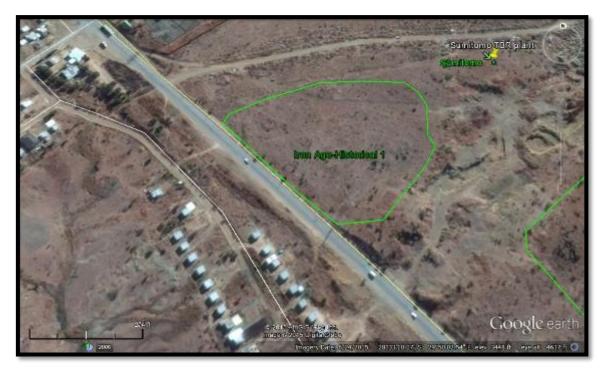
Figure 3. Heritage Sites Cluster occurring near the Footprint

Site No.	Description	Co-ordinates	Photo
Iron Age- Historical 1	Remains of Iron Age-Historical Circle Cluster.	28°33'9.00"S, 29°50'3.72"E	Figure 3
Iron Age- Historical 2	Remains of Iron Age-Historical Circle Cluster.	28°33'2.69"S, 29°50'8.82"E	Figure 4
Iron Age- Historical 3	Remains of Iron Age-Historical Circle Cluster.	28°32'58.48"S, 29°50'11.23"E	Figure 4
Iron Age- Historical 4	Remains of Iron Age-Historical Circle Cluster on the actual proposed Footprint.	28°33'6.10"S, 29°50'8.89"E	Figure 5
Iron Age- Historical 5	Remains of Iron Age-Historical Circle Cluster to the South-east of the proposed Footprint.	28°33'20.18"S, 29°50'31.55"E	Figure 6
Cultural Material	Cluster of Heritage-Cultural Material lying to the south-east of the proposed footprint.	28°33'11.32"S, 29°50'11.67"E	Figure 7
LSA/LIA	Recorded LSA and LIA Site to the east f the proposed Footprint.	28°33'3.81"S, 29°50'44.17"E	Figure 8

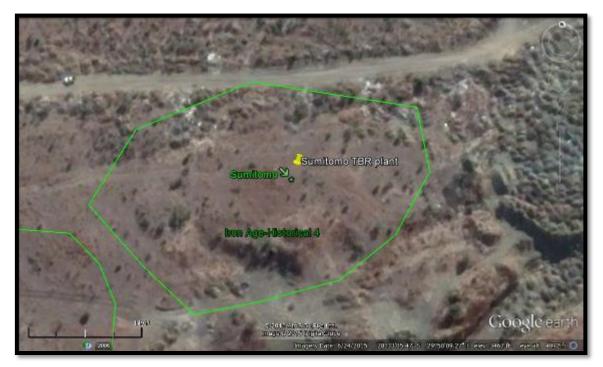
Figure 5. Heritage Sites occurring on the Footprint.

The apparent Iron Age sites within the footprint area display extensive stone robbing and degradation. The immediate area surrounding the footprint appears to be very disturbed.

The proposed footprint lies upon, and is surrounded by, a possible Iron Age-Historical Settlement. One kilometre to the east of the proposed factory site lies a recorded LSA and LIA site (Figure 8). Ladysmith town and surrounds also forms part of the Battlefields Cultural Heritage Landscape. The recorded LSA and LIA site must have a buffer of 20 m protection from any form of disturbance, or construction.
