SUMMARY OF HERITAGE ISSUES ON THE ARIADNE-EROS POWER TRANSMISSION LINE

27 August 2018

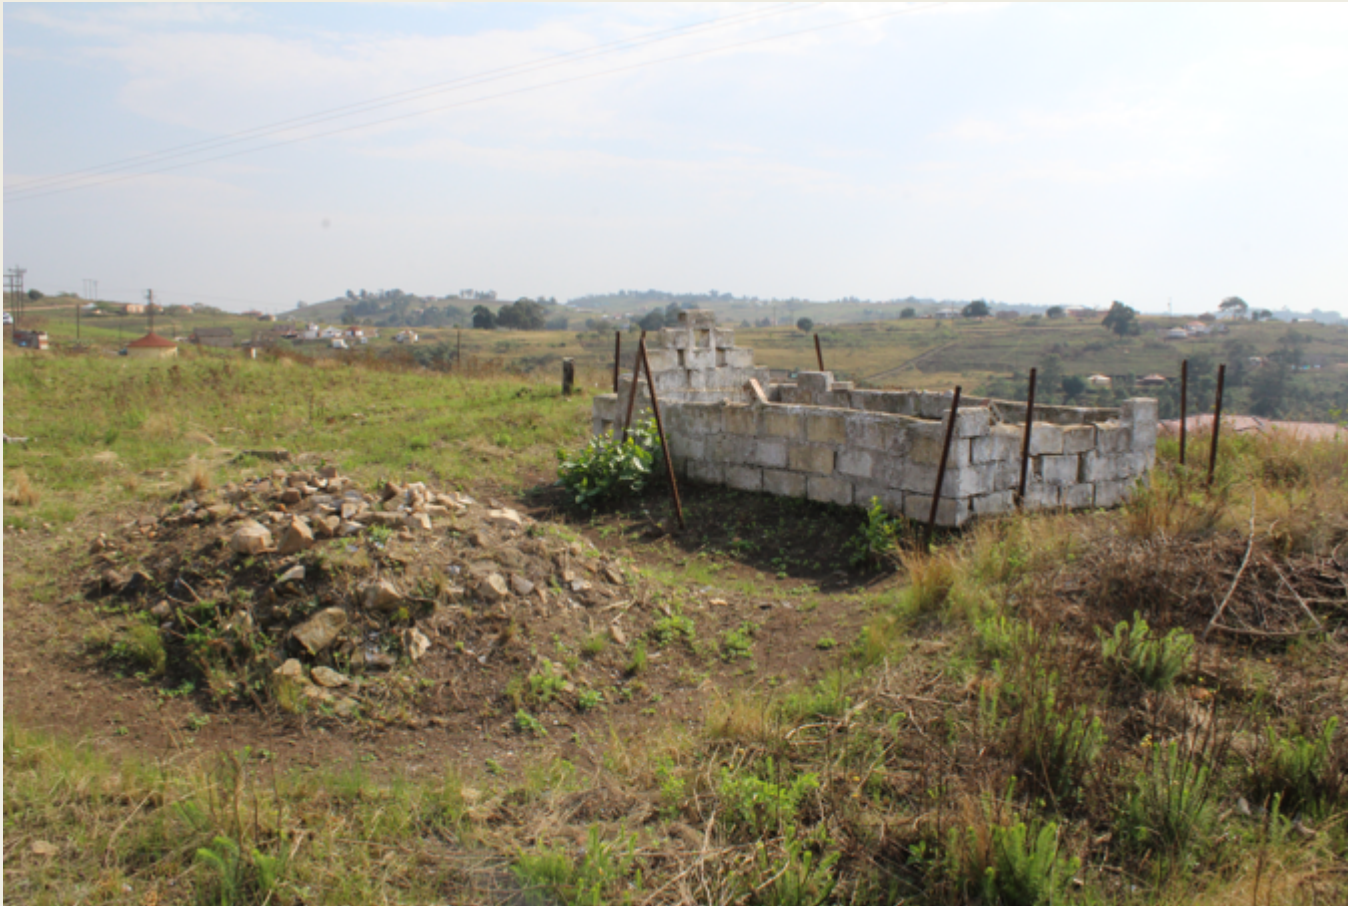
- Near 147 there are 2 graves that belong to the parents of Inkosi LD Mkhize. The graves will not be directly impacted by the tower construction. There are situated 20m away from the tower centre position.

Figure 1- Inkosi LD Mkhize family graves

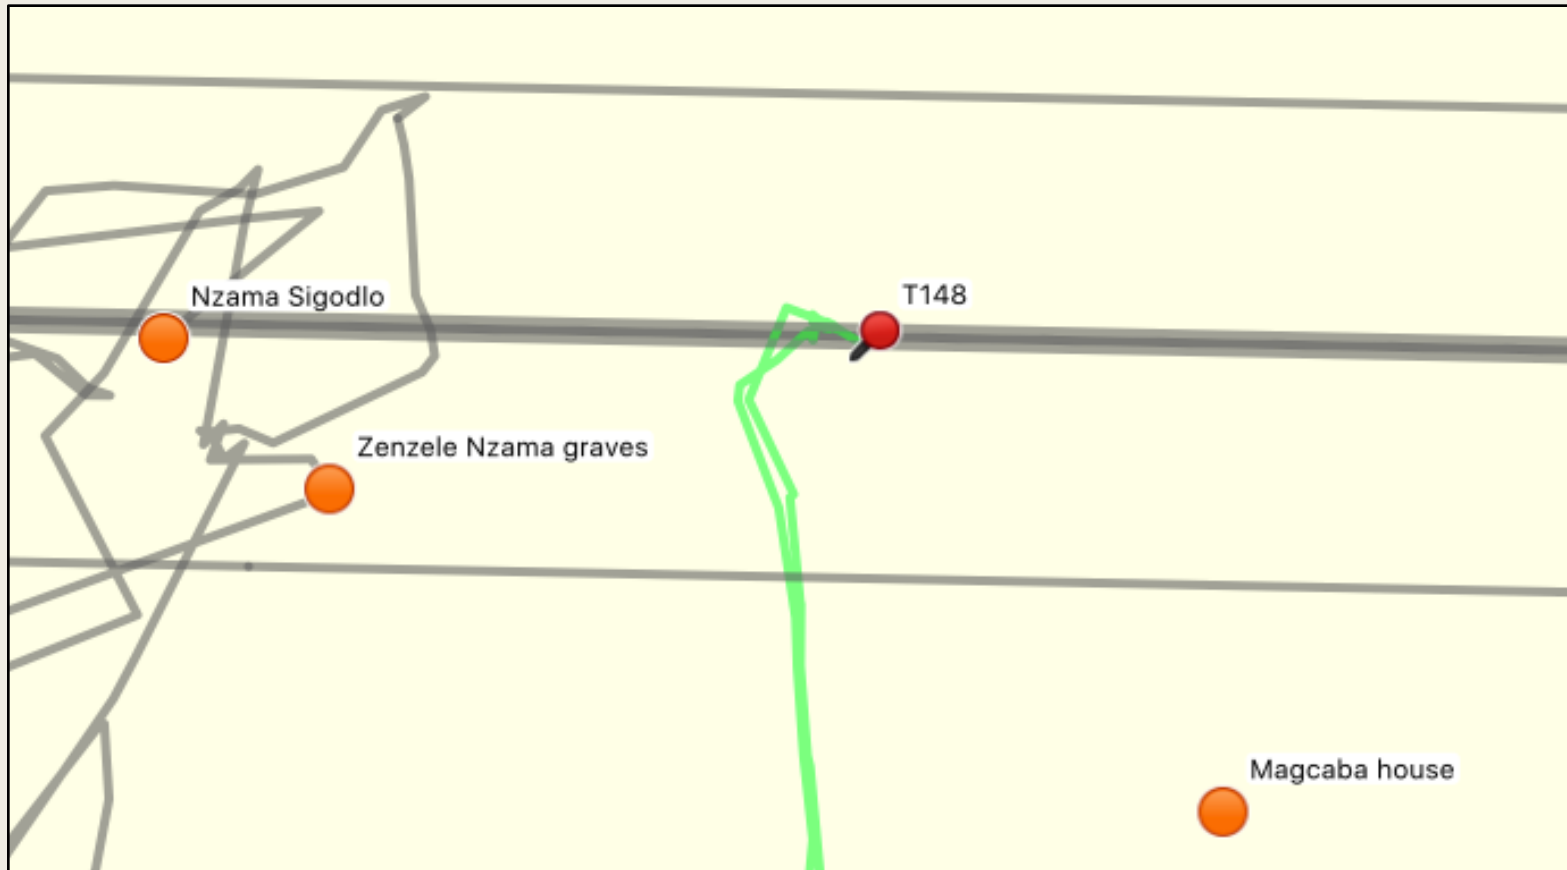
- The tower has no graves. It is situated in an open area with no ruins or foundations of former homesteads. However, north of the tower and south there are households known to contain graves (*Figure 2*).

Figure 2- Tower 148 with no graves

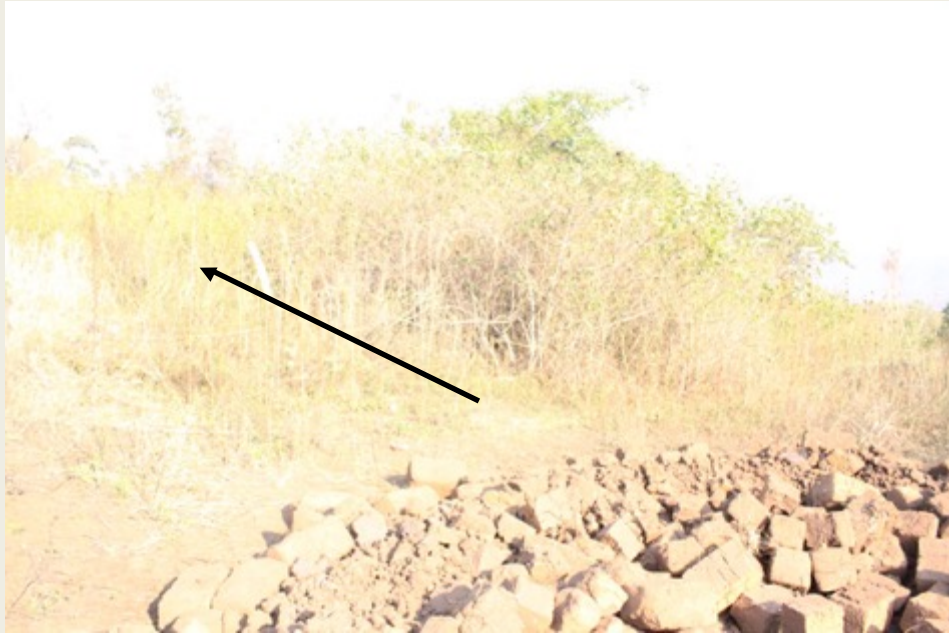
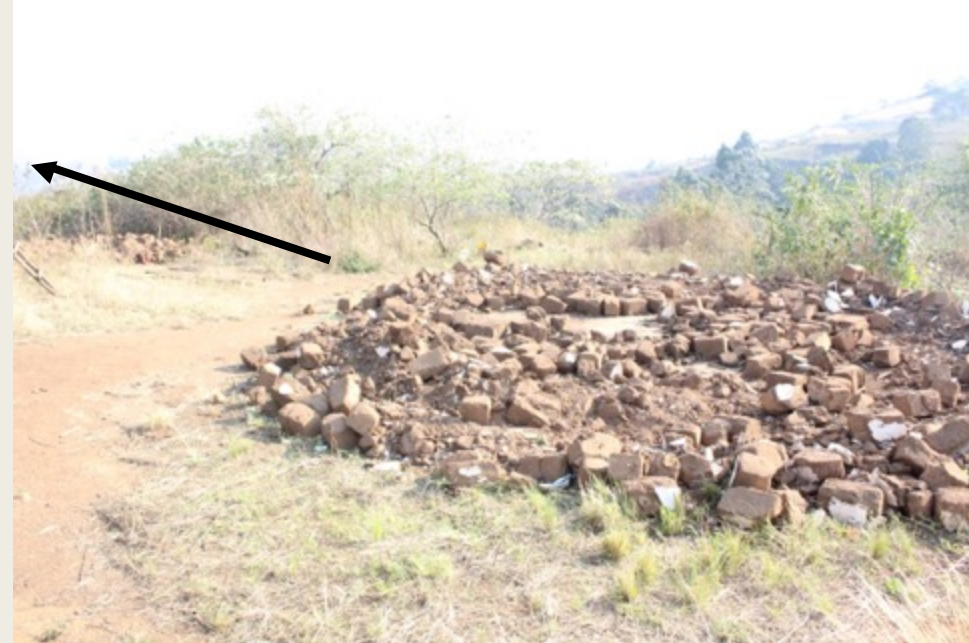
- The tower is located in the Mthembu homestead and south of Maphumulo homestead. There are approximately 9 graves in the homestead. They are situated approximately 12m from the current tower position and to the south of the tower (*Figure 4*). The tower has been moved to the area where the family old three rondavels were built. The rondavels have since been demolished to make space for the tower (*Figure 3*)

Figure 3- Mthembu family ruins. Here there we three rondavels that have since been demolished to make way for the tower. Arrows show position of graves

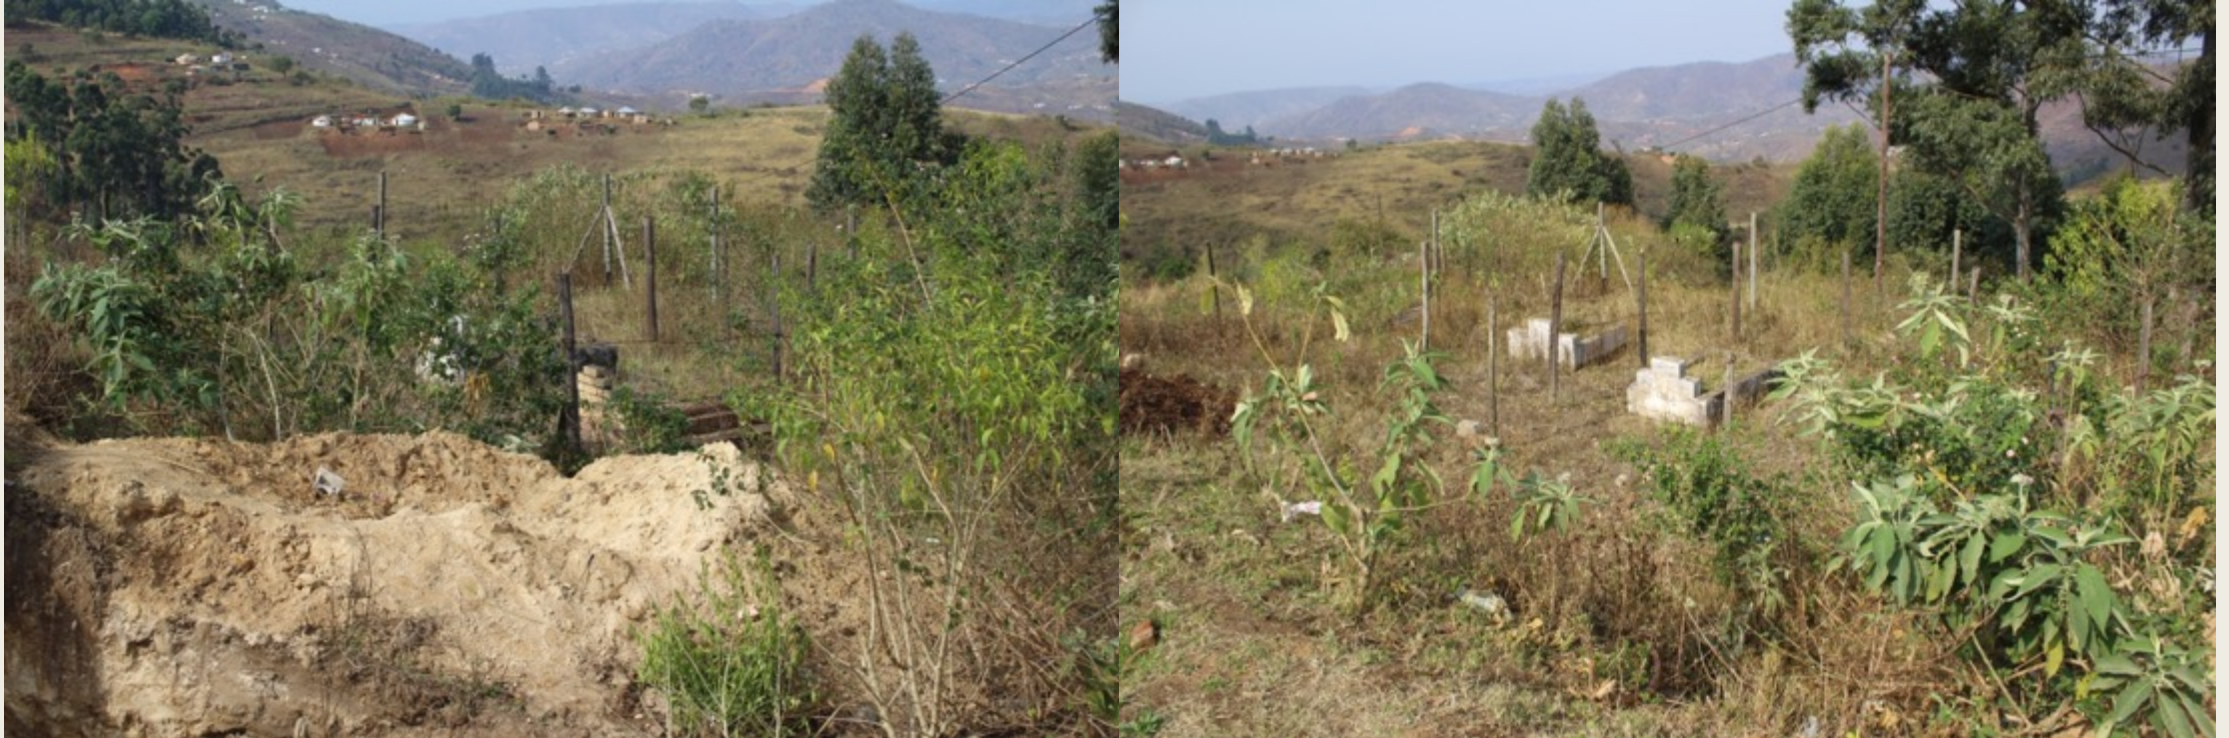
- The tower is situated in the former Koyama family homestead. Here construction activities are underway. The graves are situated south of the tower (*Figure 5 and 6*).

Figure 5- Sifiso Koyama family graves situated south of tower 150 whose foundations are nearly complete.

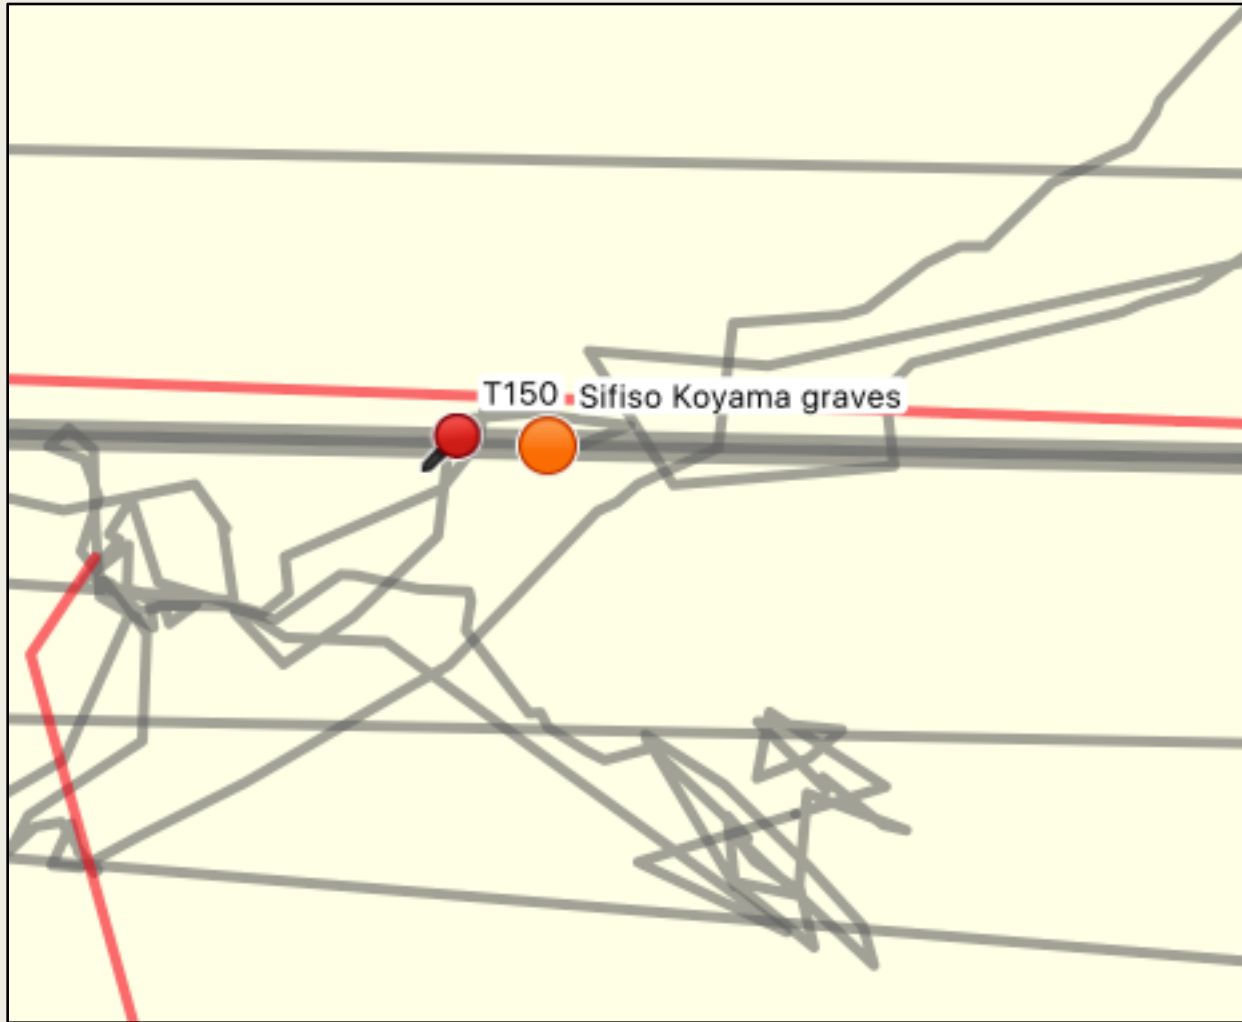
Figure 6- Sifiso Koyama family graves in relation to the tower position.

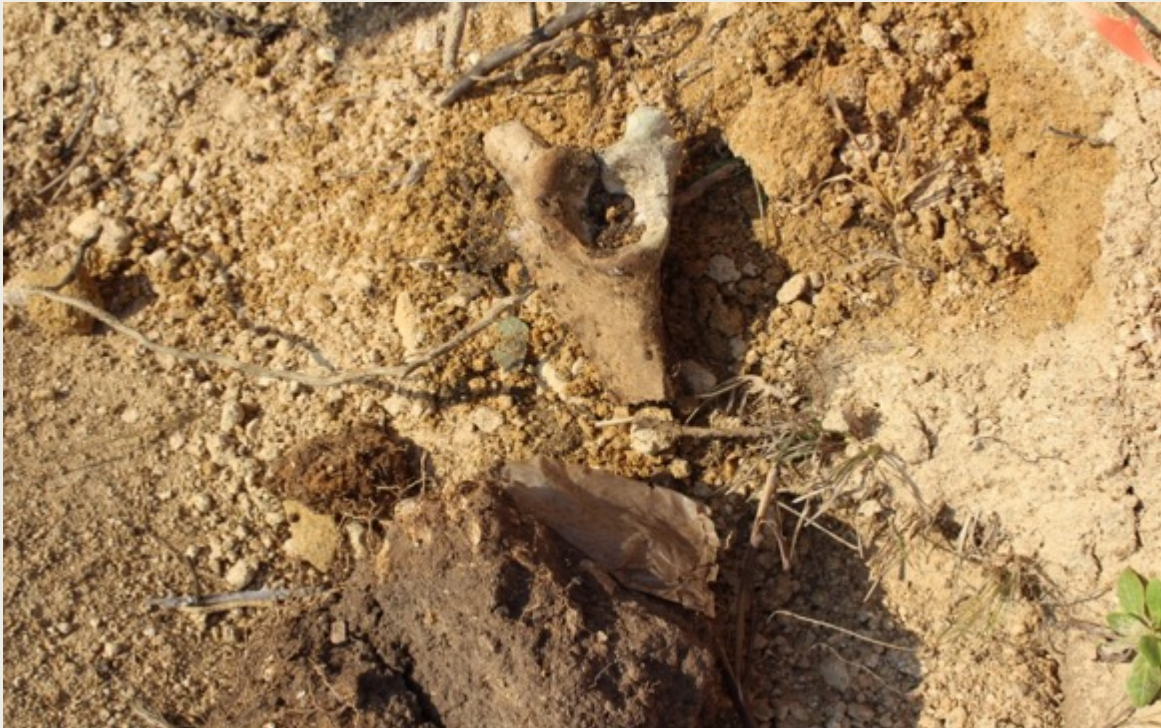
The tower has no graves on tower 151. Tower **152** has issues. There are known graves south, east and west of the tower. There are also ruins east and west of the tower. The tower foundation have already been dug up and cement poured. An assessment of the tower foundation yielded the following information:

- A human heap bone was found (*Figure 7*)
- There were also stained clothes that were found in the soil – this is typical of stained clothes during burial decomposition process (*Figure 8*)
- A metal zinc was also found on the soil dump – this is another indicator of grave disturbance since metal zincs are often place above the casket in burial processes (*Figure 9*)

Figure 7- Part of human pelvis bone found in the excavated soil

- There are three issues on site. There have been accidental desecration of graves during construction activities on Tower 152. The tower is constructed in an area with ruins both east and west of the tower position. The contractor would have not known about the graves since they are not clearly marked. However, whenever there are ruins there is always high likelihood that there will be graves.

- The survey conducted on this site yielded a fraction of human pelvis bone and other grave indicators such as stained clothes which would have been associated with the burial as well as plastic that remains when a casket decomposes (*Figures 7 to 9*).

- It is recommended that construction activities should be stopped in Tower 152 until NGT obtain a grave rescue permit from Amafa KwaZulu-Natali. NGT will commence with the application on Monday the 27 August 2018

- It is recommended that construction activities may proceed as planned in all other tower with exception to Tower 152 which requires urgent rescue permit.

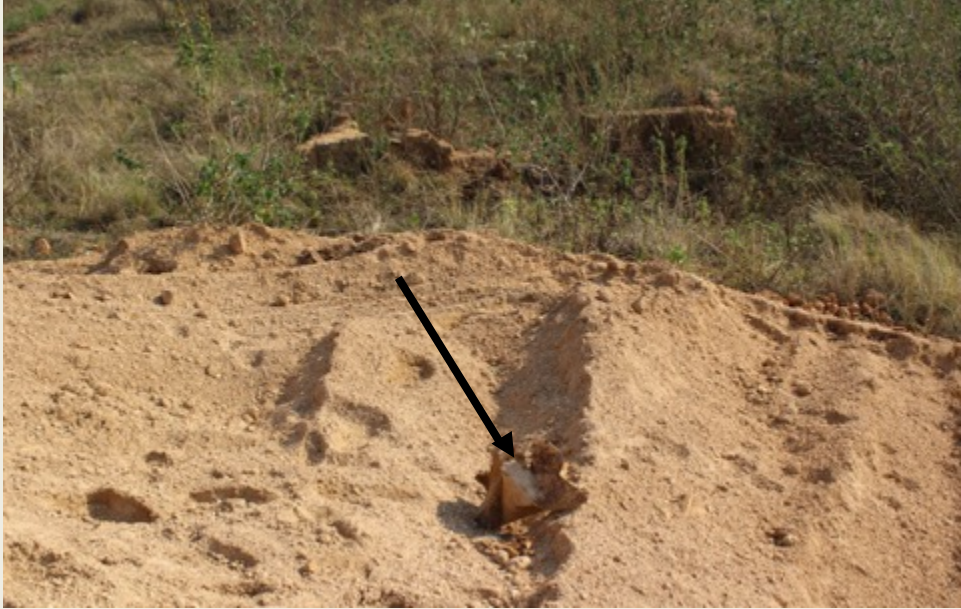
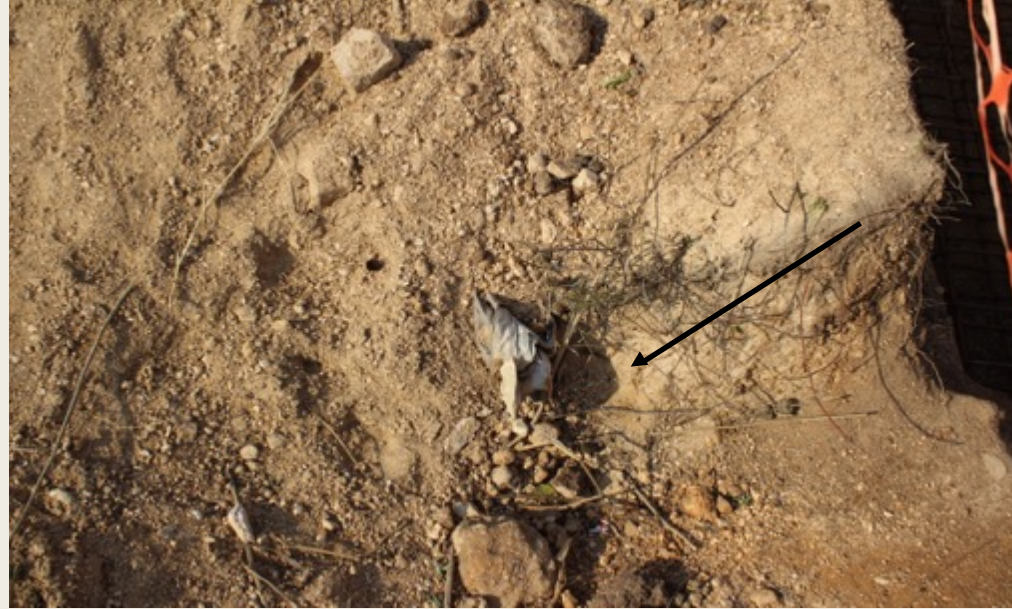
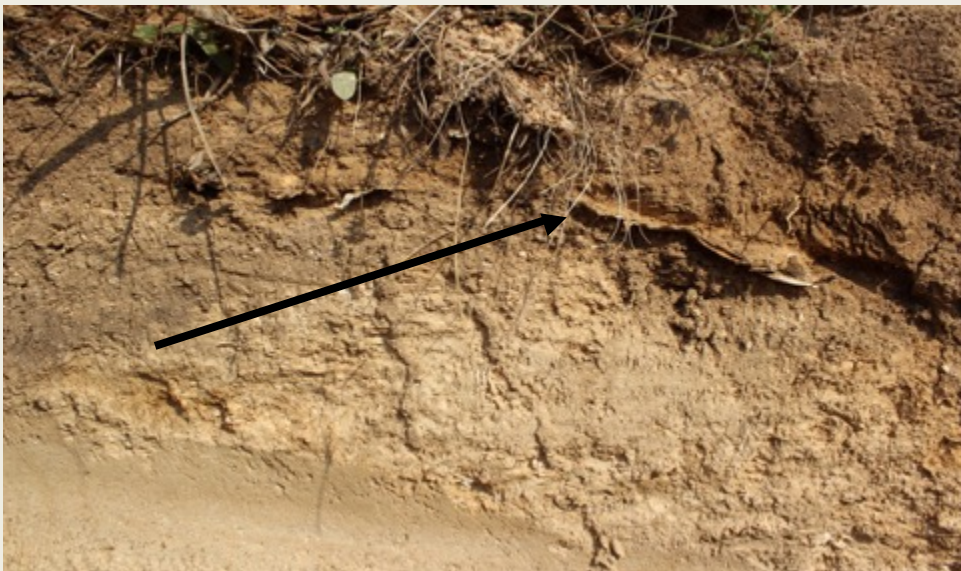
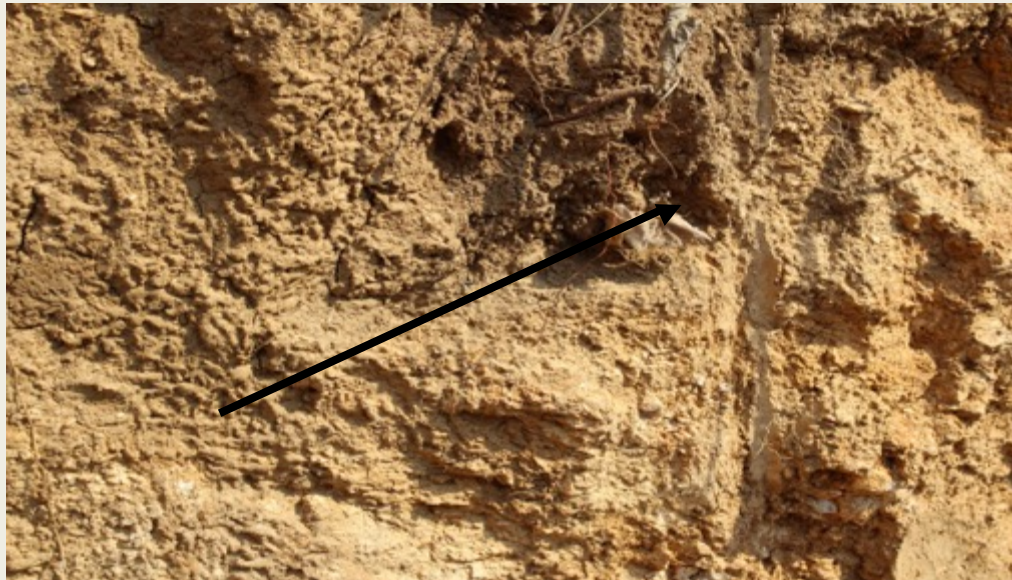
casket plastic and clothes (*Figure 10*)

*Figure 8-
Grave indicators*

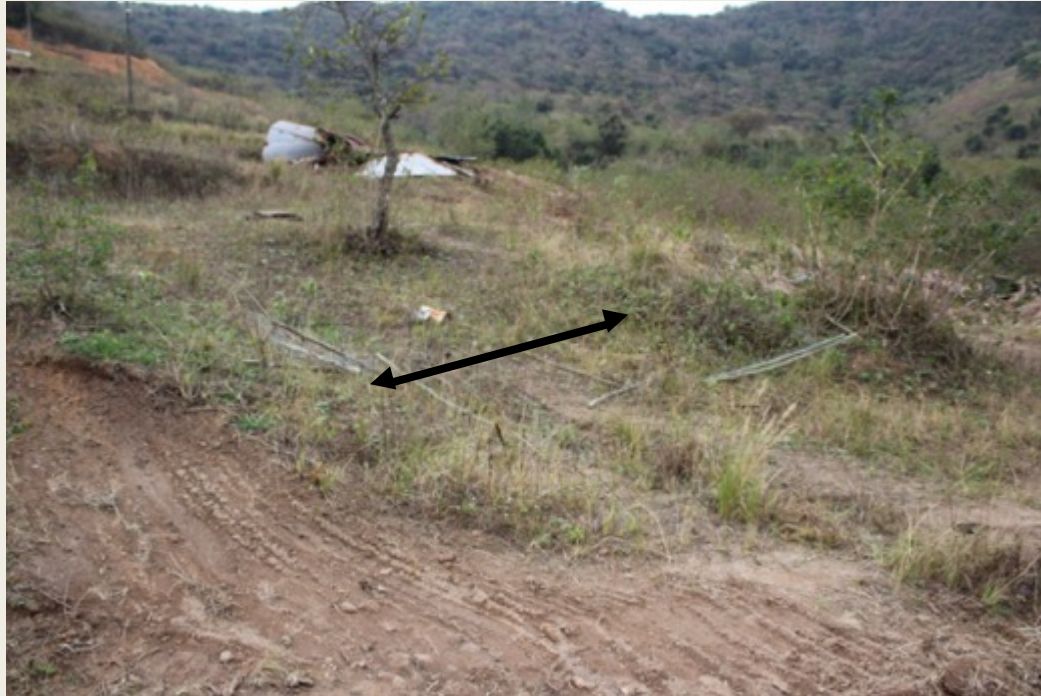
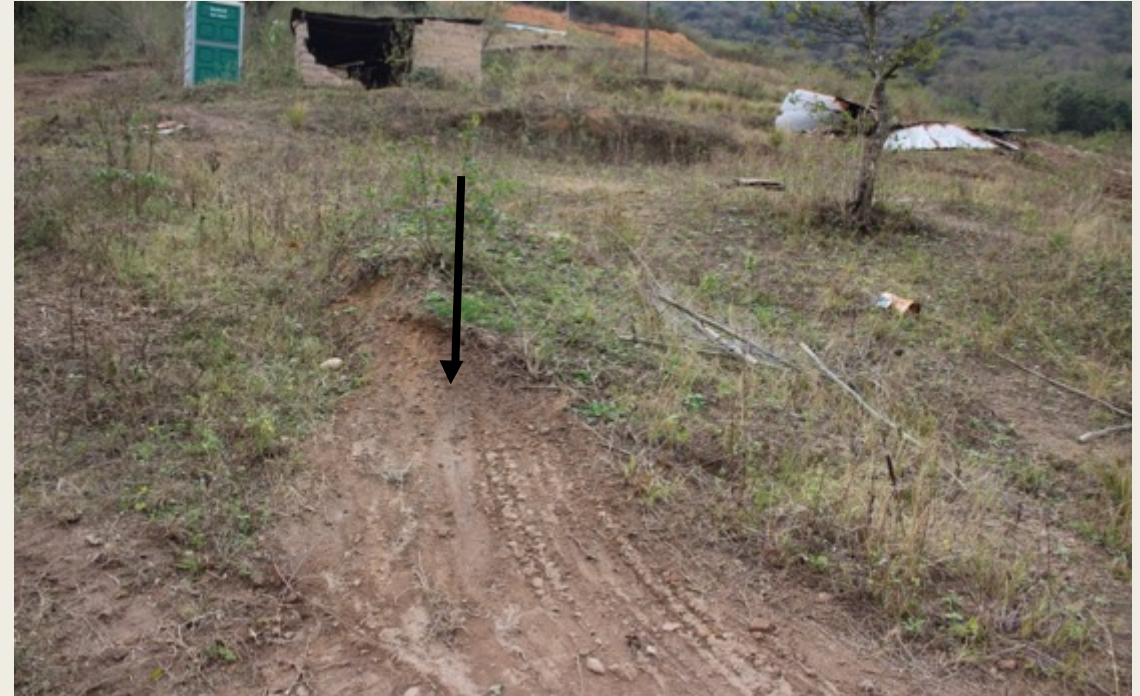
- The tower has no graves. However, south-east of the tower and on the road that has been created to access the tower two graves have been found (*Figure 10 and 11*). One of the graves is slightly scraped by the grader.

Figure 10- Two graves located next to a road used to access tower 153

- On the road to Tower 153 a grave has been slightly scrapped by a grader. The disturbance is not that significant (*Figure 10 and 11*)
- A grave between Tower 154 and 155 was disturbed during the construction of access road to 155 which has since been abandoned and diverted to the south. This issue is suggested to have been reported to the contractor. However, there has been no solution to this matter and it has created a social risk to the project as the Mkhize family is considering pursuing a legal case against the project proponent i.e. Eskom, if the matter is not addressed. The other social risk is associated with Tower 155. Near this tower there are graves that belong to the Ngcobo family which is no concerned about the construction activities on site and the possibility of desecration of their family graves. The concern comes as the result of the contractor not attending to and addressing the the issue of Mkhize family grave (*Figure 12*)

- The graves on the road to Tower 153 should be immediately fenced off to avoid them be disturbed by trucks/graders working on Tower 153. An instruction has also been issued to the family and they will commence with the fence from Monday 27 August 2018

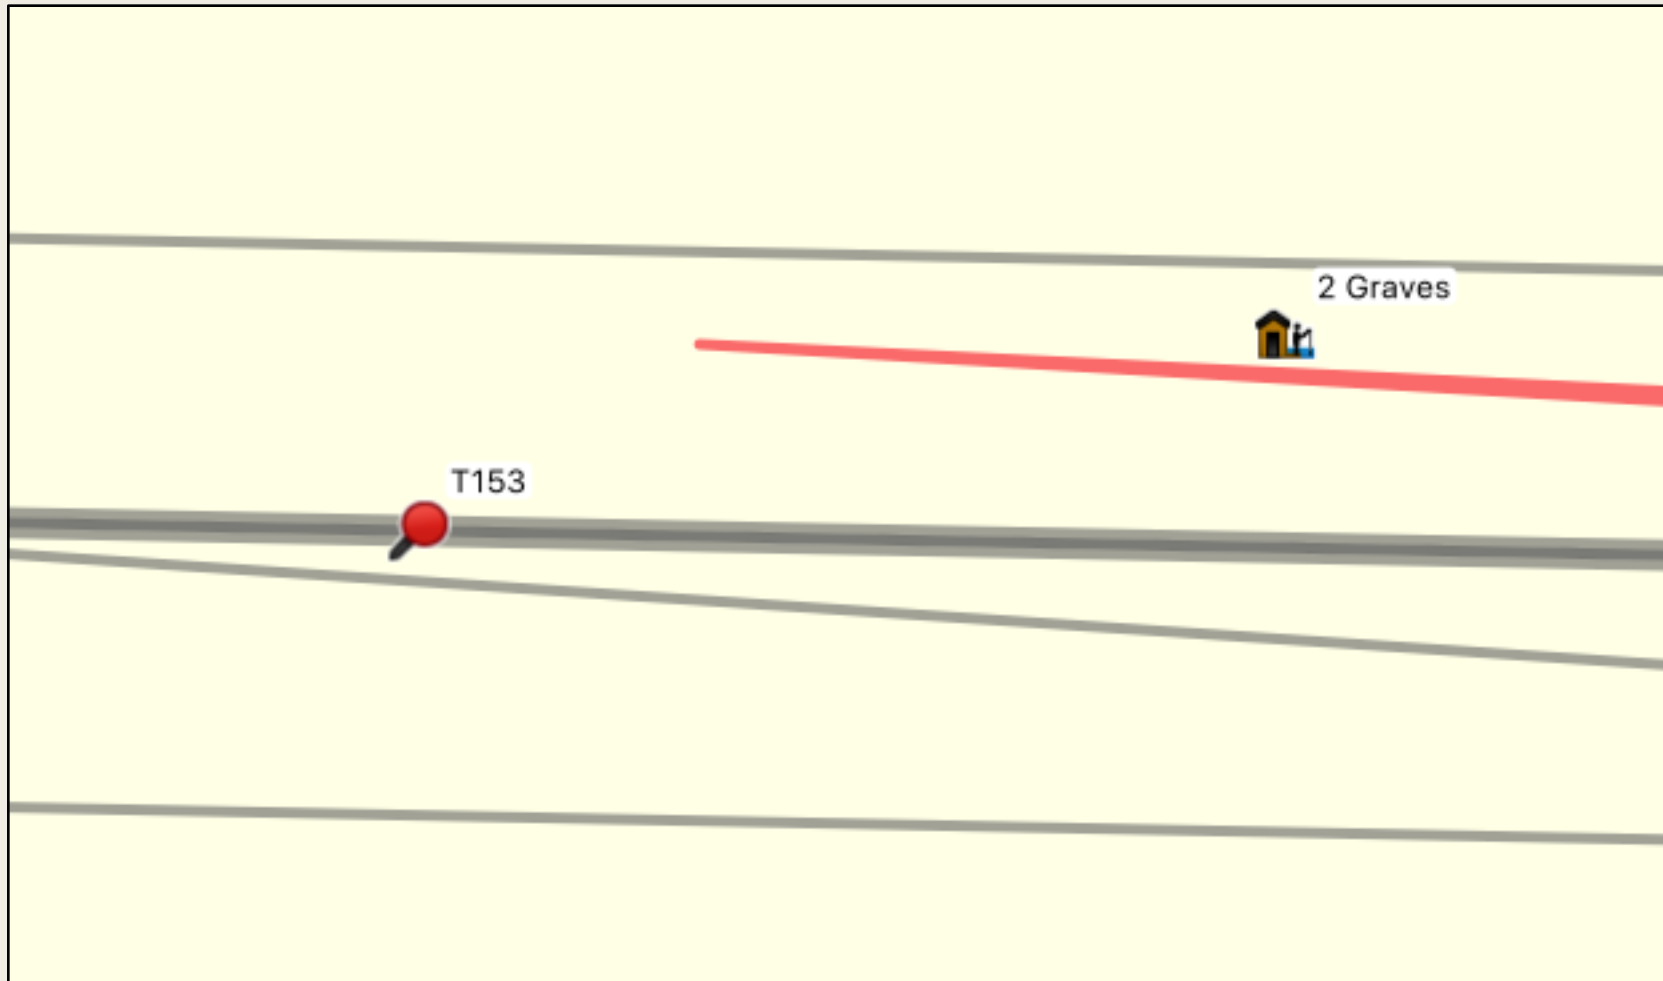
Figure 11- Location of the two graves in relation to tower 153

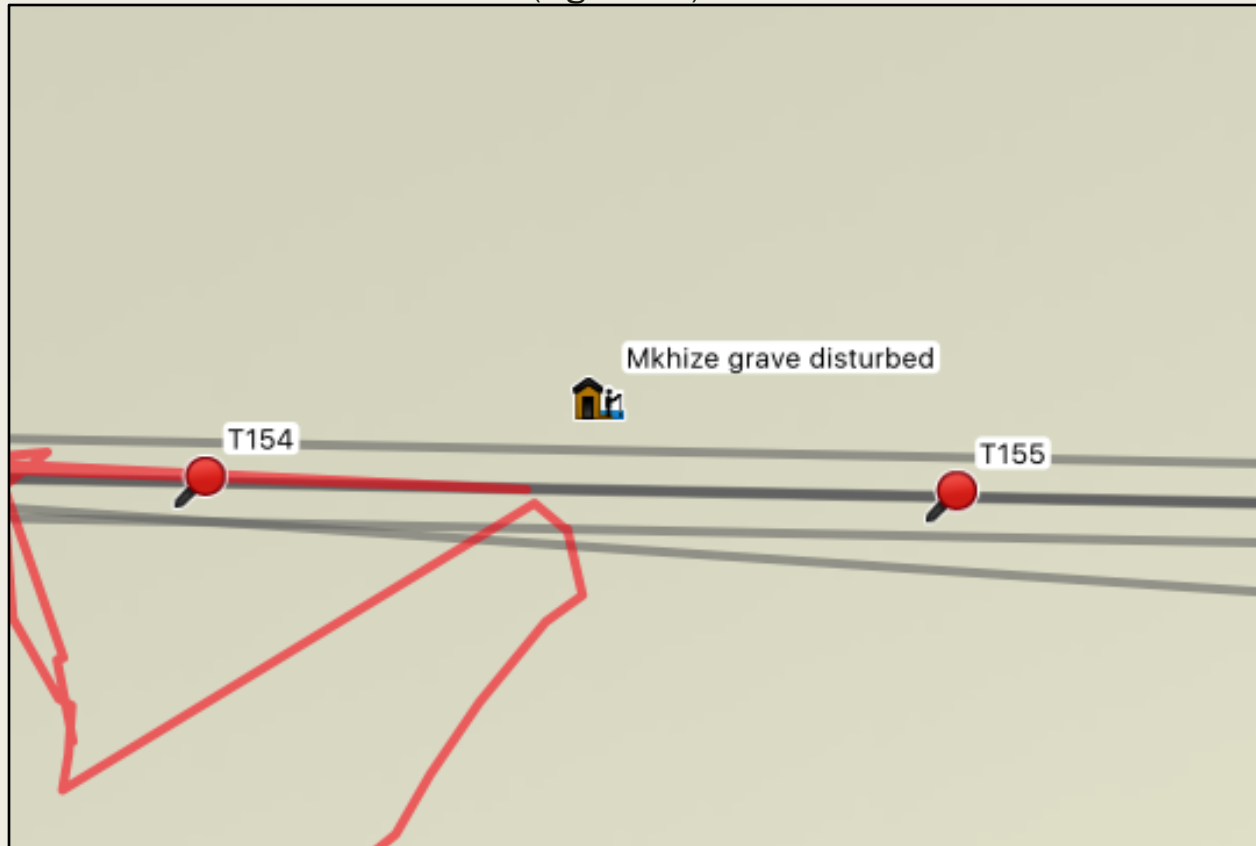
- There are no issues in terms of Tower 154. There is, however, a challenge between Towers 154 and 155. When a road to access Tower 155 was initially constructed, it disturbed a grave belonging to the Mkhize family. The road has since been diverted to a new location, but the grave issue still stands as it has not yet been addressed. The figure below show the location of the grave in relation to Tower 154 and Tower 155 (Figure 12).

Figure 12- Location of the Mkhize family grave that was disturbed through road construction activity

- The issue of Mkhize grave should be attended to with immediate effect – Induna Meyiwa has reported the issue to the contractor and the social team on site which was represented by Ms Snenhlanhla Mngadi. However, nothing has been done to date and this has posed social risks to the project – the Ngcobo family with ruins near Tower 155 is concerned that the contractor might desecrate their family graves.

- The issue of Mkhize grave should also be attended to so that the Ngcobo family which has graves near Tower 155 may be at ease and allow construction activities to proceed on Tower 155
