**PROPOSED DEVELOPMENT OF THE 132KV OYA OVERHEAD POWER LINE NEAR
MATJIESFONTEIN, WESTERN AND NORTHERN CAPE (SAHRIS CASE NO. 15709)**

An archaeological walkdown of the Northern Cape section of the Oya OHL was conducted by Mr Nic Wiltshire (CV attached) on 07 January 2021 (see tracks included in Figure 1 below). This letter is therefore submitted to SAHRA in fulfillment of the above requirement and must be read in conjunction with the HIA for this project that is attached to the Case on SAHRIS. This letter does not constitute a complete HIA, but forms a letter supplementary to the existing HIA.

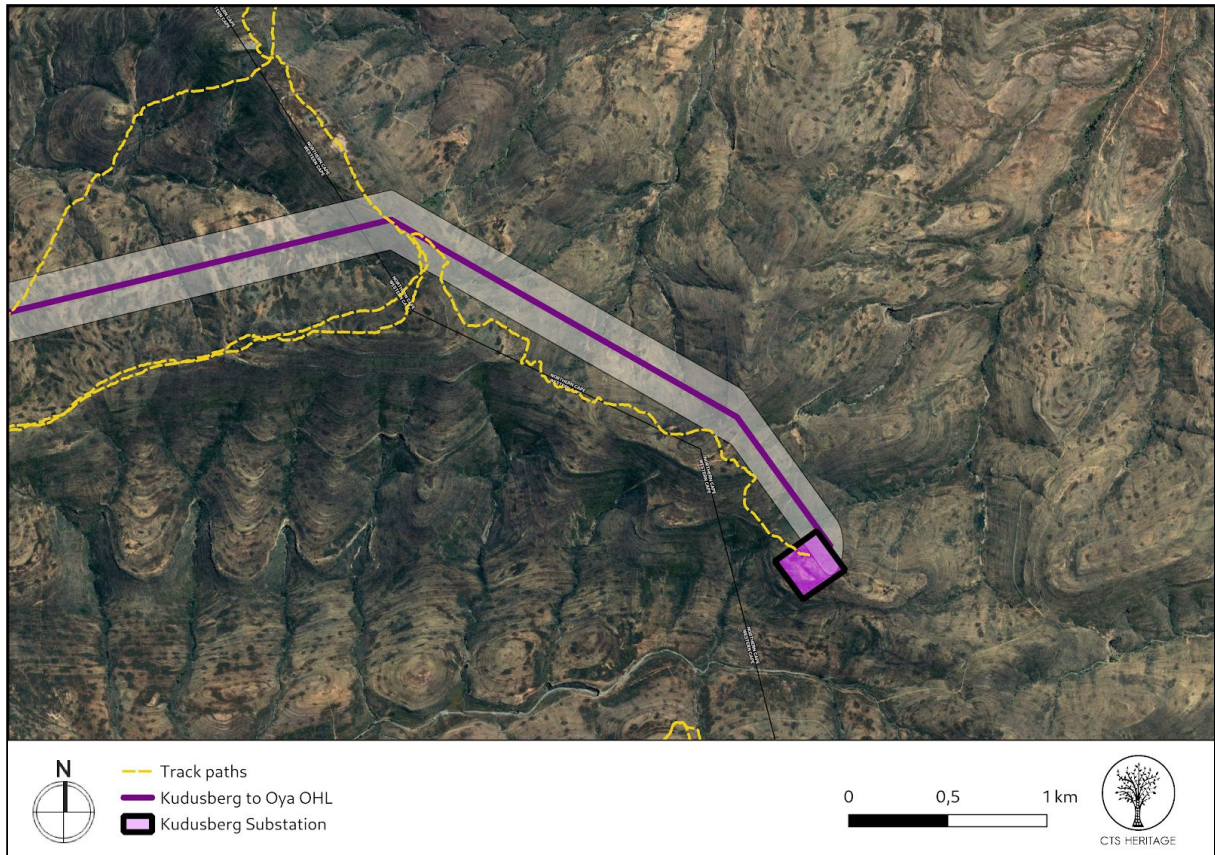
Figure 1: Updated track paths covering the Northern Cape section of the proposed Oya OHL

No heritage resources of any kind were identified along the Northern Cape section of the Oya OHL alignment during the field assessment conducted on 07 January 2021. The proposed alignment traverses a series of cliff lines and slopes approaching 60 degrees, and, as such, it was not possible to follow the exact line of the route. The most accurate possible assessment was conducted by navigating the ridgelines overlooking the drop. Images of the area proposed for the Oya OHL are included below.

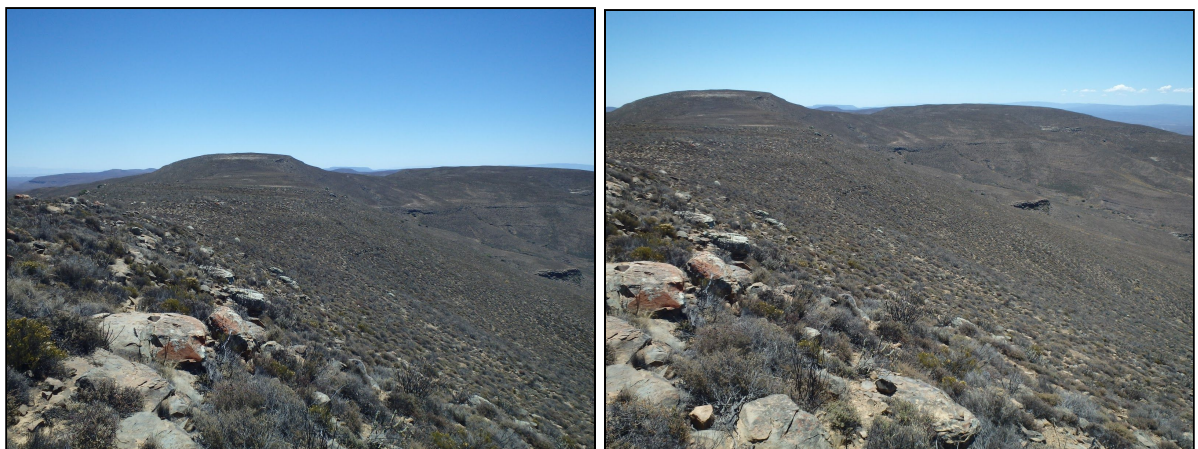
The images below are indicative of the views along the proposed alignment:

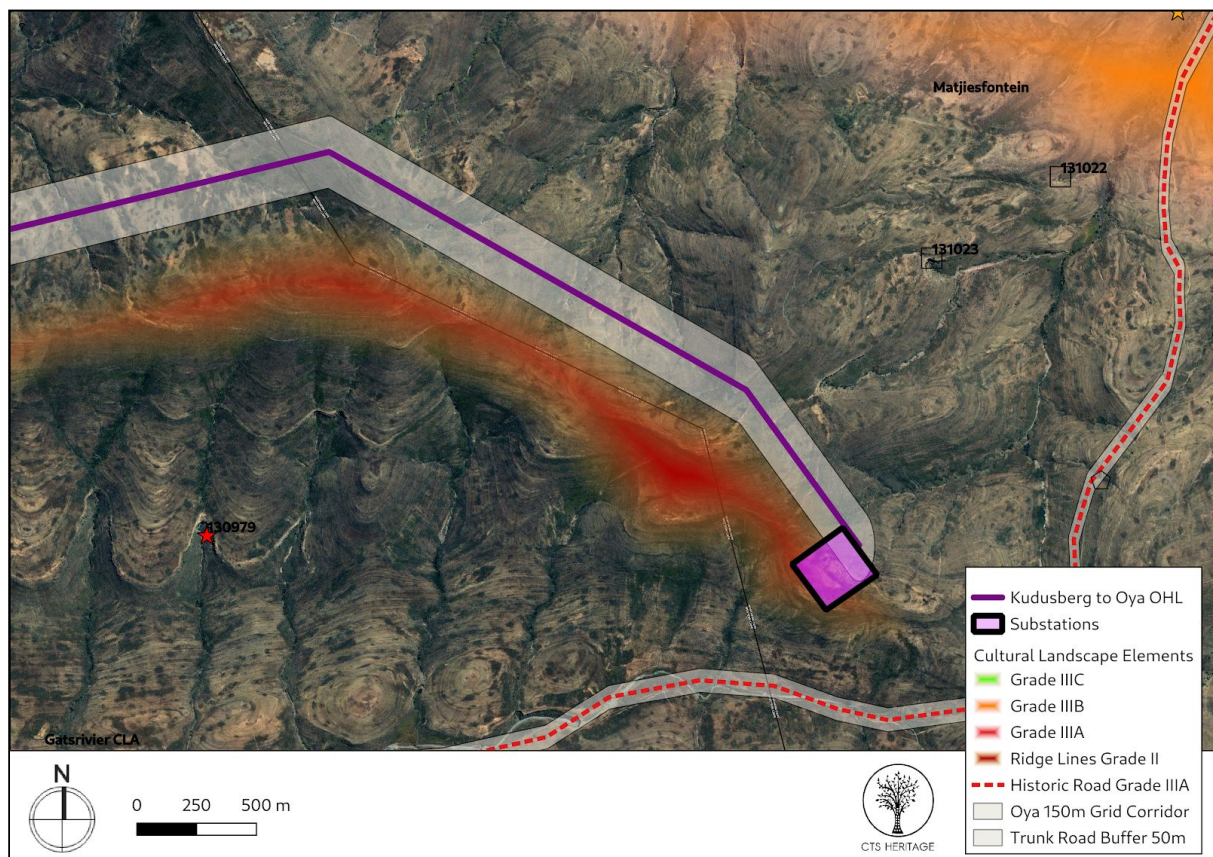
Figure 2: Heritage resources located in proximity to the Northern Cape section of the Oya OHL

As no heritage resources were identified within the Northern Cape section of the proposed Oya OHL alignment, no additional mitigation measures are required for inclusion in the recommendations as per the HIA submitted to SAHRA (Case No. 15709). In their letter, SAHRA raised concern regarding two heritage sites located in close proximity to the Northern Cape section of the proposed development. The only known sites located in proximity to the proposed Oya OHL in the Northern Cape are sites 131022 and 131023 (Figure 2 below). These sites are located more than 950m from the proposed alignment and therefore fall well outside of the recommended buffer of 50m. Both of these sites are not archaeological or palaeontological in nature, but are natural features (Site 131022 is an overhang and Site 131023 is a waterfall).

The recommendations as included in the HIA therefore remain applicable and are repeated below, edited for relevance only to the Northern Cape section of the Oya OHL (ie. SAHRA's jurisdiction):

There is no objection to the proposed development on heritage grounds and the following is recommended:

- No mitigation is required prior to construction operations commencing.
- During the construction phase all excavations must be monitored for fossil remains by the
