SURFACE WATER & HYDROLOGICAL ASSESSMENTREPORT FOR

The proposed mining development for Diamond kimberlite (DK) and Diamond General (DG) on Farm Viljoenhof 1655 in Boshof, Free State, South Africa.

Report No: 2023/WET/04

Date: June 2023

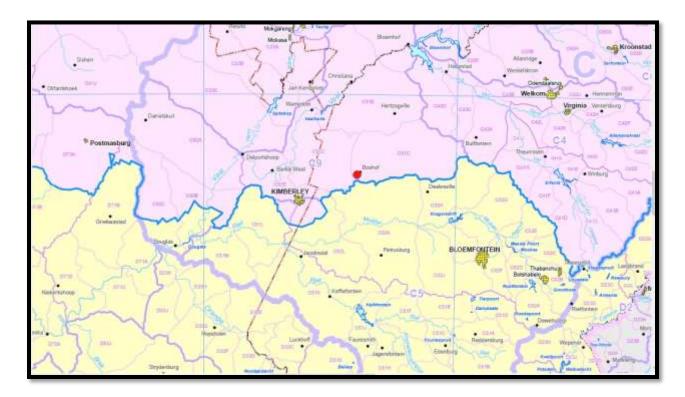
Figure 2: Water Management Area Map.

The study area falls within water management area number 05– Vaal. WMA 05 includes the following major rivers Wilge, Liebenbergvlei, Mooi, Renoster, Vals, Sand, Vet, Harts, Molopo, and Vaal Rivers. Water management area 05 primarily drains in region C. Figure 4 shows water management area No. 05.

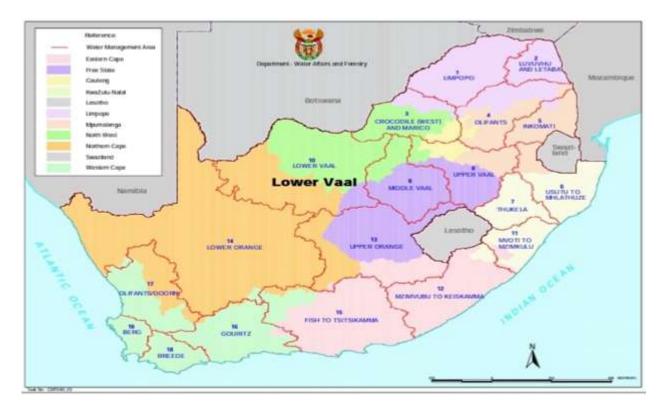
Figure 4: Lower Vaal Management Area

The proposed site is in the Lower Vaal Management Area. The site is drained by means of run-off, with storm water collection towards the northwest and north of the site. No prominent surface drainage features are developed within the proposed site boundaries. See below Figure 6.
