**PHASE I ARCHAEOLOGICAL SURVEY REPORT AND ASSESSMENT OF THE
AREA DESIGNATED AS THE MANDELA MUSEUM AT MVEZO IN THE EASTERN
CAPE, SOUTH AFRICA (Site 3128DC1)**

MH Schoeman
Curator: Historical Anthropology
Albany Museum
Somerset street
Grahamstown
6139
Tel: (046) 622-2312
e-mail: a.schoeman@ru.ac.za
July 2000

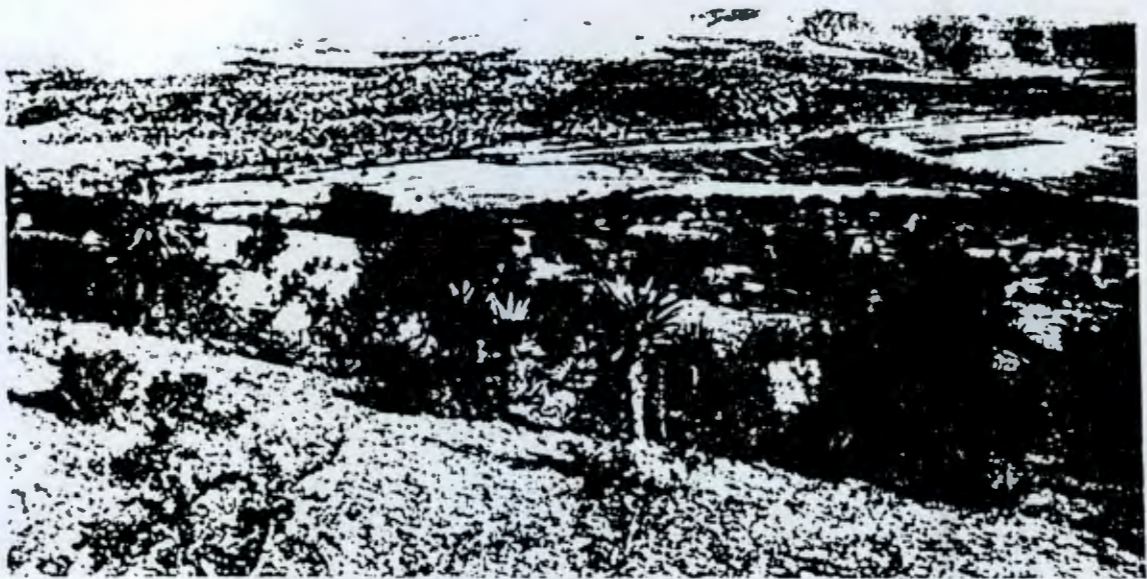
The survey was conducted on foot. It focused on the area within the fence (Fig. 1), which is at high risk of further destruction. Features in this area were mapped and photographed. Remains outside the fence were investigated, but not mapped or photographed as they are not under immediate threat by further developments.

Figure 1 Photograph showing view of Occupation Areas within the fenced area at Mvezo

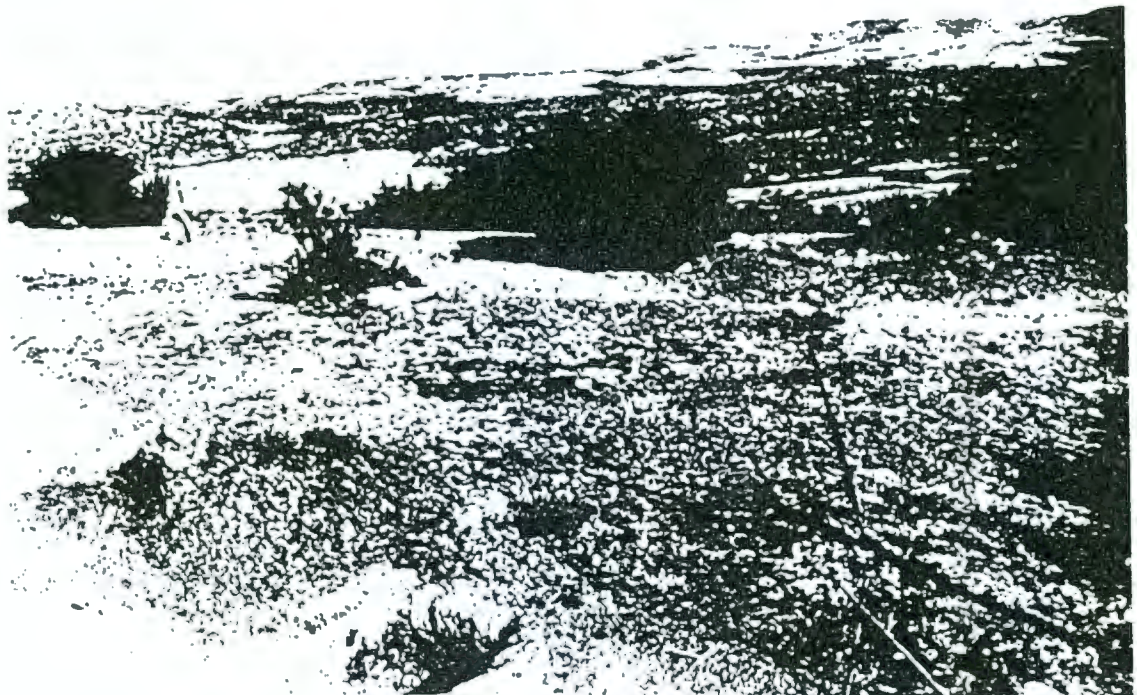
House remains A1 is the least visible in Occupation Area A. It consists of a low mound with no visible wall remains. Of note is that this area is associated with a low flat stone (Fig. 3). When the survey was undertaken there was an Upper Grindstone placed on it, however the smoothed areas do not resemble that of traditional grindstones (see Fig. 22), but is rather similar to stones found on Iron Age sites on which spears have been sharpened. This implies that the stone might have been part of the male assembly area, which suggests that the A1 remains predate the settlement at Occupation Area A, as a building would not have marked this area. A square shallow hole has recently been excavated into this mound.

Figure 3 Photograph of house remains A1 associated with a large flat stone

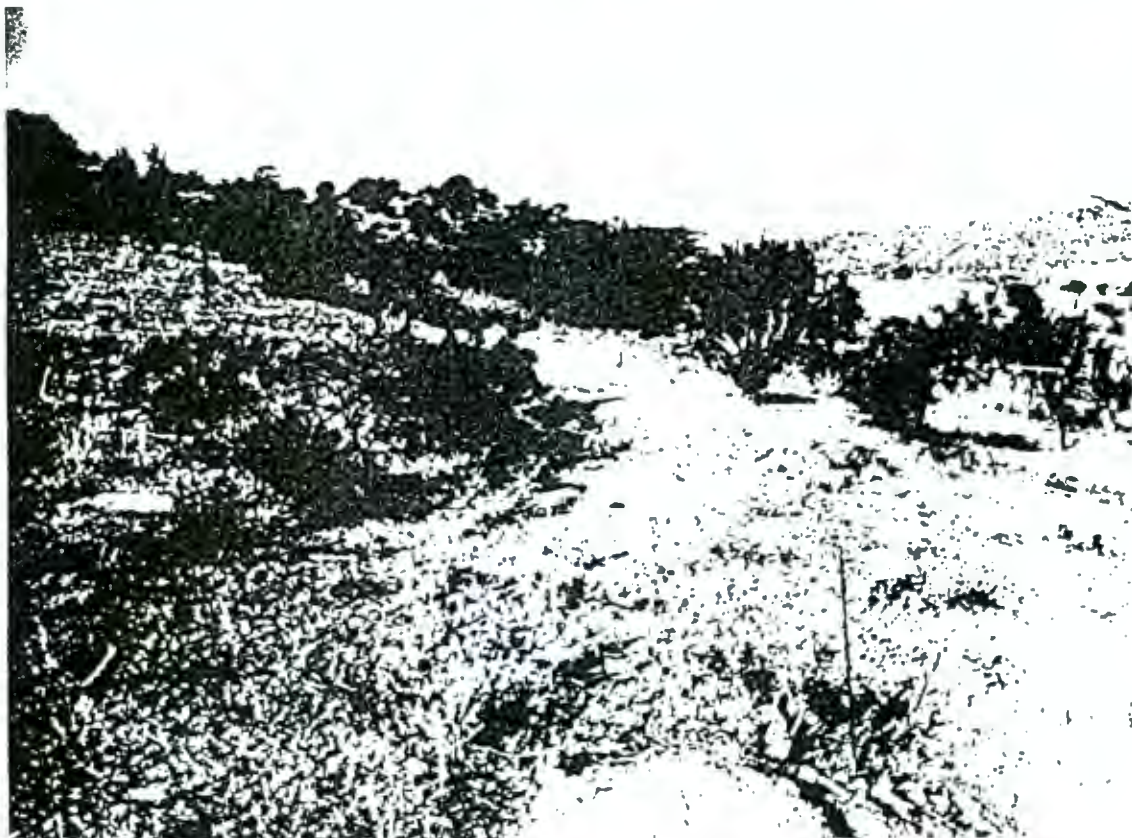
The house platform at A6 was formed through excavation at the up slope side into the hill. The down slope side has been built up. The base for this consists of uncut stone (Fig. 6). The up slope areas of A7 and A8 were also cut into the hill. The mound at A9 is smaller than that of the house remains (Fig. 7). It consists of a raised mound ridge with a more shallow centre. A smaller mound is associated with it. The nature of this collapse and placement in the occupation area suggests that it was a granary.

Figure 6 Photograph of house platform A6

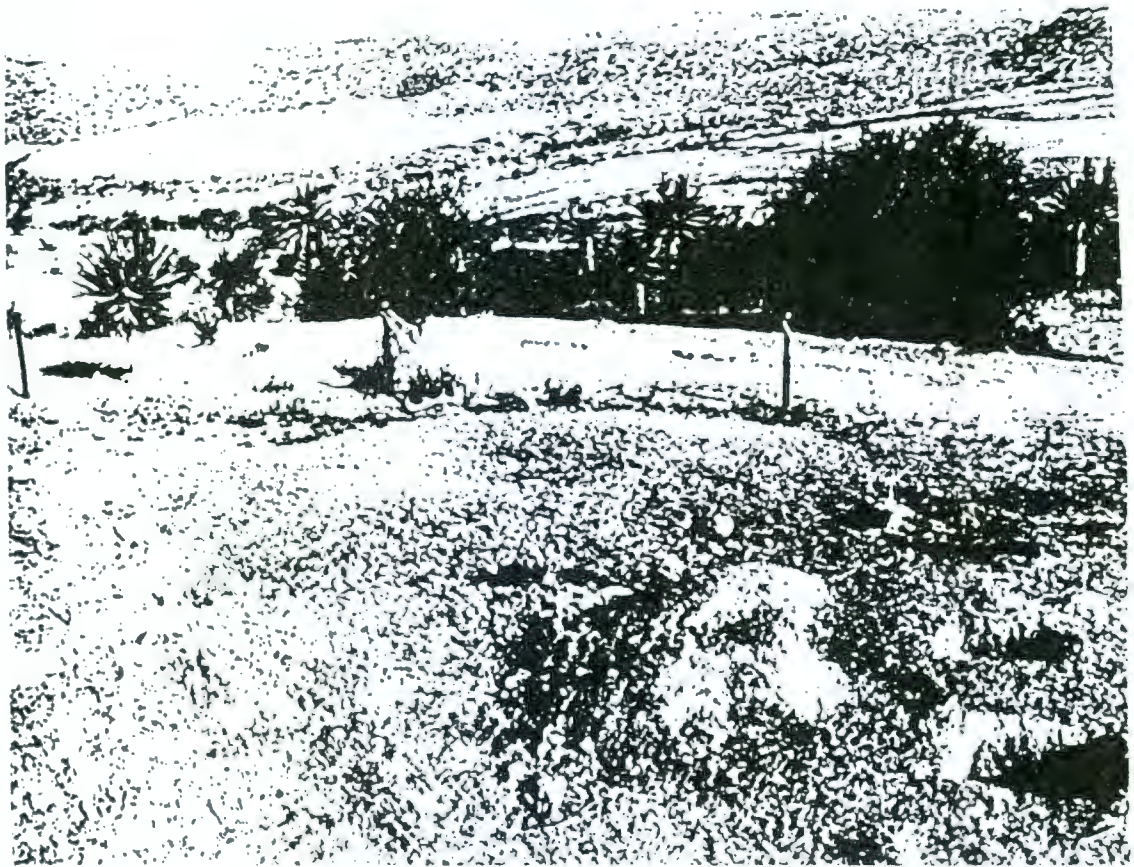
Figure 7 Photograph of the A9 granary mound

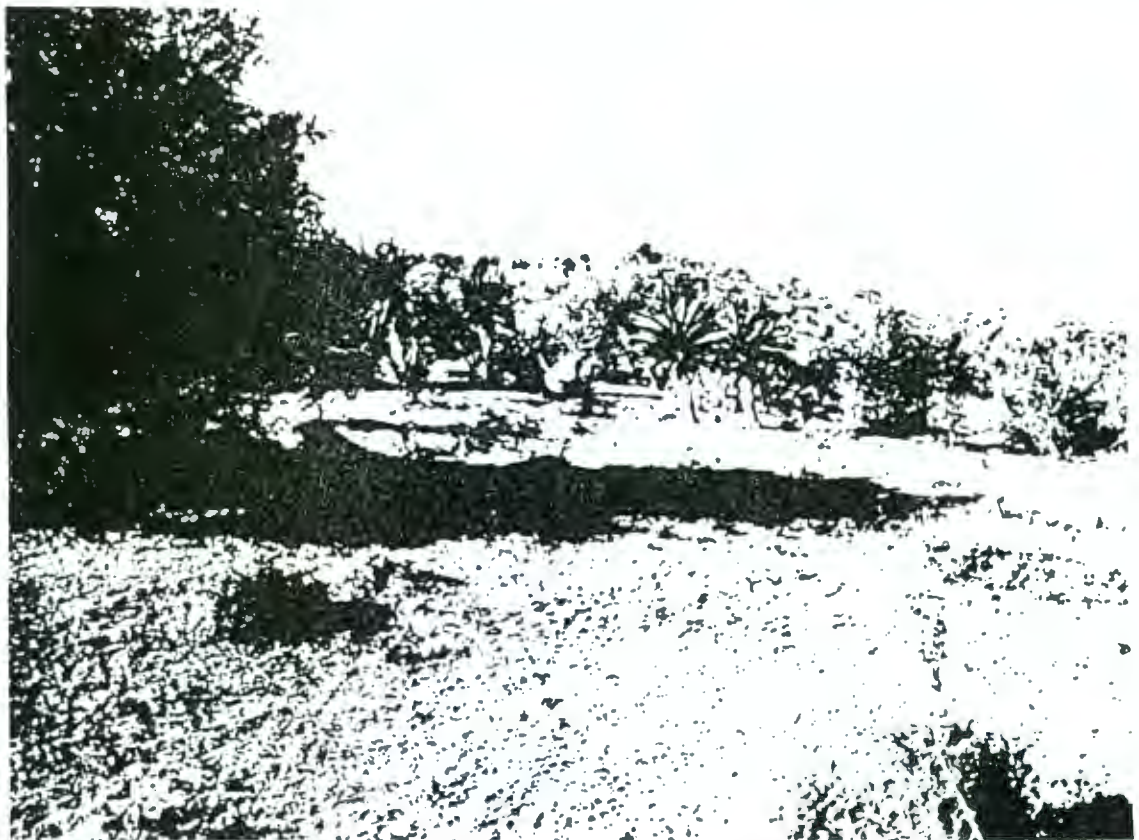
Below Occupation Area A there are two parallel rows of large unworked stones. This seems to form a level section between the more sloping areas to either side (Fig. 8). Directly below the stone rows is a stone walled enclosure. The walls have been constructed in the traditional method, with larger stones on the outside and smaller stones filling the centre

Figure 8 Photograph of parallel rows of stone in Occupation Area A

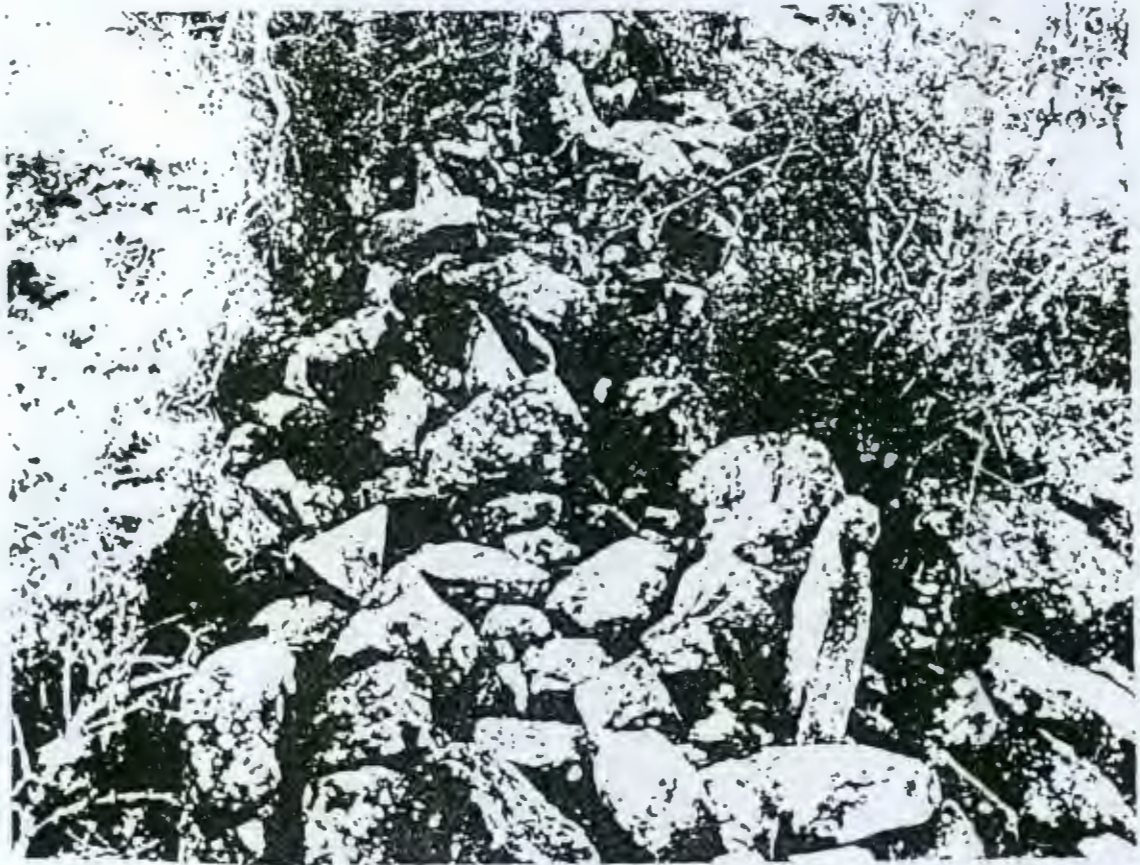
(Fig. 9). The oral information suggests that this was the tobacco garden. If this is correct it implies that tobacco occupied a very important role in the homestead as this is the only visible stone wall on the site and would have required a large amount of energy to construct. It is more likely, however that this was the kraal. This is indicated by the time and energy spend in construction as well as by the location immediately down slope from the rondawels.

Figure 9 Photograph of stone enclosure wall

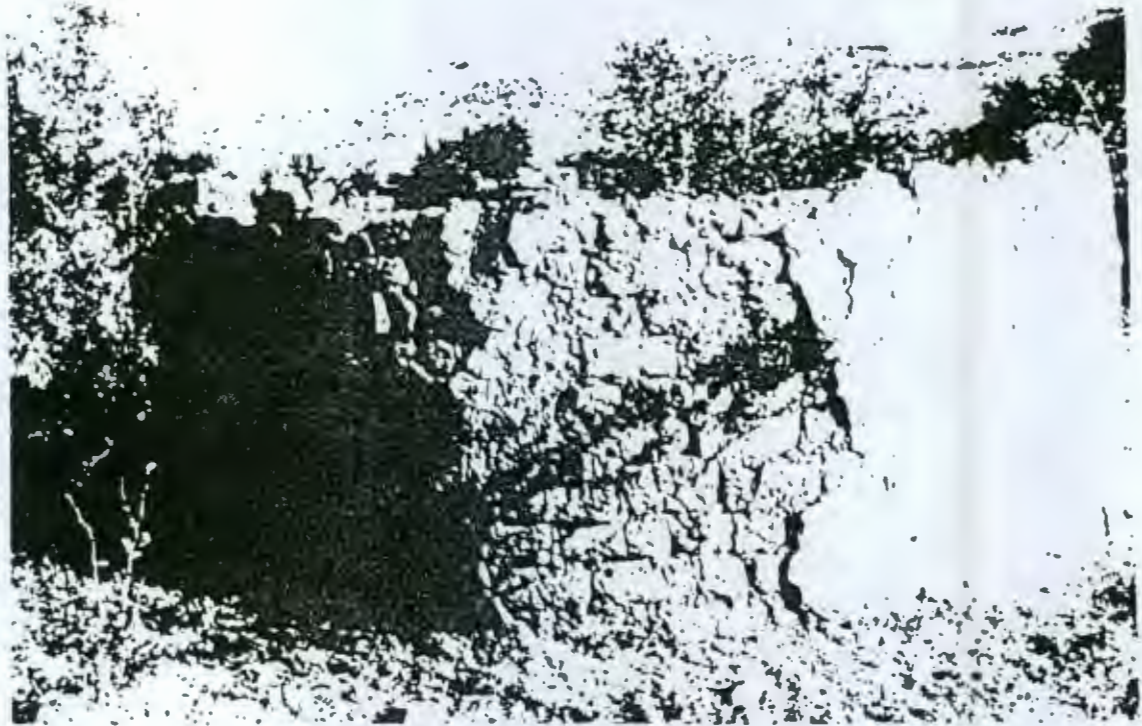
The preservation of house structures in Occupation Area B is the best of the occupation areas within the fence. The north eastern wall of house B1 is still in tact (Fig. 10). The area where the plaster has peeled off clearly shows the building technique of overlaid clay box bricks. A small window is present near the top of the wall.

Figure 10 Photograph of intact walling of house B1

The site at Mvezo is clearly rich in material from past Thembu occupations. The most abundant remains are of rondawel houses. These need to be stabilised and protected from further damage and erosion. Ways to support and prevent the collapse of the intact wall at Occupation Area B need to be found. This must include the stabilisation of the wall plaster.

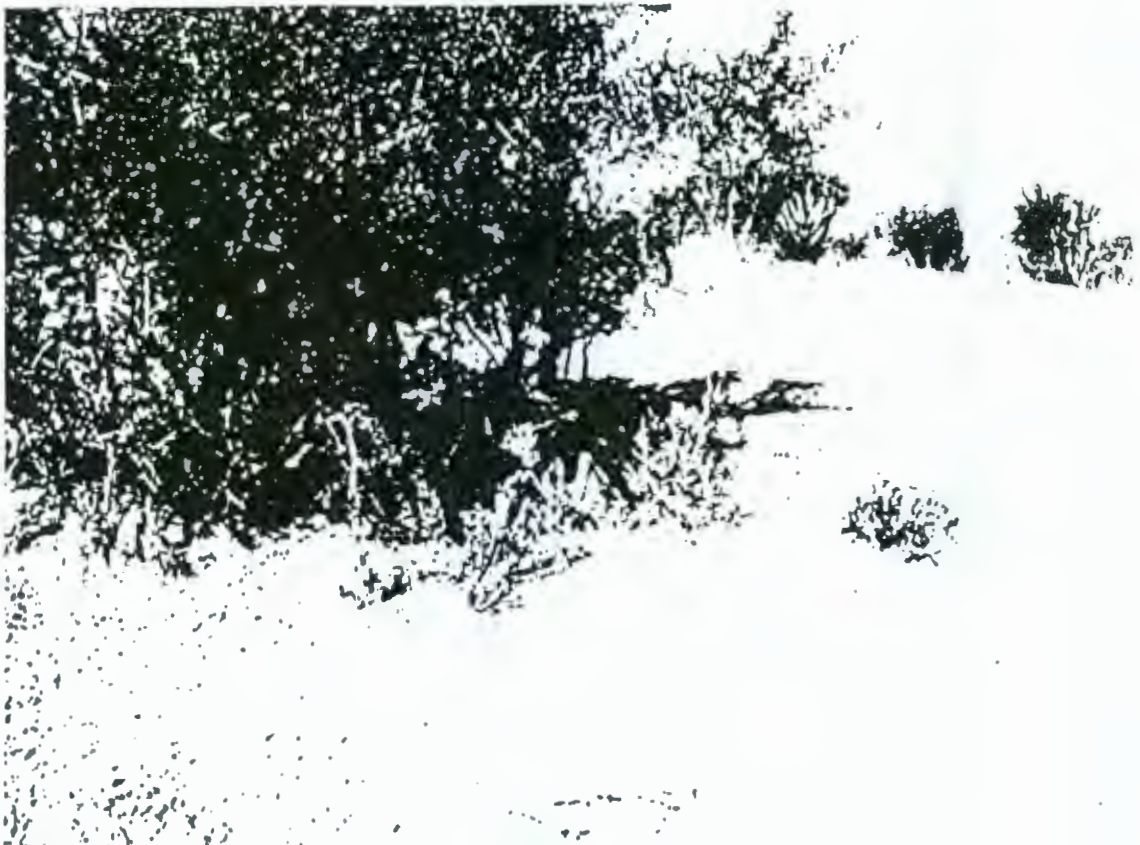
The B2 remains are less well preserved. They consist of a mound with a hollow in the middle. This is similar to the remains at A9, suggesting that this could have been a granary. Clay box bricks are still visible in the remains of B3 (Fig. 11). Wall remains are also visible at B4, where a three brick high section of the wall is still standing. A broken lower grindstone is located to the east of this house (Fig. 12).

Figure 11 Photograph of B3 house remains

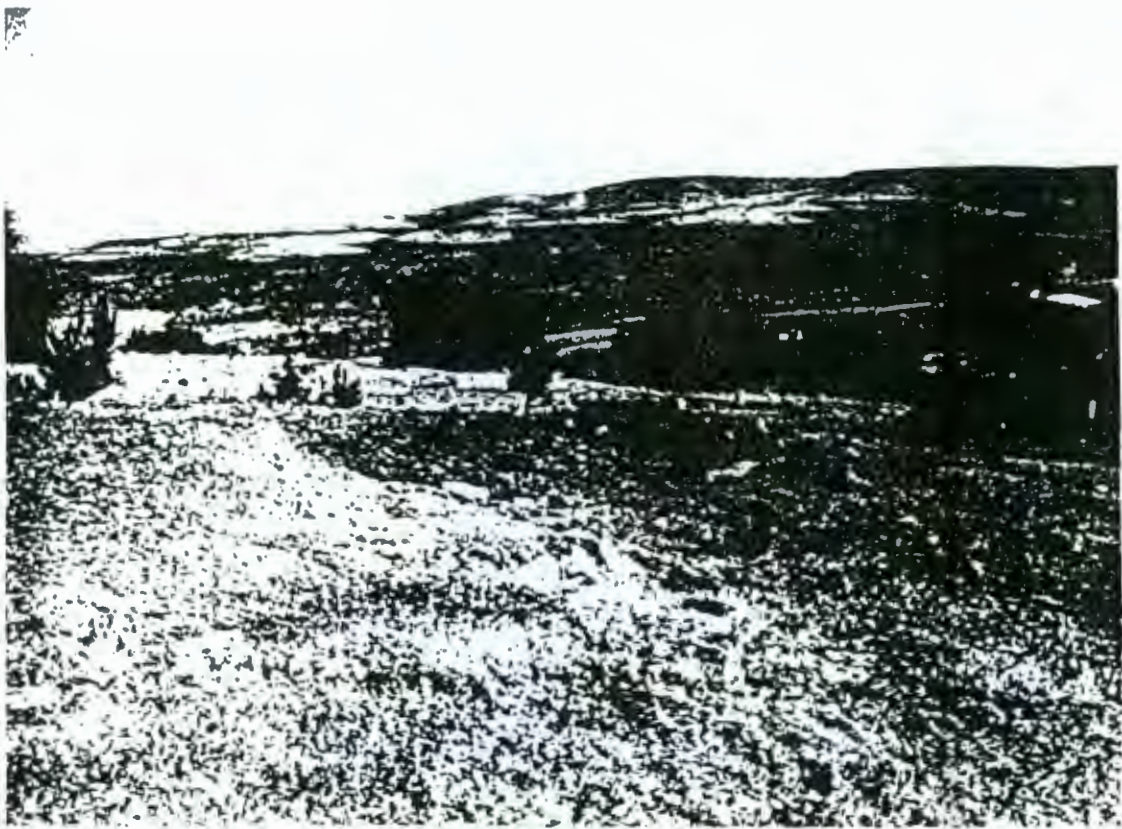
Figure 12 Photograph of B4 house remains with a broken lower grindstone

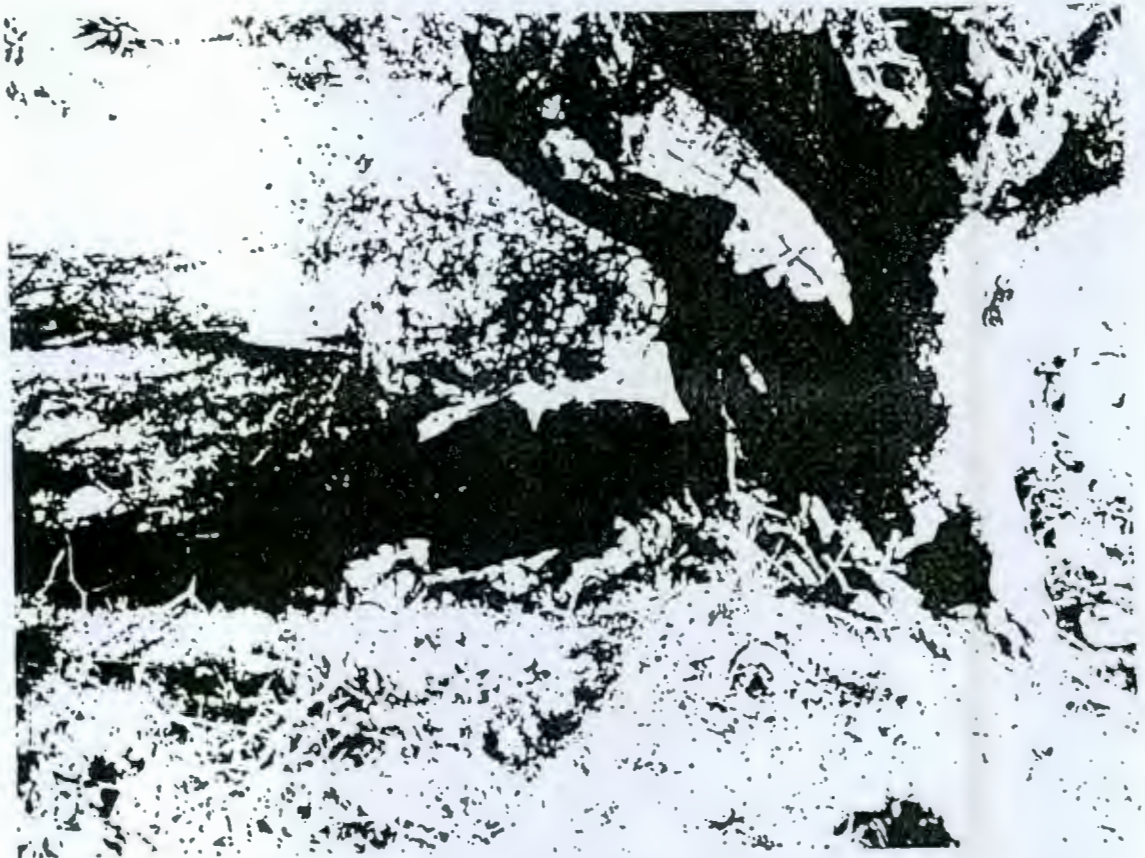
A cluster of large uncut stones is associated with this occupation area. (Fig. 13).

Figure 13 Photograph of large uncut stone cluster at Occupation Area B

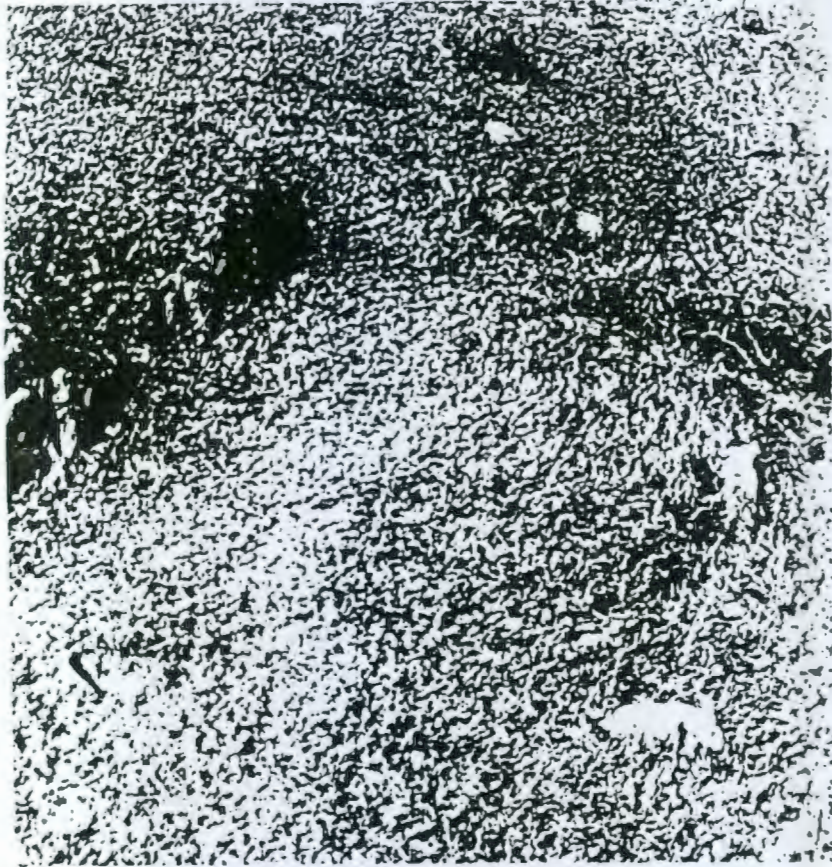
Figure 15 Photograph of platform and stone ring associated with C1

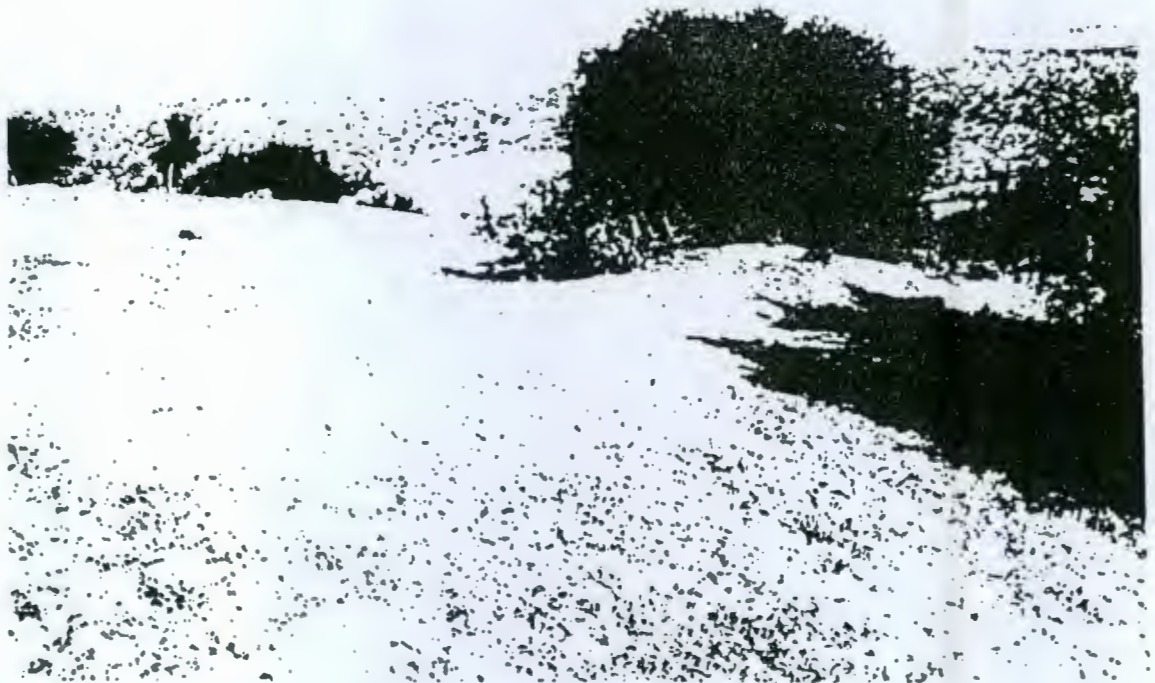
Figure 16 Photograph of C2 house remains

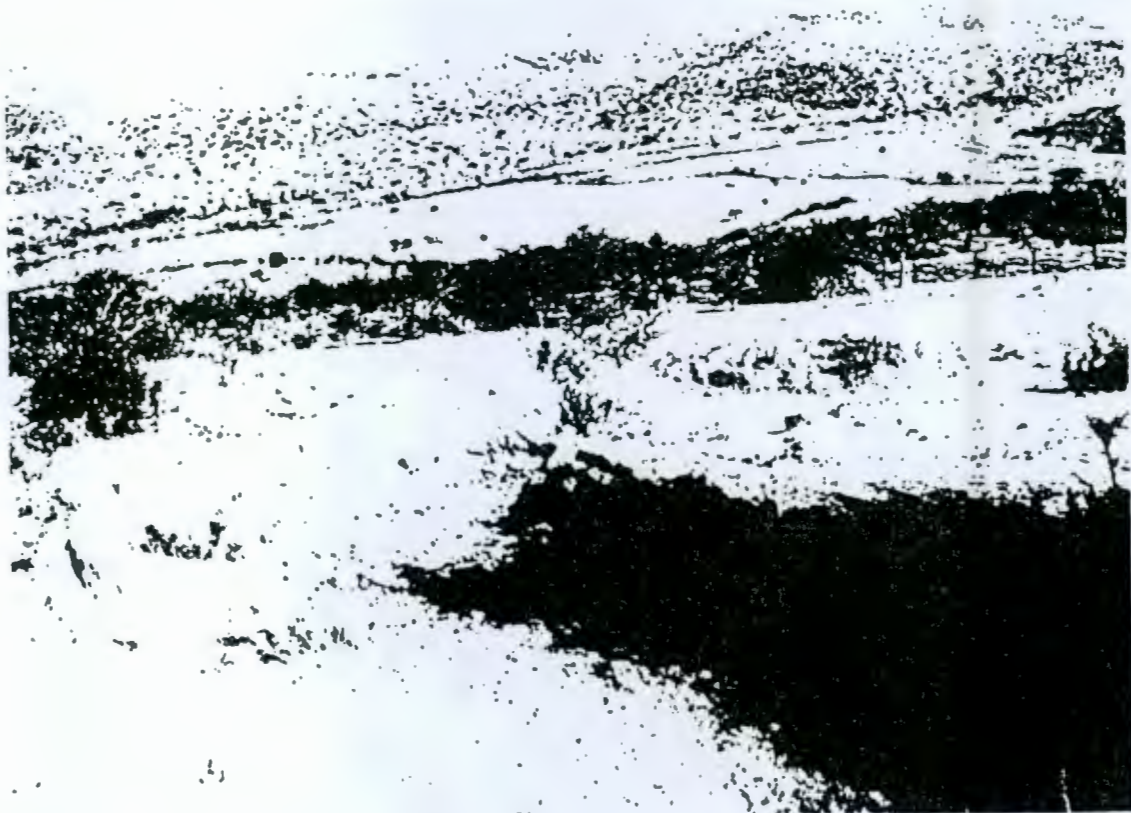
The lower sections of the walling at C3 and C4 houses are in tact. The remaining walling consists of clay box bricks (Fig. 16). Part of the C4 wall has intact wall plaster. The doors to these houses seem to have faced in a northerly direction (Fig. 17).

Figure 17 Photograph of house remains C3 and C4

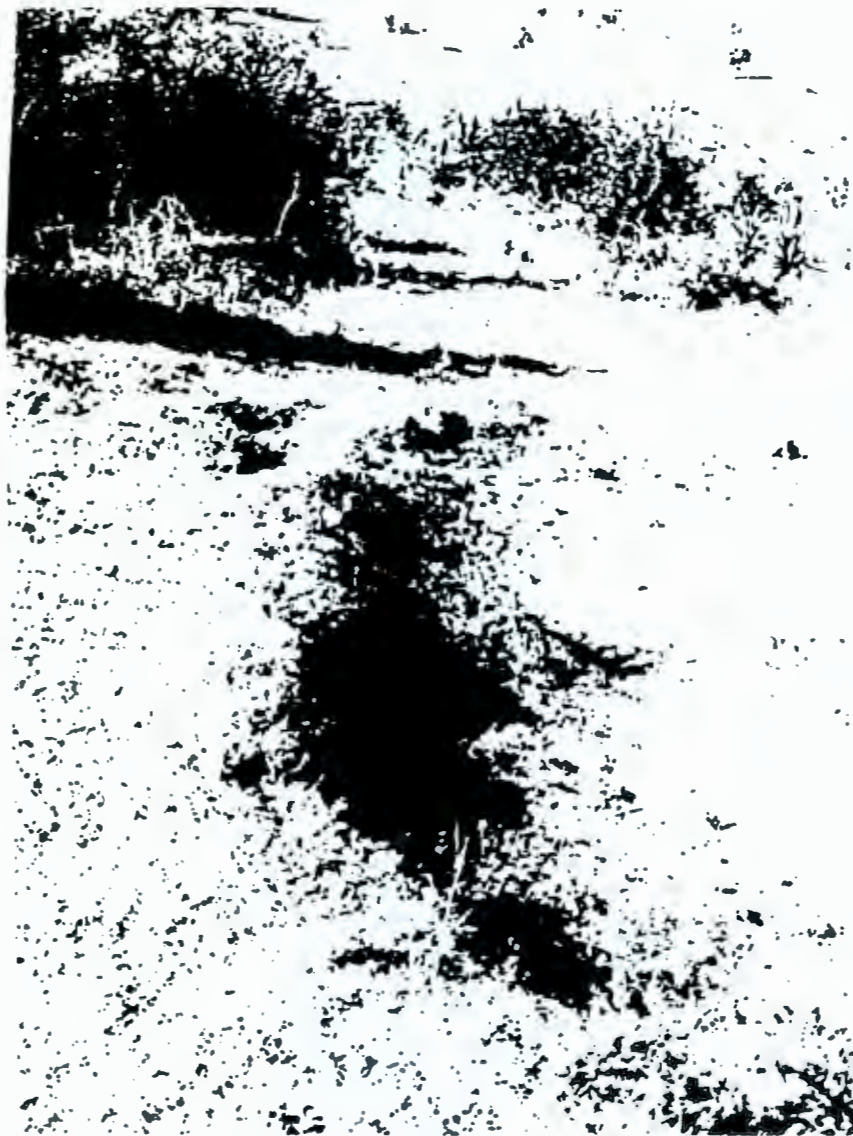
Courtyards C5 and C6 on which houses would have been located, were formed by cutting into the hill (Fig. 18) and building up the platform down slope. This resulted in two artificial terraces (Fig. 19). There seem to have been no support constructed for the up slope cuttings which are now eroding away.

Figure 19 Photograph showing terrace cutting detail

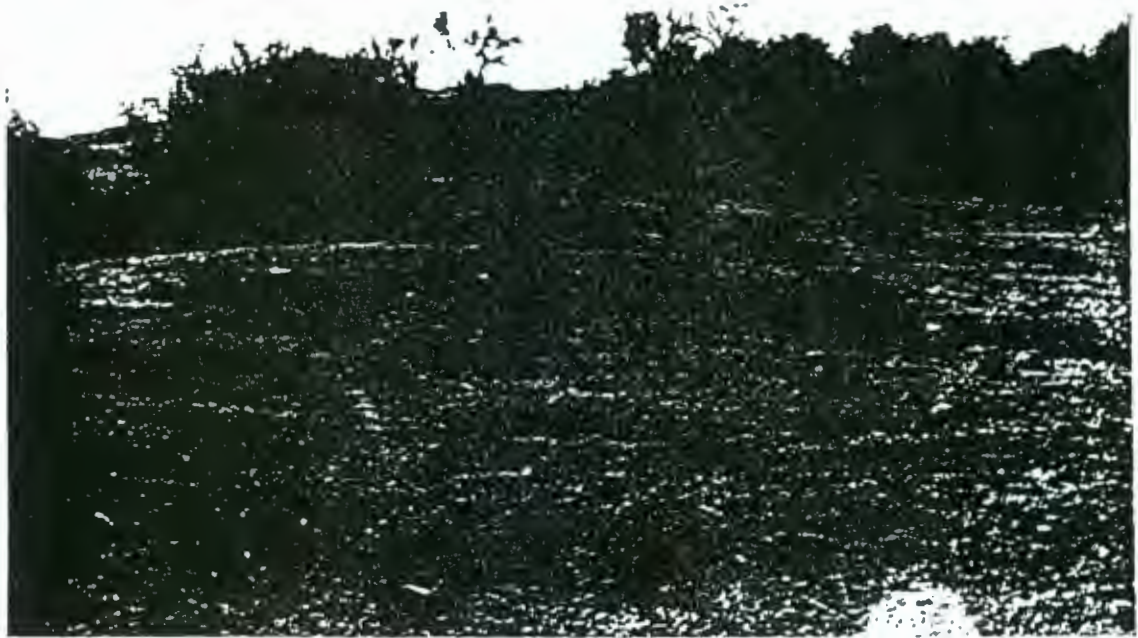
Figure 20 Photograph of terrace detail at Occupation Area C viewed from down slope
