## **A) Survey and condition assessment of archaeological sites in Weenen Nature Reserve and B) investigation into the possibility of opening a low-impact archaeological tourism destination**

Date visited	20 June 2018
Prepared by	Ms. Celeste Rossouw
Accompanied by	Mr. Frik Lemmer, Officer-in-Charge of Weenen Nature Reserve
Date completed	28 June 2018

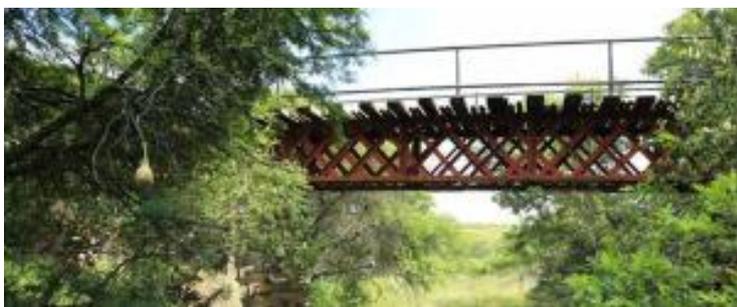
Figure No. 1: One of the old metal bridges in the Weenen Nature Reserve.

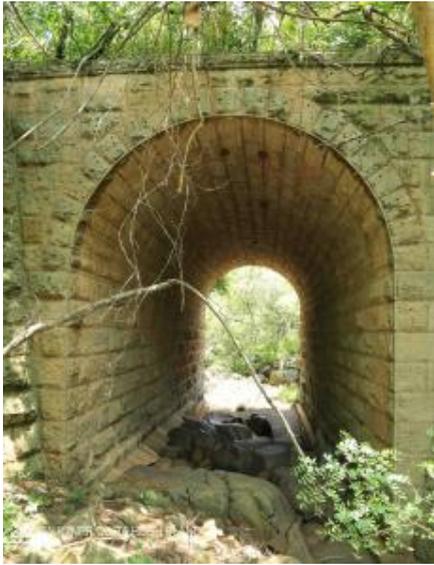
Figure No. 2: The Tierkloof sandstone bridge.

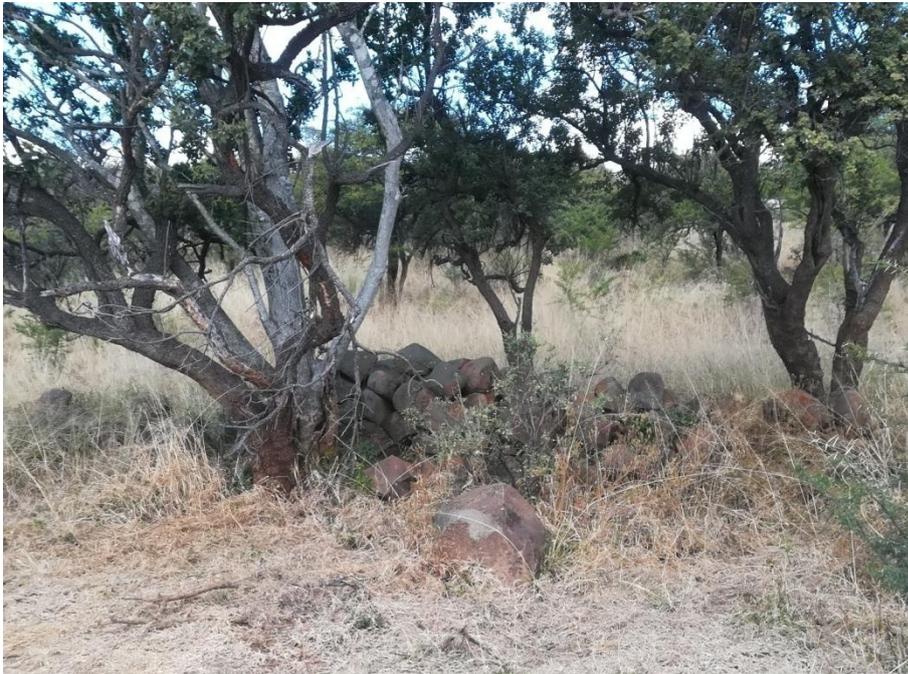
Figure No. 4: Example of soil reclamation work next to the road.

Weenen Nature Reserve has a collection of 51 clusters of soil reclamation systems. They are found next to roads in river beds and on terraces, descending from higher areas to lower sections. These “rock walls” endeavour to contain moisture, conserve soil nutrients and lessens soil erosion.

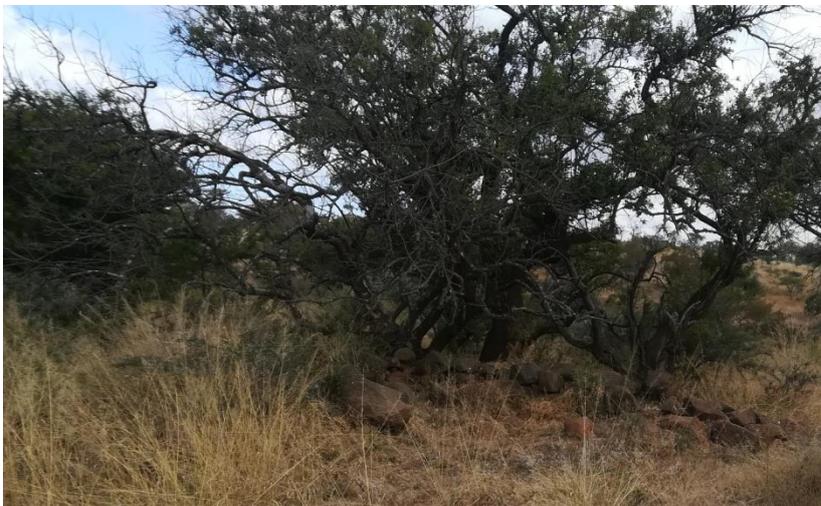
Figure No. 5: Another example of soil reclamation work.

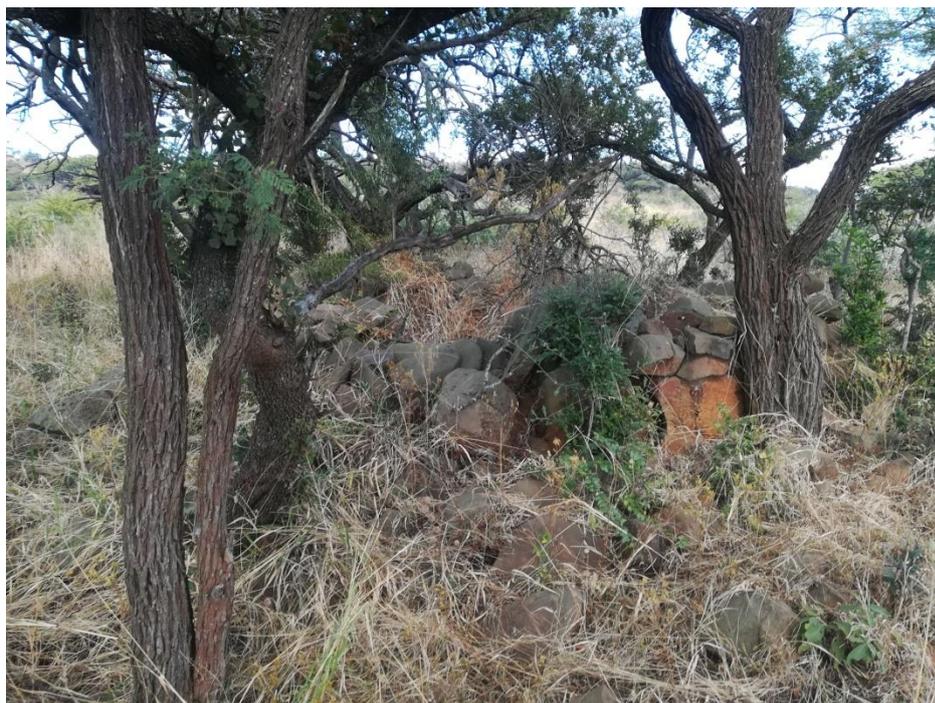
Figure No. 6: Grain bin holder (*izilulu*) with a diameter of 1,5m. The walls are about 1m high and it is in a good condition.

The grain bin holder is in a good condition.

No collection of stones from any archaeological or historically built structure is allowed based on both Ezemvelo KwaZulu-Natal Wildlife's management policies as well as Amafa/Heritage/Erferis KwaZulu-Natal's Heritage Act No. 4 of 2008, Section 36. (No one may alter, damage, destroy any archaeological....site).

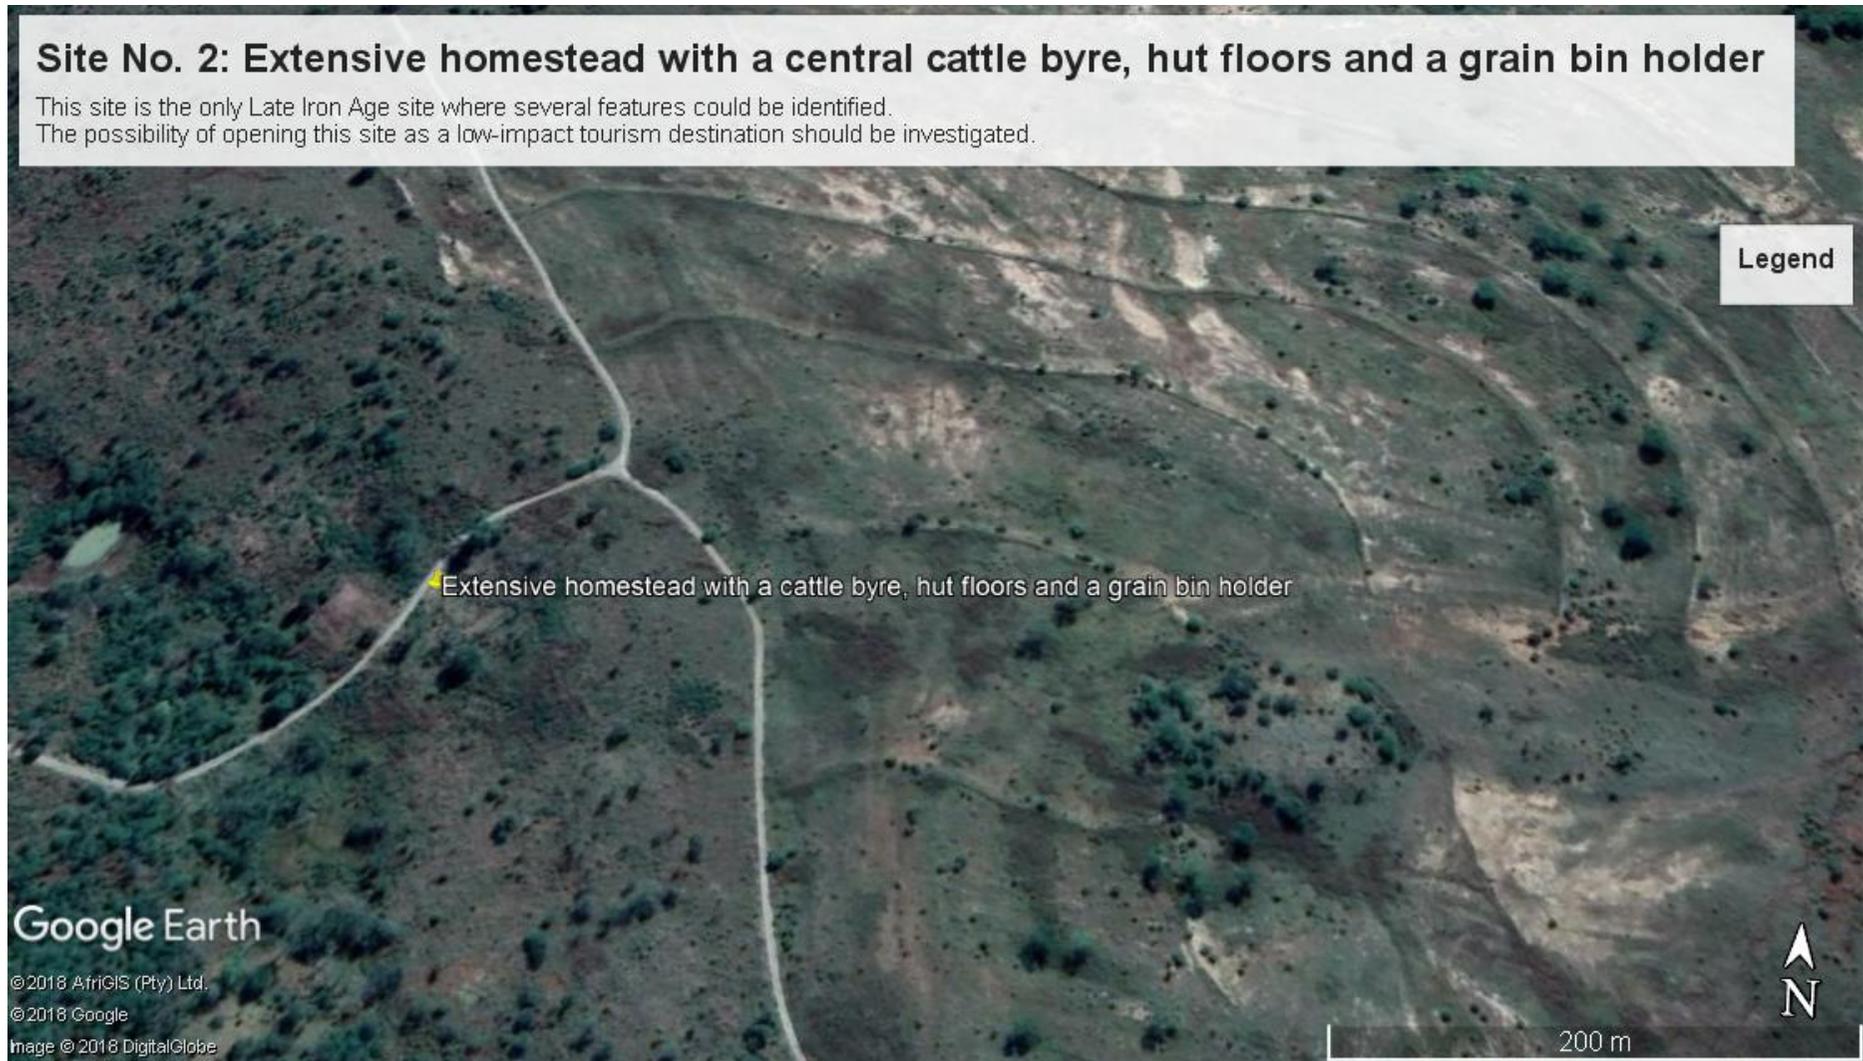
Figure No. 7: Example of the best preserved homestead (*umuzi*). Such a site can be developed as a low-impact Late Iron Age archaeological tourism destination.

It is recommended that the site should be burnt so that other features can be identified if they still exist. This will add to its research value and will ensure that all the features are conserved.

An initial proposal to develop this site as a low-impact tourism destination would have included the creation of a circular pathway around the *umuzi*. However, after discussion with Amafa's Deputy Director, Mr. James van Vuuren, concerns were raised that guests would be enticed to leave the pathway and walk over fragile hut floors while other visitors could illegally collect some of the stones from the livestock pens. These problems were solved when Mr. Frik Lemmer, Officer-in-Charge of the Weenen Management Unit proposed that, since there is area behind the *umuzi* that is much higher than the *umuzi* – that this area could act as a space where the cars could park and from where people could view the lay-out of the settlement pattern. The entrance to this higher portion of ground would be 15m from the *umuzi*.

After visiting Weenen and discussion the different sites identified and documented in 2014 and in 2018, with Mr. Lemmer, it was decided that Site No. 2 would be the best choice to open as a low-impact archaeological tourism site.

Site No. 2 has several advantages in comparison with the other sites identified and documented. This is the only site discovered, so far, where several features linked to the Late Iron Age, Central Cattle Pattern, is still present and can be seen. For instance the kraal in the centre, three hut floors surrounding the kraal as well as one grain-bin holder. None of the other sites documented had this much features that were still visible. There might still be other sites where these features can be found, taken into consideration that the site was occupied extensively from the 1850s to 1948. However, Site No. 2 is close to the road, it is easy to access and there it will be easy to create parking space on the opposite side of the road.

Other management considerations applicable to Site No. 2: No ash heap or artefact scatters were found. It is recommended that the site be burnt before any further development (such as the creation of a circular pathway around the *umuzi*) takes place to uncover any feature that was not identified.

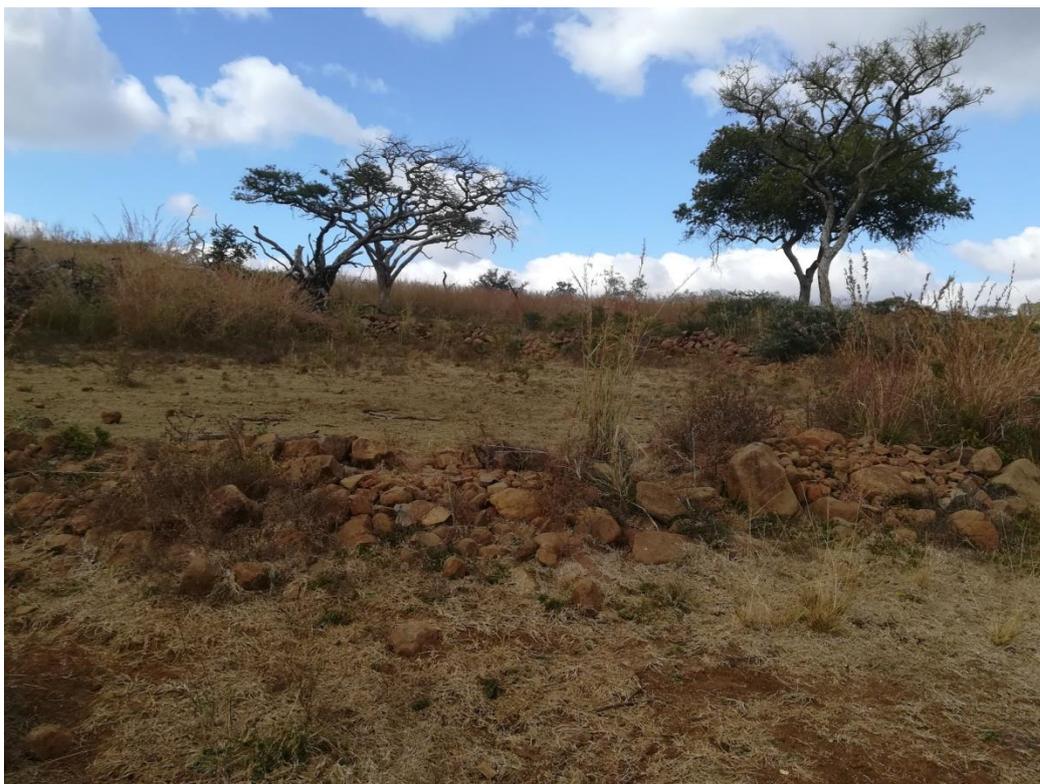
Figure No. 8: Large cattle byre in the centre of the Late Iron Age settlement.

The reason why the cattle byre/kraal (*isibaya*) is located in the centre of the homestead (*umuzi*) refers to the importance of cattle: The chief's wealth depended on the extent of his cattle stock, cattle was also offered during religious ceremonies to the ancestors<sup>4</sup>, mostly, inside the cattle byre. Cattle were used to obtain wives<sup>5</sup> via the “*lobola* system<sup>6</sup>” and cattle were traded for items such as glass beads, weapons, material, etc.

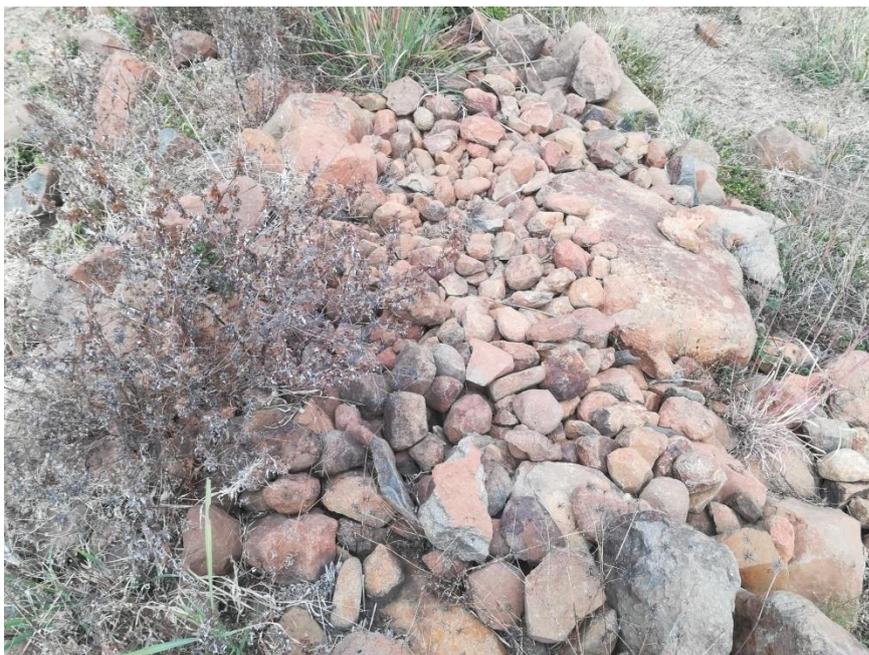
Figure No. 9: shows the building technique of the cattle byre – large boulders are used, to create the outer-limits of the wall, while the inside is filled with smaller random rubble.

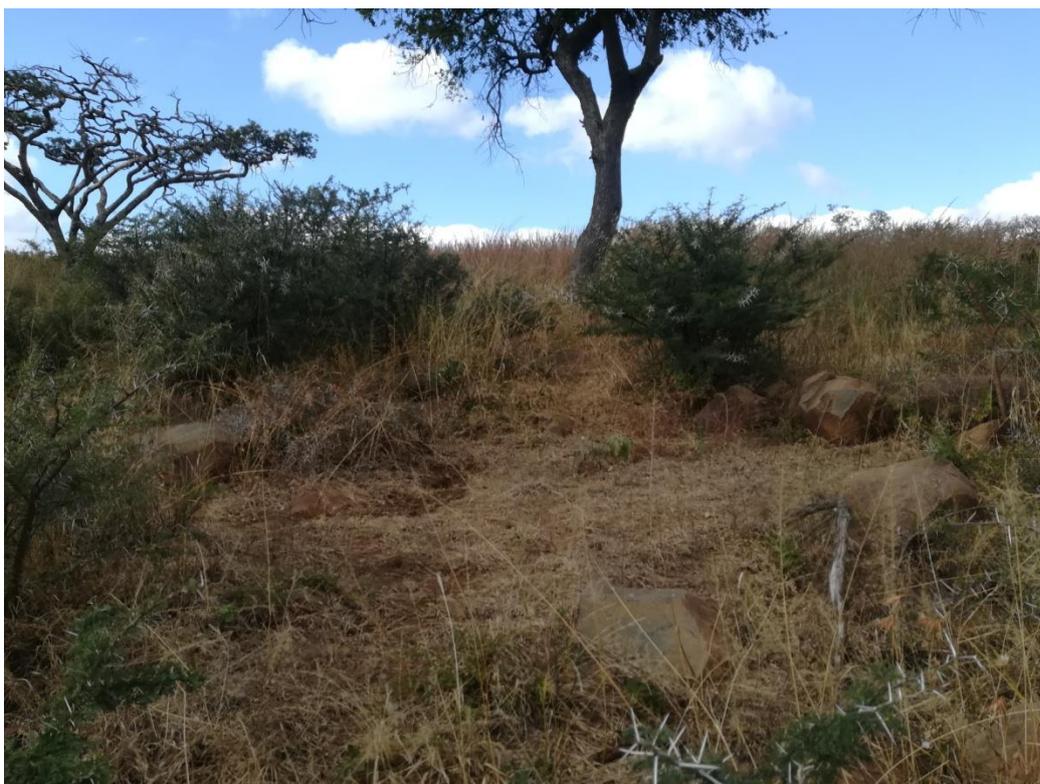
Figure No. 10: Hut floor one. Hut floors can be identified as whitish or ashy circular areas where vegetation does not grow.

The reason why vegetation does not cover hut floors is because the floors consist of a mixture of ant heap clay and cattle dung and these floors were restored every year by the addition of more of this mixture to the top of the floor. Secondly, if a fire is applied to these areas, the

floor hardens even more. This would be the case, since these sites are located within a protected area where fire zones and -breaks are burnt on an annual basis in the winter.

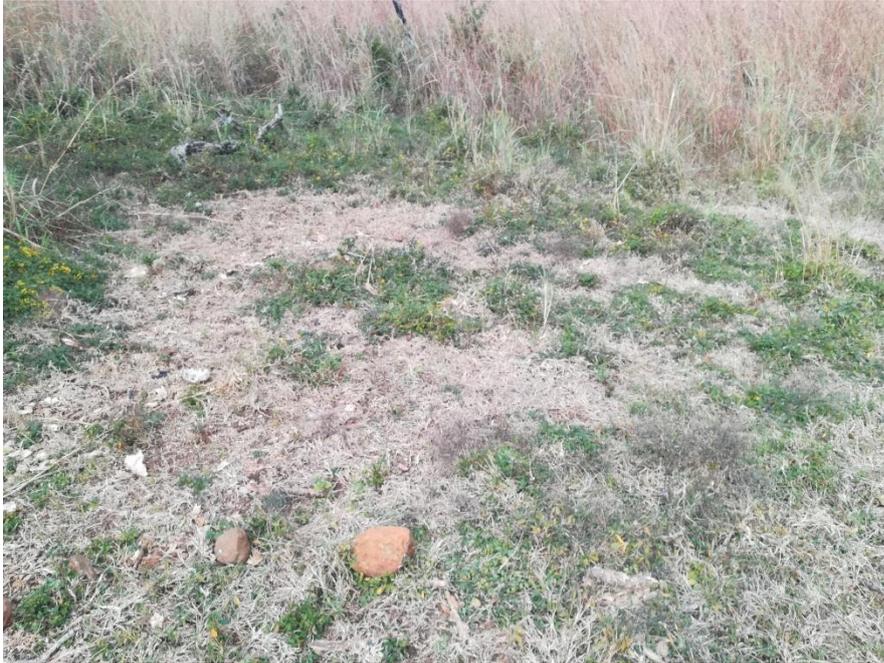
Figure No.11: Hut floor two in close approximation to the central cattle byre.

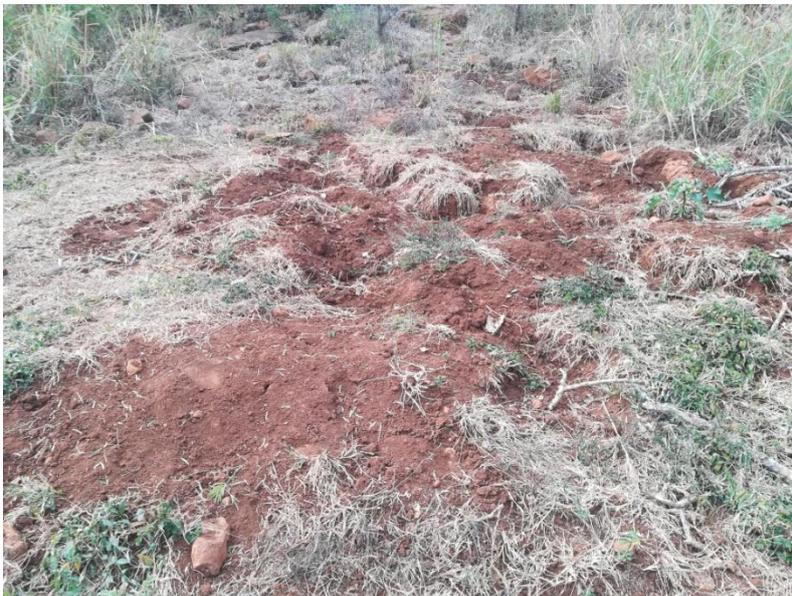
Figure No. 12: Hut floor three, possibly destroyed by the burrowing actions of porcupines.

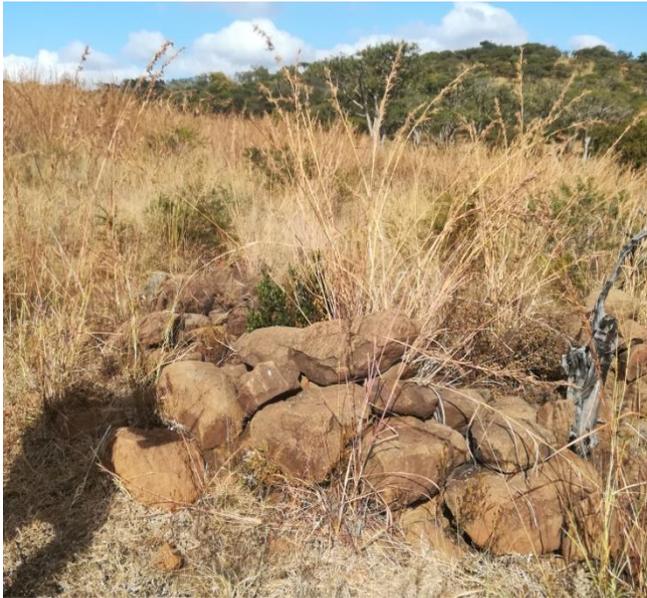
Figure No. 13: Grain-bin holder (The small circular structure is too small to function as an area where a milking cow or goats can be kept. It is also not a grave since the structure consists of a circular wall measuring about 1m in diameter.

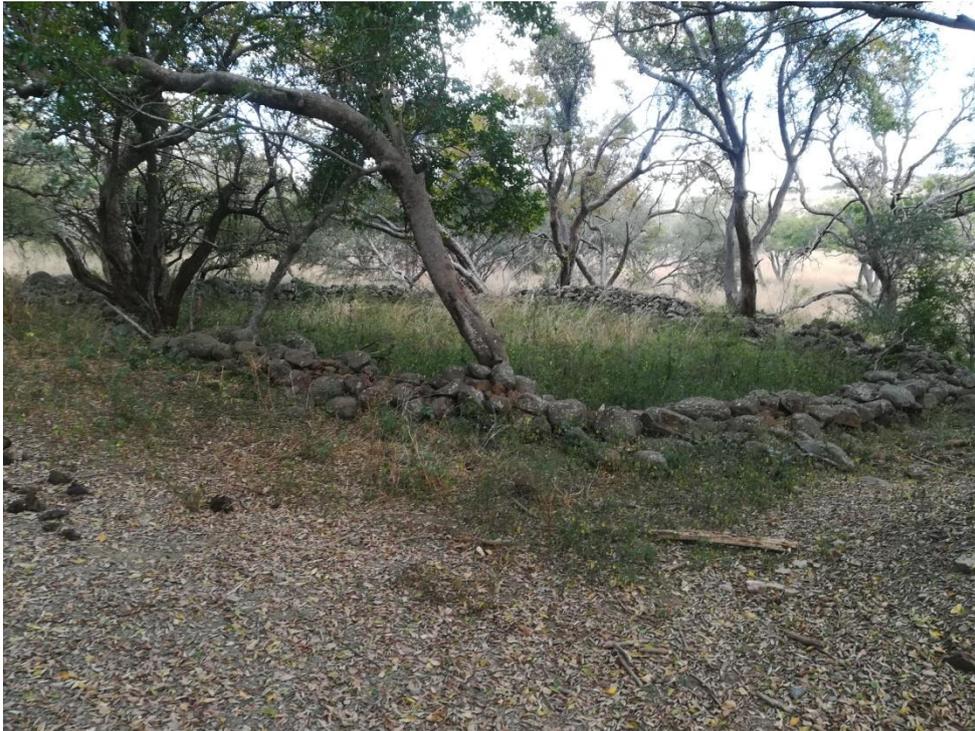
Condition: All the cattle live stock pens are well conserved.

Figure No.21: One large circular kraal on the left side of the road (going out of the nature reserve).

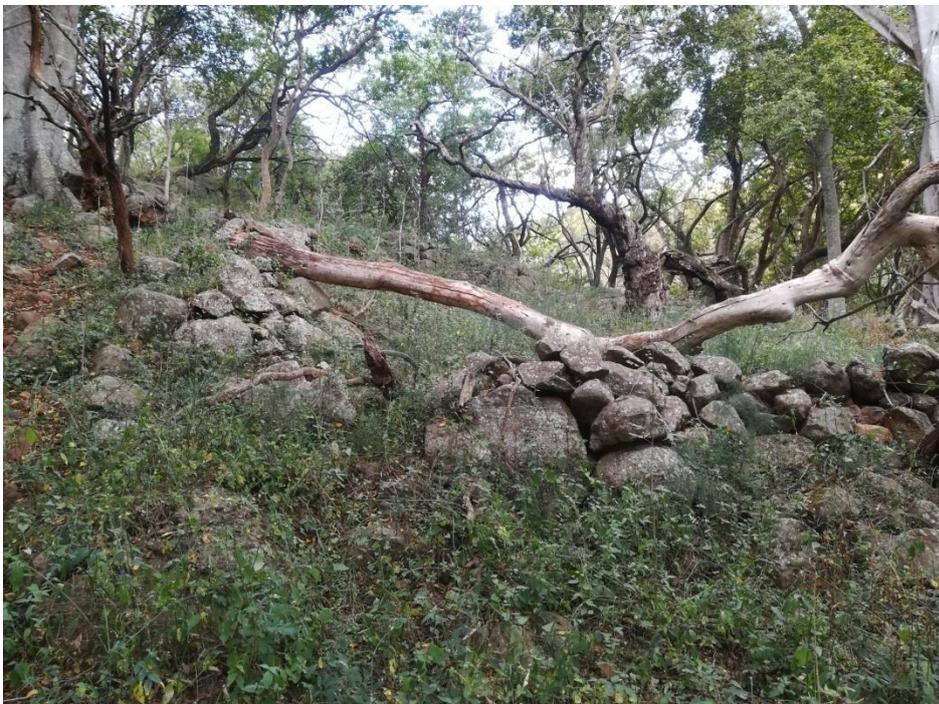
Figure No.22: Another large circular byre to the right of the road across Figure No.17.

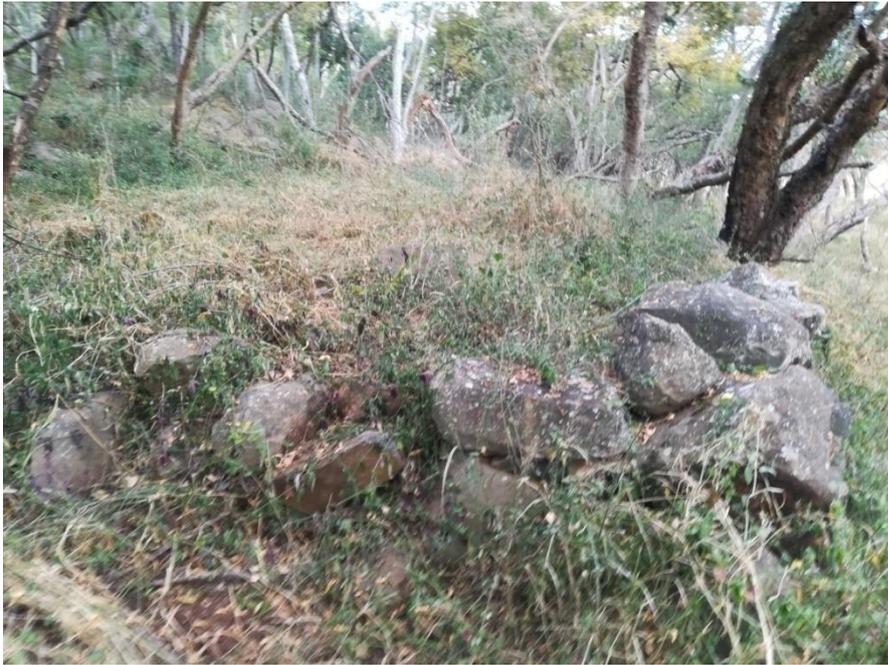
Figure No.23: A large rectangular byre about 200m from the other circular byres.

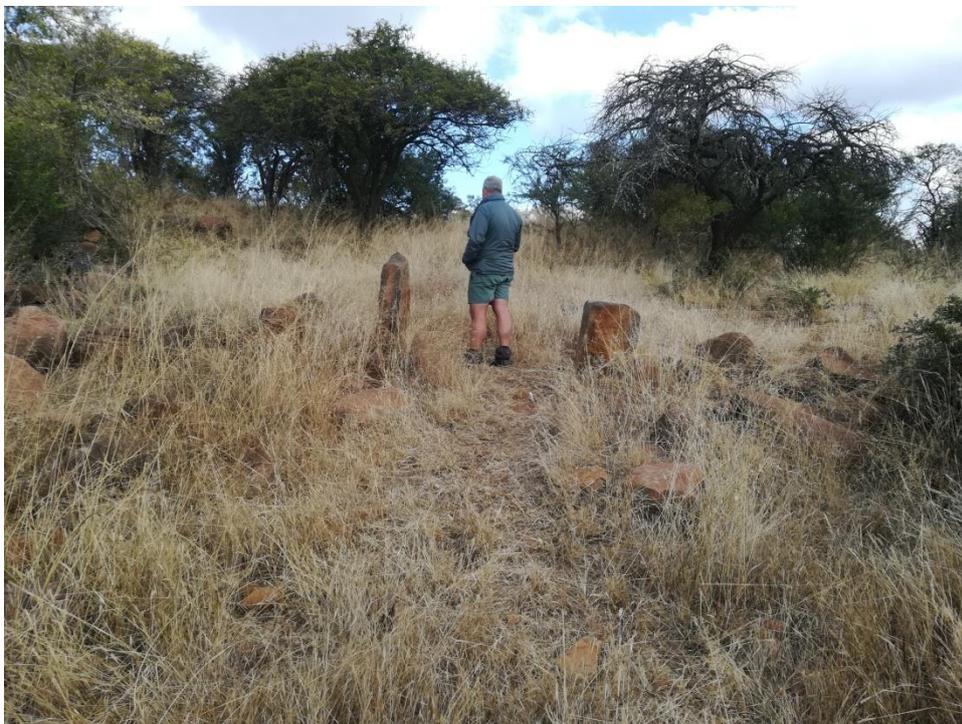
Site with several circular enclosures, what is unique to this site, is that the entrance is marked with two upstanding stones.

Figure No. 26: Shows a settlement pattern with a marked entrance to the cattle byre. The site has several enclosures, large and small close to each other.

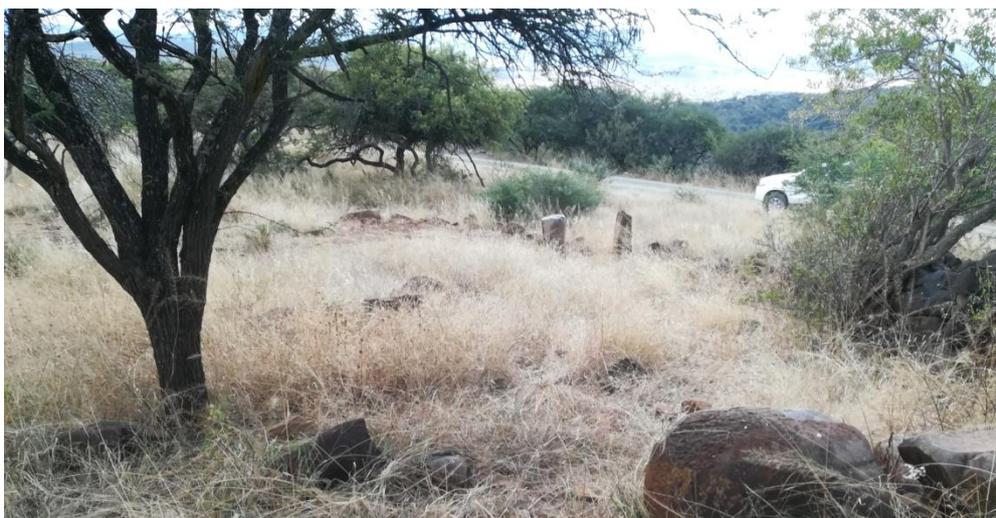
Figure No.27: Central Cattle byre, the kraal's walls are not as well conserved in comparison with the previously discussed site. However, other byres behind the central cattle kraal are in a better condition and the walls are nearly a meter high.

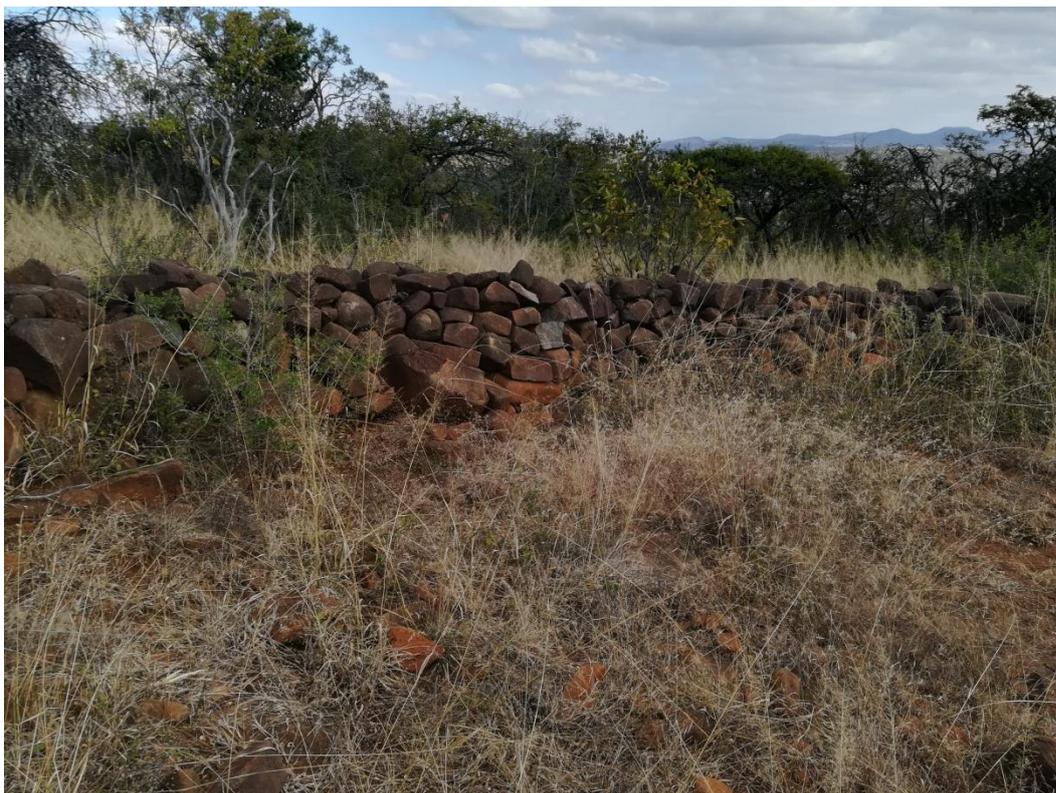
Figure No.28: Large oval byre behind main entrance byre. The walls are well conserved and nearly a meter in height.

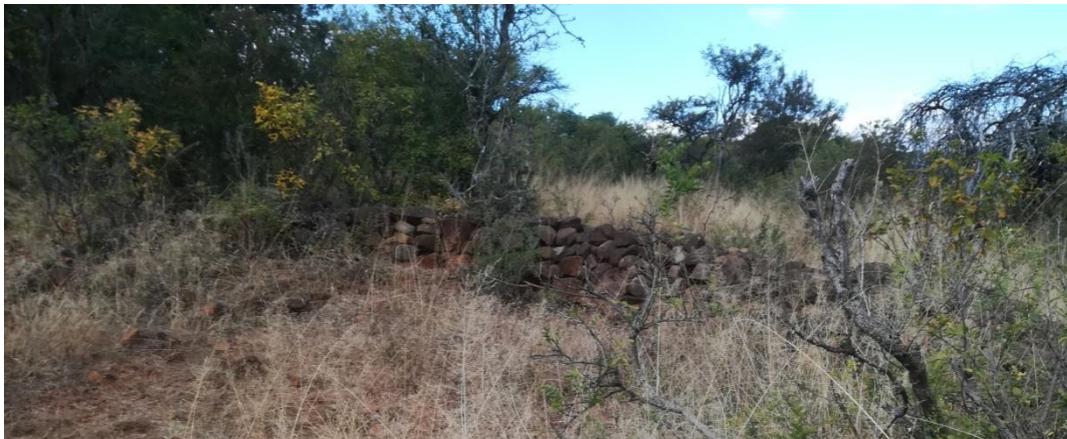
Figure No. 29: More kraal walls behind the entrance byre - some of the kraals are modern since their shapes are rectangular.

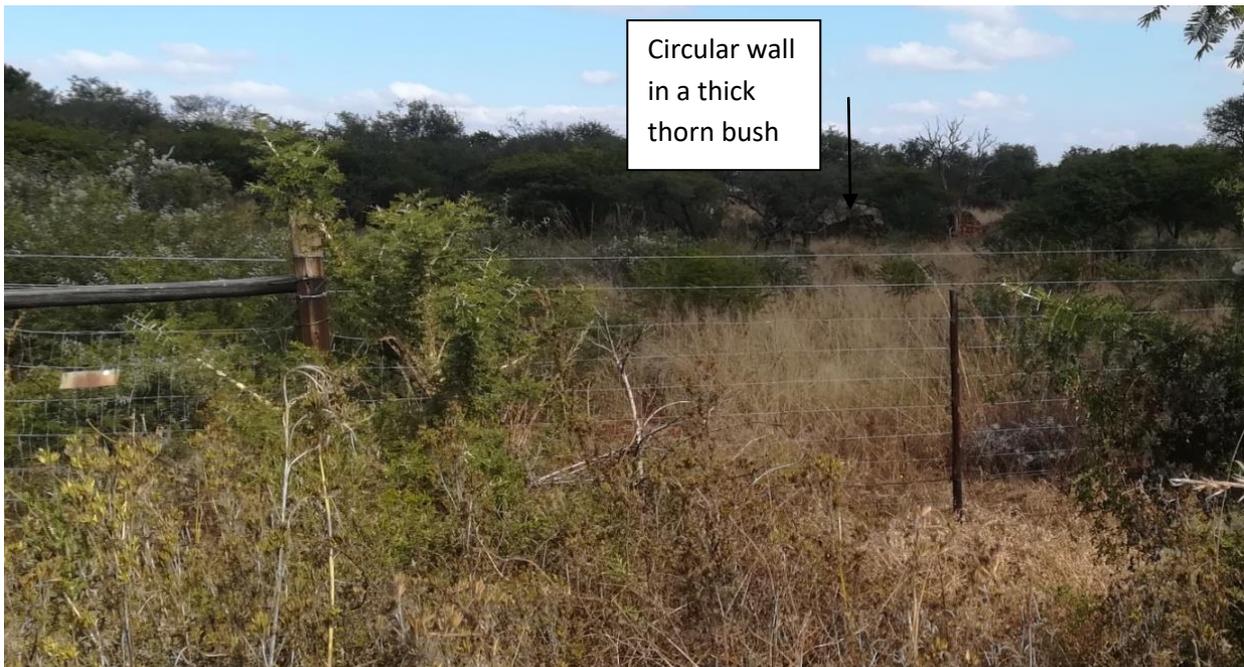
Figure No. 31: The site's wall can be seen from the road.

It is difficult to access the site, since it is fenced-off from the R74 road. Secondly, if this site was to be developed as a low-impact tourism destination, the site would pose an accident hazard since the area is on a small hill, and a blind bend – the cars parking and leaving the terrain (if a parking area was to be developed next to the road) would not be able to see oncoming cars.

For the above-mentioned reasons it is not recommended to open the site as a public destination. Even if the site was not “dissected” from the Weenen Nature Reserve it would cost EKZNW too much to create a road to the site, as it is far from any vehicle route inside the reserve.
