**NATIONAL MONUMENTS COUNCIL
SURVEY OF CONSERVATION-WORTHY
PROPERTIES IN
HANOVER**

**DRAFTED FOR USE AS A
DOCUMENT FOR CONSULTATION
BETWEEN THE NMC
AND THE HANOVER MUNICIPALITY**

**COMPILED BY: R.W. BRANN
REGIONAL REPRESENTATIVE
NORTHERN CAPE**

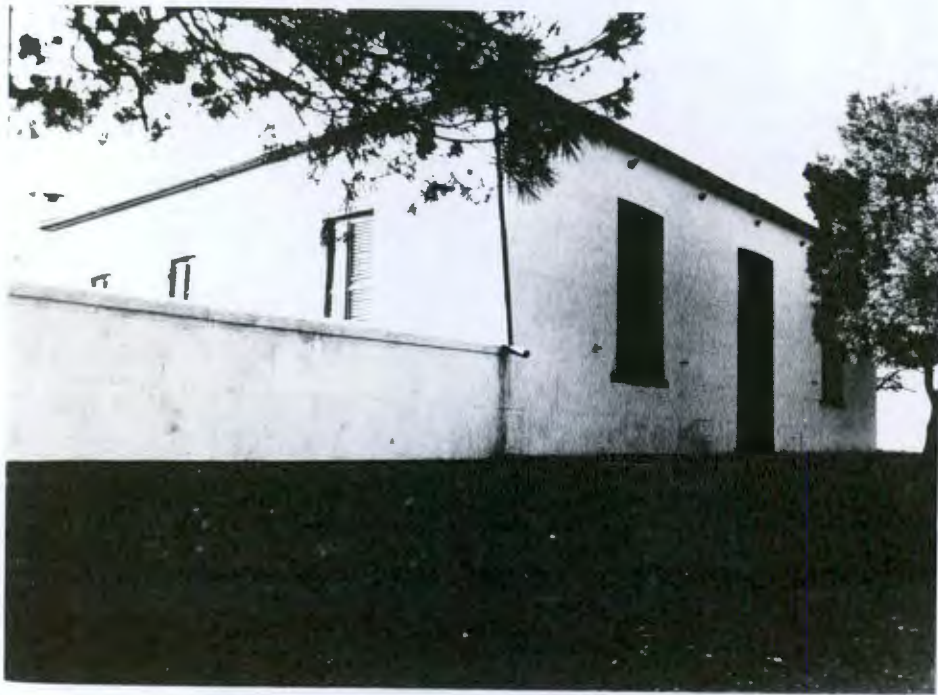
1.1

LOCATION : Hanover
ERFNO : 49, Hanover
SIGNIFENG : Single storey Karoo building of square form with hipped roof. Original fenestration - sliding sash windows with shutters. Building is on a raised stoep. Surrounded by high boundary wall with stone base.

SIGNIF : Intact Karoo dwelling with interesting site features, including boundary wall and outbuilding.

CURRENTCOND : Good
CURRENTUSE : Residential
CONSTRDATE : Late 19C
DATEALTERED : N/A
CONSTRMAT : Plastered Brick, corrugated-iron roof
CATRATING : 2
NMCCAT : Register
CATALOGUE : NMC Survey of Hanover, August 1991. Brann RW P 1; Block 01, Bld 1

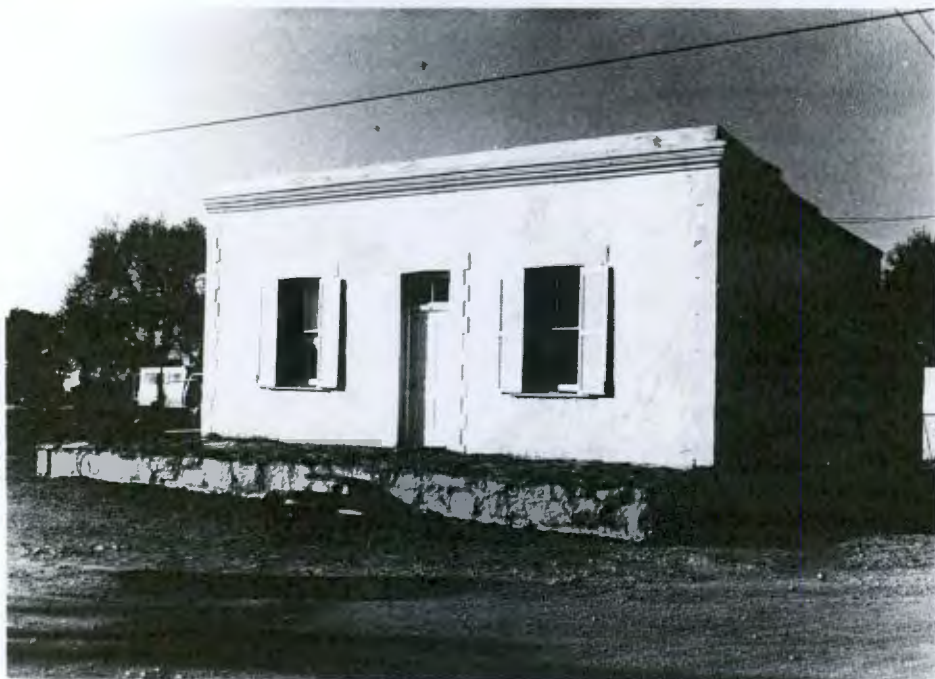
2.1

LOCATION : c/o Burger and New Streets, Hanover
ERFNO : 50, Hanover
SIGNIFENG : Single storey Karoo house of square form with flat roof. Decorative cornice on front facade and quoining to parapet. Symmetrically placed 2X2 sliding sashes. Central double Victorian door. Building is on raised shale stoep.

SIGNIF : Fine example of a Karoo building with decorative cornice and quoining round openings.

CURRENTCOND : Good
CURRENTUSE : Residential
CONSTRDATE : Late 19C
DATEALTERED : N/A
CONSTRMAT : Plastered Brick, corrugated-iron roof
CATRATING : 2
NMCCAT : Register
CATALOGUE : NMC Survey of Hanover, August 1991. Brann RW P 1; Block 02, Bld 1

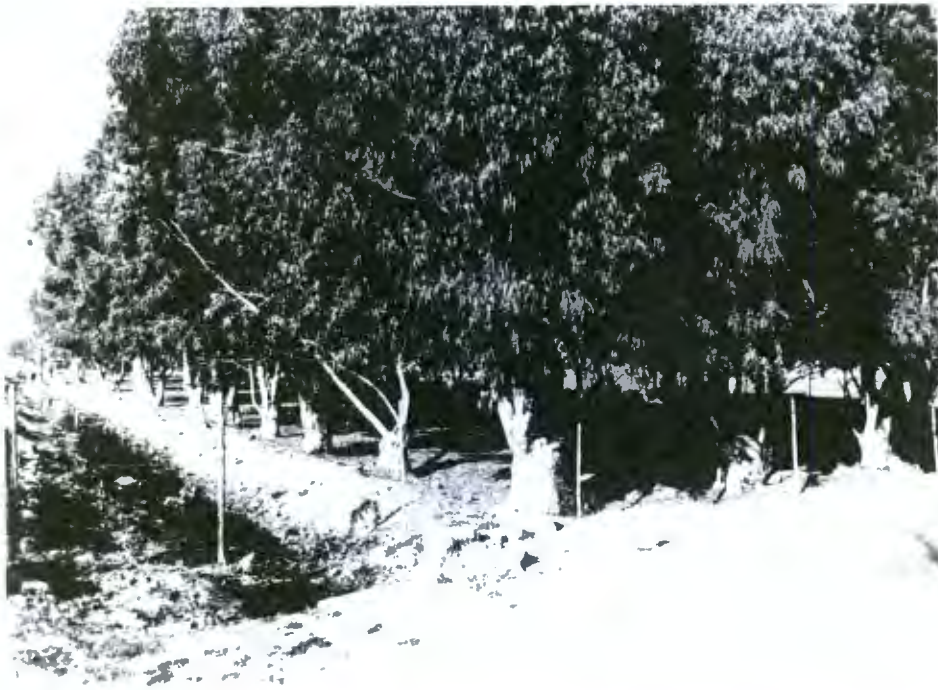
3.1

NAME : Irrigation furrow and trees on eastern side of town, Hanover

SIGNIFENG : Open space with numerous gum trees. Irrigation canal.

SIGNIF : Aesthetically pleasing precinct which gives character to Christoffel Street.

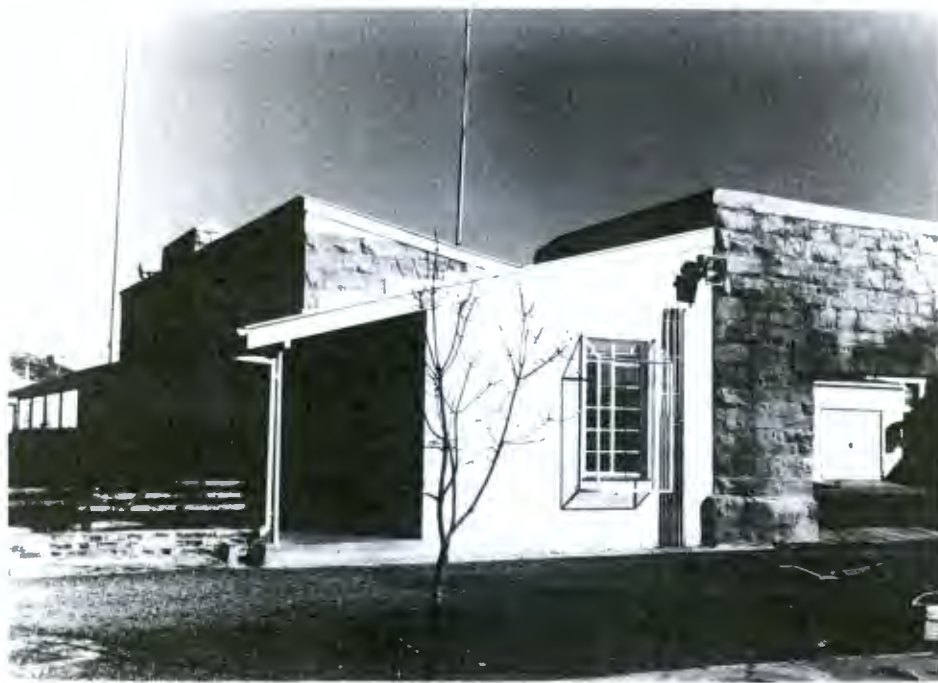
NAME : Police Station and Gaol 3.2

SIGNIFENG : Interesting stone buildings, the gaol has a flat roof, the police station - a saddle roof. Parapet above the main entrance of the gaol. Original sash windows on the gaol, also Victorian verandah. Stone-work has been painted grey.

SIGNIF : Fine example of a late 19th century police station and gaol of stone construction.

CURRENTCOND : Good

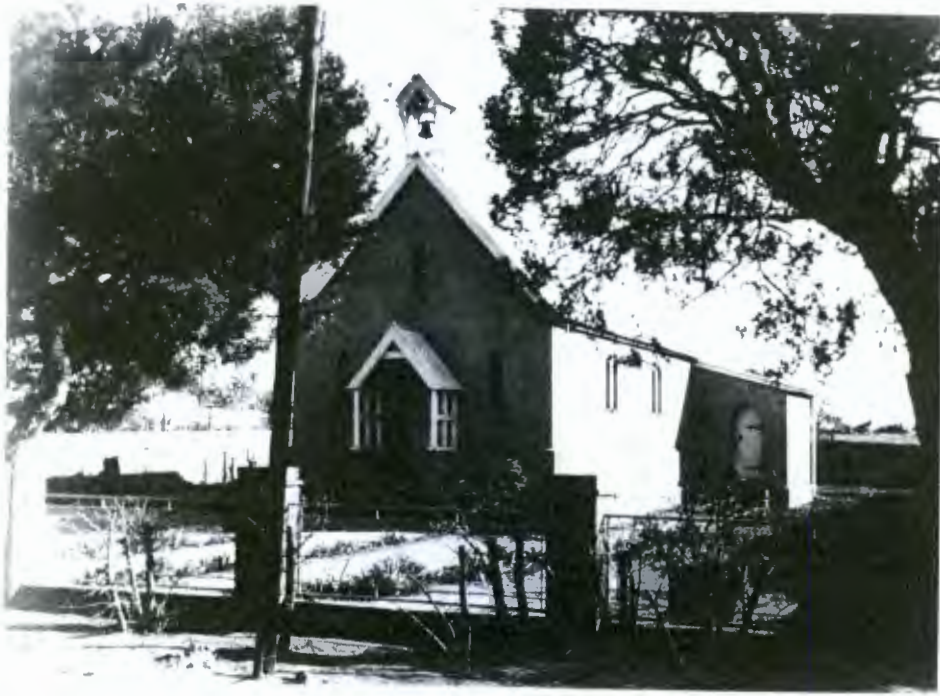
NAME : Church, Church Street, Hanover 3.3

SIGNIFENG : Small church with front wooden portico and saddle corrugated iron roof. Lean-to on eastern facade. Vernacular with simple gothic elements. Property partially Surrounded by stone wall.

SIGNIF : A fine example of a vernacular church building which is intact.

CURRENTCOND : Good

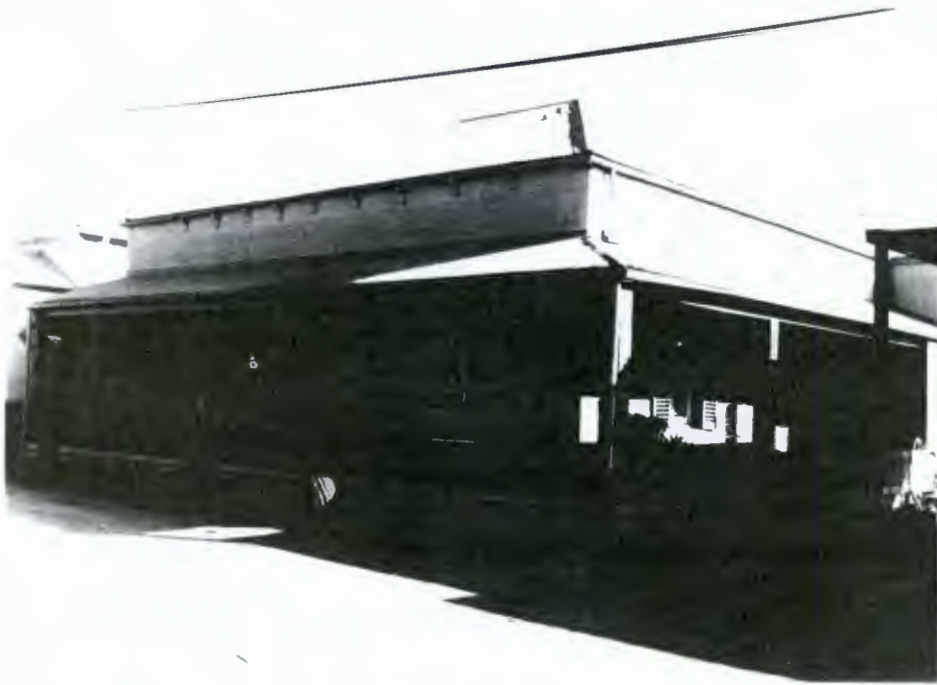
3.4

NAME : Dwelling, 7 Church Street, Hanover

SIGNIFENG : Karoo style building with hipped roof. Original 12X12 sliding sash windows with shutters and central double door with fanlight on front facade. Raised stoep and wrap-around verandah. Alteration to east facade - steel window replacing original.

SIGNIF : Fine example of a Karoo dwelling in Hanover which is largely intact with the exception of an insensitive steel window on the east facade.

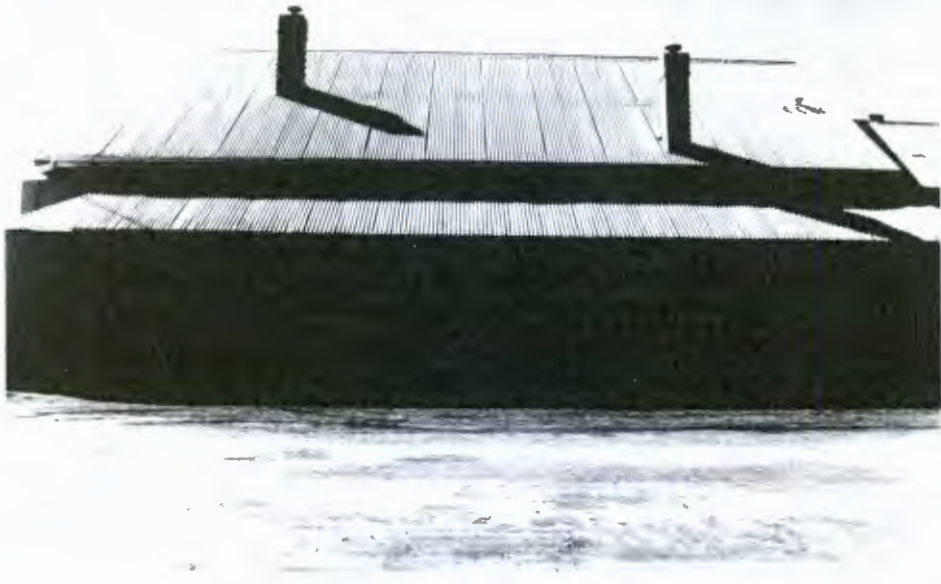
7.1

NAME : Dwelling, c/o Queen and Church Street, Hanover

SIGNIFENG : L-shaped Karoo style cottage with hipped L-form corrugated iron roof. Original 6X6 sliding sash windows and central door. Original verandah appears to have been removed - one stoepkamer window. Low front boundary wall.

SIGNIF : Fine example of a Victoria-Karoo style building on a corner site opposite the old prison. Boundary walls are a special feature.

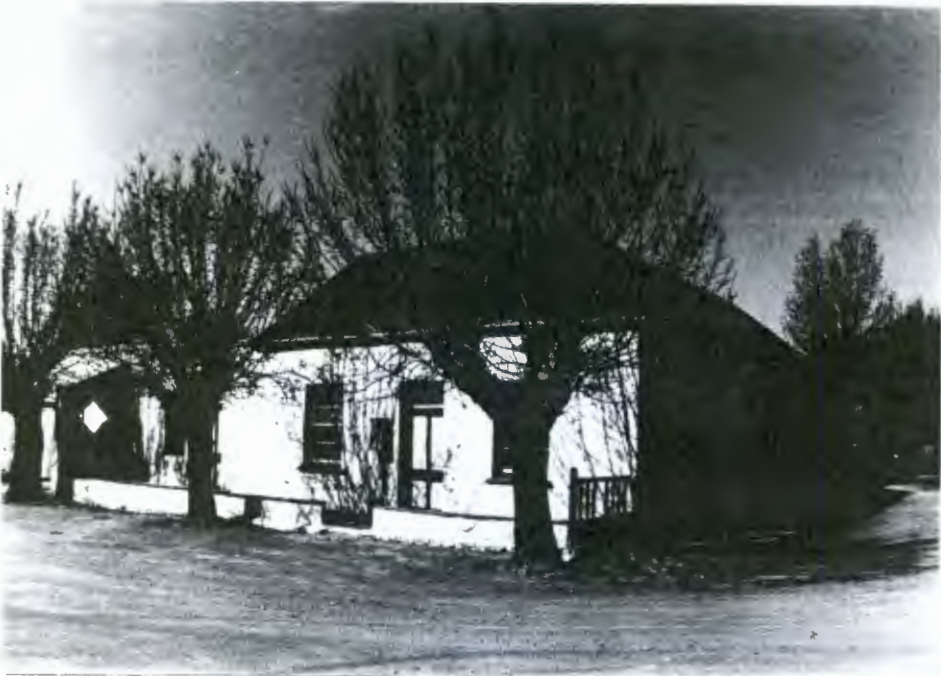
8.1

NAME : Dwelling, c/o Rhyneveldt and Darling Street, Hanover

SIGNIFENG : Single storey Victorian house with complex roof. Verandah enclosed by modern windows. Two forward projecting bays. Original windows on these bays. Quoining on forward projecting bays. Decorative finials, air vents and barge boards.

SIGNIF : Fine Victorian building. Modern enclosure of verandah damages appearance to some extent.

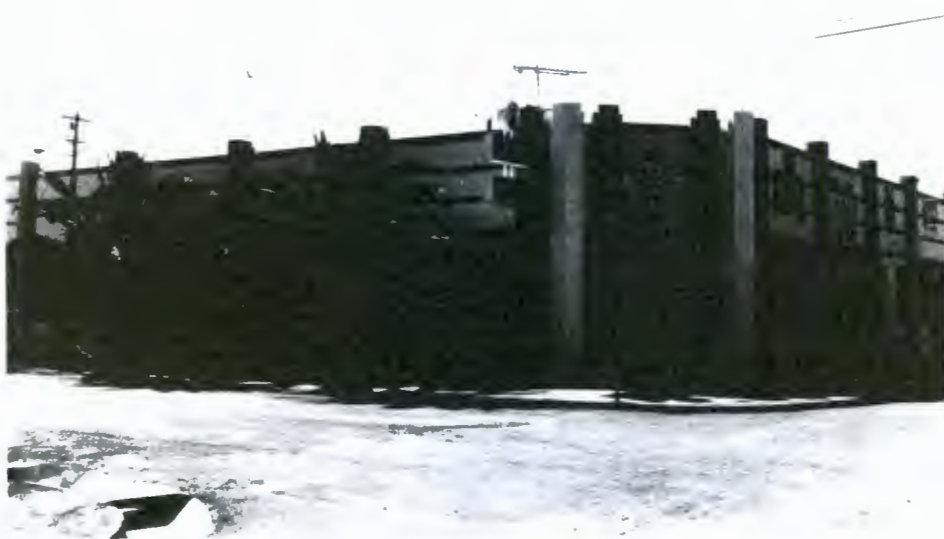
NAME : Shop complex, Market Street, Hanover 10.1
LOCATION : Market Street, Hanover
ERFNO :
SIGNIFENG : Single storey rectangular form shop complex with some original sliding sash windows and doors. Complex roof. Cape rivival gable. Ogee verandah supported by bullet head piers. Raised stoep
SIGNIF : This building contributes to the environment in Market Street.
CURRENTCOND : Fair
CURRENTUSE : Unoccupied
CONSTRDATE : Early 20c
DATEALTERED : N/A
CONSTRMAT : Plastered brick, corrugated iron roof.
CATRATING : 2
NMCCAT : Register
CATALOGUE : NMC Survey of Hanover, August 1991. Brann RW P 10; Block 10, Bld 1

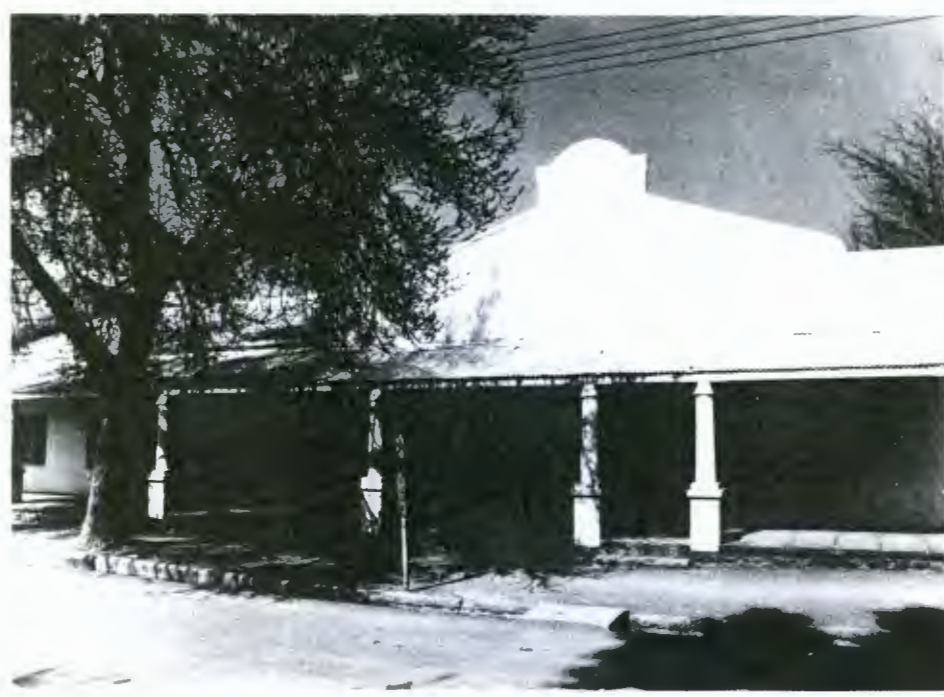
NAME : Shop c/o Daling and Loop Street, Hanover 10.2
LOCATION : c/o Darling and Loop Street, Hanover
ERFNO : 294, Hanover
SIGNIFENG : Vacant shop. Single storey with corrugated iron saddle roof and forward projecting gablet with dormer window. Original 2X2 sliding sash windows, symmetrically placed on either side of front door. Raised stoep
SIGNIF : Fine early corner building in Hanover with original doors and windows.
CURRENTCOND : Fair - deteriorating
CURRENTUSE : Vacant
CONSTRDATE : Late 19c
DATEALTERED : N/A
CONSTRMAT : Plastered brick, corrugated iron roof.
CATRATING : 2
NMCCAT : Register
CATALOGUE : NMC Survey of Hanover, August 1991. Brann RW P 10; Block 10, Bld 2

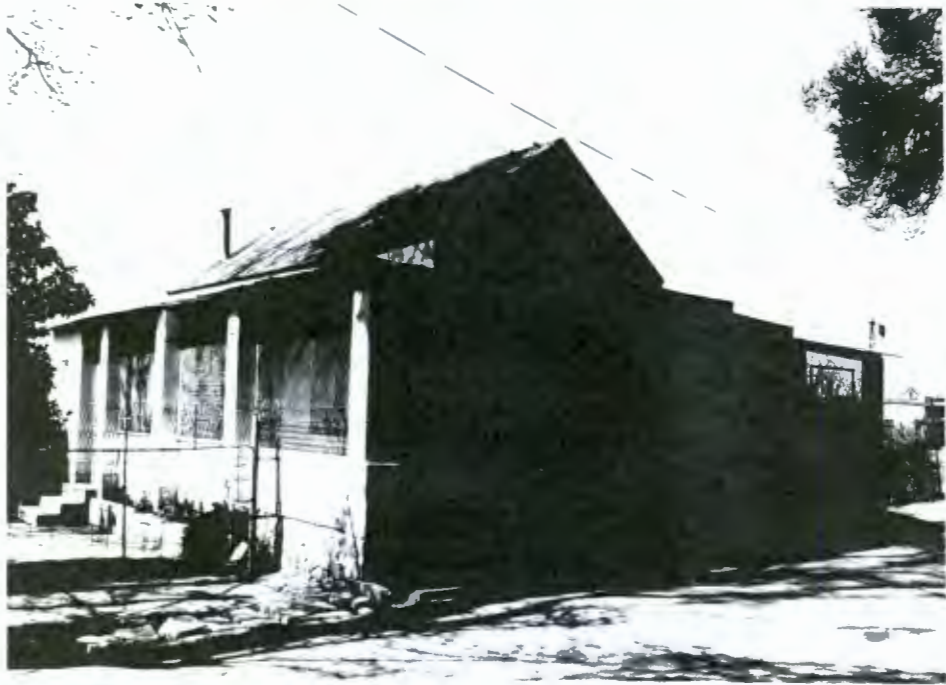
NAME : Dwelling, Bell Street, Hanover 11.2

SIGNIFENG : Interesting vernacular building with saddle roof and lean-to additions. Buttresses support lean-to at rear of building. Raised stoep, wrap-around verandah. Original windows and doors intact. Property is situated on large erf. Verandah fenced in.

SIGNIF : Fine example of vernacular architecture in Hanover.

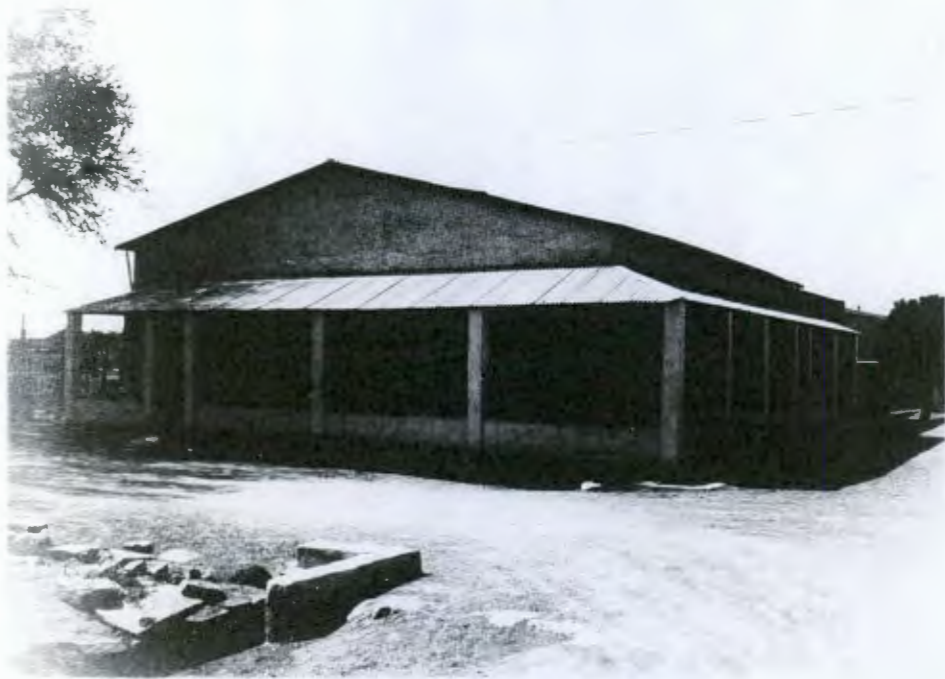
11.3

LOCATION : Dwelling c/o Bell and Berg Street, Hanover
ERFNO : 380, Hanover
SIGNIFENG : Single storey house of square form with low saddle roof and wrap-around verandah supported by brick columns on raised stoep. Original doors and windows. Windows and door surrounded by quoining on front facade.

SIGNIF : The building contributes the environment and although not of great intrinsic merit is intact.

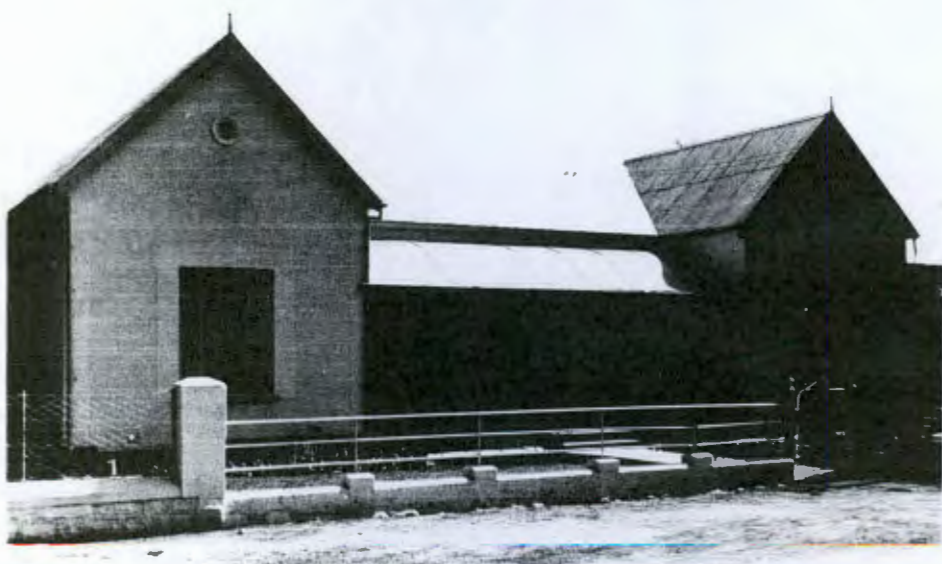
12.1

LOCATION : Dwelling c/o Darling and Berg Street, Hanover
ERFNO : 515, Hanover
SIGNIFENG : Single storey Victorian house with corrugated iron saddle roof and two forward projecting bays on either side of ogee verandah supported by a modern brickwork columns. Lean-to additions on Darling and Berg Street elevations. Original casement windows.

SIGNIF : Fine example of Victorian house in Hanover. Largely intact.

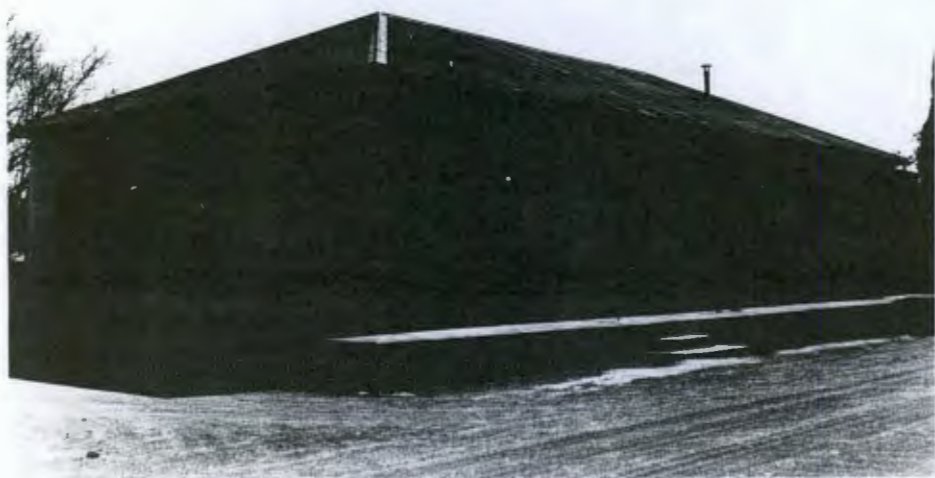
NAME : c/o Duncan and Darling Street, Hanover 12.2

SIGNIFENG : Single storey rectangular form house with hipped roof. Double doors on both elevations. 2X2 sliding sash windows with shutters. Decorative detailing above all openings. Roof support trusses visible on exterior of building. Raised wrap-around stoep.

SIGNIF : Excellent example of historic architecture in Hanover. Building is intact and makes a major contribution to the environment.

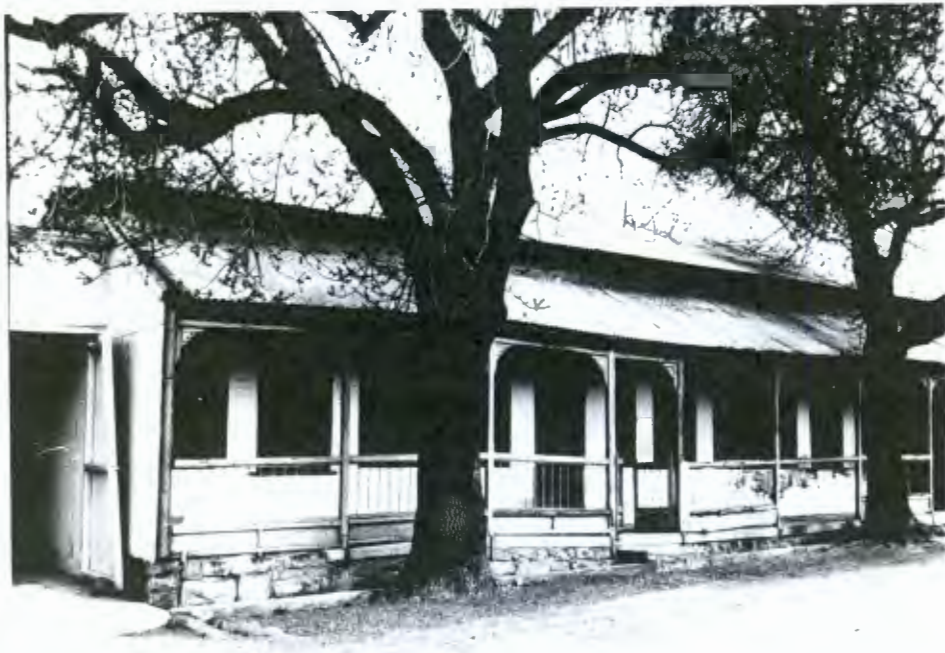
NAME : Ryneveldt Street, Hanover 14.3
LOCATION : Ryneveldt Street, Hanover
ERFNO : 222, Hanover
SIGNIFENG : Rectangular form Karoo building with hipped corrugated iron roof with front verandah supported by decorative wooden pillars and brackets and railings. Quoining surrounds original window openings with shutters and central door.
SIGNIF : Good example of Karoo architecture in particular important context facing the Dutch Reform Church.
CURRENTCOND : Fair but deteriorating
CURRENTUSE : Vacant
CONSTRDATE : Late 19c
DATEALTERED : N/A
CONSTRMAT : Plastered brick, corrugated iron roof
CATRATING : 2
NMCCAT : Register
CATALOGUE : NMC Survey of Hanover, August 1991. Brann RW P 19; Block 14, Bld 3

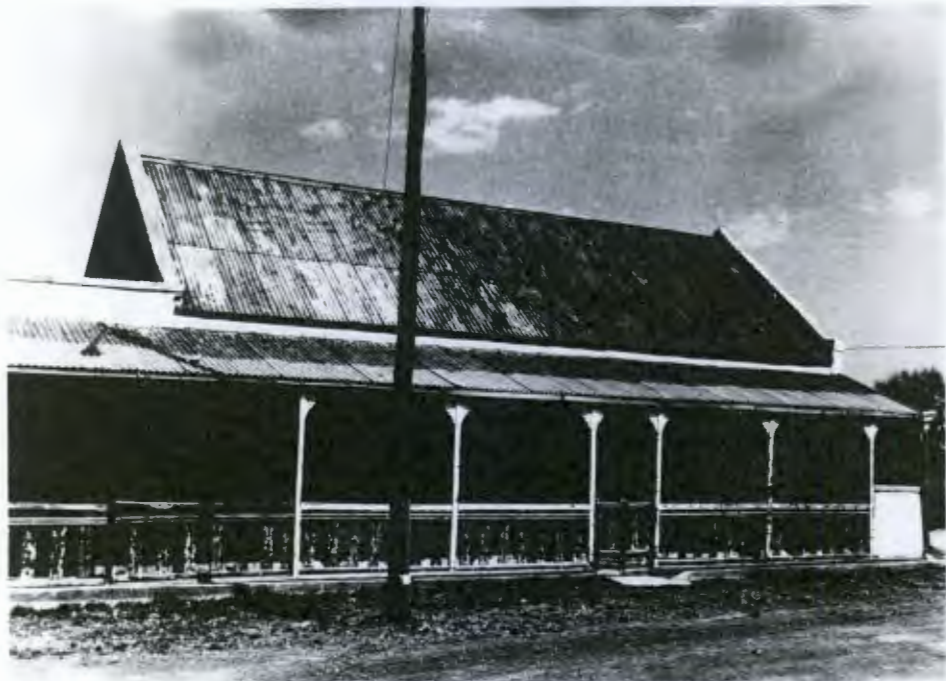
NAME : Dwelling, c/o Ryneveldt and Boom Street, Hanover 14.4
LOCATION : c/o Rhyneveldt and Boom Street, Hanover
ERFNO : 221, Hanover
SIGNIFENG : Narrow rectangular cottage with saddle roof and end gables. Front verandah supported by wooden columns and decorative brackets. Decorative railings and front gate. Symmetrically placed central door with original windows and shutters.
SIGNIF : Fine example of the vernacular cottage architecture in a prominent position facing church square.
CURRENTCOND : Fair but deteriorating
CURRENTUSE : Vacant
CONSTRDATE : Mid - Late 19c
DATEALTERED : N/A
CONSTRMAT : Plastered brick, corrugated iron roof
CATRATING : 2
NMCCAT : Register
CATALOGUE : NMC Survey of Hanover, August 1991. Brann RW P 19; Block 14, Bld 4
