**NATIONAL
MONUMENTS
COUNCIL**

**SURVEY OF CONSERVATION-WORTHY PROPERTY.
FOR**

**De Beers
Consolidated
Mines LTD**

**COMPILED BY : MR.RUSSELL BRANN
MR.CECIL VERTUE
MRS.LEIGH DEYZEL**

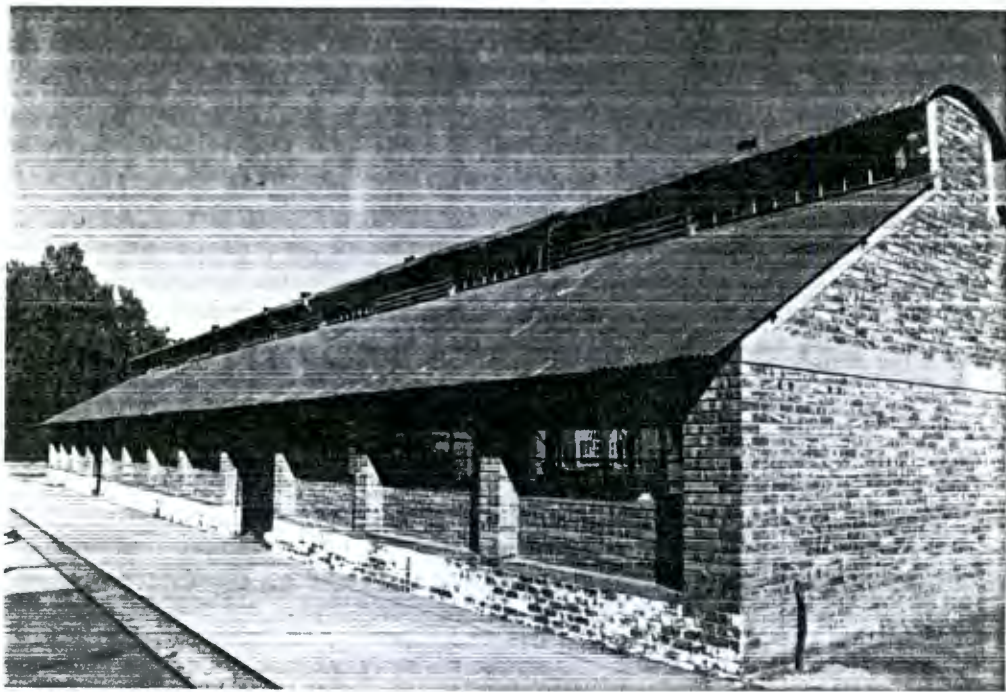
CATALOGUE : NMC survey of De Beers Property R Brann & C Vertue 1993
CATNO : 1.1 - 1.2
NAME : Dutoitspan Single Quarters
LOCATION : De Beers Consolidated Mines Limited
ERENO : Portion of Farm Dorstfontein 77
TYPE : Residential
CURRUSE : Partially used
CONDITION1 : Good
DESCRIP : Single storey compound complex of square plan form with large enclosed courtyard including lapa, cooking and washing facilities. Buildings have verandahs and semi-circular form roof ventilators.

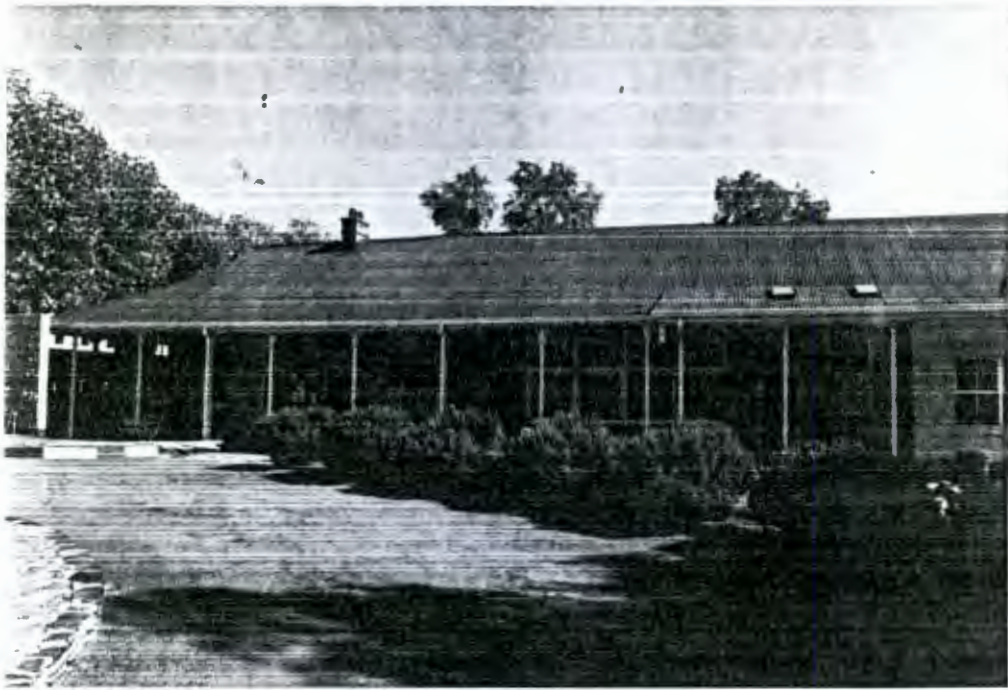
CATALOGUE : NMC survey of De Beers Property R Brann & C Vertue 1993
CATNO : 1.4
NAME : Dutoitspan Training Centre
LOCATION : De Beers Consolidated Mine Limited
ERFNO : Portion of Farm Dorstfontein 77
TYPE : Mining: offices
CURRUSE : Offices
CONDITION1 : Good
DESCRIP : Single storey building of rectangular form with saddle roof. Partially enclosed verandah supported by wooden poles with decorative wooden brackets. Four original 2X2 sliding sash windows.

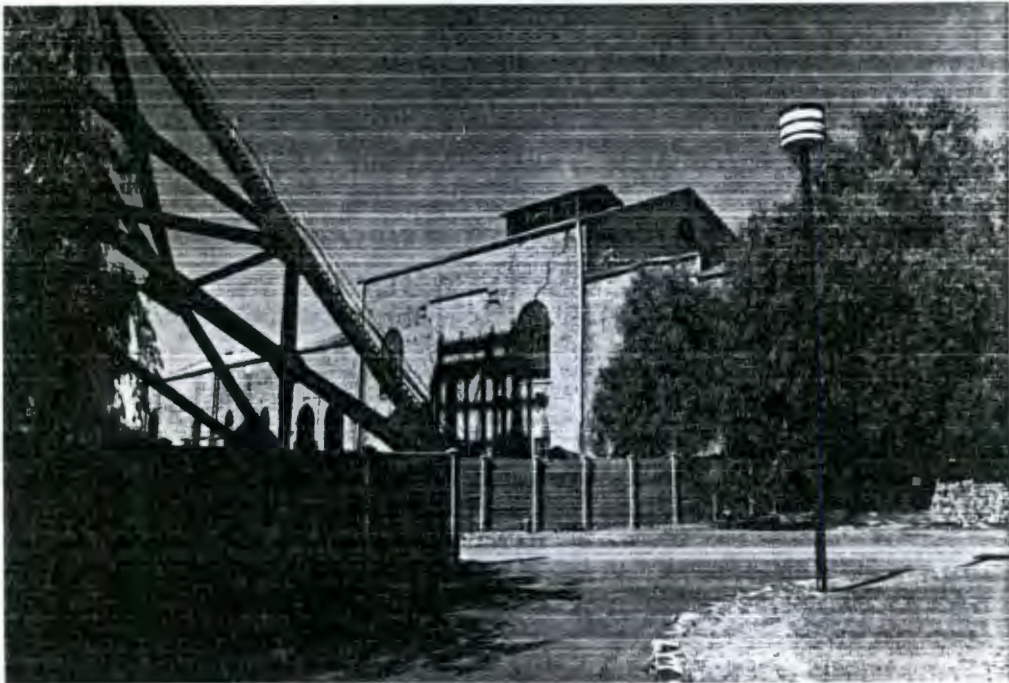
CATALOGUE : NMC survey of De Beers Property R Brann & C Vertue 1993
CATNO : 1.5 - 1.9, 2.6, 2.8 - 3.3
NAME : Dutoitspan Mine Engine House and Headgear
LOCATION : De Beers Consolidated Mine Limited
ERFNO : Portion of Farm Dorstfontein 77
TYPE : Engine Rooms and Headgear
CURRUSE : Unused
CONDITION1 : Poor
DESCRIP : Large engine room complex of rectangular form with saddle roofs and large industrial windows with semi-circular tops. Headgear consists mainly of wrought iron and steel of Z-shaped profile.

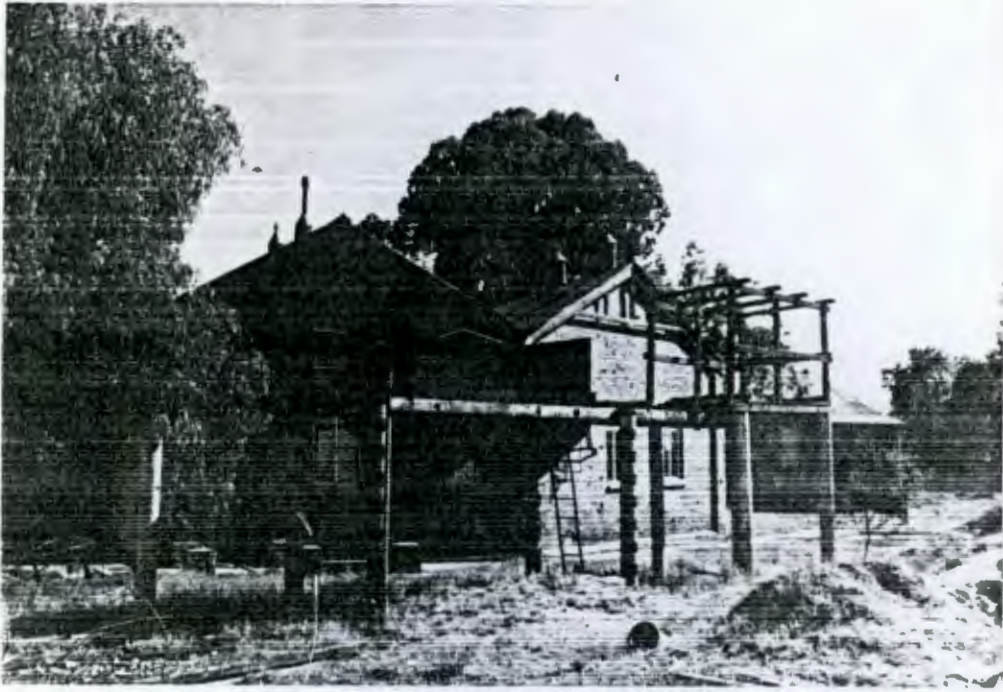
CATALOGUE : NMC survey of De Beers Property R Brann & C Vertue 1993
CATNO : 1.7
NAME : Change house
LOCATION : De Beers Consolidated Mine Limited
ERFNO : Portion of Farm Dorstfontein 77
TYPE : Mining: change house
CURRUSE : Unused
CONDITION1 : Good
DESCRIP : Buildings of rectangular form with corrugated iron saddle roofs and decorative bargeboards. Victorian roof ventilators.

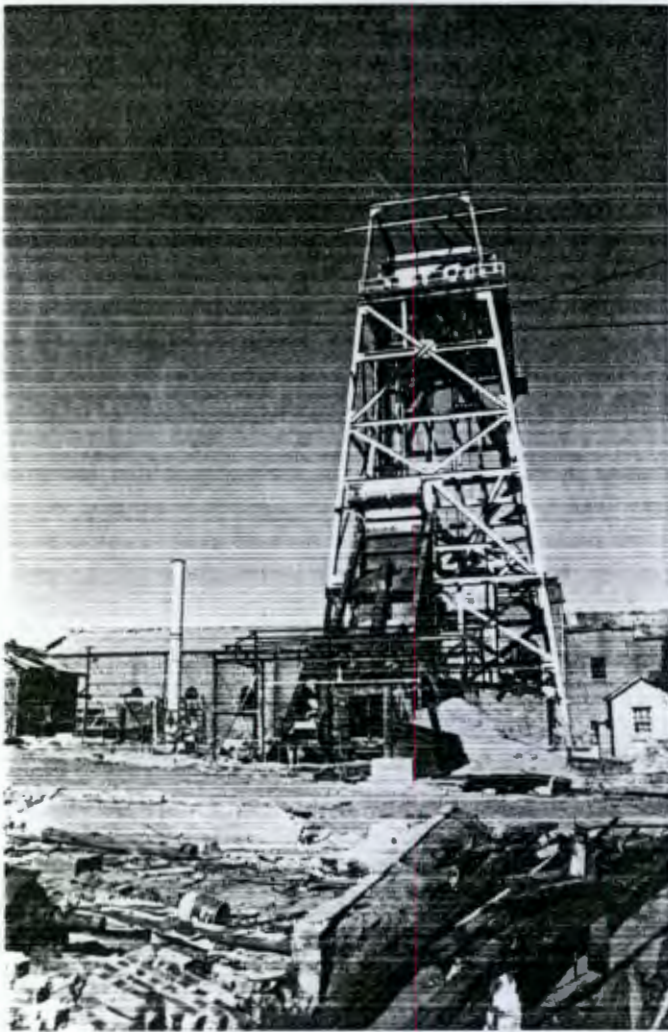
2.1

CATALOGUE : NMC survey of De Beers Property R Brann & C Vertue 1993
CATNO : 2.1, 2.2, 2.3, 2.4
NAME : Old Allis Chalmers 9K Crushers
LOCATION : De Beers Consolidated Mine Limited
ERFNO : Portion of Farm Dorstfontein 77
TYPE : Mechanical
CURRUSE : Unused
CONDITION1 : Good
DESCRIP : N/A

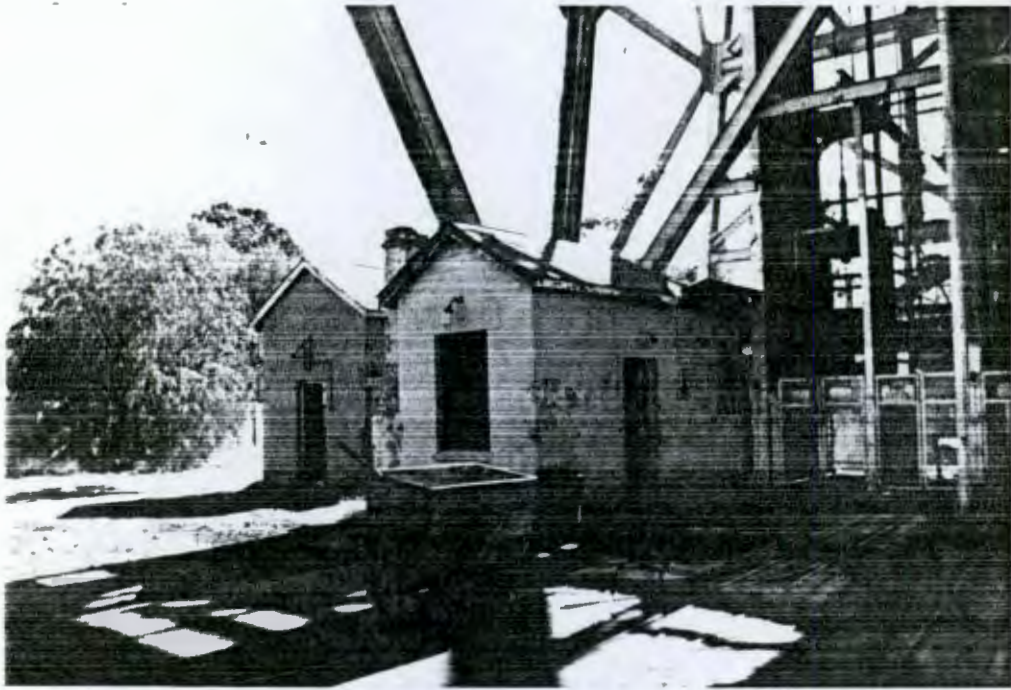
CATALOGUE : NMC survey of De Beers Property R Brann & C Vertue 1993
CATNO : 2.7
NAME : The Banksman Cabin and First Aid Room
LOCATION : De Beers Consolidated Mine Limited
ERFNO : Portion of Farm Dorstfontein 77
TYPE : Mining: Building
CURRUSE : Unused
CONDITION1 : Good
DESCRIP : Small single storeyed structure with saddle roof.

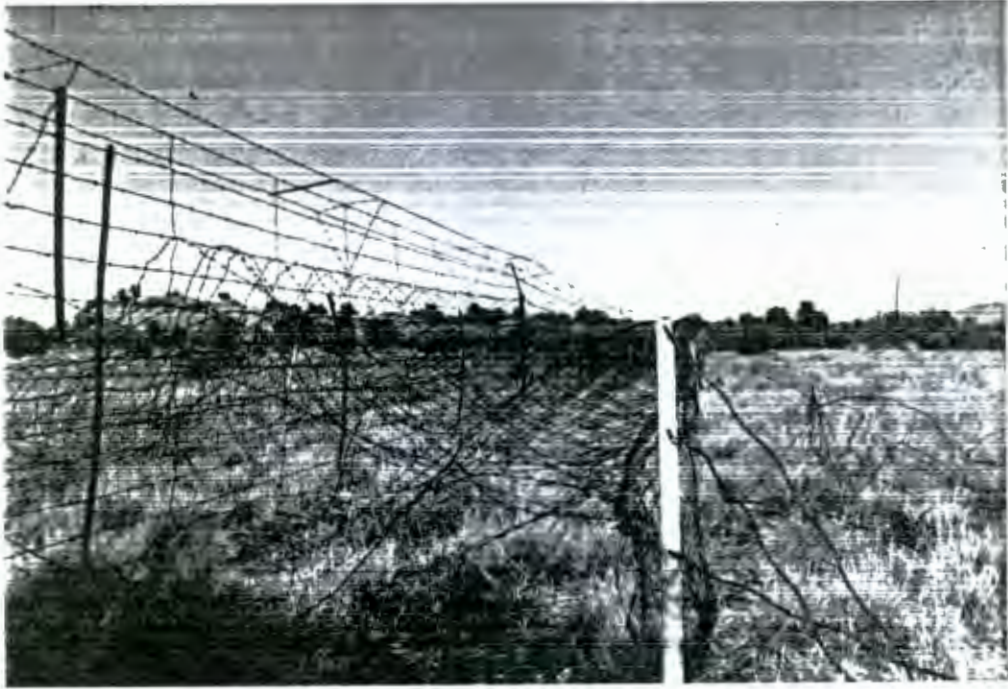
CATALOGUE : NMC survey of De Beers Property R Brann & C Vertue 1993
CATNO : 3.8
NAME : Security Fence
LOCATION : De Beers Consolidated Mine Limited
ERFNO : Portion of Farm Benaauwdheidsfontein
TYPE : Fencing
CURRUSE : Disused
CONDITION1 : Good
DESCRIP : Triple barbed wire fence and electric fence.

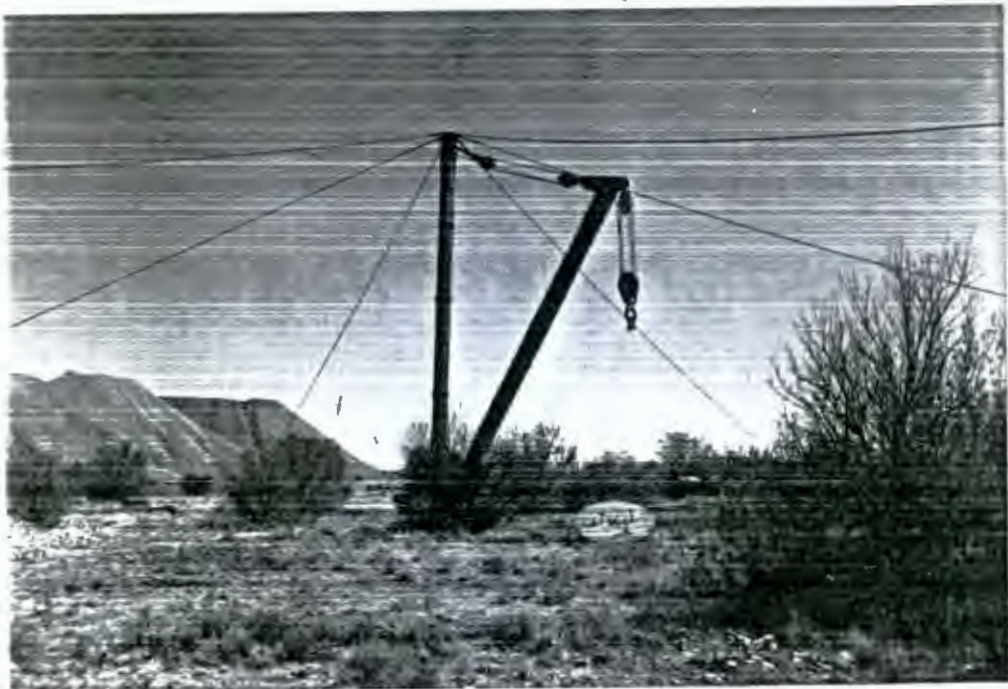
CATALOGUE : NMC survey of De Beers Property R Brann & C Vertue 1993
CATNO : 3.9
NAME : Check Crane
LOCATION : De Beers Consolidated Mine Limited
ERFNO : Portion of Farm Benaauwdheidsfontein
TYPE : Mechanical
CURRUSE : Disused
CONDITION1 : Good
DESCRIP : The crane consists of two wooden pillars which are hinged at the base and supported by steel cables. The pillar at an angle from the vertical moves on a rope and pulley to lift items.

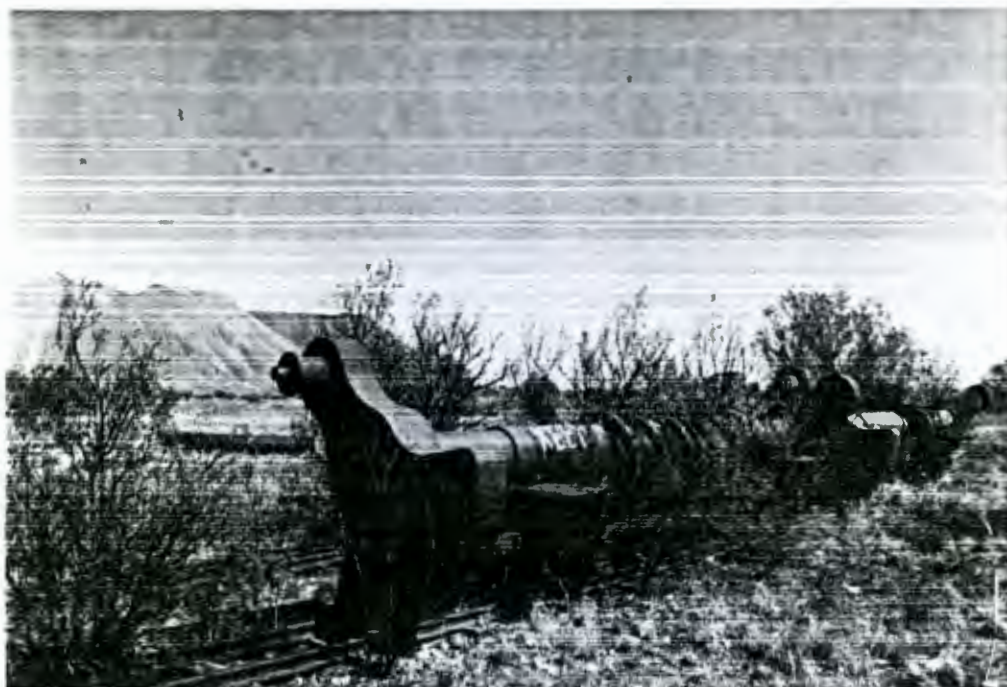
4.2

CATALOGUE : NMC survey of De Beers Property R Brann & C Vertue 1993
CATNO : 4.2, 4.3, 4.5
NAME : Various crankshafts
LOCATION : De Beers Consolidated Mine Limited
ERFNO : Portion of Farm Benaauwdheidsfontein
TYPE : Mechanical
CURRUSE : Disused
CONDITION1 : Good
DESCRIP : Unused late early 20th century mining technology.

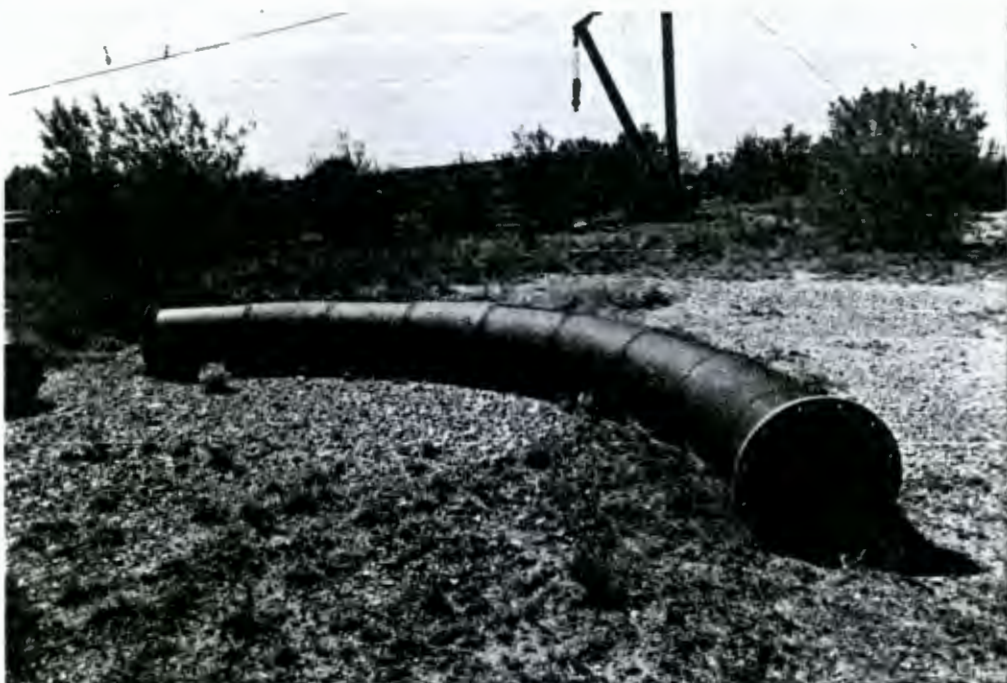
CATALOGUE : NMC survey of De Beers Property R Brann & C Vertue 1993
CATNO : 4.4
NAME : Steam pipe bend
LOCATION : De Beers Consolidated Mine Limited
ERFNO : Portion of Farm Benaauwdheidsfontein
TYPE : Mechanical
CURRUSE : Disused
CONDITION1 : Good
DESCRIP : Cylindrical pipe consisting of rivetted sections. The one end has a bronze flange which is unusual.

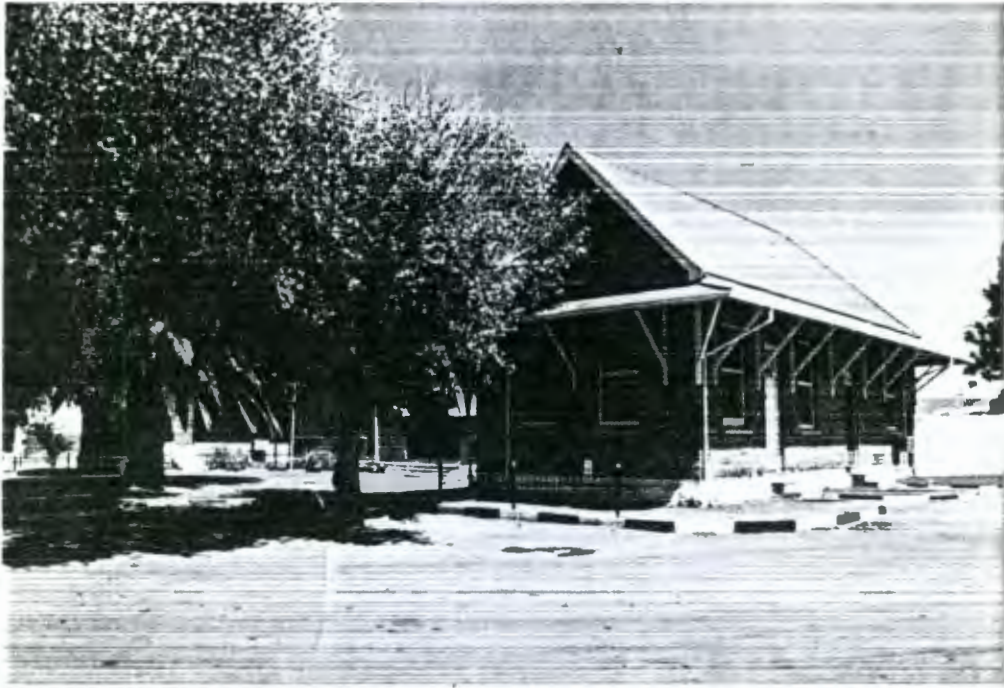
CATALOGUE : NMC survey of De Beers Property R Brann & C Vertue 1993
CATNO : 5.2
NAME : Mine Offices at Wesselton Mine
LOCATION : De Beers Consolidated Mine Limited
ERFNO : Portion of Farm Benaauwdheidsfontein
TYPE : Offices
CURRUSE : Offices
CONDITION1 : Good
DESCRIP : U-shaped single storey building with saddle roof.
Foward projecting bays have rectangular ventilators in
gables. Wrap around verandahs supported by wooden
brackets. Original 2X2 sliding sash windows. Very few
minor changes - largely original
CONSTRMAT : Building: Brick Roof: Corrugated Iron
ENVIRON : Medium
SIGNIF : Intrinsic aesthetic/ environmental merit.

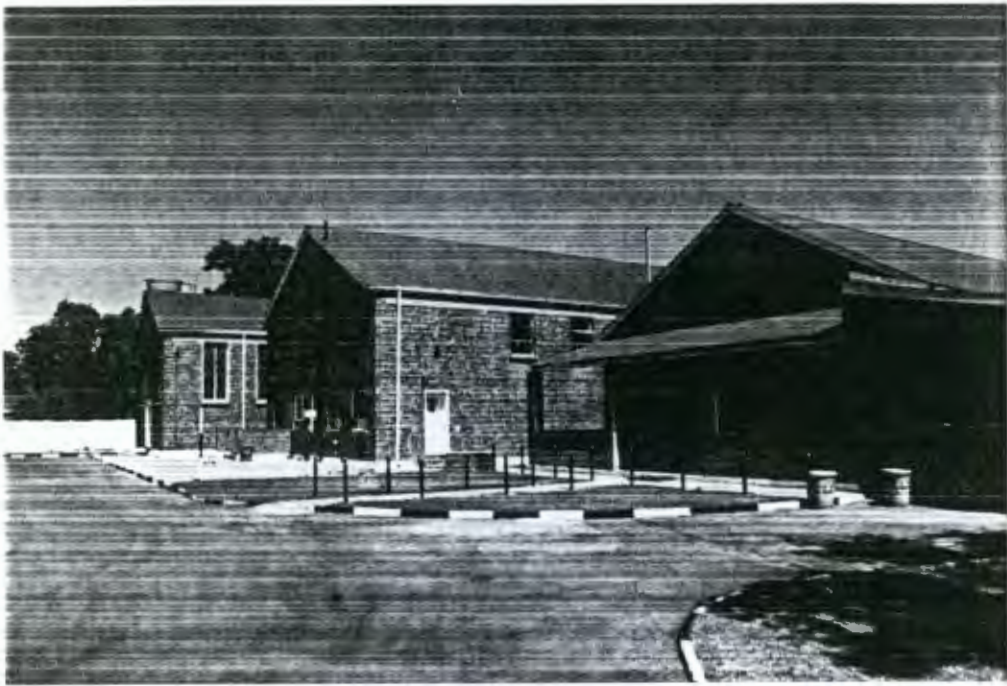
CATALOGUE : NMC survey of De Beers Property R Brann & C Vertue 1993
CATNO : 5.3
NAME : Change Houses at Wesselton Mine
LOCATION : De Beers Consolidated Mine Limited
ERFNO : Portion of Farm Benaauwdheidsfontein
TYPE : Building
CURRUSE : Unknown
CONDITION1 : Good
DESCRIP : Single storey, large rectangular buildings with saddle
roofs. Steel industrial windows.

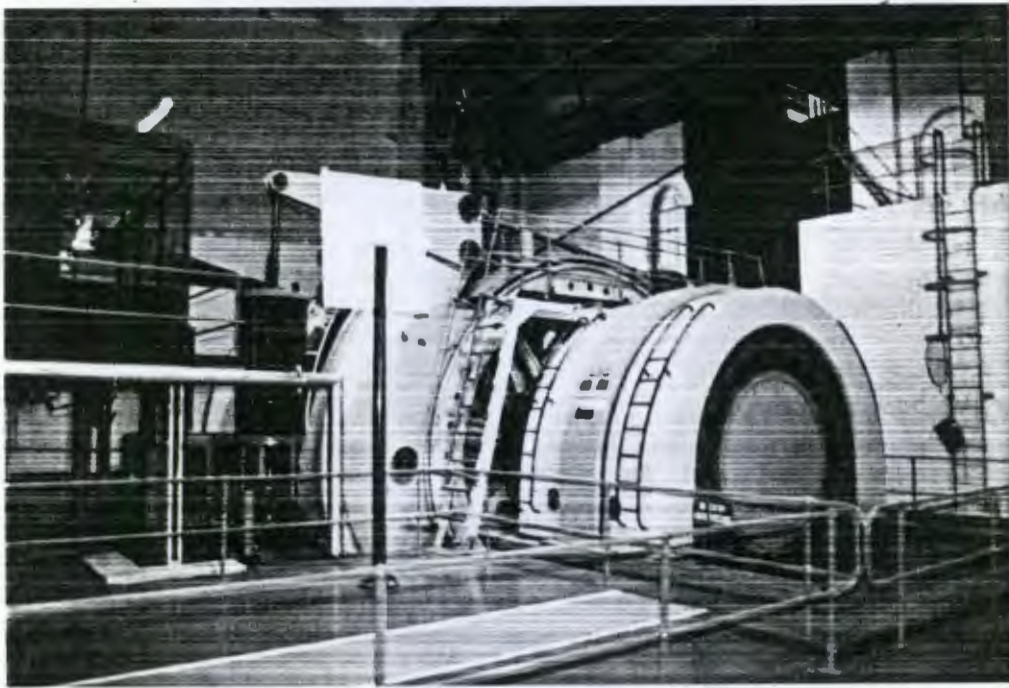
CATALOGUE : NMC survey of De Beers Property R Brann & C Vertue 1993
CATNO : 5.6
NAME : View of Rock Hoist at Wesselton Mine
LOCATION : De Beers Consolidated Mine Limited
ERFNO : Portion of Farm Benaauwdheidsfontein
TYPE : Machinery
CURRUSE : Machinery
CONDITION1 : Good
DESCRIP : The rock hoist was installed in 1970's and is probably
one of the most modern in South Africa. Extremely
powerful machine and hoists 13 ton capacity skips

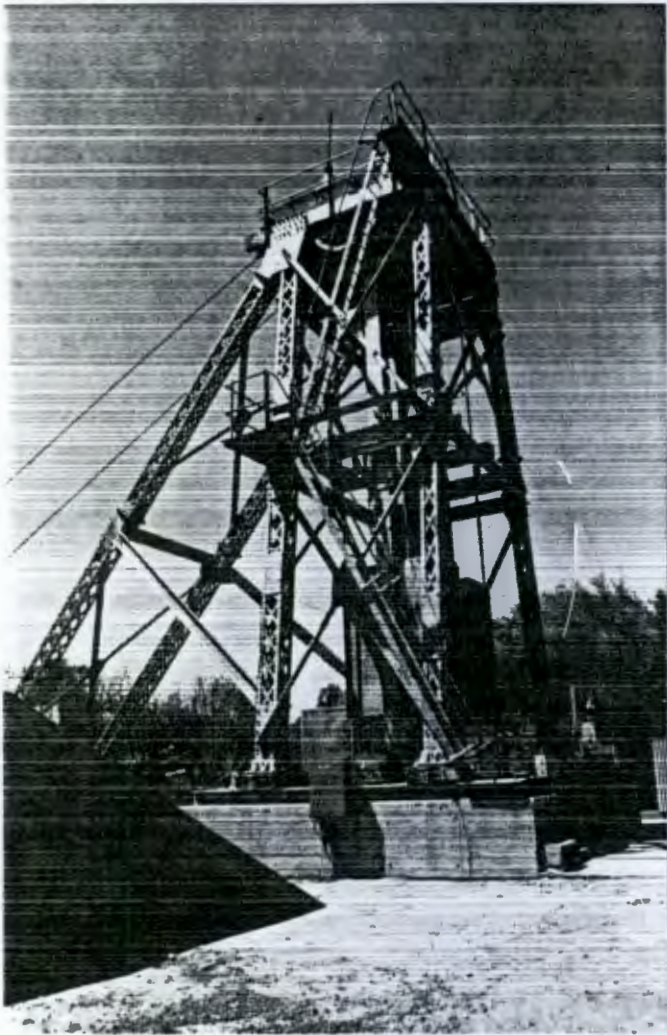
CATALOGUE : NMC survey of De Beers Property R Brann & C Vertue 1993
CATNO : 5.9
NAME : Wesselton Mine Ventilation Shaft
LOCATION : De Beers Consolidated Mine Limited
ERFNO : Portion of Farm Benaauwdheidsfontein
TYPE : Machinery
CURRUSE : Disused
CONDITION1 : Good
DESCRIP : The building used to house fans. These have been moved
underground where they are more efficient. The chimney
is tapered downwards, has a square profile with a steel
ladder to the top and is built of concrete.

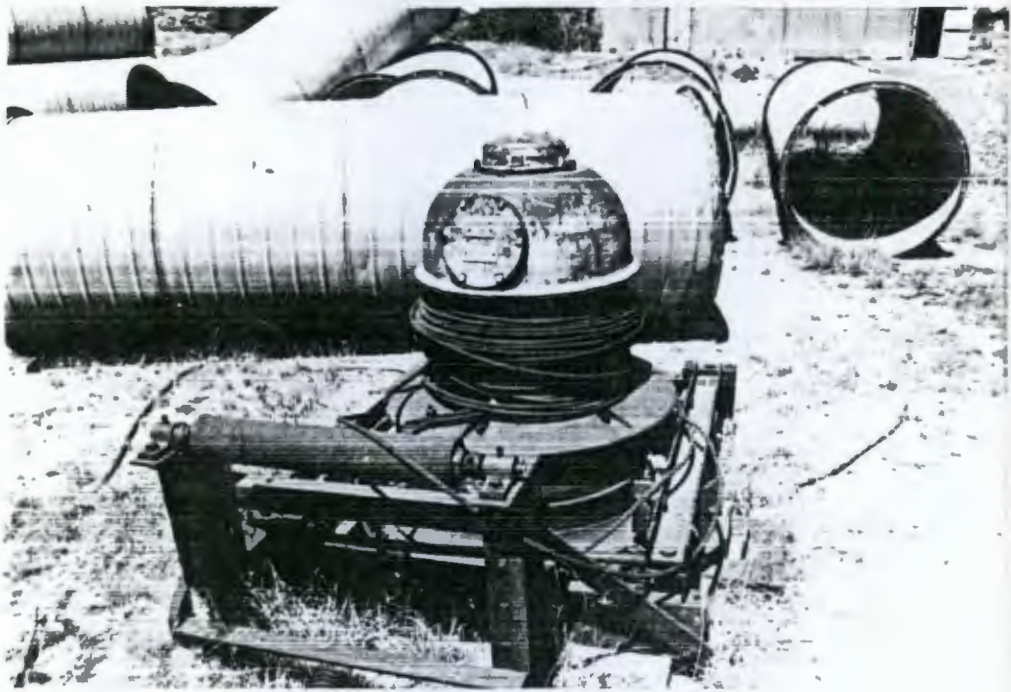
CATALOGUE : NMC survey of De Beers Property R Brann & C Vertue 1993
CATNO : 6.1
NAME : Old Capston Winch
LOCATION : De Beers Consolidated Mine Limited
ERFNO : Portion of Farm Benaauwheidsfontein
TYPE : Machinery
CURRUSE : Disused
CONDITION1 : Good
DESCRIP : Steel cable winch with domed engine head on steel
mounting

CONSTRMAT : Steel
ENVIRON : Medium
SIGNIF : These winches date to the late 19th century and
replaced mules to move trucks into position at the
loading boxes. It was later found that mules were
possibly more efficient.

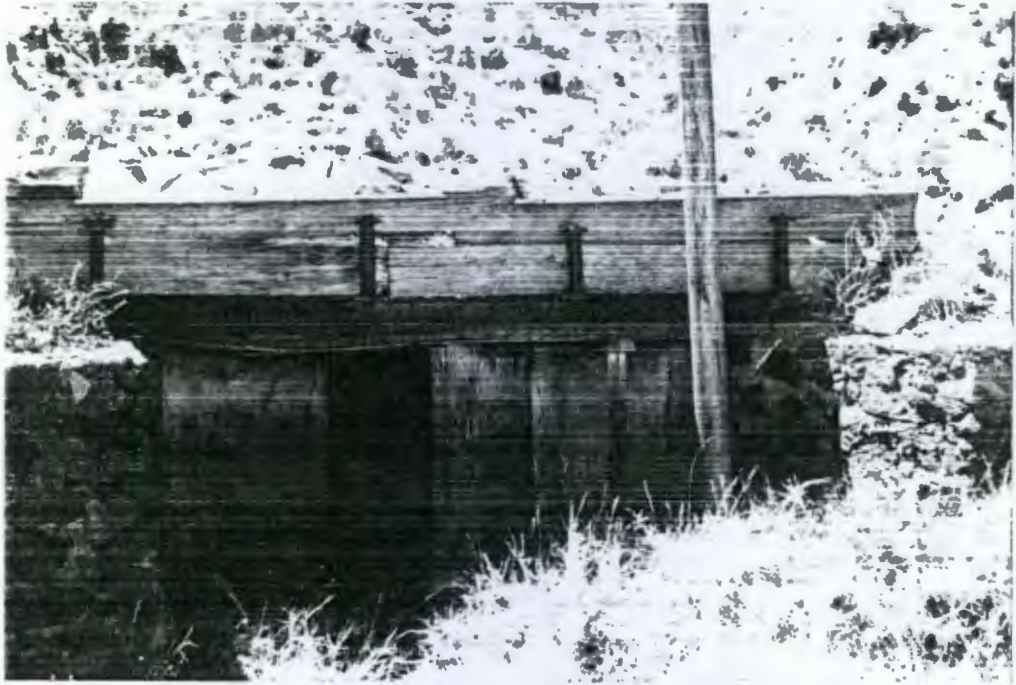
CATALOGUE : NMC survey of De Beers Property R Brann & C Vertue 1993
CATNO : 6.2
NAME : Old Explosives Magazines Beneath Dumps
LOCATION : De Beers Consolidated Mine Limited
ERFNO : Portion of Farm Benaauwheidsfontein
TYPE : Magazine
CURRUSE : Disused
CONDITION1 : Fair
DESCRIP : Bunker beneath dump material. Steel double doors. Stone
wall surrounds

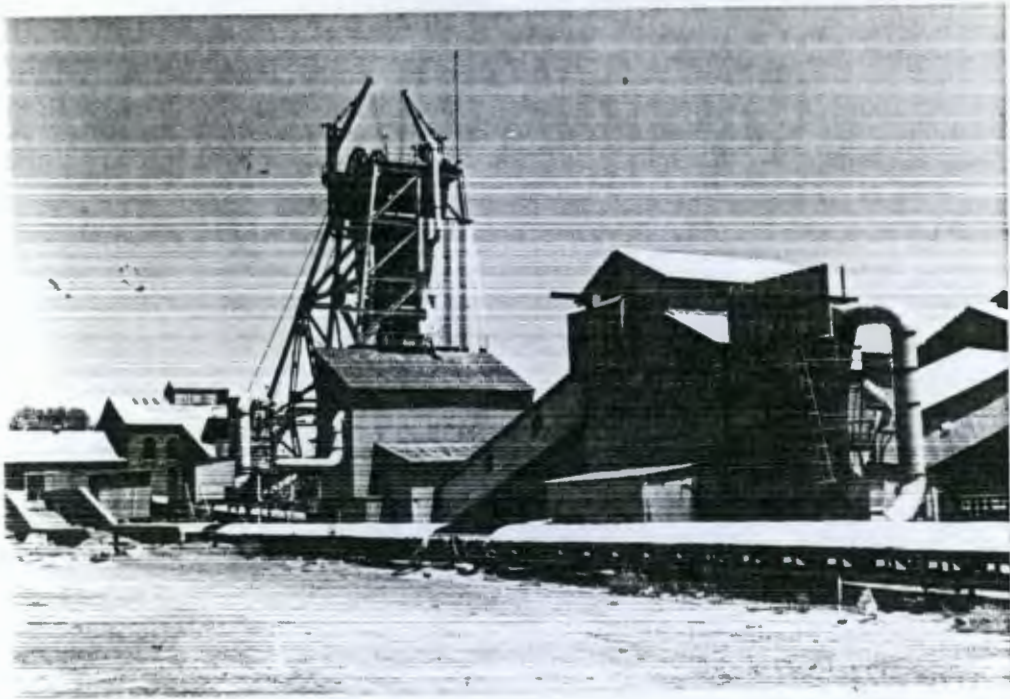
CATALOGUE : NMC survey of De Beers Property R Brann & C Vertue 1993
CATNO : 6.6
NAME : Crushing plant at Bultfontein Mine
LOCATION : De Beers Consolidated Mine Limited
ERFNO : Portion of Farm Bultfontein 80
TYPE : Building
CURRUSE : Building
CONDITION1 : Good
DESCRIP : Rear view of head gear in the photo. In the background one can also see the engine room which is very much as Dutoitspan Mine. Still in use

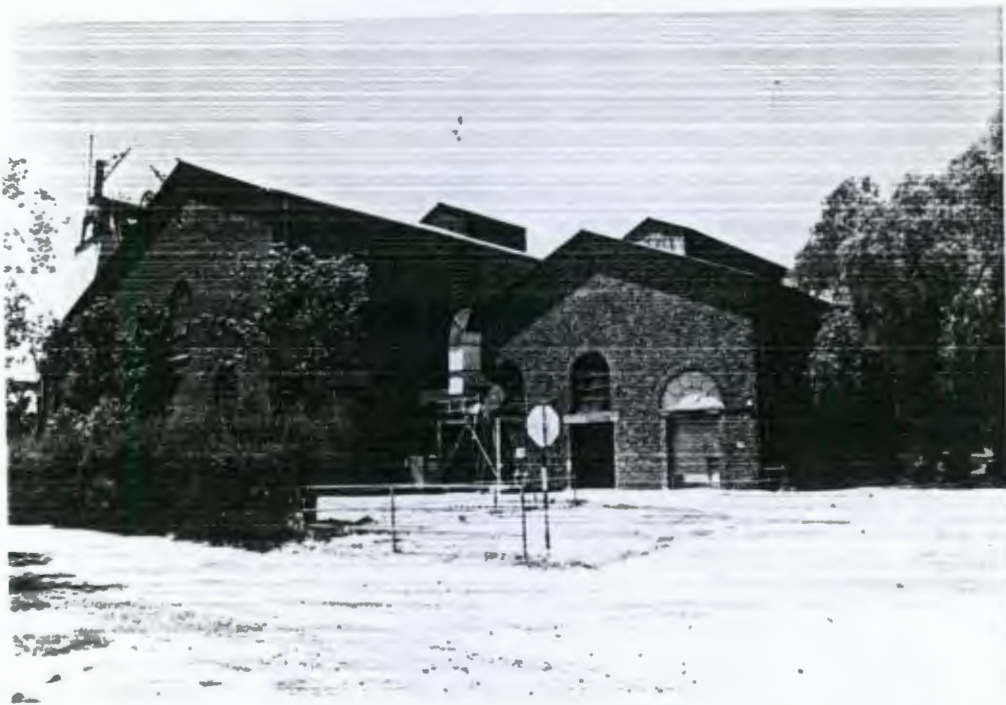
CATALOGUE : NMC survey of De Beers Property R Brann & C Vertue 1993
CATNO : 6.7
NAME : Engine Room at Bultfontein Mine
LOCATION : De Beers Consolidated Mine Limited
ERFNO : Portion of Farm Bultfontein 80
TYPE : Mining building
CURRUSE : Engine room
CONDITION1 : Good
DESCRIP : Two large red brick industrial buildings with saddle roofs and industrial steel windows with semi-circular tops. Roof ventilators on both buildings.

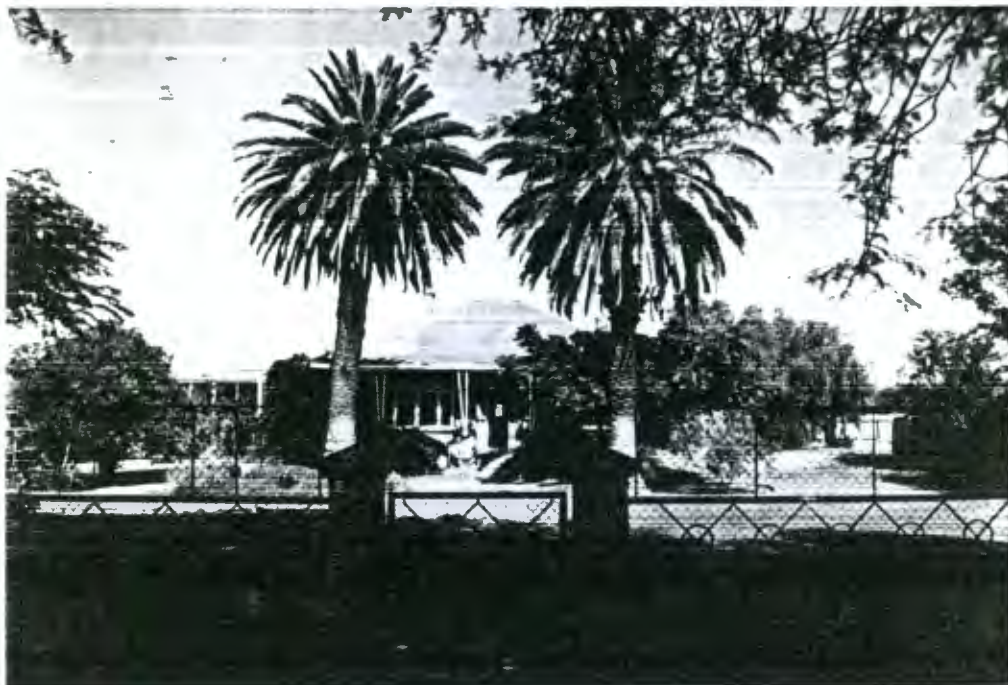
CATALOGUE : NMC survey of De Beers Property R Brann & C Vertue 1993
CATNO : 7.3
NAME : Foreman Fitters Residence for Dutoitspan Mine
LOCATION : De Beers Consolidated Mine Limited
ERFNO : Portion of Farm Bultfontein 80
TYPE : Dwelling
CURRUSE : Offices
CONDITION1 : Good
DESCRIP : Single storey residence with hipped roof and verandah supported by recent metal pipes. Symmetrically placed bay windows on either side of central door with fanlight and glazed side panels. Building is set back from road. Palm trees an interesting feature

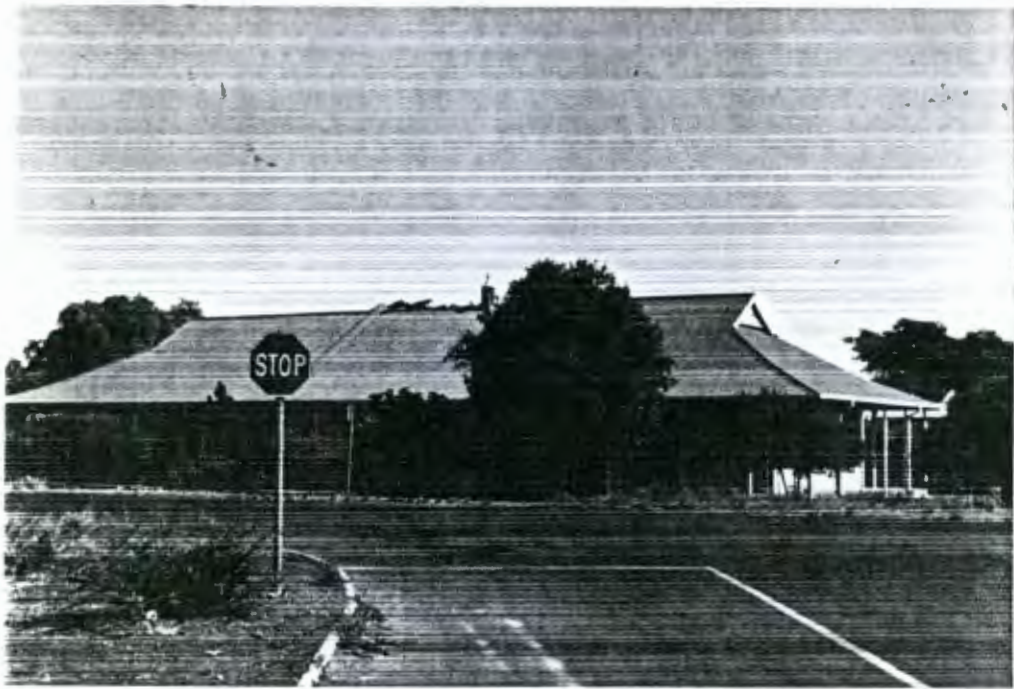
CATALOGUE : NMC survey of De Beers Property R Brann & C Vertue 1993
CATNO : 8.1
NAME : De Beers Mine Security dept.
LOCATION : De Beers Consolidated Mine Limited
ERFNO : Portion of Farm Dorstfontein 77
TYPE : Telephone exchange
CURRUSE : Offices
CONDITION1 : Good
DESCRIP : Single storey building of rectangular form with saddle roof. Wrap-around verandah form continuous line with roof pitch and is supported by steel cylindrical columns. Original 6x6 sliding sash windows.

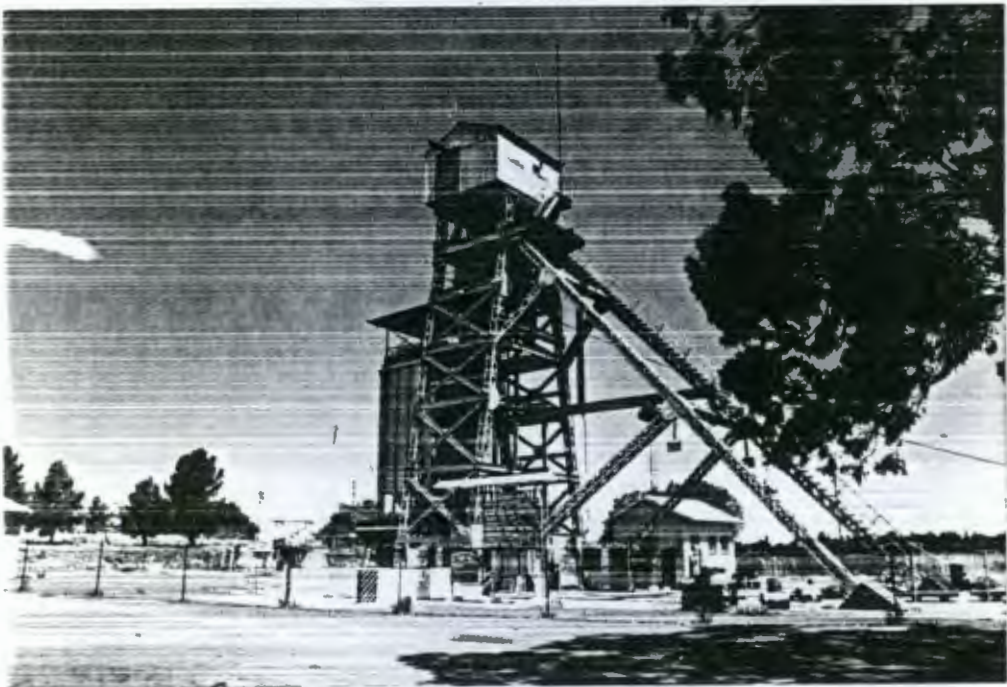
CATALOGUE : NMC survey of De Beers Property R Brann & C Vertue 1993
CATNO : 10.3
NAME : Head Gear on No 3 Shaft . De Beers Mine
LOCATION : De Beers Consolidated Mines Limited
ERFNO : Portion of Farm Vooruitzigt 81
TYPE : Machinery
CURRUSE : Machinery - Head Gear
CONDITION1 : Good
DESCRIP : Steel head gear and winder supported by angled steel foot.

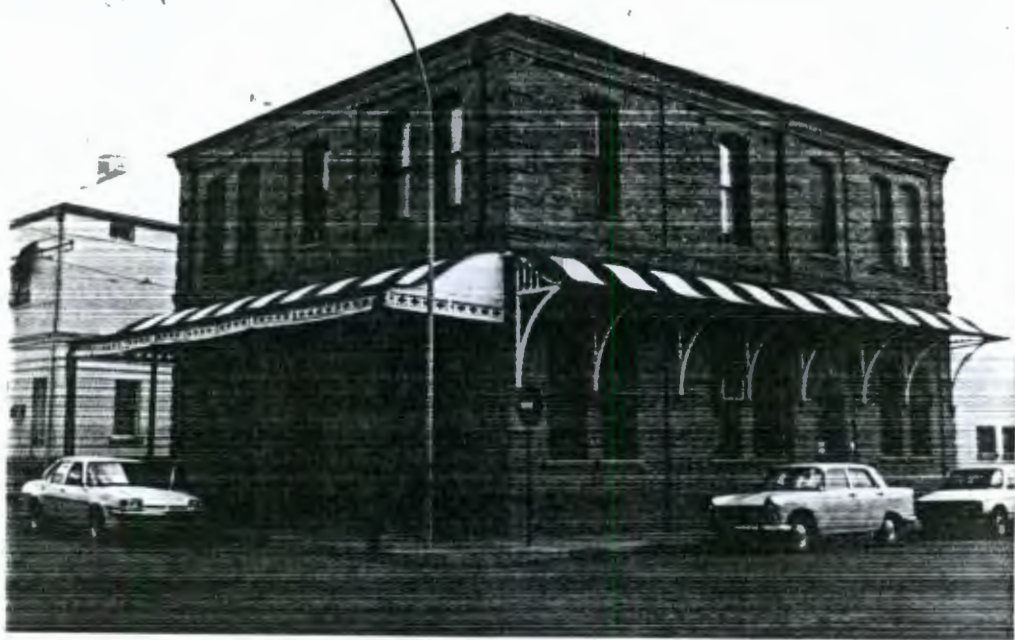
CATALOGUE : NMC survey of De Beers Property R Brann & C Vertue 1993
CATNO : 10.9
NAME : Consolidated House
LOCATION : Stockdale Street, Kimberley
ERFNO : 2460
TYPE : Offices
CURRUSE : Offices
CONDITION1 : Good
DESCRIP : Interesting double storey neo-classical building with heavy parapet. Set on stone foundation the ornamental plaster detailing in the rustication on the lower level. Doric pillars on either side of entrance, deep curved window detailing.
CONSTRMAT : Building: Plastered Brick Roof: Corrugated Iron
ENVIRON : High
SIGNIF : It was built in the site of the old original diamond market and Craven club. It housed the headquarters of the Diamond Corporation Limited and was purchased by De Beers to become their central sorting office. It now houses the computer division.
HISTORY : The building was built in 1926 and it now houses Sir Ernest Oppenheimer's Library.

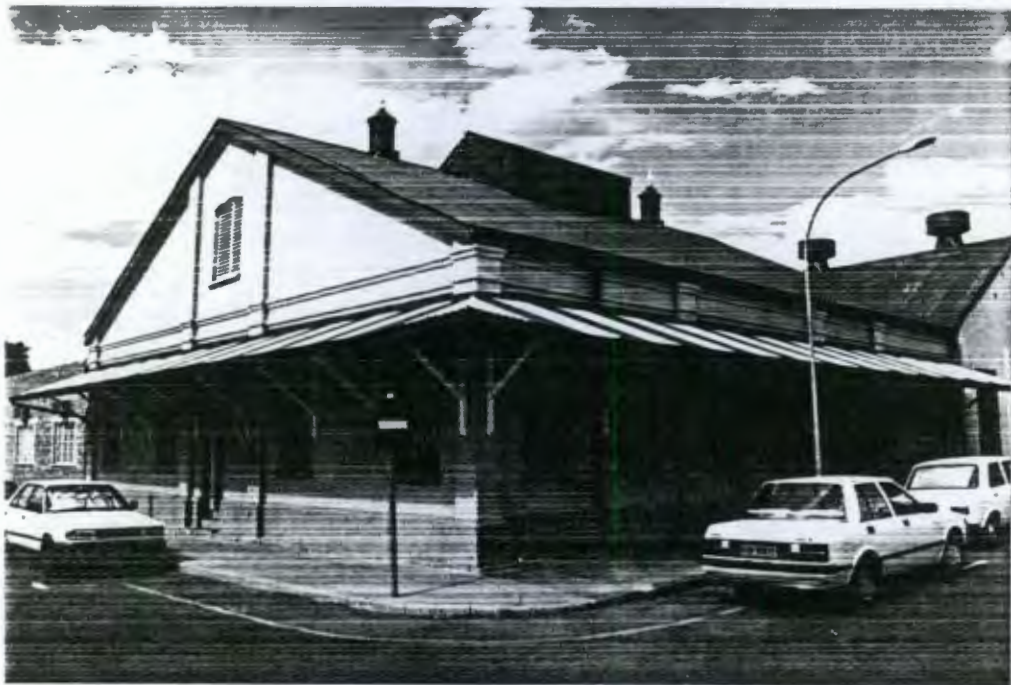
CATALOGUE : NMC survey of De Beers Property R Brann & C Vertue 1993
CATNO : 11.4
NAME : Rhodes Boardroom
LOCATION : 4 Warren Street, Kimberley
ERFNO : Remainder of Erf 3168
TYPE : Offices
CURRUSE : Offices
CONDITION1 : Good
DESCRIP : Single storey building of rectangular form with hipped roof. Bullnosed verandah supported by wooden pillars with decorative brackets on central forward projecting section. Original 2X2 sliding sash windows, french doors and interior.
