BASIC ASSESSMENT REPORT

Basic Assessment for the Proposed Construction and Operation of Electrical Grid Infrastructure to support the Sutherland, Sutherland 2 and Rietrug Wind Energy Facilities (WEFs), Northern and Western Cape Provinces

APPENDIX D.4: Heritage Impact Assessment (Archaeology, Palaeontology and Cultural Landscape)

**HERITAGE IMPACT ASSESSMENT: PROPOSED CONSTRUCTION OF
A MAJOR TRANSMISSION SUBSTATION, 400 KV TRANSMISSION LINE
AND 132 KV DISTRIBUTION LINE TO SUPPORT THE PROPOSED
RIETRUG, SUTHERLAND AND SUTHERLAND 2 WEFs, SUTHERLAND
AND LAINGSBURG MAGISTERIAL DISTRICTS,
NORTHERN AND WESTERN CAPE**

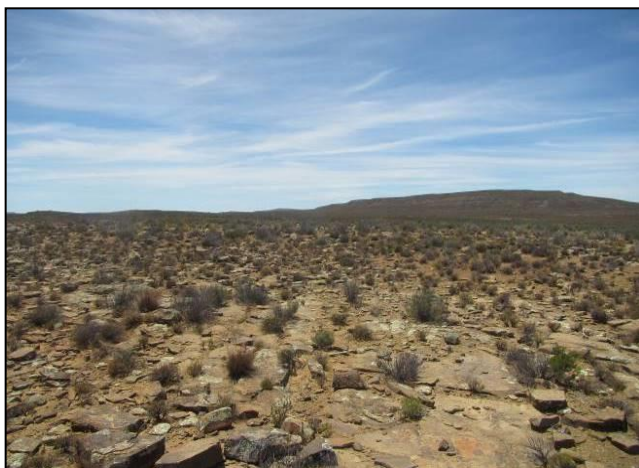
Figure 3: Flat rock slabs in the central part of the Northern Cape section.

Atop the escarpment the study area is comprised of gently undulating hills. The vast majority is undeveloped land, but some small areas of agricultural land do occur in the wider area (the nearest to the power line route is about 1 km away). Although the terrain is often very rocky, the rocks tend to be flat (Figure 3). Small ridges do protrude in places though (Figure 4). Vegetation cover is usually low but, because of the slightly higher rainfall on the escarpment, it is fairly continuously present. In the river valleys there is somewhat denser bush (Figure 5). Although the rock is largely quite solid sandstone, there are places where dark shale bands occur which are eroding heavily (Figure 6). These are generally present on slopes or on the sides of incised valleys.

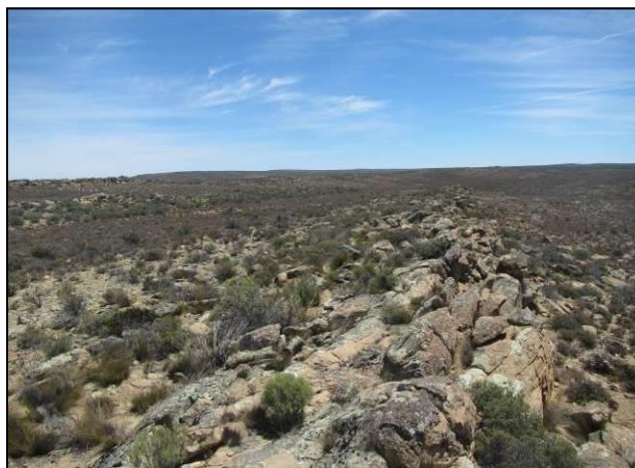
Figure 4: A low rocky ridge in the central part of the Northern Cape section.

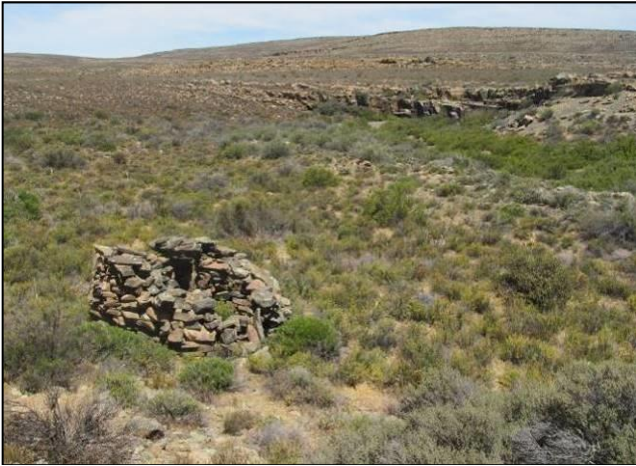
Figure 5: View up a river valley in the central part of the Northern Cape section showing the denser bush in the actual stream bed.

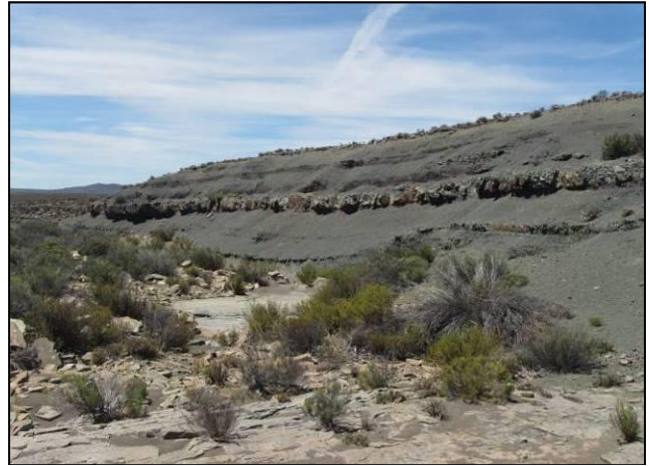
Figure 6: Weathering and eroding shale band in the side of a small river channel near the eastern end of the power line route.

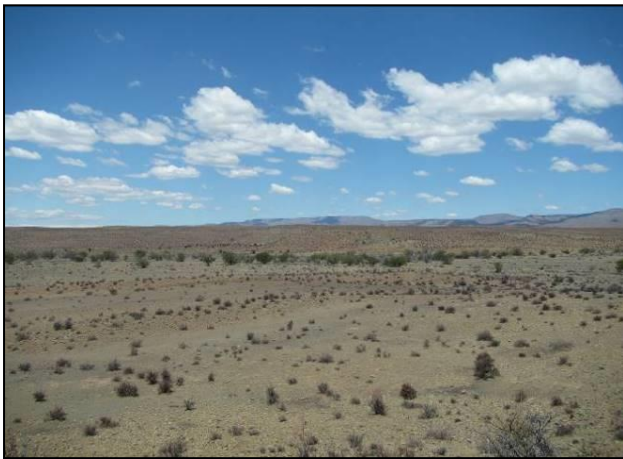
Figure 7: View towards the south in the far eastern part of the study area. A small drainage line is marked by denser vegetation.

The easternmost part of the study area that lies within Western Cape was mildly undulating with stream beds of varying size but was much less rocky than the escarpment area (Figure 7). Low scarps occurred in places with the largest of these being in the region of 20 m high (Figure 8). The southern part of the study area is very flat and dominated by river floodplains (Figures 9 & 10). The main relief is a slightly higher-lying area to the west of the line where the substation would be built. The bulk of the visible bedrock in the Western Cape portion of the study area was highly weathered shale but the remains of more resistant rocks were often lying on the surface as gravel (Figures 11 & 12). Fine gravel tended to be widespread on the surface.

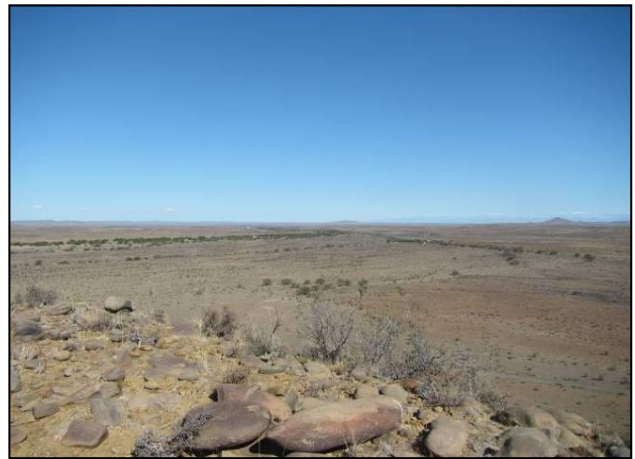
Figure 8: View towards the southeast from the top of a rocky scarp with river beds visible in the distance.

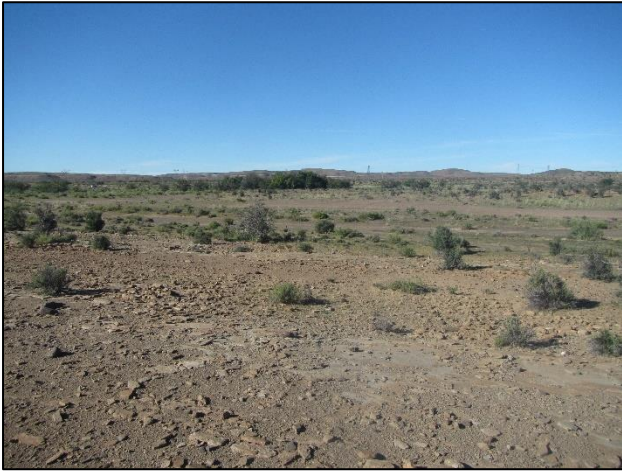
Figure 9: View towards the south from near the substation location showing a river floodplain. The clump of trees lies alongside a reservoir and wind pump. The large power lines are visible in the distance.

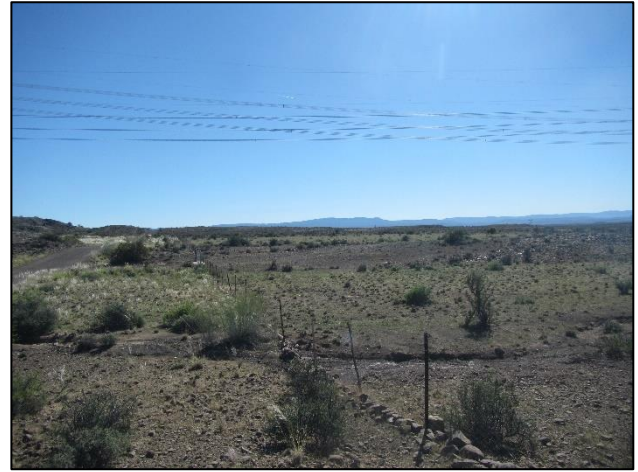
Figure 10: View towards the north from the very southern end of the power line route showing stream beds and gravel. The main gravel road through the area is visible at far left.

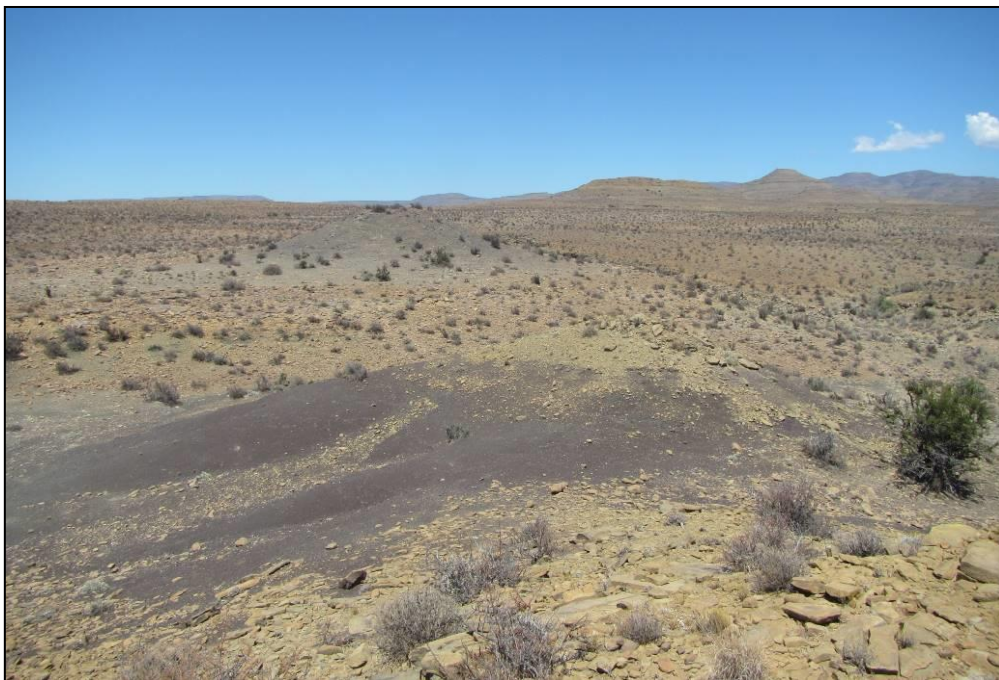
Figure 11: View towards the southwest along a low rocky ridge in the eastern part of the study area showing the dark-coloured weathering shale overlain by the remnants of more resistant pale orange-coloured sandstone.

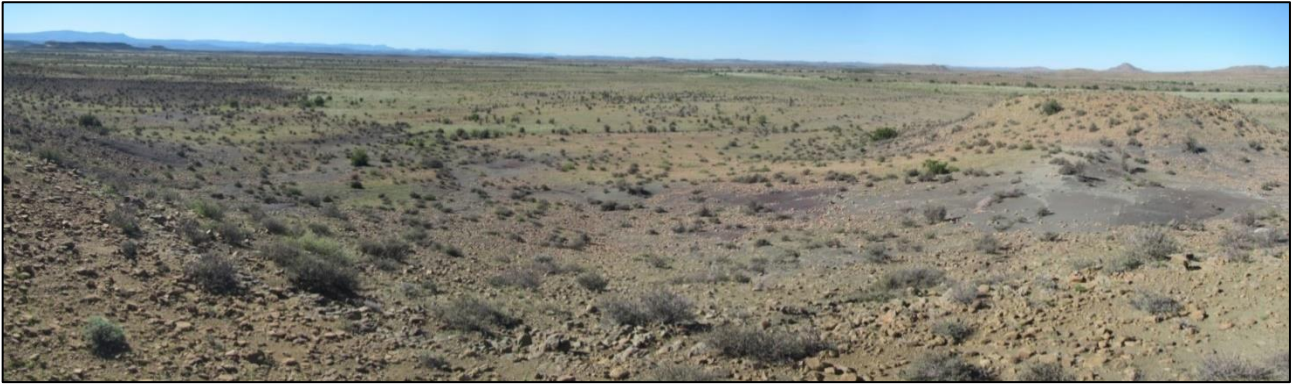
Figure 12: View towards the east across the original substation location. The new location is just to the northwest of this position (i.e. behind the camera and to the left).

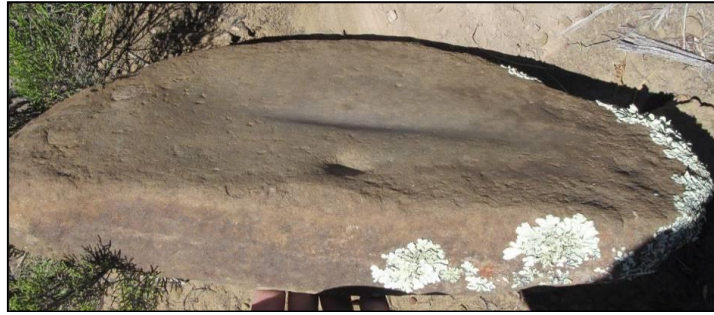
Figure 13: Isolated grooved lower grindstone found alongside a stream at waypoint 515 in the western part of the study area. It is approximately 60 cm long and 37 cm wide.

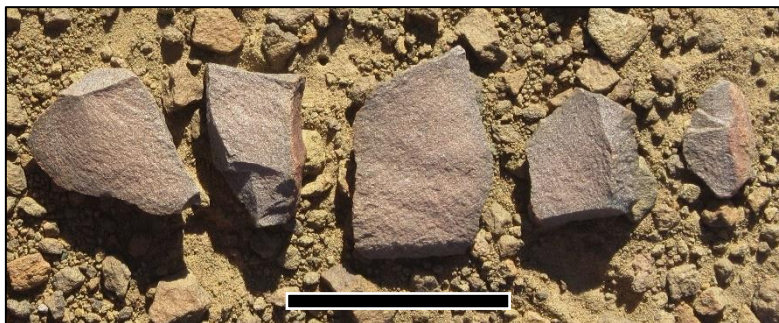
Figure 15: Artefacts from an ephemeral scatter of quartzite flakes on high ground overlooking a stream bed.

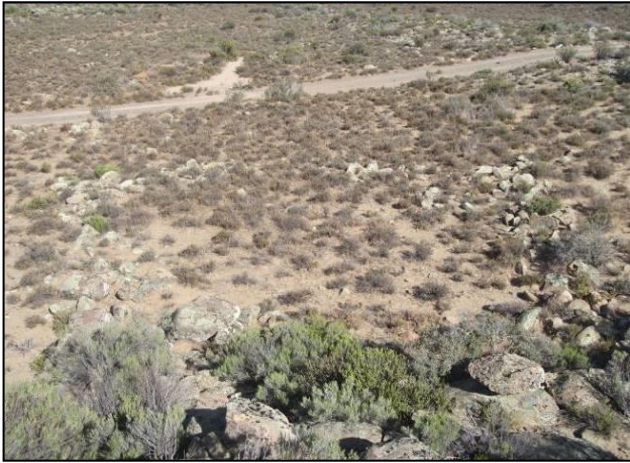
Figure 16: View of a large enclosure on the east side of the rock outcrop.

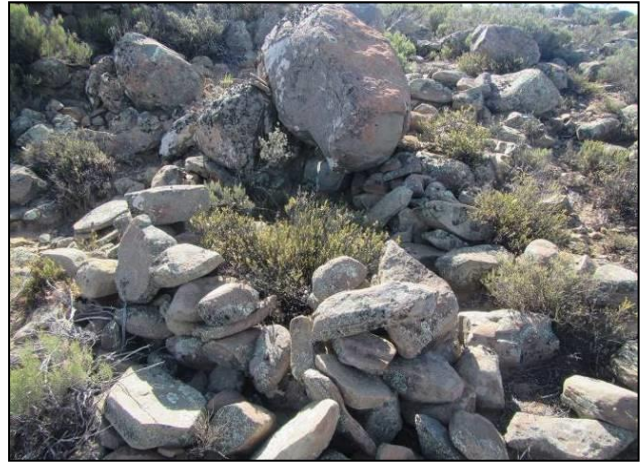
Figure 17: A very small enclosure on the northeast side of the rock outcrop.

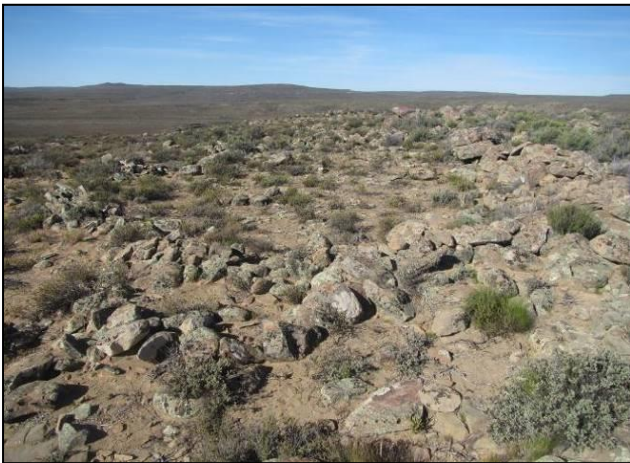
Figure 18: Two enclosures, one very large, on the north-western side of the outcrop.

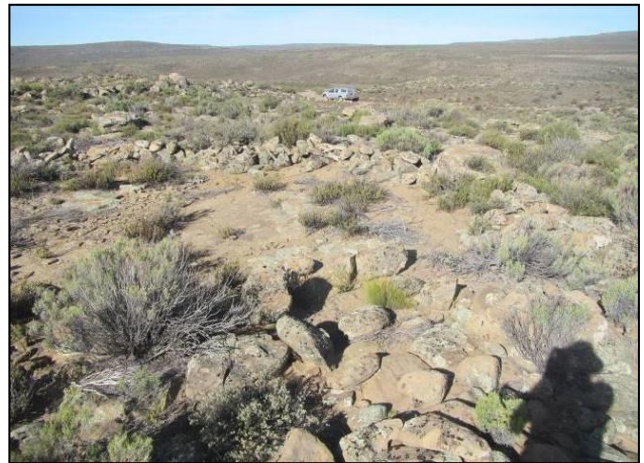
Figure 19: An enclosure on the top of the rock outcrop.

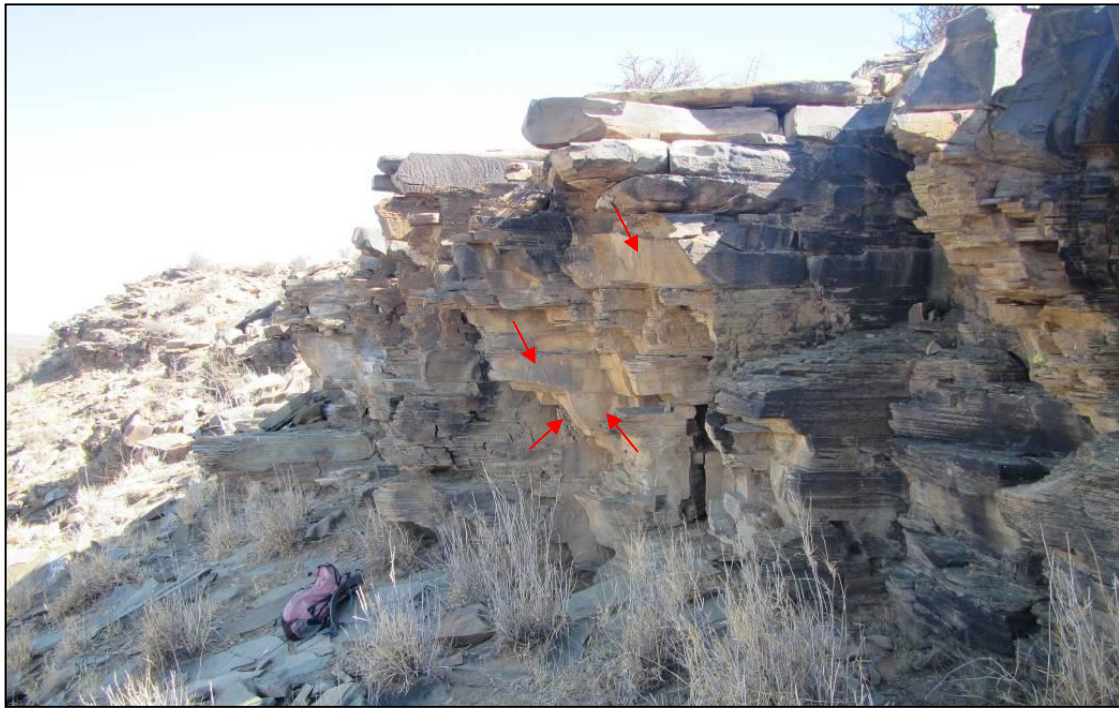
Figure 23: View towards the south of the low cliff line on which the geometric paintings were located (waypoint 492). The red arrows indicate the approximate positions of the finger-painted smears.

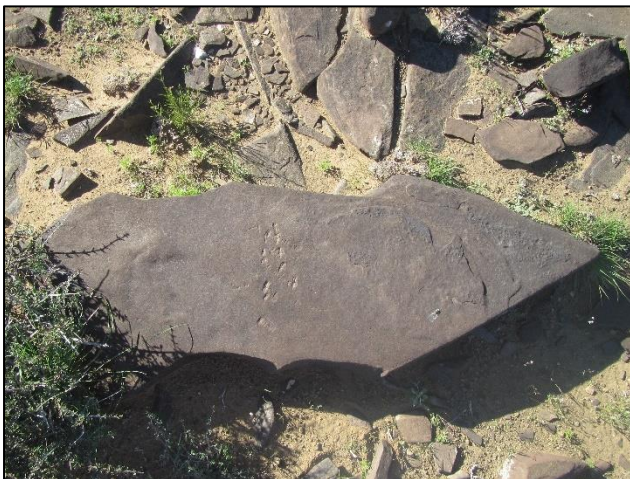
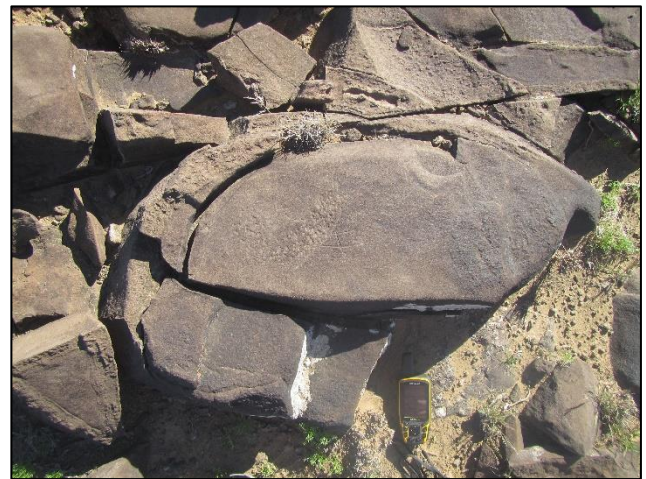
Also in Western Cape and along the southernmost section of the power line route a small rock outcrop capping a low, 90 m long rise was found to have three marked stones on it. These included a rock that had been used as a chopping block at the western end of the rise (Figure 24), another with an engraving at the eastern end (Figures 25 & 26), and a third in between with very faint scratches on it (they made some sort of composition but this could not be discerned). All are historical.

Figure 24: The chopped stone at waypoint 1783. **Figure 25:** The engraved rock at waypoint 1785.

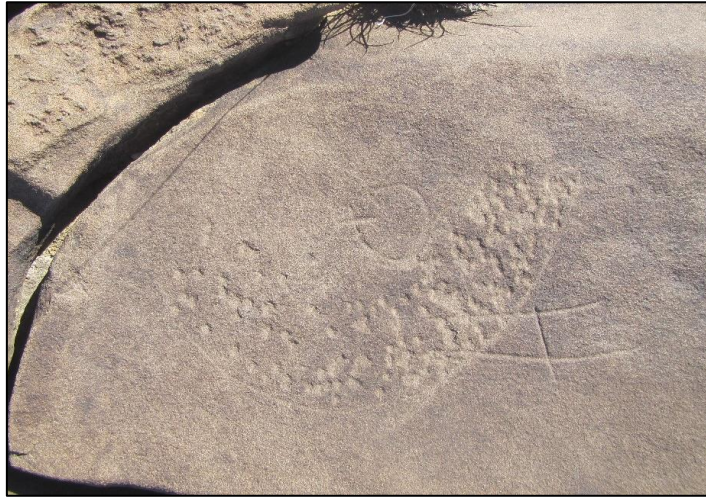
Figure 26: Close-up of the engraving at waypoint 1785.

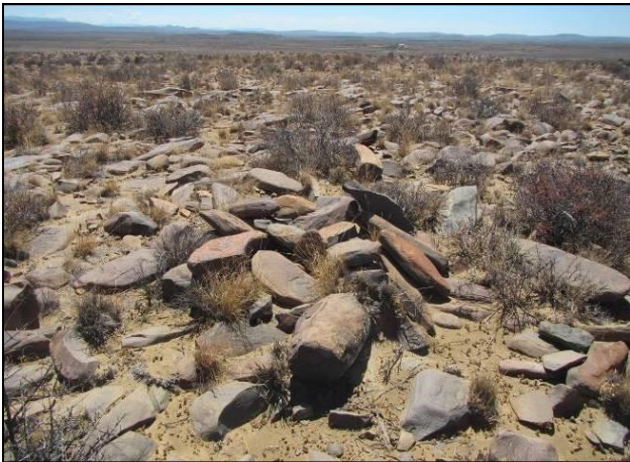
Figure 27: A loosely-packed stone cairn on a rocky ridge at waypoint 613.

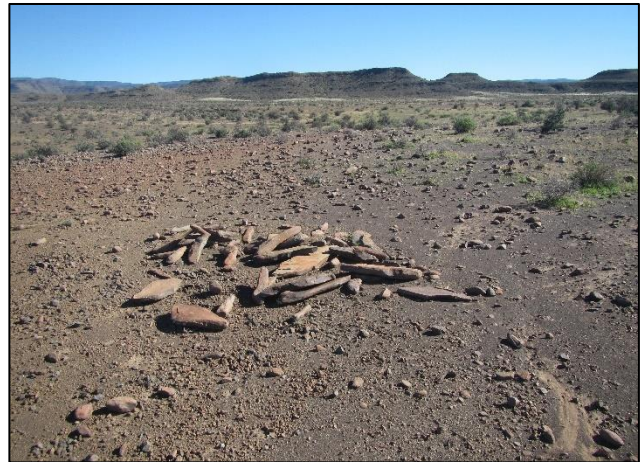
Figure 28: A loosely-packed stone cairn built on bedrock at waypoint 1787.

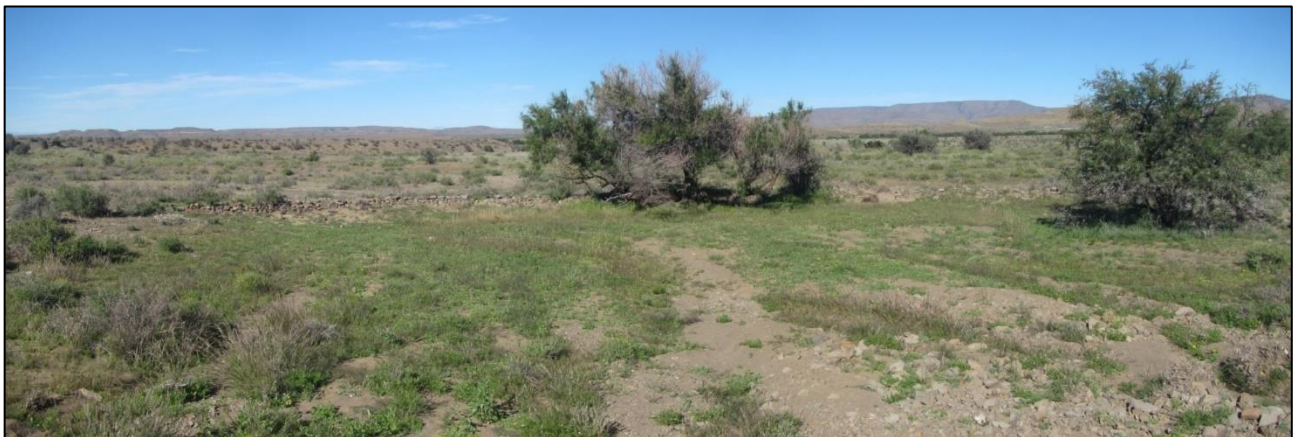
Figure 29: A small stone-walled in-stream dam at waypoint 1788.

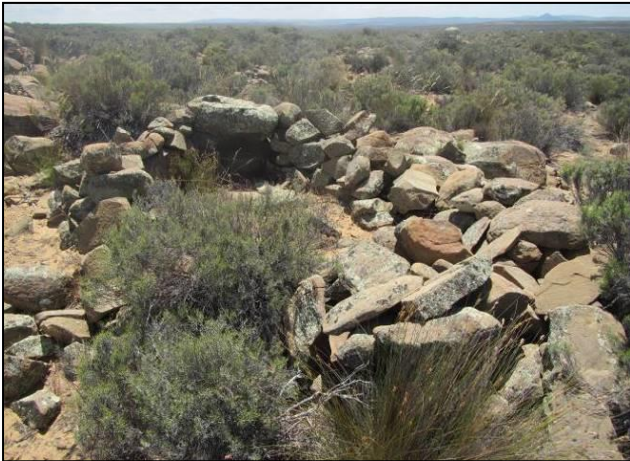
A number of small, usually isolated and very low structures were found above the escarpment in Northern Cape. These may well relate to shepherds constructing small shelters for themselves. At waypoint 576 a small, isolated stone structure with tumbled walling retained enough integrity to see that it had been packed in the traditional historical style (Figure 30). Three fragments of bone, one of them burnt, were found there. A more formal but still very small structure formal was a stone hut with a doorway that was located in a small but pronounced river valley close to a small waterfall which no doubt provided water during wetter times (Figure 31).

Figure 30: A small oval structure standing in the open away from any landscape features at waypoint 576.

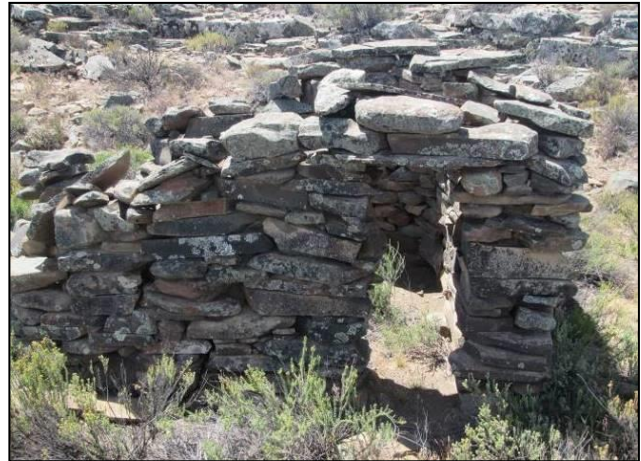
Figure 31: View of the south face and entrance of the small stone hut at waypoint 524.

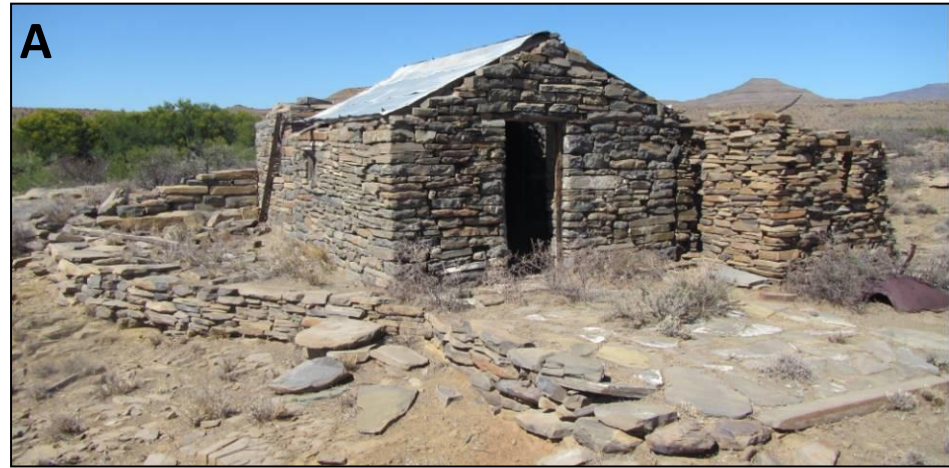
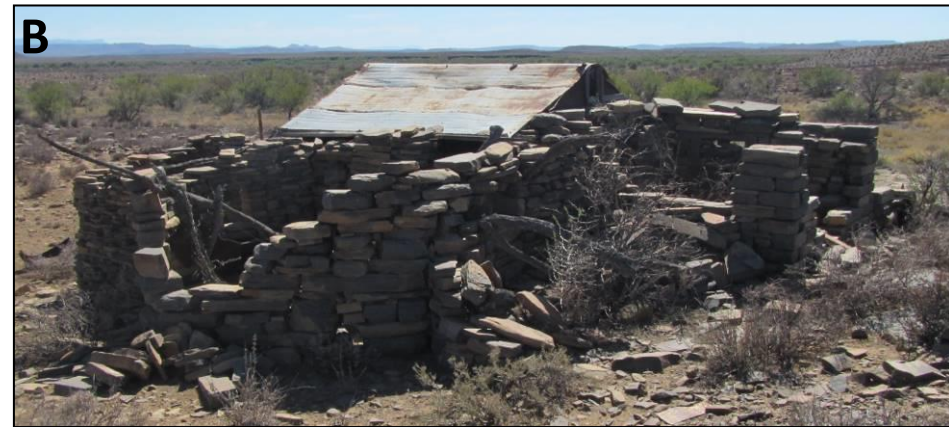
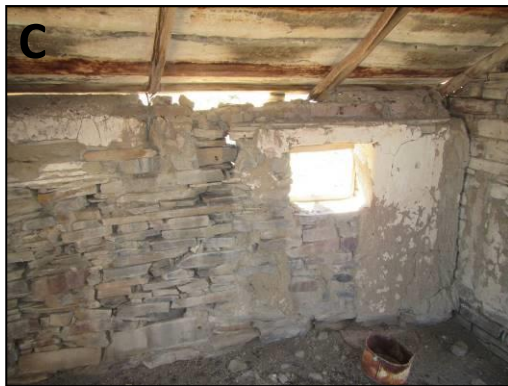
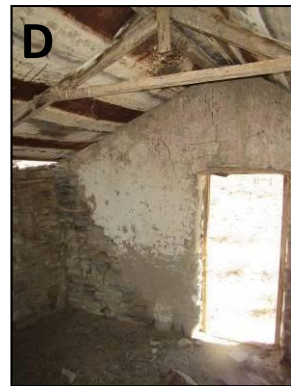
Figure 32: Plan of the ruined stone-walled house at waypoint 498 with (A) a view of the entrance and north-eastern corner, (B) View of the south-western corner of the site showing the curved walling, (C) the east-facing window in the central structure, and (D) the north-facing doorway in the central structure. Not to scale but approximate measurements are indicated.

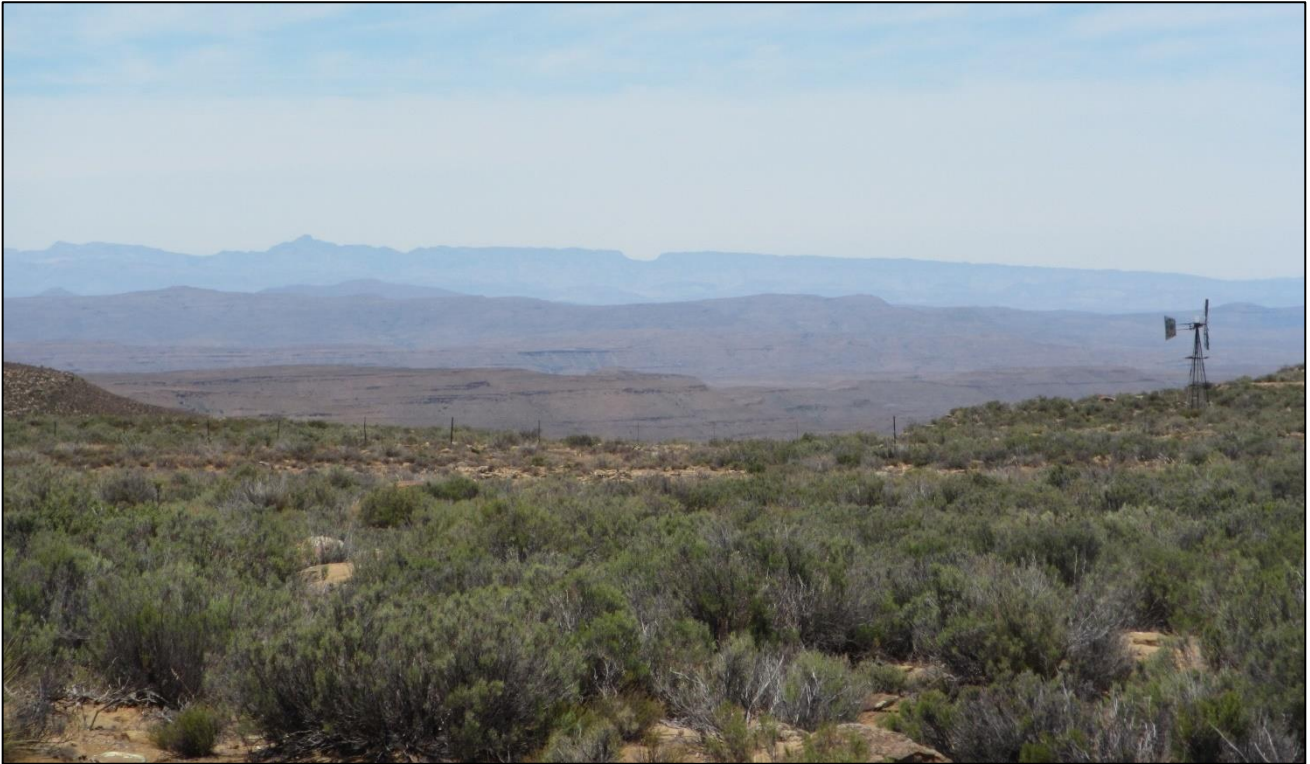
Figure 38: View from the crest of the escarpment towards the south into Western Cape. The edge of the escarpment and the provincial boundary are at the fence line in view. The power line would pass about 200 m north of this point (i.e. behind the camera).

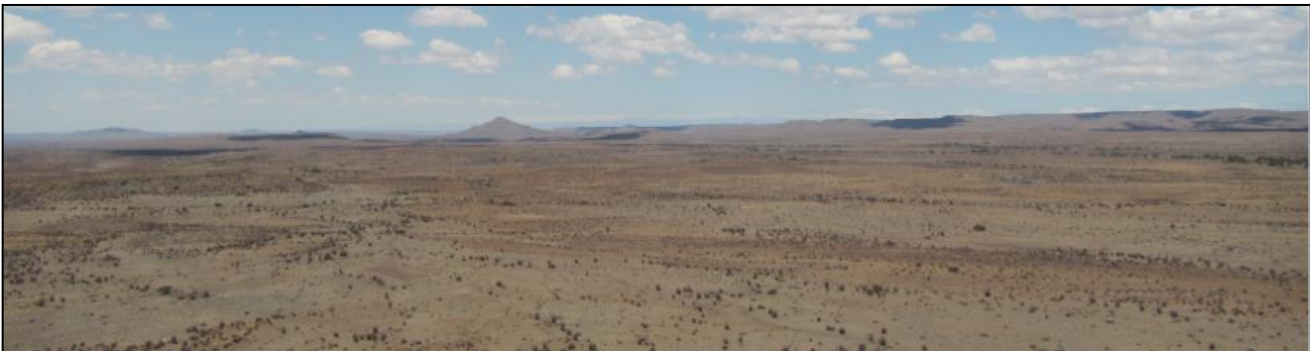
Figure 39: View towards the southeast in the eastern part of the study area showing the typical landscape below the escarpment. It is comprised largely of plains and low hills.

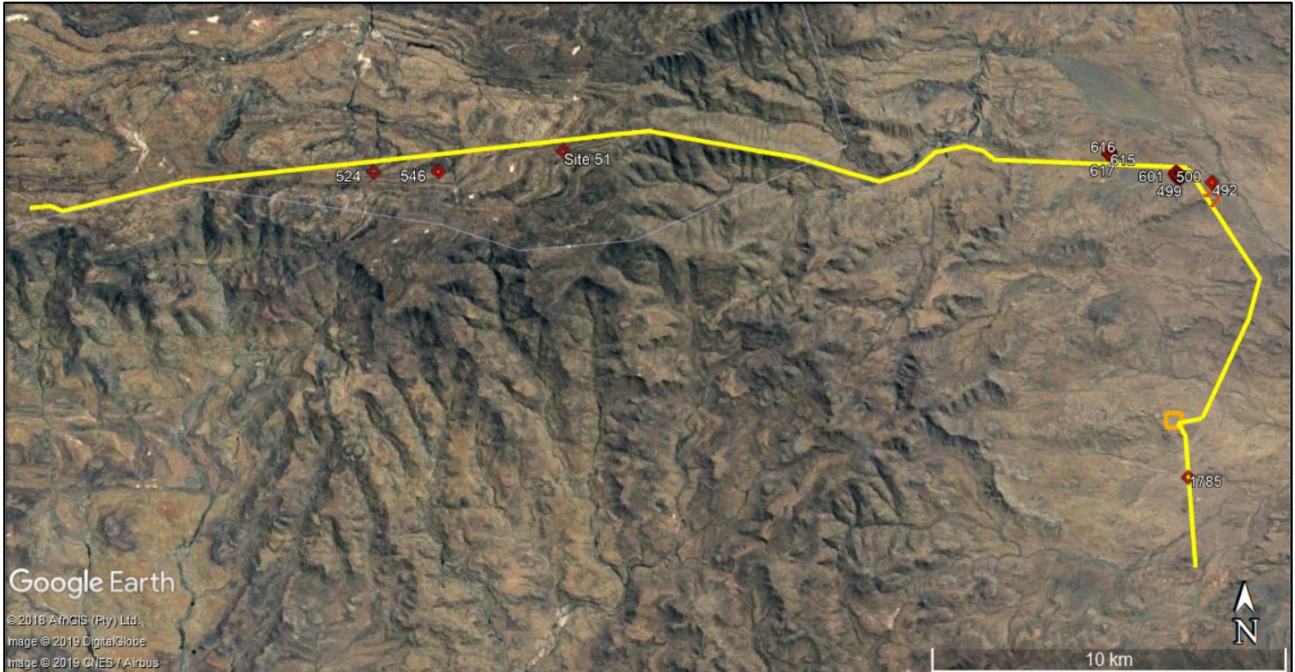
Figure 41: Overview of the heritage sites within 500 m of the power line route that should be protected and avoided.

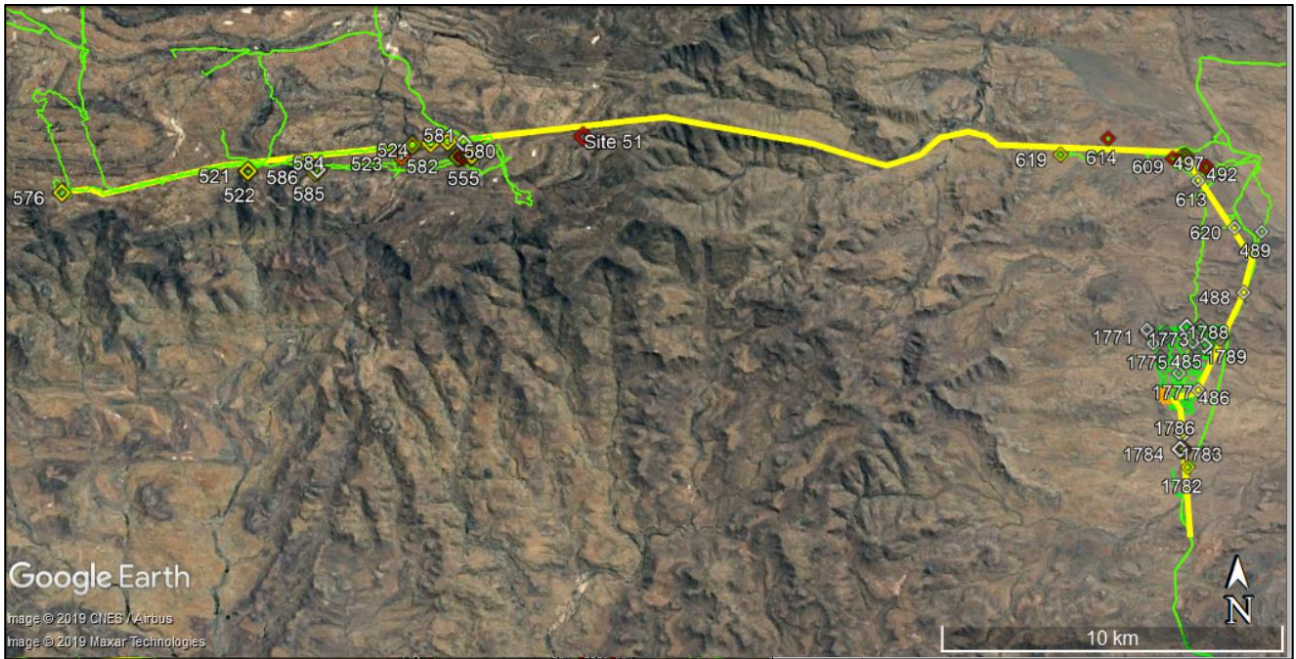
Figure A2.1: Aerial view of the study area showing the recorded waypoints along the power line route. The yellow line indicates the power line routing and the numbered symbols are waypoints. The green lines are survey tracks.

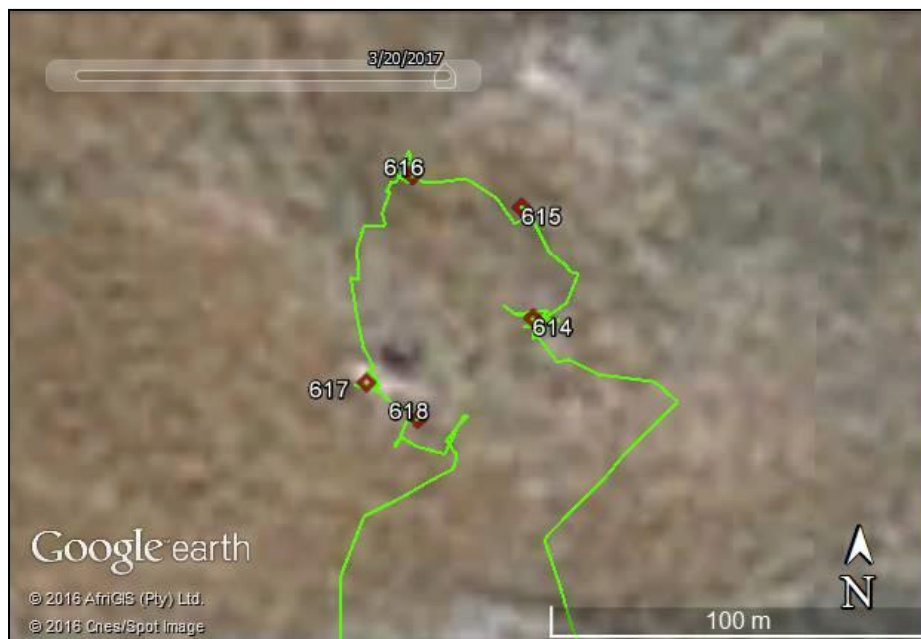
Figure A2.6: Aerial view of the historic farm outpost around waypoint 614.
