**REPORT ON GRAVE SITE FOUND AT PORTION 7 OF TEKWANE 537JU, IN WAY
OF AMENDED BULK SEWER PIPELINE, KANYAMAZANE
MPUMALANGA PROVINCE**

MARCH 2017

**ADANSONIA HERITAGE CONSULTANTS
CHRISTINE ROWE
P.O. Box 75
Pilgrim's Rest, 1290
Cell: 0828719553**

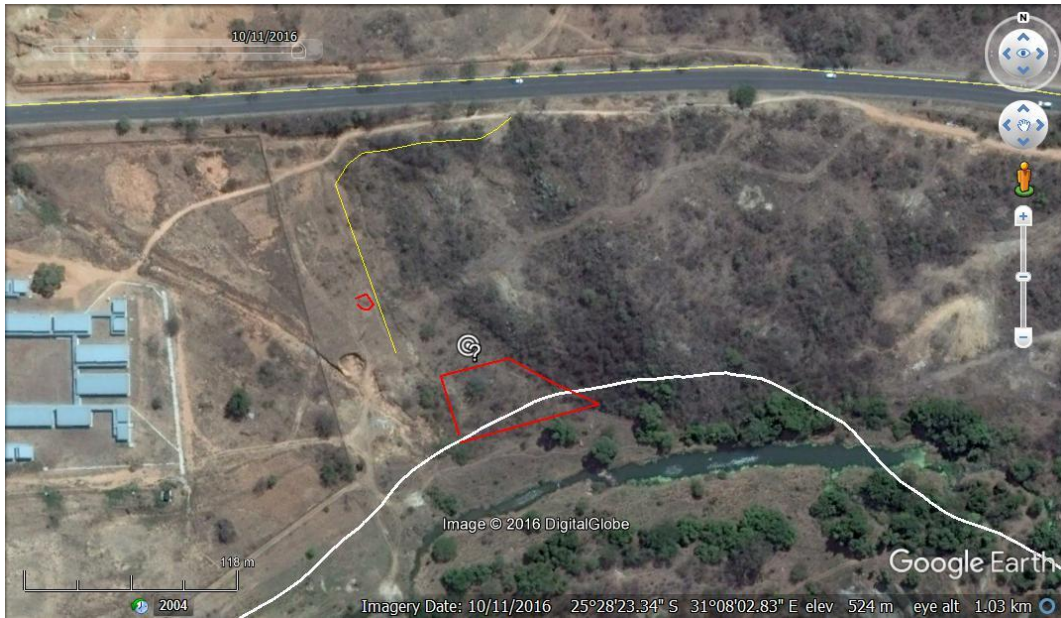
MAP 3: Two burial sites are indicated in red.

The legal context of the report is grounded in the NHRA no. 25, 1999. The burial site was discovered between a sand quarry to the west, and a low hill in the north and north east, with the Crocodile River to the south (see Google image Map 3). Graves are regarded as a high priority by the NHRA, and an assessment for the significance of the find was made, as well as plans for measures of mitigation.

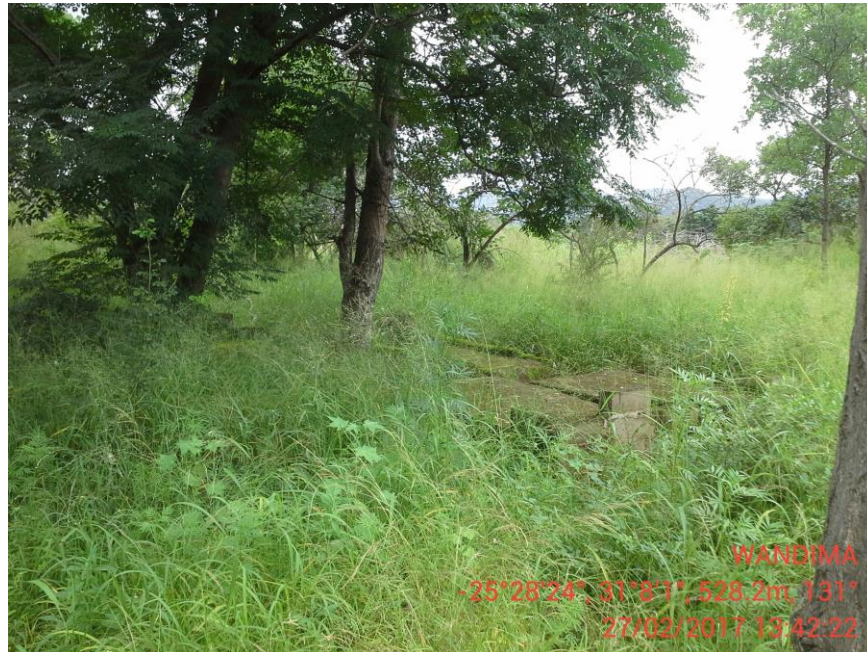
Fig. A: The initial photograph provided by WANDIMA ENVIRONMENTAL SERVICES cc (Photo provided by Mpendulo Gama, 2017-02-27).

At first it was thought that the burial site consisted of 5 graves as only the four graves with the concrete casings, as well as the grave (1984) with a marble gravestone (figs. 2, 5 & 7), were visible. The site was extremely overgrown and the extent of the site at the time, could not be determined (see Fig. A in text). The site was subsequently cleared of vegetation and revealed a number of 72+, as well as the possibility of 22 more graves which were not easily identified. Sections between graves which have no evidence of circular stone casings, might contain more graves.
