HERITAGE IMPACT ASSESSMENT FOR THE PROPOSED ZEN WIND ENERGY FACILITY, TULBAGH MAGISTERIAL DISTRICT, WESTERN CAPE

(Assessment conducted under Section 38 (8) of the
National Heritage Resources Act (No. 25 of 1999) as part of an EIA)

09 November 2012

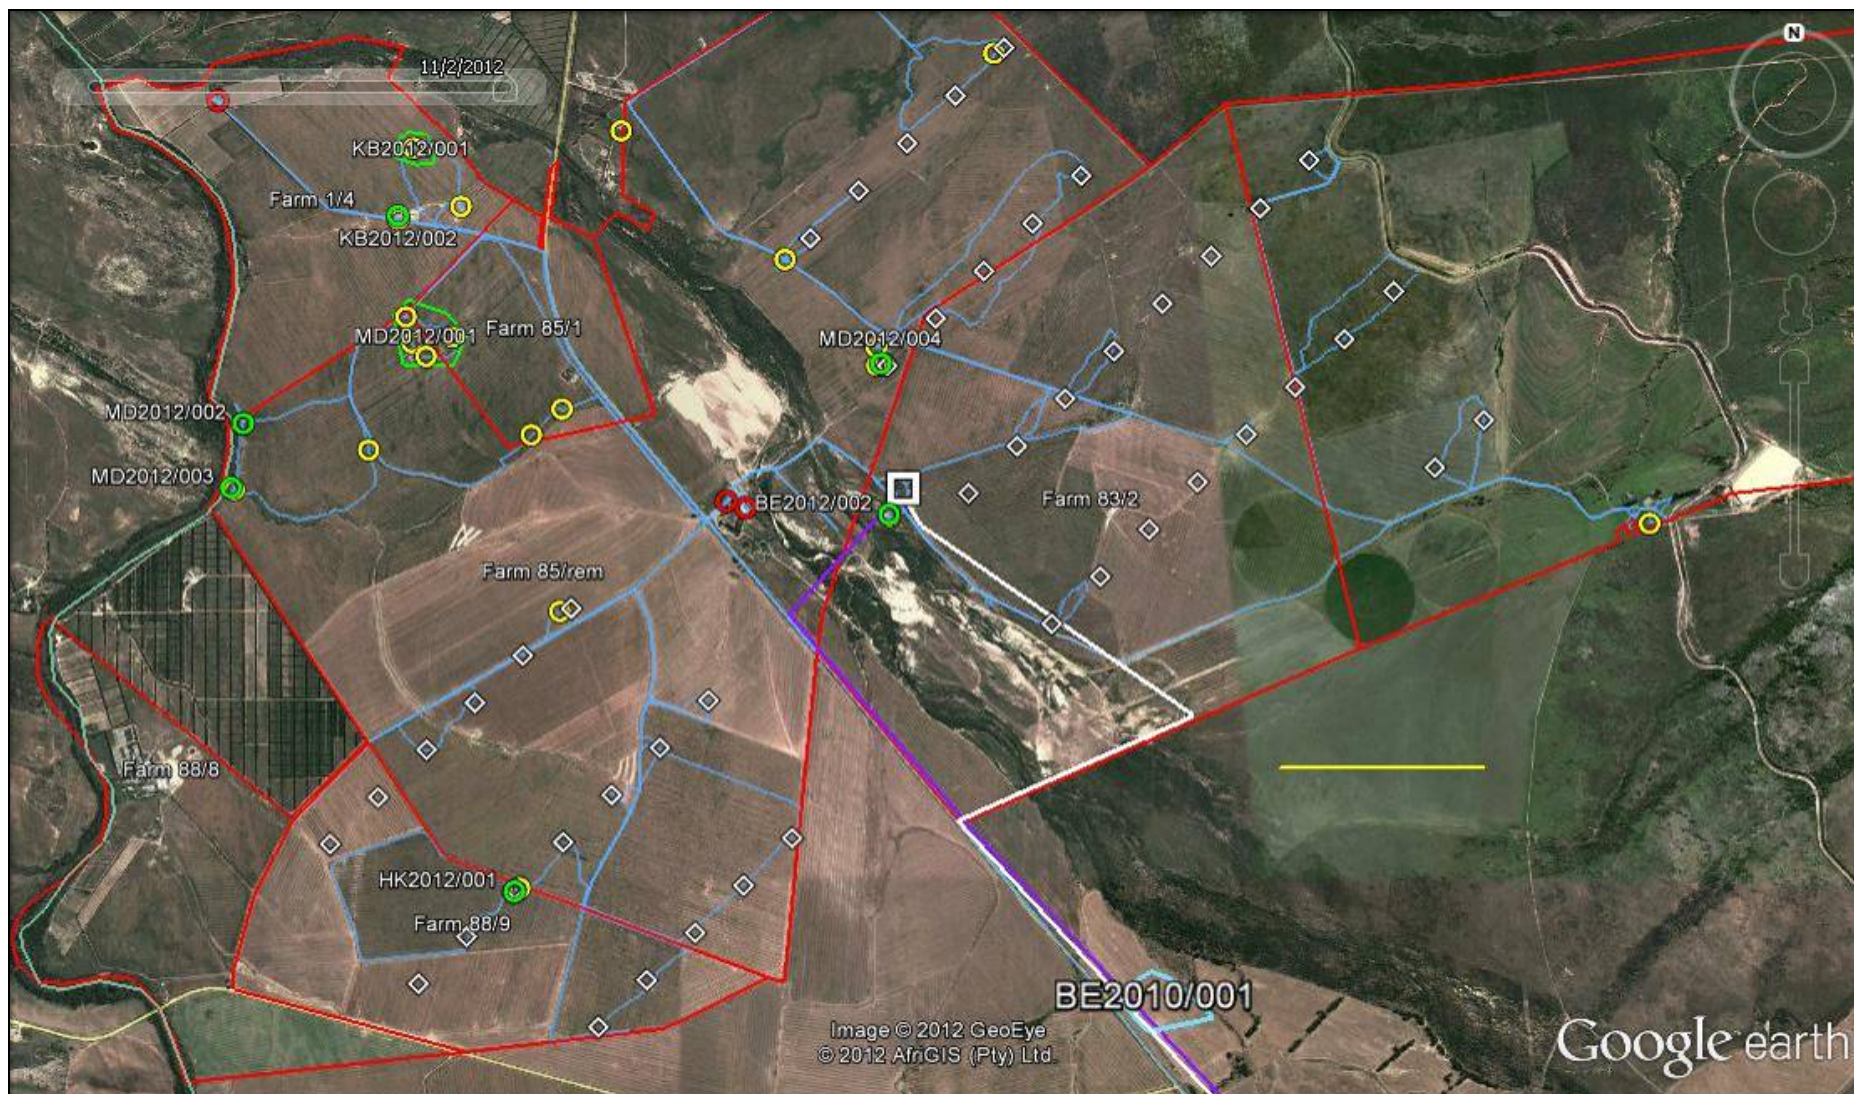
Figure 12: Aerial view of the study area showing the locations of the dense ESA scatters. Green circles and polygons denote archaeological sites, yellow circles denote other archaeological occurrences and red circles denote built environment features greater than 60 years of age. The white diamonds are the turbine locations, the white square the substation and the blue lines the walk-paths from the survey. The yellow bar for scale at lower right is 1 km long.

Figure 12 shows the location of the two old structures in the Kleinberggrivier Farm werf (red circles in the centre of the image) and those at Die Mond (upper left hand corner). The structures in Saron will not be given individual consideration here since they are relatively far from the proposed development. However, as a whole they will be considered under historical settlements below.

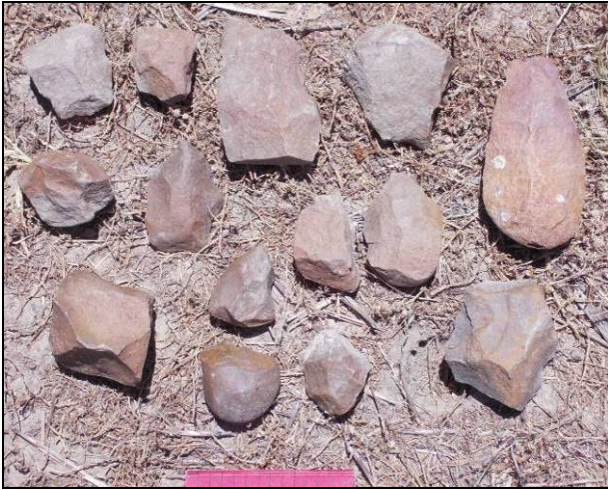
Figure 13: Artefacts from point 001 (MD2012/001).

In the areas where ESA artefacts were denser there were certainly also many more isolated artefacts. However, the good scatters were obvious when one encountered them. Figures 13 to 20 show examples of artefacts and hand-axes found at such localities, while Figure 21 shows a selection of cobble cores from a scatter that was composed almost exclusively of such artefacts. Why such a high frequency of cores should be present in the absence of large numbers of flakes is unknown. A peculiar find was an eroding sand dune close to the Klein Berg River and which contained much river gravel and weathered artefacts. These artefacts included a large number of relatively small flakes and very few larger flakes or cores (Figures 22 & 23). Whether these are ESA or MSA is unknown but, given the paucity of larger artefacts, they may well be MSA. In one or two areas there were occasional flakes which, from their smaller size and reduced patination, may well have been MSA. In general, however, it seems that the MSA is poorly represented on the landscape.

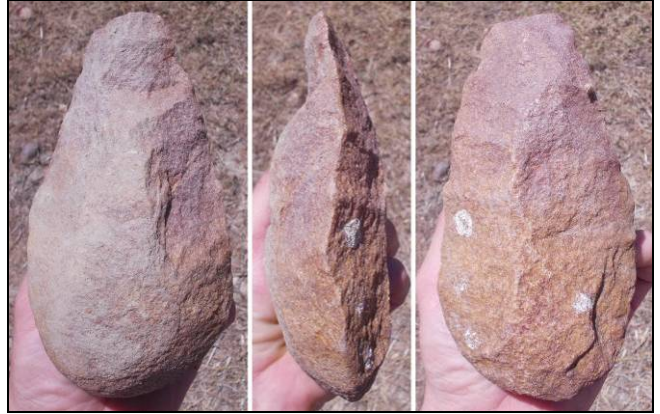
Figure 14: The hand-axe from point 001 (MD2012/001).

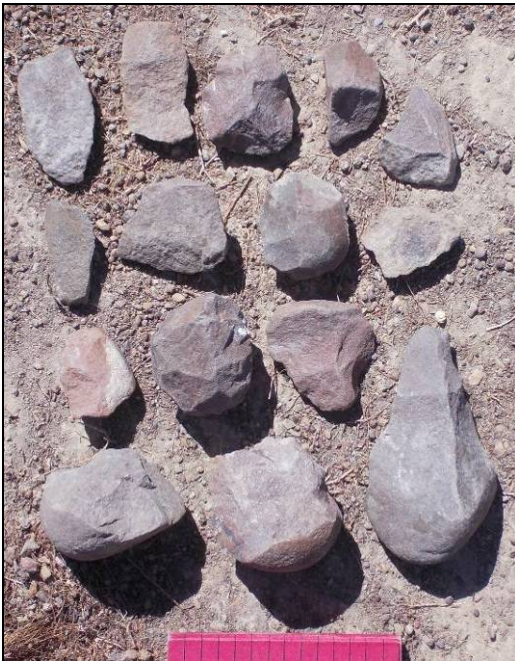
Figure 15: Artefacts from point 005 (HK2012/001).

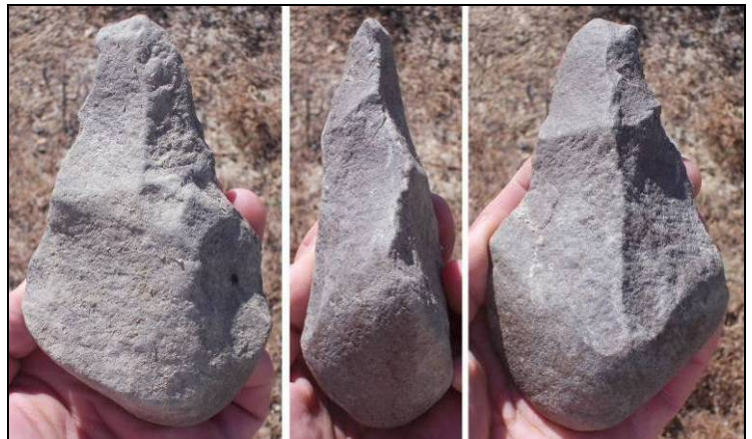
Figure 16: The hand-axe from point 005 (HK2012/001).

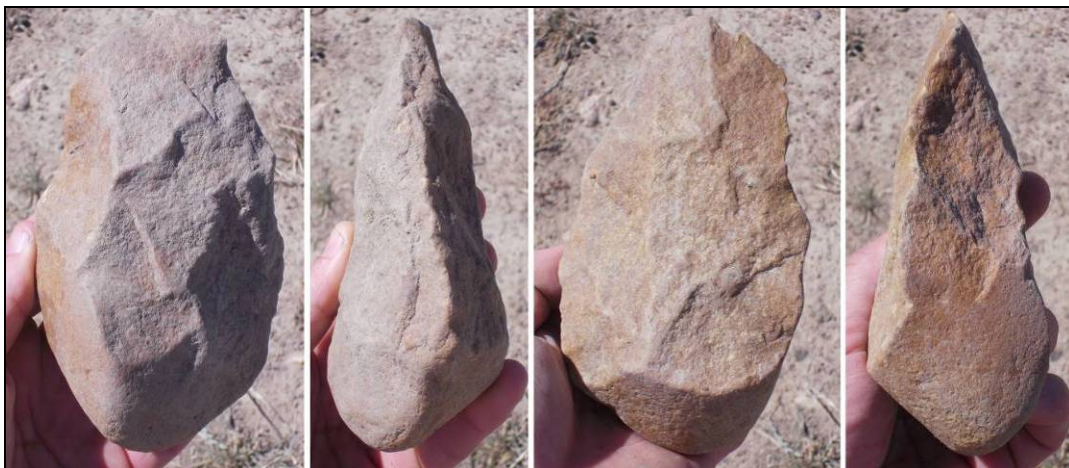
Figure 17: The hand-axe from point 006 (HK2012/001).

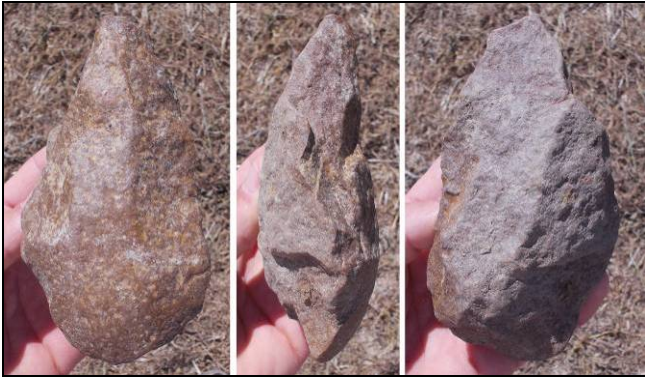
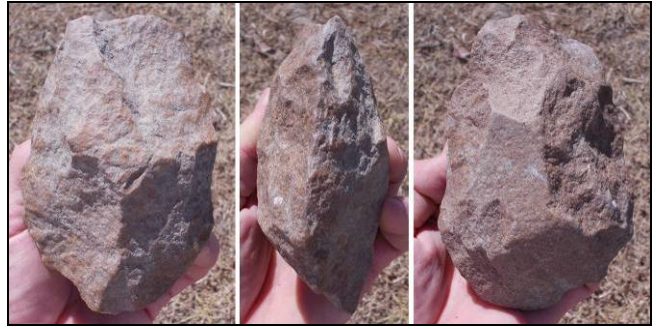
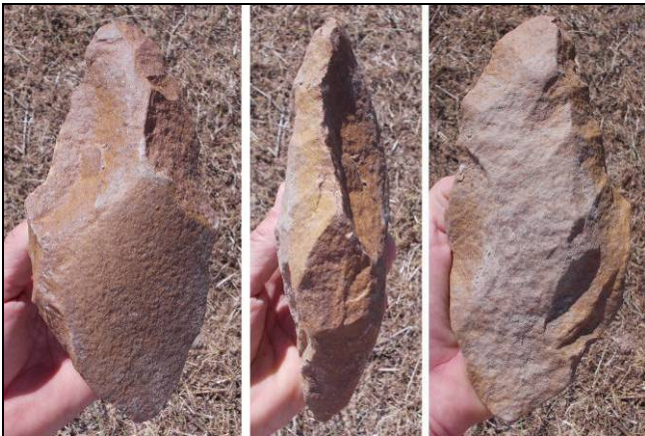
Figure 18: The hand-axe from point 023 (MD2012/004)

Figure 19: The hand-axe from point 023 (MD2012/004).

Figure 20: The hand-axe from point 023 (MD2012/004).

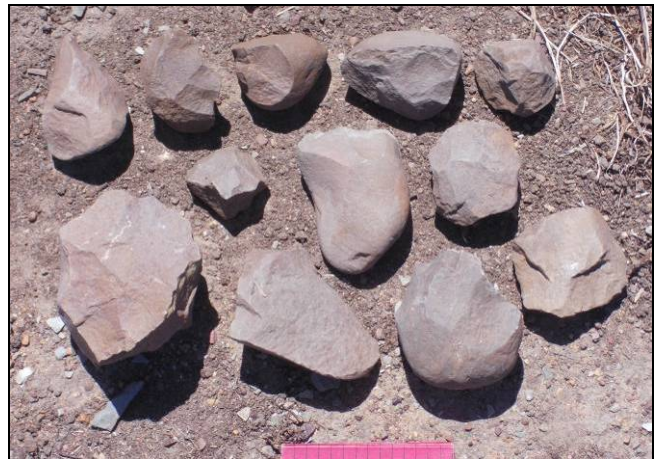
Figure 21: A selection of cobble cores from point 022 (MD2012/004).

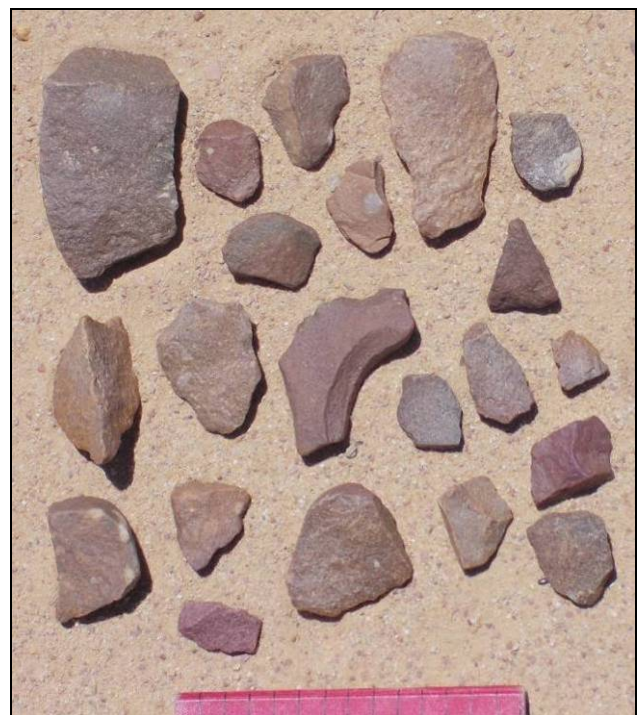
Figure 23: Artefacts from point 019 (BE2012/002).

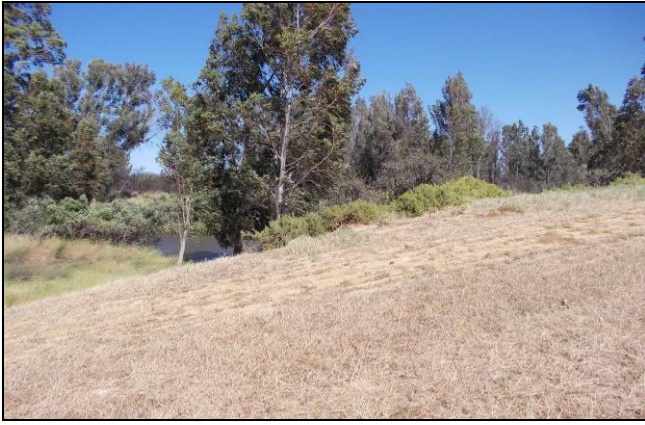
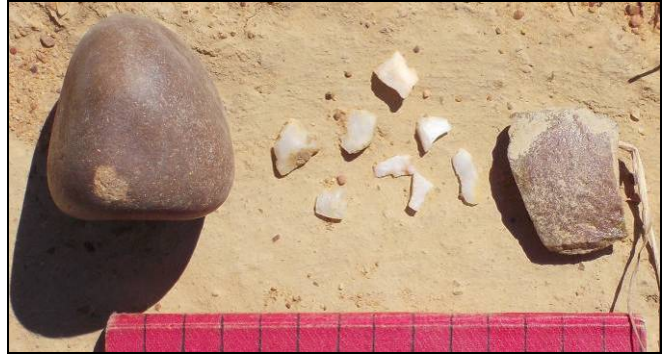
Figure 24: The location of the LSA artefacts at point 012 (MD2012/002).

Figure 25: Artefacts from point 012 (MD2012/002). At left is a quartzite hammer stone.

Two small LSA scatters were found on the banks of the Berg River in the far west of the site. Neither was dense. Both included flaked artefacts in quartz and one had a small quartzite hammer stone and one quartzite flake present (Figures 24 & 25).

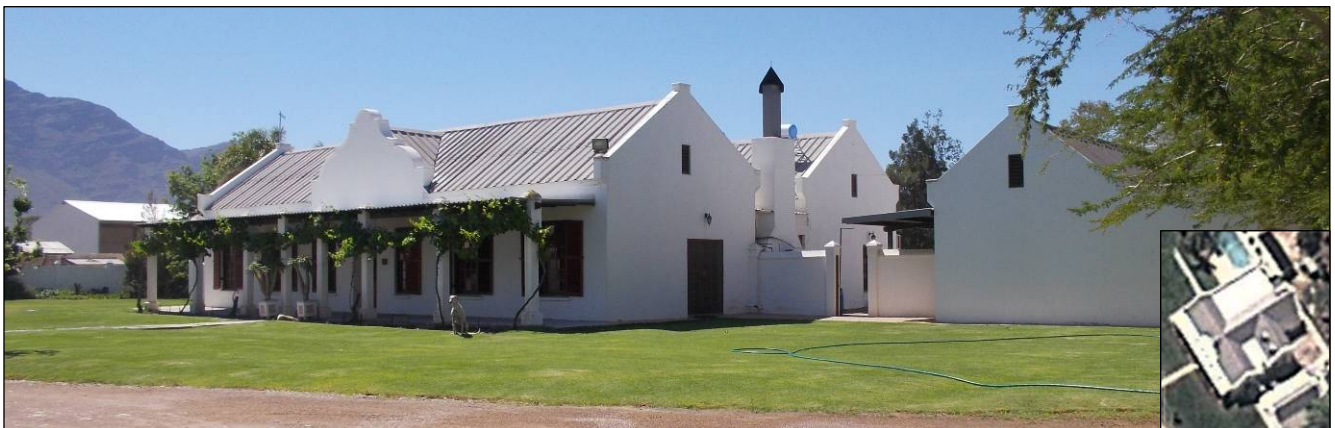
Figure 26: The main house on the Kleinberggrivier farm werf. The inset shows the roof plan of the house with the front to lower left.

The Kleinberggrivier werf has two old buildings. The main house (Figure 26) is large and it is not possible without a detailed examination to tell its original form. It has almost certainly been added to over the years but its primary plan form is still the same as it was in 1938 (Figure 27). Tim Hart (pers. comm. 2012), who has been inside the house, confirms that there is virtually no original fabric remaining visible. The second structure of antiquity is a store room/outbuilding that likely dates to the late 19th century or early 20th century. It is in very poor condition and of little heritage value (Figures 28 & 29). A few other buildings are present in the 1938 photograph but have been demolished now but one small outbuilding east of the main house may still be the same as that present today.

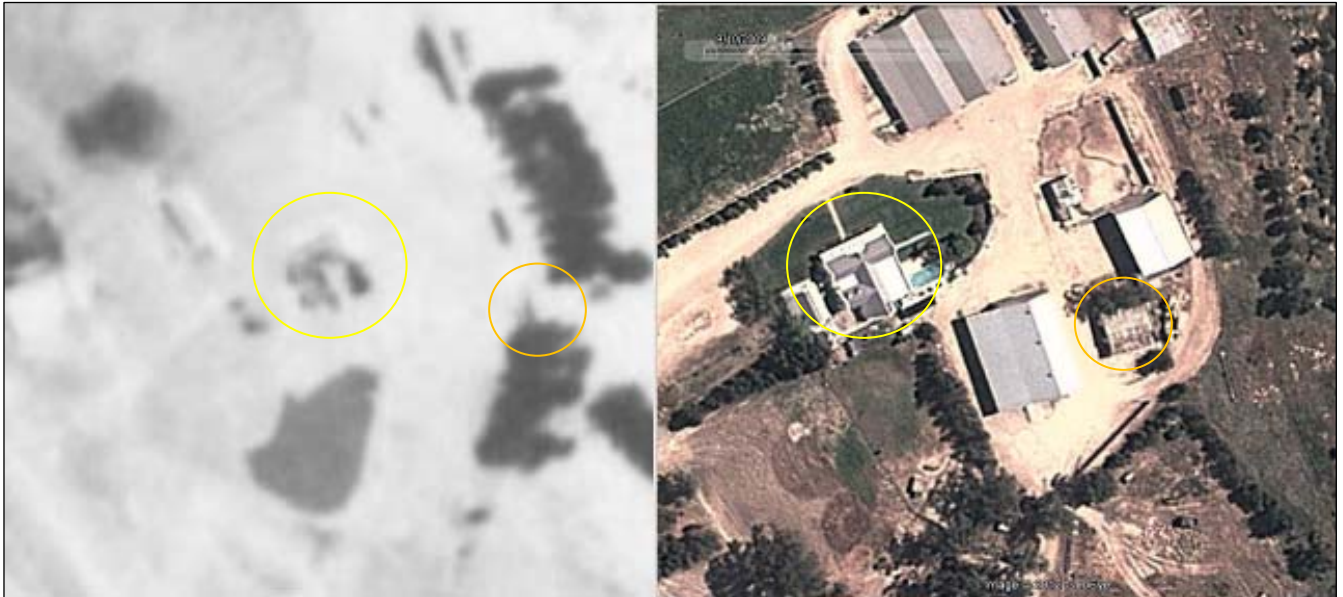
Figure 27: Extract from the 1938 (left) and modern (right) aerial photographs showing the changes to the farm werf at Kleinberg. The two house and shed described above are indicated.

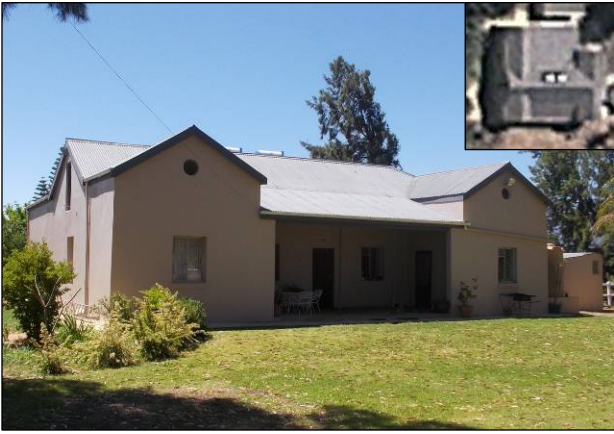
Figure 30: The main house at Die Mond. The inset shows the roof plan with the front at the bottom.

Two old buildings occur at the Die Mond werf. The werf is situated at the junction of the Kleinberg and Berg Rivers, hence its name. The main house (Figure 30), despite having been modified and added to at various times, retains enough original features to indicate a late 19th century age. There are differing roof heights which allows for the possibility that the core is older with the front and back wings having been added later. The outbuilding/barn located to the west of the main house is also of 19th century age. Its original core is obvious with the lean-tos having been added later (Figure 31). It is apparent from Figure 32 that old structures have been removed from this werf but the main house and the shed are clearly visible.

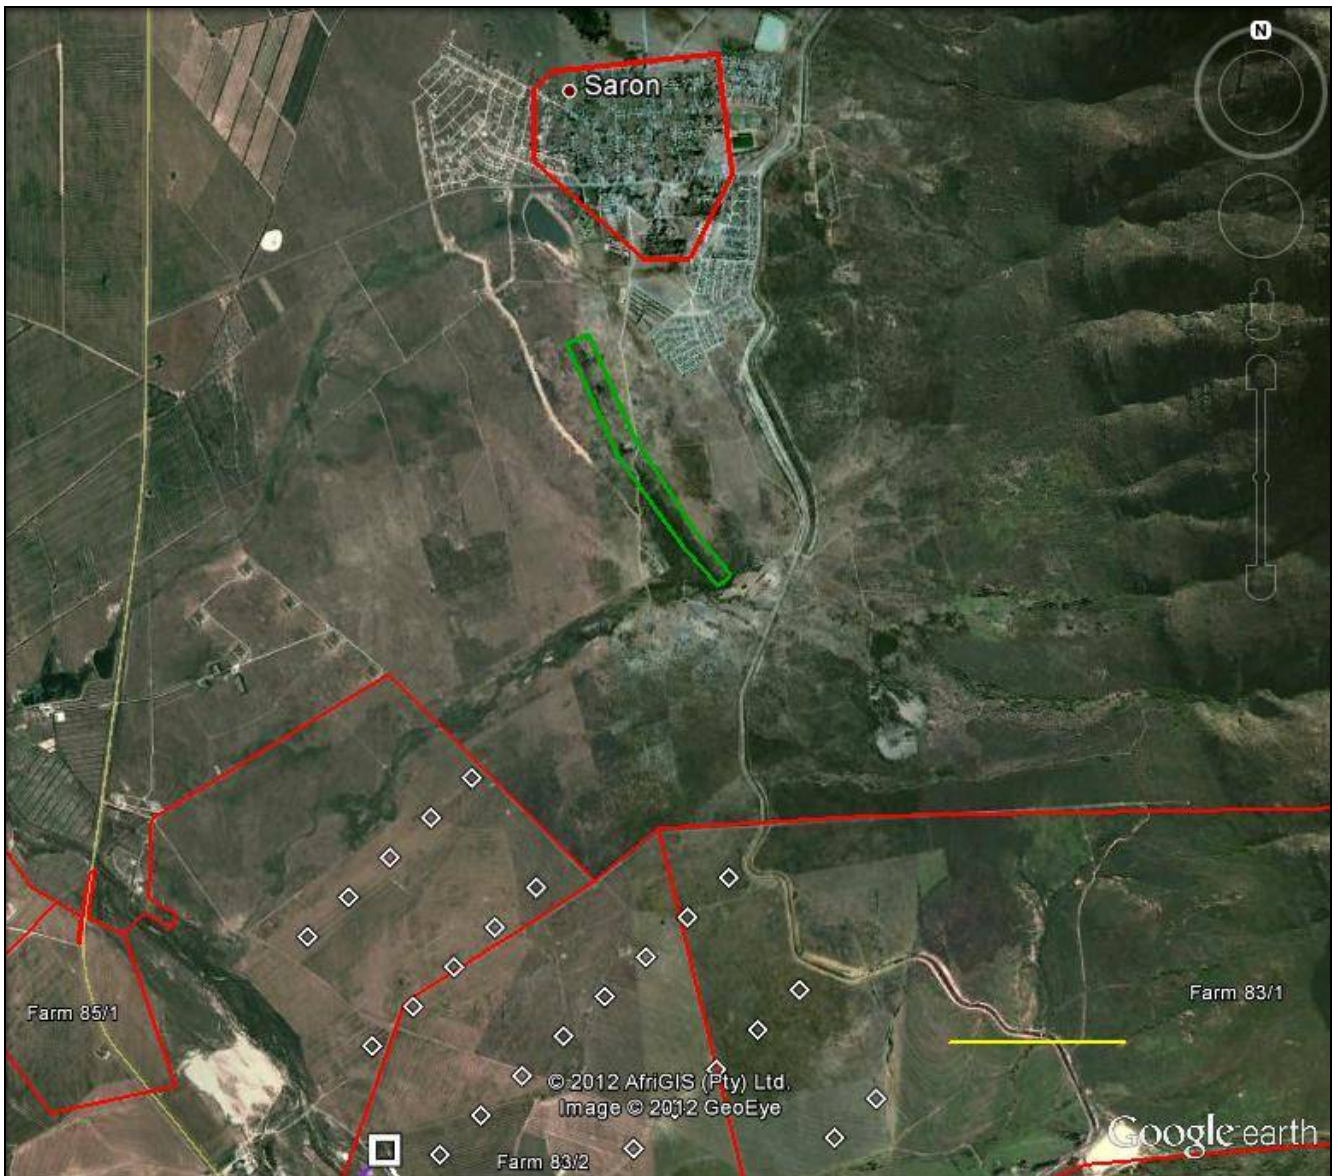
Figure 47: Aerial view of the northern part of the study area showing the relationship between the historic core of Saron (red polygon in the north) and the proposed wind turbine positions (white diamonds). The green polygon in the middle delimits the rocky ridge and the yellow bar for scale at lower right is 1 km long.

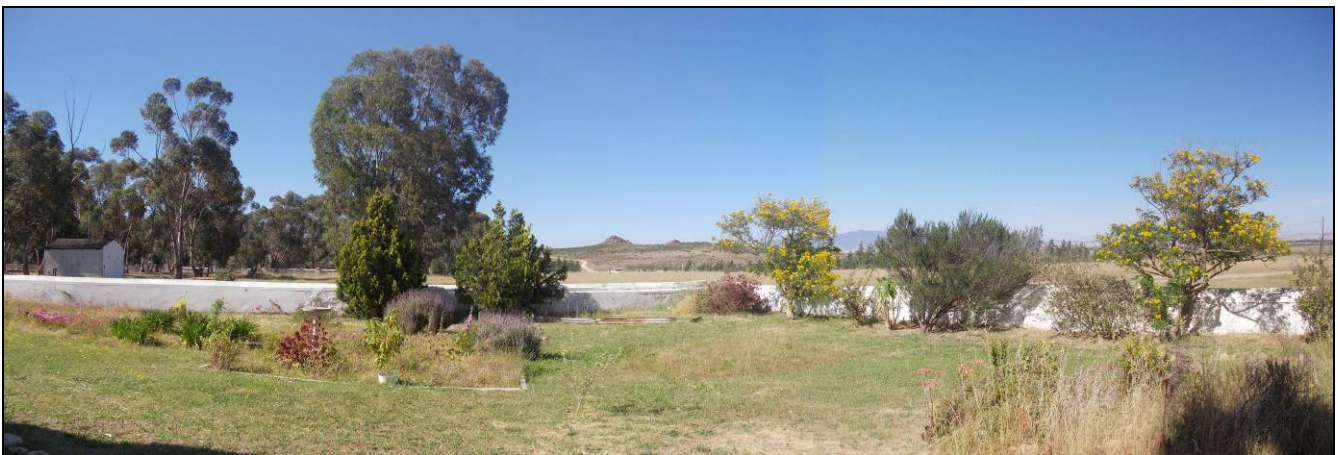
Figure 48: View southwards towards the proposed WEF (behind the rocky ridge and some 3.3 km from the photographer) from within the walled garden at the mission church.

However, taking the Figure 48 view as an example, a scale drawing suggests that a viewer standing at 100 m above sea level (the approximate elevation of the church), looking towards the ridge which is approximately 130 m above sea level and 1.2 km distant would see the top of a 100 m high tower (and, obviously, all of the blade length) standing on land at 90 m above sea level and at about 3.4 km distance. The scoping VIA suggests that this distance is still within the core area of impact (<5km) and that in general turbines in this landscape would be comfortably visible within the medium range of 5 km to 10 km (Du Plessis 2012). This view would only be from a few specific locations where trees do not shield the WEF – the vast majority of viewpoints in the village would be completely protected from seeing the WEF.

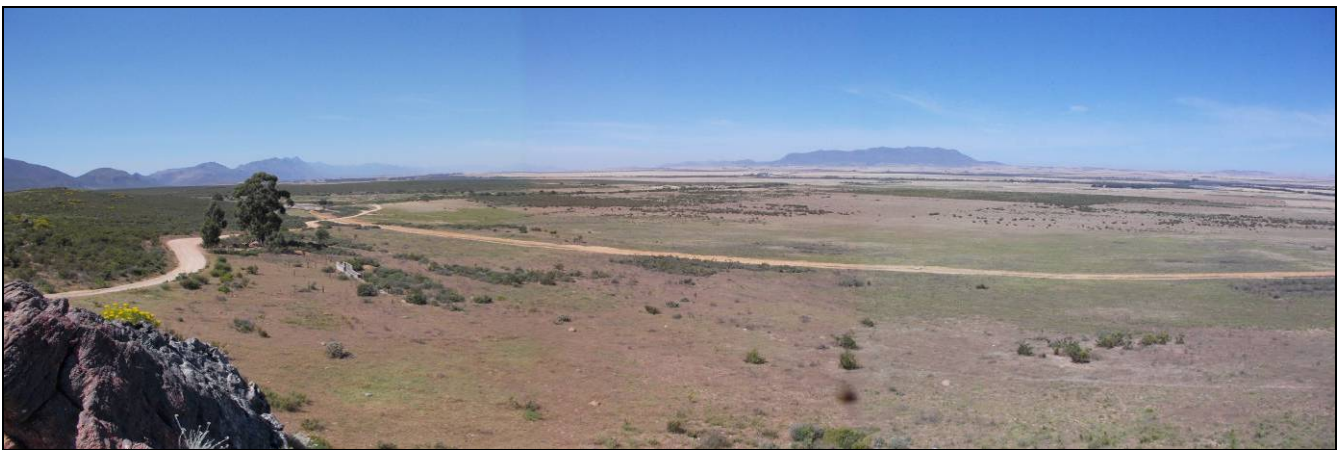
Figure 49: View towards the south from the rocky ridge south of Saron. The proposed Zen WEF will lie between 2.3 and 7.5 km from the photographer within the pale brown wheat fields visible close to the skyline.

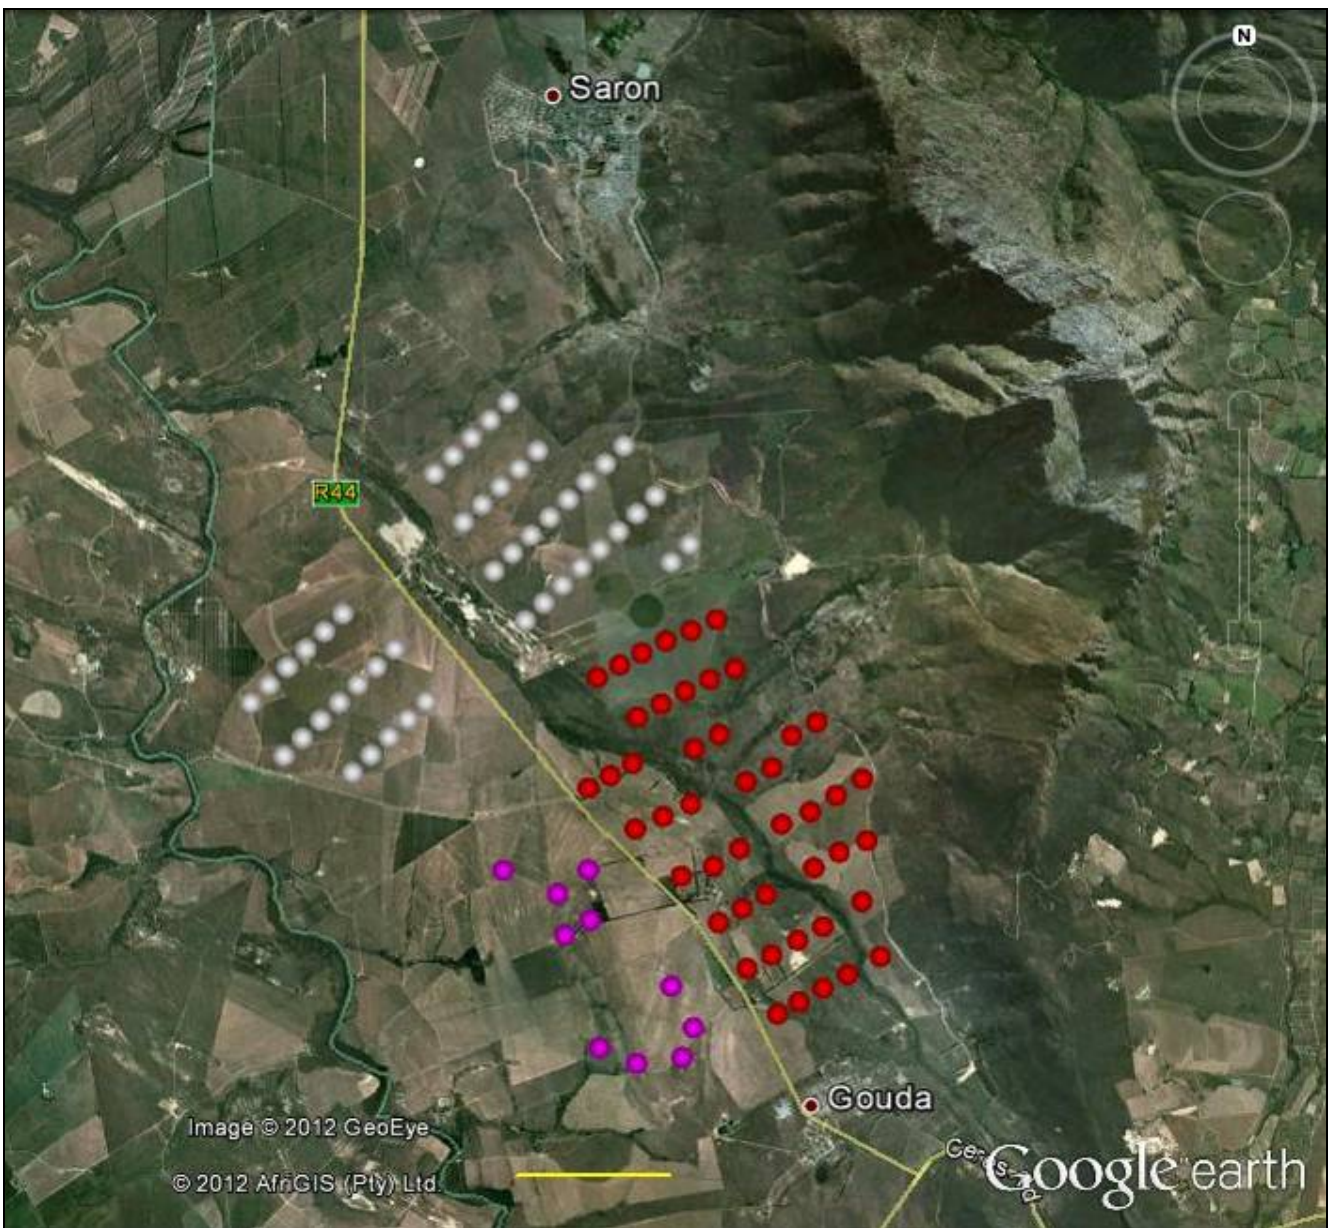
Figure 50: Aerial view of the study area showing the proposed Zen WEF, (white dots), the proposed iNca Gouda WEF (pink) and the Gouda WEF (red) which is due for construction in early 2013. The yellow bar for scale at the bottom is 2 km long.

The important aspect here is the clustering of turbines as noted by CNdV (2006). This refers to cumulative impact. CNdV (2006) recommends that clusters of wind turbines be located a minimum of 30 km and preferably about 50 km apart in appropriate landscapes. The next closest clusters (assuming construction) would be around the town of Moorreesburg, just less than 30 km to the west and Wolseley some 28 km to the southeast. Although these distances are not ideal, a precedent for WEF construction has already been set around the Saron-Gouda area by the existing authorisation of one wind energy facility. It seems best to add to this cluster rather than spreading more widely as this would contain the already unavoidable visual impacts to the scenic route.
