**HERITAGE SURVEY OF THE TETYANA TO SITEBE
KOMKULU ROAD UPGRADE, EASTERN CAPE**

FOR COASTAL ENVIRONMENTAL SERVICES

DATE: 13 MARCH 2013

**Umlando: Archaeological Tourism and Resource
Management**

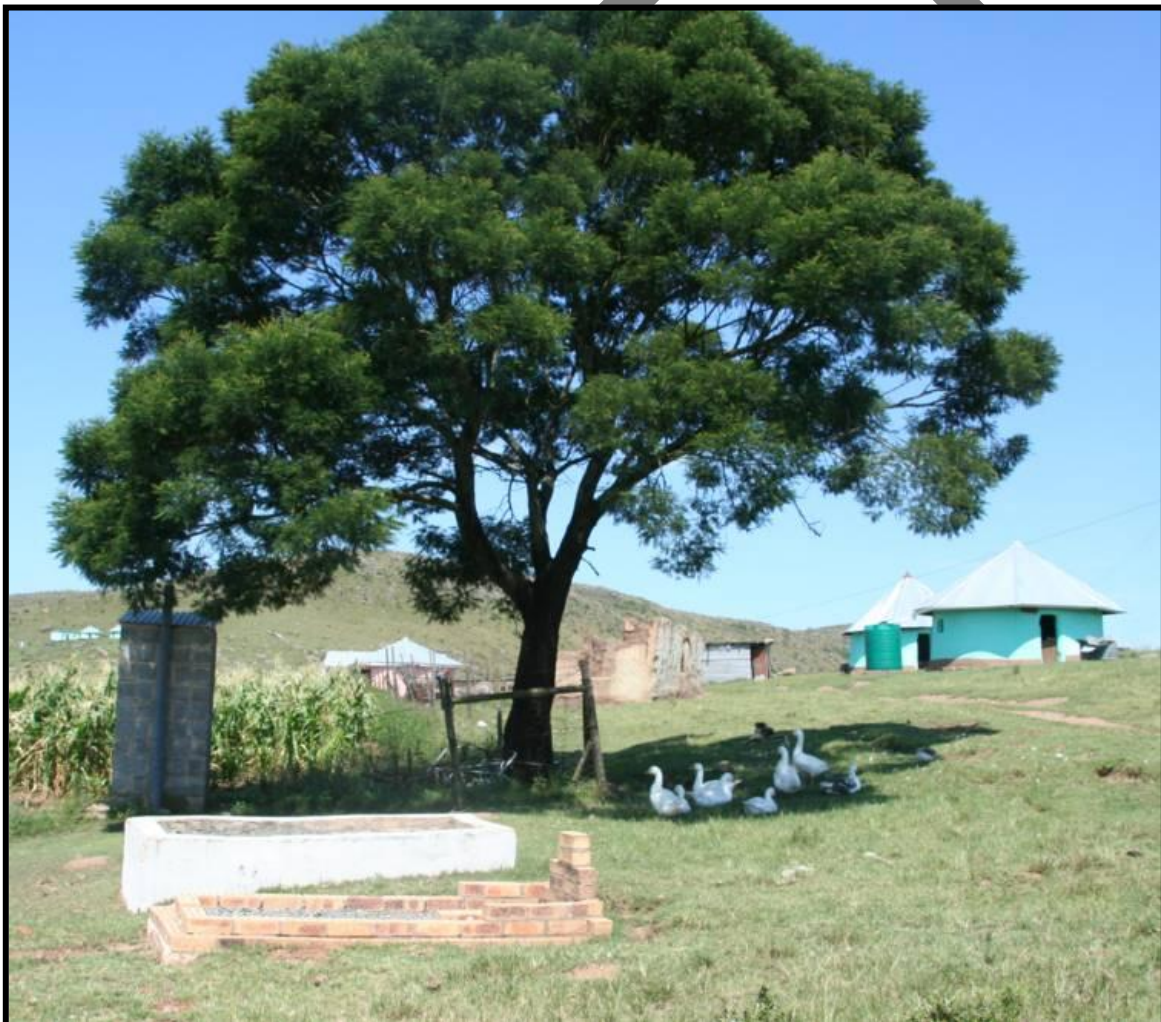
Fig. 8: Graves At TET01

TET01 is located ~30m south of the road deviation. The site consists of two recent graves near a tree (fig. 8). There are no dates on the graves.

Significance: The site is of high significance.

Mitigation: The graves should be fenced off before road construction begins and with community/individual approval.

SAHRA Rating: 3A

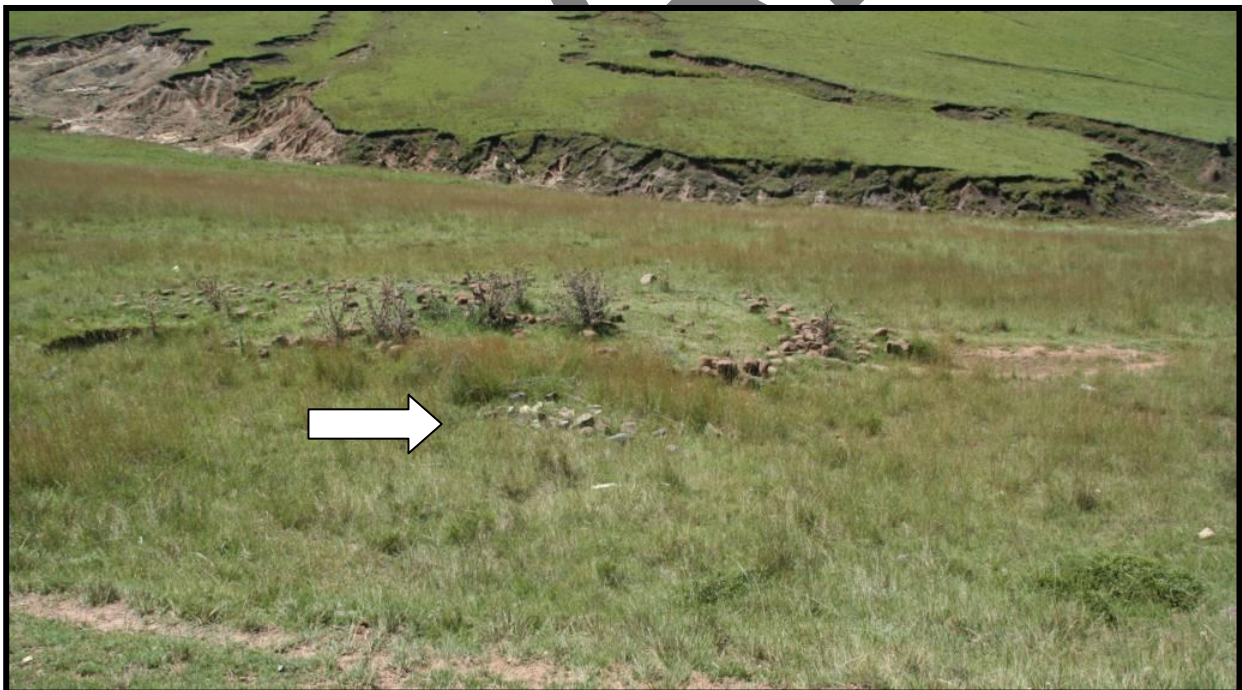
Fig. 9: Settlement and Grave At TET02³

TET02 is located to the east of TET01, and on the opposite side of the road. The edge of the site is 6m from the current road, and ~20m from the new road. The site consists of the remains of a settlement and one possible grave (fig. 9).

The road deviation will probably affect the grave.

Significance: The possible grave is of high significance while the house remains are of low significance.

³ Arrow points to grave

Mitigation: The graves should be fenced off before road construction begins and with community/individual approval.

SAHRA Rating: 3A

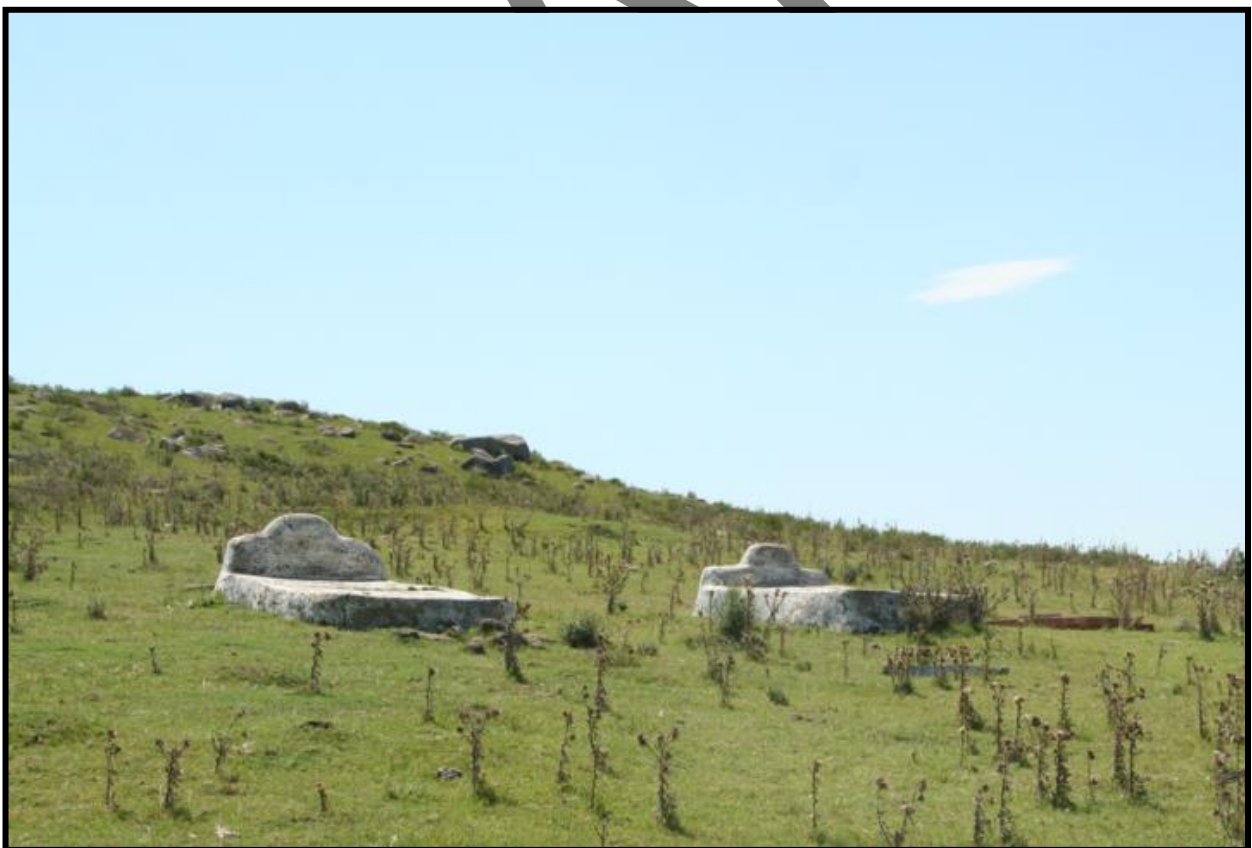
Fig. 10: Three Graves At TET03

TET03 is located near the top of a hill and ~50m from the current road. The site consists of a settlement and three graves of unknown age (fig. 10). The settlement is very vague and consists of three houses, a kraal and small agricultural field. The graves occur in front of the house foundations. TETY-15 is located ~80m south of the site, and Site 36 is located 60m to the north. Neither Site 36 nor TETY-15 was visible during the survey.

Significance: The graves are of high significance.

The site consists of a settlement and three graves of unknown age. The settlement is very vague and consists of three houses, a kraal and small agricultural field. The graves occur in front of the house foundations. TETY-15 is located ~80m south of the site, and Site 36 is located 60m to the north. Neither Site 36 nor TETY-15 was visible during the survey.

Mitigation: The graves should be fenced off before road construction begins and with community/individual approval.

SAHRA Rating: 3A

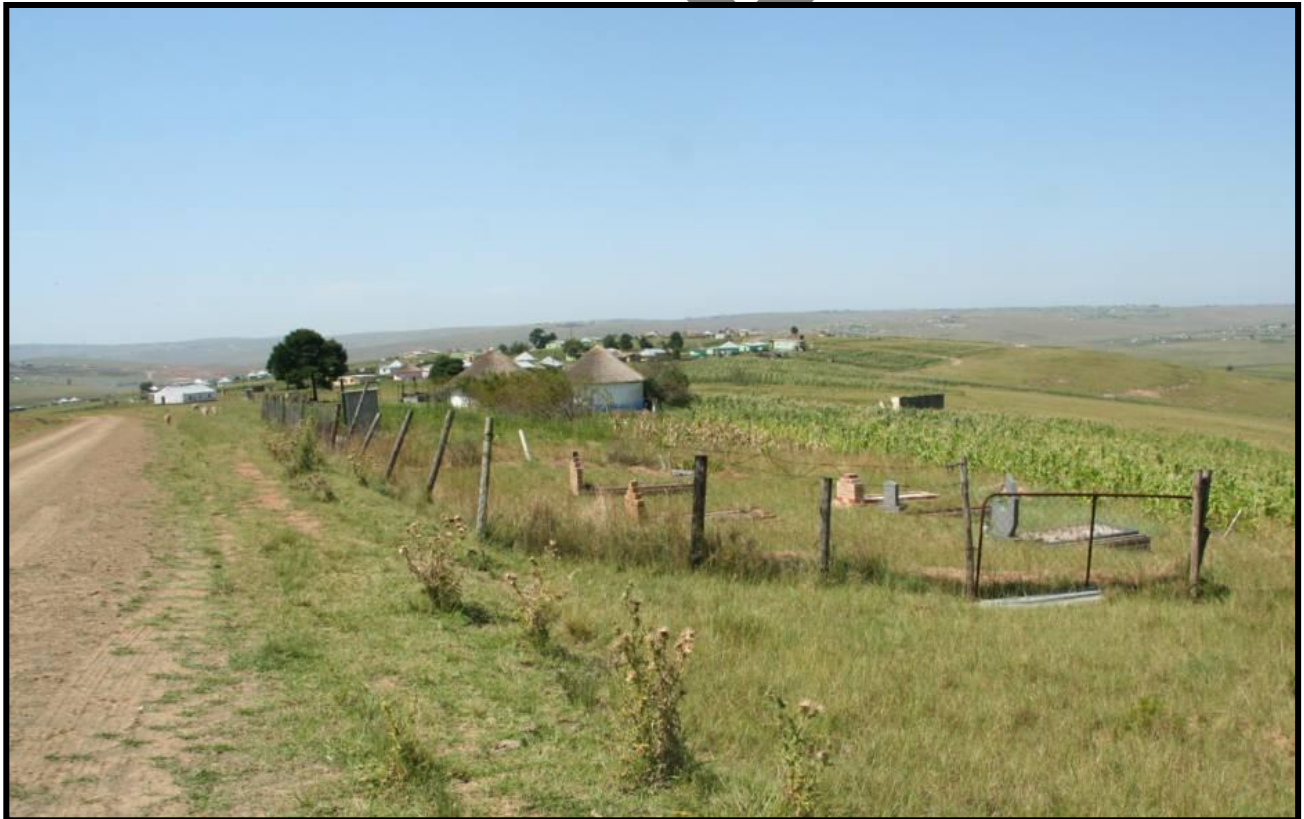
Fig. 11: Graves At TET04

TET04 is located in a fenced off homestead besides the road deviation. The site consists of five graves that are on the edge of the road reserve (fig. 11).

Significance: The site is of high significance.

Mitigation: The graves should be properly fenced off before road construction begins and with community/individual approval. The living descendants should be approached regarding the proximity of the road deviation to the graves.

SAHRA Rating: 3A

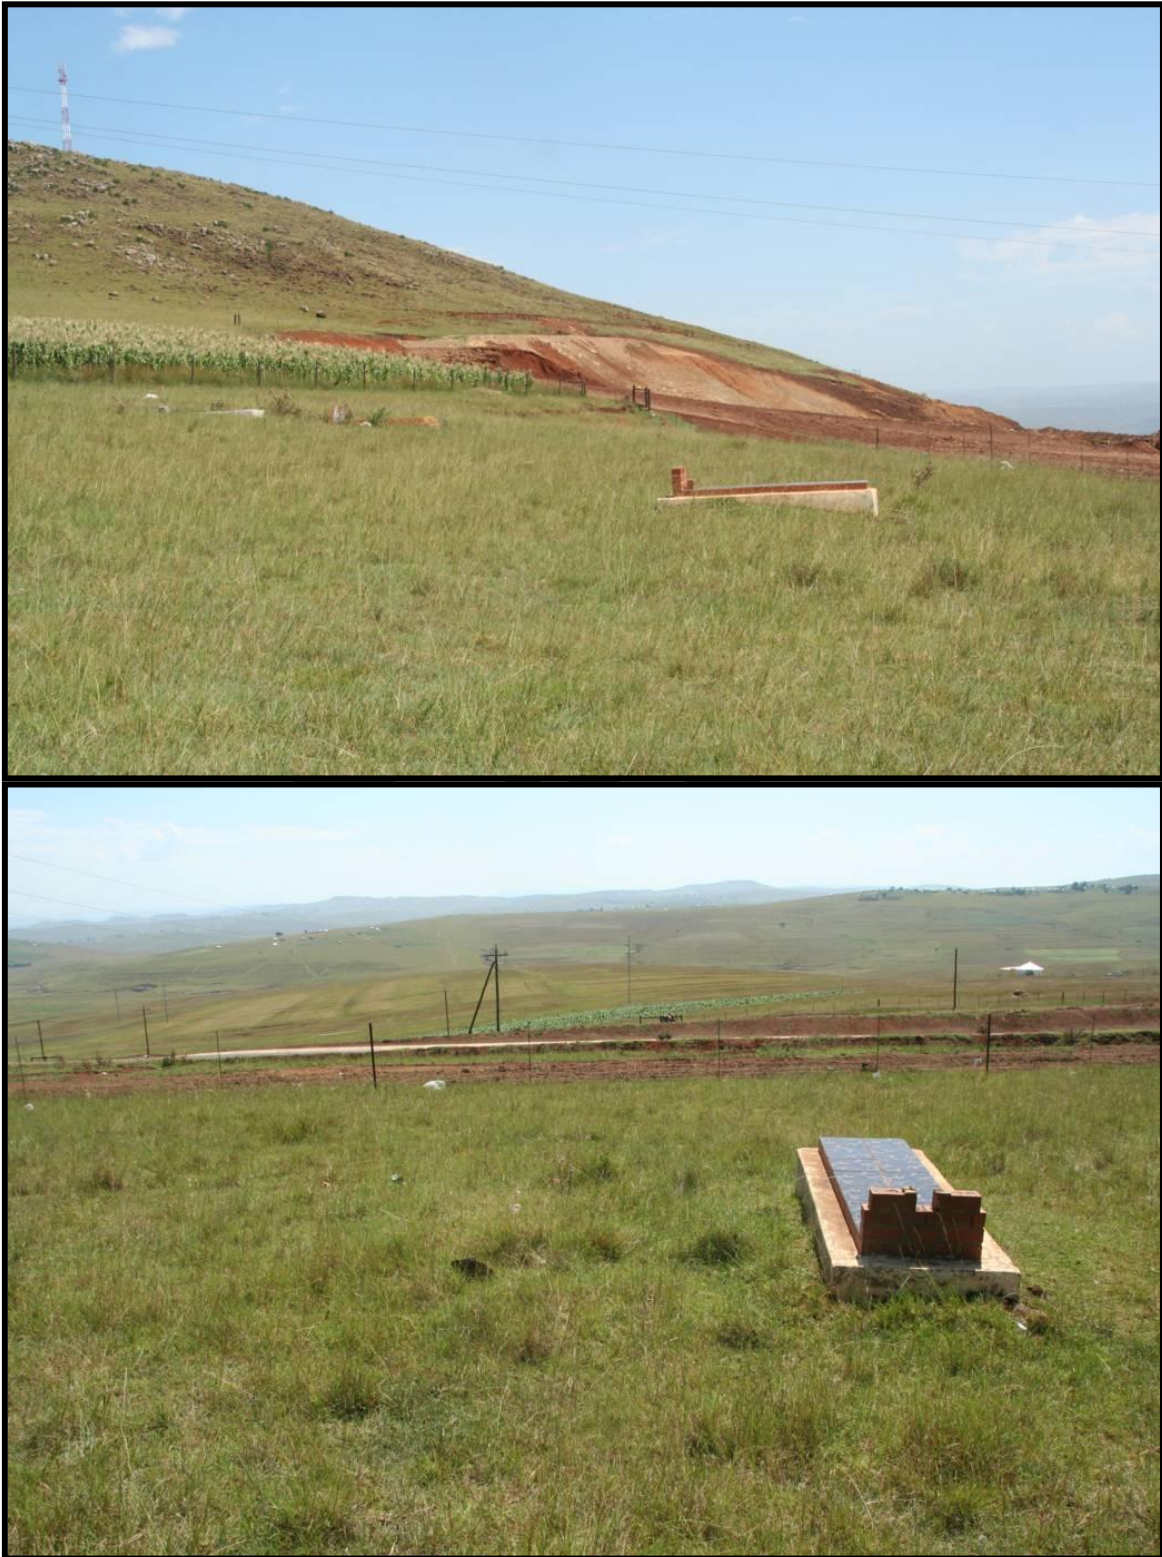
Fig. 12: Graves at TET-05

TET05 is located on the border of Quarry 2. The site consists of several graves of which only some are clearly demarcated (fig. 12). Demarcation of the graves can be via a large headstone, two small stones (head and footstones), or a small mound. The cemetery occurs between the existing dirt road and the fencing of the quarry. Some of the graves may be associated with TETY-25

The R.o.D. has already been given for Quarry 2; however, the cemetery and graves have not been properly mitigated, and presumably not correctly identified. The quarry road should be at least 20m from the edge of the graves, and the graves should have been fenced off with an access gate. At the moment, only the roadside of the cemetery is fenced off. This should be a matter of priority.

Fig. 12 shows the location of the graves in relation to the quarry.

What is also of concern for Quarry 2 is that the desktop study noted several settlements near the quarry, before it was used for the current N2 upgrade. These would be sites 6 and 7 on the 1982 topographical maps, and TETY-23 and 25 on the Google Earth imagery. These sites do not exist anymore, with a possible exception of Site 6.

Significance: The site is of high significance.

Mitigation: The graves should be fenced off before road construction begins and with community/individual approval.

SAHRA Rating: 3A

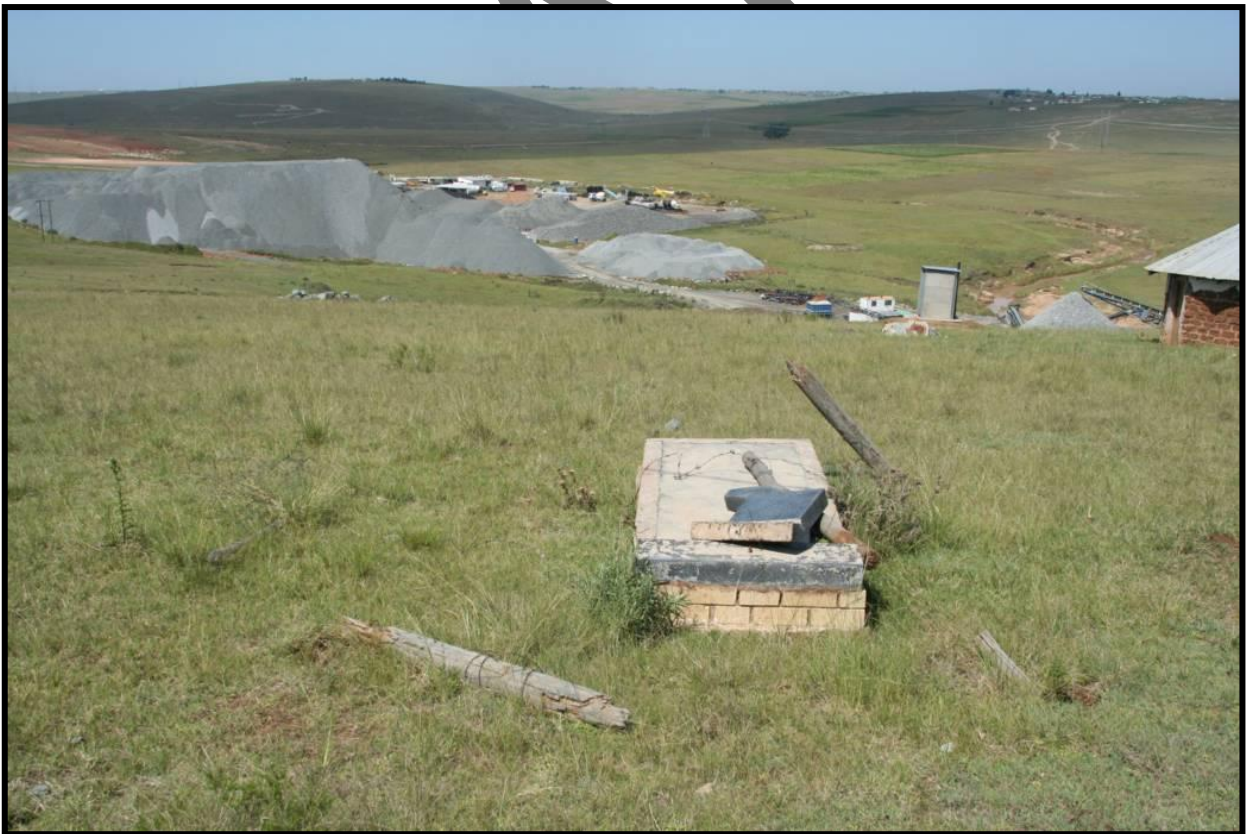
Fig. 13: Graves at TET06

TET06 is located near Quarry 1. The site consists of an existing settlement and one grave on the top of a hill (fig. 13). A possible grave occurs ~10m to the north of this grave. TET06 may be related to TETY-6 or TETY-7. Quarry 1 could affect the site if the quarry expands further west. The final extent of the quarry needs to be determined to assess the impact on this site, and others in the area.

Significance: The site is of high significance.

Mitigation: The graves should be fenced off before road construction begins and with community/individual approval.

SAHRA Rating: 3A

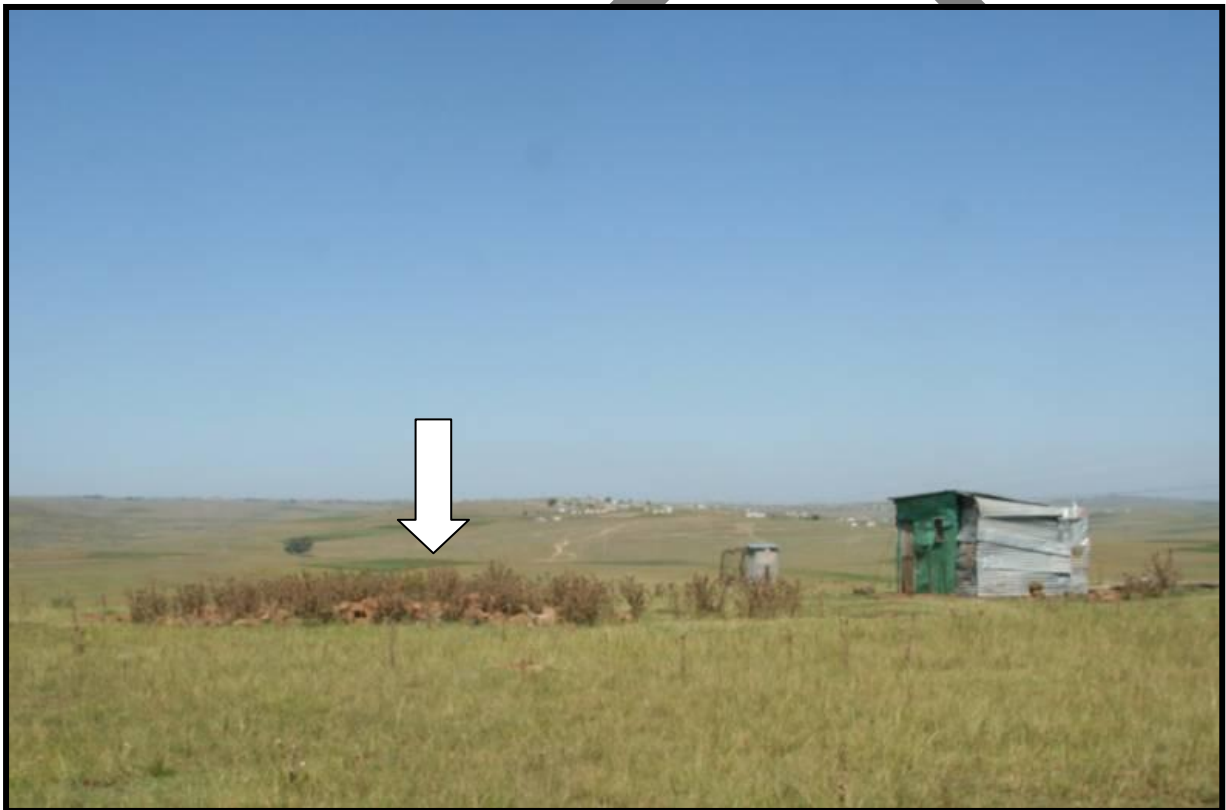
Fig. 14: House Remains at TET07

TET07 is located ~100m southwest of TET06. The site consists of a several recent ruins that form a settlement (fig. 14). No graves were observed in the area of this site. The site may relate to Site 6 from the 1982 topographical map.

Significance: The site is of low significance.

Mitigation: No Mitigation is required.

SAHRA Rating: 3A

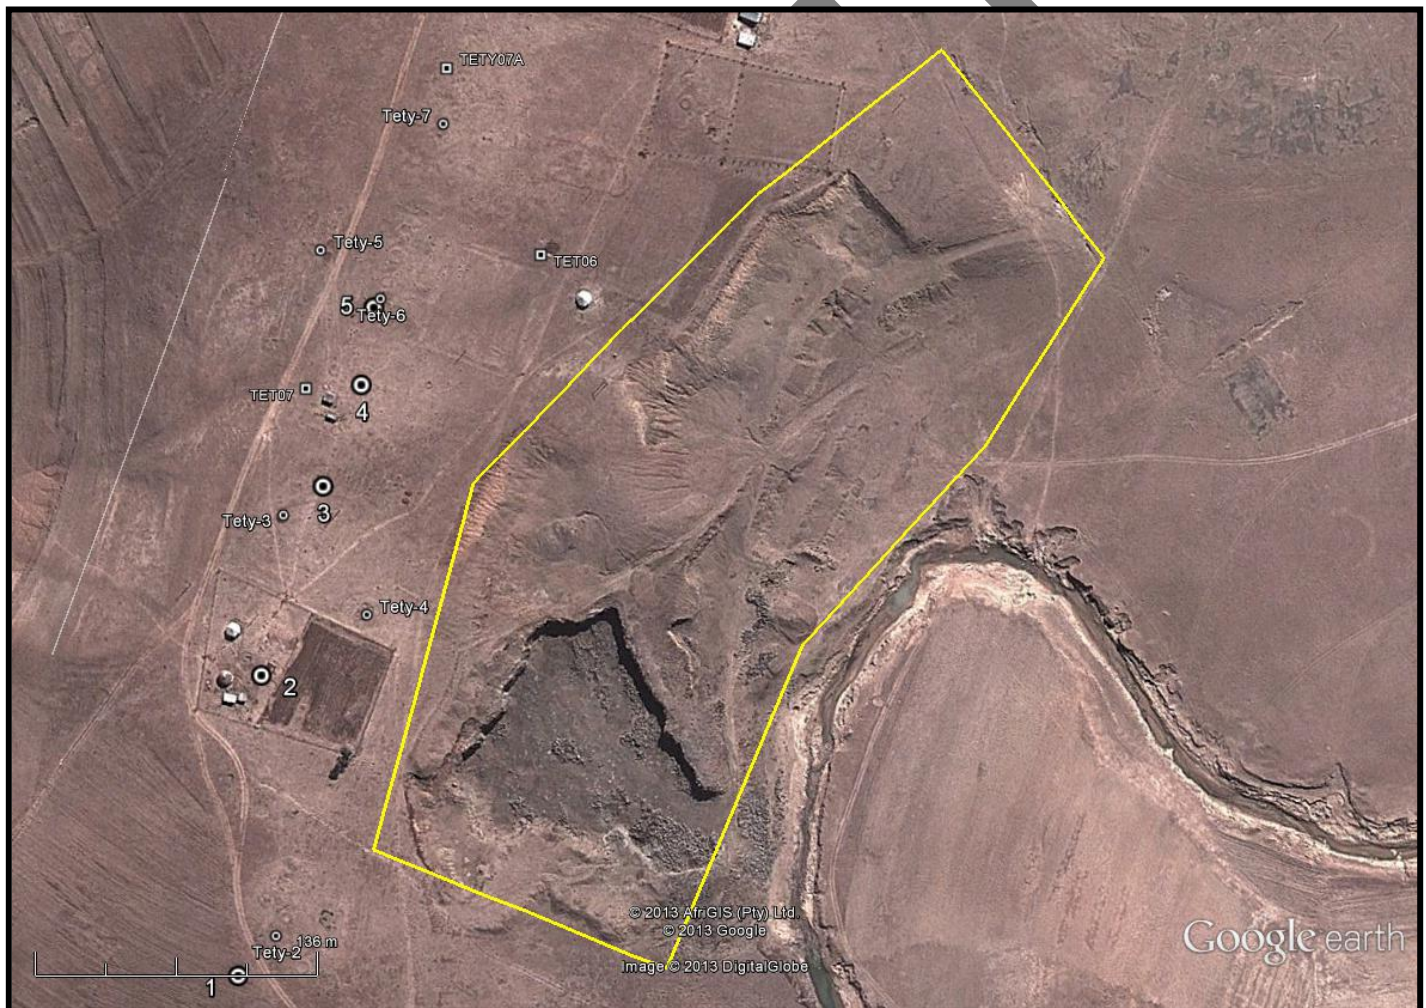
Fig. 15: Sites At Quarry 1⁴

The area to the west of Quarry 1 comprises of several old settlements that were observed on the 1982 topographical maps and the Google Earth Imagery; however, they were not clear during the survey (fig. 15). All of these sites have potential graves. It is unclear if the quarry will affect these. These sites include the following:

⁴ Yellow polygon is approximate current extent of the quarry

SAHRA Rating: 3A

The two quarries need to be assessed in terms of their maximum size in relation to graves identified on the various maps. All sites noted from the maps should have a 50m boundary placed around them and these should be noted as sensitive areas.
