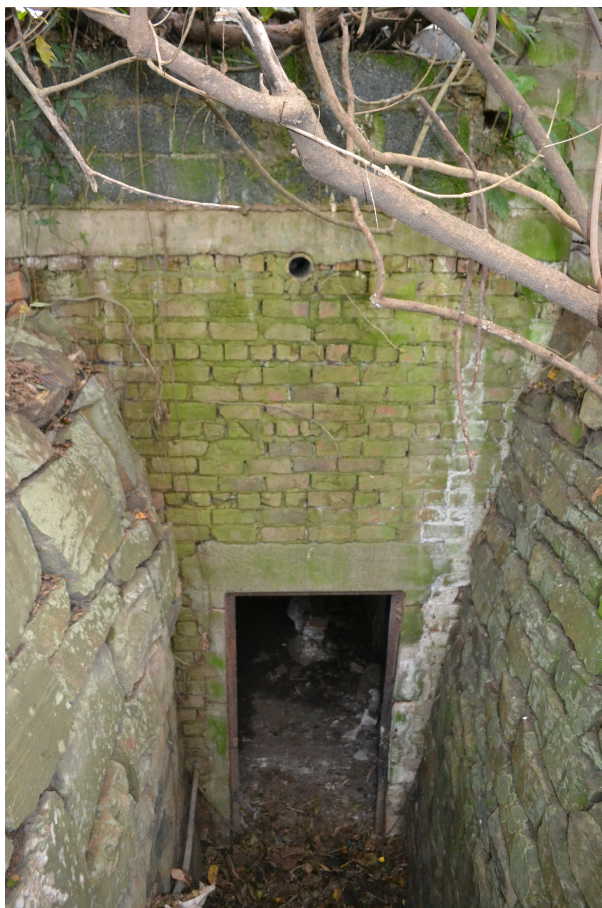
It consists of a dog-leg stair-passage descending approximately 3,75 M into the earth. The stair-passage is lined with roughly dressed stone blocks, terminating at the remains of a doorway through a brick wall. Beyond this doorway there are two subterranean chambers, each approximately 2,485 M wide and 3,405 M long, orientated north/south, with a large opening between the two chambers.

The walls of the chambers are constructed of plastered brickwork, once lime washed. The roof/ceiling is a concrete slab, cast onto corrugated iron sheets (as permanent shuttering), with two generous ventilation holes through the slab.

Other than the access stairs, the whole structure is below ground level and relatively invisible. From the garden it has little aesthetic value. Its principal import is in its socio-historic record of the communities' concerns during the Second World War. The author is not aware of another private bunker remaining in the greater Durban area.

Demolition is not an option. The structure does not appear to have any significant structural defects that would make it necessary to demolish it. The proposals for the re-development of the site do not appear to be hindered by its retention.

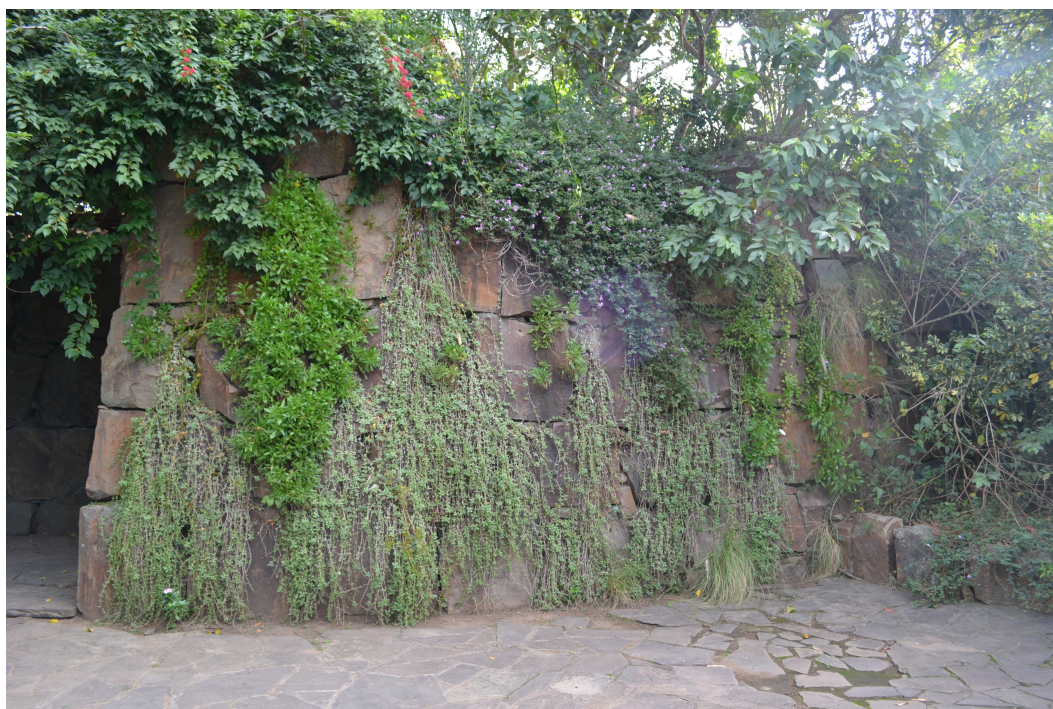
A particular feature of the landscaping of the site are the impressive retaining walls constructed along the western side of the main paved driveway, along the side of the tennis court and around the sunken garden. It is probable that William P Bawden had these retaining walls constructed while he was a Director of Coedmore Quarries.

The wall along the driveway is particularly impressive for the magnitude of some of the squared boulders that were incorporated into the wall. Starting off at the second gates, at about one meter high, the wall gradually increases in height to over four meters and includes a small "cave" close to the main house.

Demolition is not an option. These features must be integrated in the redevelopment of the property. The services of an appropriate heritage architect and, or a heritage landscaper should be engaged in specifying and supervising appropriate remedial action; the services of a competent and knowledgeable structural engineer sympathetic to heritage principles must also be engaged for the restoration of the collapsed retaining wall.

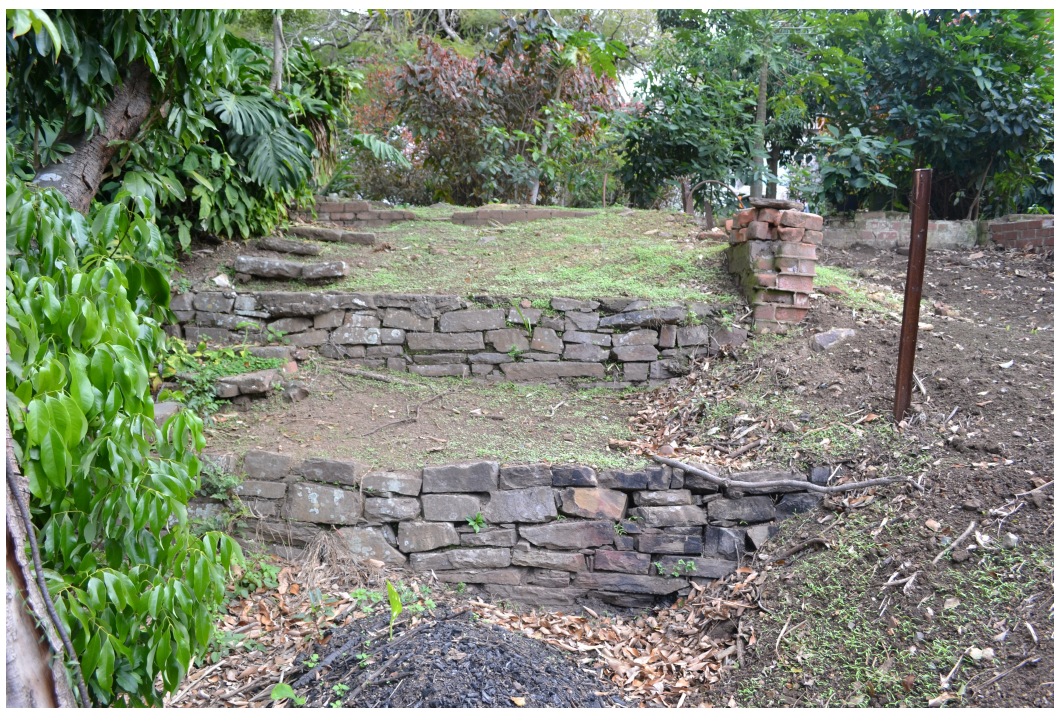
Beyond the formal gardens there are a series of residual stone retaining walls laid out for what must, at one time, have been an extensive working fruit and vegetable garden. Some of these stone walls were taken up during the last decade when there were plans to sell the lower portion of the site, but there are still sufficient immediately adjacent to the main gardens to be a record of what once was.

Demolition, should it be sought, is an option. However, there should be room on the site for the re-integration of some of these terraces in the garden proposals

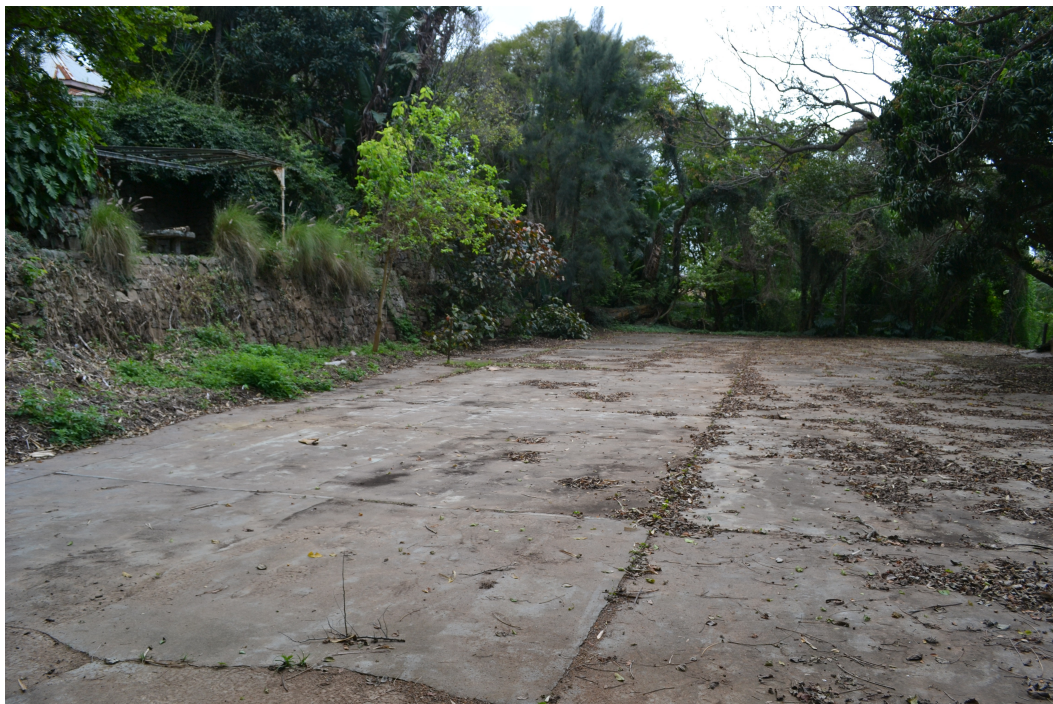
Mention has been made above of the remains of a tennis court. It is situated to the east of the main house, almost six meters below the current level of the garden platform. At some time in the past the playing surface was concreted over, and has subsequently cracked badly, making it almost impossible to play tennis on it. There are some metal posts for the net, but little else of note.

Along the pathway at the top of the first retaining wall there is a recess in the second retaining wall, obviously intended for a gazebo in which spectators could relax and observe the game. It is fitted out with a circular stone table; the current owners constructed a gazebo of salvaged cast iron columns, which has subsequently collapsed.

Demolition, should it be sought, is an option. The platform on which the tennis court stands may form a valuable base for some other development. However, any development must be kept below the sight-lines of the garden surrounding the main house.
