**PERMIT APPLICATION FOR THE TRONOX  
PIPELINE AT THE FAIRBREEZE MINE, MTUNZINI,  
KWAZULU-NATAL**

**FOR TRONOX KZN SANDS**

**DATE: 19 AUGUST 2014**

**Umlando: Archaeological Surveys and Heritage  
Management**

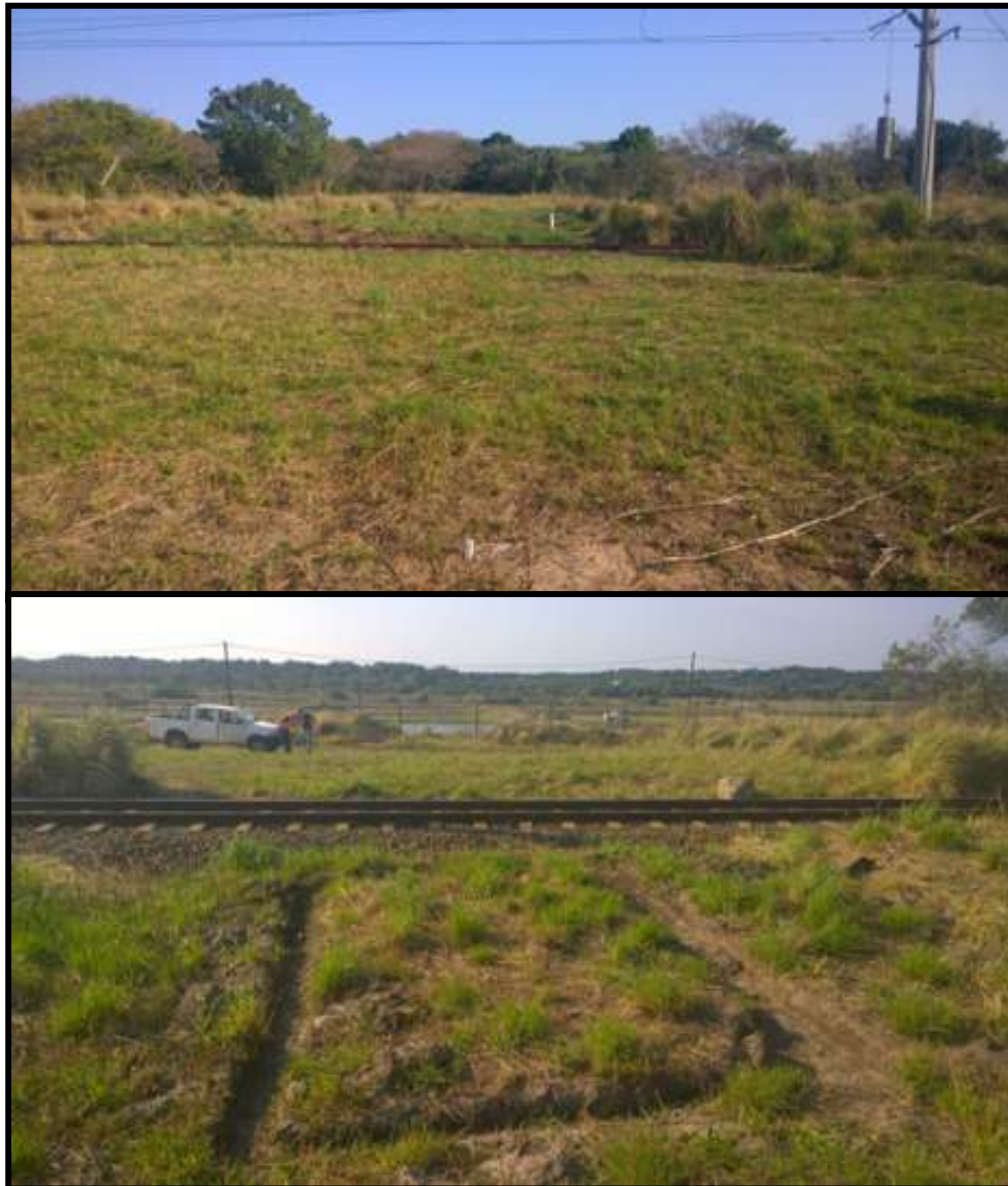
**FIG. 5: GENERAL LOCATION OF 2831DD 012**

Technically this is not a site; however, it is unlikely to have only one stone tool. The entire hill system from Mtunzini to Fairbreeze has a concentrations of of MSA and ESA artefacts that occur on the horizon between the topsoil and the ore bodies. Umlando has recorded these for the Fairbreeze mine (e.g. Tron01). Pipe jacking will occur near this site. The area where the pipe jacking occurs has been severely disturbed by railway and other pipeline construction (fig. 5).

Significance: The stone tool horizon is in a secondary context and would be ephemerally scattered along this lower section of the line. The tools would thus be of low significance.

Mitigation: A general permit for the partial destruction of the site is required.

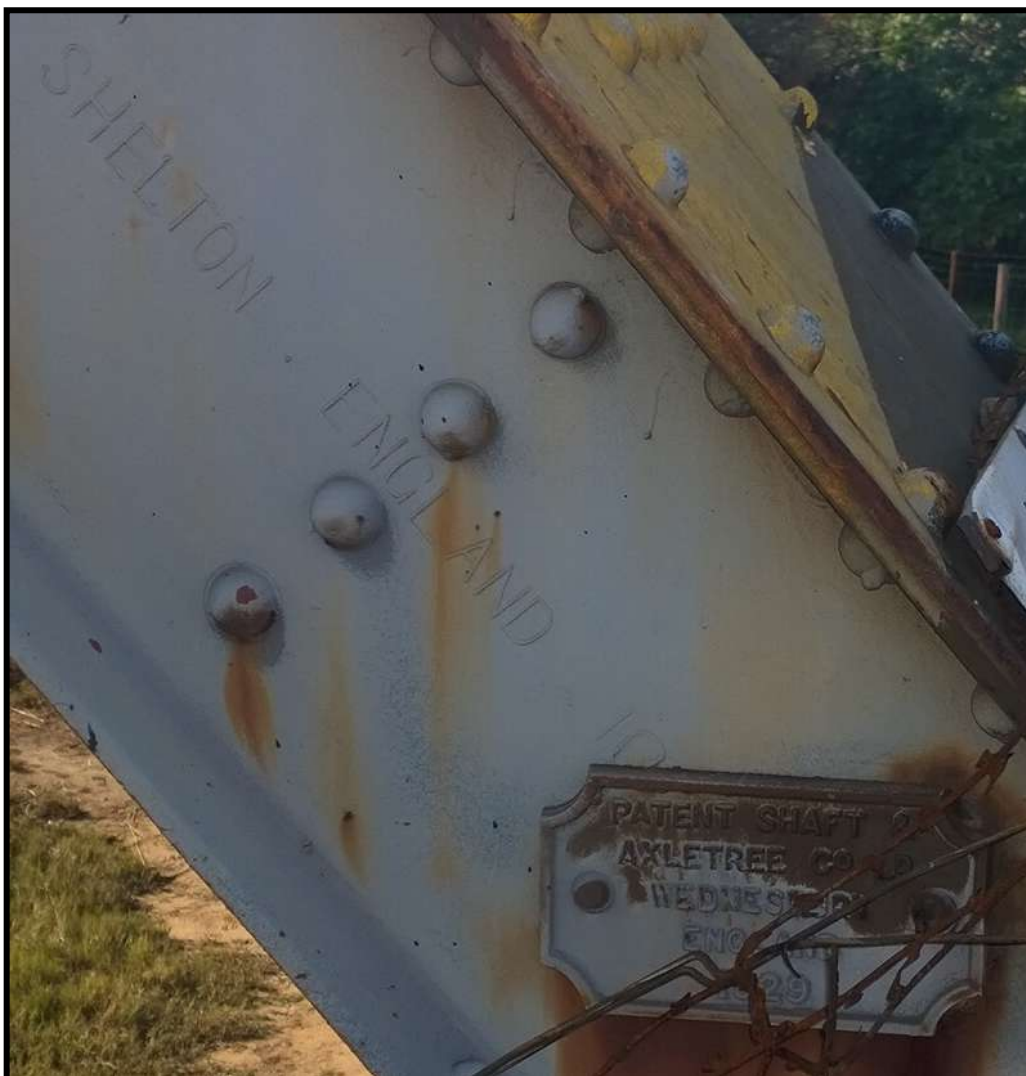
**FIG. 6: PLAQUE ON THE UMLALAZI RIVER BRIDGE**

The railway bridge crossing the Umlalazi River was built in 1929 (fig. 6). It is an iron construction made by Shelton Bar and The Patent Shaft and Axeltree Company (1840 – 1980), Wednesbury, England. The plaque on the bridge dates to 1929 and the bridge is thus automatically protected in terms of the KZNHA from any destruction, alteration or modification. The bridge is a steel railway bridge structure (fig. 7). The bridge was originally used as part of the railway system to move wood from places like Port Durnford Forest that was established in 1925 (Marwick 1973). It currently has several pipes adjoining it.

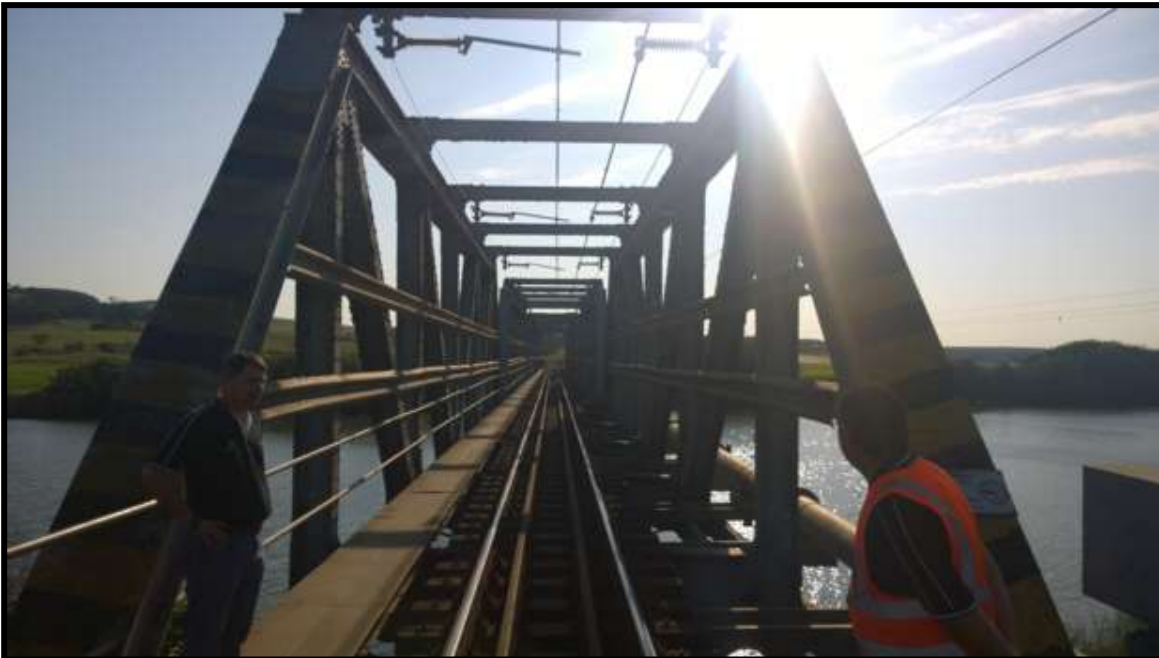
**FIG. 7: GENERAL VIEW OF THE UMLALAZI RIVER BRIDGE**

Significance: The bridge was constructed in 1929 and thus post dates any historical battles. It was originally used for the transportation of wood (products) from the newly established afforested areas such as Port Durnford, where a sawmill also existed. The bridge forms part of the railways and transportation system of early KZN, and is thus of some significance. The full significance of the bridge may need to be assessed by an architect historian. However, since this is only an attachment to the bridge that already has several attachments, I do not believe this is necessary.

Mitigation: The pipeline intends to use the lower western side of the bridge as a support to cross the Umlalazi River. It will thus be visually and physically altering the bridge. The physical alteration is in the construction of the pipeline on the bridge. Minimal impact should be on the bridge, and its foundations should not be affected. The visual impact will be in the colour of the pipeline that is in contrast to the bridge. I suggest the pipeline is painted in a similar colour as the bridge.

A permit from Amafa KZN Built Environment will be required for the modification/alteration of the bridge.

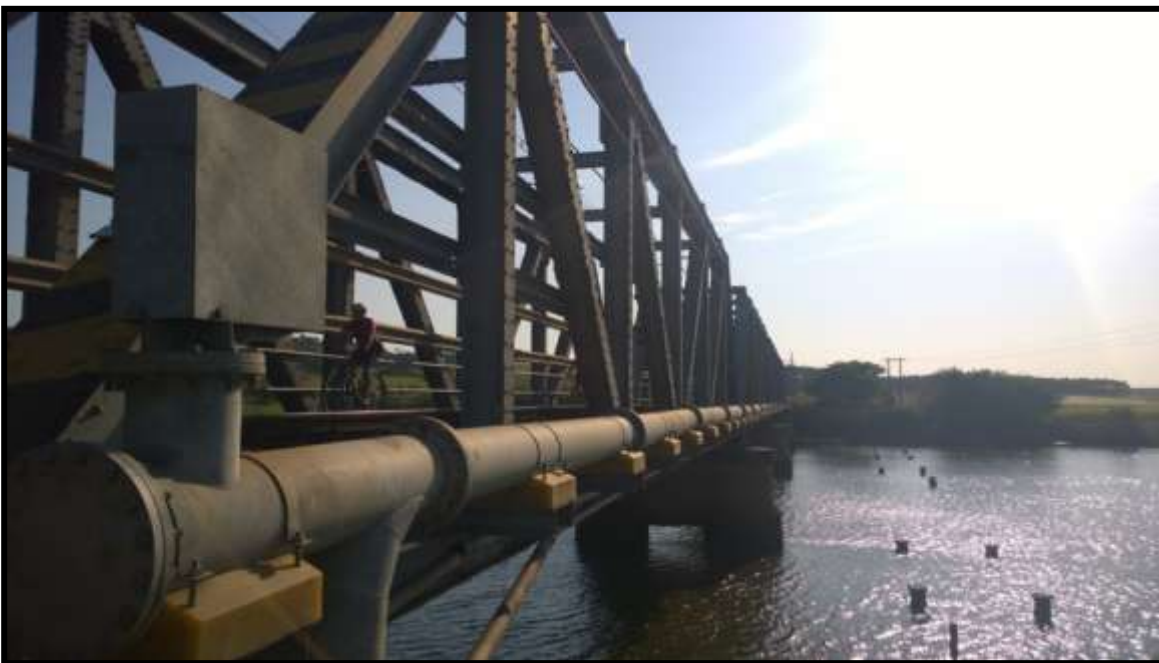
**FIG. 8 EXISTING PIPELINE ON THE EASTERN SIDE OF THE BRIDGE**

The pipeline will be attached to the western side of the bridge, in a similar manner to the pipeline along the eastern side (fig. 8).

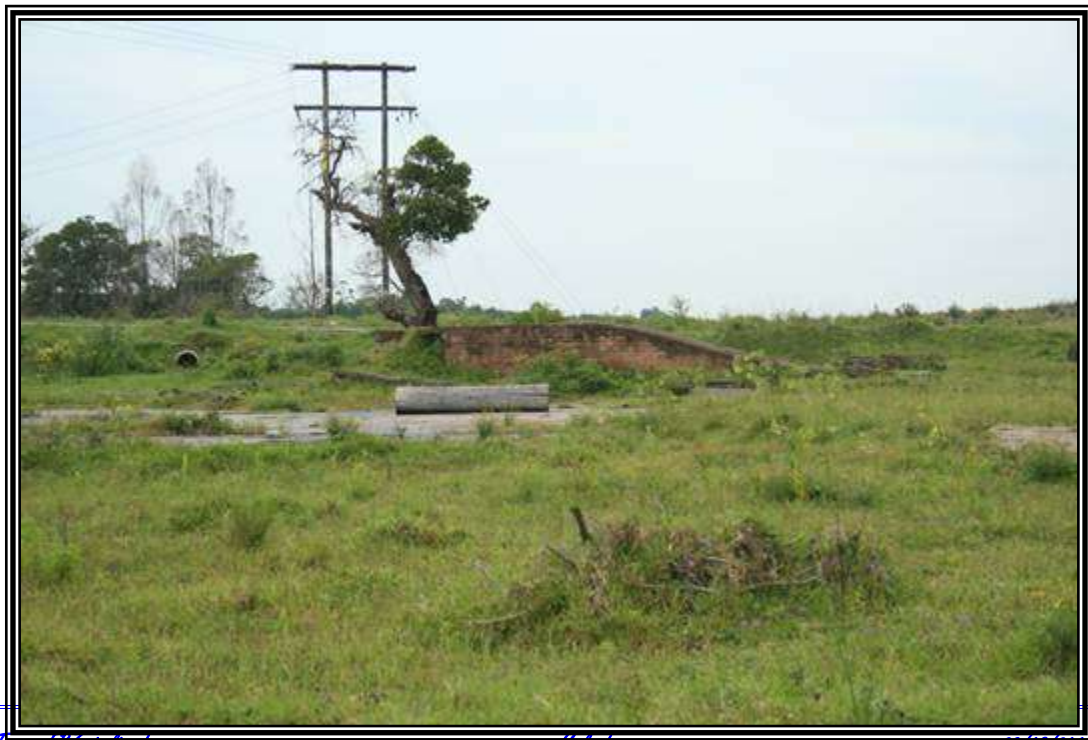
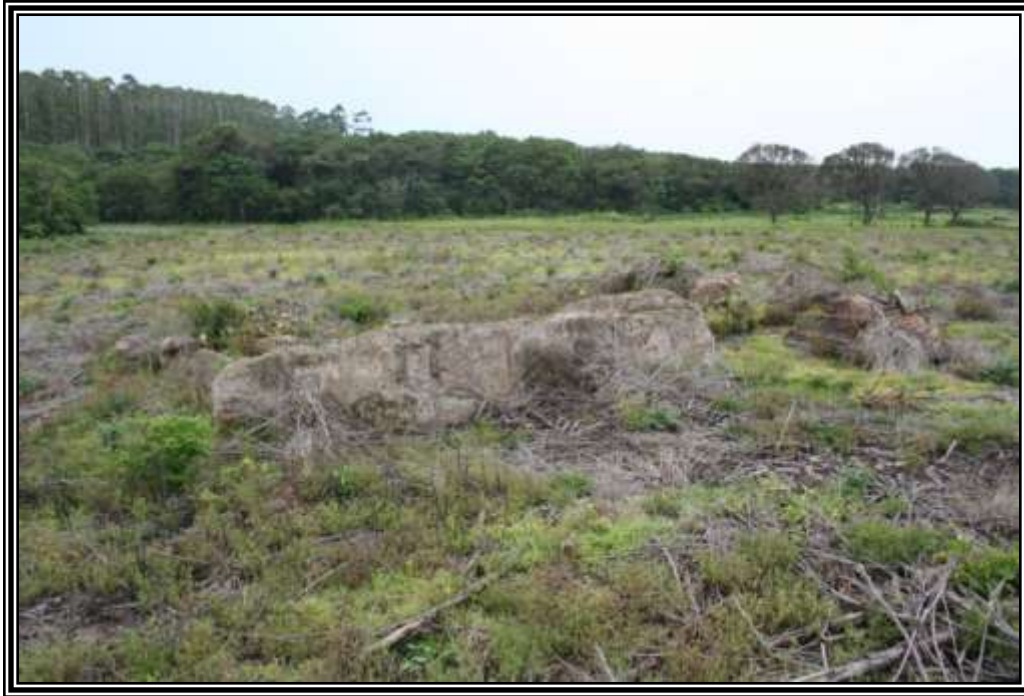
**FIGURE 9: PD22a AND PD22b – OLD SAW MILL**

The site was recorded in 2007 by Umlando. PD22a-b is in the area of the sawmill (fig. 9). The original sawmill occurred in the general area as early as 1915. It has relocated since then, and the current sawmill (ruins) are the remains of the last sawmill, dating to the 1950s. There are some old oak trees on the border of the saw mill area.

Significance: The site is in ruin with only a few foundations remaining. It is of low significance.

Mitigation: The pipeline footprint will not affect the ruins. If any built structures are noted during construction activity, then this will need to be reported to the HIA officer and Amafa KZN.

No permit is required, as the site is not affected.

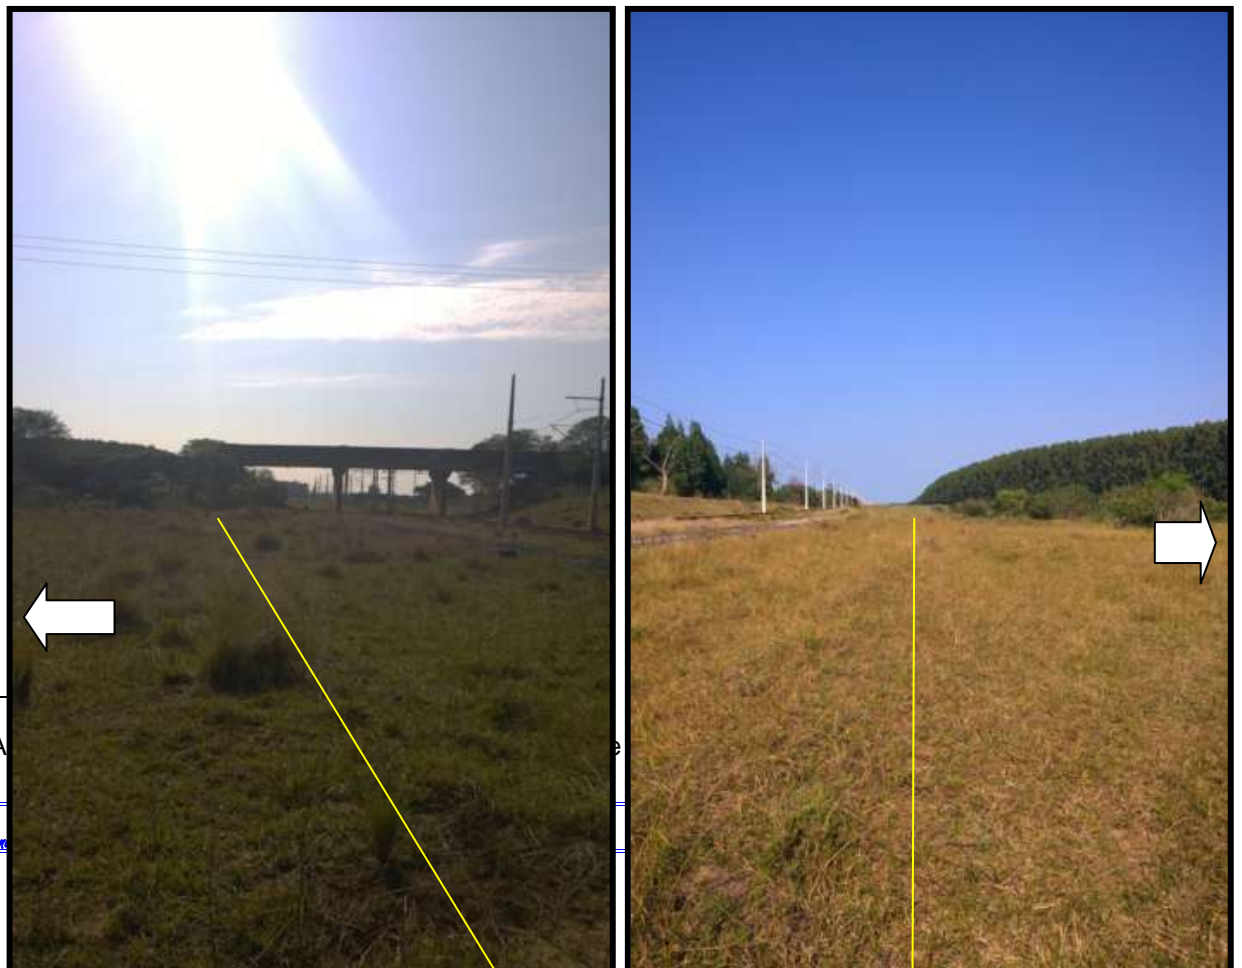
FIG. 10: LOCATION OF PIPELINE<sup>1</sup>

The pipeline will occur ~60m from PD22a and is unlikely to impact on the site. The field survey noted that there are no structures in the footprint of the pipeline (fig. 10).

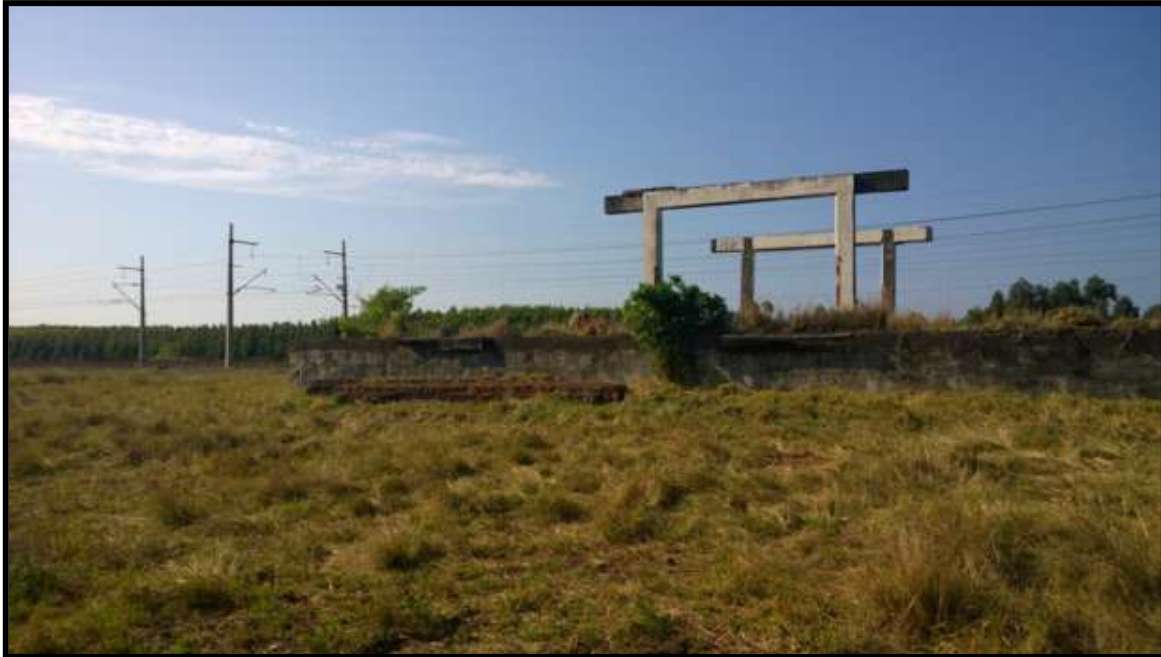
**FIG. 11: PORT DURNFORD STATION PLATFORM**

Three structures related to the railway line occur within 50m of the pipeline footprint: Fort Napoleon, Port Durnford and Mzingwenya. Only Port Durnford station occurs on the pipeline side of the railway. The station platform is in ruin and falls outside of the pipeline footprint (fig. 11).

Significance: The station appears to be of low significance.

Mitigation: The pipeline will not affect the station platform. If any built structures are noted during construction activity, then this will need to be reported to the HIA officer and Amafa KZN.

No permit is required, as the site is not affected.

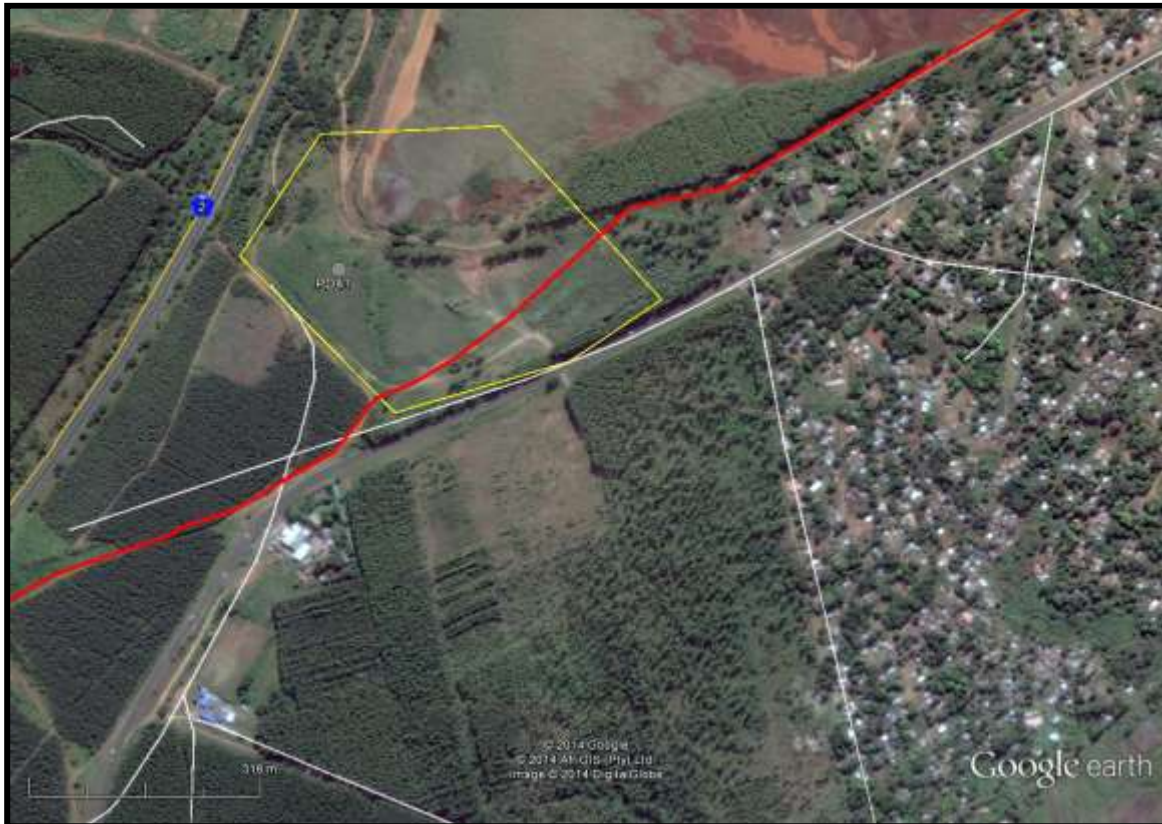
**FIG. 12: GENERAL EXTENT OF PD41**

Umlando recorded the site in 2008. PD41 is located on along an afforested hill near the R103. The site consists of an ephemeral scatter LSA tools and

pottery probably dating to the HP. The British Military maps indicate settlements in this area. The stone tools are on quartz and consist of general flakes. The tools appear to be in a secondary context as the area has been under afforestation and sugar cane cultivation for many years. This is similar to the sites recorded by Umlando along the rest of this hill for the Hillendale mine from 2005 – 2011. The Late Stone Age sites from Hillendale mine have been sampled and discussed in the various Hillendale Mine reports.

Significance: The site is of low significance

Mitigation: No further mitigation is required. A permit will be required to partially impact on the site. Fig. 12 shows the general extent of the site
