5 BACKGROUND STUDY

6 SURVEY FINDINGS

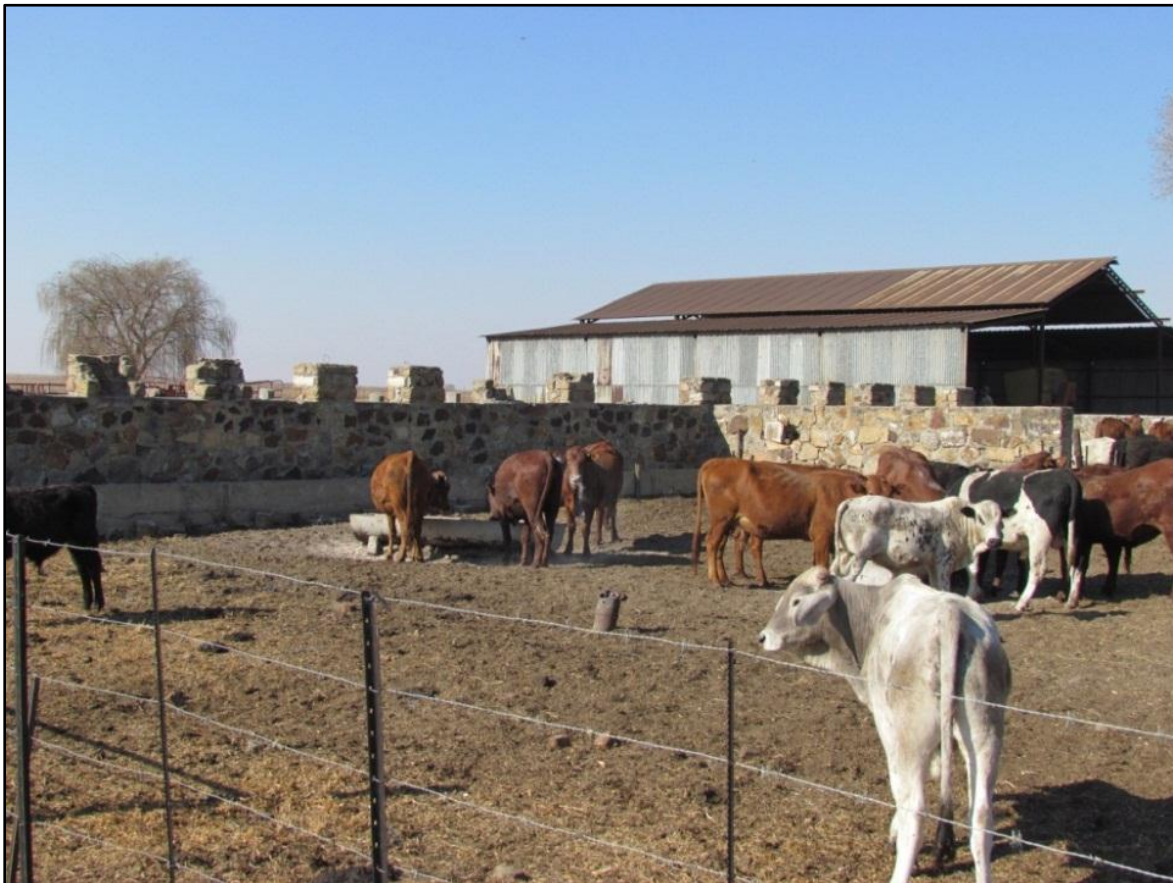
The complex consisted of a residence, workshops, and sheds, as well as cemented stonewalled cattle enclosures. A segment of stonewalling with wagon wheels were noted on the perimeter of the complex, possibly indicating an old entrance.

Figure 6-1: Cemented stonewalling around cattle pens at H001

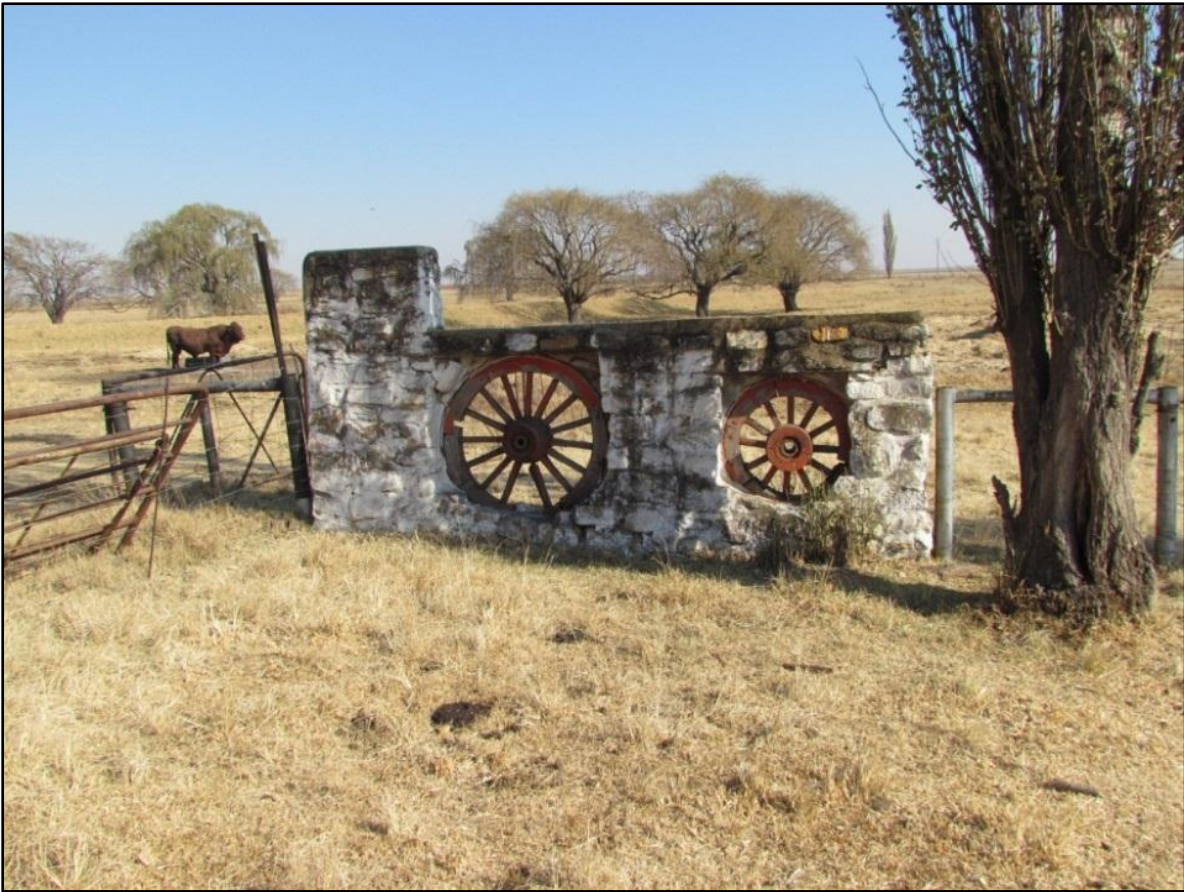
Figure 6-2: Wagon wheel wall segment identified at H001

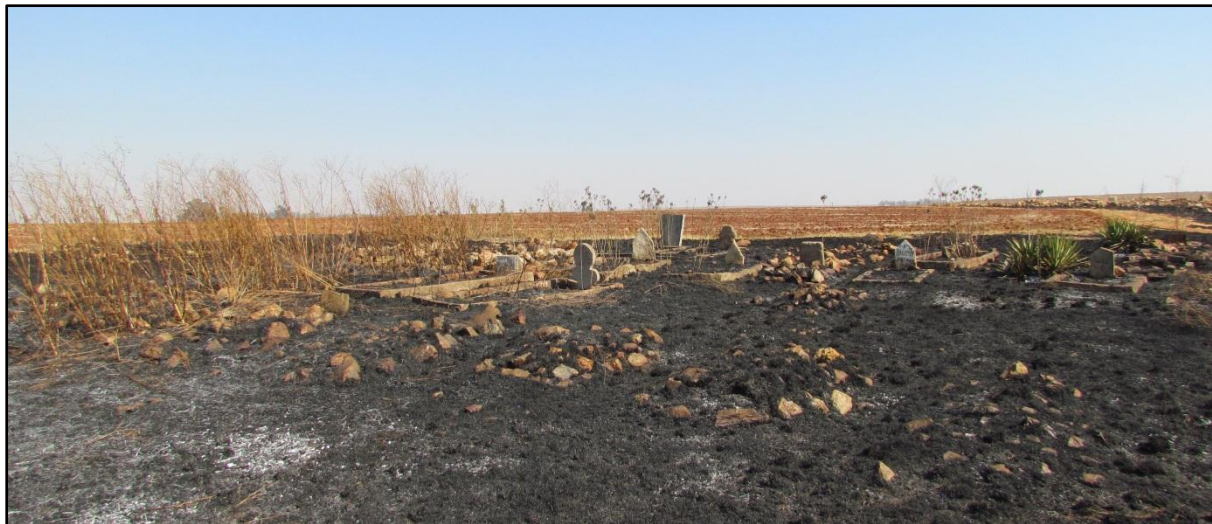
An unfenced burial ground comprising 43 individual graves was found. The graves were oriented east-west, in at least four rows. Eleven graves comprised formal headstones (granite and cement headstones). The dressing of nine graves comprised concrete borders. The remaining consisted of borders created with stones and/or modern bricks. Dates noted on graves with inscriptions provided a range from 1971 to 1985. Table 6-1 below provides details of headstone inscriptions.

Figure 6-3: General view of burial ground H002

- *In situ* preservation of all burial grounds and graves where:
 - A 20 m bufferzone be fenced / demarcated around each burial ground within the project area to minimise accidental damage;

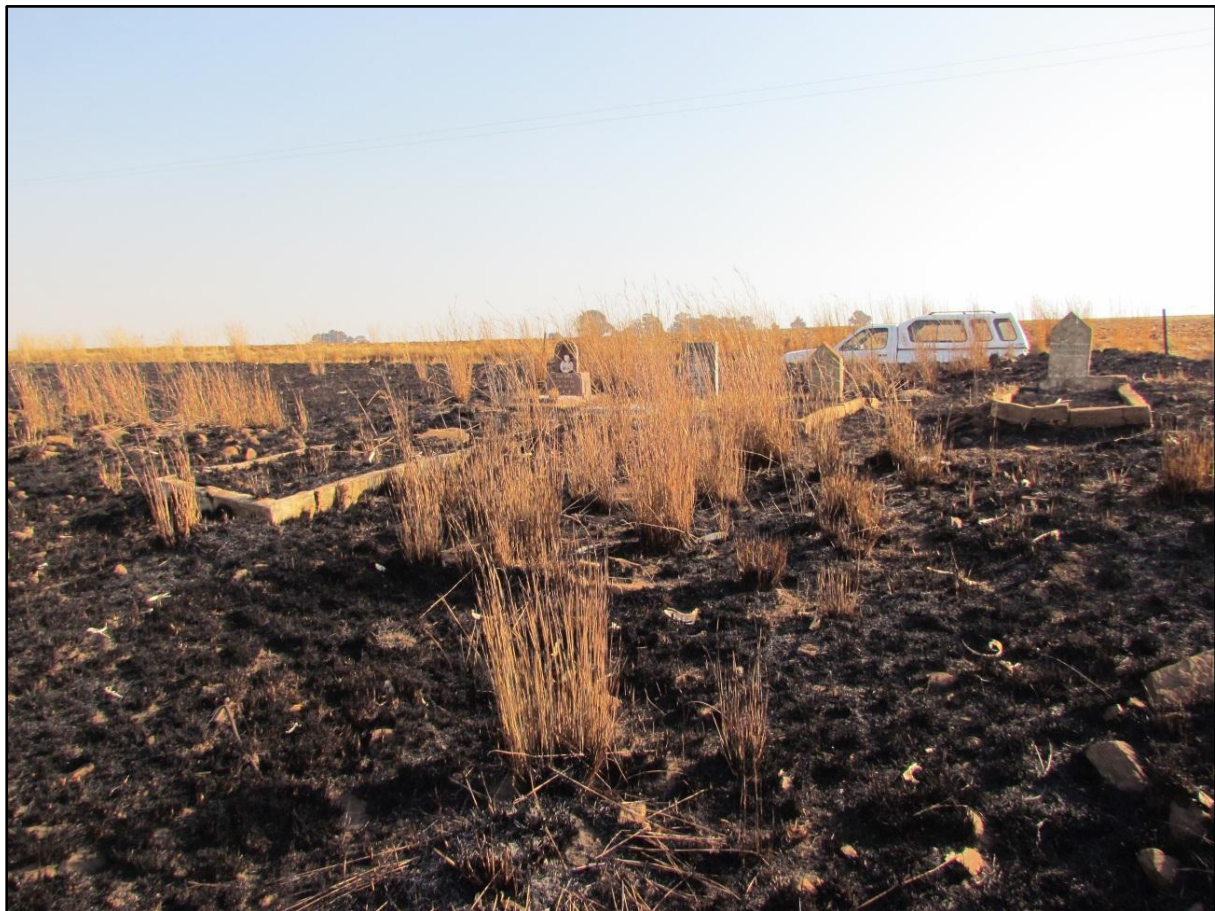
An unfenced burial ground comprising of 14 individual graves. Dressings comprised the following: five with cement headstones; six were bordered with stone/bricks; six framed with cement; and two were granite framed with granite headstones. The visible dates ranged from 1989 to 2000. Table 6-2 provides details of inscriptions

Figure 6-6: General view of cemetery identified at burial ground H003

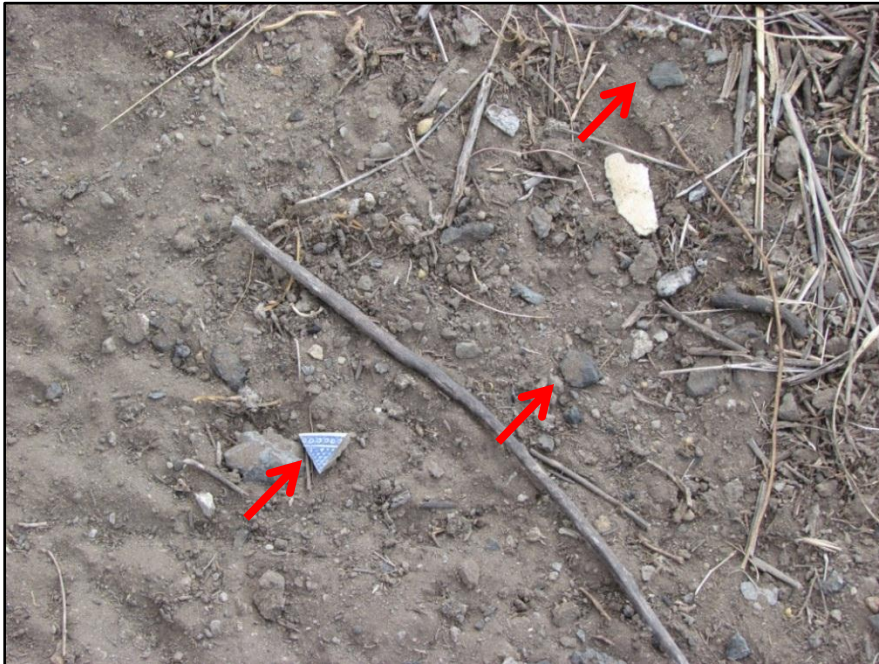
An ash midden was identified on top of small cliff overlooking the Wilge River. Burnt bone and glazed ceramic fragments were found in the exposed deposit were identified within the midden. Dense grass cover hindered further observations.

Figure 6-9: Ashy midden deposit at H004. Note the glazed ceramic ware in the centre and burnt bone.

- A Phase 2 archaeological study on 004 (the ash midden) if the current mine plan changes and development activities are to occur within the vicinity of the site H004;

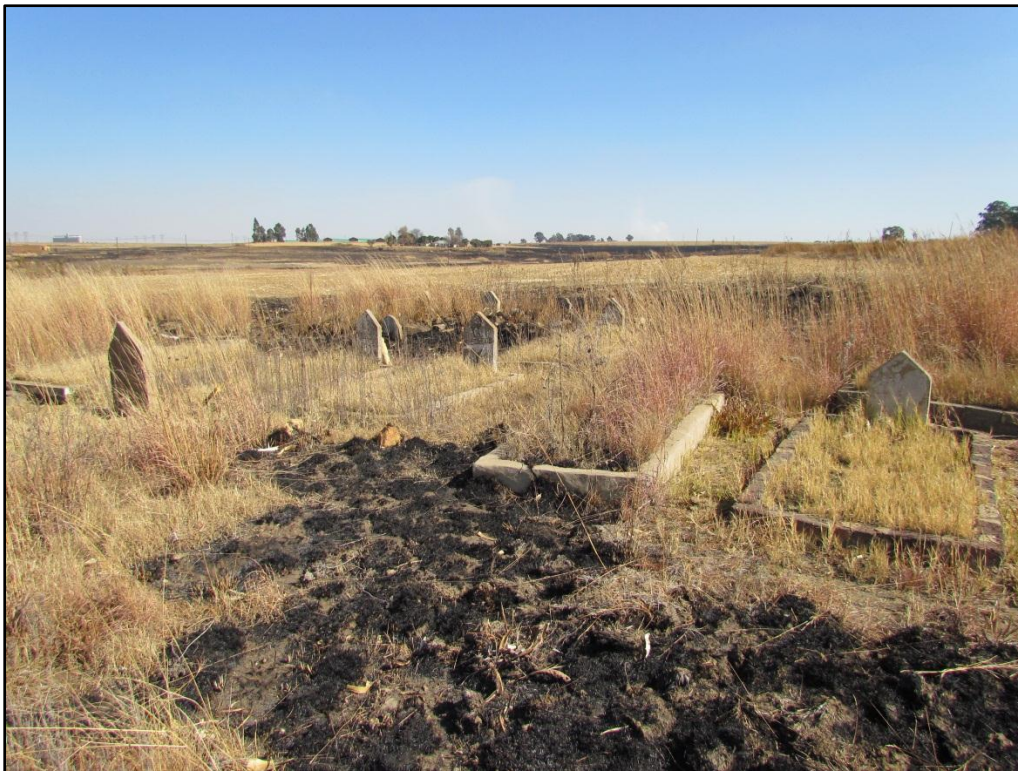
An unfenced burial ground containing 62 graves was identified at this point. A total of 40 formal headstones were observed including granite, stone and cement headstones. The dates of the graves range from 1949 to 2000. Please see Table 6-3 for headstone inscriptions.

Figure 6-11: View of burial ground H005 looking south

H005 (-26.223485 28.841899)	C, O	Site clearing and construction, underground section, access routes, servitude	No mitigation required as it lies on the underground section, however the cemetery should be fenced off and a management plan should be developed and implemented. Access should be granted to affected families.	4	64	34
H006 (-26.222939 28.843765)	C, O	Site clearing and construction, underground section, access routes, servitude	No mitigation required as it lies on the underground section, however a destruction permit may be required	2	50	29
H007 (-26.21736 28.833295)	N/A	No current planned construction activities	No mitigation required as it lies in an area with no planned construction activities. Destruction permit may be required if mine plan changes.	2	32	26
H008 (-26.219527 28.871661)	C, O	Site clearing and construction, open cast section, access routes, servitude	Adjust mine plan as much as possible as to minimise the impact on the cemetery	4	116	34

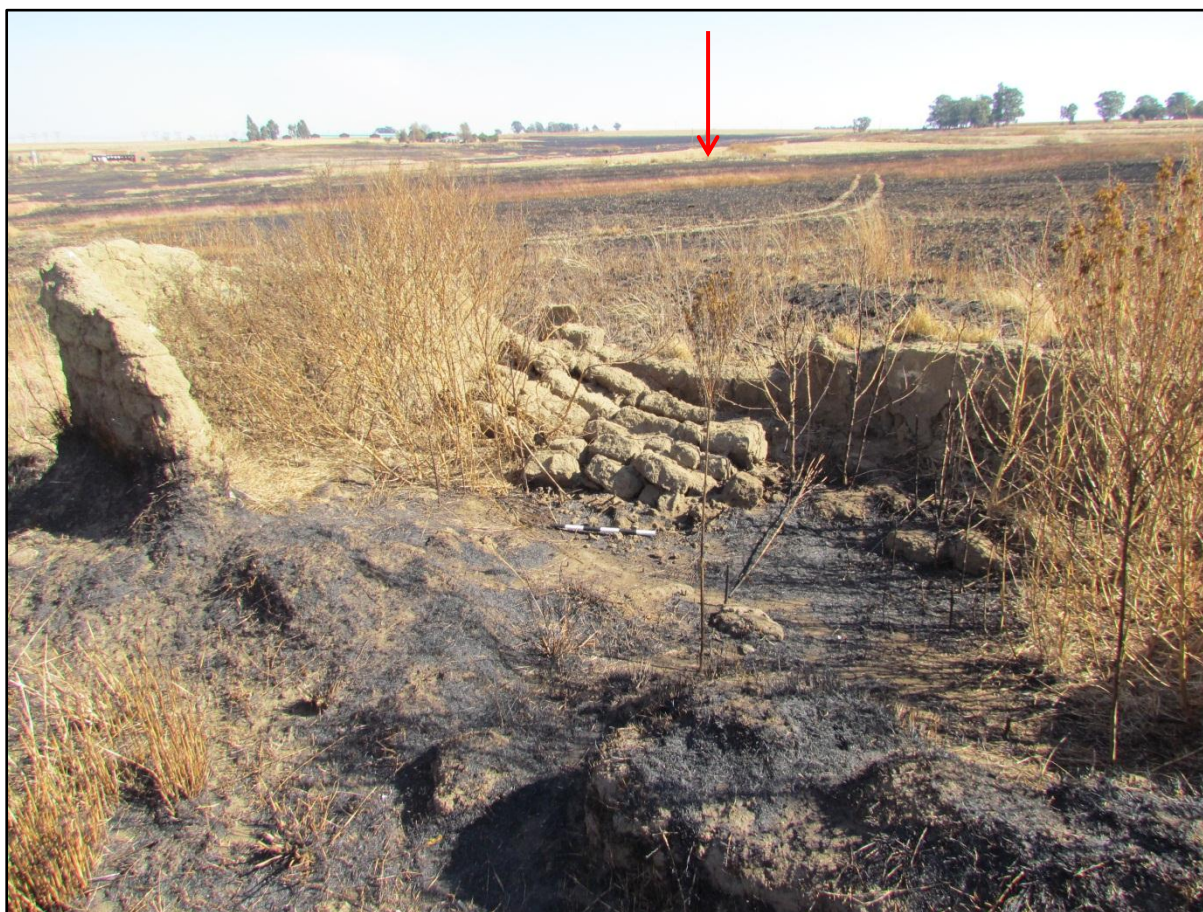
A dilapidated structure comprising of mud bricks and measuring approximately 6 m in length and 3 m in width was identified. Additional mud brick structures were also noted. Traces of blue plaster were noted on a wall of the main structure. Two middens were identified next to the structure with green glass fragments, modern bricks, glazed ceramic fragments, burnt bone, batteries and a rubber shoe. A possible stone feature was also noted next to the midden.

The site may represent historic or past labour cottage, and may also be associated with the burial ground H005 located approximately 100 m away.

Figure 6-13: Dilapidated mud brick house at H006. Arrow indicates burial ground H005.

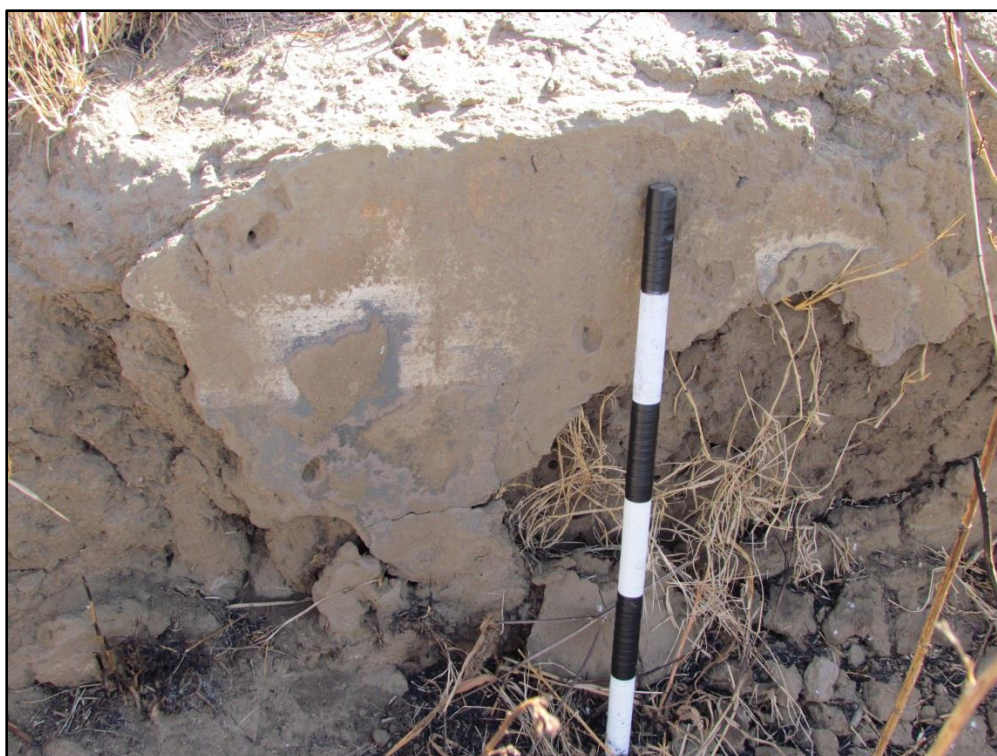
Figure 6-14: Plaster evident on mud brick house walls at H006

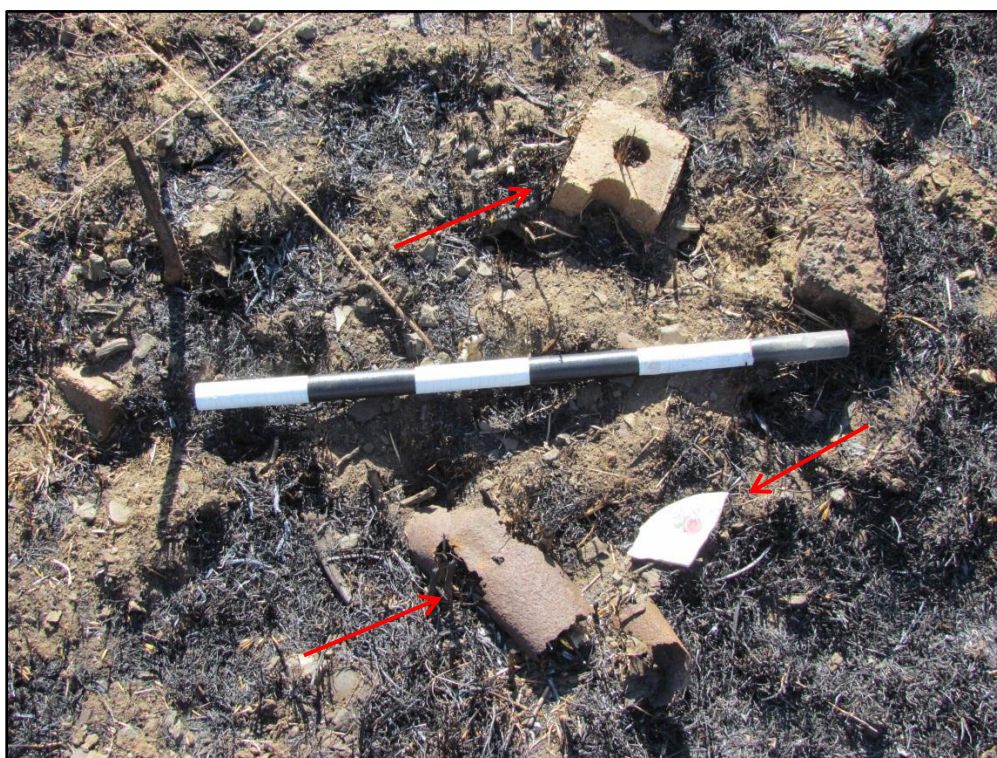
Figure 6-15: Surface view of a midden identified at H006. Note modern bricks, glazed ceramic and metal fragments.

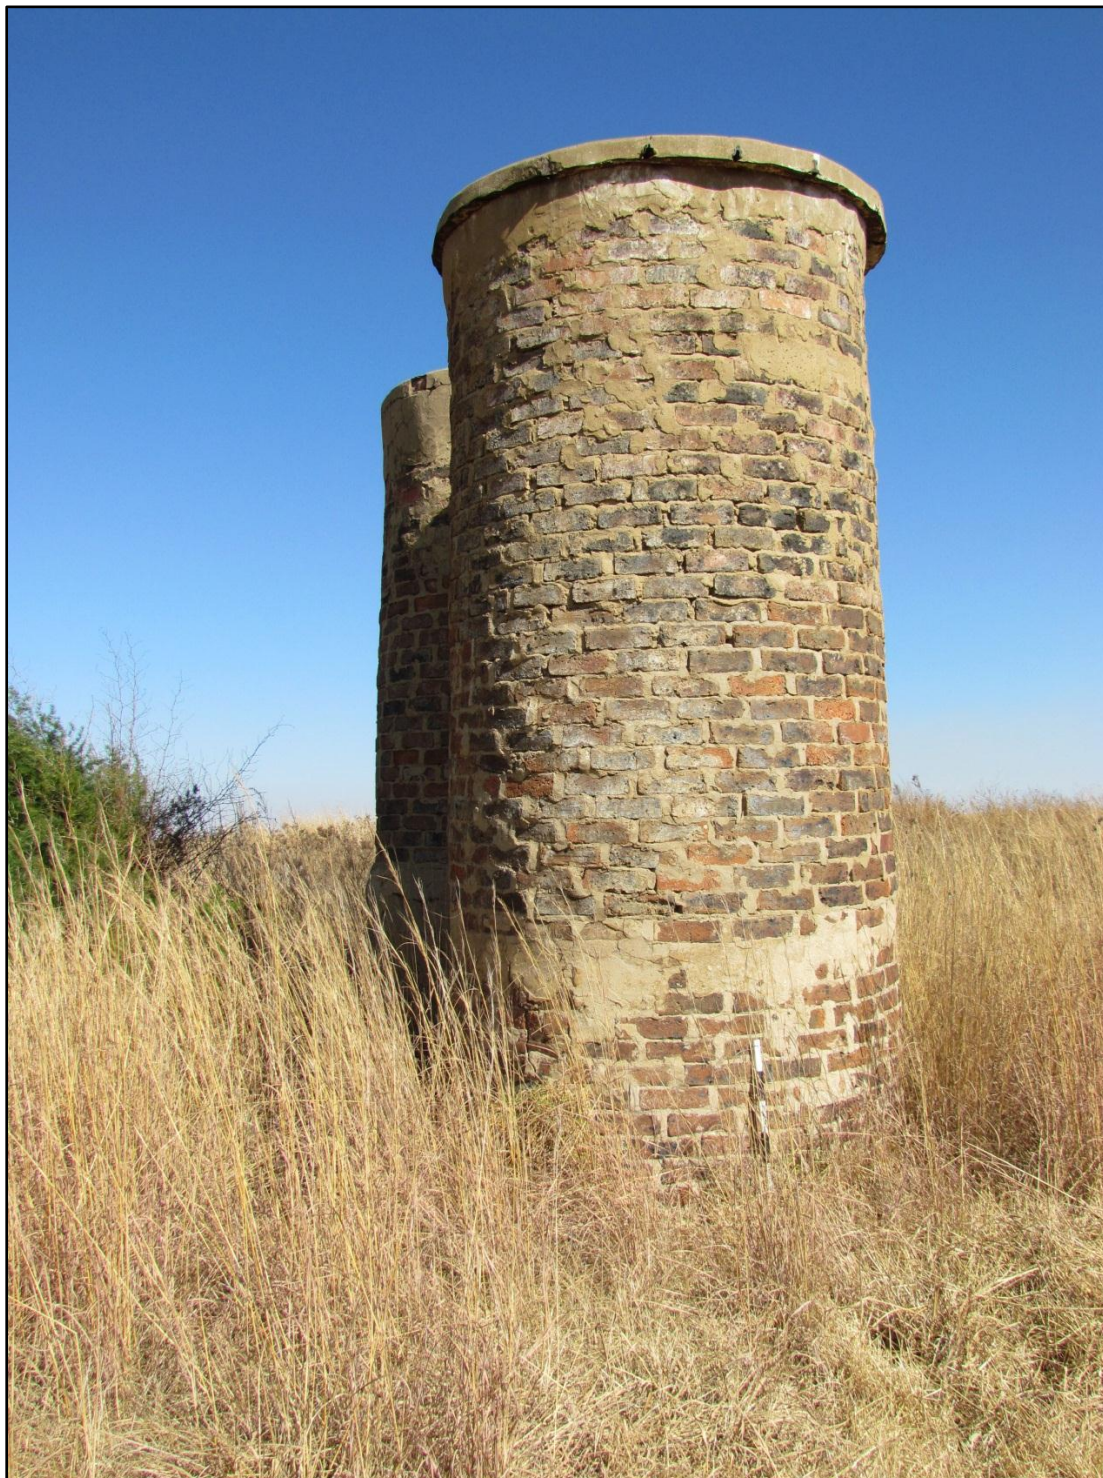
Two cylindrical brick towers with cement caps and no identified opening/entrance, approximately 8 m high were observed at this point. They are located at the end of a maize field within tall grasses. A foundation and some remaining walls were observed adjacent to the towers.

Figure 6-16: Cylindrical brick towers identified at H007

- Application of Destruction Permit for structures older than 60 years (H007, H009, H010 and H011), which will require:
 - Detailed mapping and recording of structures; and

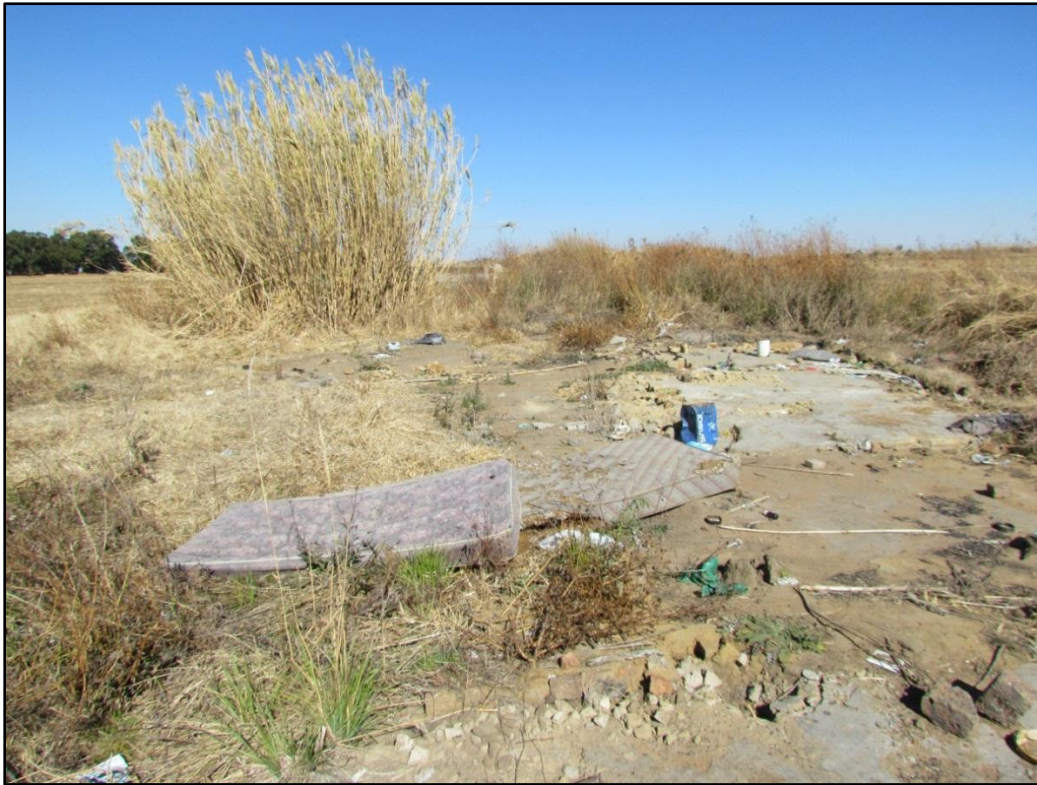
Figure 6-17: Remains of cement foundations identified at H007. Note disturbance caused by vagrants.

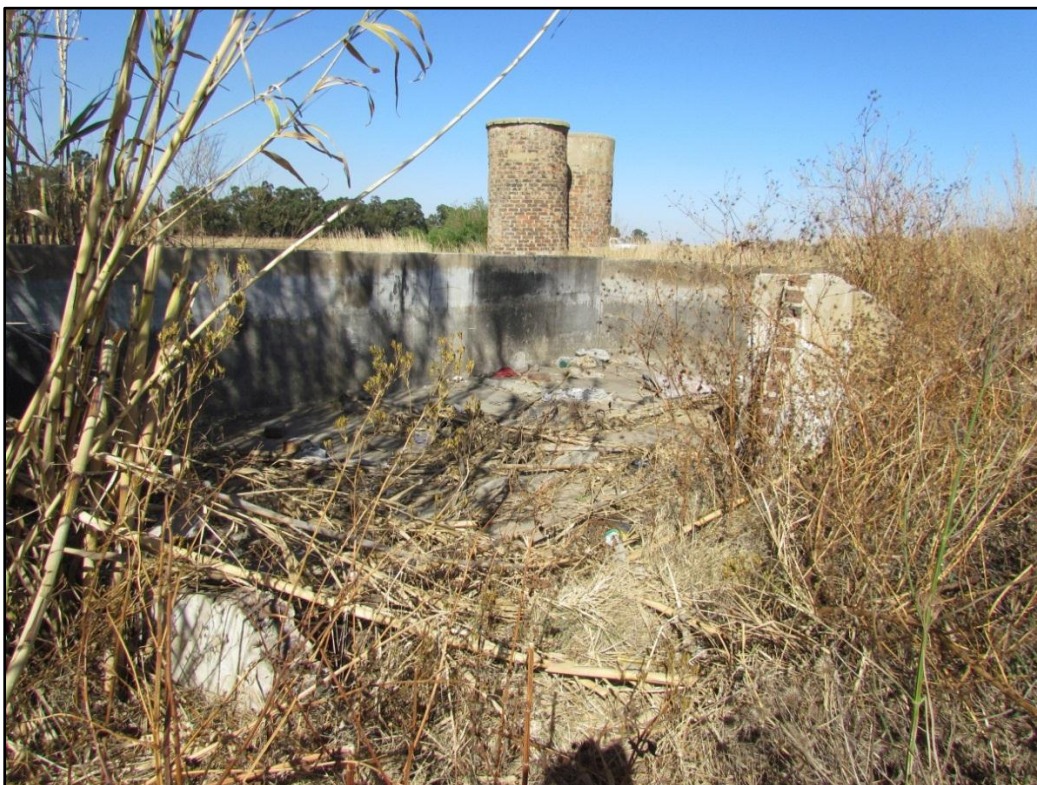
Figure 6-18: Remains of walls identified at H007

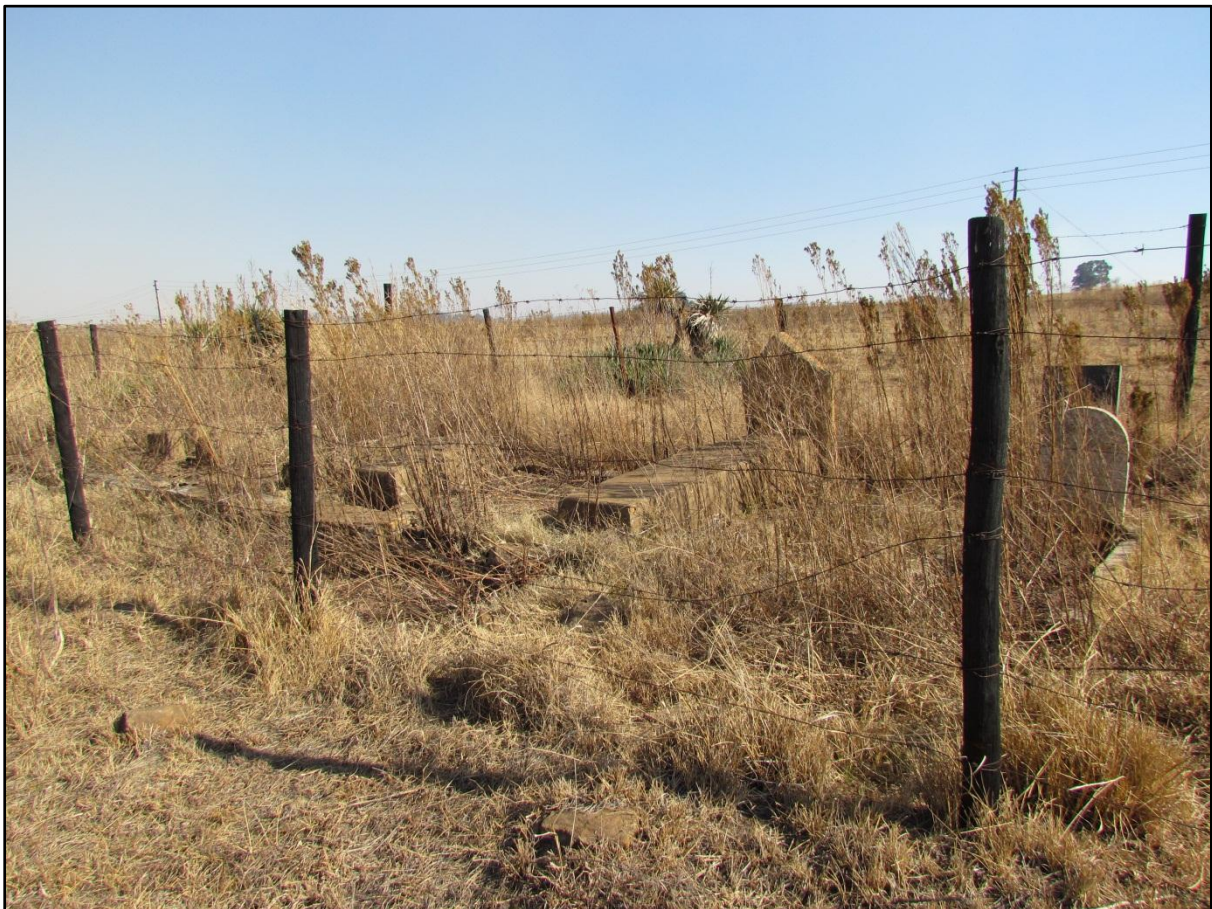
A fenced burial ground containing 11 graves was identified at this point. A total of five formal headstones (cement and granite) were observed and six small cement casket type graves with one large cement casket type grave were observed. The seven cement casket type graves had been placed side-by-side. The dates of the graves range from 1932 to 1978. Please see Table 6-4 for headstone inscriptions.

Figure 6-19: View of burial ground identified at H008

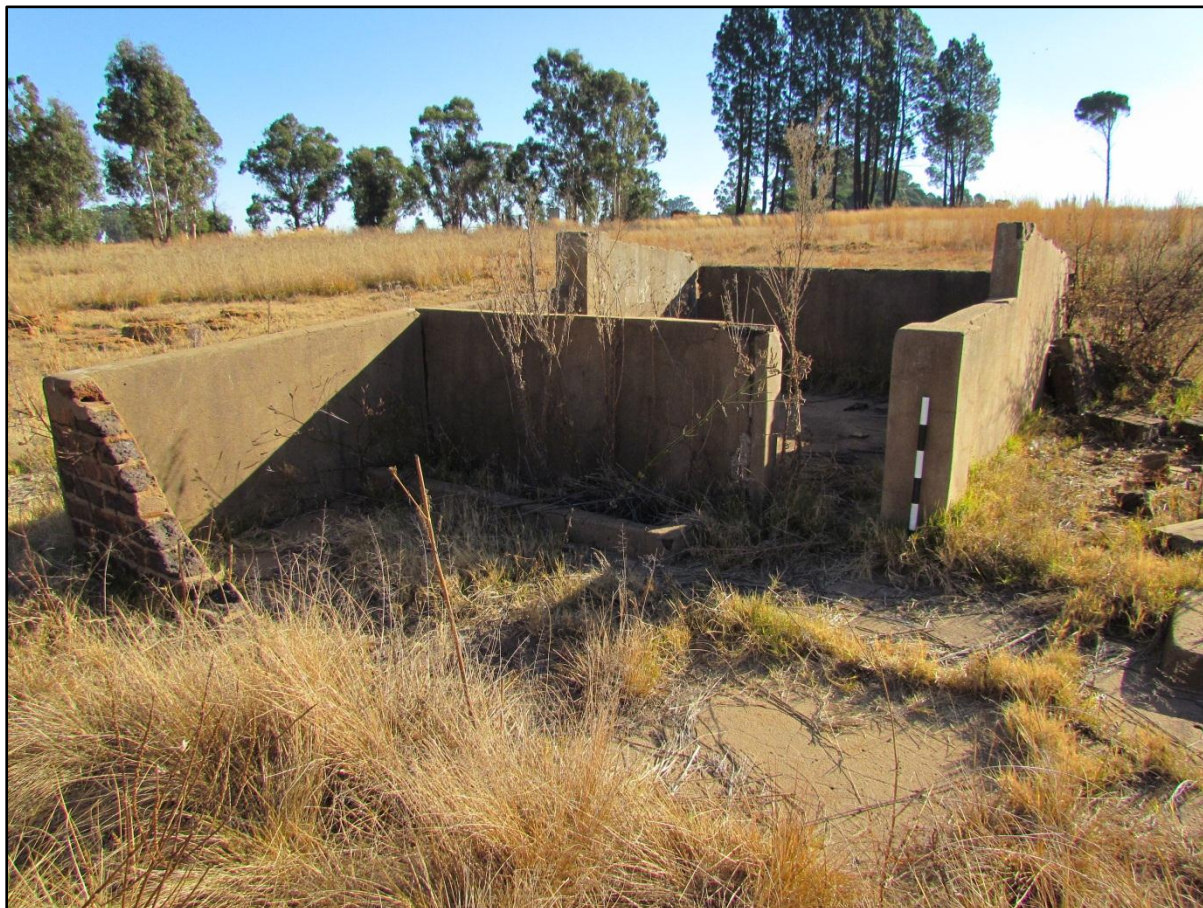
A small two room structure (4 m x 3 m) was observed at this point. It is a possible storage room, and might be associated with the large house identified at H010 approximately 100 m away. The structure does not have a roof and glass and metal fragments were identified in the vicinity. It may have been a pen for animals.

Figure 6-22: Small two room structure identified at H009

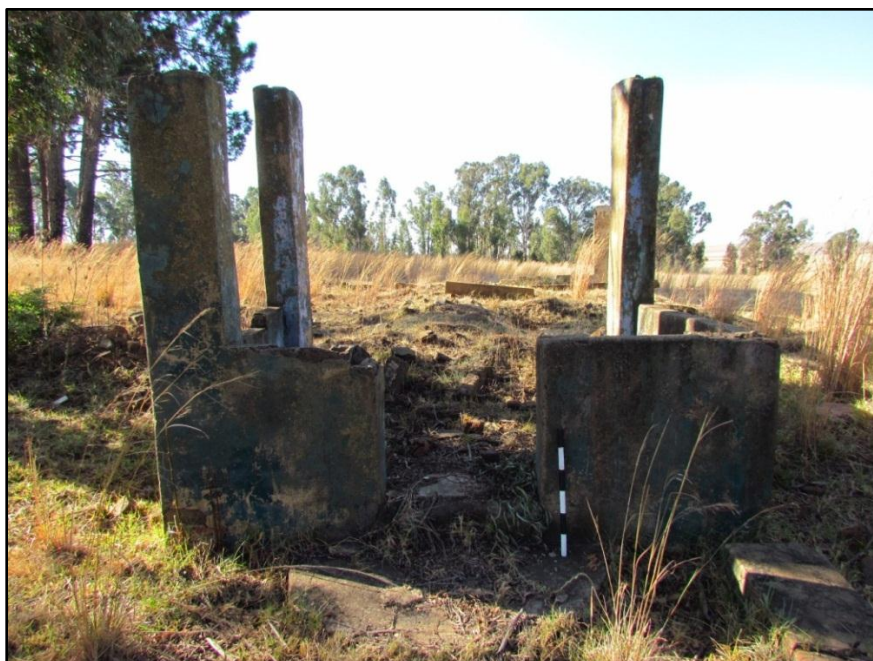
Two structures beside each other: a larger one structure approximately 30 m in length and 15 m wide, and a smaller one approximately 15 meters long and 10 meters wide. The larger structure consisted of an entrance hall and a three meter diameter room to the left of the entrance. The walls were constructed from modern bricks with cement plaster. A mud brick structure approximately four meters long and three meters wide existed was located near the entrance. Fragments of glass, metal and building rubble were present.

Figure 6-23: Remains of large structure identified at H010 looking north

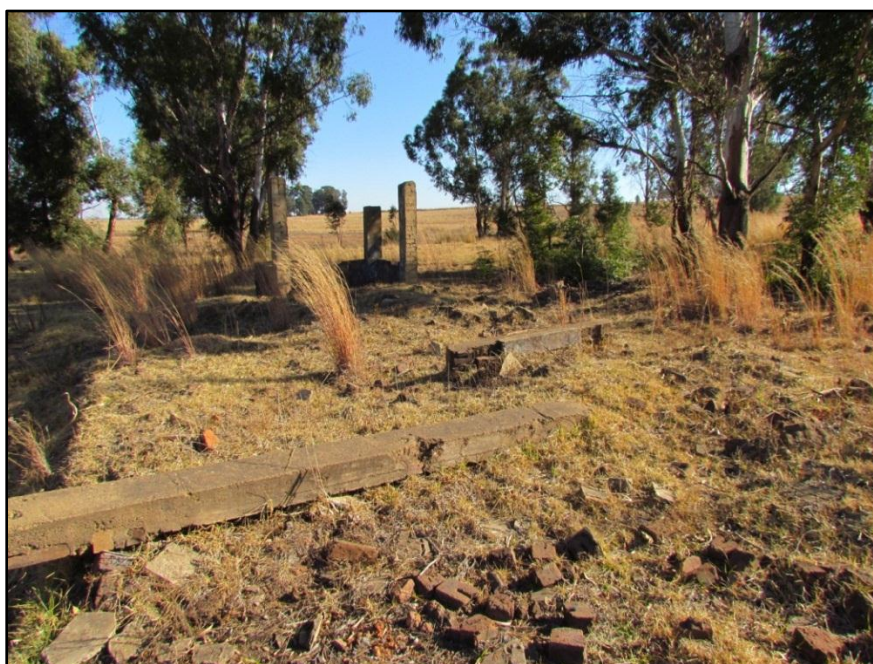
Figure 6-24: View from the south of remains of structure identified at H010

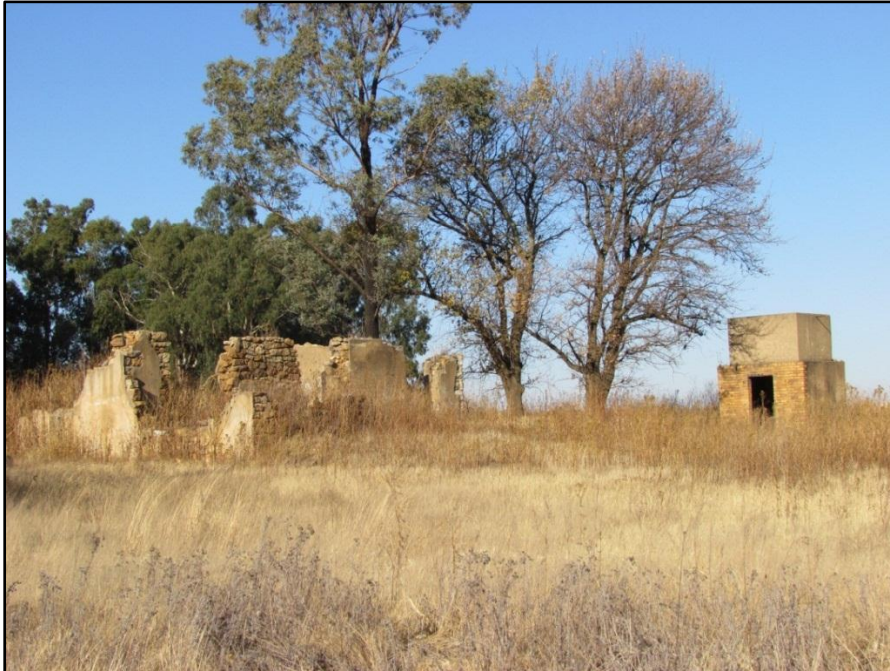
A plastered stonewall structure measuring approximately 30 meters long and 20 meters wide was identified. The walls were constructed with a combination of daga and cement mortar. The structure comprised three large rooms divided by mud brick walls. A brick and cement structure – possibly a water tower – was located 10 m from the main structure.

Figure 6-25: Large stone walled structure with water tower identified at H011

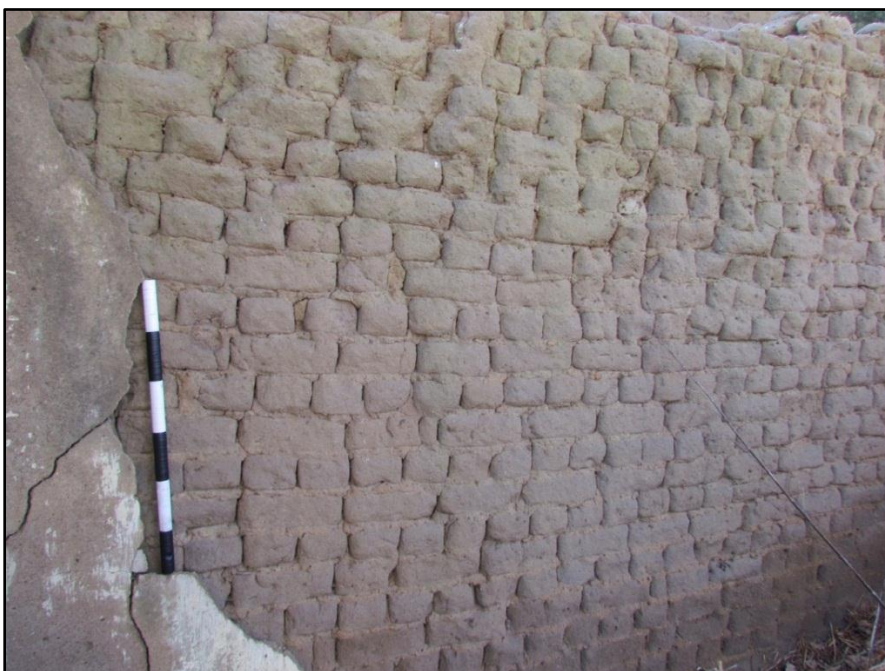
Figure 6-26: Mud brick interior walls of structure identified at H011

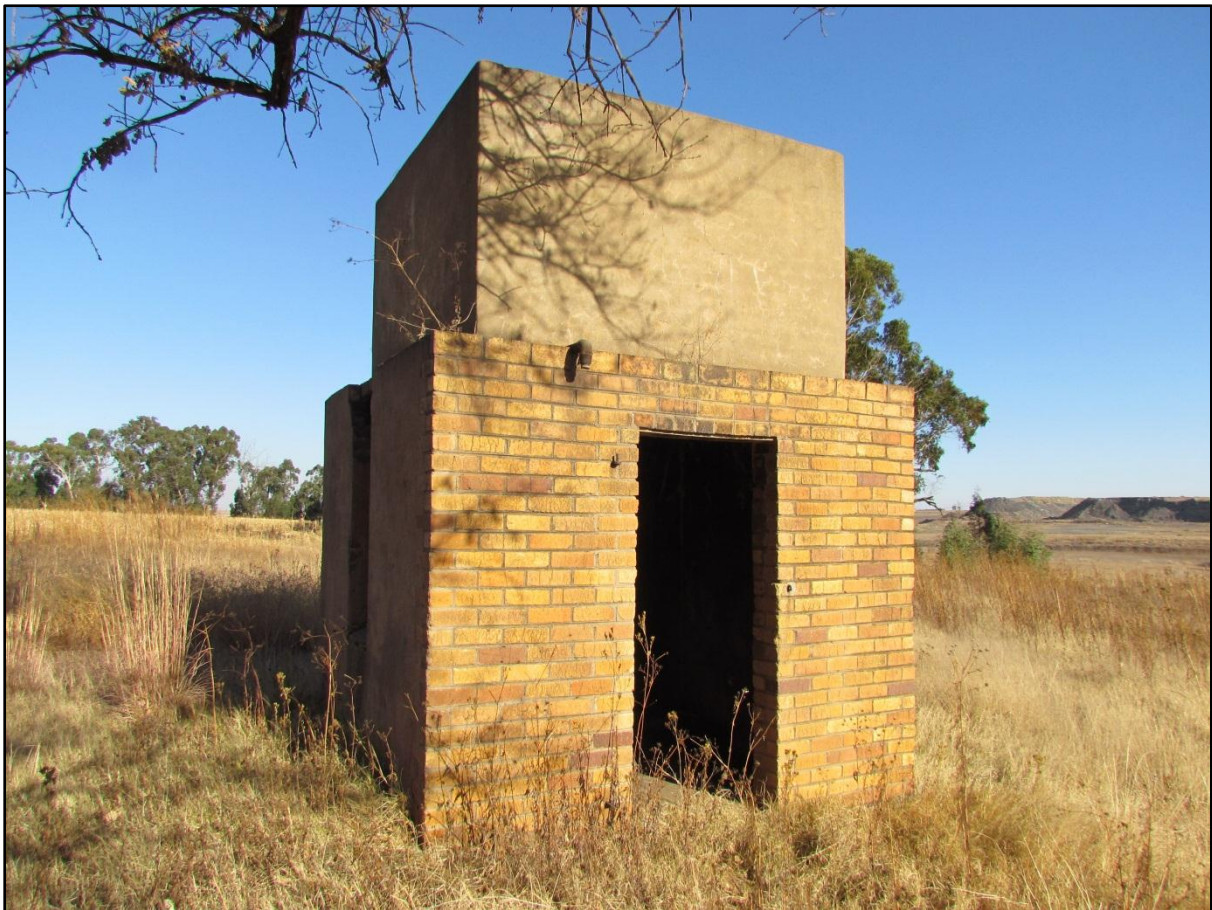
Figure 6-27: Water tower (water tank missing) identified at H011

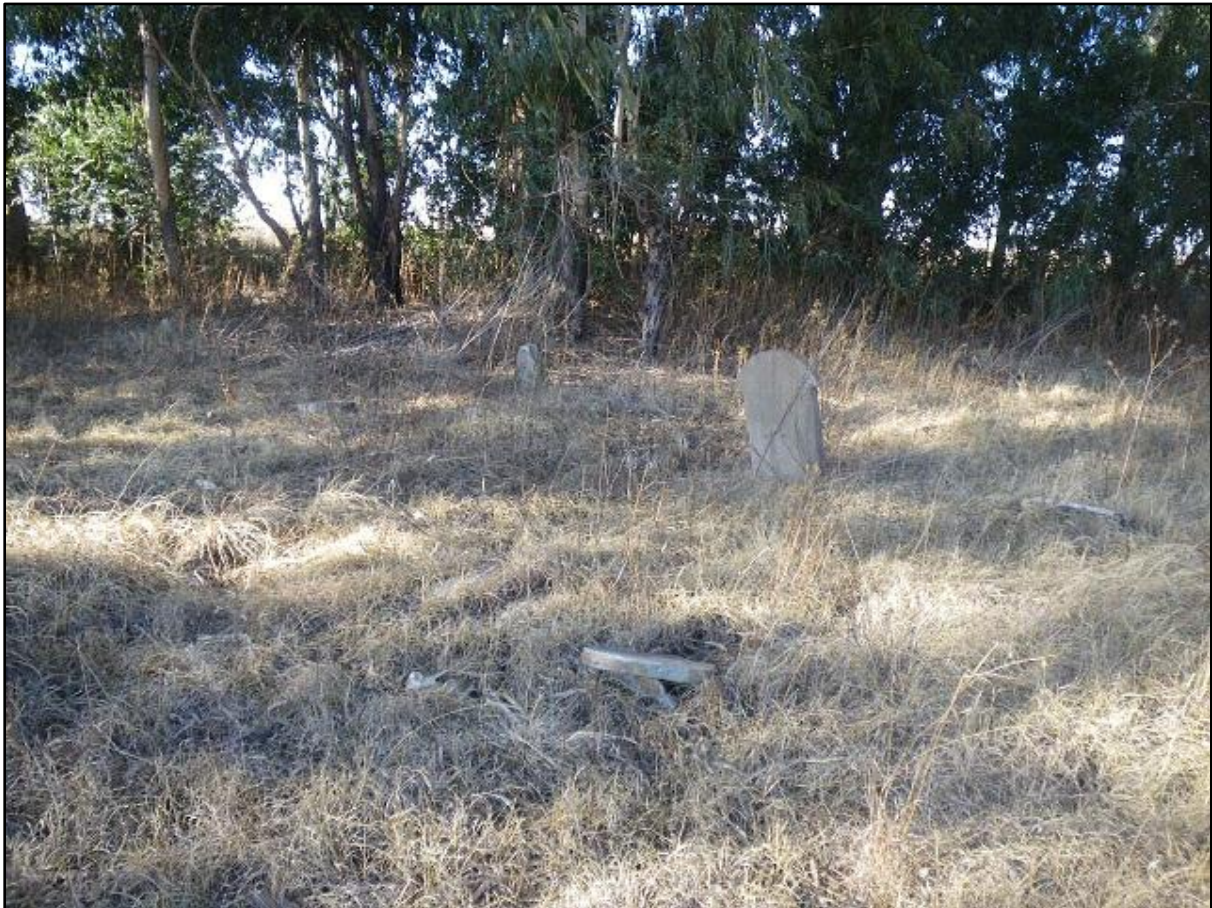
An unfenced burial ground was found in close association with the structure identified at H011, approximately 50 m to the south east from the structure.

This site was identified after the physical survey was completed by the soil specialist and due to time constraints, this could not be verified by the archaeologist. Approximately 9 graves were observed with cement headstones.

Figure 6-28: View of unfenced burial ground identified at H012.
