HERITAGE REPORT

APPLICATION TO
HERITAGE WESTERN CAPE
IN TERMS OF SECTION 34 of
NATIONAL HERITAGE RESOURCES ACT NO 25 OF 1999
AND
CITY OF CAPE TOWN PLANNING AND BUILDING DEVELOPMENT MANAGEMENT
(REGULATION E1 OF THE NATIONAL BUILDING REGULATION)

212A BUITENGRACHT STREET, BO-KAAP
URSULA RIGBY

ARCHITECT (B Arch) & PROFESSIONAL HERITAGE PRACTITIONER (M Phil CBE)
20 ALEXANDRA AVE, ORANJEZICHT, CAPE TOWN, 8001, SOUTH AFRICA
Email: ursula@ursularigby.co.za Mobile: +27 82 415 0990

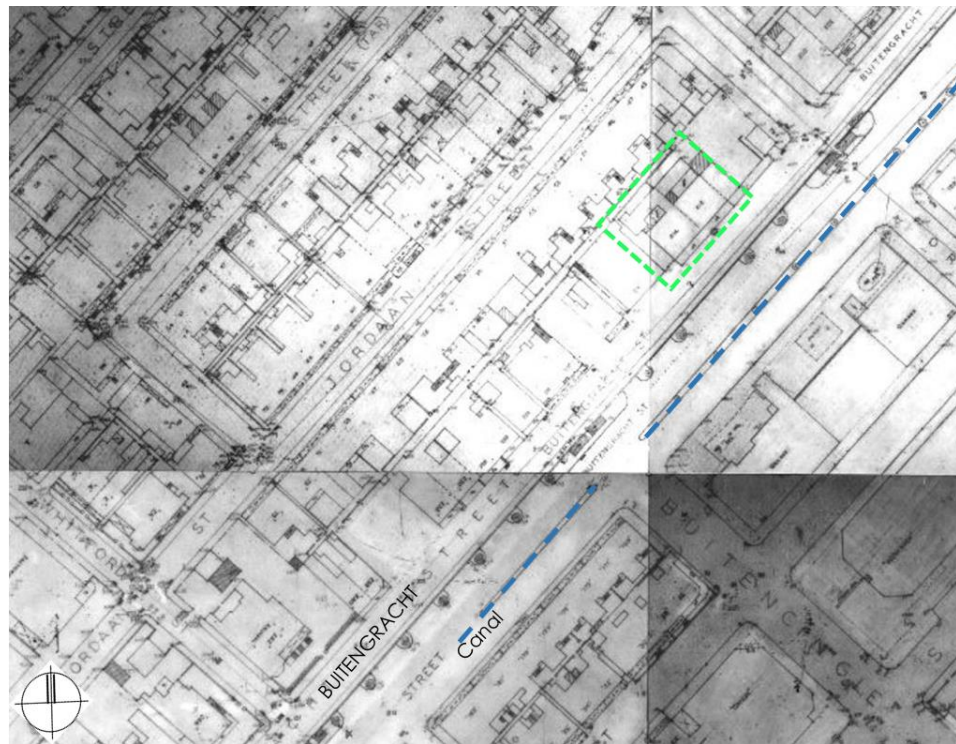
Figure 12: CoCT 1944 – 66 Survey
 Source – CoCT. Shows the new parcel of land on the corner of Buitengracht and Orphan Street as part of the 1961 Surveyor General Diagram no. 7306/61 (Erf 3094) and then again on SG Diag no. 1912/61 (Erf 3093). Note corner is not shown as splayed on CoCT Survey map.

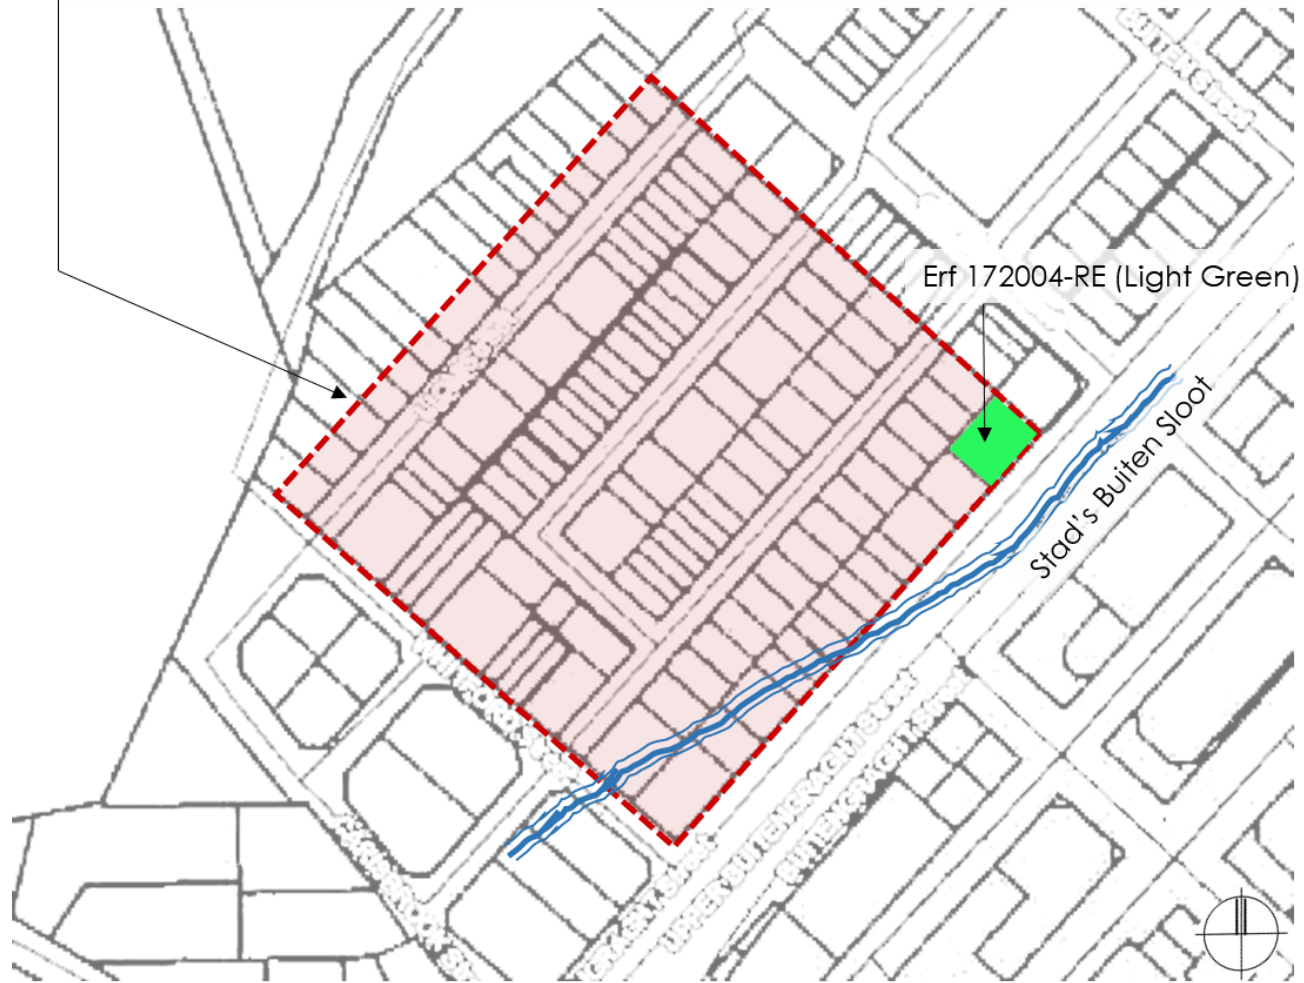
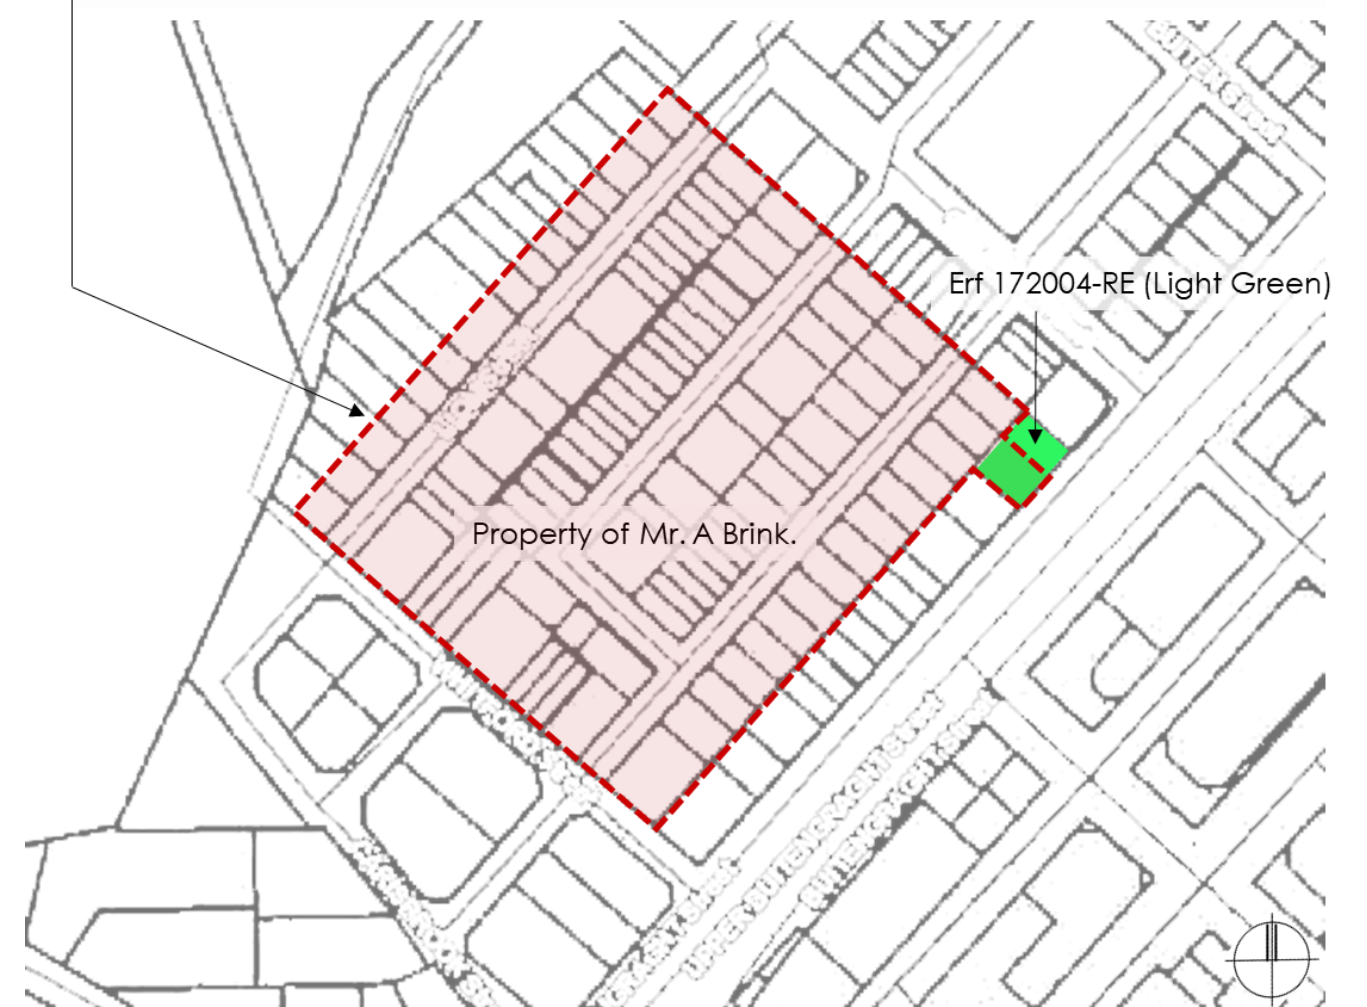
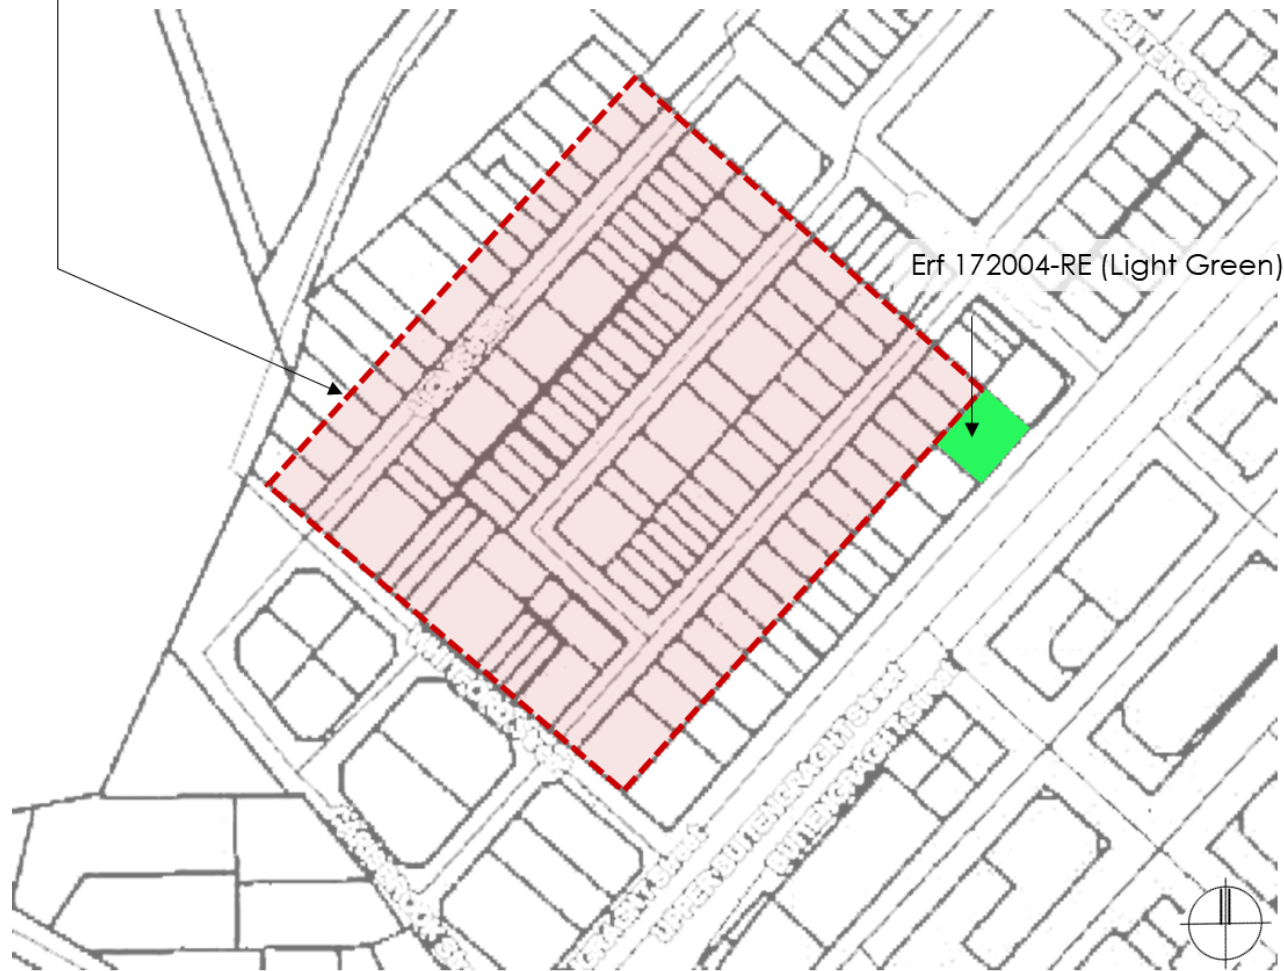
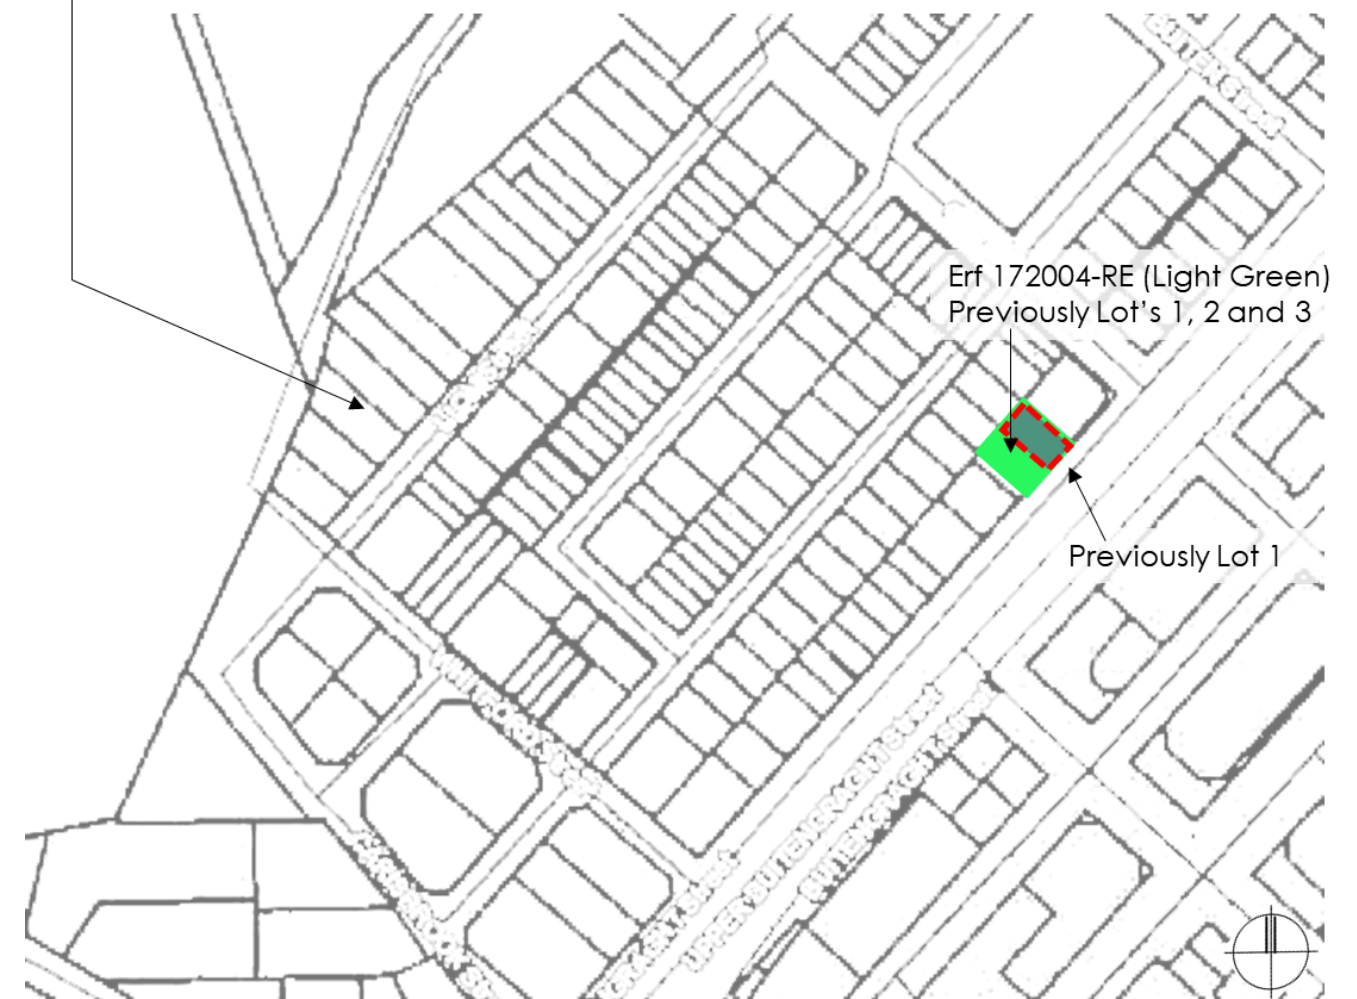
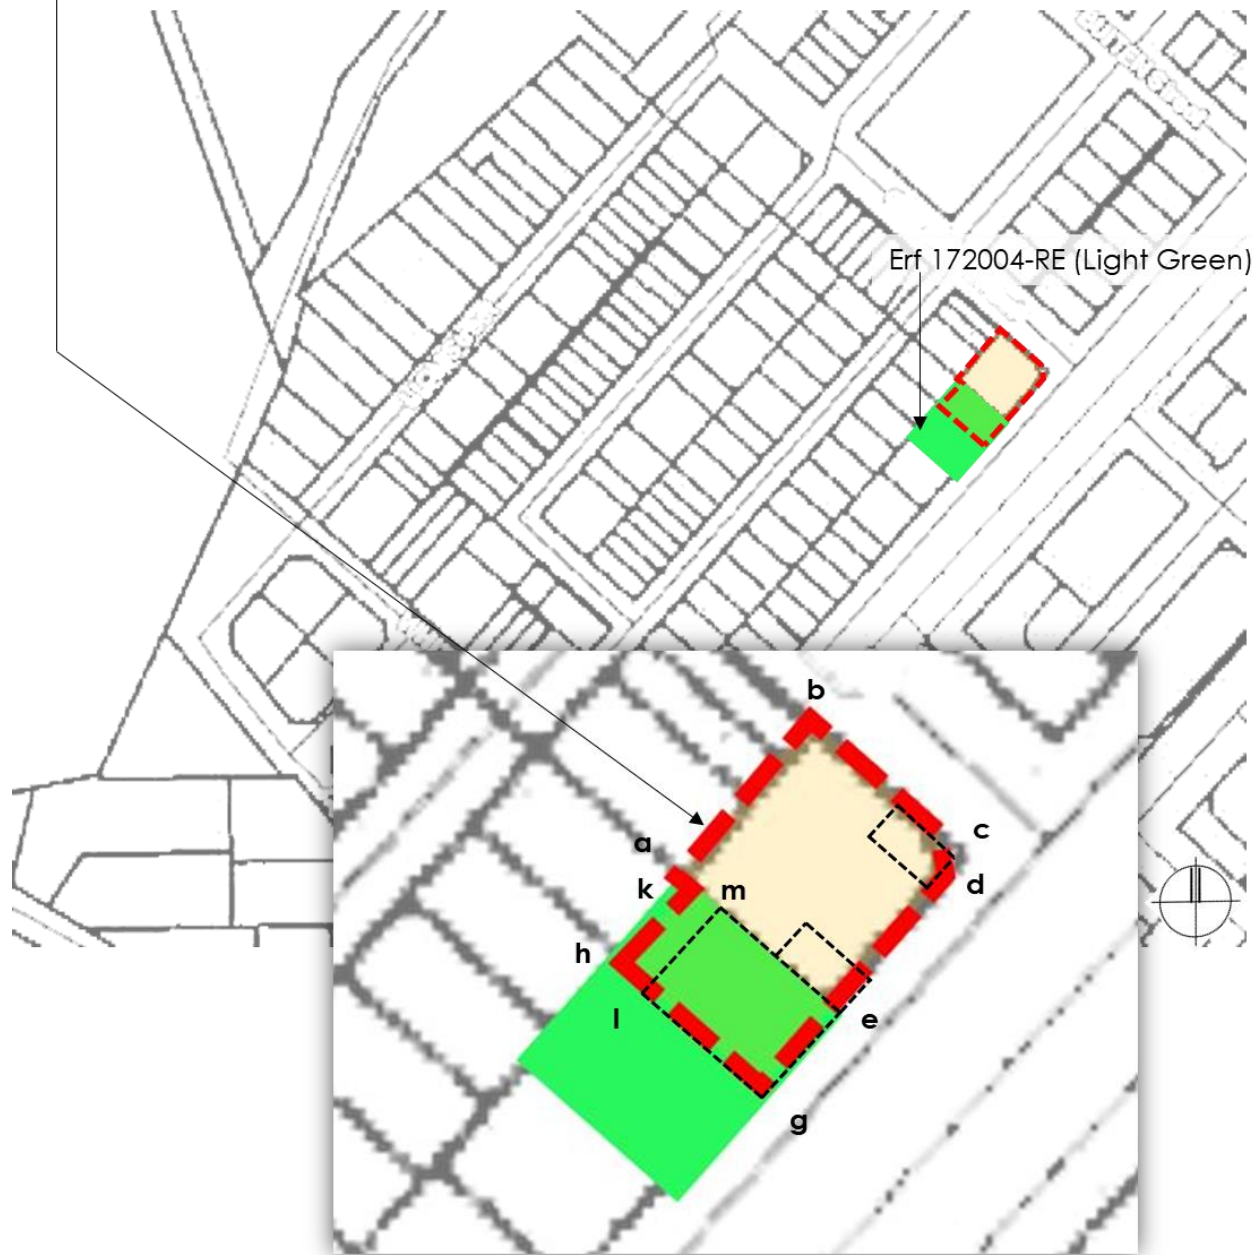
Dotted line and shaded area denotes:-
 Figure in Table Valley between the land of A. Cruywagen and the "Stadt's Sloot"
 at the foot of "Leeuwenbergs gelegen".
 Size 2 Morgen, 460 Quadraat Roeden.

Notes translated and diagram formulated from SG Diagram No. 57/1808

Dotted line and shaded area denotes:-
 Annexed figure of 166 Sq roods of land situated near the western extremity of
 Cape Town between the produced Buitengracht and the Property of Mr and Mrs
 Brink and Son, extending NW to said property, NE towards Stone Quarries, SE to the
 produced Buitengracht and SW to Government Land

Notes from SG Diagram No. 16/1834

Dotted line and shaded area denotes:-
 The diagram represents Two Morgen 439 Sq roods and 36 Sq feet of land, situated between the lands now or lately the Property of Ad Cruywagen and the Town Canal at the declivity of the Lions Rump. The diagram represents part of the property transferred to Mr and Mrs Brink C. Son and is taken from the Original laid down on the Title deed granted to F. C. Bresler on the 15th June 1808

Notes from SG Diagram No. 327/1839

Dotted line and shaded area denotes:-
 The figure represents 11 Sq Roods and 36 Sq Feet of Land in the Division of the Cape in Cape Town in Buitengracht Street being portions of the land granted to JC Braslan, 15th June 1808 and of the land transferred to A Brink C. son on the 14th February 1834, and last transferred to Baard on the 9th August 1889, forming Lot No. 1. Bounded Northwesrwd by Private Property, North Eastwd by Municipal land, South Eastwd by Buitengracht Street and SW'd (sic) by Lot No. 2.

Notes from SG Diagram No. 1201/1891

Dotted line and pink shaded area denotes:-
 1. The figure a,b,c,d,e representing Portion 3 of Lot BOJ in extent 3292 Sq Feet.
 Diagram no. 1912/1961 annexed to D/T 1962
 2. The figure h,k,e,g, representing Land D/T dated 23rd Dec 1891 in extent 1620 Sq Feet,
 Diagram No. 1201/1891. D/T 1891-77-6296.
 The figure a,b,c,d,e,g,h,k represents 4,912 Sq Feet
 Note: lg is a party wall. Vide D/T.1891-77-6296

Notes from SG Diagram No. 7306/61

The first built form visual image of this residential unit can be dated to Millard c1859 via the ClfA Building of Cape Town 1983 survey which notes "flat roof and parapet being clearly visible".¹³ The first subdivision's off the original parent farm land parcel took place in 1834 which is 25 years earlier than the earliest record of built form on this site. In 1834, the row of properties now located on Buitengracht where subdivided off from the farm – presumably for farm workers accommodation. Interestingly, part of Erf 172004-RE was retained with the farm in the 1834 subdivisions and subdivided off later in 1839. (Ref Figure 15)

Later subdivisions and consolidations occurred post 1960 where part of Erf 172004-RE is consolidated with the now new corner site on Orphan Street. In 1961 the site on the corner of Buitengracht and Orphan Street with its splayed corner was subdivided off completely. In 2006 it was consolidated with the land containing the two semi-detached units and shortly thereafter subdivided off and sold to the present owner. This convoluted land ownership and subdivision/consolidation history is presumably as a result of the attached structure which is evident on the CoCT 1955-66 survey map and the proposed redevelopment of the site intended by the then owners of the property, Mr and Mrs Dixon. Diagrams illustrating the history of land divisions are presented in Figure 15.

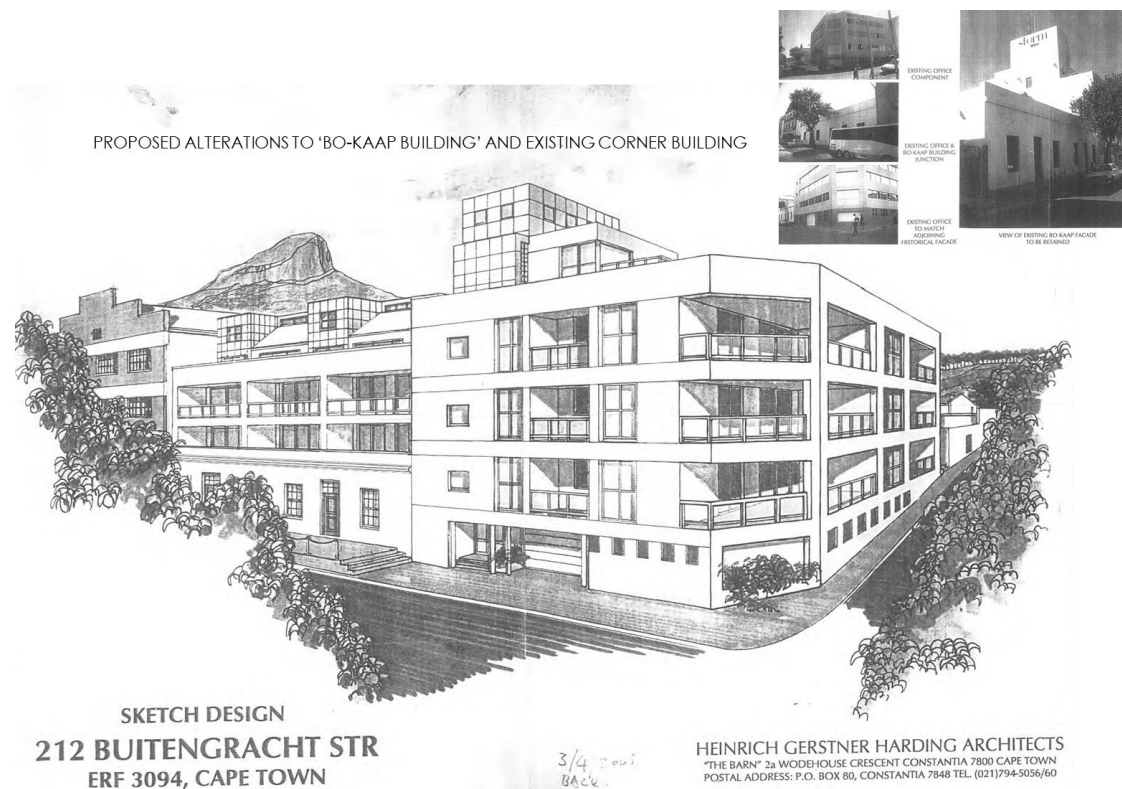
Figure 25: Extracted text from The Buildings of Cape Town: Phase Two 1983 Volume Three: Catalogue and Classification of the survey undertaken during 1982/3

erven : 3094, 3094, 3094, 3076, 2975
 prop. ref. : WD 23D 16, 16, 16, 14, 15
 inspected : June 1983
 record : 61.109, 61.110 : Thom c1895-site undeveloped
 61.111, 61.112 : T126/14-1834 transfer deed, sites recorded as undeveloped in 1839
 Millard c1859-flat roof and parapet, clearly visible
 Snow c1862-site developed
 CA (E 8137), c1865-facades visible

61.111 and 61.112 : Extensively altered, mid 19th-century, 3-bay. Flat roof and parapets, probably contains old wall fabric. Raised stoep, quarry tiles, modern steel chain and post railing. Modern sashes, glazed door and fanlight, old bead mould beams, new pine ceiling boards, metal roof sheeting. Plastered string course replacing moulded cornice.
 61.110 : Plastered brick addition, steel windows, modern timber sash on Buitengracht.

Building of Cape Town 1983 Survey notes document an extensively altered mid-century 3-bay flat roofed structure behind a parapet wall. Refer to Figure 21 and Figure 25.

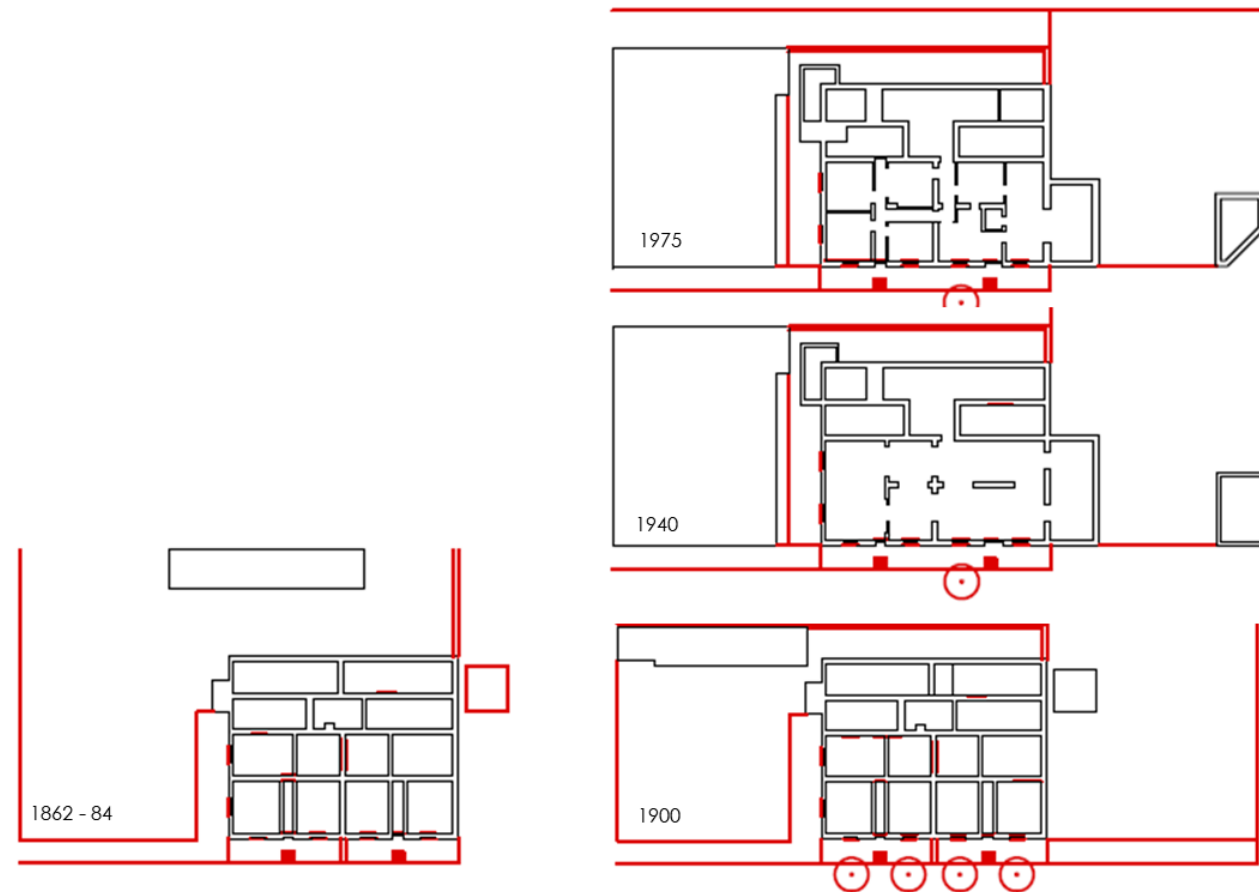
The following illustrations illustrate the Built Form Morphology from 1862 to 2020 (imagined). The plan forms show changes made which radically affected the existing built form between 1940 and 2014 where internal walls were demolished and the units were used as one space for business purposes.

Figure 26: Plan diagrams showing changes over time 1862 – 2014. Source - Source – KFA. Information extrapolated from drawings obtained via the CoCT archive which are presented in Section 3e.

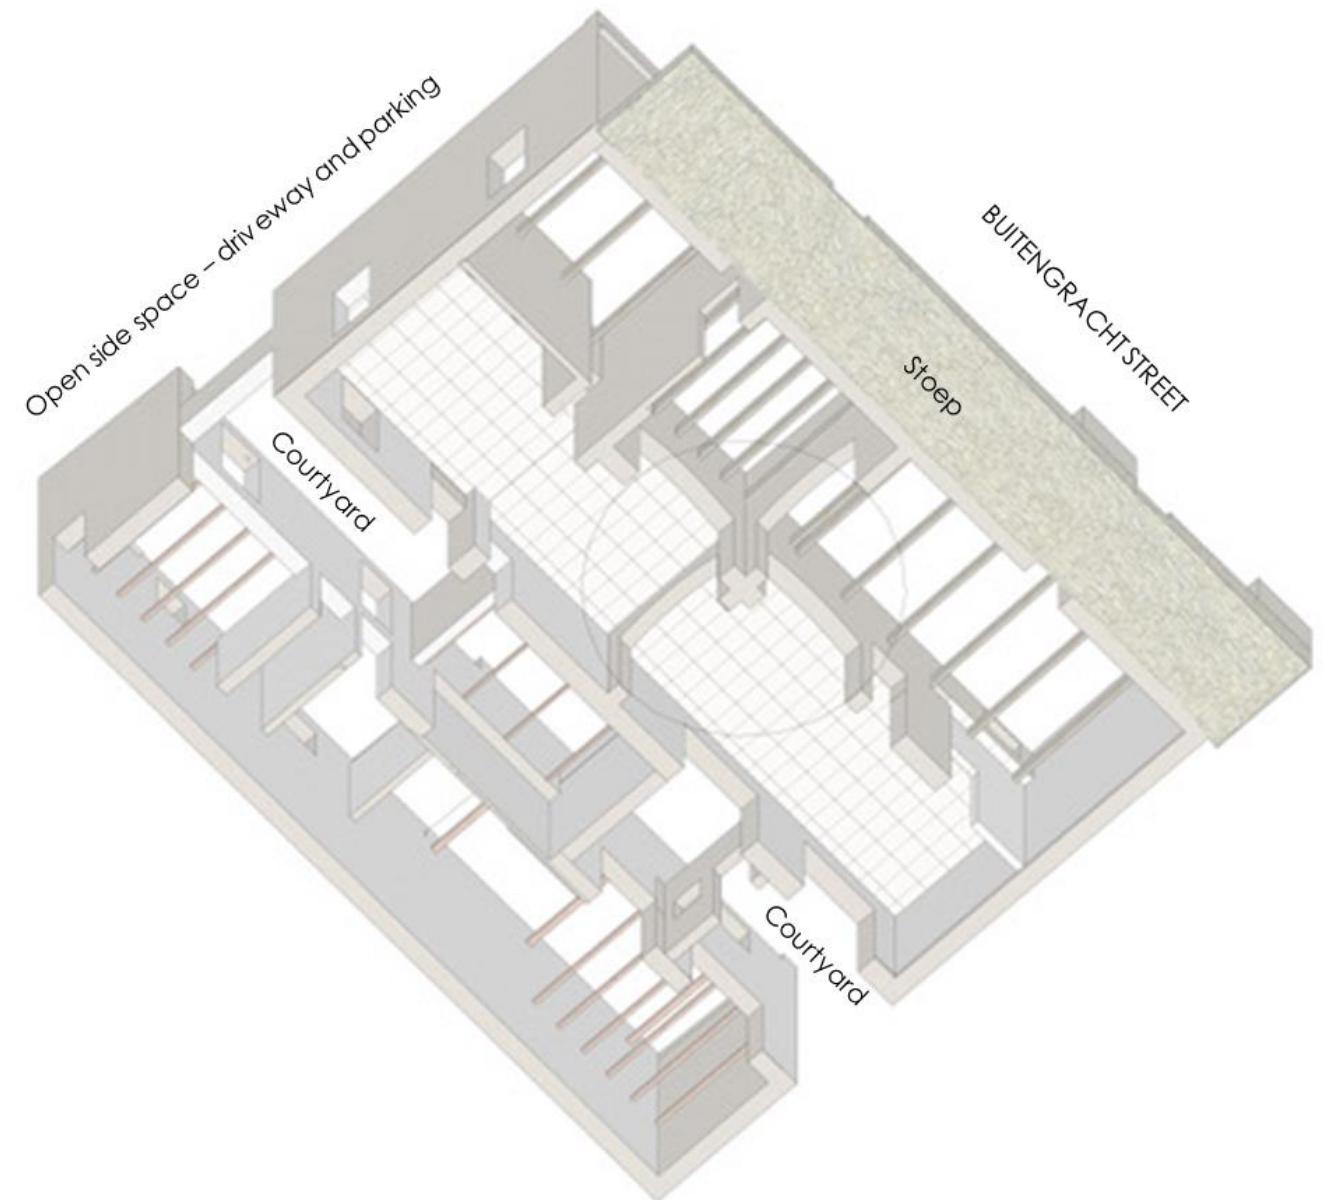
Figure 29: 2014 Record of "As-bought" layout – view from below
Source – KFA.

RECORD OF 2014 'AS-BOUGHT' LAYOUT – VIEW FROM BELOW
Showing wall positions and openings and ceiling beams.

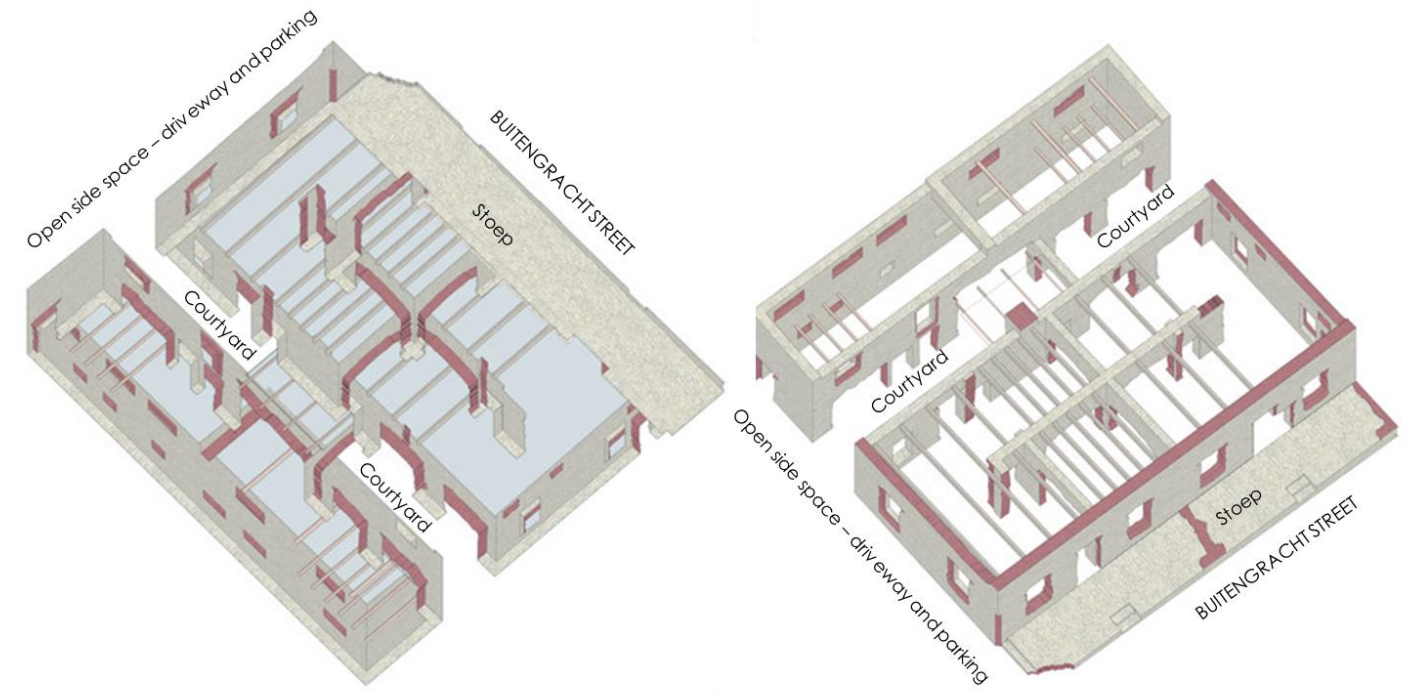
Red denotes all demolition of original fabric as derived from KFA survey of fabric whilst renovating.
 Read in conjunction with timeline study of CoCT record drawings which record various stages of alteration over a period of 65 yrs. (1947 to 2014)

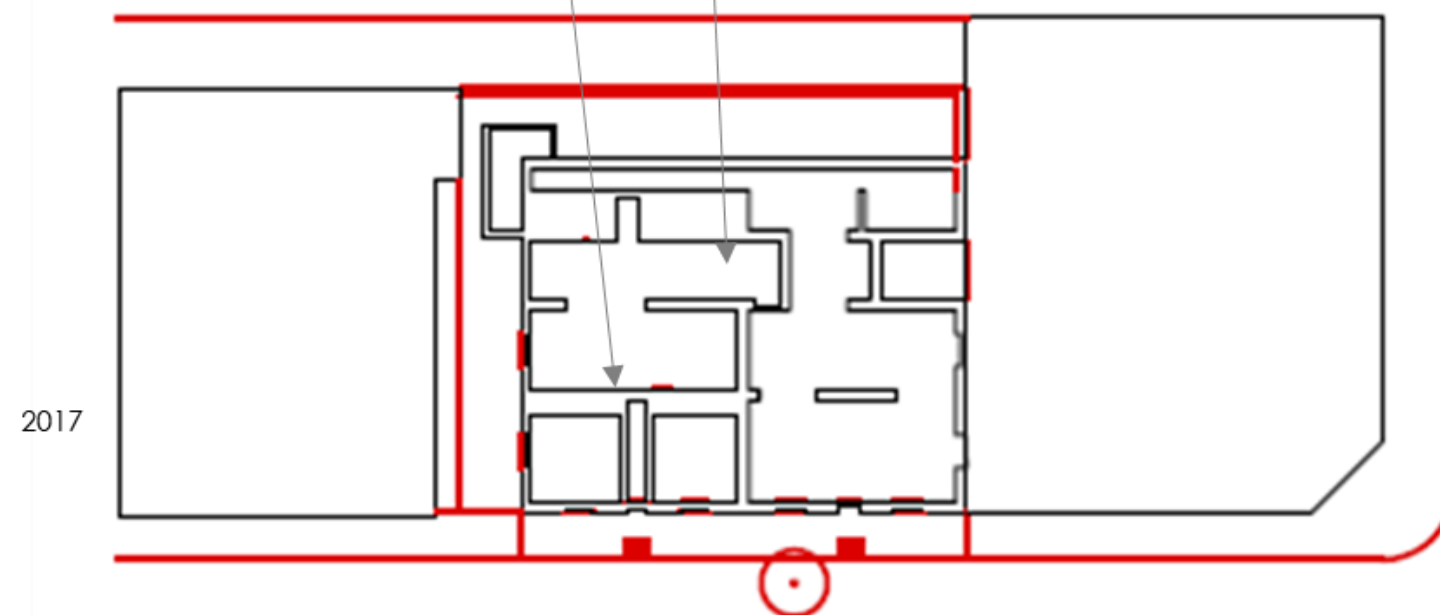
Figure 32: 2019 Annotated Record of "As-built" layout
Source – KFA

- We plastered the infill walls, and skimmed but did not paint them- instant patina.
- Similarly the floor, The brick paving is the cheapest extruded brick for RDP housing, laid over the old screed by driveway pavers, The bricks are really soft and uneven in colour and are already weathering outside, and even inside. Also instant patina. These will have to be ripped up if we do any more building. If the experiment works we will use them again.

- We replaced the door frame into the house from the office with one we found with its fanlight buried in the wall to what had been the courtyard, which I believe to be from the 1973 rebuilding of the interior.

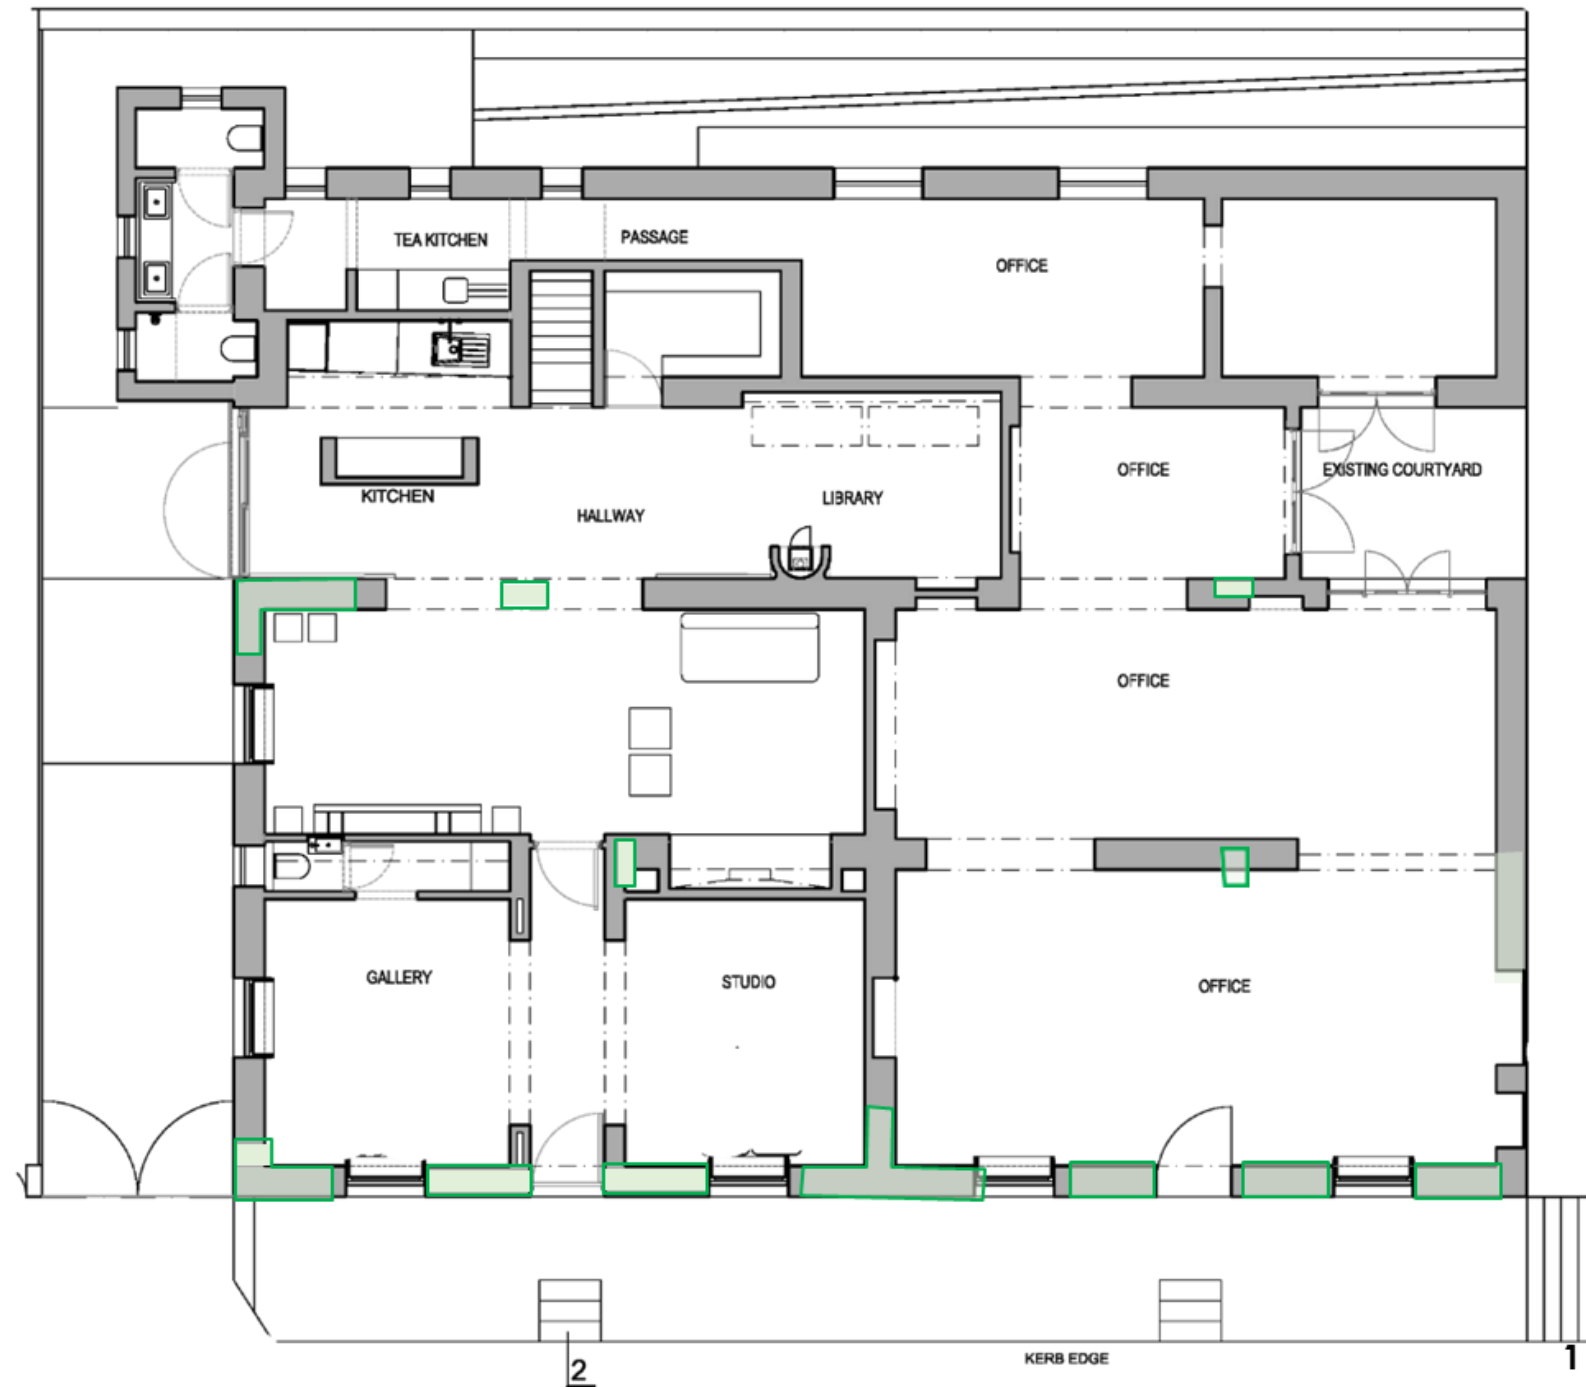
An assessment of CoCT Record drawings from 1947 to 2014 representing 65 years' worth of alterations have been analysed in order to understand where possible pre 1947 fabric may exist. The green highlights on this 2018 As-Built floor plan show results from the following study which tabulates and illustrates all changes over the 65 year period.

Figure 33: Analyzing 65 yrs. of alterations (1947 - 2014) to determine possible pre 1947 fabric
Source – KFA and URA+HP

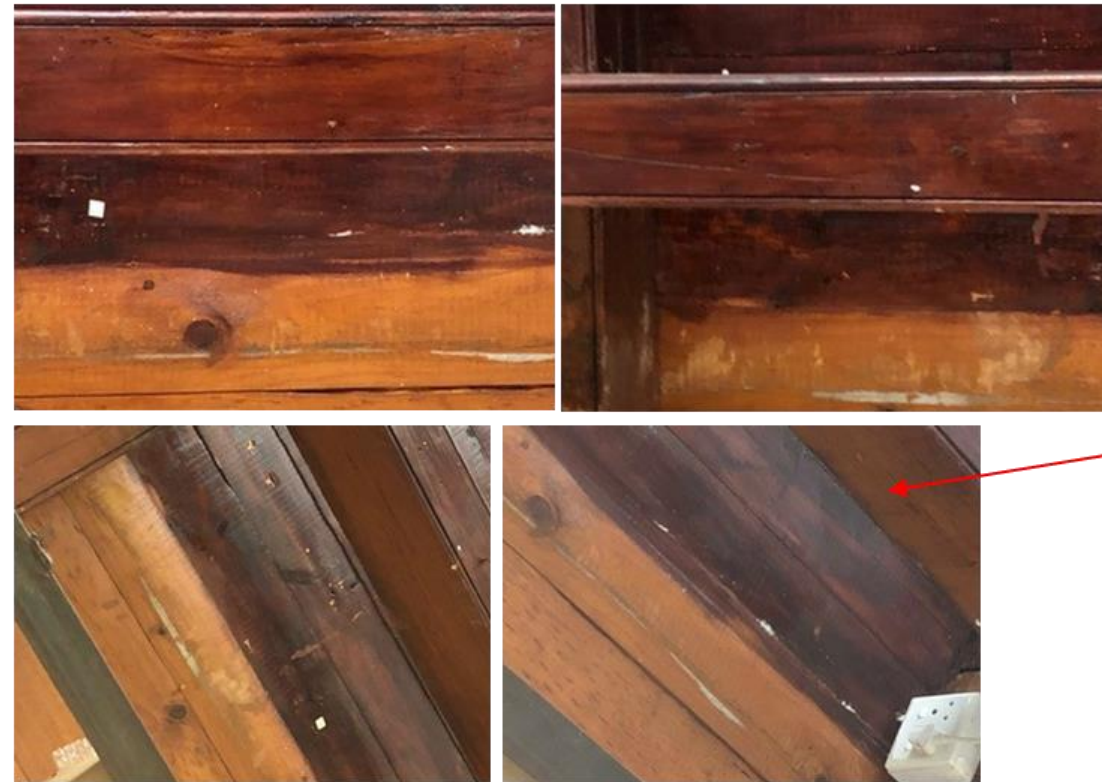
1. This is unlikely to be pre 1947 fabric. The five storied building on the site next door was constructed in 2006/2008. Both erven were owned by Dixon Electronics at that time. The structure next door is a concrete column and beam structure with a suspended stair. It is unlikely that the pre 1947 fabric in this area would have remained intact or survived this type of construction intervention.

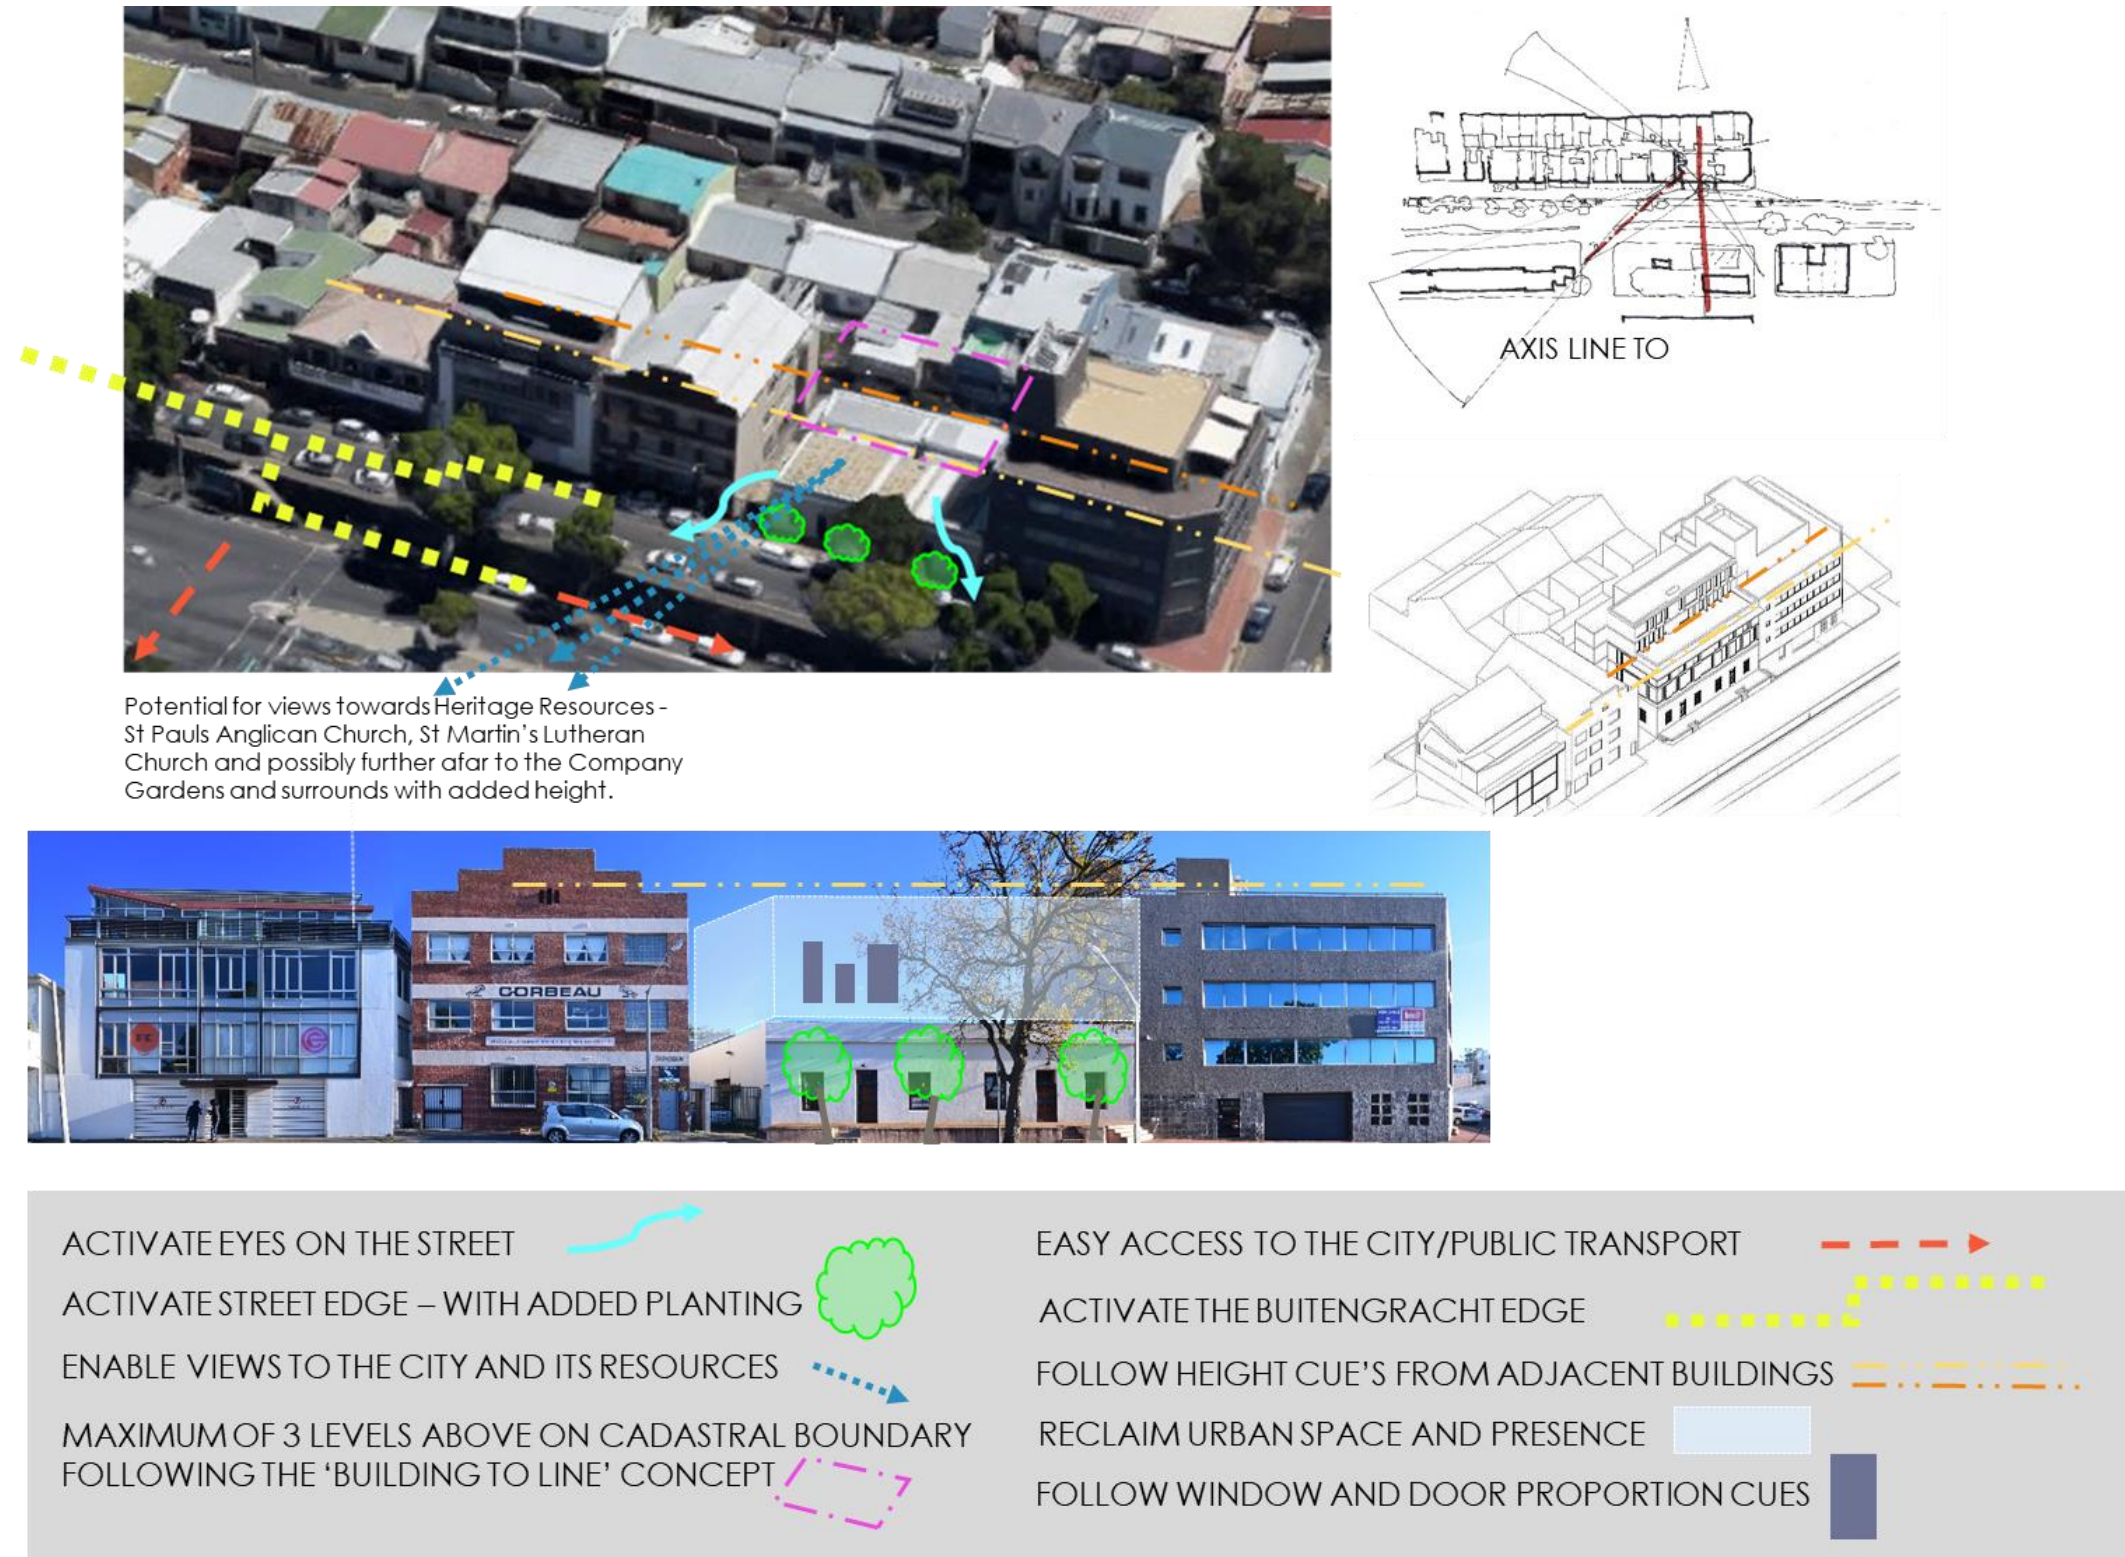
The following diagram represents the process of contextual analysis which informed the development proposal. The process of design development has been an iterative process and further amendments may be implemented as outcomes from the assessment process which is presents recommendation in this report. Refer to Section 6 – Conclusion and recommendation.

Figure 37: Initial conceptual analysis with height indicators
Source – URA+HP and KFA
