HERITAGE REPORT

APPLICATION TO
HERITAGE WESTERN CAPE
IN TERMS OF SECTION 34 of
NATIONAL HERITAGE RESOURCES ACT NO 25 OF 1999
AND
CITY OF CAPE TOWN PLANNING AND BUILDING DEVELOPMENT MANAGEMENT
(REGULATION E1 OF THE NATIONAL BUILDING REGULATION)

212A BUITENGRACHT STREET, BO-KAAP
URSULA RIGBY

ARCHITECT (B Arch) & PROFESSIONAL HERITAGE PRACTITIONER (M Phil CBE)
20 ALEXANDRA AVE, ORANJEZICHT, CAPE TOWN, 8001, SOUTH AFRICA
Email: ursula@ursularigby.co.za Mobile: +27 82 415 0990

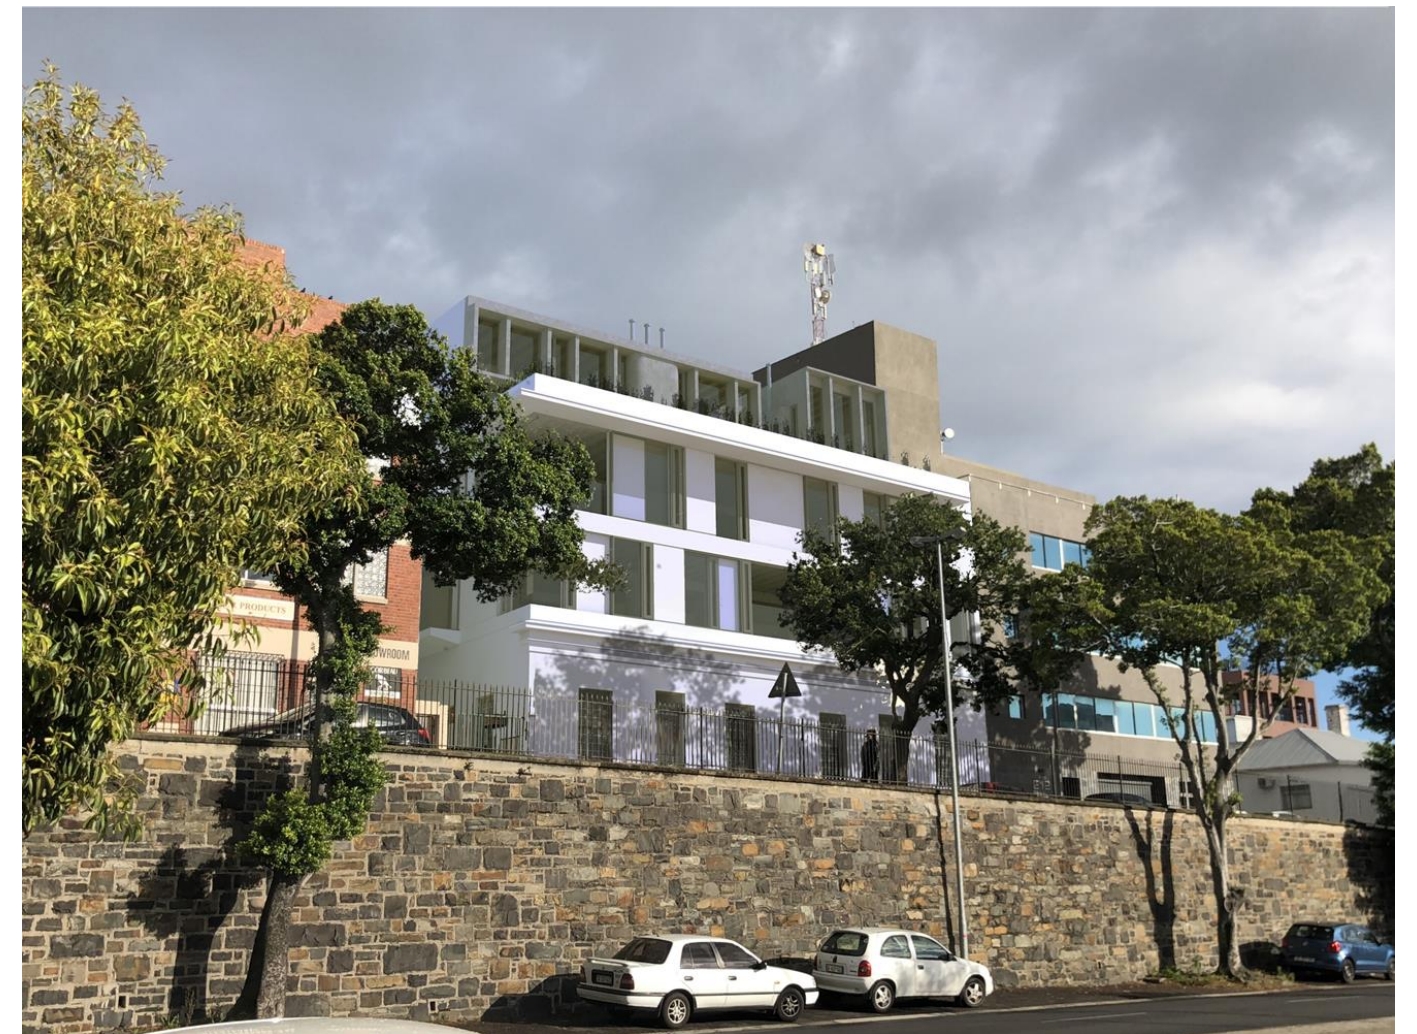
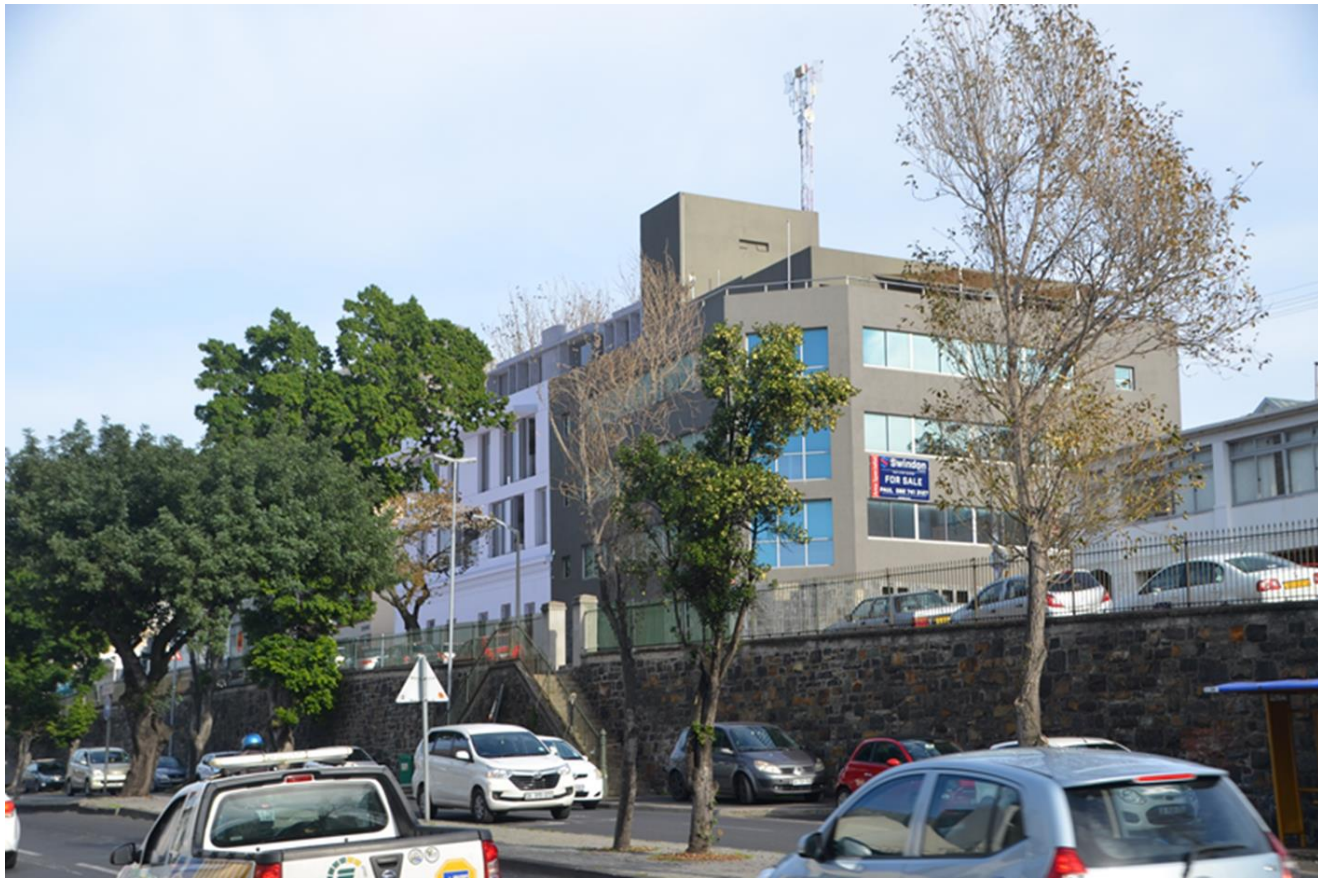
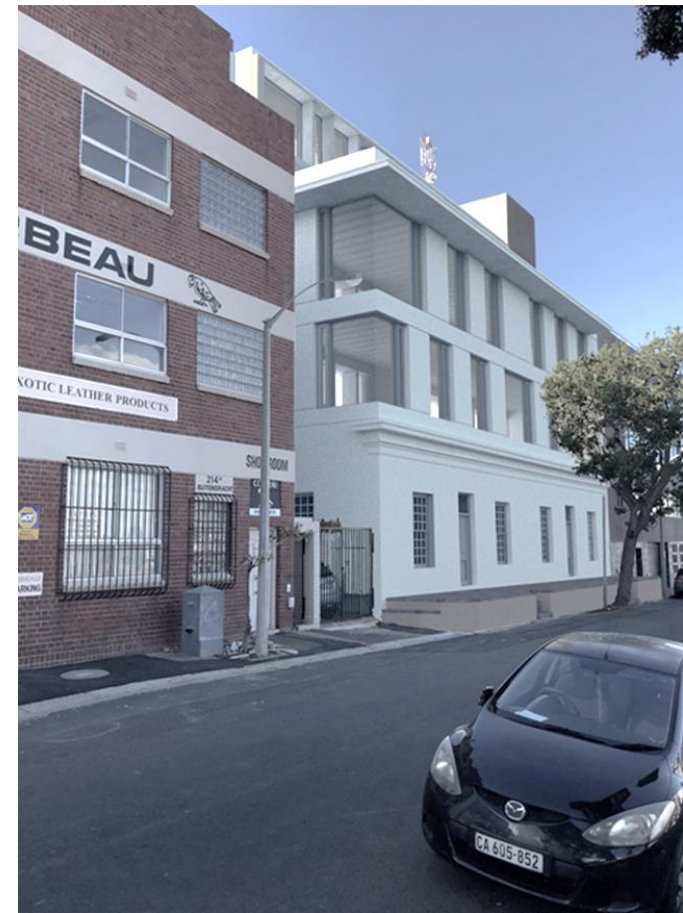
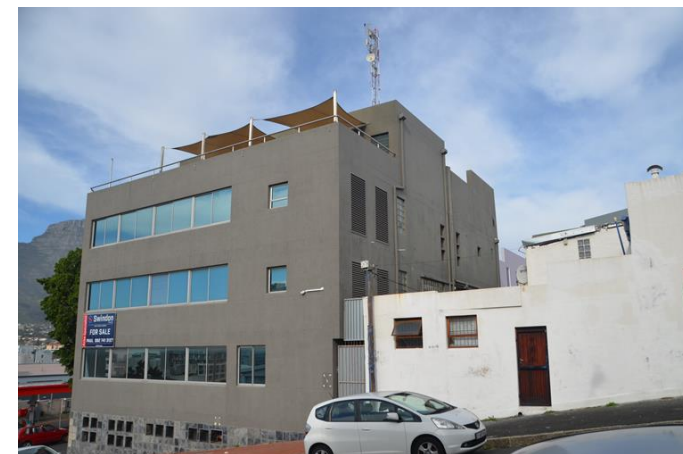
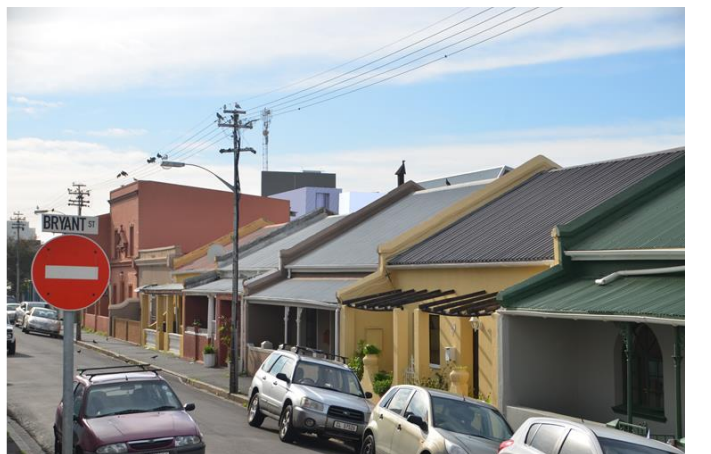
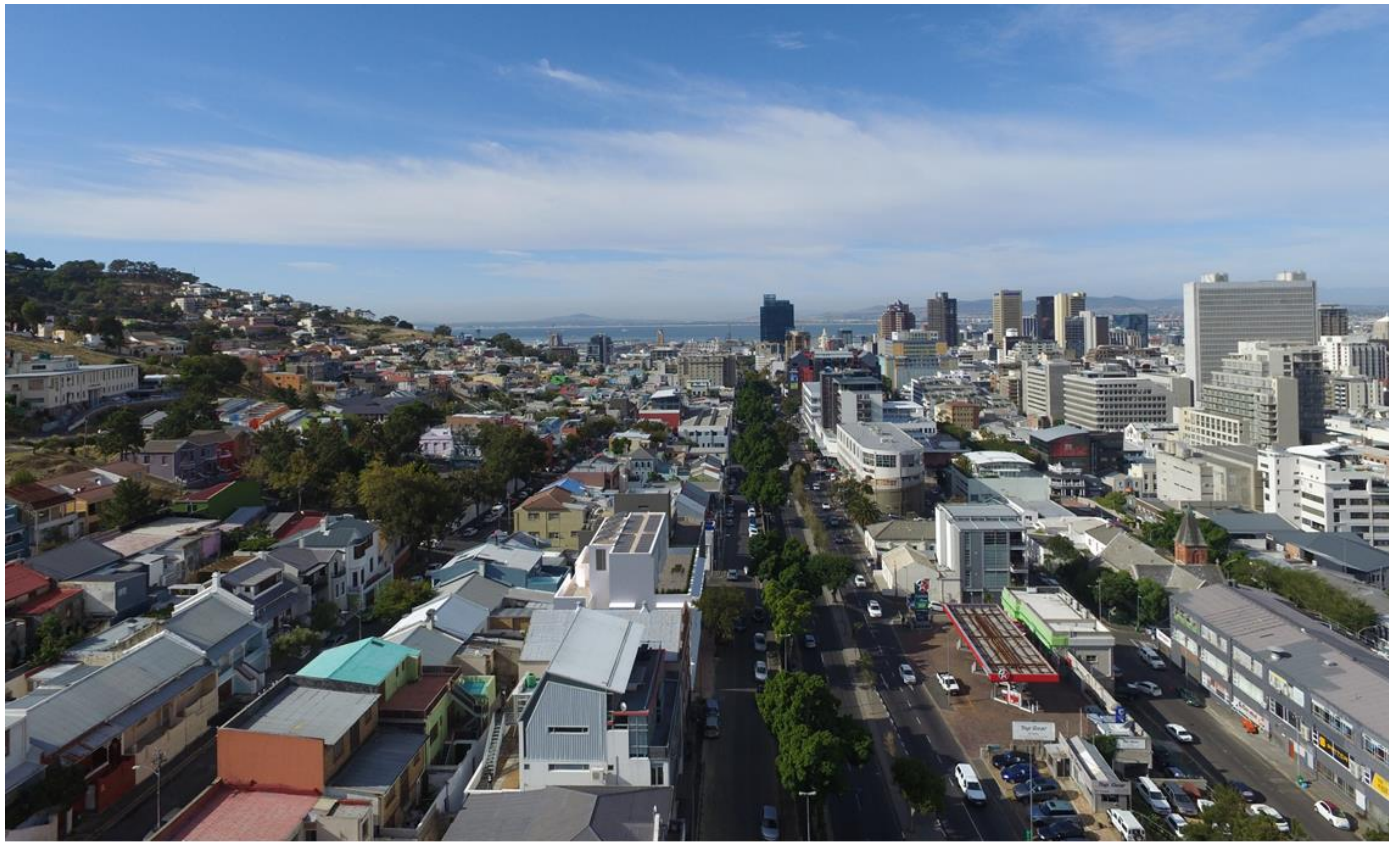
Figure 39: 3D Images of the Development proposal
Source – KFA

View from Buitengracht corner Orphan

Views from no. 218 and no. 212 on Buitengracht

Views from Orphan Street and Jordaan Street

Aerial View looking NE

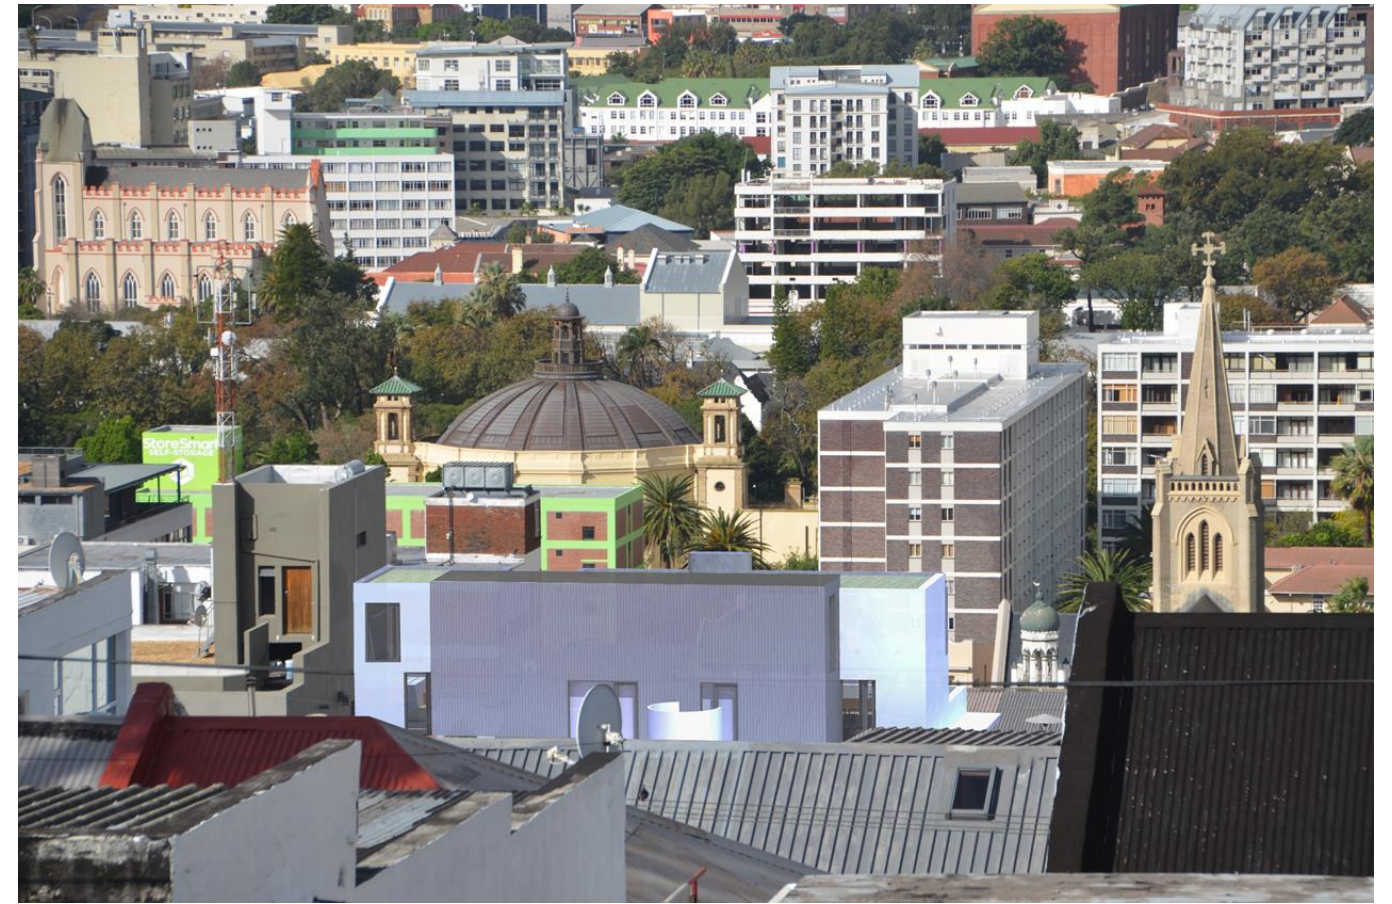
Figure 39: 3D Images of the Development proposal
(Continued...)

View from Military Road

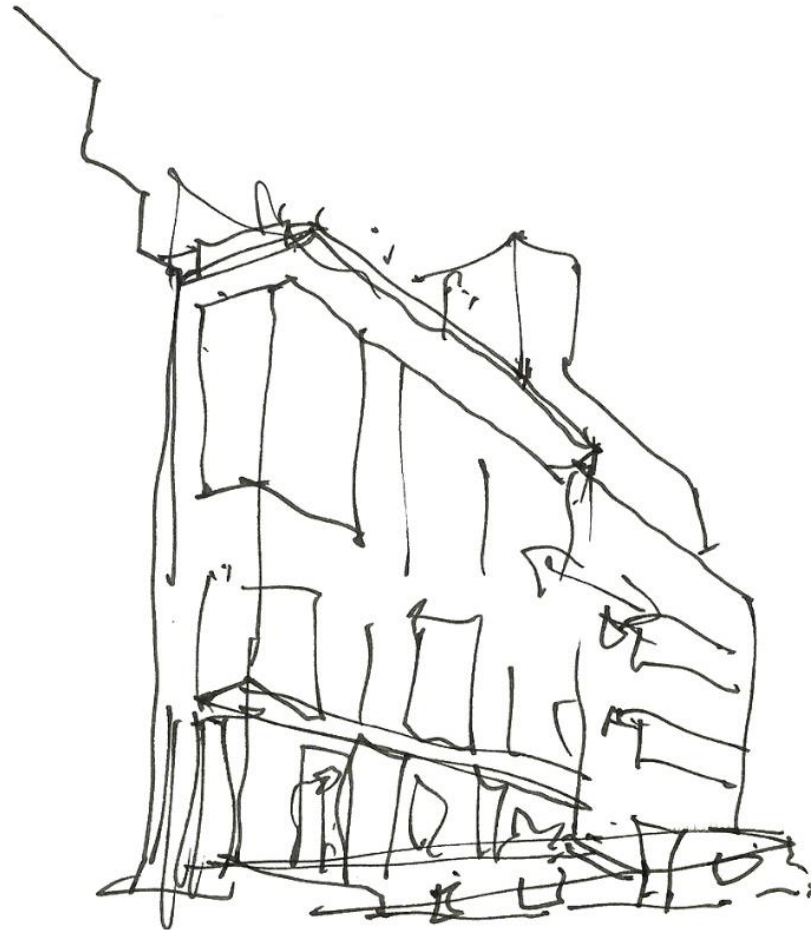
Corner emphasis

The design of the facade seeks to reconcile the simple internal program of two flats per floor with the symmetry and duality of the existing building and the asymmetrical diagonal emphasis. Internally, the southernmost flat on each floor will benefit from a corner window /Juliet balcony looking towards the mountain, and thus the decision was made to wrap the southernmost windows on both new street facing levels around the corner. The decision was also made to reverse the proportions of glazing to solid wall at the upper levels in order to visually lighten the facade as it ascended, to bring more light into what is of necessity a southeast facing building, and to allow generous views out over the city and Devils Peak. The decision to offset the windows emerged during the proportional studies for the facade. Placing a large window at the centre of the first level states the symmetry of the facade, and expresses that the internal layout is potential a single large apartment or two differently sized apartment, the larger located to the south where the better view and light will make it more valuable. The offset also conforms to the structural reality of the building, which is that a concrete table standing on columns located behind the existing walls makes a clean structural break between the floors, the wall becoming a screen rather than a structural element.

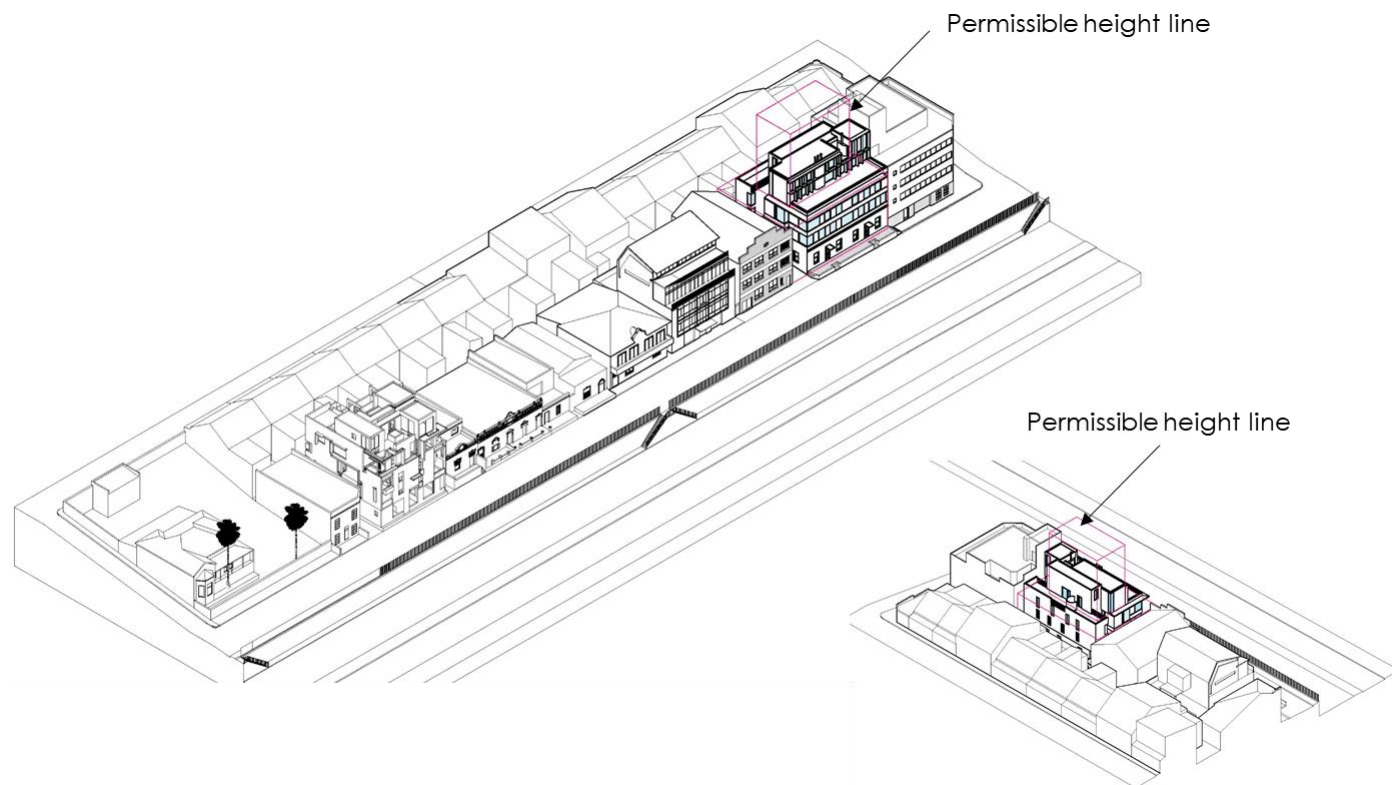
Figure 41: Isometric contextual illustrations
 MU2 zoning envelope shown in Magenta dotted line
 Source: KFA

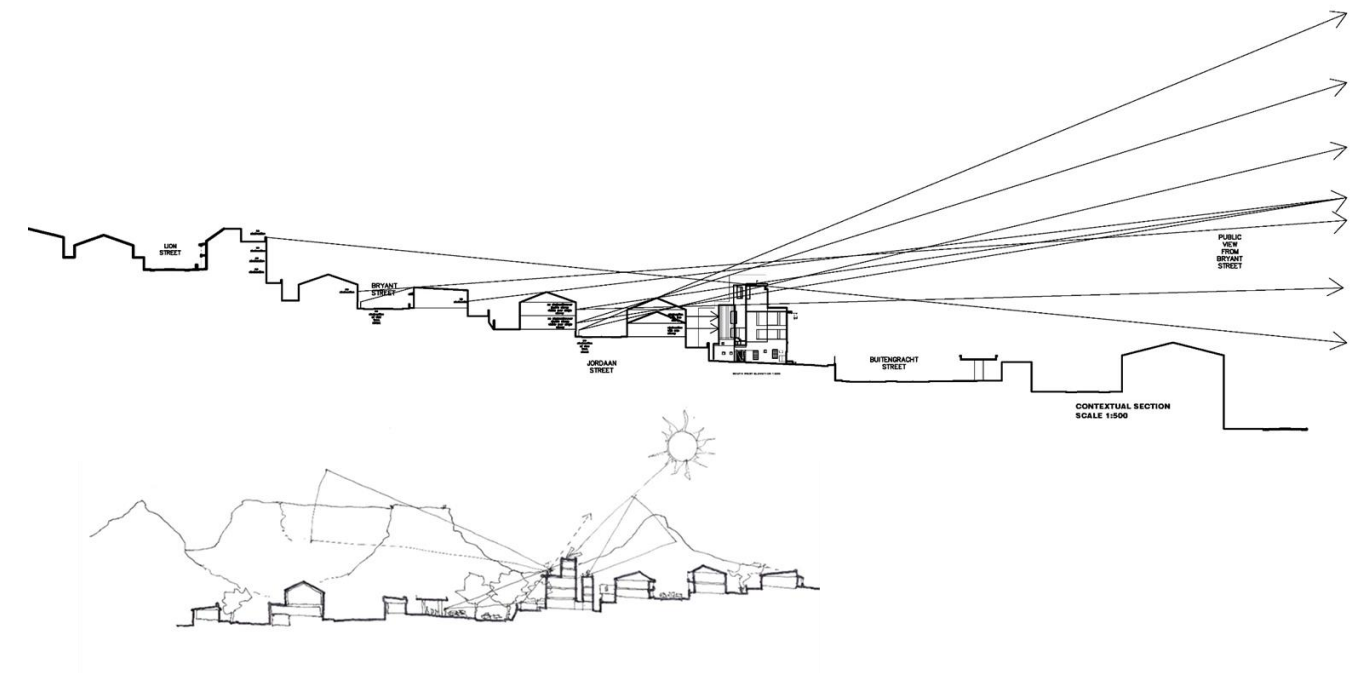
Figure 44: Model diagrams illustrating view lines
Source – KFA

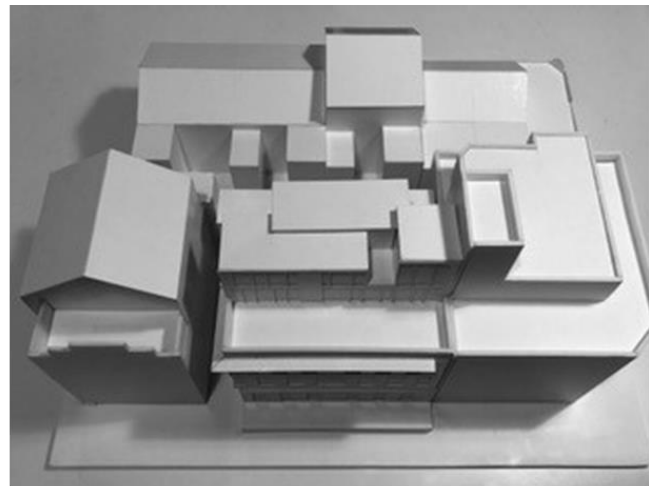
KFA DEVELOPMENT PROPOSAL
 FAÇADE TO BUILDING LINE, STAGGERED SETBACK TO THE REAR,
 A CORNICE WITH OPEN SIDE SPACE WHICH ALL WHITTLE THE
 FLOOR AREA DOWN BY A THIRD
