HERITAGE REPORT

VERSLUIS-OLIVER RESIDENCE
ERF 457
NO. 1 ROSEBANK PLACE
VILLA CATHARINA
ORANJEZICHT
CAPE TOWN

ARCHITECT (B Arch) & PROFESSIONAL HERITAGE PRACTITIONER (M Phil CBE)
20 ALEXANDRA AVE, ORANJEZICHT, CAPE TOWN, 8001, SOUTH AFRICA
Email: ursula@ursularigby.co.za Mobile: +27 82 415 0990
DRAFT I – 28 June 2022

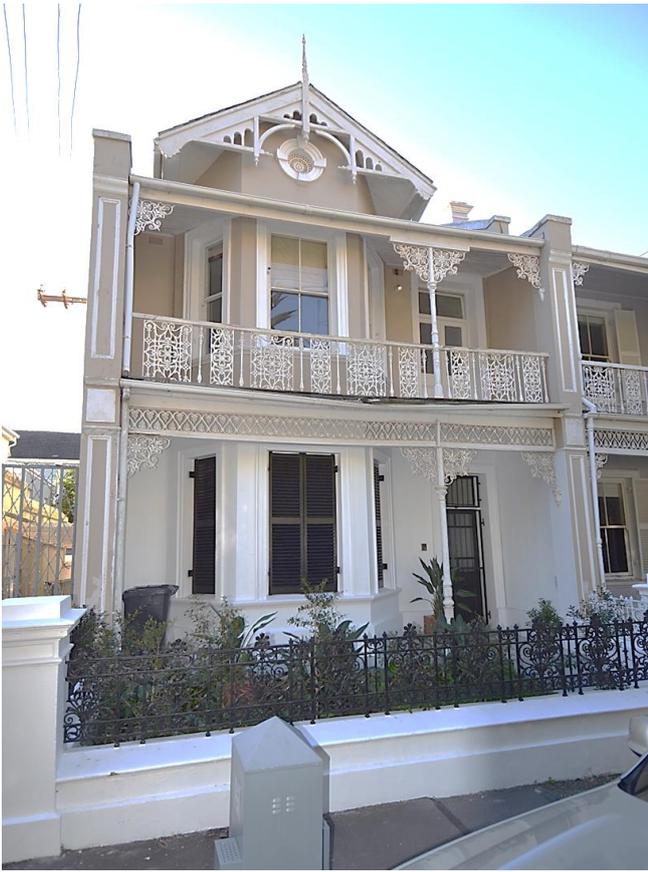
Figure 1: Existing building – looking east on Rosebank Place. June 2022
Source: URA+HP image

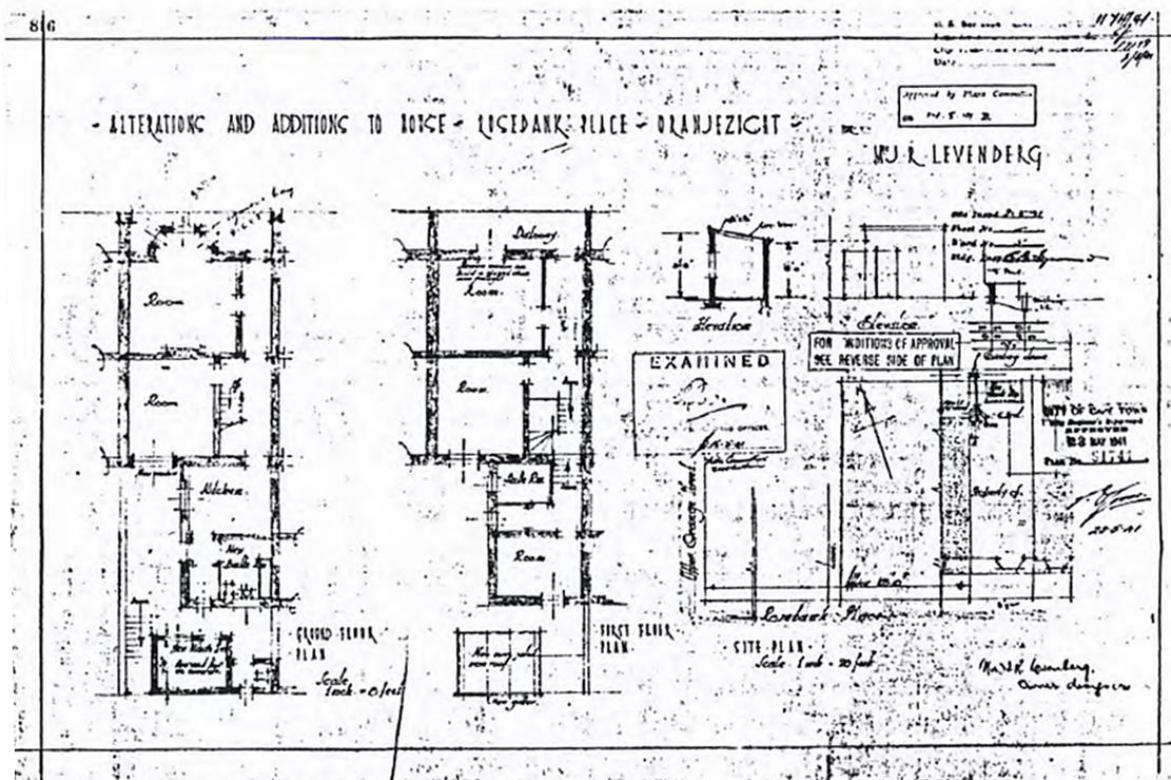
Figure 24: Plan for 1941 alterations to Erf 459 – 5 Rosebank Place.

Figure 10: Plan for the villa on Erf 459 - a mirror image of 1 Rosebank Place (Erf 457)

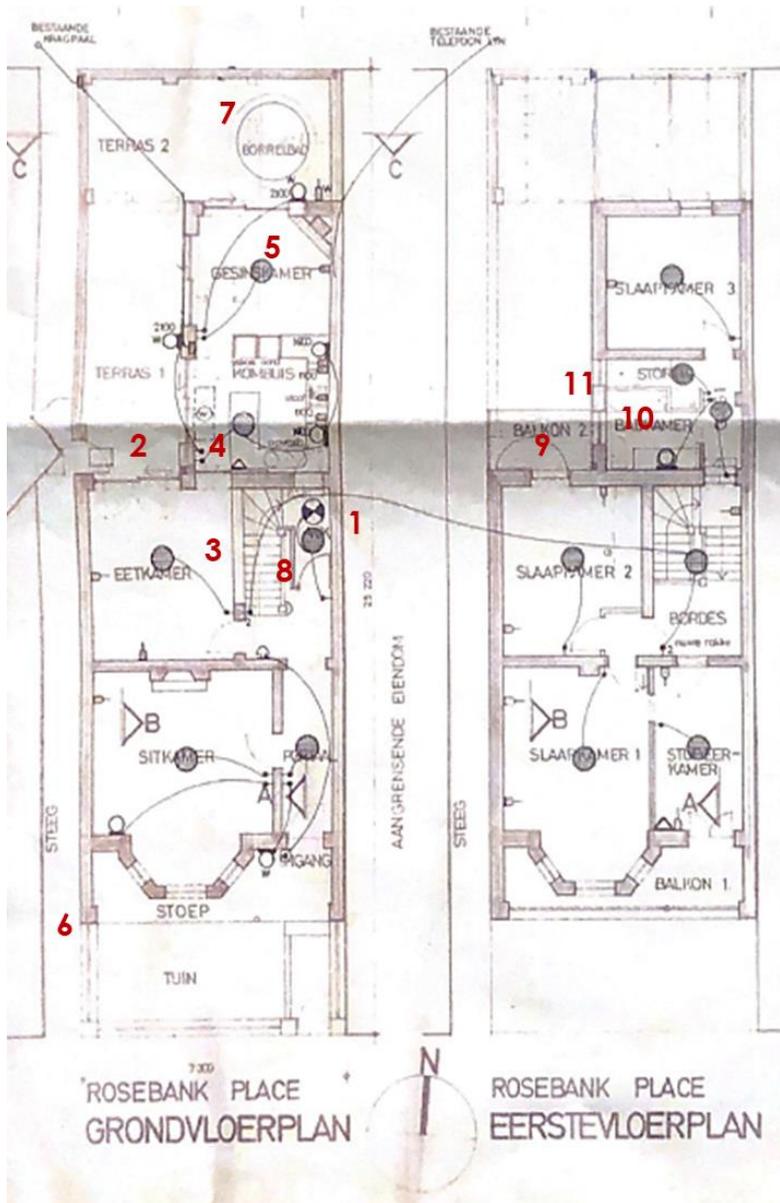
Figure 12: Changes to the built form – GF and FF plan circa 1973
 Source: URA+HP

1. WC added under the stair
2. Glass sliding door was added in the dining room, leading to the patio;
3. Wall between the stairs and dining room opened up to let in more light;
4. Door way to the kitchen opened up and the kitchen rearranged;
5. Ex downstairs bedroom and pantry were consolidated to form a less formal sitting room with a fireplace and sliding doors were added for light and access to the outside
6. The sanitary lane was closed off;
7. There was a toilet in the backyard (for staff);
8. Small skylight above the landing was replaced with a larger one;
9. Guest bedroom window replaced with a glass door - intention was to add a balcony;
10. WC and bathroom spaces were altered – a new WC was added to the bathroom and the separate room that housed the WC was converted to a shower;
11. Louvre windows were installed

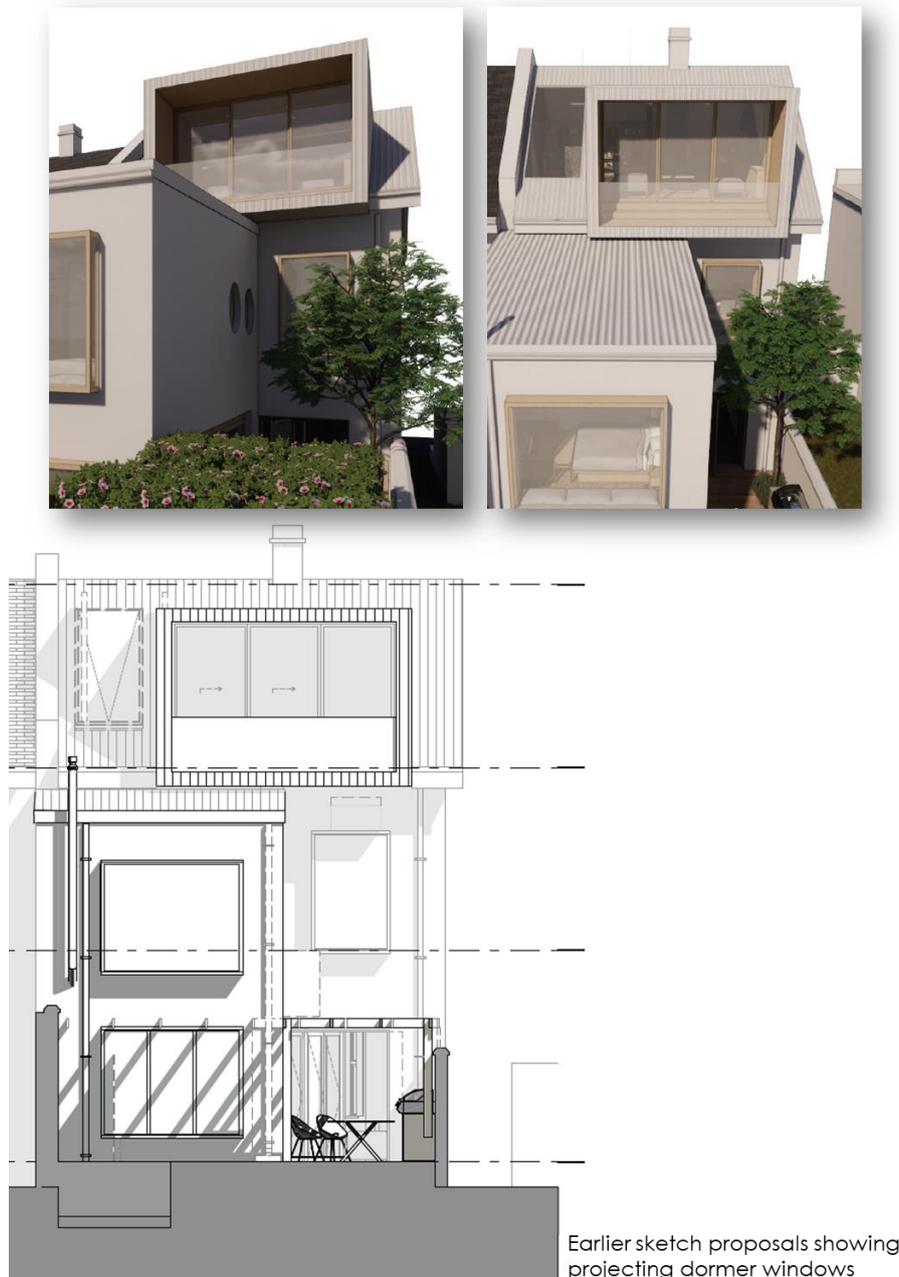
Figure 14: Early dormer window explorations
Source: Swansilva Architecture

Early sketch options were explored for roof space access and utilisation - refer to Figure 14 below. These early proposals were discussed with the CoCT EHM officials who provided guidance and reference to the Heritage Advice Pamphlets. The comment obtained, at that time, stated that the roof addition would not be supported *“as it will detract from the significance of the typology, the historical significance of the grouping and the roofscape of the area. A smaller scaled addition i.e roof dormer that is stylistically in keeping with the period of the house could be the way forward.”*

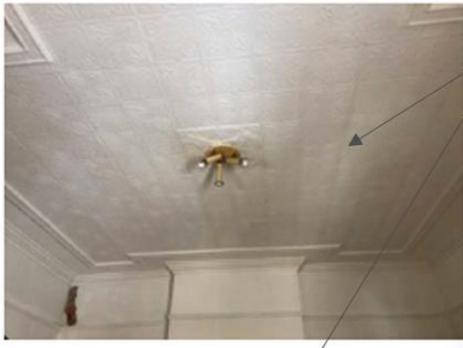
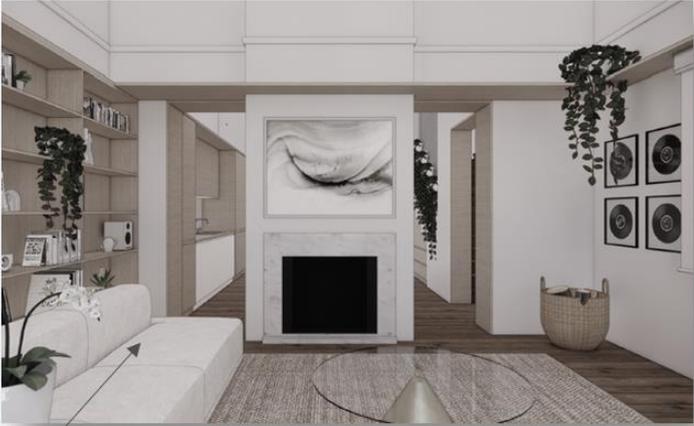
Figure 15: Proposed work: new wall opening living room – kitchen
 Source: Swansilva Architecture with URA+HP notes added

Ceiling, picture rails, cornice and fireplace to remain intact

Two 850mm wide openings with timber lining to reveals

- **New openings between living room and new kitchen (ex dining room)**
Refer to Figure 15
- **Convert existing dining room into a kitchen;**
Refer to Figure 16
- **Convert existing altered kitchen area into a dining room and retain existing associated lounge space;**
Refer to Figure 17

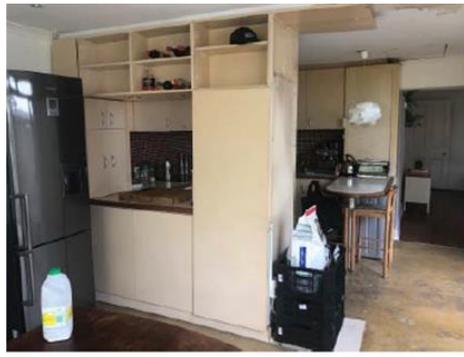
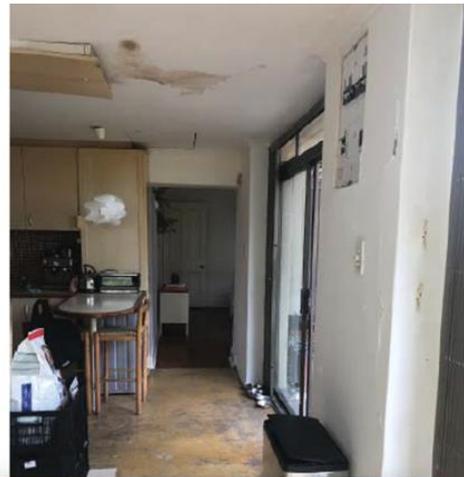
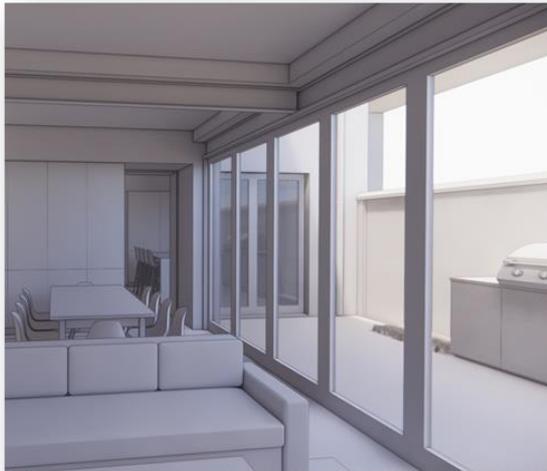
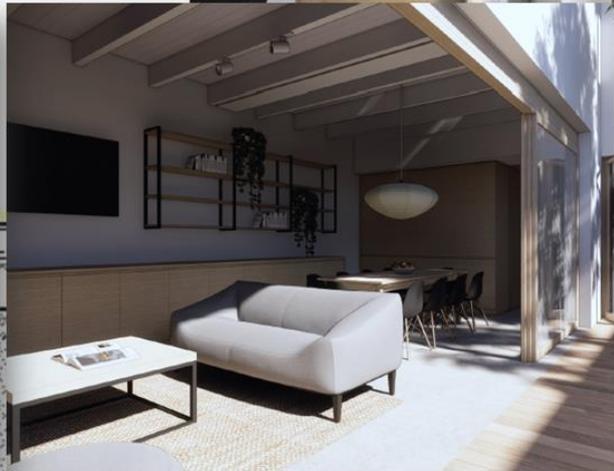
Figure 16: Proposed work: convert existing kitchen to dining room
Source: Swansilva Architecture with URA+HP notes added

Existing kitchen

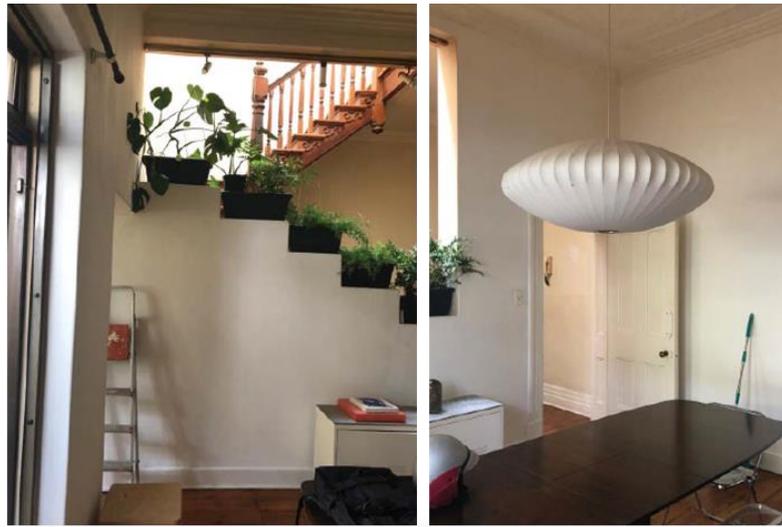
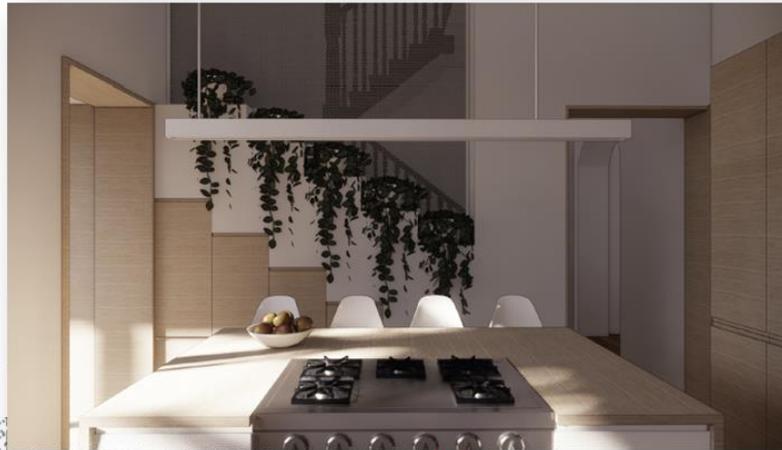
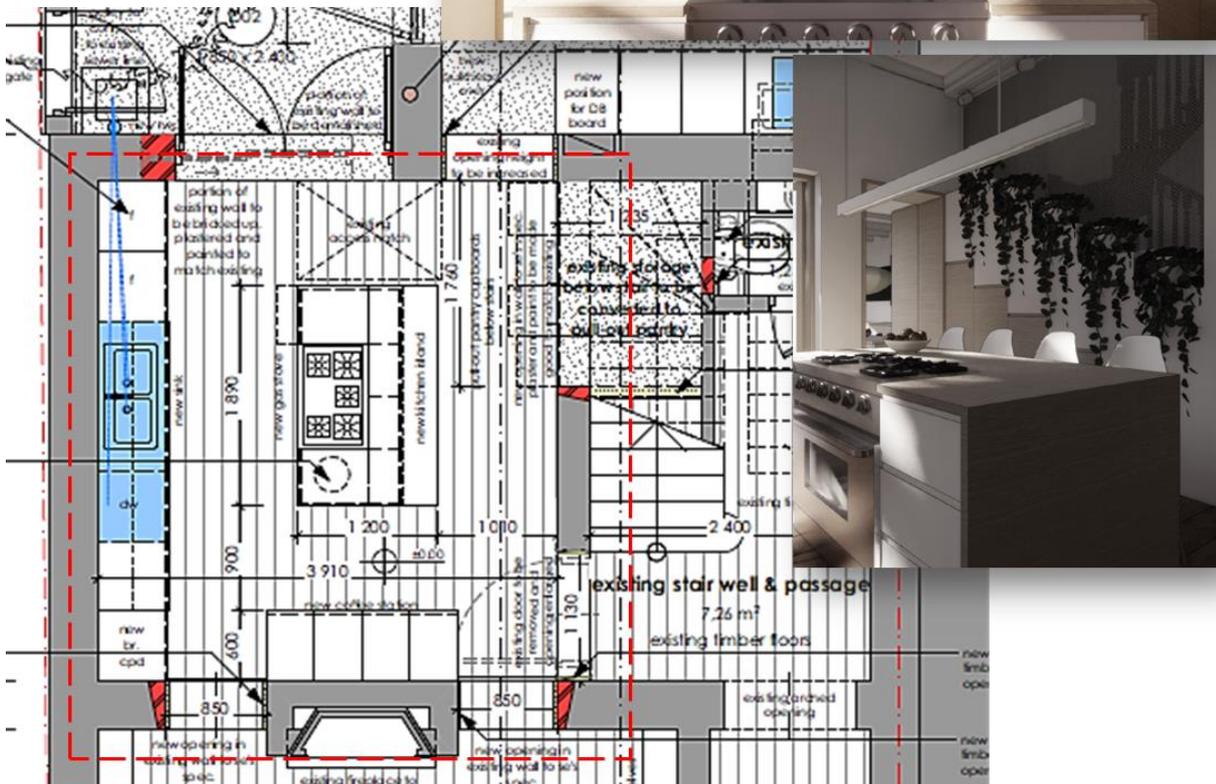
Figure 17: Proposed work: convert existing dining room to kitchen
Source: Swansilva Architecture with URA+HP notes added

Existing dining

New kitchen

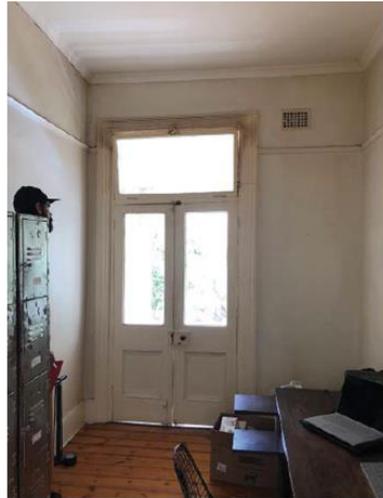
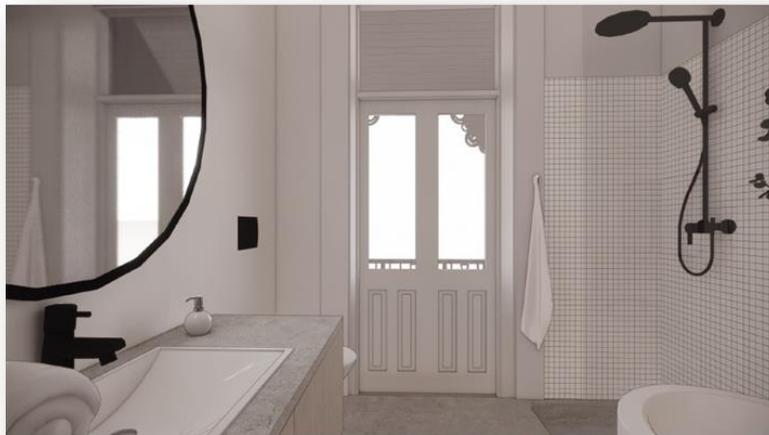
Existing study

New main bathroom

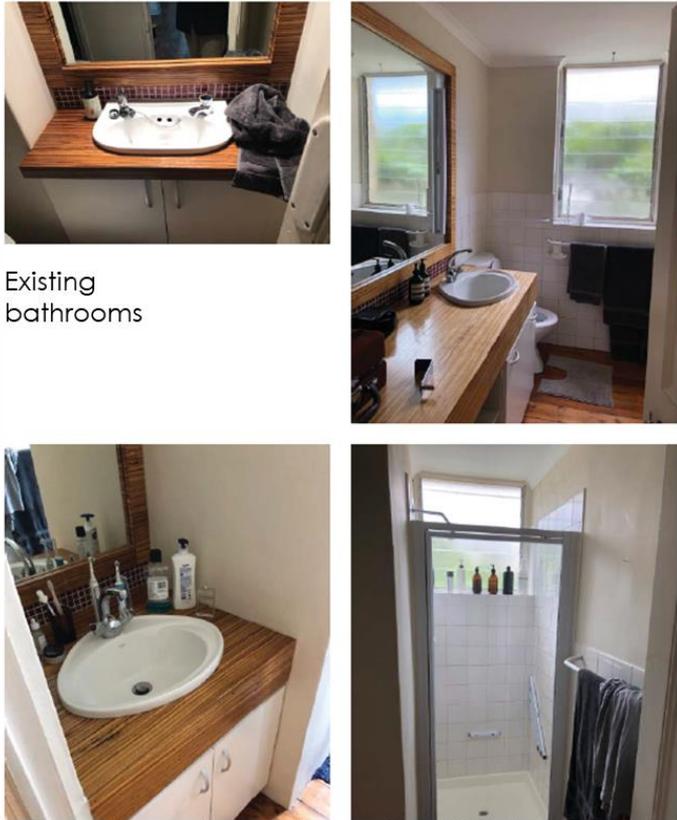
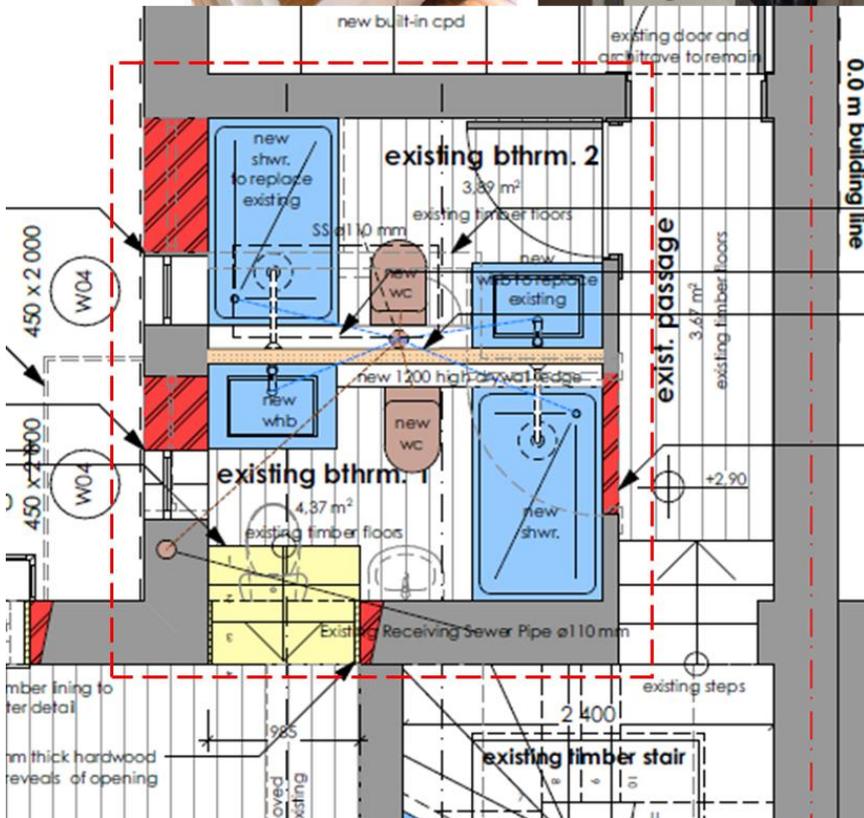
Figure 19: Proposed work: convert altered bathroom to two separate bathrooms
Source: Swansilva Architecture with URA+HP notes added

Existing
bathrooms

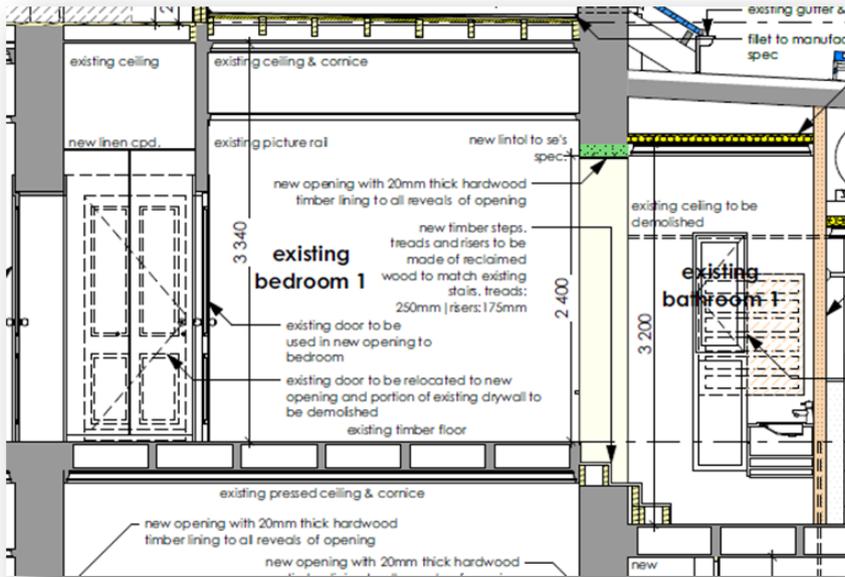
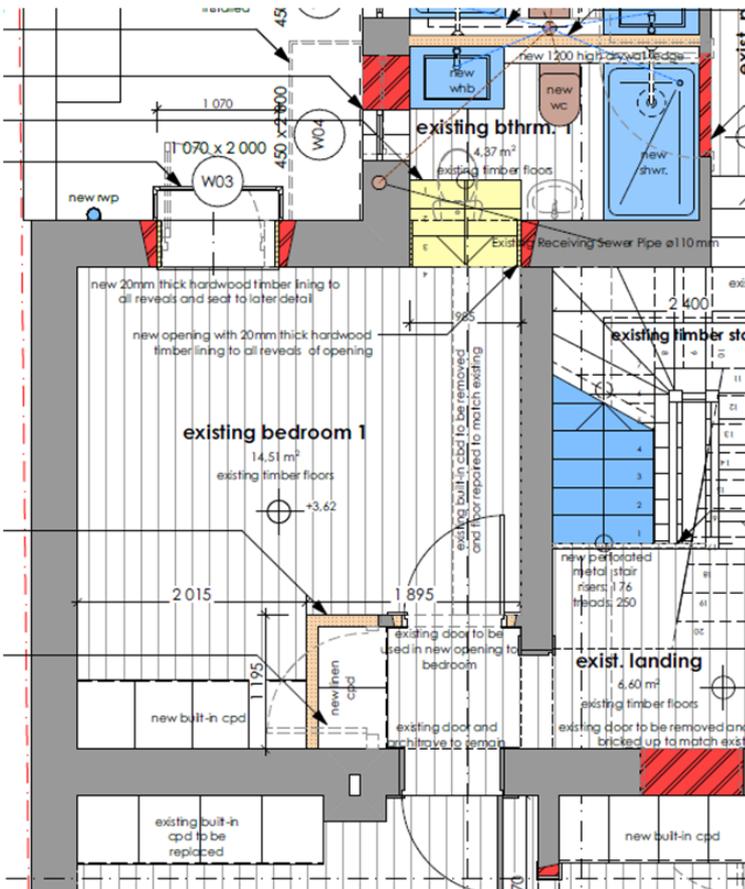
Figure 20: Proposed work: new opening from bedroom 1 to en-suite bathroom
Source: Swansilva Architecture with URA+HP notes added

New access from existing bedroom to bathroom

Exterior window changes

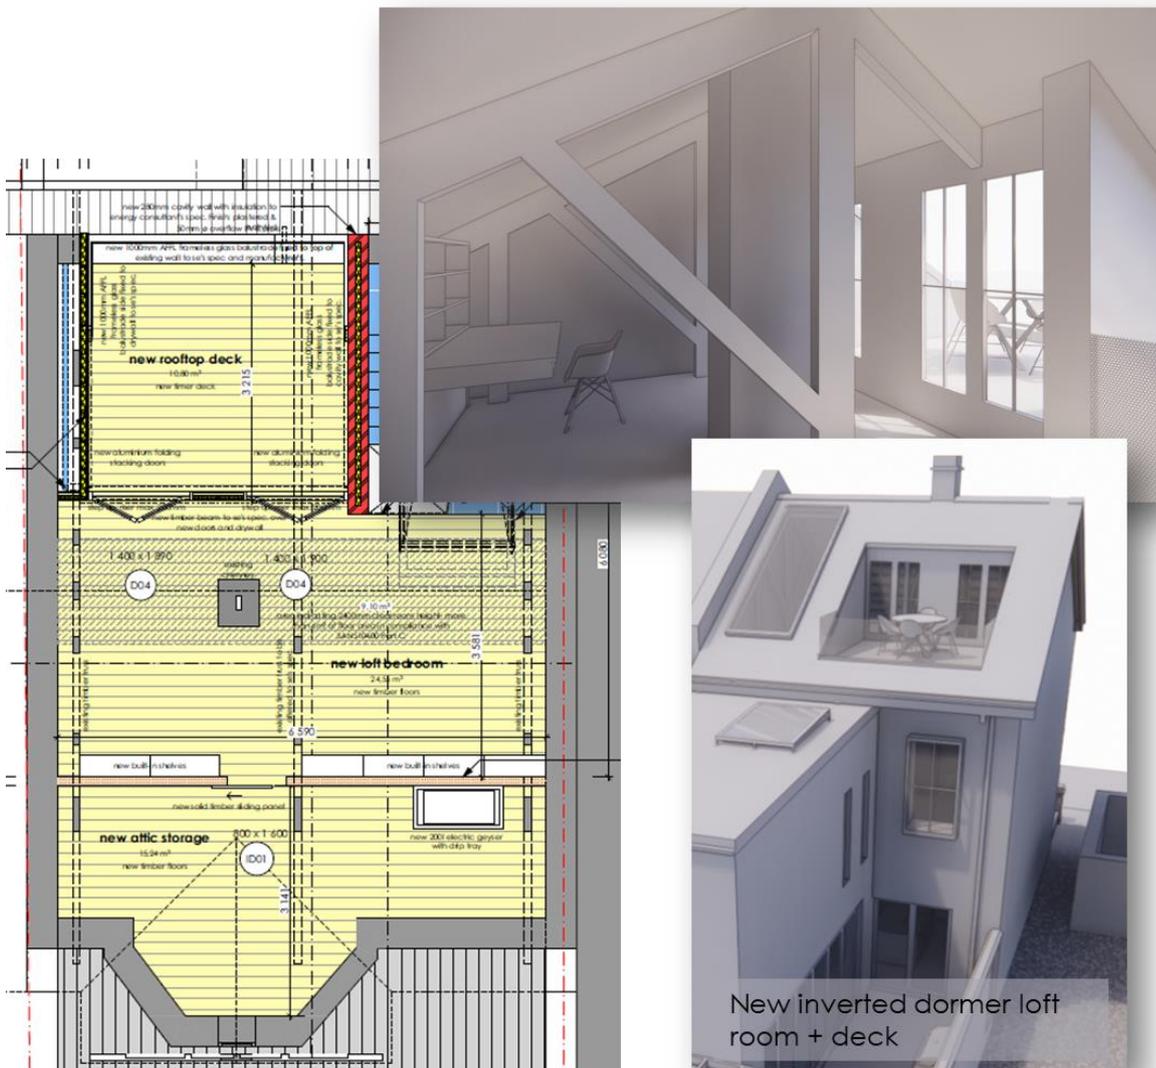
Figure 21: Proposed work: new loft bedroom space within the existing roof space
 Source: Swansilva Architecture with URA+HP notes added

Existing roof space

The overall character and shape of the existing roof is largely preserved internally and externally. Furthermore, the material choices are contemporary and complementary to the asbestos replacement roofing material which is a dark grey metal sheeting.

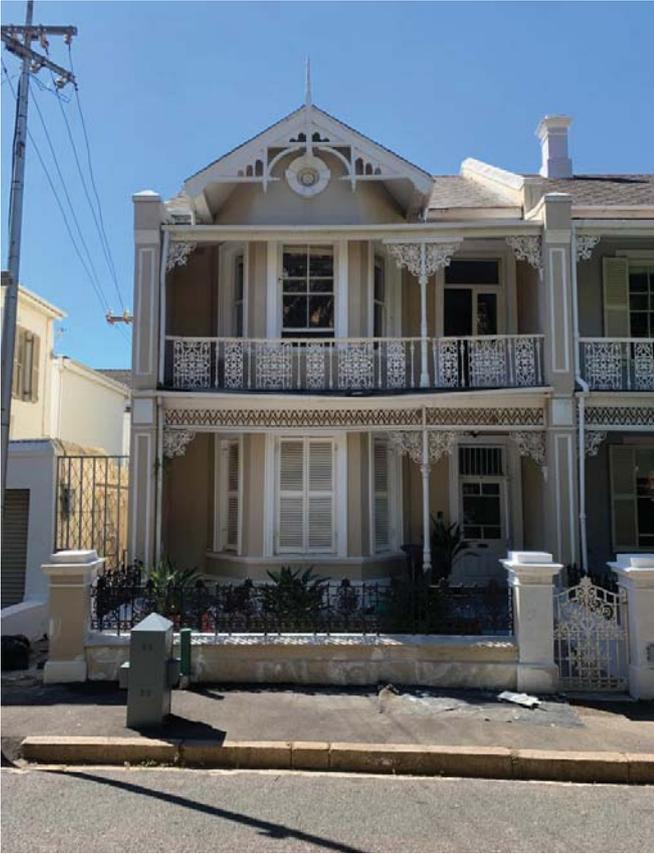
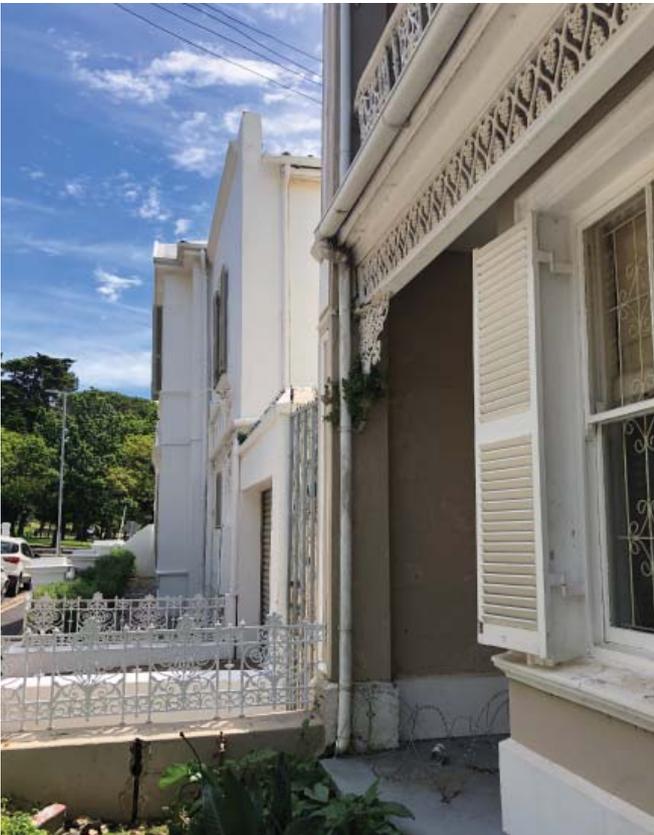
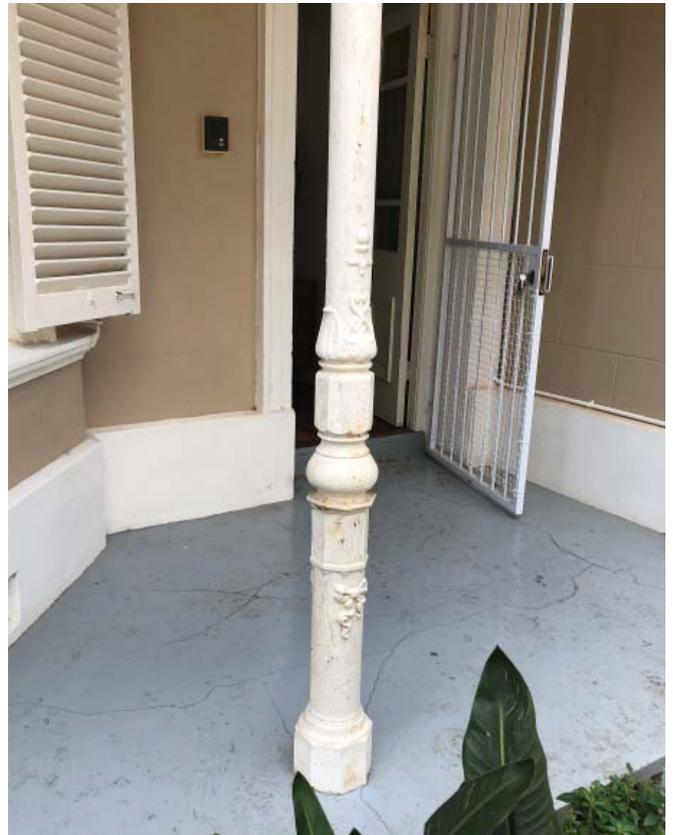
Exterior | Existing Elevation on Rosebank Place & Facade Details

Exterior | First Floor Balcony (currently deteriorating and unstable - refer to engineer's report)

An Emergency Permit application was submitted to HWC in April 2022 by Swansilva Architecture, to repair unsafe and structurally unsound balcony facing onto Rosebank Place and internal timber floorboards. This work is currently in progress.

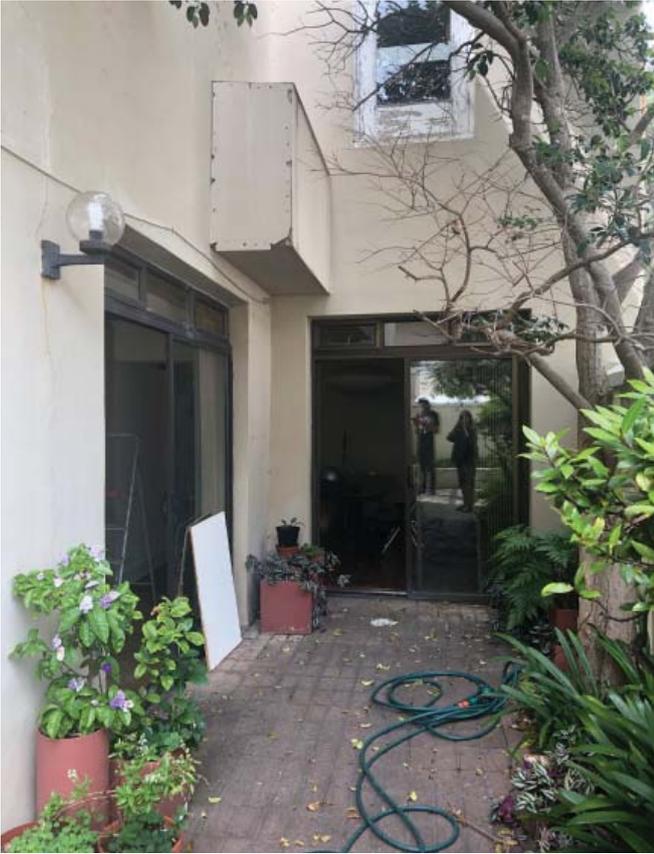
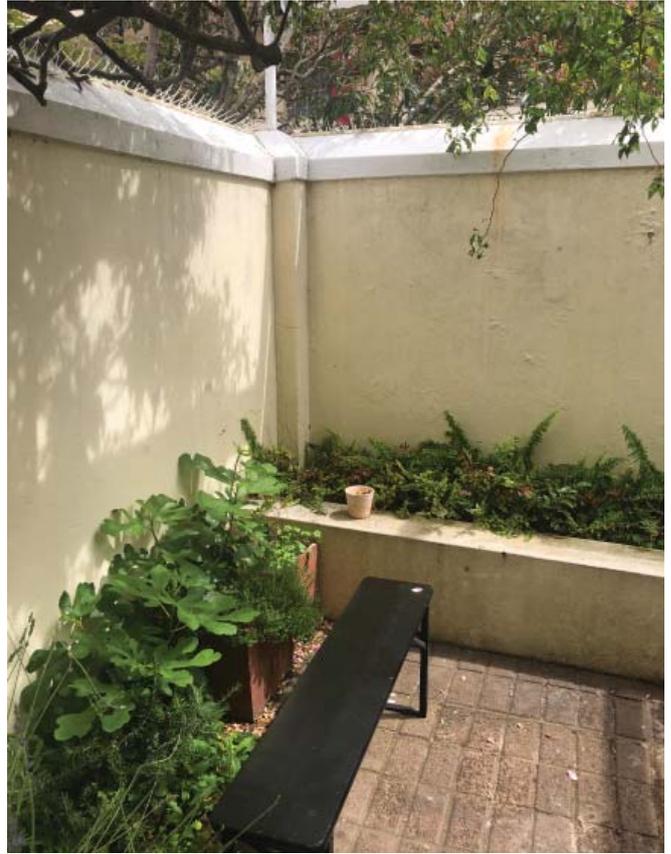
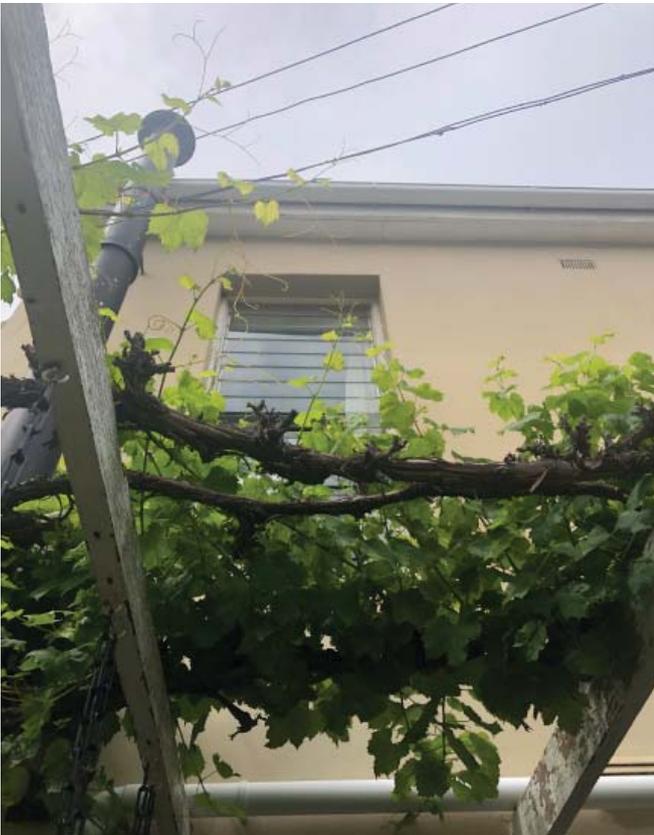
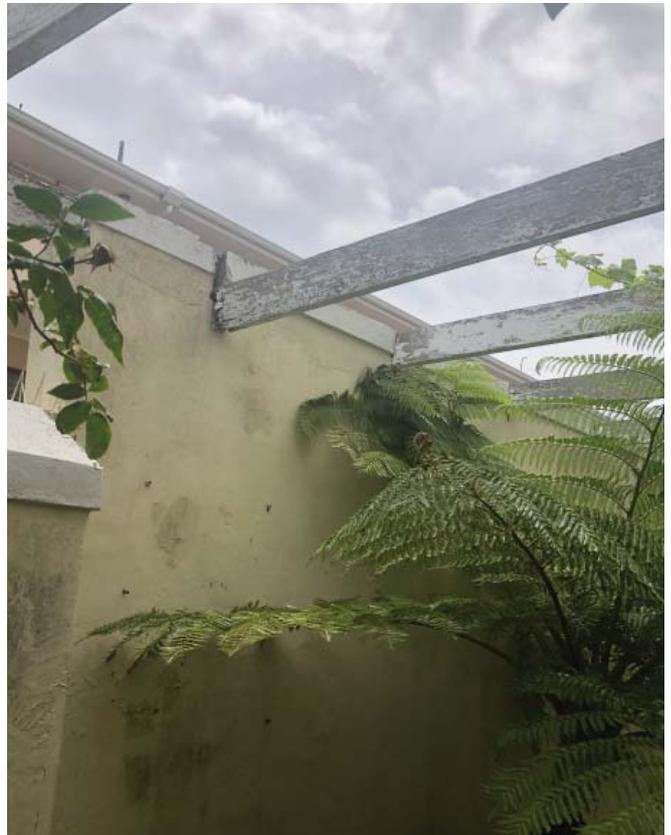
Exterior | North & Western Garden, Aluminium Windows Installed by Previous Owner and Deteriorating Pergola

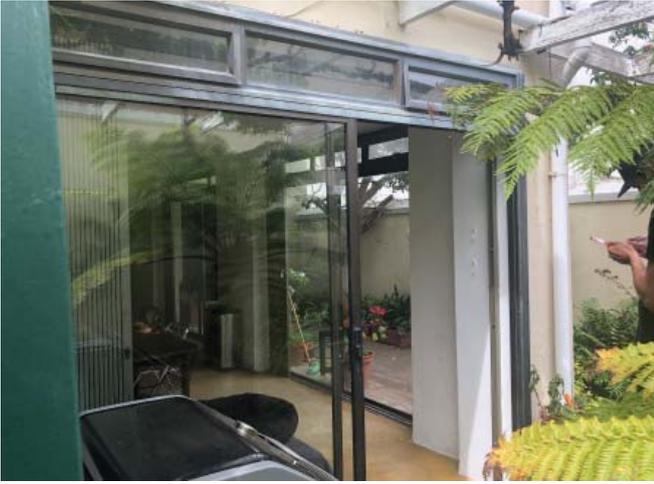
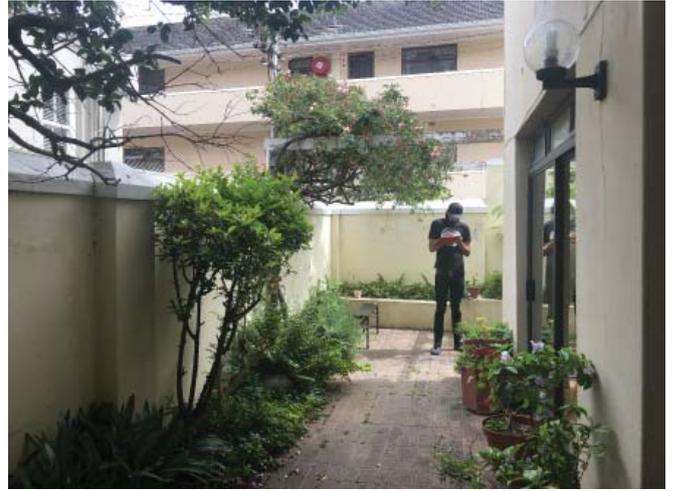
Exterior | North & Western Garden, Aluminium Windows Installed by Previous Owner and Maintenance Required to External Walls

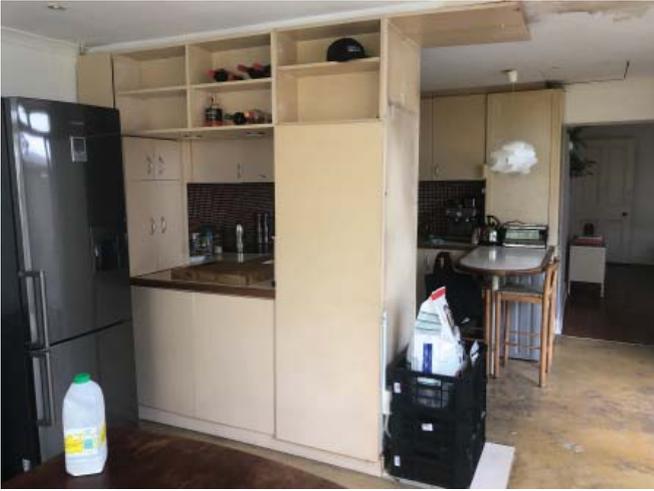
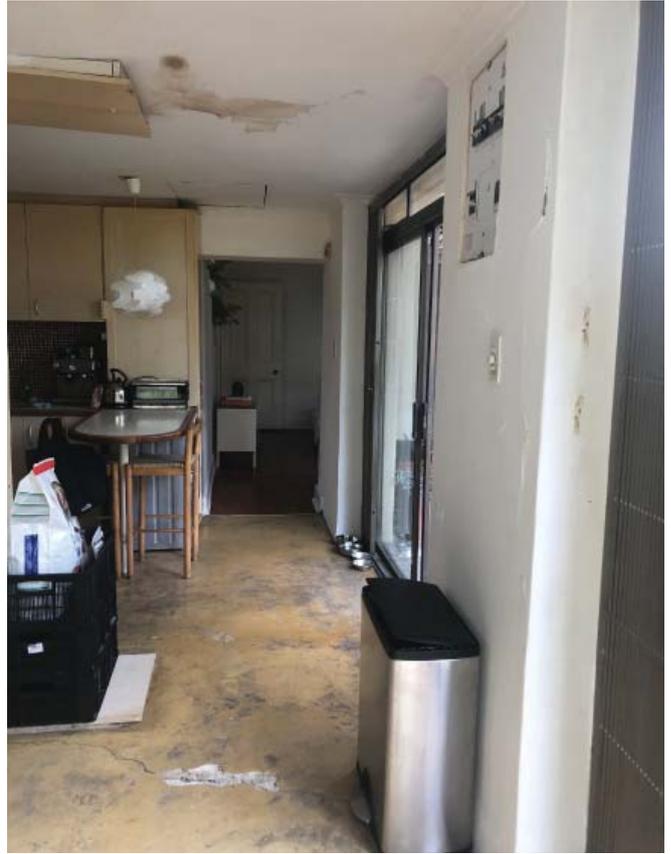
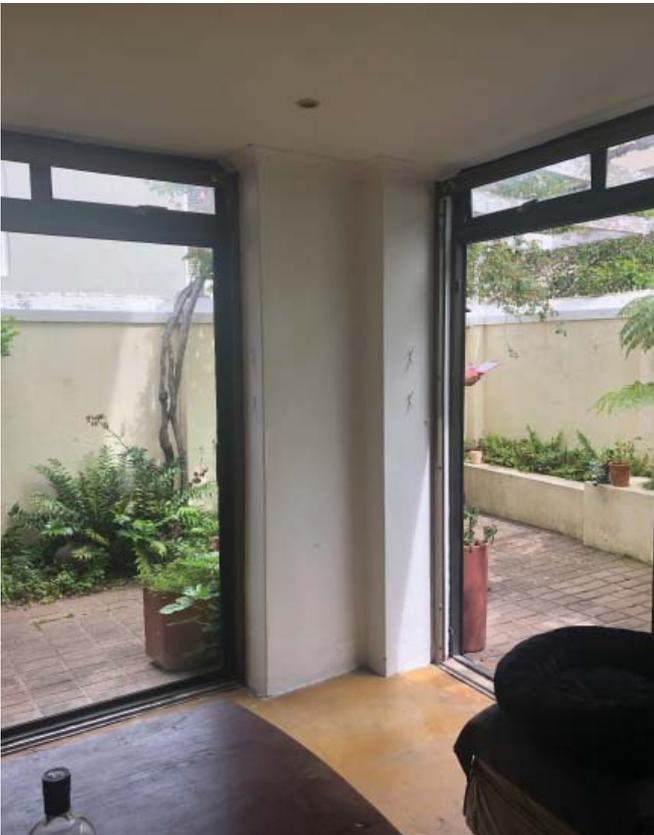
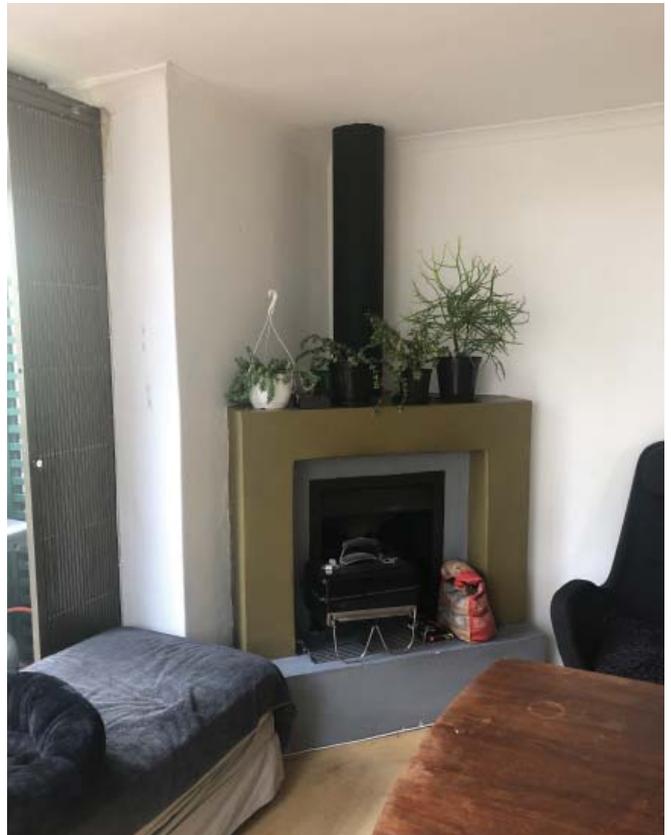
This home has been altered to the rear where a new kitchen and lounge space were created from an ex bedroom and pantry. There are currently two bathrooms on the first storey. The windows, doors and fittings which were used when these spaces were altered are not of a high quality. They have deteriorated and are dated.

Interior | Existing dilapidated Kitchen (please note that a portion of the dilapidated joinery has been removed since picture was taken)

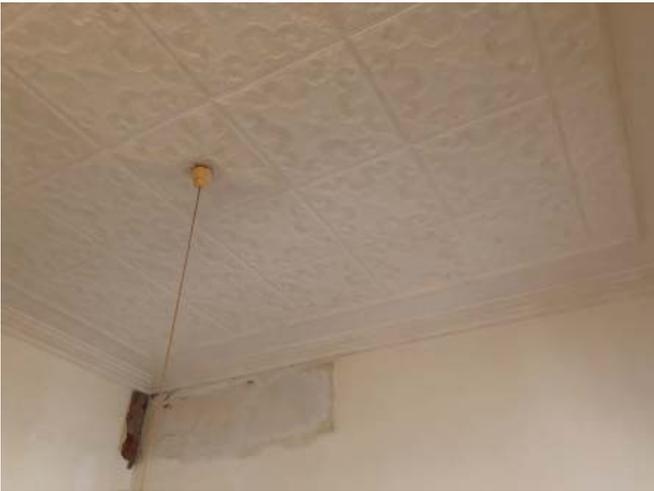
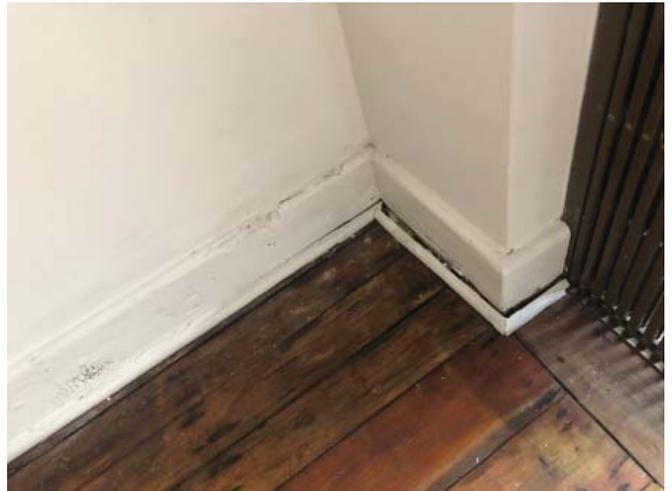
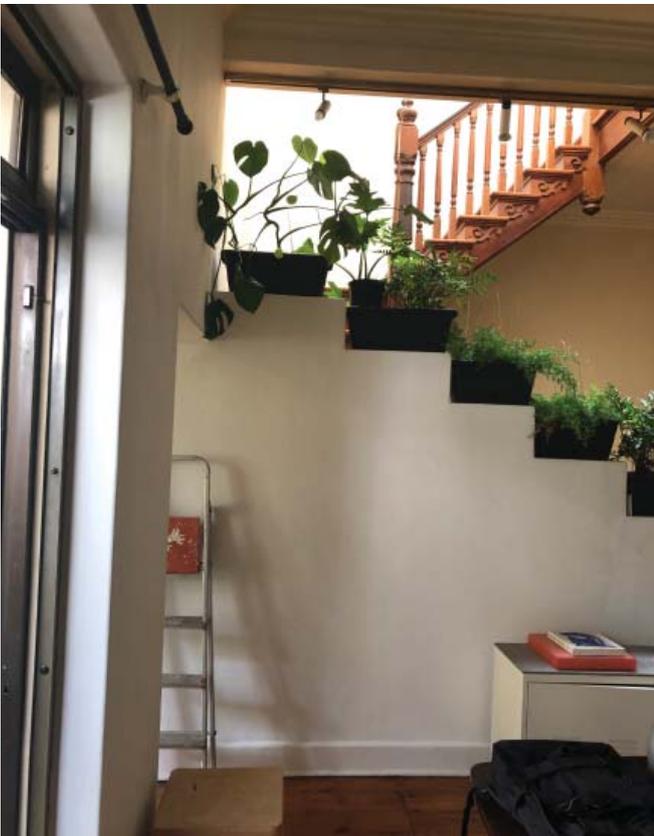
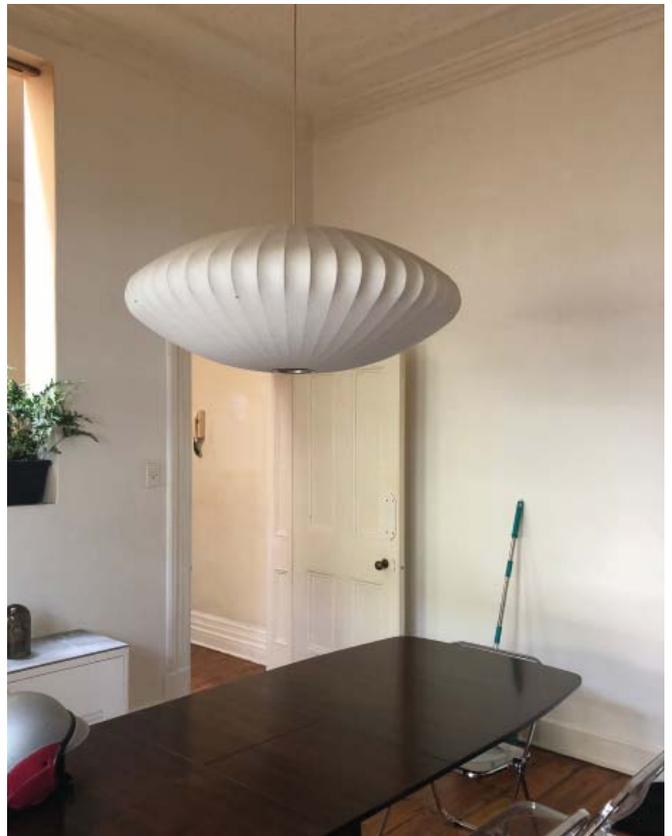
Interior | Existing Dining Room Pressed Ceiling, deteriorating floor boards and View Towards Central Stair

32	Retain suspended timber floors and match where repairs are required;

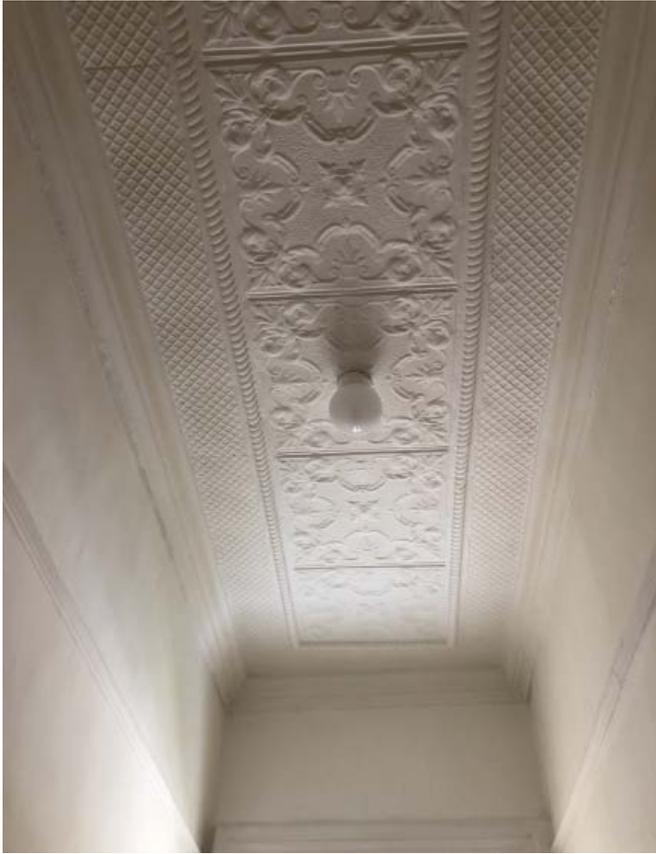
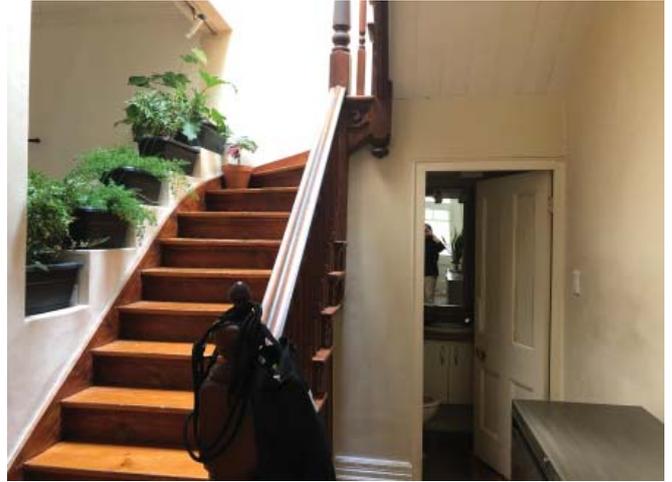
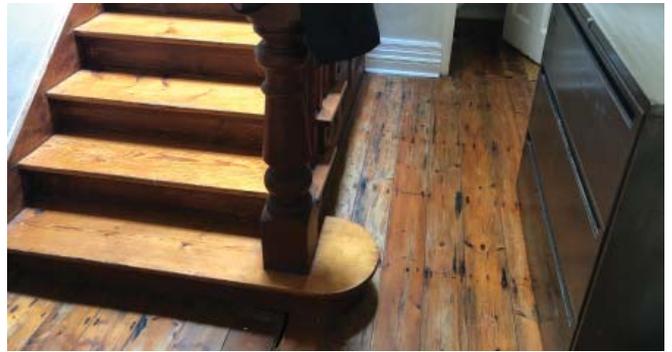
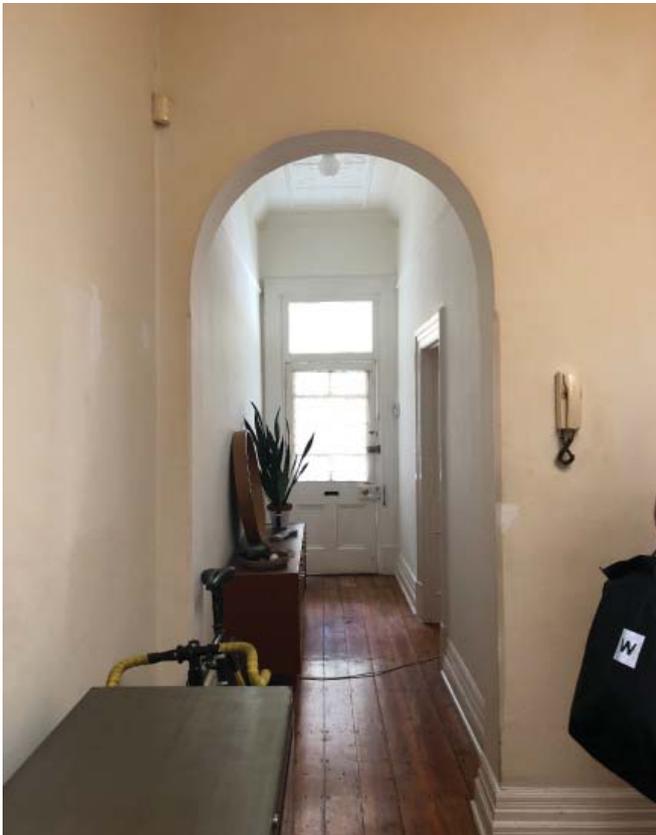
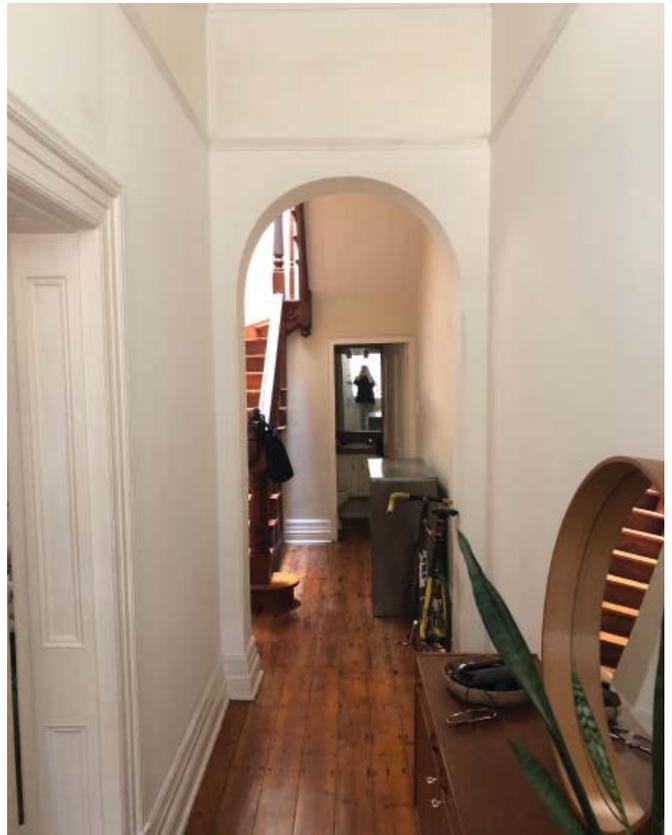
Interior | Existing Entrance Lobby Pressed Ceiling, Existing stair, Guest WC and View Down Entrance Lobby to and from Front Door
