HERITAGE REPORT

VERSLUIS-OLIVER RESIDENCE
ERF 457
NO. 1 ROSEBANK PLACE
VILLA CATHARINA
ORANJEZICHT
CAPE TOWN

ARCHITECT (B Arch) & PROFESSIONAL HERITAGE PRACTITIONER (M Phil CBE)
20 ALEXANDRA AVE, ORANJEZICHT, CAPE TOWN, 8001, SOUTH AFRICA
Email: ursula@ursularigby.co.za Mobile: +27 82 415 0990
DRAFT I – 28 June 2022

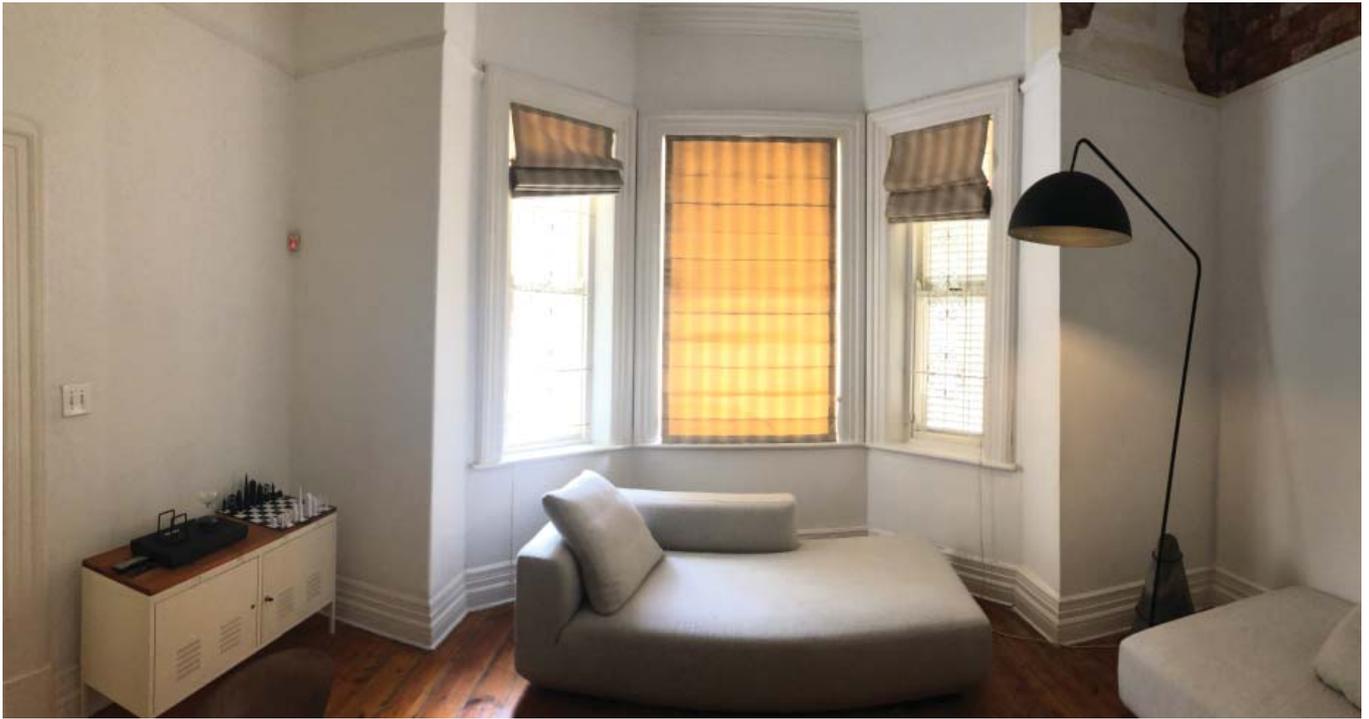
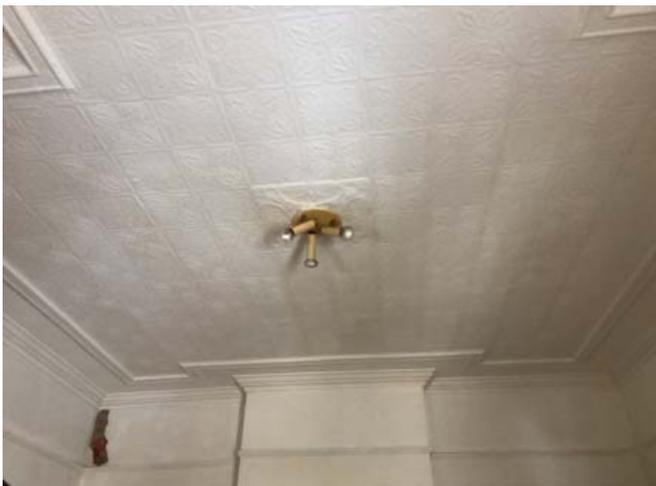
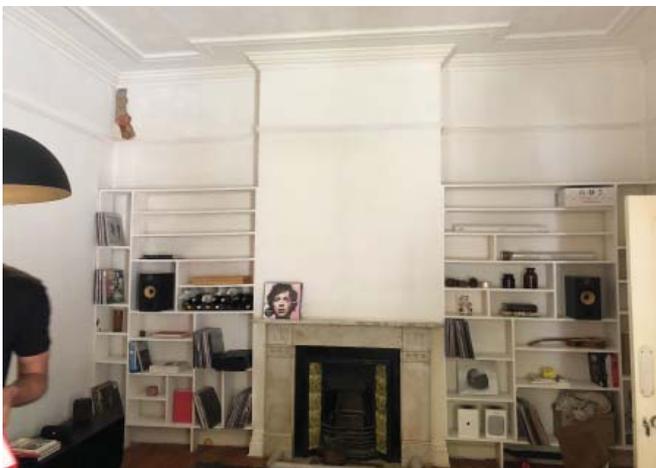
Interior | Existing Living Room (Bay window, pressed ceiling, fireplace and door from entrance lobby)

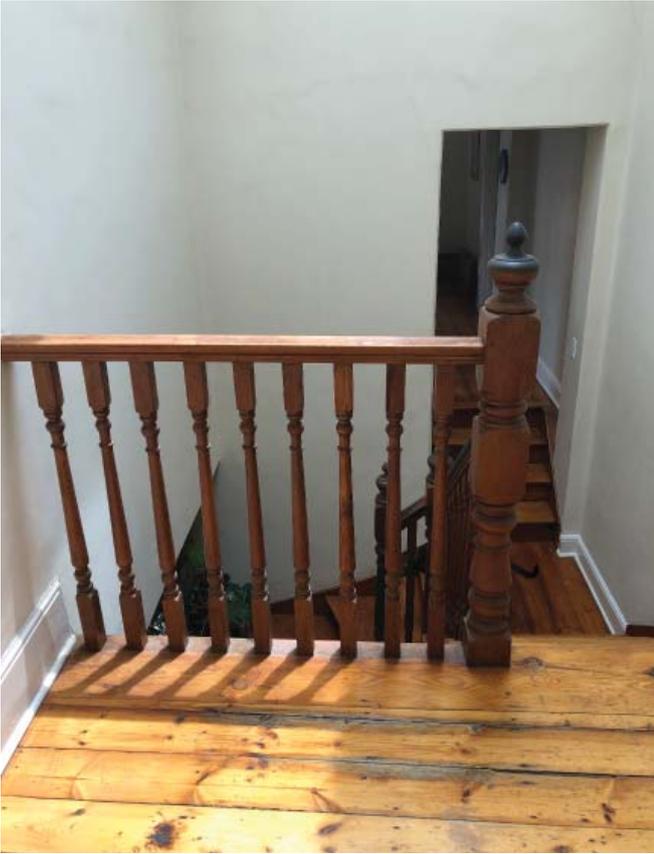
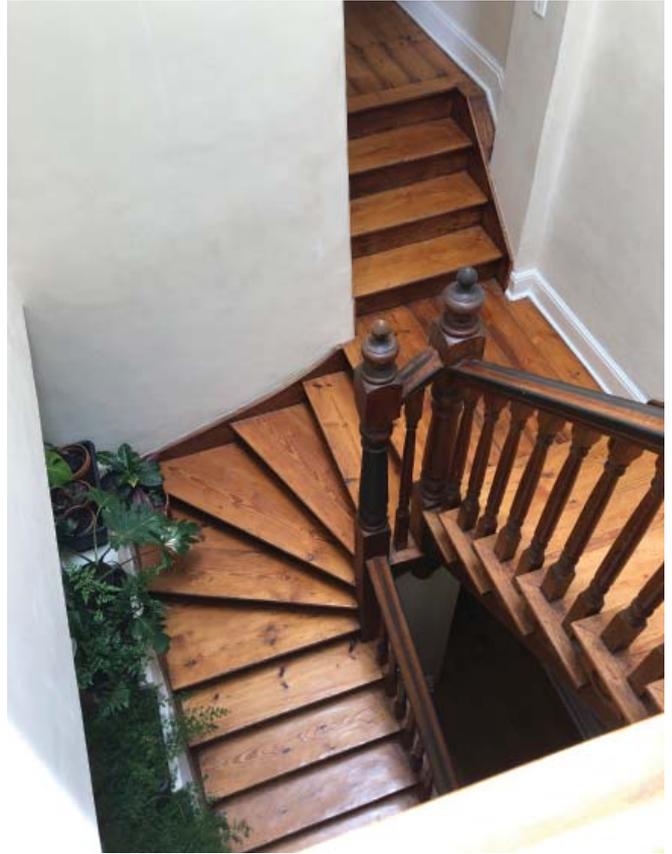
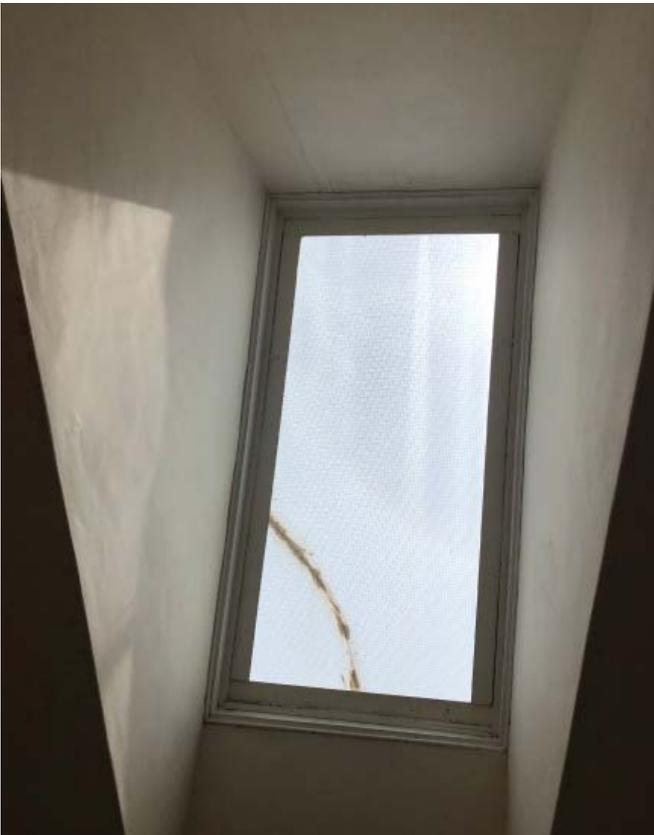
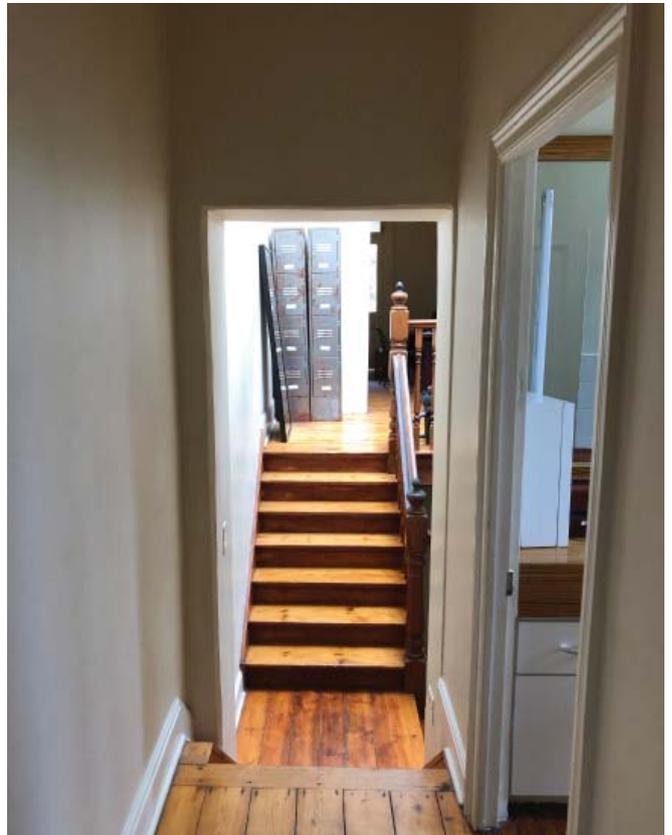
Interior | Existing Stair & Skylight (skylight requires replacement)

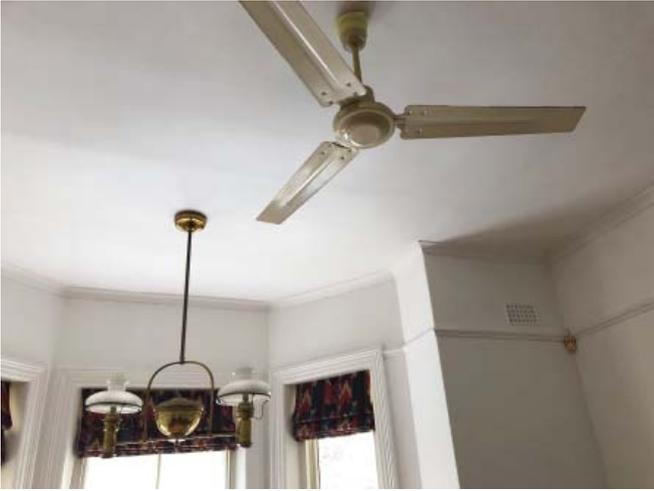
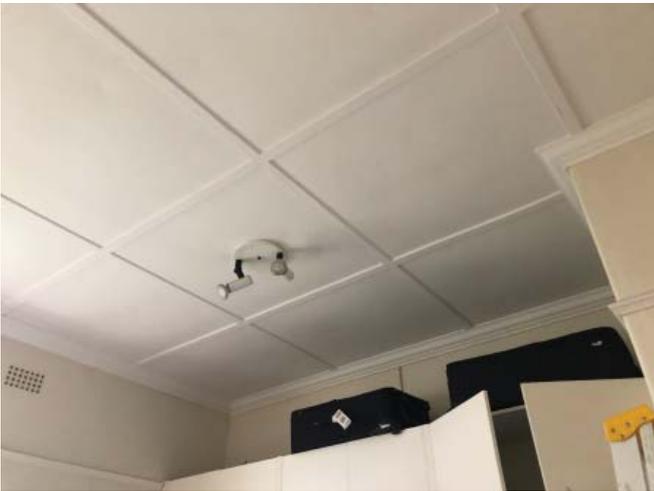
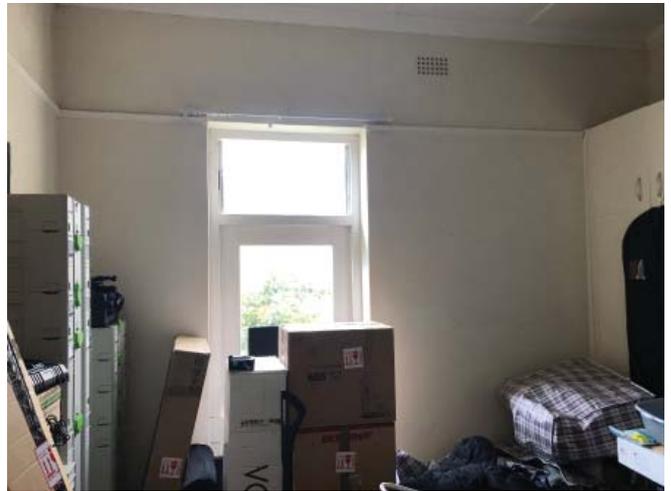
Interior | Main Bedroom Ceiling and Window with View to Balcony and Guest Bedroom below.

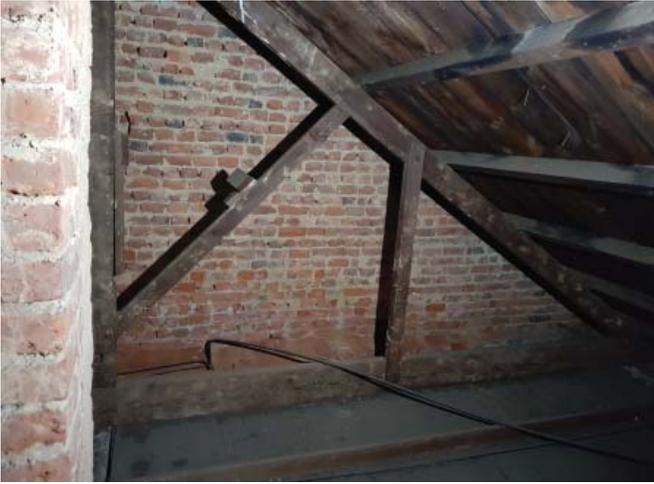
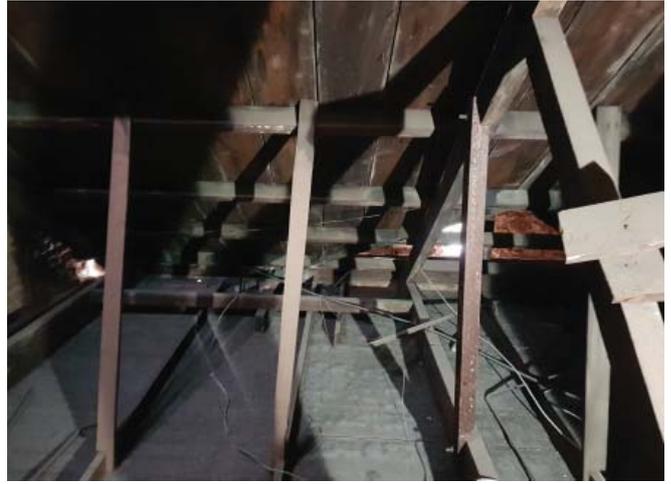
Interior | Existing Roof Space & Trusses
