REPORT ON THE PHASE II ARCHAEOLOGICAL  
INVESTIGATION

**VARSCHE DRIFT HOUSE  
MALTA PARK, OBSERVATORY**

**ERF 26162  
MUNICIPALITY OF CAPE TOWN**

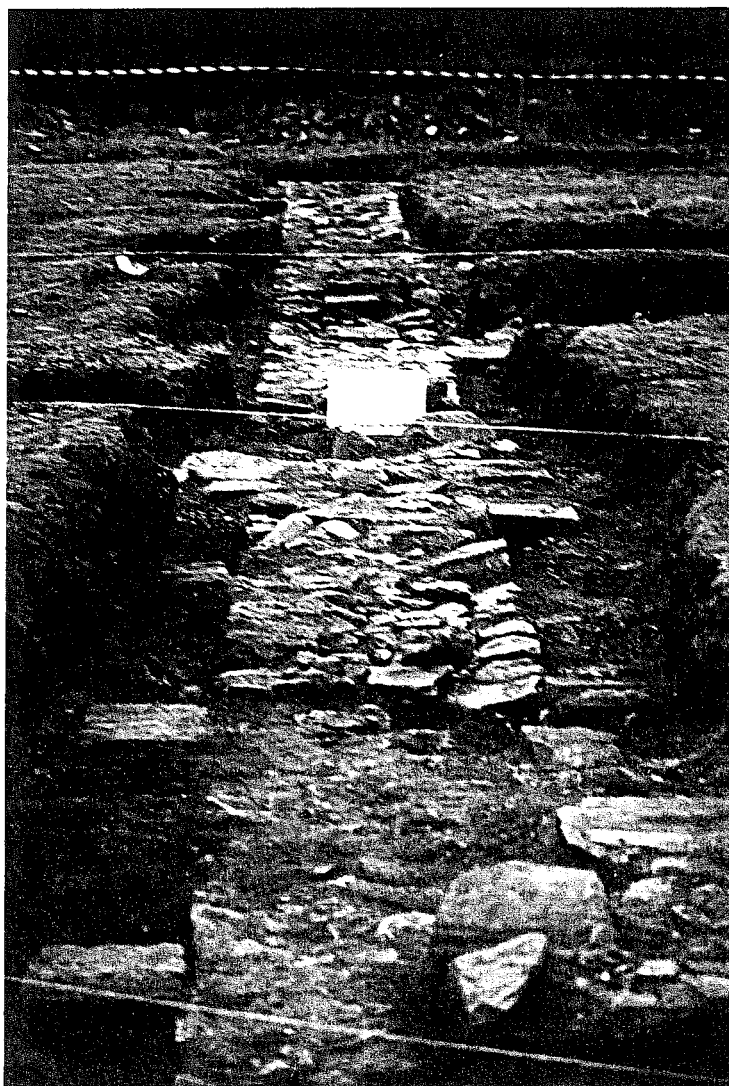
Fig. 2. The foundations for the earliest dwelling.

The wall foundations of the earliest dwelling were carefully constructed in one episode from semi-dressed stones, fragments of ferrocrete nodules found in the neighborhood on the slopes of the Table Mountain chain, placed in layers with narrow bands of flat shale fragments, yellow clay nodules, pebbles and a shelly mortar<sup>7</sup> (Fig. 2).

The consistency of the mortar is indicative of 18<sup>th</sup> century building material<sup>8</sup>. The interlocking foundations are between 630 mm and 670 mm wide, enough to support an outer brick wall of two bricks with a cavity in between<sup>9</sup>. The foundations were placed directly onto bedrock about 500 mm to 700 mm and are level. This and the amount of soft orange brick rubble and plaster with lime wash found all over the site supports the notion of brick- as opposed to dressed mountain stone outer wall superstructure. It appears that the foundations for the outbuildings along the long axis (called "tail" in T houses<sup>10</sup>) were built at a later stage as the workmanship is of an inferior standard and the foundations abutted the earlier walls in room nine.

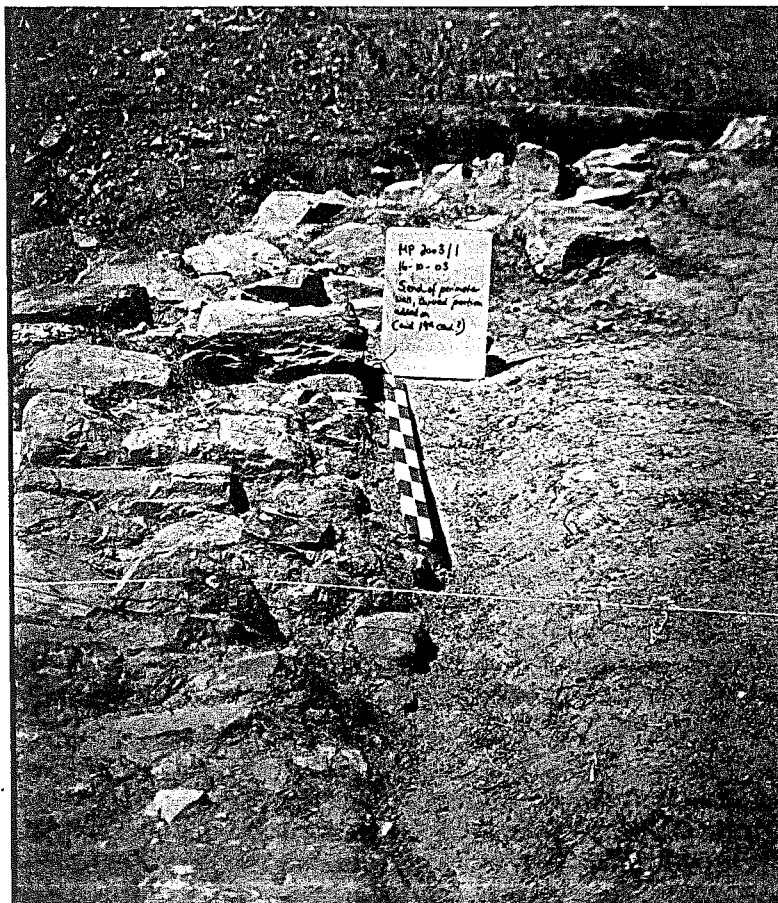
Fig. 5. The curved part of the east *stoep*.

Material evidence uncovered on the north side of the dwelling suggests that the house's earliest main entrance was placed here. The *stoep*, demarcated with a low perimeter wall, plastered on the outside contains undisturbed earth infill throughout. Building rubble did not cover the *stoep* area to any extent, but it was in this area that most of the yellow *klinkers* were found. These were hard-fired bricks imported from the Netherlands as ballast in ships and used where resistance to wear was needed, i.e. for steps, *stoep* edges, entrances and kitchen floors. The *stoep* also contains foundations for a *stoep* bench on each end, a *stoepkamer* at the western end and a central staircase of three steps leading down to the garden or passing road. The front door opened directly into the main living area of the house, the *voorkamer*. The *stoep* wall on the east side of the house is identical in construction. Four steps at the center of the east *stoep* (Fig. 4) led down to the *werft* area via a cemented walkway. The curved part of the east *stoep* was added hastily, probably in mid-nineteenth century, and incorporated into the uniform appearance of the house by plastering and painting the outside (Fig. 5).

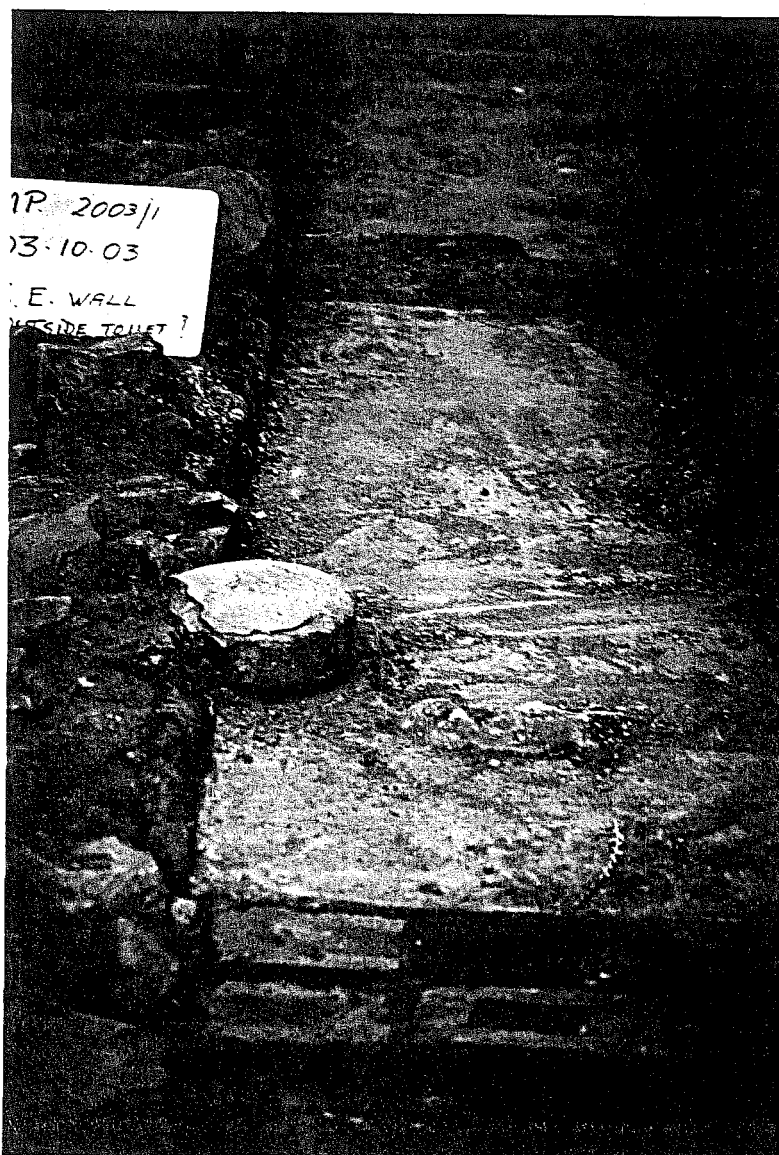
Fig. 6. The remains of the “modern” bathroom and flush toilet.

The "modern" bathroom and flush toilet near the southern end of the east *stoep* is typical for late 19<sup>th</sup> / early 20<sup>th</sup> century extensions to existing houses (Fig. 6). As we will see later it is depicted in one of the photographs of the house, dated to ca 1890.

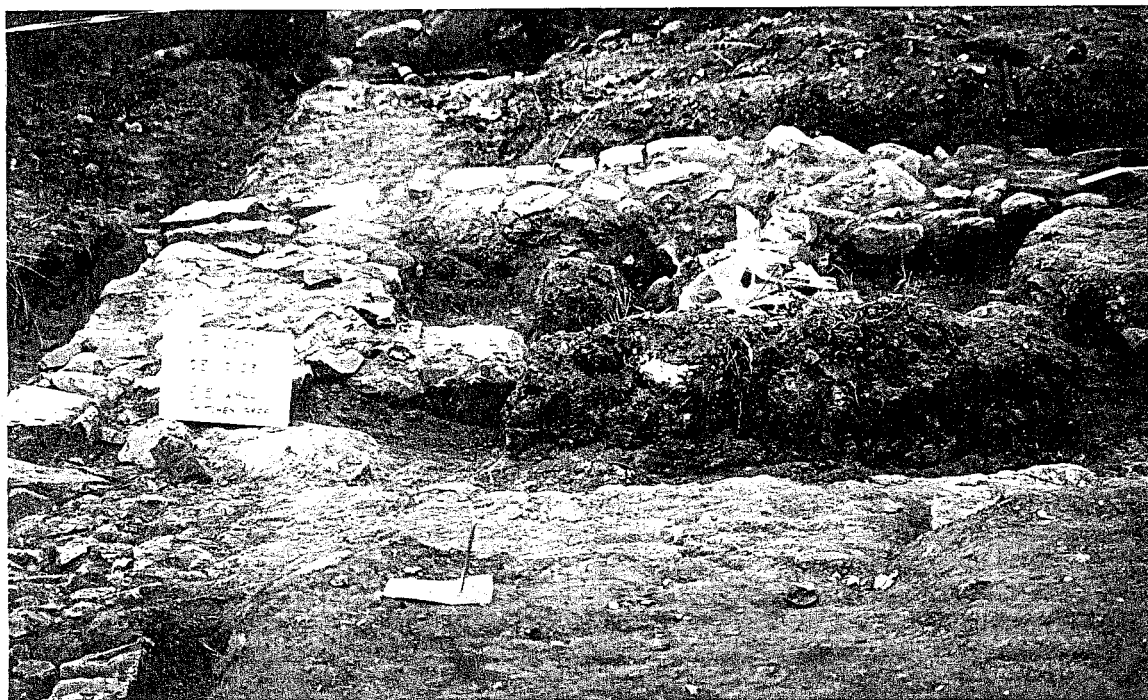
Fig. 11. Possibly the earlier kitchen, room nine in our plan.

It is possible that the *achterhuis* (rooms seven and eight) was divided by a wall with wall cupboards. An early kitchen hearth has not survived, but foundations in room nine suggest a hearth and baking oven area and/or a pantry<sup>12</sup> (Fig. 11).

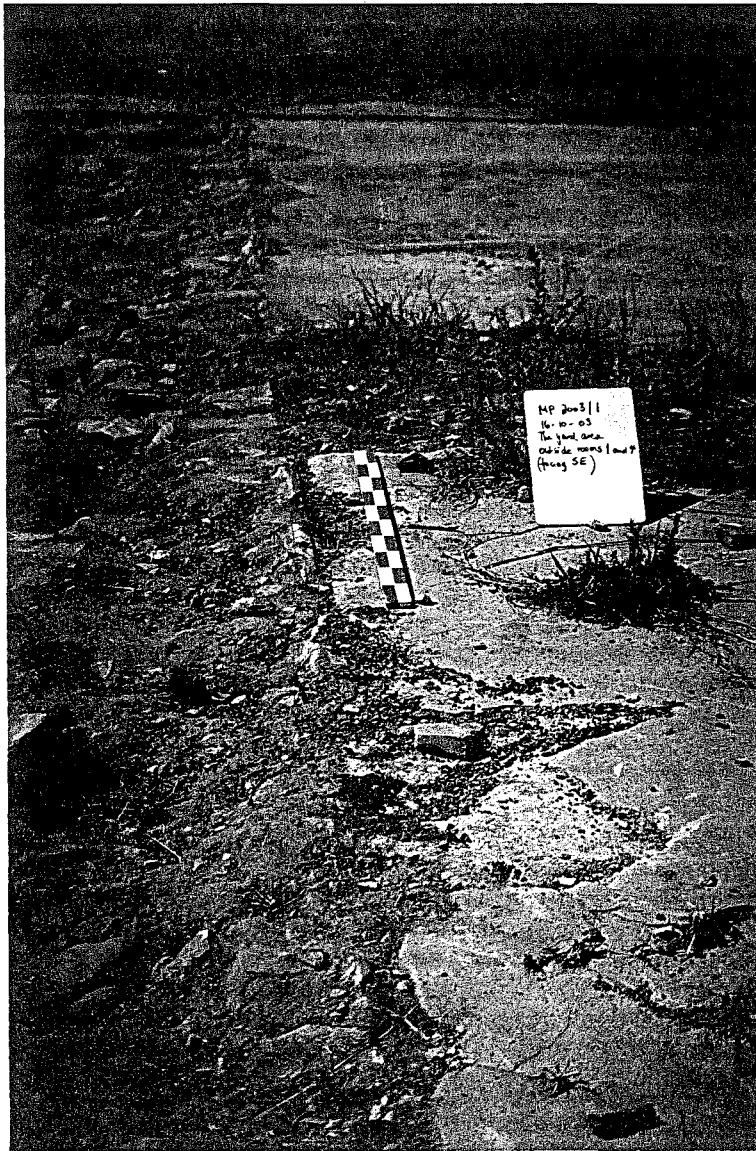
Fig. 14. Cement 'collar' around the outside of the dwelling, yard area, 2003.

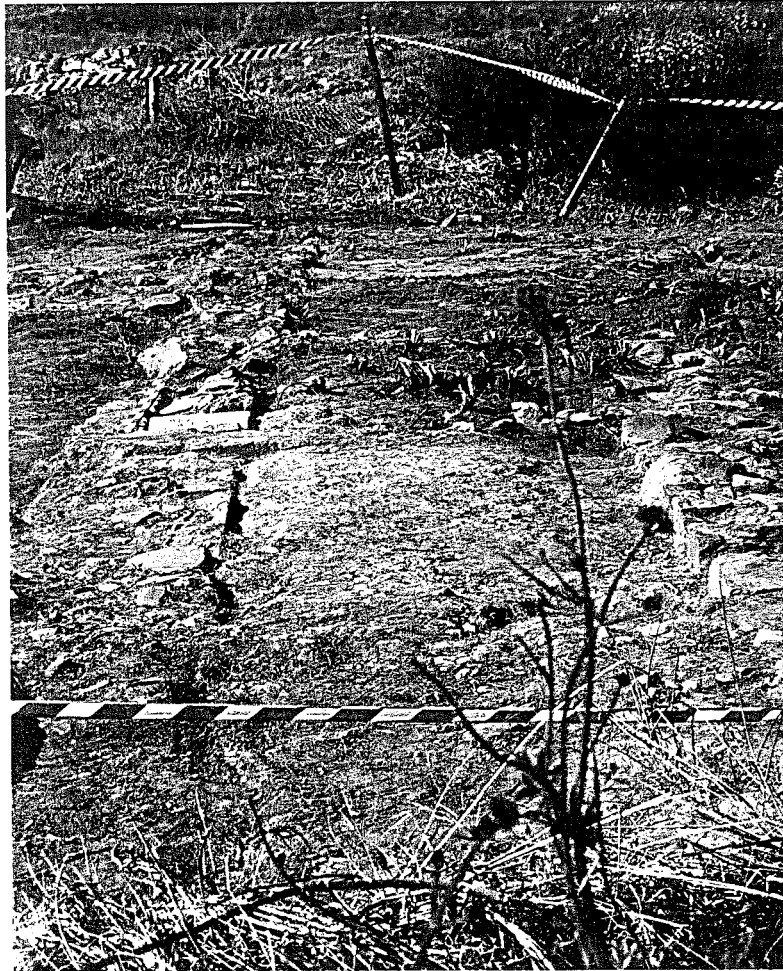
Fig. 15. The farmstead's stable and working areas, not much remained after the demolition in the early 1940s. photo taken 2003.

Wall foundations of several outbuildings and a cobbled yard area towards the south end of the farmstead beyond the 'knee-bend' remained unexplored, apart from being exposed and a surface collection of portable artifacts made (Fig. 15). This area seemed to be the working area of the farm or smallholding. It contained wall footings of small sheds, stables, remains of broken tools, building material, broken and discarded farm implements and various other detritus of a semi-rural lifestyle. These were left *in situ*.

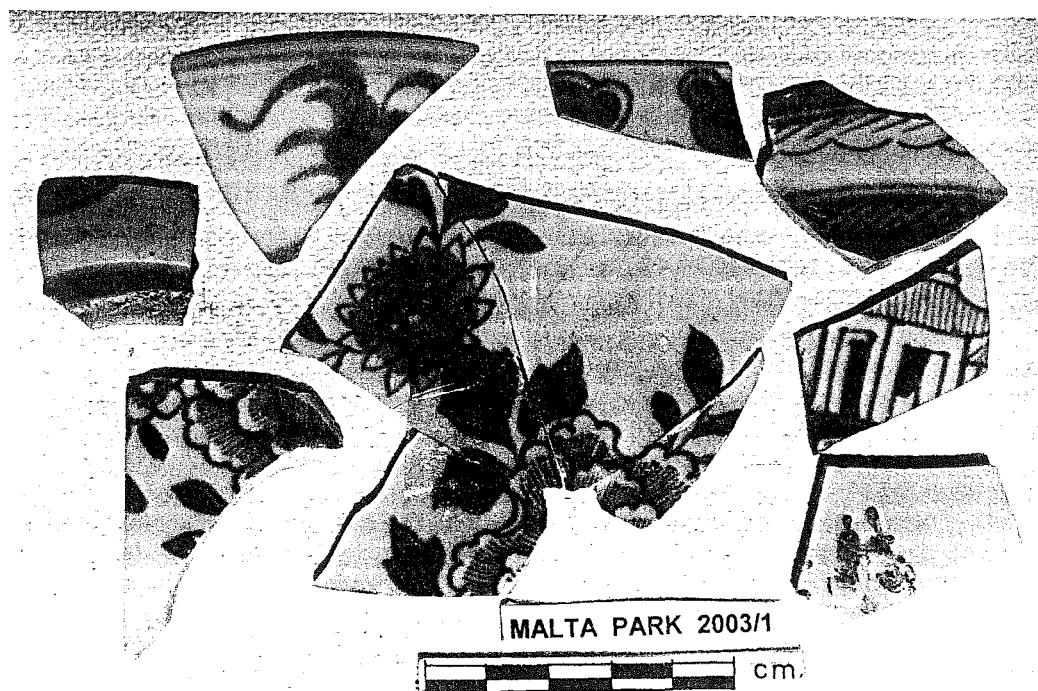
Fig. 17. Chinese export porcelain of the late 18<sup>th</sup> / early 19<sup>th</sup> century. Found on domestic sites all over the Cape.

The ceramic collection can be divided into three very distinct periods of occupation of the site. The first cluster consists of a collection of Chinese export porcelain dating to the second part of the 18<sup>th</sup> / early 19<sup>th</sup> century, largely made up of fine tableware, with some *grof* kitchen bowls (Fig. 17). This Asian export porcelain component, the largest in the collection, indicates that people of means occupied the Varsche Drift House for some time. This is also borne out by the presence of fragments of mid-18<sup>th</sup> century British "Jackfield Ware"<sup>16</sup>, a black, basalt-like form of ceramics, symbol of high social status (Fig. 18). This distinct cluster places the first occupation of the site into the last quarter of the 18<sup>th</sup> century.

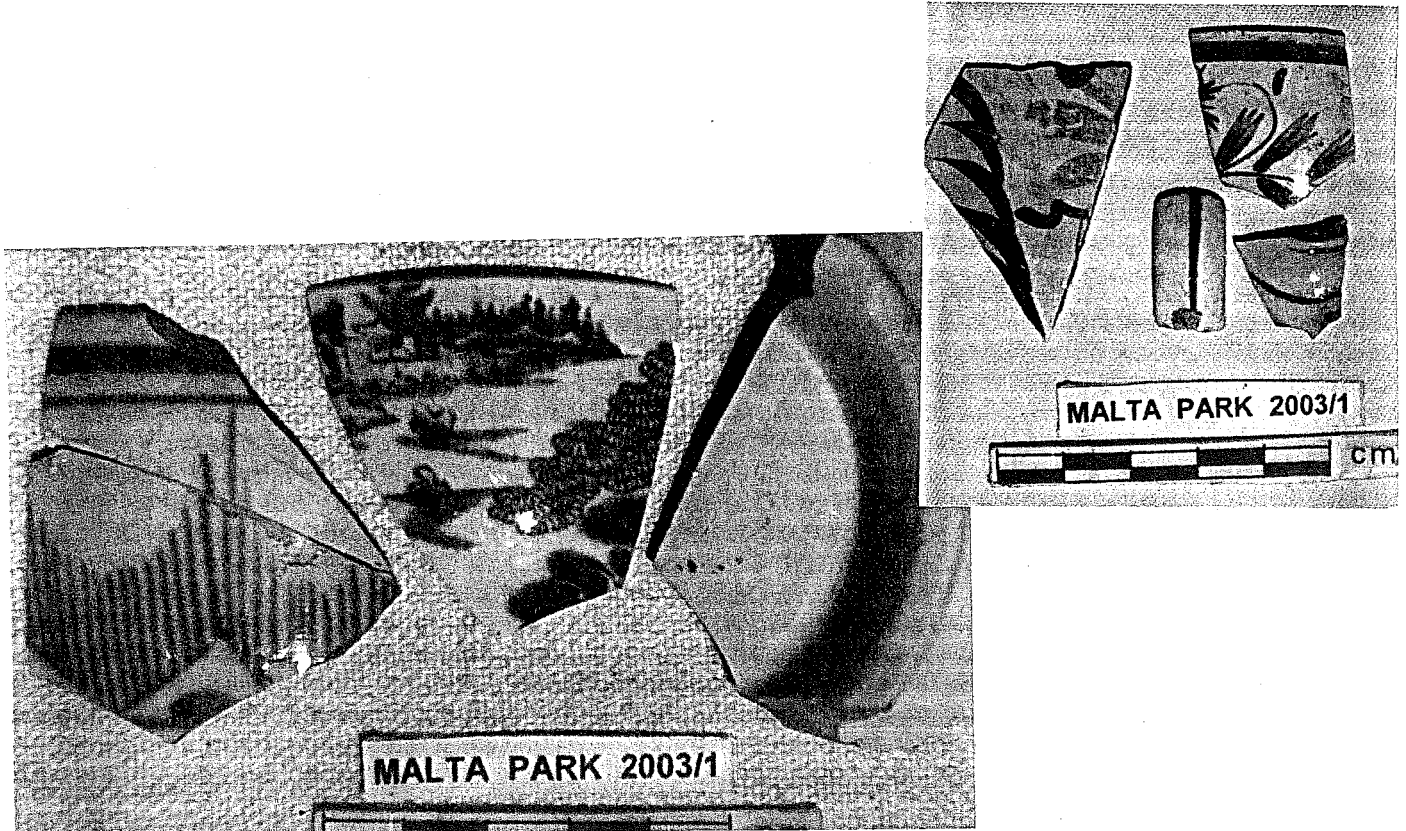
Fig. 21. Left: Blue and white underglaze printed "Chinoiserie" bowls, British, early 19<sup>th</sup> century. Right: the colourful hand-painted teaware is of the same period.

The next period in fashionable British refined ware is only present in the collection with a few pieces: an occasional blue and white underglaze decorated teacup, small bowl and saucer from the period of about 1810 to 1830 (Fig. 21). The teacups had no handles and the saucers no footings at this time. The small bowls are underglaze printed in Chinoiserie patterns. A jar and a teacup fragment, hand-painted in soft mustard yellow, olive green, blue, red and yellow with a floral motif are fine examples of expensive teaware.

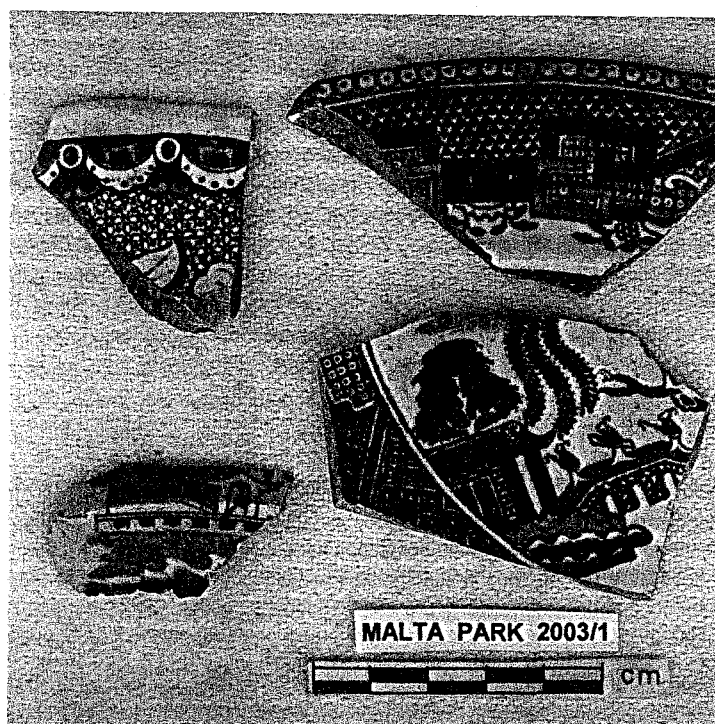
Fig. 22. "Willow Pattern" tableware, still popular today. This British pearlware dates from the mid- 19<sup>th</sup> century.

The third homogenous ceramic collection dates to the middle of the 19<sup>th</sup> century, the familiar British 'willow patterned' plates, servers and eating bowls (Fig. 22). The willow pattern was developed and standardized from Chinese porcelain patterns and has been in production ever since. The servants and working class people ate and drank from industrial slipware bowls and mugs, decorated with relief bands of bright colours or trailed 'cable' designs (Fig. 23).

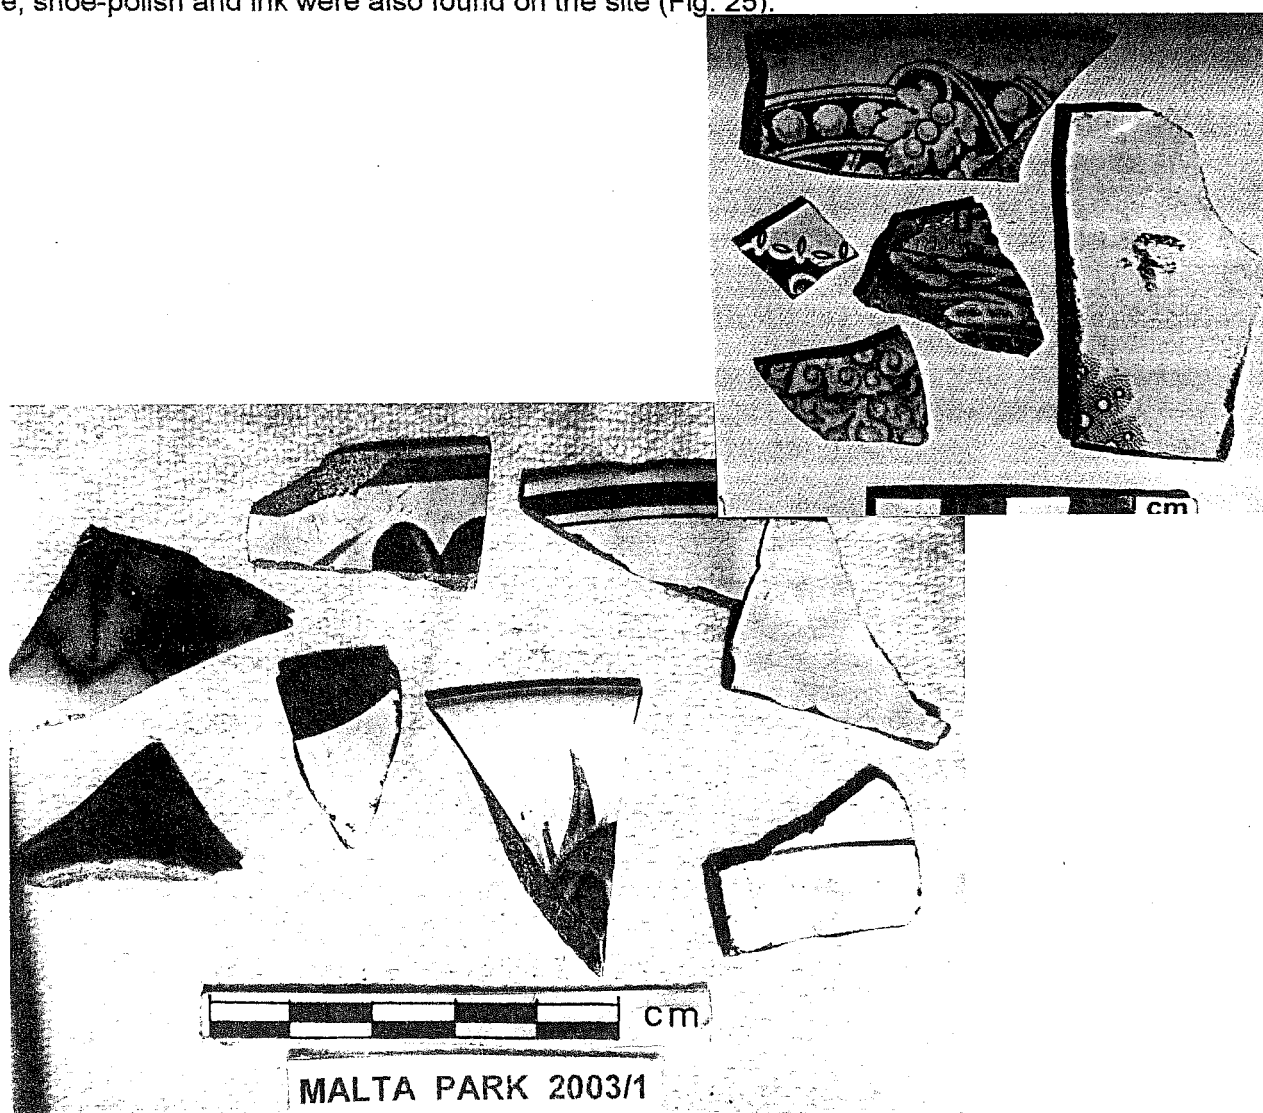
Fig. 24. Mid- to late 19<sup>th</sup> century British ceramics. Left: 'flow-blue' dish and cup, middle: '*boerebont*' bowl and cup fragments, right: band and line decorated dinnerplates. On the right are some underglaze printed dishes in black and green colour.

The late 19<sup>th</sup> century collection of ceramics is sparse: a cup and a plate fragment of 'flow-blue' underglaze printed pearlware, some green, grey and red underglaze printed creamware plates and dishes, band and line decorated dinner plates, brightly hand-painted "*boerbont*" ware of the late 19<sup>th</sup> century (Fig. 24). These are all evidence of respectable lower class family life.

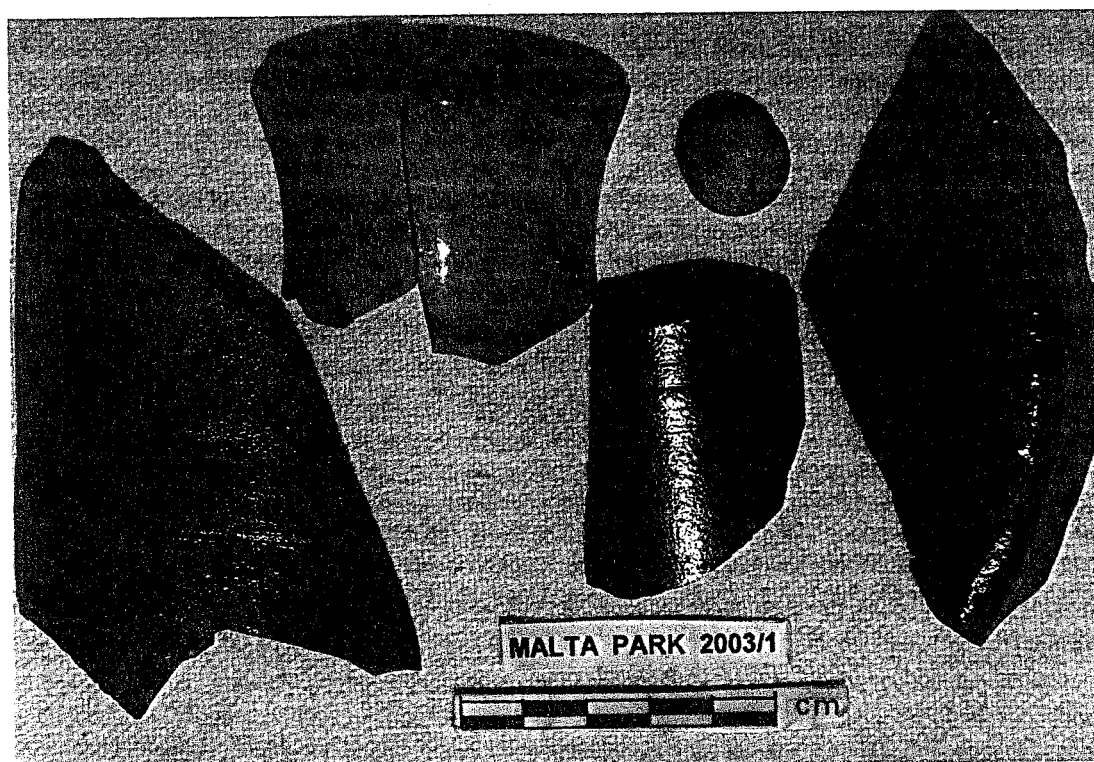
Fig. 25 British stoneware, from ca 1860 onwards. Left: gingerbeer bottle, middle: shoe polish bottle top, beer bottle stopper, right: ink pot and storage jar.

Several British stoneware, salt-glazed bottle fragments for gingerbeer and beer, food storage, shoe-polish and ink were also found on the site (Fig. 25).

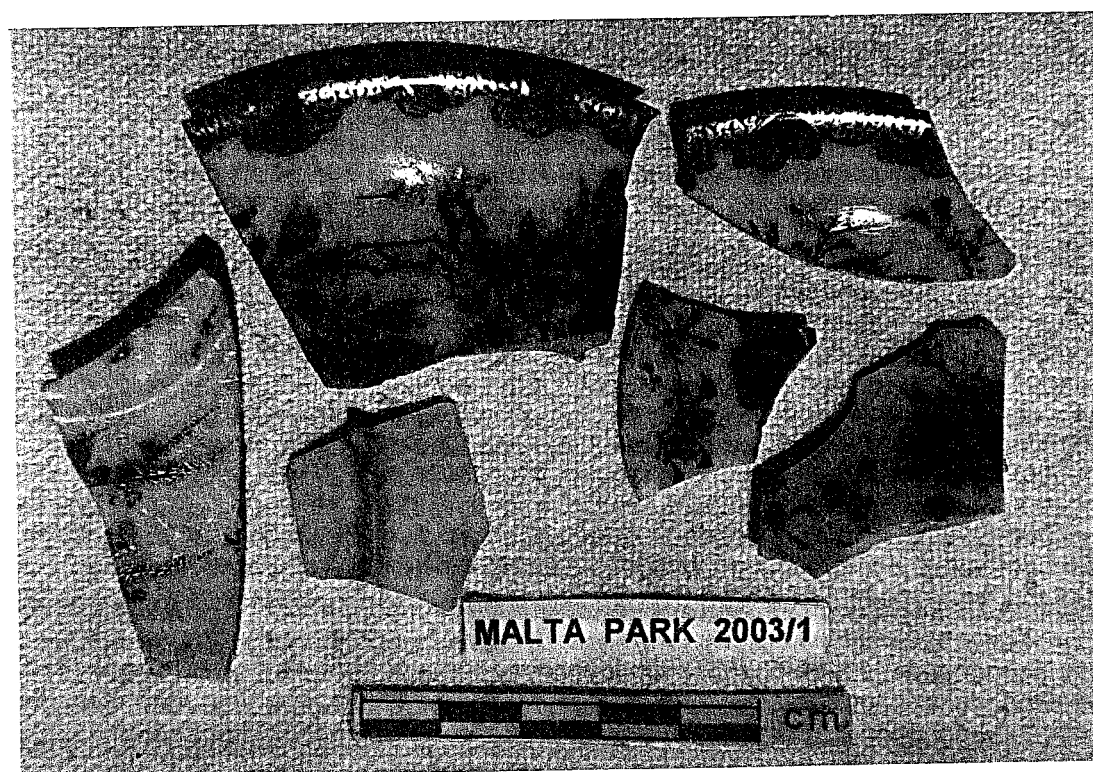
Fig. 26. This saucer needs to be included in the collection as it is often mistaken for 18<sup>th</sup> / 19<sup>th</sup> century Chinese or Japanese porcelain. However, it dates from the 1940s / 1950s,

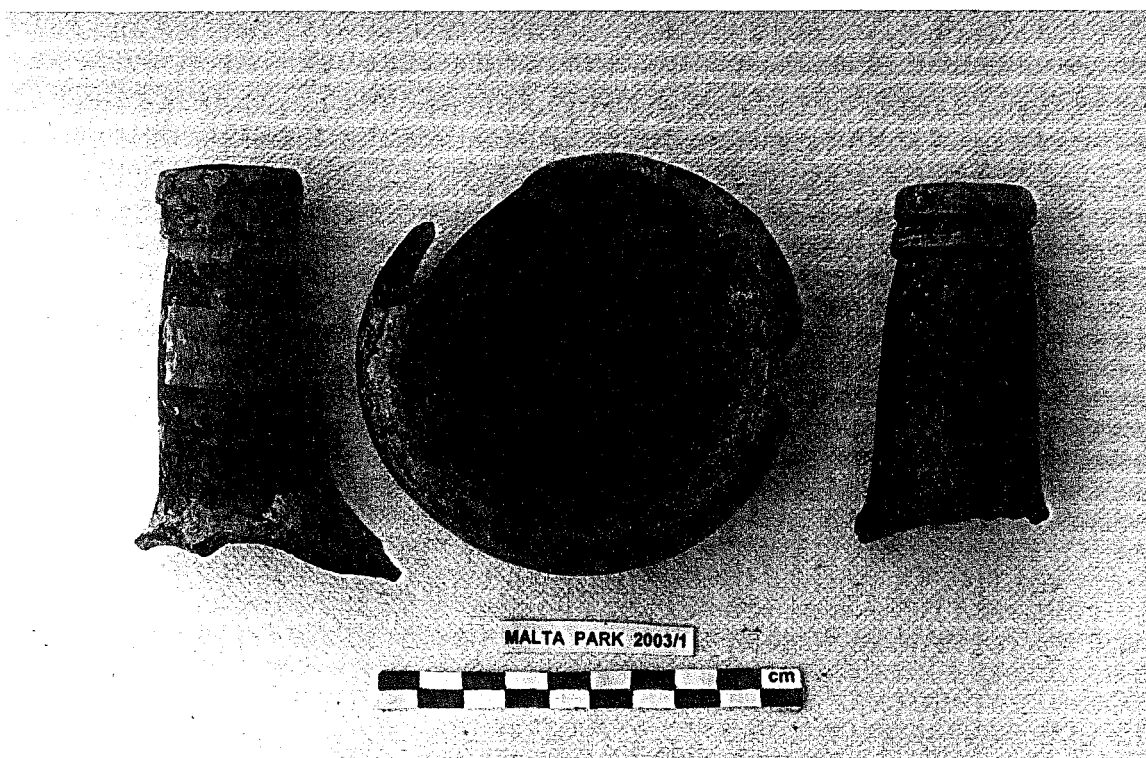
Fig. 28. Squat, early 18<sup>th</sup> century European wine bottles.

Three squat, early 18<sup>th</sup> century bottle base fragments are the earliest examples of wine bottles found on the site (Fig. 28). About thirty Constantia wine and French Champaign bottles could be counted, found in all areas outside the house and dated to before 1810 (Fig. 29), when two and three piece moulded bottles first appeared on the market. This collection of tightly dated wine and Champaign bottles suggest fine dinner parties and very many festivities at this country house.

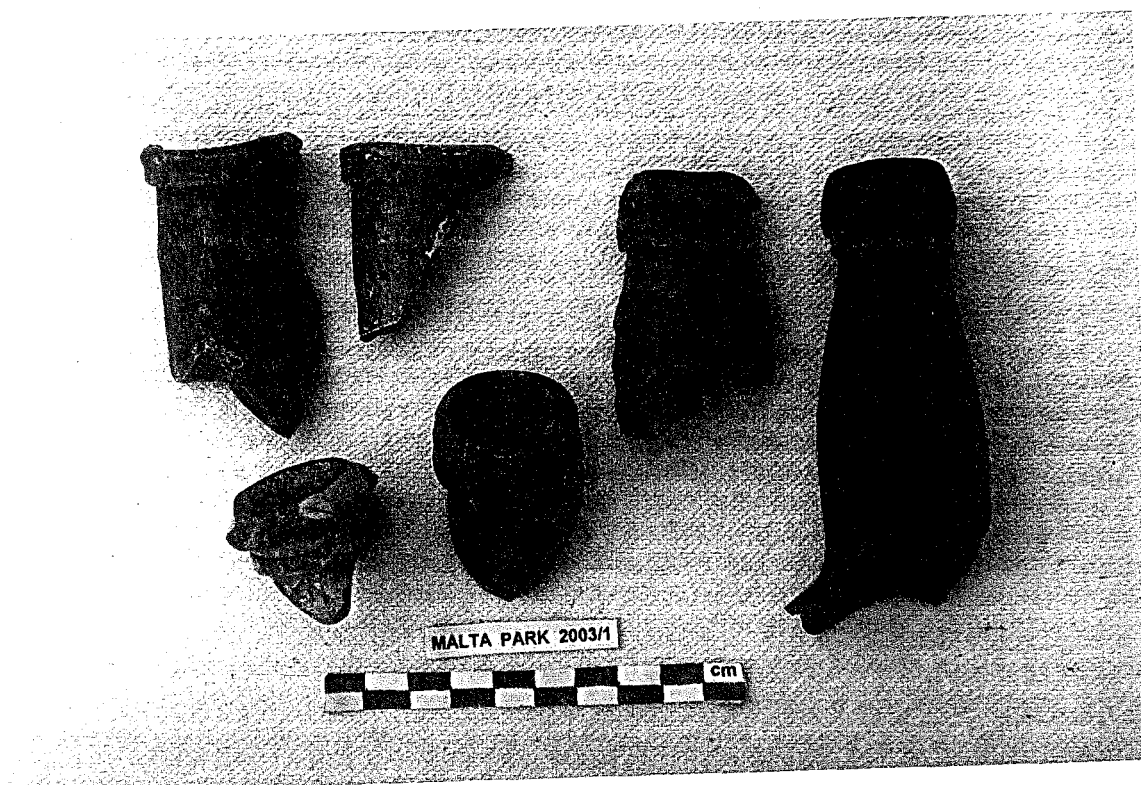
Fig. 29. Constantia and French Champaign bottles, imported from Europe, dated to before 1810.

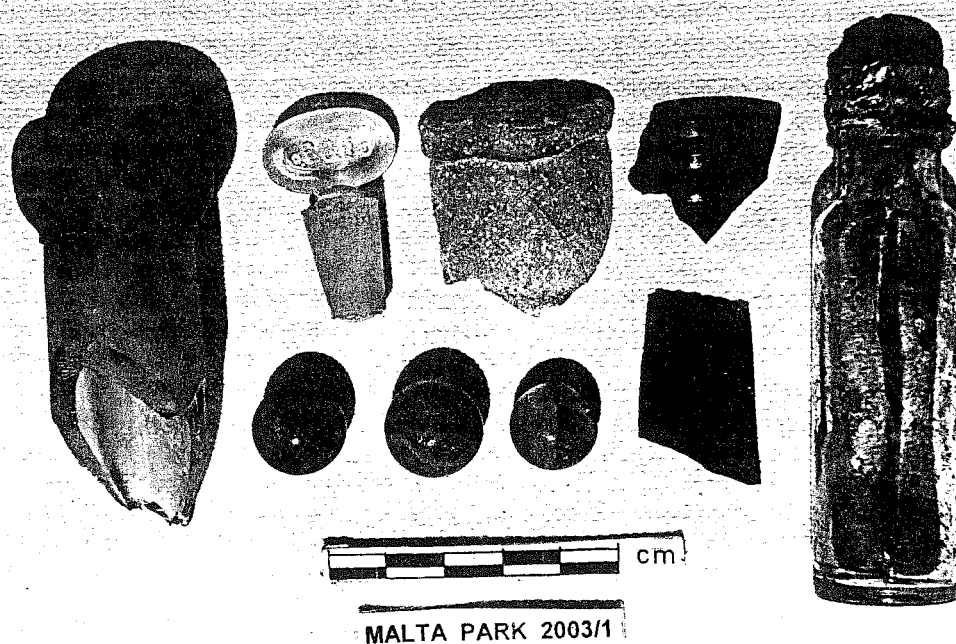
Fig. 30. Left: a 'Codd' bottle for aerated water with marbles. Top: stopper of medicine bottle, food bottle, poison bottle. Right: medicine bottle. All mid-late 19<sup>th</sup> / early 20<sup>th</sup> century.

The middle to late 19<sup>th</sup> century bottles are all of the food storage and medicine bottle variety, clear or aqua coloured and a few blue poison bottle fragments (Fig. 30). Aerated water in "Codd" bottles were sold from about 1880 and their marbles used by children as toys after the bottles broke<sup>19</sup>. Samples of 'Bashew Brothers' and a few 20<sup>th</sup> century cooldrink bottles were also collected.

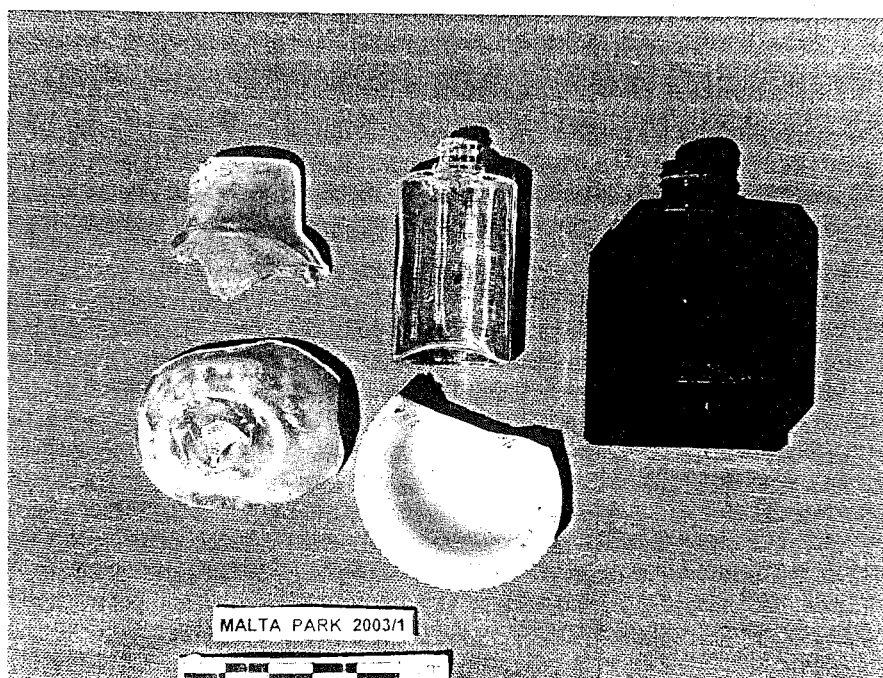
Fig. 31. Utility glass.

Top: scent bottles and a scent jar, top middle: "Californian Poppy" scent bottle, regarded as 'cheap' 1940s scent. Top right: "Posh(?) Blazer", men's scent 1950s, bottom: jar of "MUM, I never go anywhere without my MUM" underarm deodorant, 1940s and 1950s.

Under the rubric of utility glass one would count several lamp chimney fragments of clear and ornamental glass, indicating first paraffin and later electric lighting. Dark green moulded and wine-red window glass fragments came possibly from the entrance door or fanlight above. Scent bottles, milky white ointment jars and globes, glass stoppers from decanters and mirrors of the 20<sup>th</sup> century are also present. One clear glass lid fragment, a moulded "Maria van Riebeeck" bust in the form of a lid handle was probably sold for the tri-century commemoration / festival in 1956 (Fig. 31).

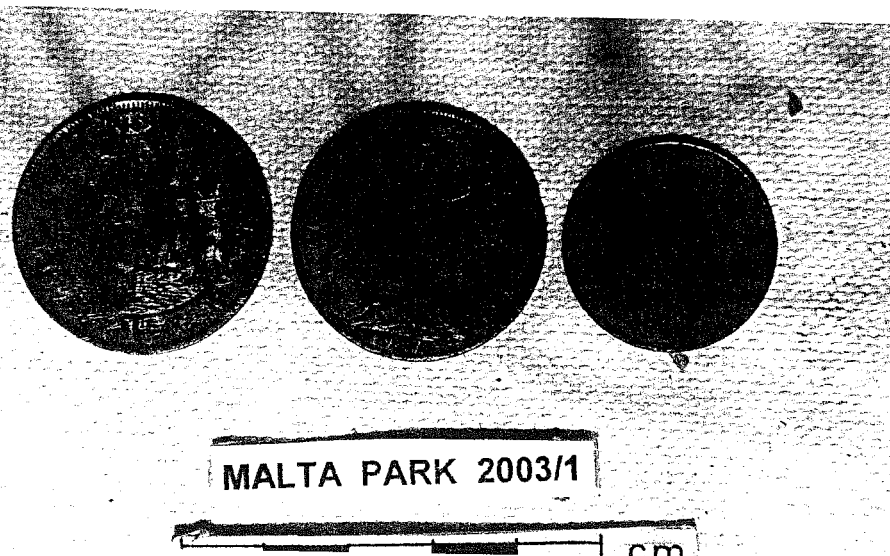
Fig. 33. From left: British coin, dated 1917; South African coins dated 1941 and 1946.

Four coins from area two, together with the previously found, dated 1826 and 1907, span the time of occupation of the house rather nicely: a George V one penny, dated 1917, one George VI penny dated 1941 (South African coin), a George VI half-penny (South African coin) dated 1946 and a South African one cent coin dated 1983 (Fig. 33).
