**HERITAGE SURVEY OF THE PROPOSED UMGAZI
CITRUS PROJECT**

FOR COASTAL & ENVIRONMENTAL SERVICES

DATE: APRIL 2010

**Umlando: Archaeological Tourism and Resource
Management**

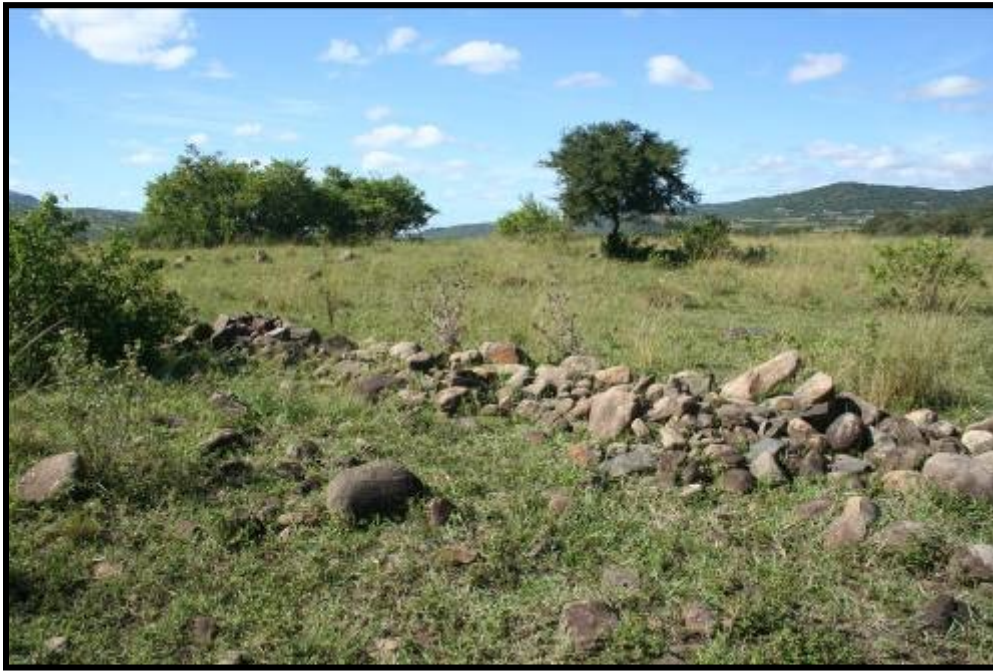
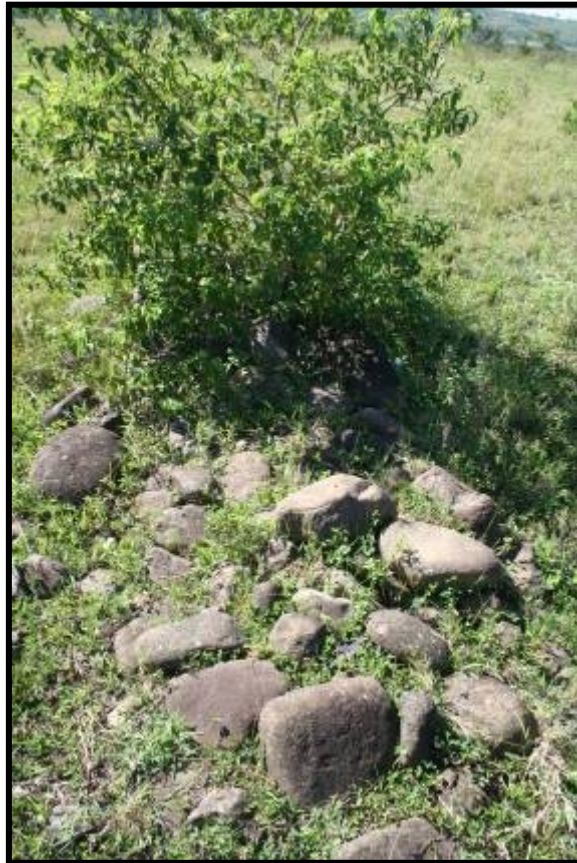
FIG. 4: STONE WALLING AND POSSIBLE GRAVE AT GAZ01

GAZ01 is located on a slightly elevated area near the Umgazi River. It consists of three rows of walling and a few circular features, of which three could be graves (fig. 4). Two MSA flakes were also observed. The walling and features do not appear to be older than 100 years.

Significance: If the three features are human graves, then these are of high significance.

Mitigation: The community should be consulted about possible graves in the area. If no one claims these possible graves, then the development has two options. First, they must pay for the excavations of the possible human remains and these remains will then need to be reburied elsewhere within the community. Second, the graves can be fenced off and not disturbed by the proposed agricultural activity. The second option is the preferred option.

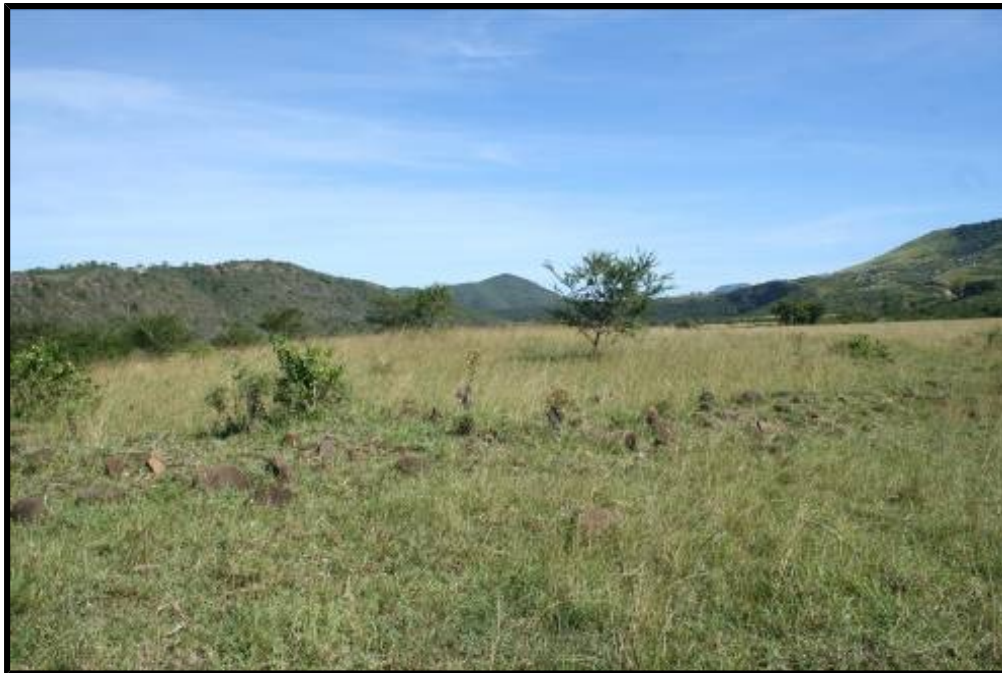
FIG. 5: STONE WALLING AT GAZ02

GAZ02 is located on another slightly elevated piece of ground, ~380m east from GAZ01. It consists of a fragmented wall around the base of the hill (fig. 5). The wall appears to be less than 100 years in age.

Significance: The site is of low significance.

Mitigation: No further mitigation is required.

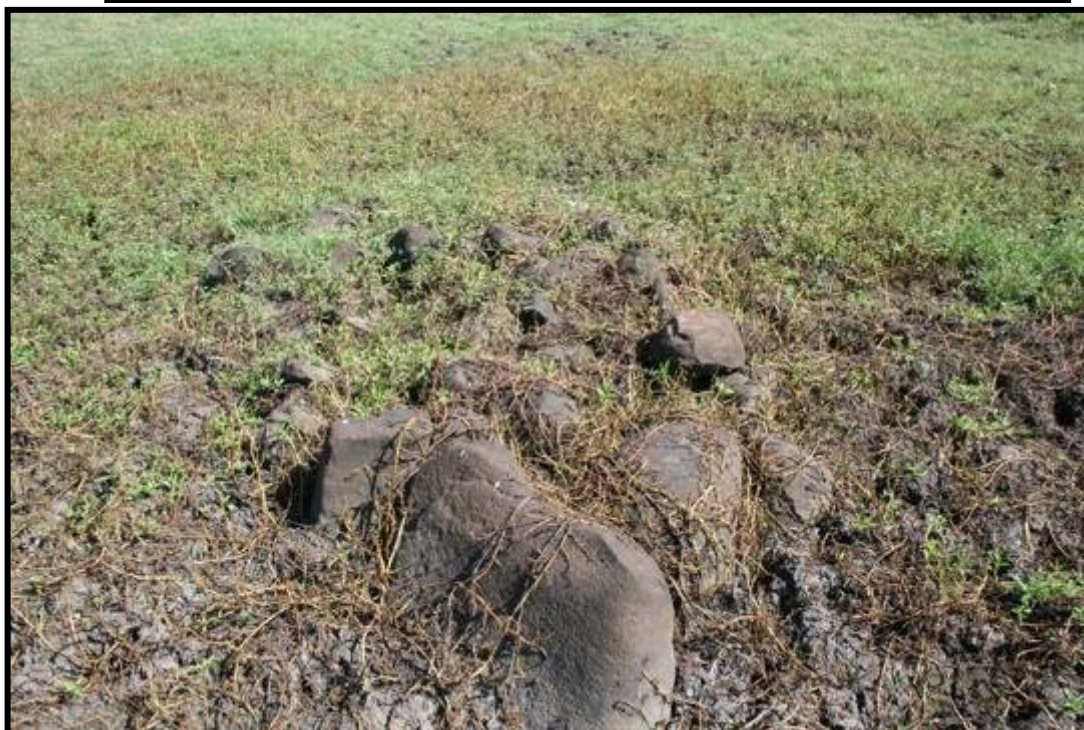
FIG. 6: POSSIBLE GRAVE AT GAZ04

GAZ03 is located ~50m downhill from GAZ02 and is in the centre of a small dam. This dam may or may not be natural. The site consists of a single stone cairn that may be a possible grave (fig. 6)

Significance: If this is a grave then it is of high significance.

Mitigation: The cairn should be fenced off and remain undisturbed if the community does not claim this grave, nor want it removed.

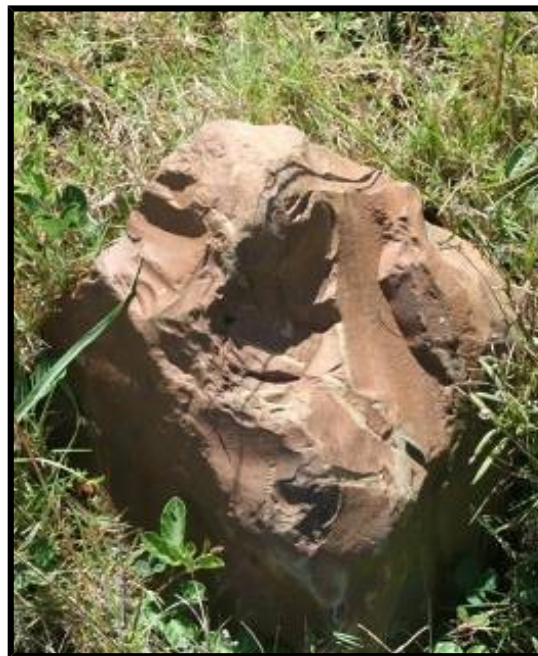
FIG. 7: (MIDDLE) STONE AGE CORE AT GAZ04

GAZ04 consists of a large stone core located at the base of a small hill (fig. 7). The core may date to the MSA due to its heavy patination. No other artefacts were observed.

Significance: The core is of low significance.

Mitigation: No further mitigation would be required.

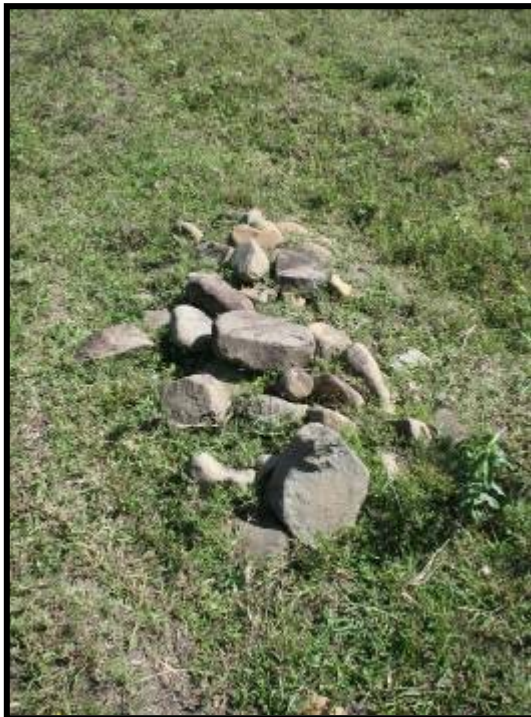
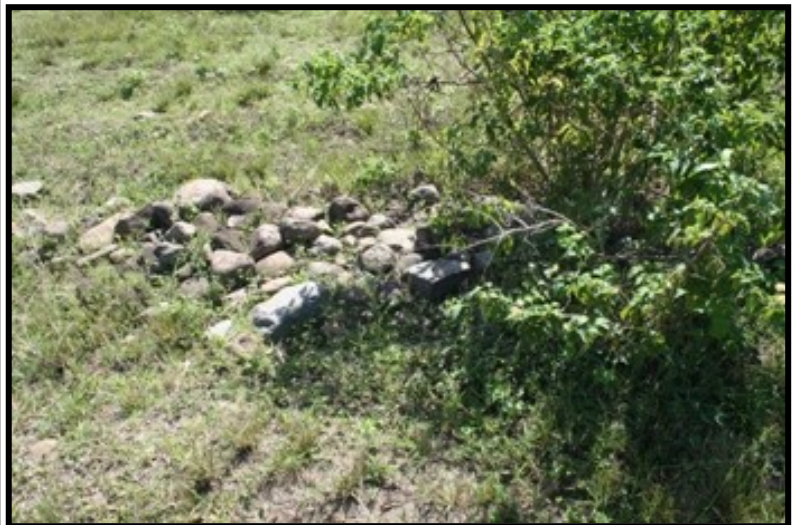
FIG. 9: THREE GRAVES AT GAZ09

GAZ06 consists of three stone cairns that appear to be either graves or field clearance (fig. 9). I believe they are graves.

Significance: these features have high significance if these are graves.

Mitigation: The features should be fenced off and not disturbed during agricultural activity.

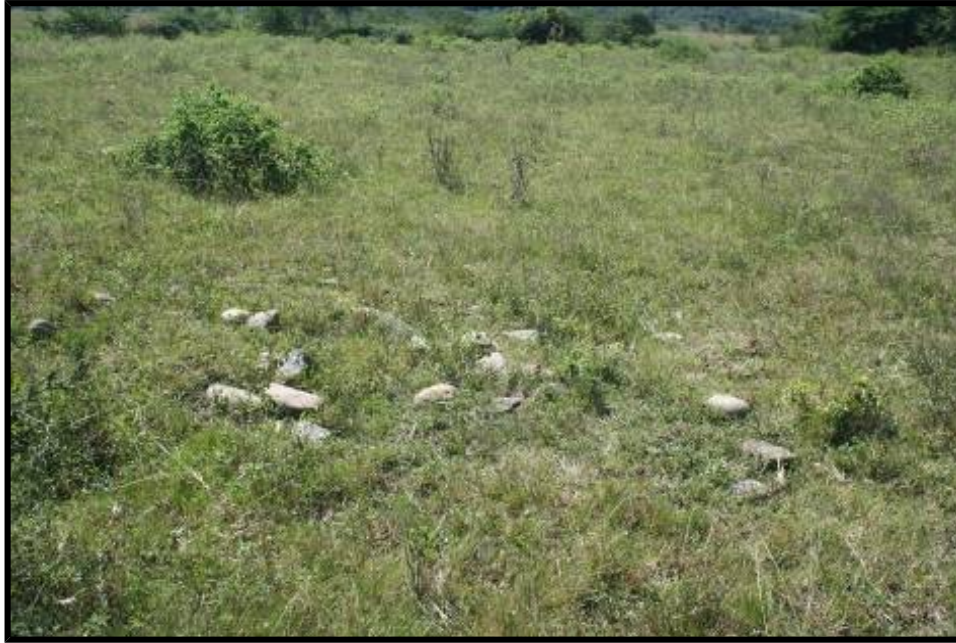
FIG. 10: CIRCLE OF STONES AT GAZ07

GAZ07 consists of a circle of stones and two upper grinding stones just above the flood plain (fig. 10). It may be the base of a hut. It does not appear to be older than 100 years. This area has been extensively ploughed.

Significance: The site is of low significance

Mitigation: No further mitigation is required.

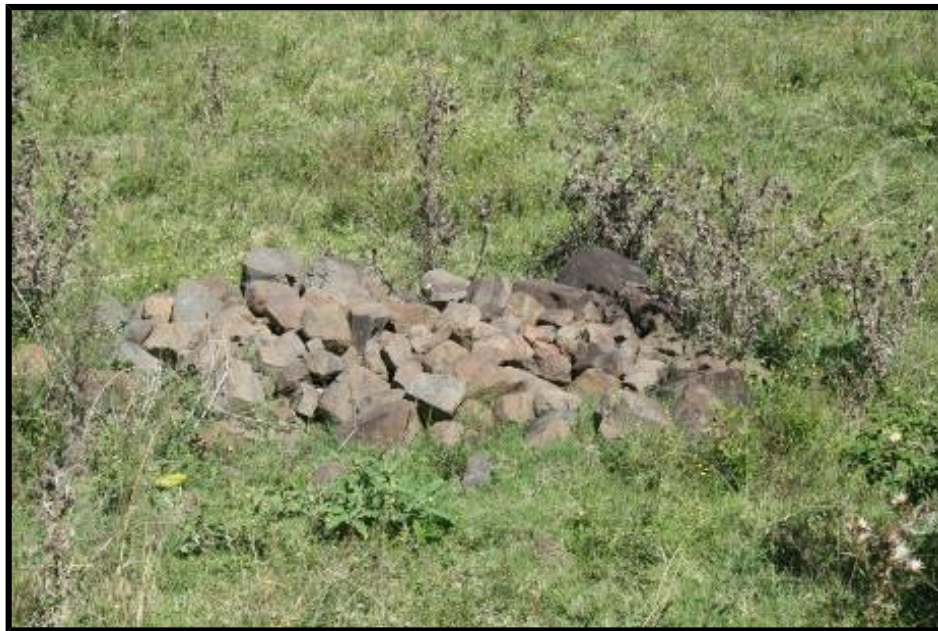
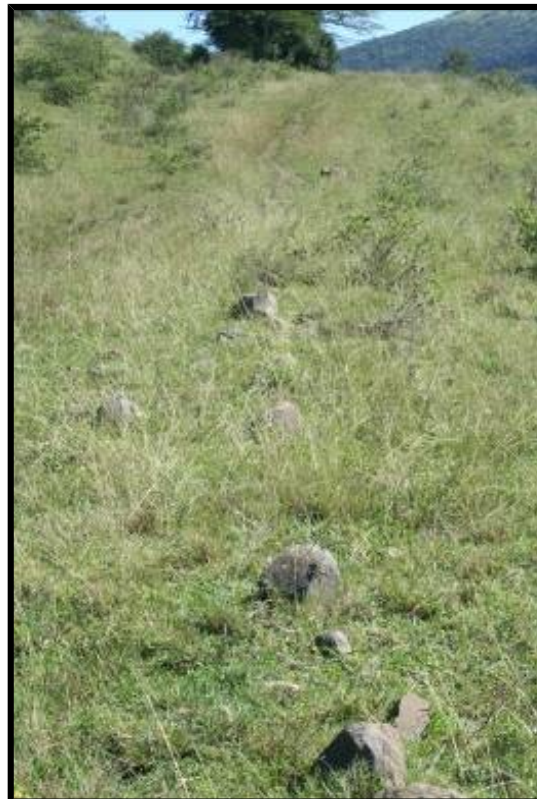
FIG. 11: POSSIBLE GRAVE AT GAZ08

GAZ08 consists of a stone cairn and a faint stonewall (fig. 11). The cairn may be a grave. The walling and possible grave is just outside of the proposed area.

Significance: The cairn is of high significance if it is a grave. The community would be able to comment, as it is recent in age.

Mitigation: The cairn should be fenced off as it may be damaged if an access road is made.

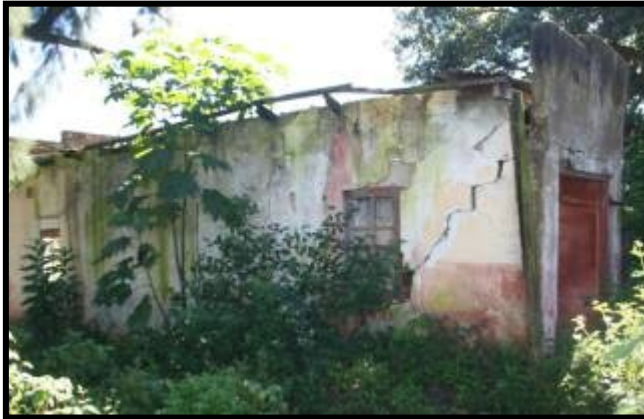
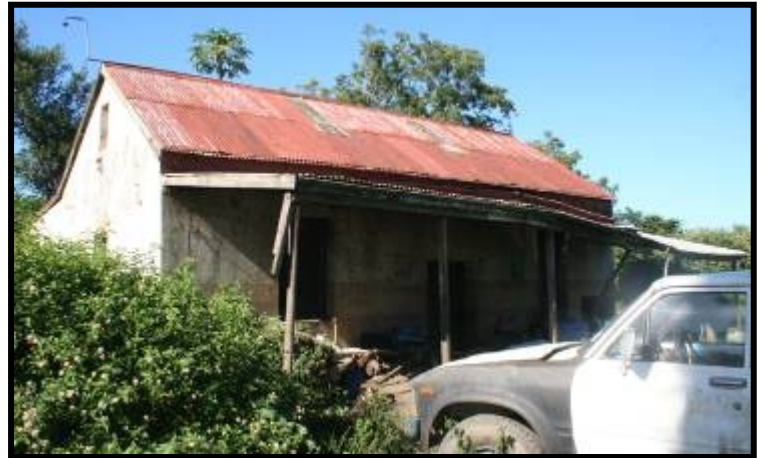
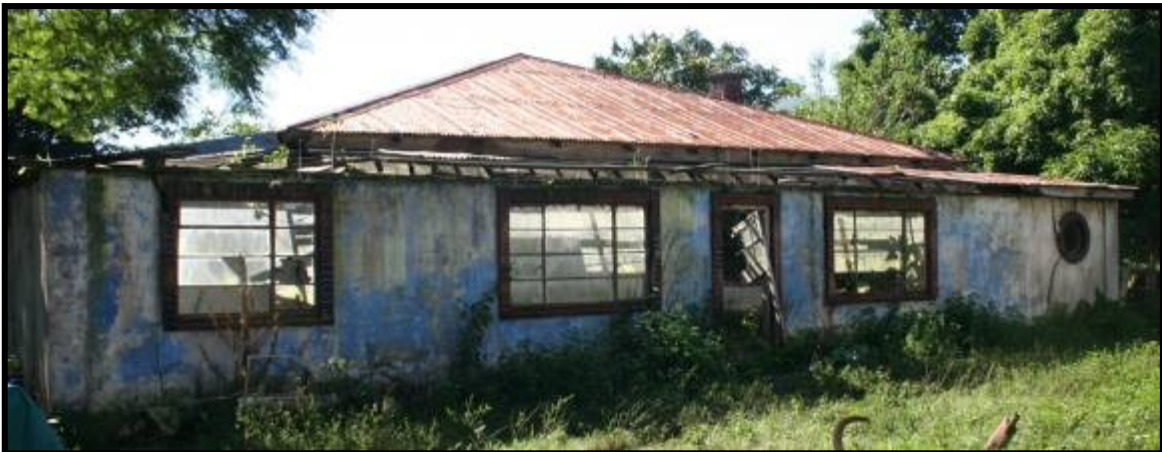
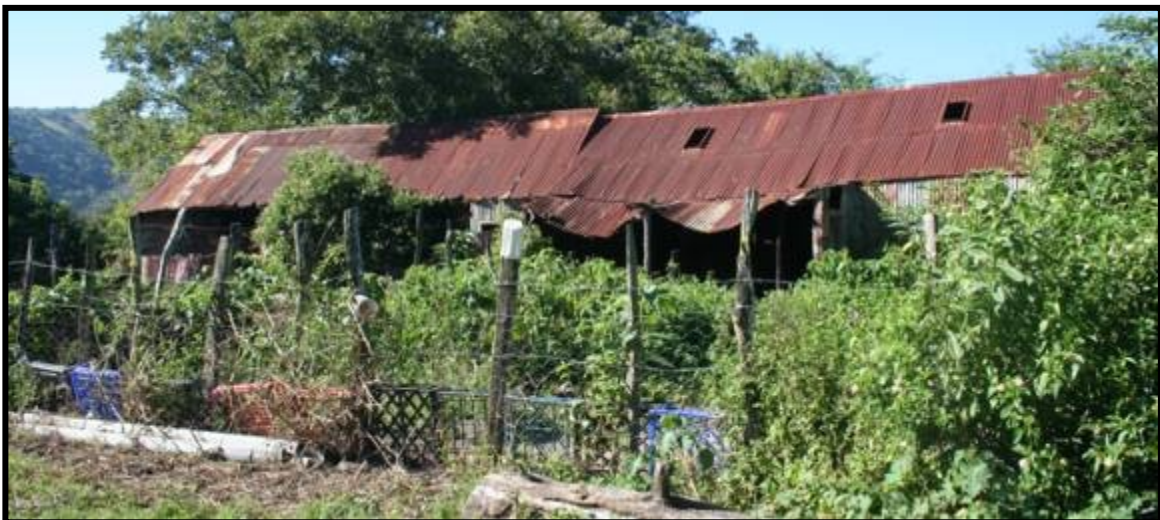
FIG. 12: BUILDINGS AT GAZ010

GAZ010 consists of a farm complex. The farm buildings appear to be built at various stages and some are older than 60 years (fig. 12). The buildings are in

various states of disrepair. Debbie Whelan has commented on the buildings (see Appendix B). The lines of trees that form the driveway are also older than 60 years and should be considered as part of the cultural landscape.

Significance: The buildings have low significance.

Mitigation: While the buildings are not of great architectural value, or significance, they should be properly recorded if they are to be demolished for the proposed citrus project. While the trees are not of significance, they should be preserved if possible.

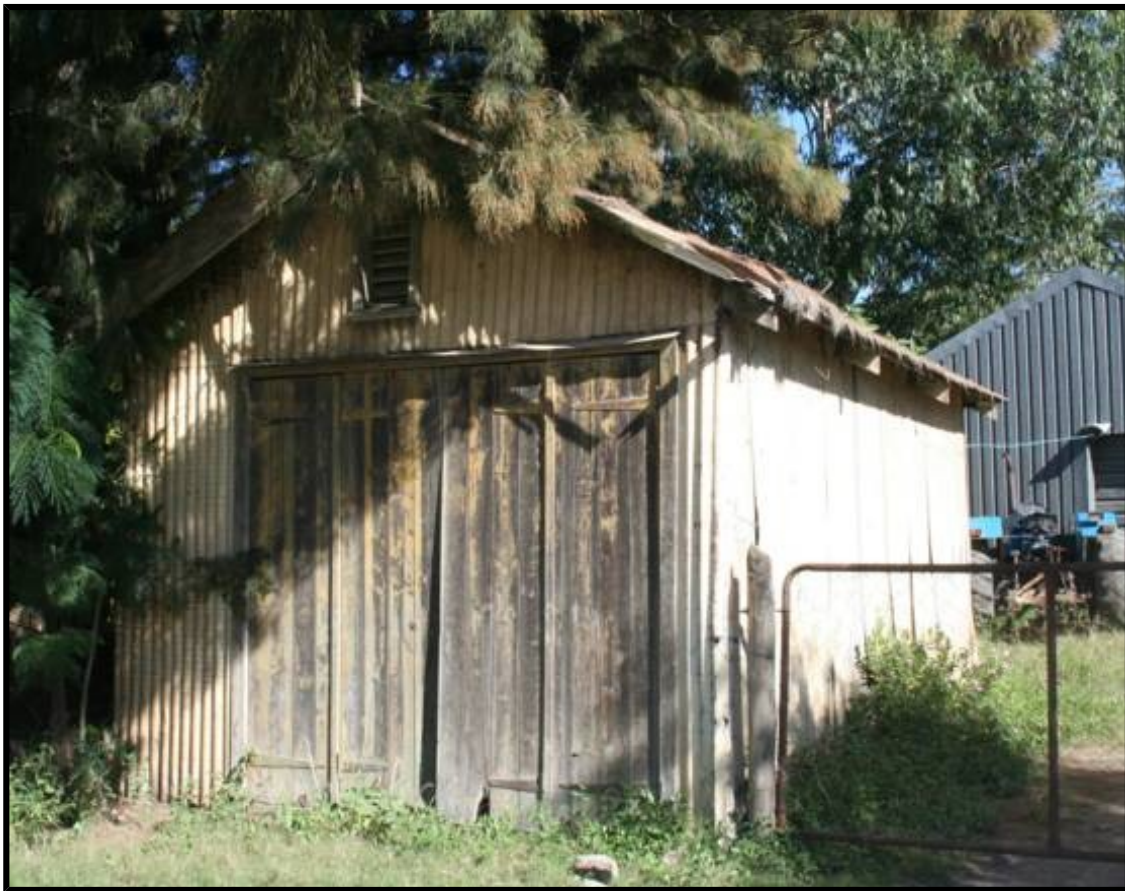
FIG. 13: BUILDINGS AT GAZ011

GAZ011 is a single wood and corrugated iron structure that probably predates the 1920s (fig. 13).

Significance: The building has architectural significance

Mitigation: If the building is in the way of the development, it should be moved to a nearby area and renovated.

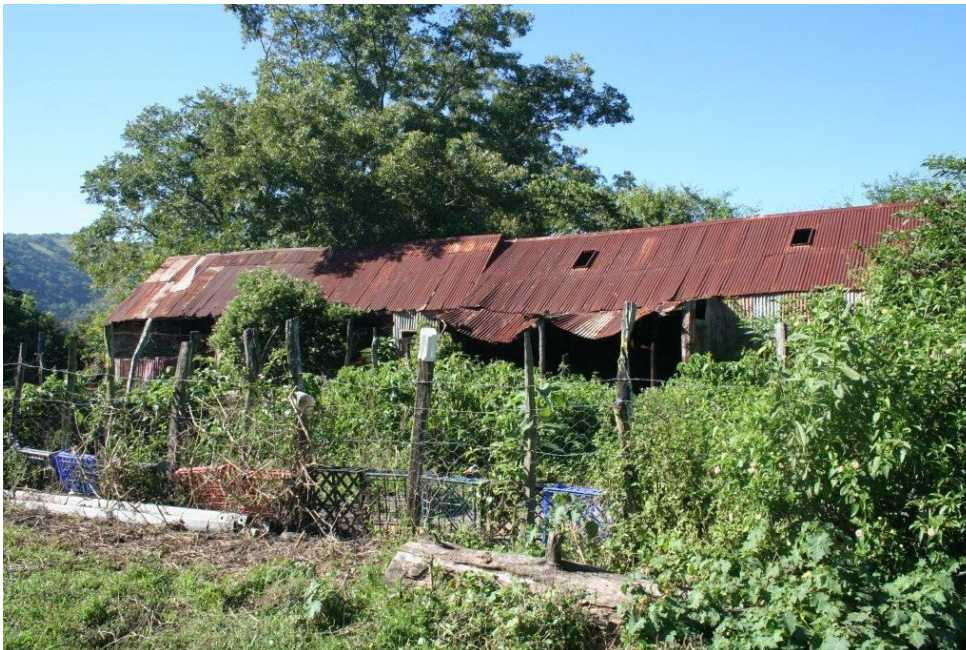
Fig 2: The old shed

1. Old Shed- Possibly late 1890's to 1915

Constructed of wood and iron with skylight apertures, more than likely turn of the twentieth century and dating back to the first farm settlement, this structure is ramshackle and would need extensive and expensive rebuilding in order to restore it to a practical and meaningful building. This would appear to be an unviable proposition, and in the opinion of the author, demolition could be considered as an option.

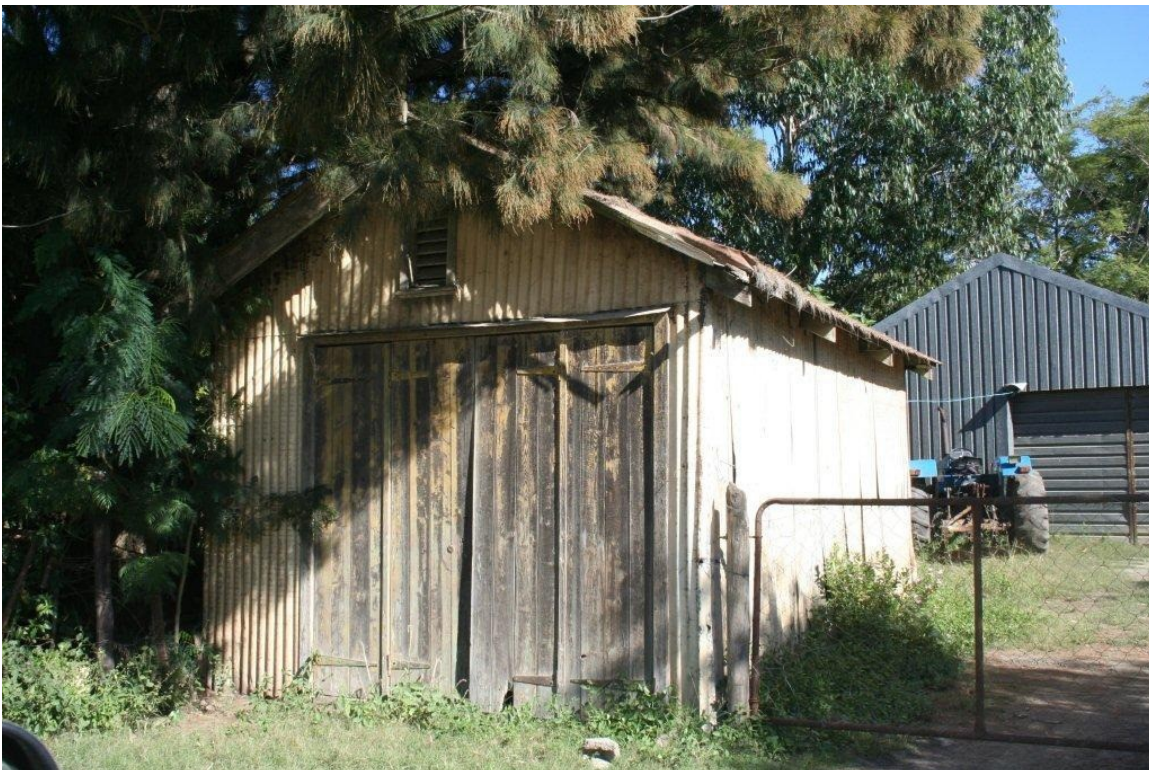
Fig 3: the old coach house/ garage

2. The coach house/ garage- Possibly late 1890's to 1915

More than likely contemporary with the old shed in item 1 above and the cottage in item 3 below, this small coach house would date to the first occupation of the farm. It is wood and iron like the one above, in infinitely better condition, with timber ventilators, and timber doors. Given the nature of its prefabrication, this building could feasibly be moved and replaced and reused on a different part of

the site, given its condition. Commenting on the condition of the structure is beyond the scope of this report.

old coach house could be moved and reused. However, not knowing the condition of the building makes a value judgment difficult. In both cases, this can only be made knowing the condition and structural integrity of the buildings, which could realistically result in demolition. The shed, in its dilapidated condition would be difficult to fix or reuse and thus demolition is recommended.

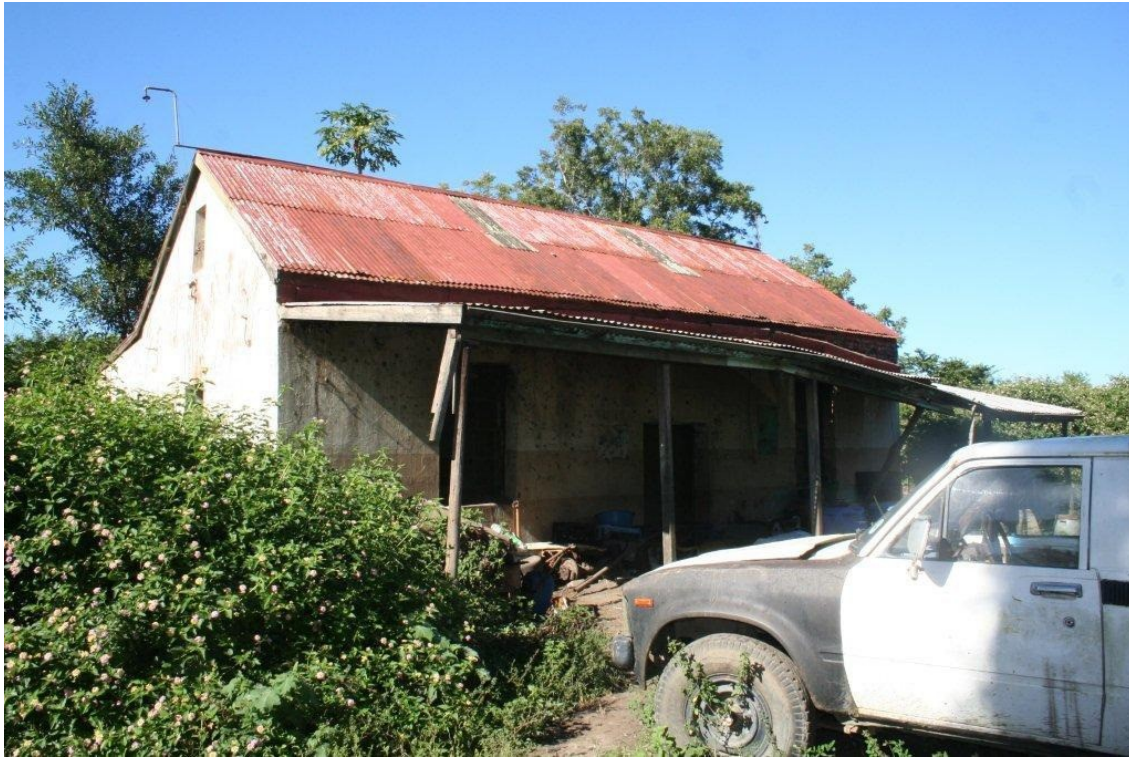
Fig 4: the cottage

3. The cottage

It is suspected that this was the first house on the site and would have been contemporary with the prefabricated buildings above. It is of indeterminate construction, with a saddle roof, an extended rear kitchen, and a veranda to the front. There is a ventilated attic space. Its condition is reasonable, given its age, and is a good example of settler vernacular. It is hoped that the client would be able to repair it and reuse it for an office or storage, but at the same time it is recognized that the practicalities of this are possibly slim.

Of the buildings which are definitely older than 60 years, it is hoped that the cottage may be repaired and reused for administration or the like, but this suggestion is made without knowing the condition of the building. Similarly the

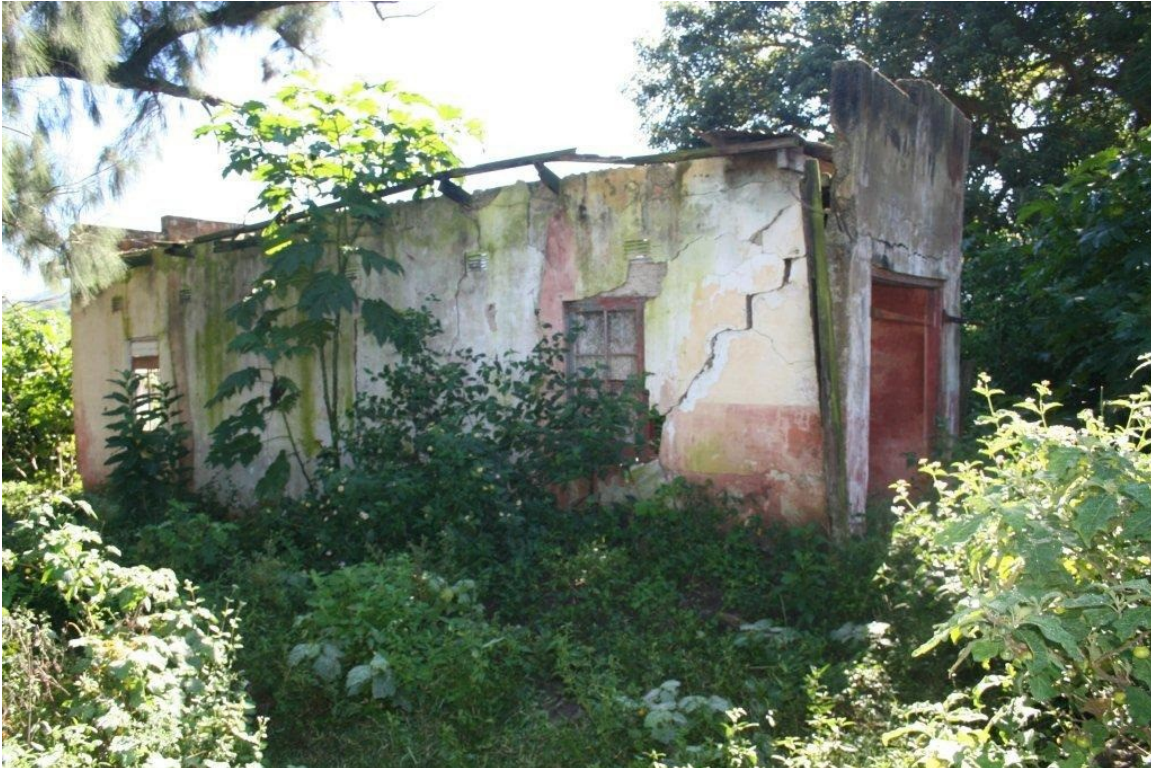
Fig: the store

4. The store- 1950's onwards

This structure is characteristic of store buildings with a mono-pitched roof and a parapet. This is possibly constructed later than the 1950's and is not likely to fall within the 60 year clause. In addition, it is structurally unsound. Demolition is recommended.

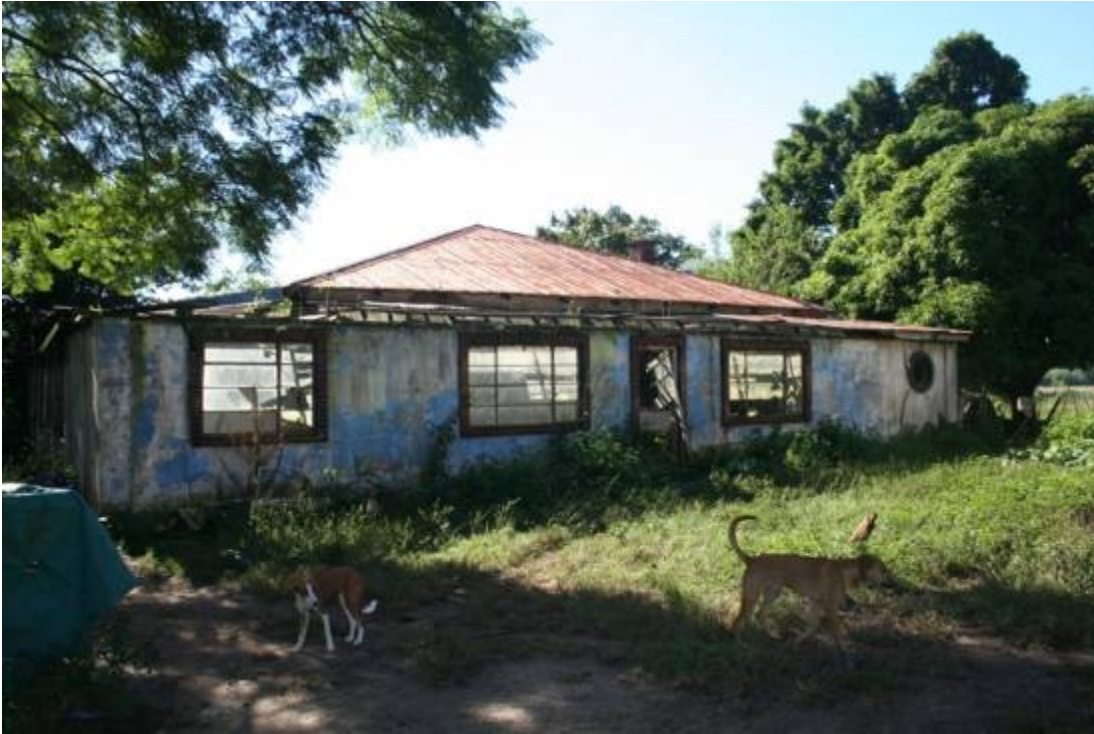
Fig 6: the new house

5. The new house- ca 1950's

Constructed most likely of brick and mortar which has been plastered and painted, this has a pyramidal corrugated iron roof and is surrounded by enclosed verandas. The windows are standard steel section. It is not a particularly spectacular example of a farmhouse tradition, and its disrepair recommends demolition.
