**HERITAGE SURVEY OF THE UMSOBOMVU WIND
ENERGY FACILITY, EASTERN AND NORTHERN CAPE**

**FOR EOH COASTAL AND ENVIRONMENTAL
SERVICES**

DATE: 27 OCTOBER 2013

**Umlando: Archaeological Surveys and Heritage
Management**

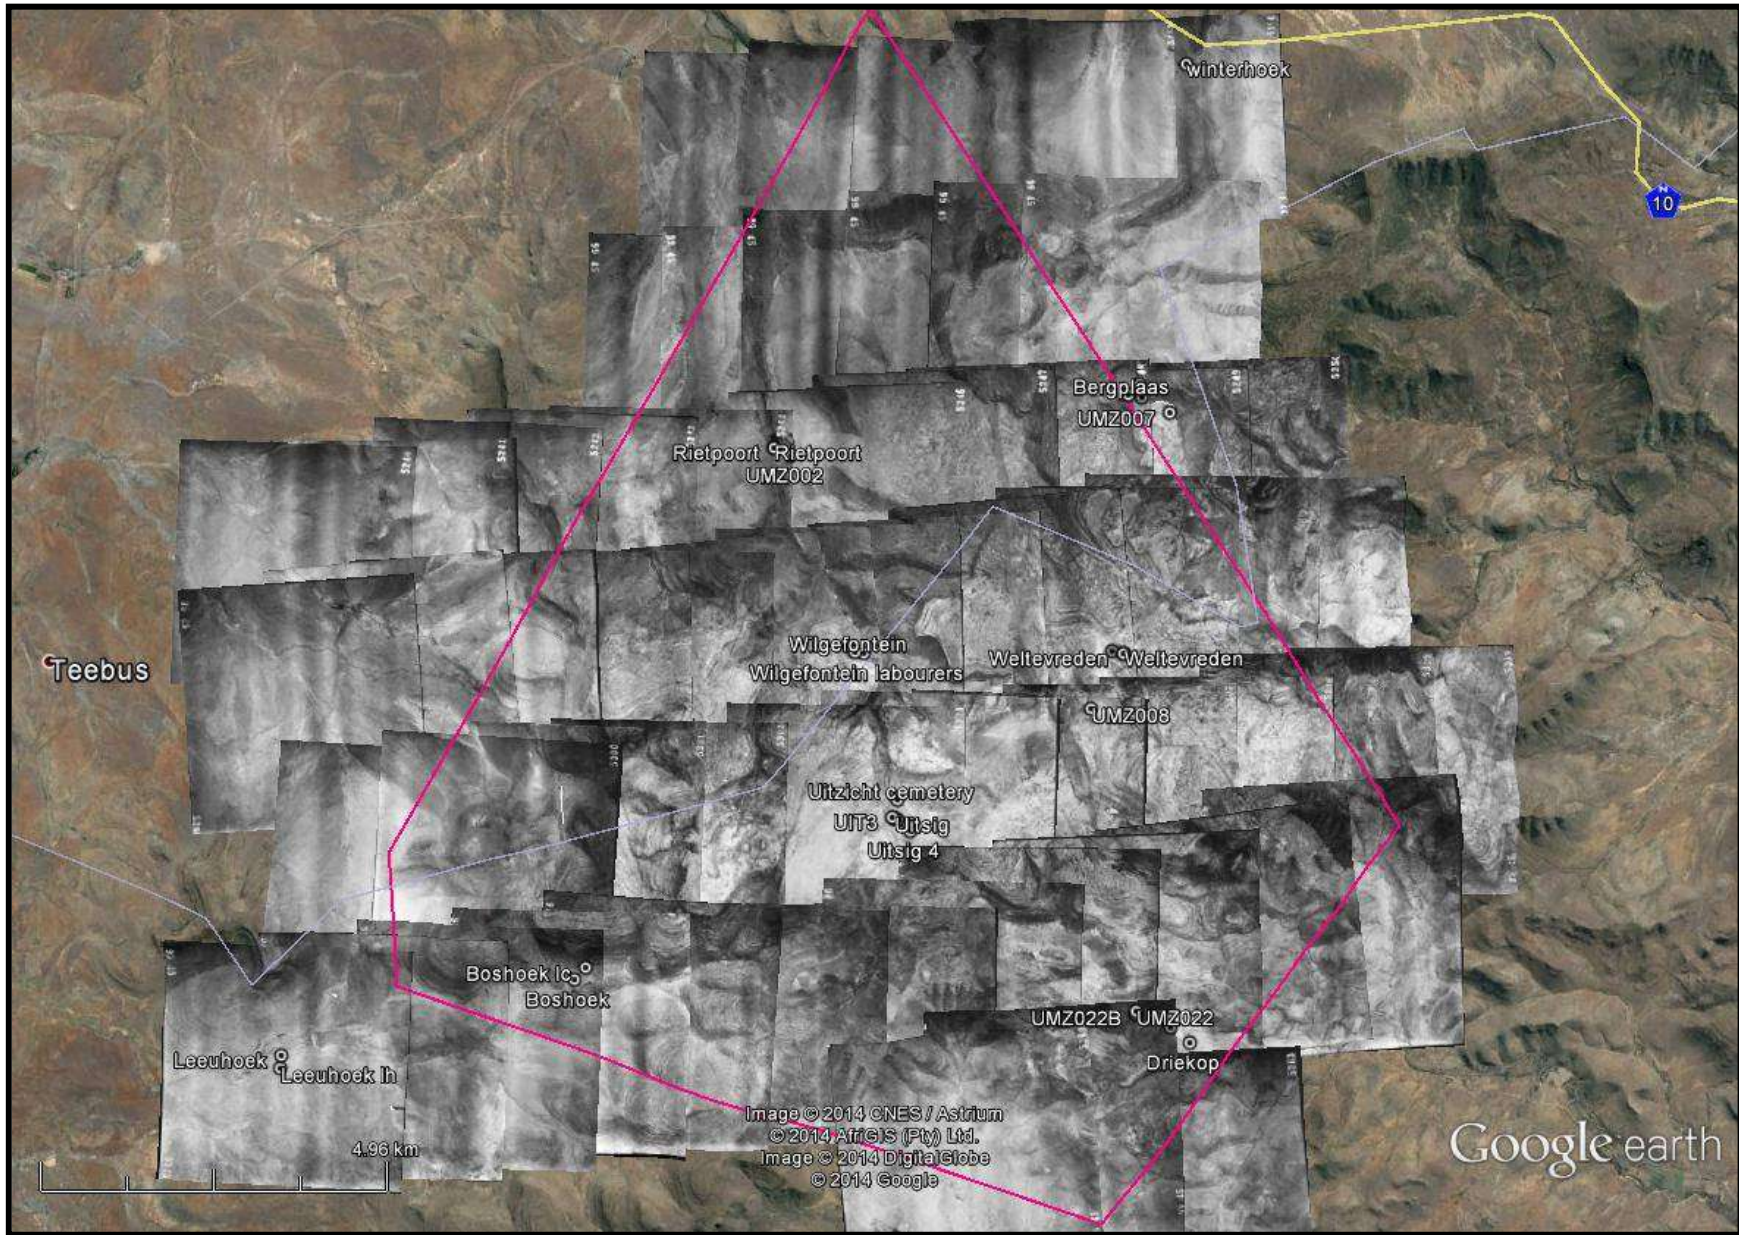
FIG. 6: LOCATION OF FARMS AND FEATURES IN 1945

The 1945 aerial photograph indicates that most of the kraals and buildings were already built (fig. 6). This would be confirming the SCG records. Thus most built features are more than 60 years in age and are automatically protected by the NHRA.

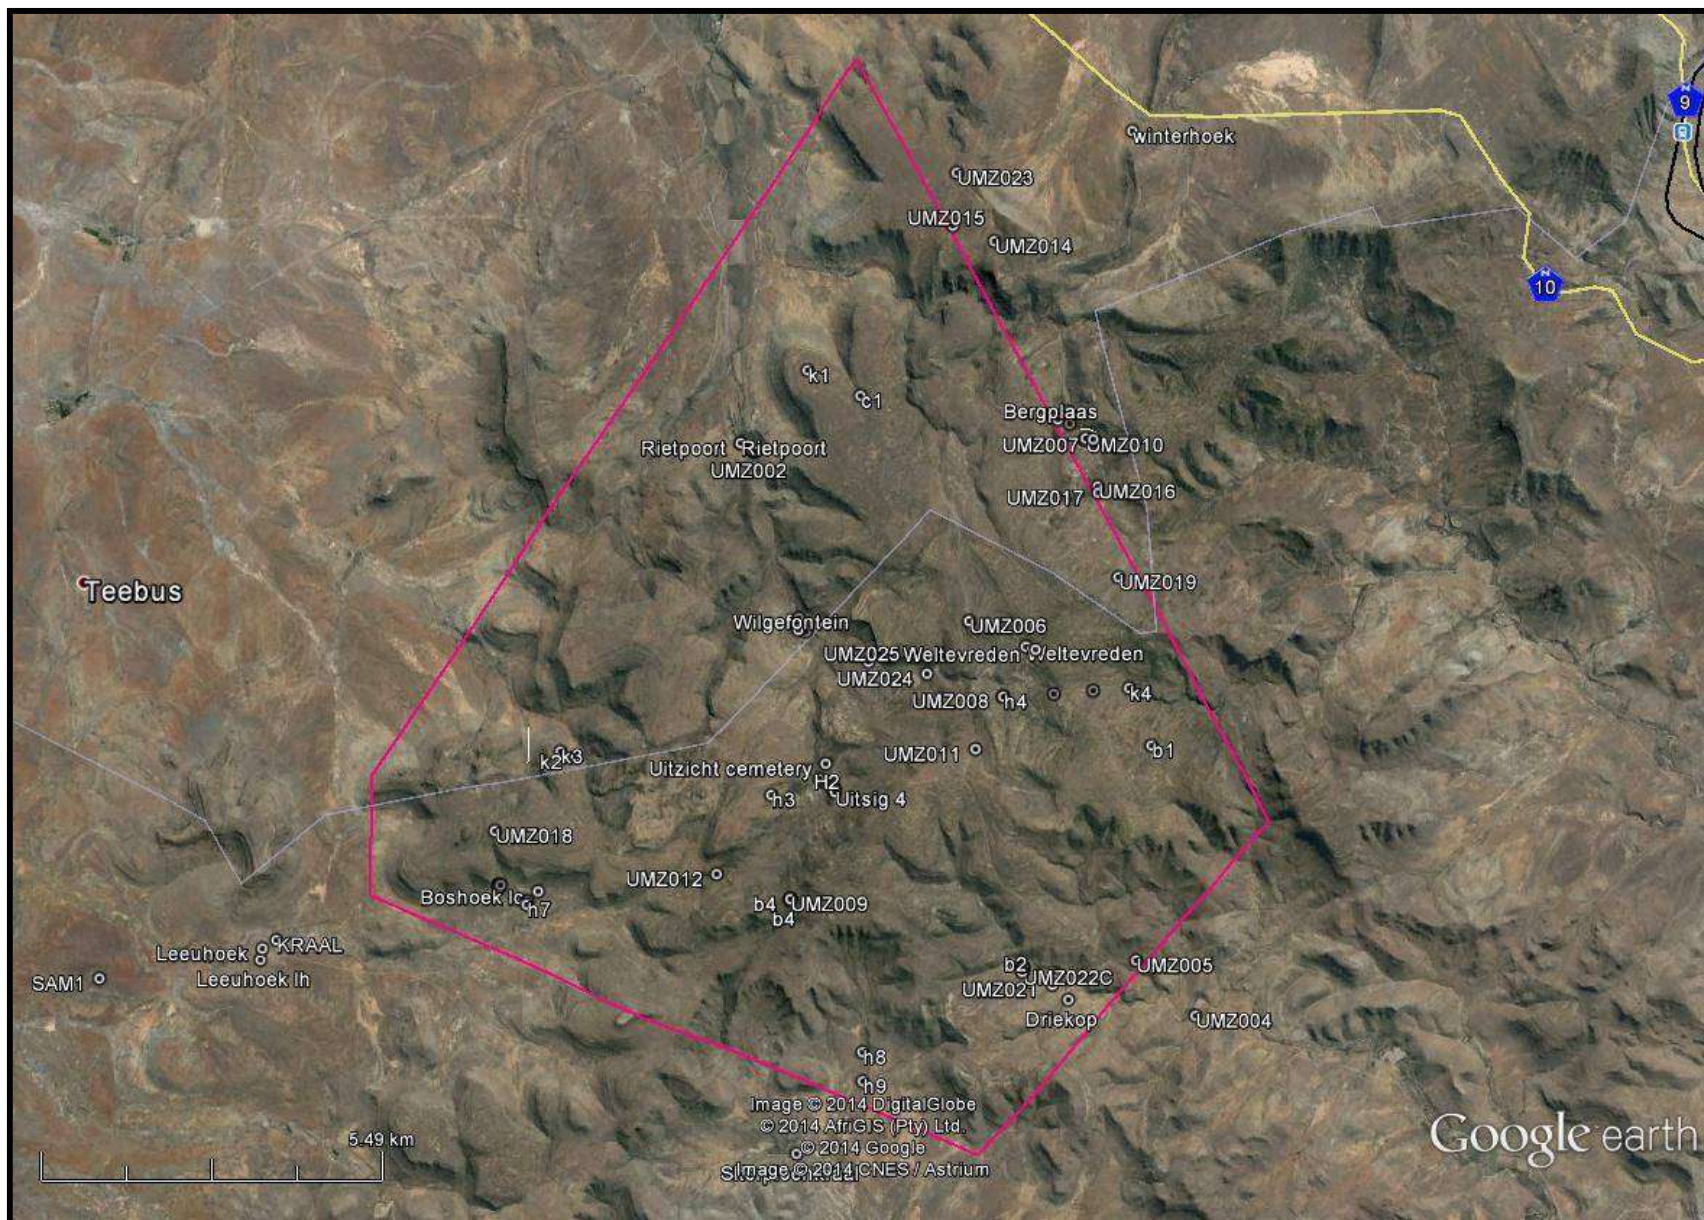
FIG. 8: LOCATION OF RECORDED HERITAGE SITES

Table 2 lists the sites recorded during the field survey. Figure 7 shows some of the general views of areas most likely to be effected. Figure 8 shows the location of the recorded heritage sites.

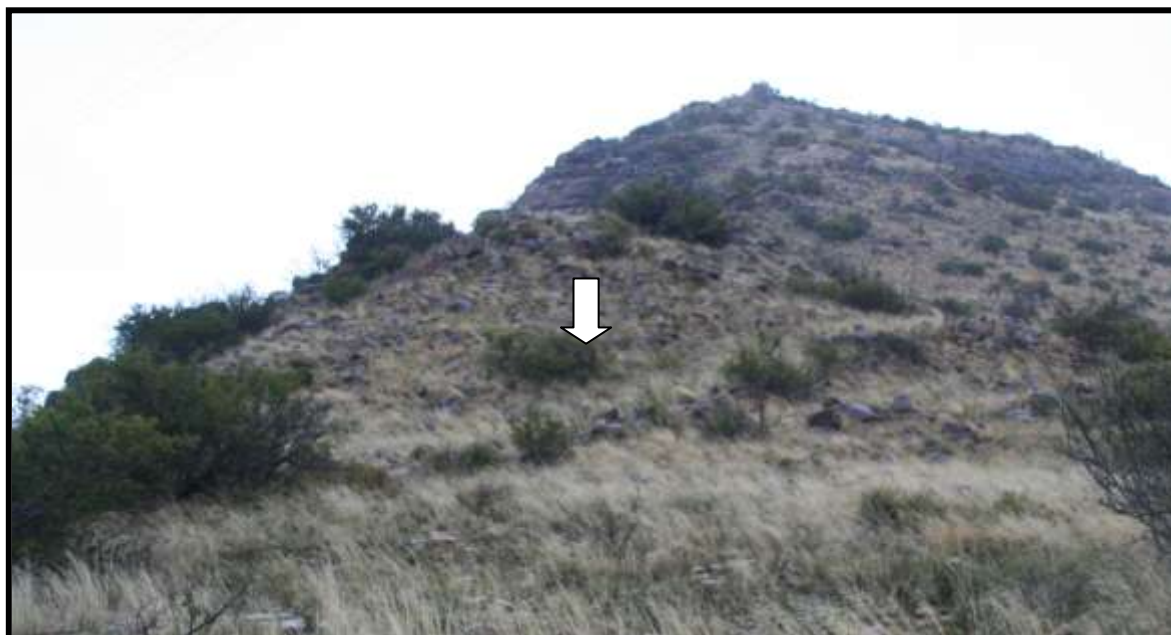
FIG. 9: STONE WALLING AT UMZ001

The site is located near the beginning of the Rietpoort Pass. The site consists of a single stone walled kraal located halfway up a small hill. The kraal is on the slope of the hill and is broken in places (fig 9.). The kraal is ~7m in diameter with varied height. The access road will negatively affect the kraal if it is placed here.

SAHRA Rating: 3C

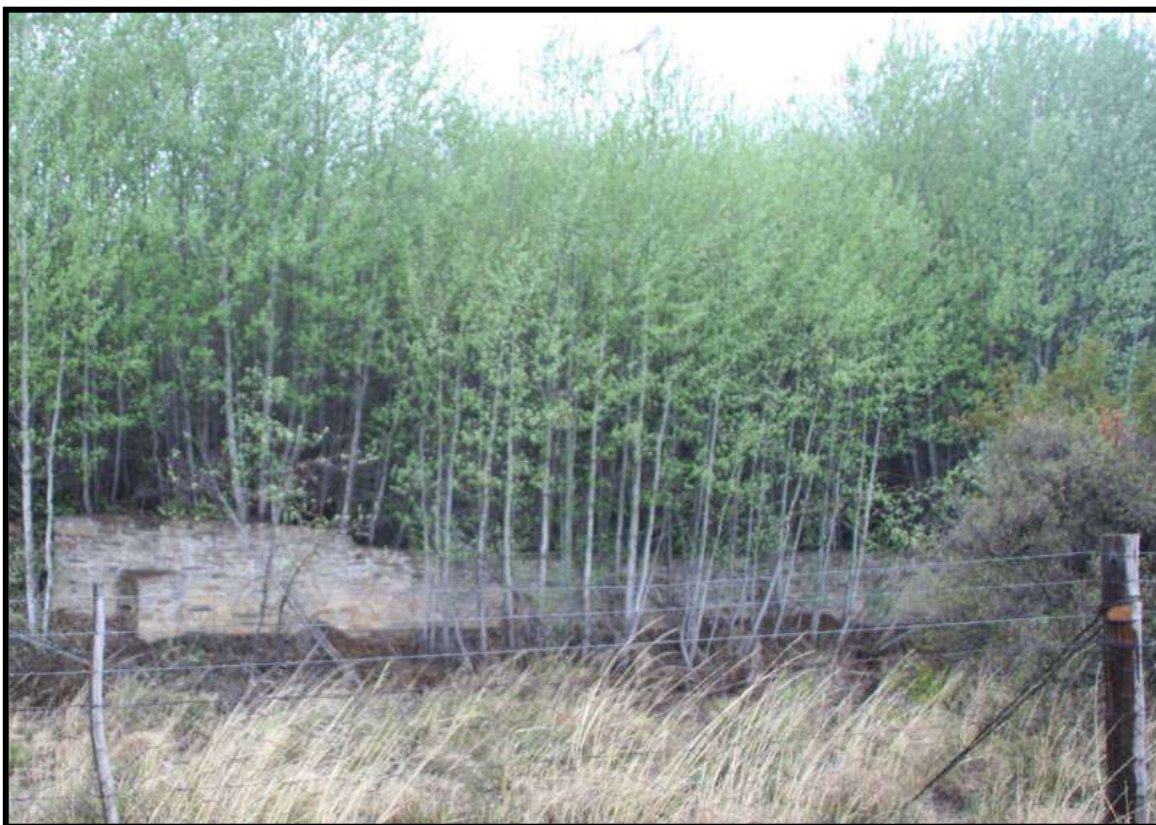
FIG. 10: WALLING AT UMZ002

The site is located directly opposite UMZ002 on the eastern side of the river. The site is a stone walled feature that is probably an old retaining wall (fig. 10). Elm trees currently surround the site.

SAHRA Rating: 3C

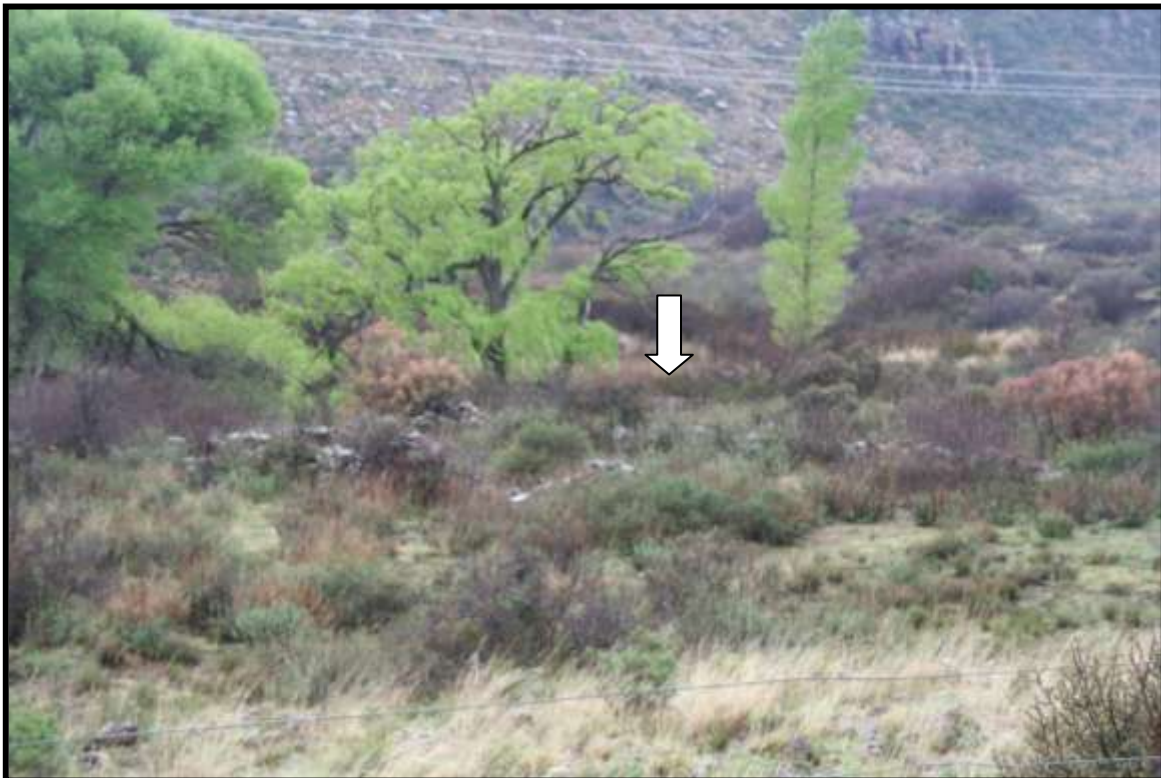
FIG. 11: WALLING AT UMZ003

The site is located ~35m east of the existing road, near a river. The site consists of a stone walled kraal 30m x 10m in size. There are several secondary walls within the main enclosures (fig. 11).

SAHRA Rating: 3C

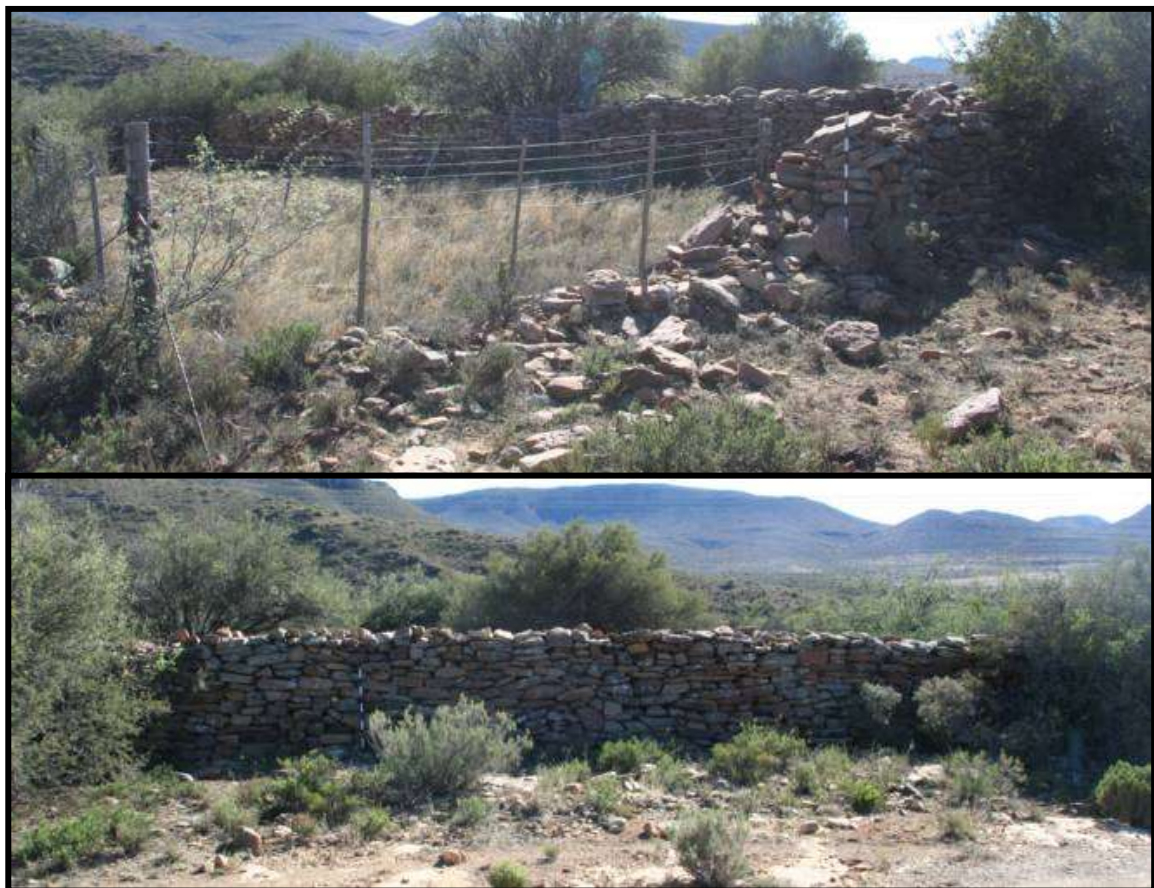
FIG. 12: STONE WALLED KRAAL AT UMZ004

The site is located on a raised area just above a stream. The site consists of a rectangular stone walled kraal that is 35m x 25m inside (fig. 12). There are secondary walls attached to the western wall. The kraal is still in use today. The kraal appears to be similar to other kraals in the area and may be older than 60 years. UMZ004 is located within 5m of the existing road, and will be damaged if the main access road is placed here.

SAHRA Rating: 3C

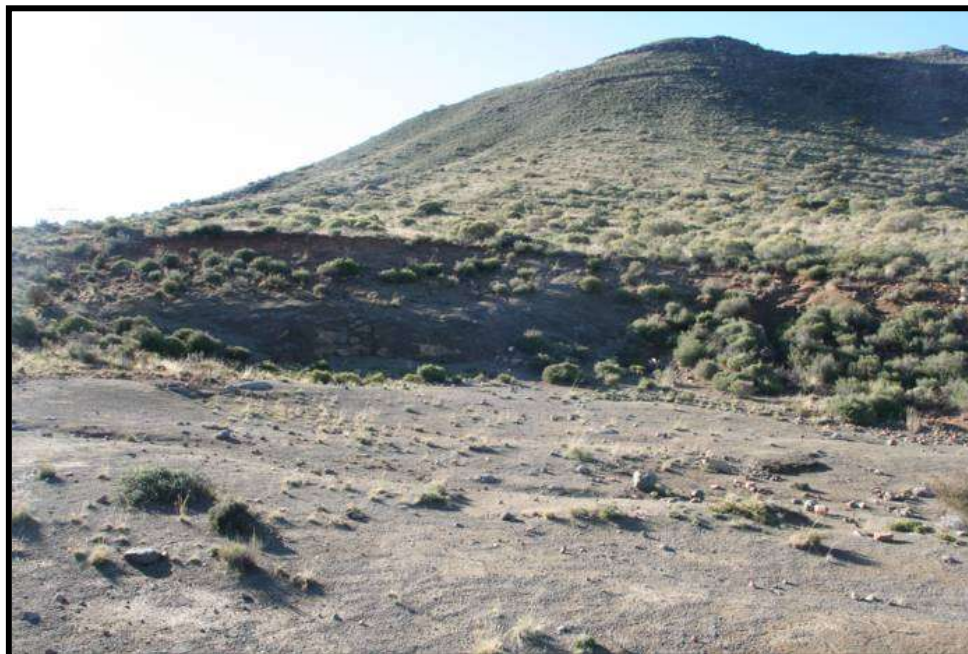
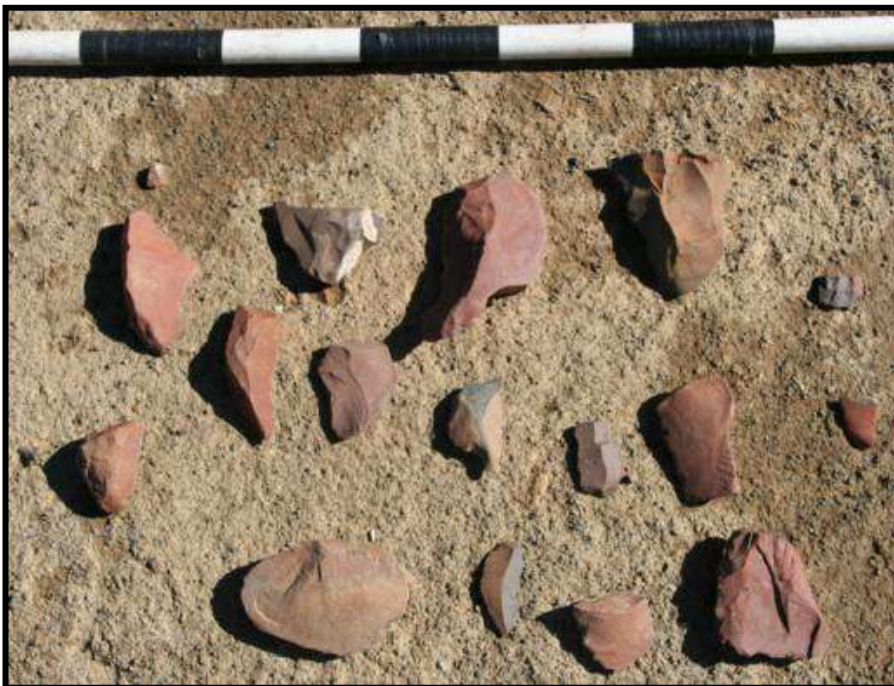
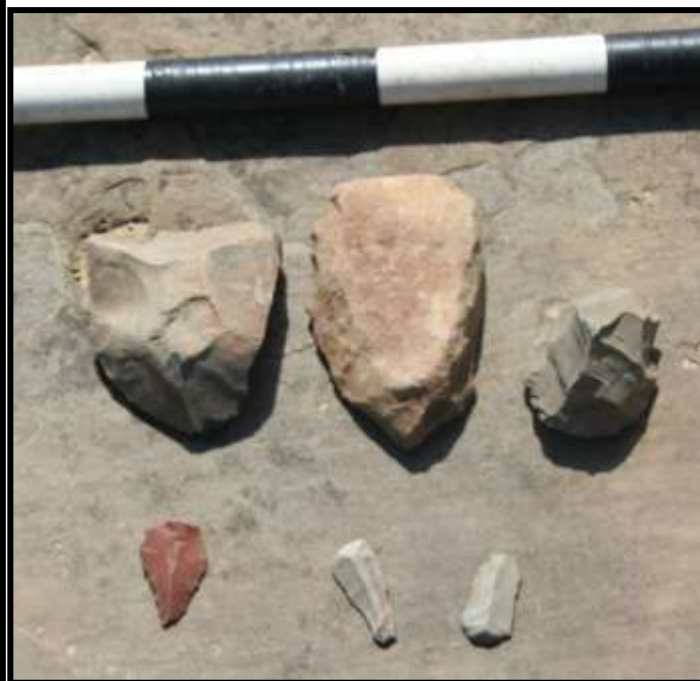
FIG. 13: STONE TOOLS AT UMZ005

UMZ06 is located on a flattened area halfway down the mountain. The area has been exposed by a borrow pit that allows for stone tools to wash down the slopes and become exposed (fig. 13). The site extends across the entire hillside. The site consists of stone tools made from hornfels that date to the Early Stone Age (ESA), Middle Stone Age, and Late Stone Age. These include:

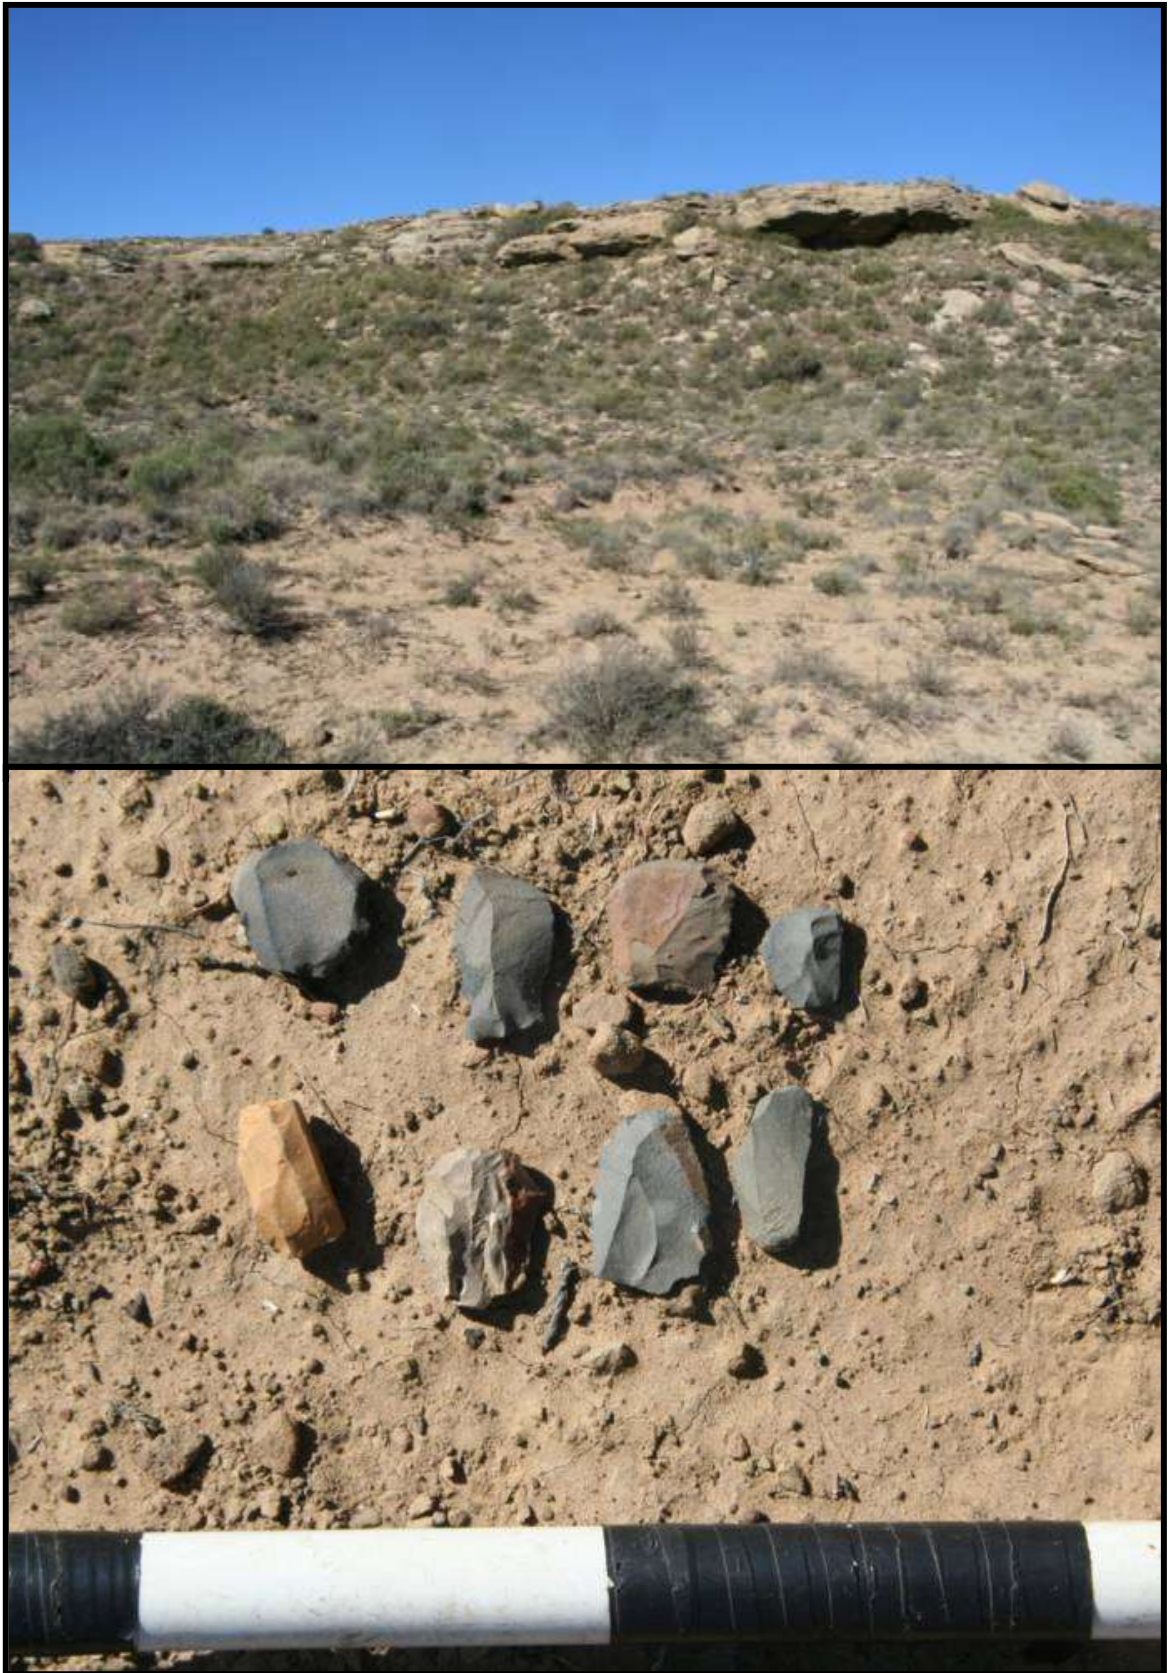
FIG. 14: STONE TOOLS AT UMZ006

The site is located at the head of a valley at ~1800m asl. The site consists of a flat area with several small overhangs just above the stone scatters. These shelters do not have any deposit and are less than 1m in depth (fig. 14). The artefacts are found at the base of the hill towards the edge of the cliffs in a sandy soil. The scatters have been slightly affected by an Eskom transmission line.

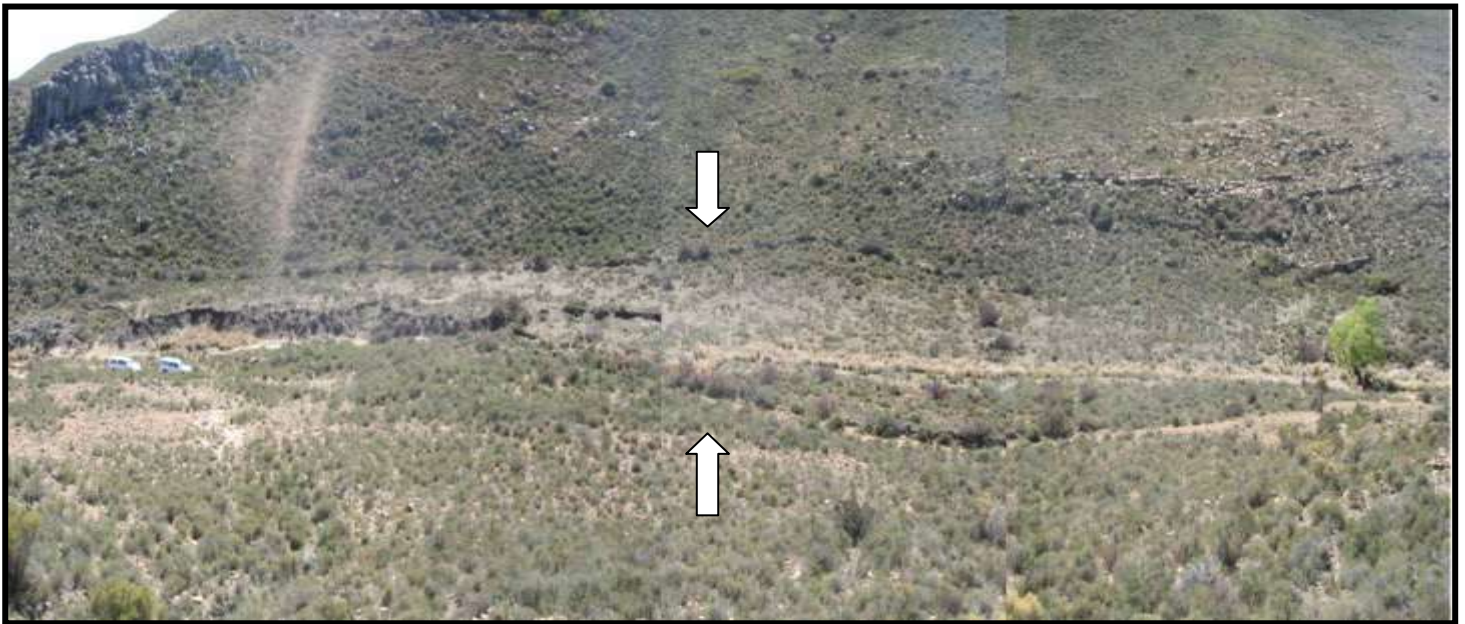
FIG. 15: WALLING AT UMZ007

UMZ007 is located ~400m southeast of Bergplaas. The site is a long stone wall that appears to be built around both sides of the river (fig. 15). The walling forms a rough rectangle ~250m x 75m in size. The walling appears to be that of an old kraal and is probably related to the farm Bergplaas. The walling will form part of the cultural landscape.

SAHRA Rating: 3C

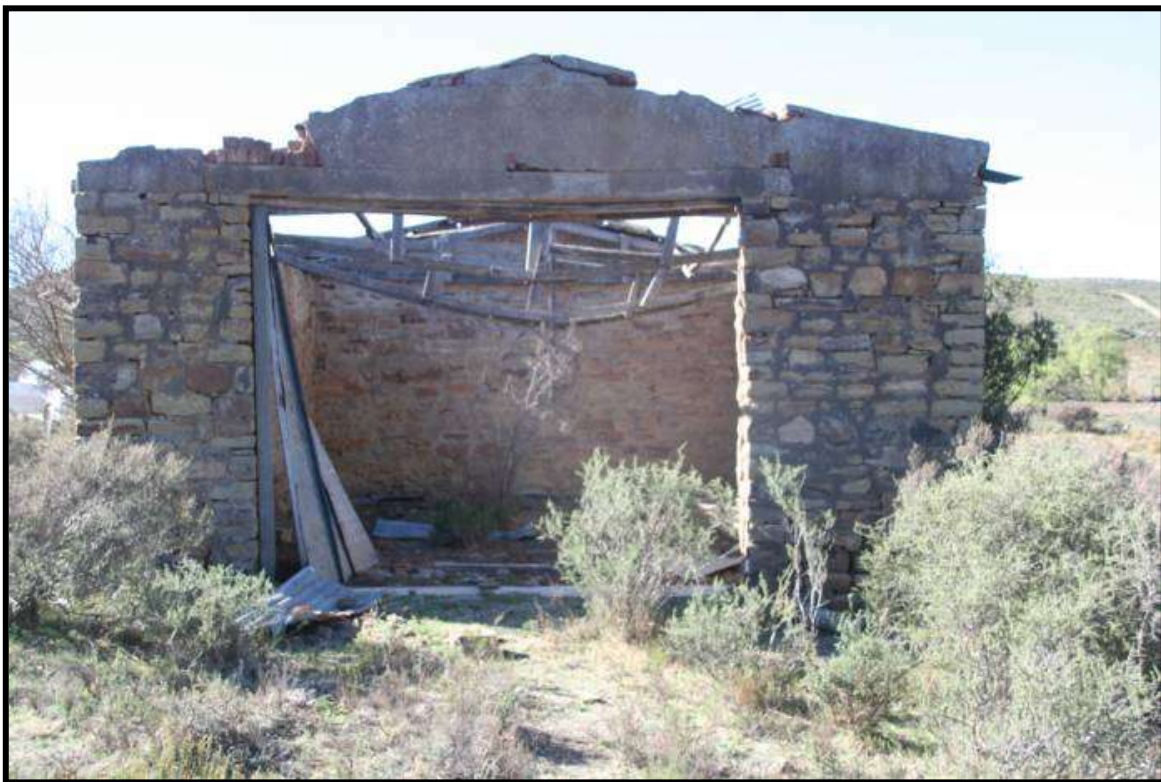
FIG. 16: SHED AT UMZ008

The site is located just above a dam. UMZ008 consists of a shed that is now a ruin and is 10m x 8m in size (fig. 16). The shed was built with local raw materials and with dry stone walling. Plaster was added more recently as was the roof. The lintel is made of a cement mixture; however, this may be a more recent addition, as there are more recent bricks above it. There are stelae near the shed. The shed is probably related to the farm Weltevreden.

SAHRA Rating: 3C

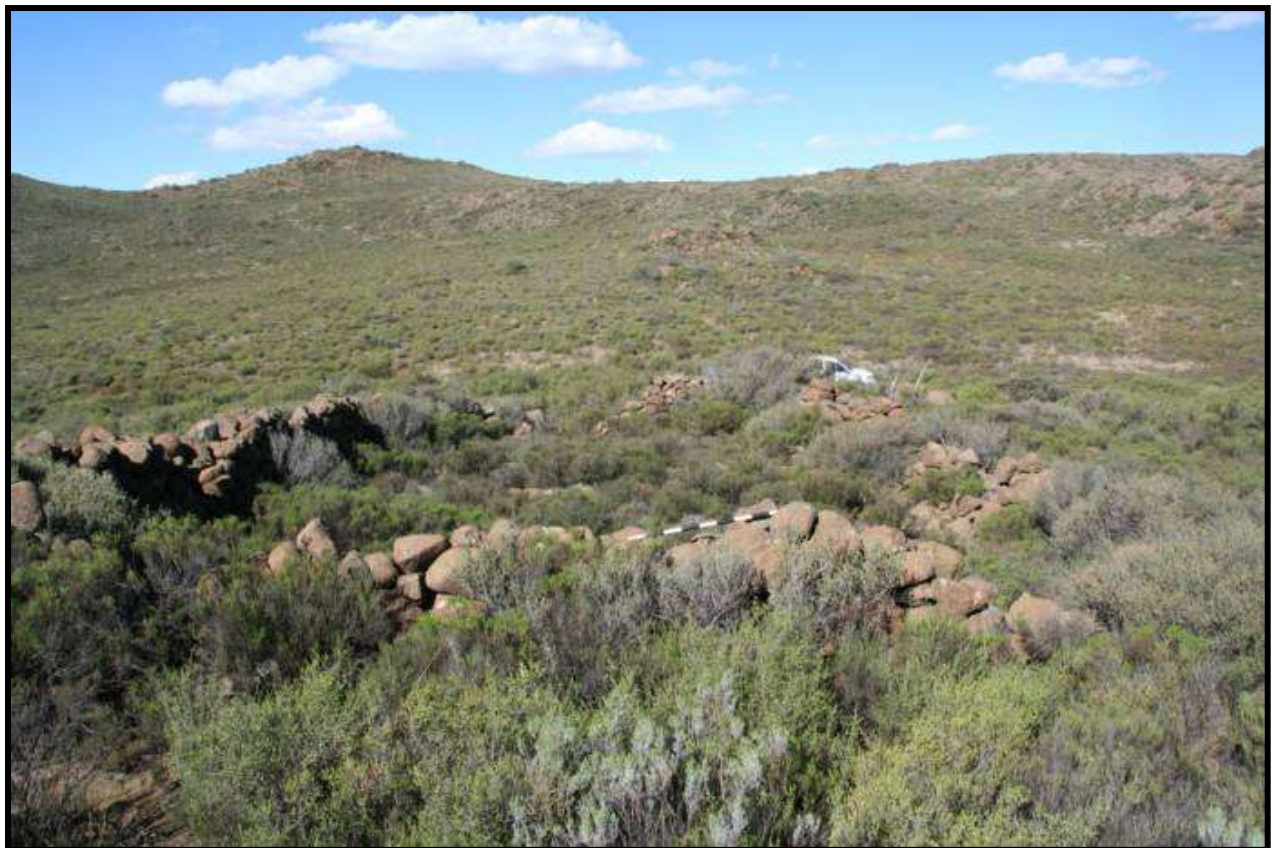
FIG. 17: RECTANGULAR KRAAL AT UMZ009

The site is located at the head of a valley and consists of two stone walled kraals. The main kraal is rectangular and 20m x 10m in size (fig. 17). The smaller kraal occurs 20m to the northeast and is ~12m in diameter. Both kraals are no longer in use.

SAHRA Rating: 3C

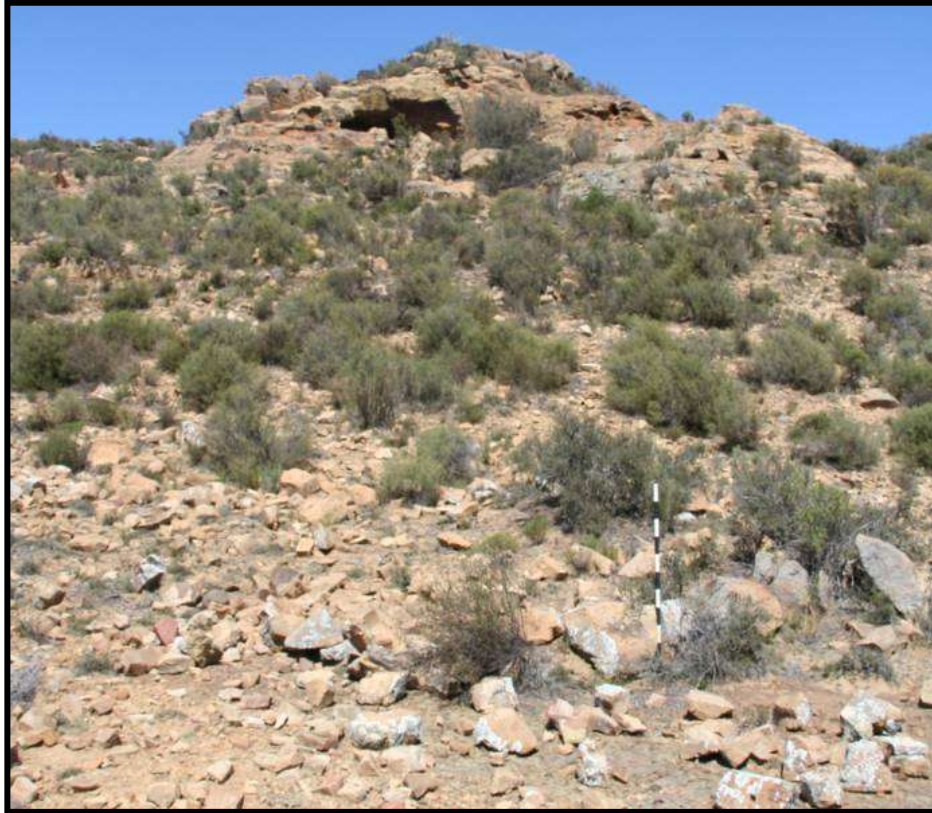
FIG. 18: WALLING AND OVERHANG AT UMZ010

The site is located 500m southeast of Bergplaas and uphill of UMZ007. The site has two related components (fig. 18). The first component is a ruined stone wall circle (fig.19) at the base of the hill. The kraal is circular and ~2.5m in diameter. Only the base stones remain in place while the others have fallen over. Several artefacts occur in the general area that includes generic LSA stone tools, glass, metal and ceramics. These tend to be 20th century artefacts.

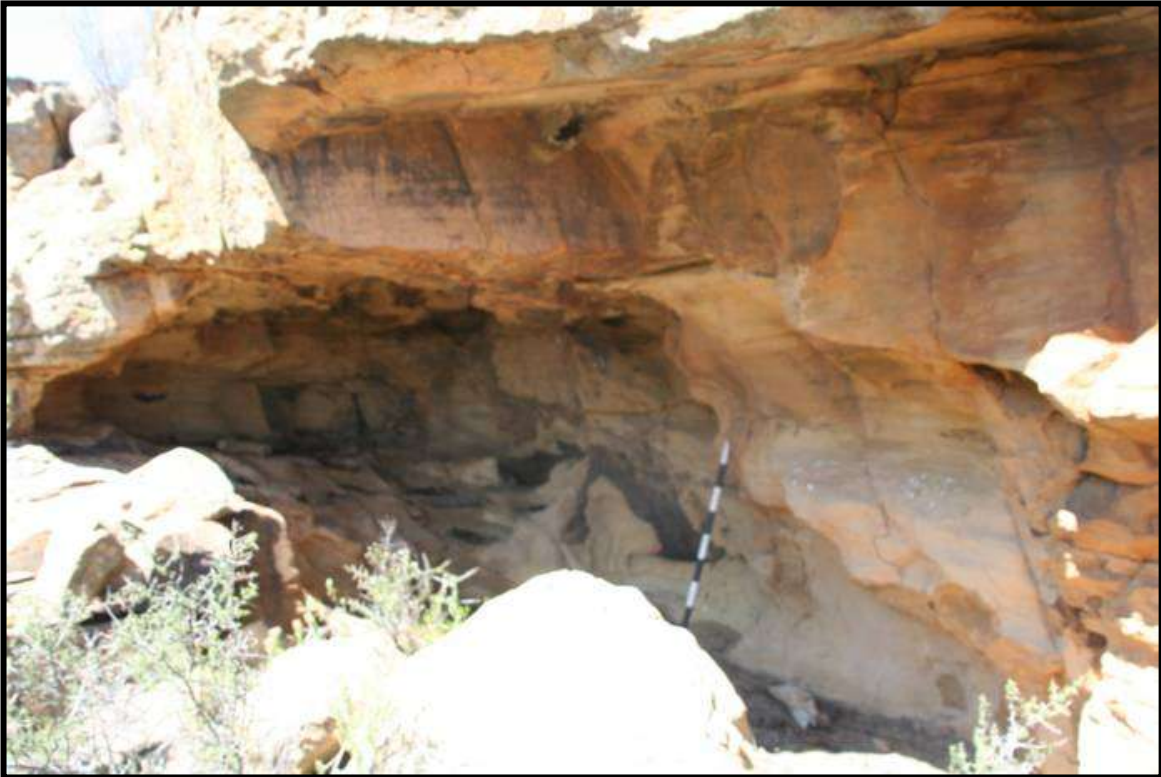
FIG. 20: SHELTER AT UMZ010

A further 30m uphill is a small overhang with a possible wall at the entrance. The overhang is ~3m wide, 1.5m deep and 1.5m high (fig. 20). There is a sandy deposit where two stone tools were noted on the surface. The overhang is in a sandstone ridge that has been heavily eroded by the wind. There is charcoal scratching on the western wall. On the southern wall is a very faded red antelope in the fine-line tradition: it is probably an eland (fig. 21).

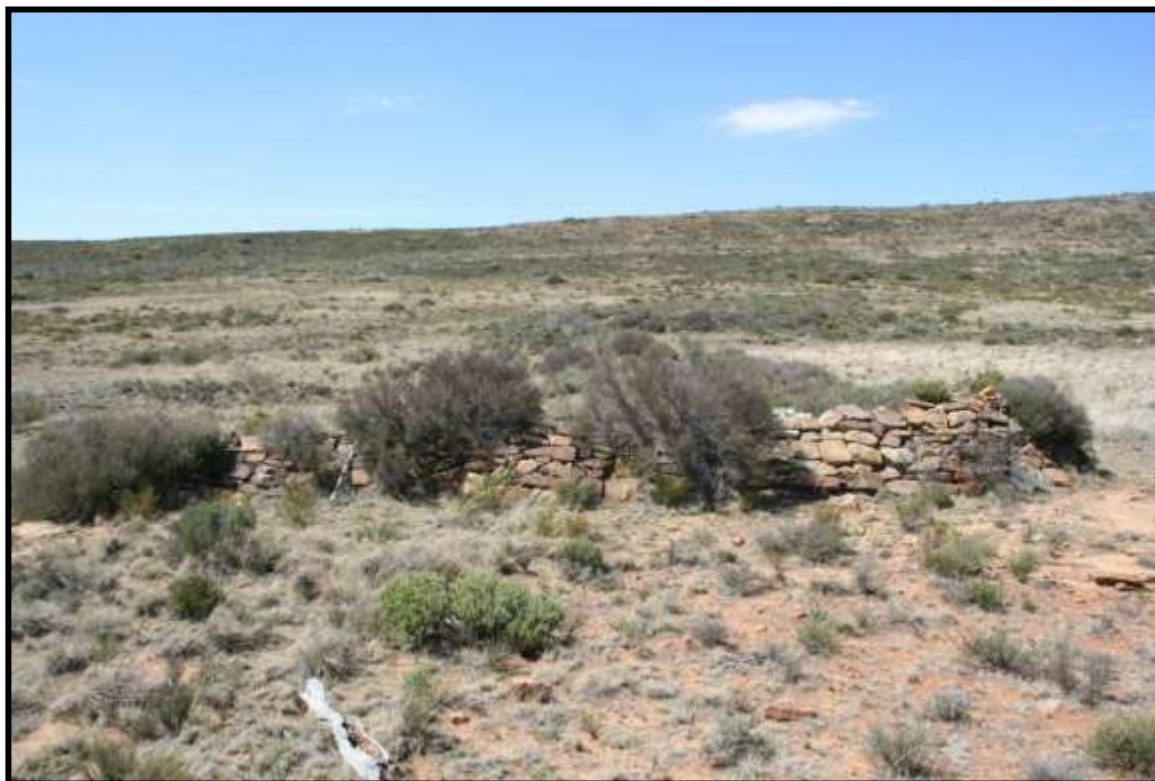
FIG. 22: SUPPORTING DAM WALL AT UMZ011

The site is located in a small valley within a riverbed. UMZ011 is a reinforced dam wall and an example of most dam walls in the area. The wall is an earthen wall that is reinforced with dry stone walling on the side (fig. 22). The age of each wall will vary but they are probably older than 60 years. The reinforced dam walls are examples of farming practices.

SAHRA Rating: 3C

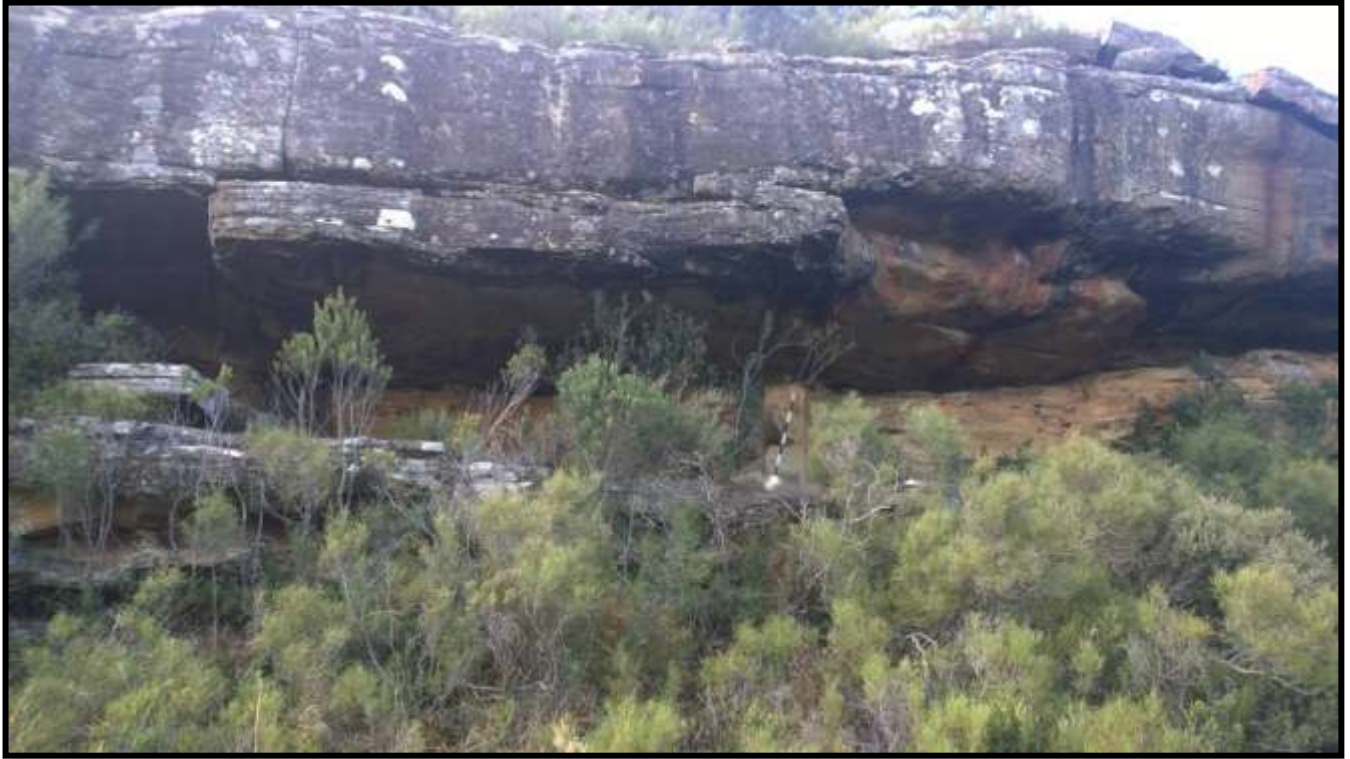
FIG. 23: OVERHANG AT UMZ012¹

UMZ012 is a small overhang 1.5m x 2m x 8m that is located near the top of the valley, on a sandstone ridge (fig. 23). The shelter has a minimal deposit that occurs in the front of the overhang. There is an upper and lower grinding stone on the surface; however, there are no stone tools. The ridge above the shelter has many LSA stone tools. The art consists of three main panels. The first panel is located on the left of the shelter (fig. 24). The panel consists of a black amorphous object with five limbs – there are presumably six, but the one is covered with calcium. The image appears to be a bag with tassels. The ‘bag’ is painted in the fine line tradition. To the right of the ‘bag’ is a horizontal row of 20+ short finger smears in red.

SAHRA Rating: 3A

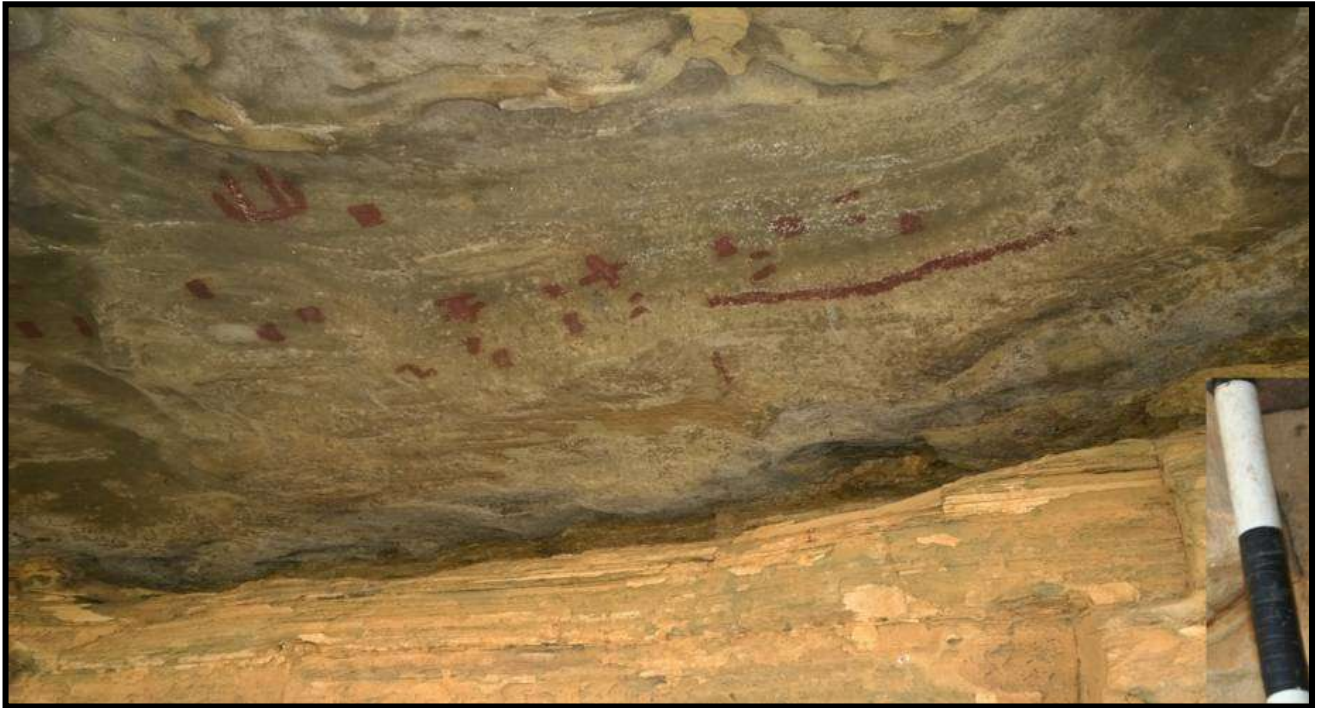
FIG. 25: RED IMAGES AT UMZ012

The second panel is also a combination of fine line and finger painted images. The finger-painted images dominate the panel and consist of several rectangles, finger smears, one long line, two crosses and an indeterminate symbol (fig. 25). Some of these images have been scratched. Below the middle ‘cross’ and to the right of a finger smears is a male painted in black with two small antelope to the right. These three images are in the fine line tradition. There is a black smear above the cross in similar paint to that of the male.

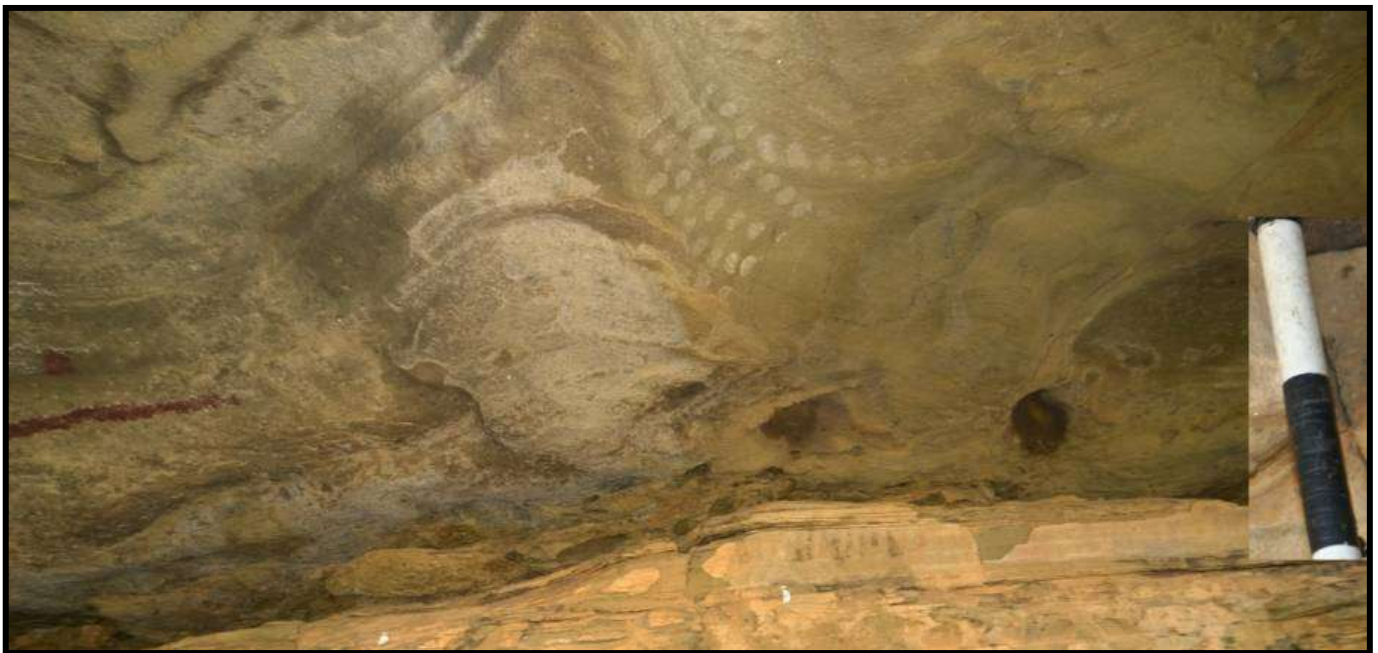
FIG. 26: WHITE FINGER DOTS AT UMZ012

The third panel occurs to the right of panel three, and in a small alcove. The panel consists of white fingers dots and a fine line male painted black (fig. 26). The finger dots occur in five horizontal rows. The male occurs to the right of the finger dots and has someone has encircled him with charcoal ‘graffiti’. This ‘graffiti’ is similar to that at UMZ010.

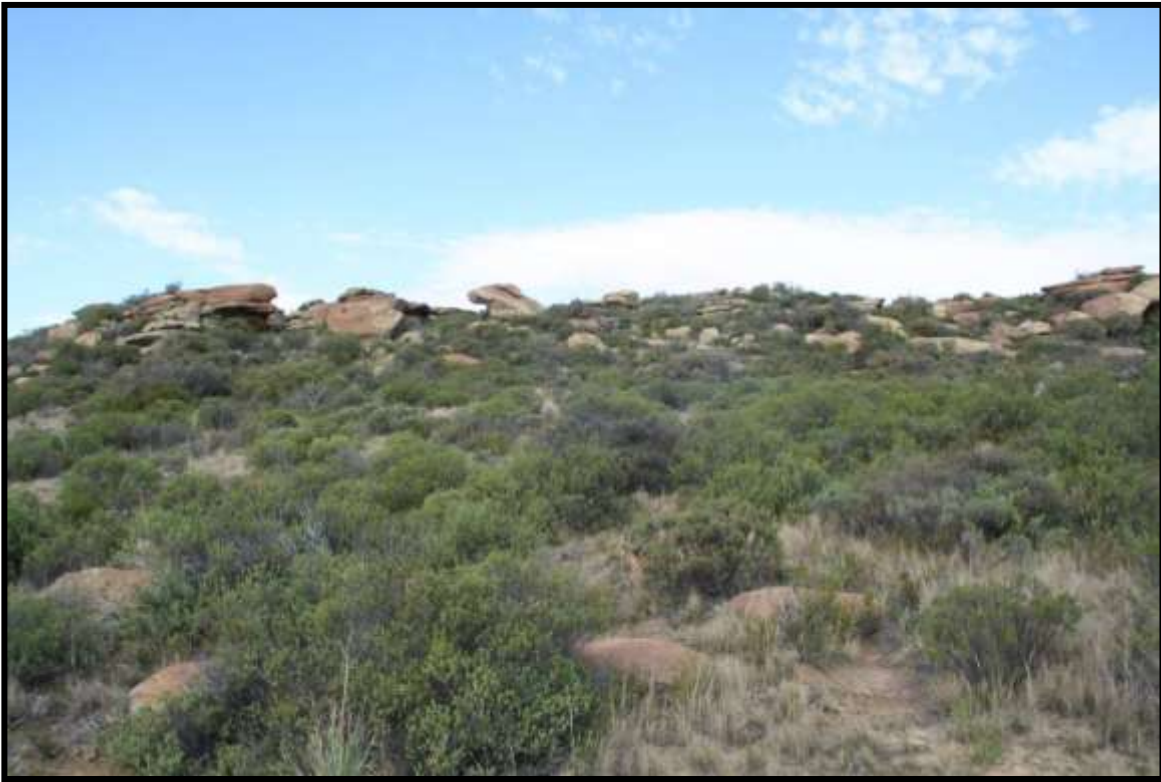
FIG. 27: GENERAL VIEW OF UMZ013

The site is located on a flattened surface at the base of a small outcrop (fig. 27). There are several small overhangs at the outcrop; however, none of these has deposit. The stone tool scatter occurs at the base of the outcrop and extends for an area of ~100m x 30m: it is not a dense scatter. The stone tools are all made from hornfels and consist of single platform cores, flakes, utilised flakes, a scraper-adze, and a double-sided adze (fig. 28). All of these are LSA tools; however, some are made from MSA flakes. The tools vary in degrees of patination.
