**HERITAGE SURVEY OF THE UMSOBOMVU WIND
ENERGY FACILITY, EASTERN AND NORTHERN CAPE**

**FOR EOH COASTAL AND ENVIRONMENTAL
SERVICES**

DATE: 27 OCTOBER 2013

**Umlando: Archaeological Surveys and Heritage
Management**

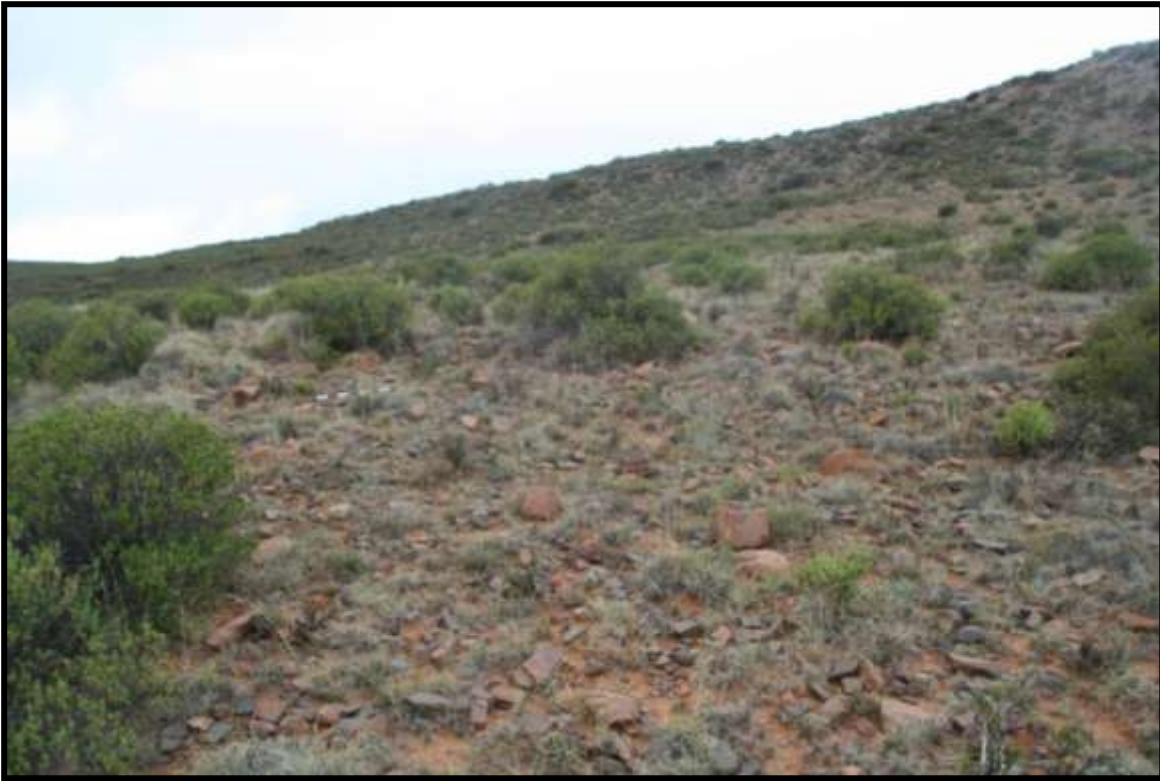
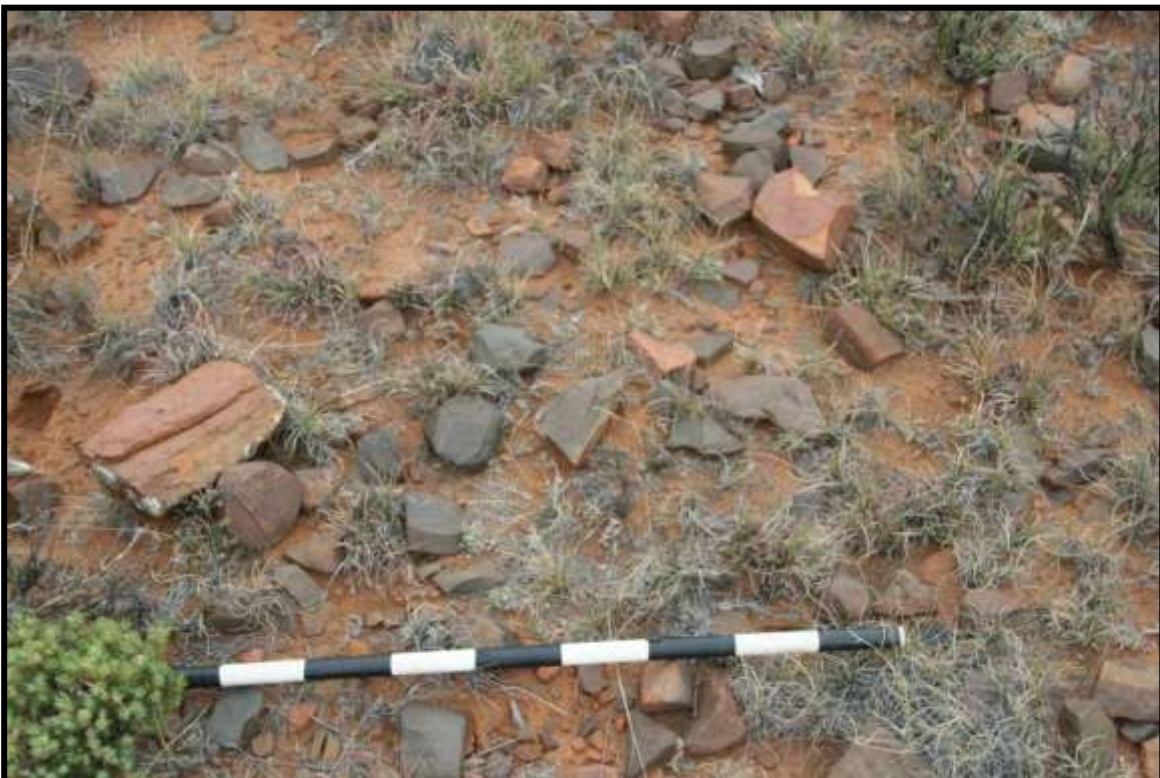
FIG. 31: GENERAL VIEW OF AND COREST AT UMZ015

The site is located ~800m downhill from UMZ014 (fig. 31). The site is situated at the flattened base of a small hill and extends over an area of 50m x 80m. The site consists of naturally occurring outcrop of loose hornfels rocks. Many of the smaller rocks have been used for cores to produce flakes. There appears to be substantially more cores than flakes in the area. The site is thus mostly a quarry site, although some stone tool knapping did occur. The site appears to date to the MSA and LSA. Given the size of the cores, it is unlikely that many are in a secondary context.

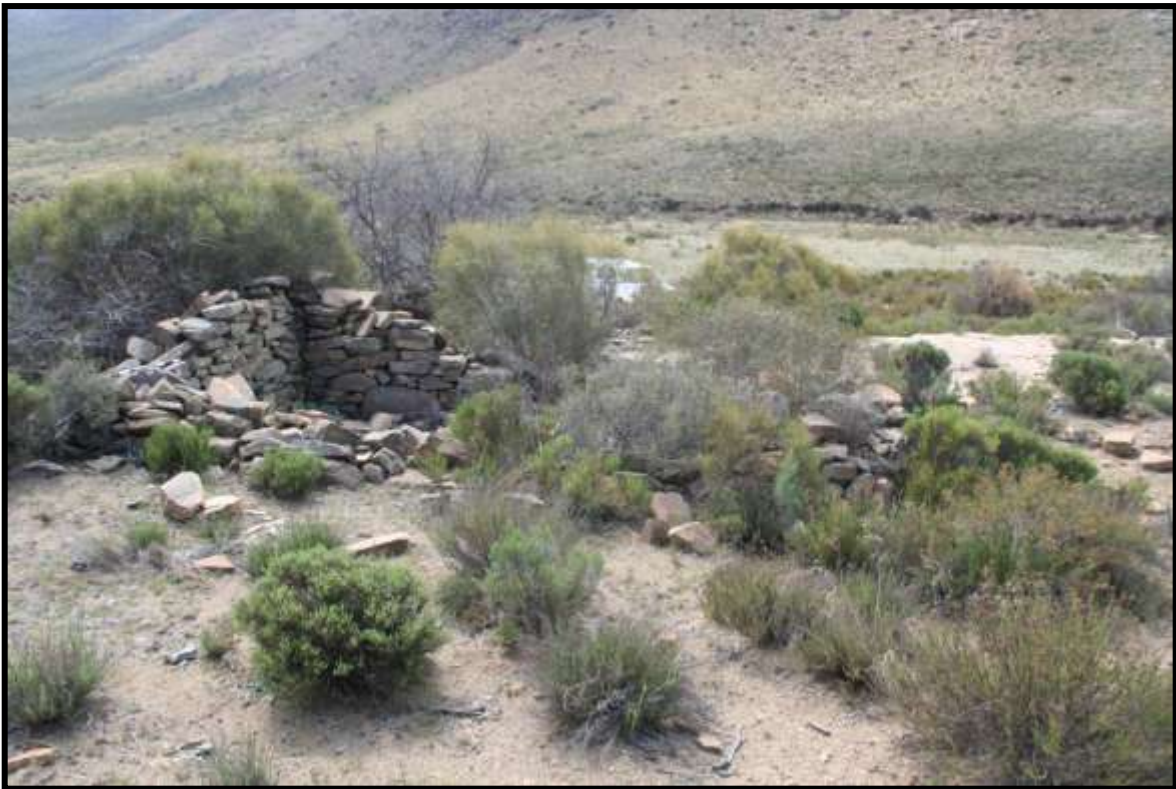
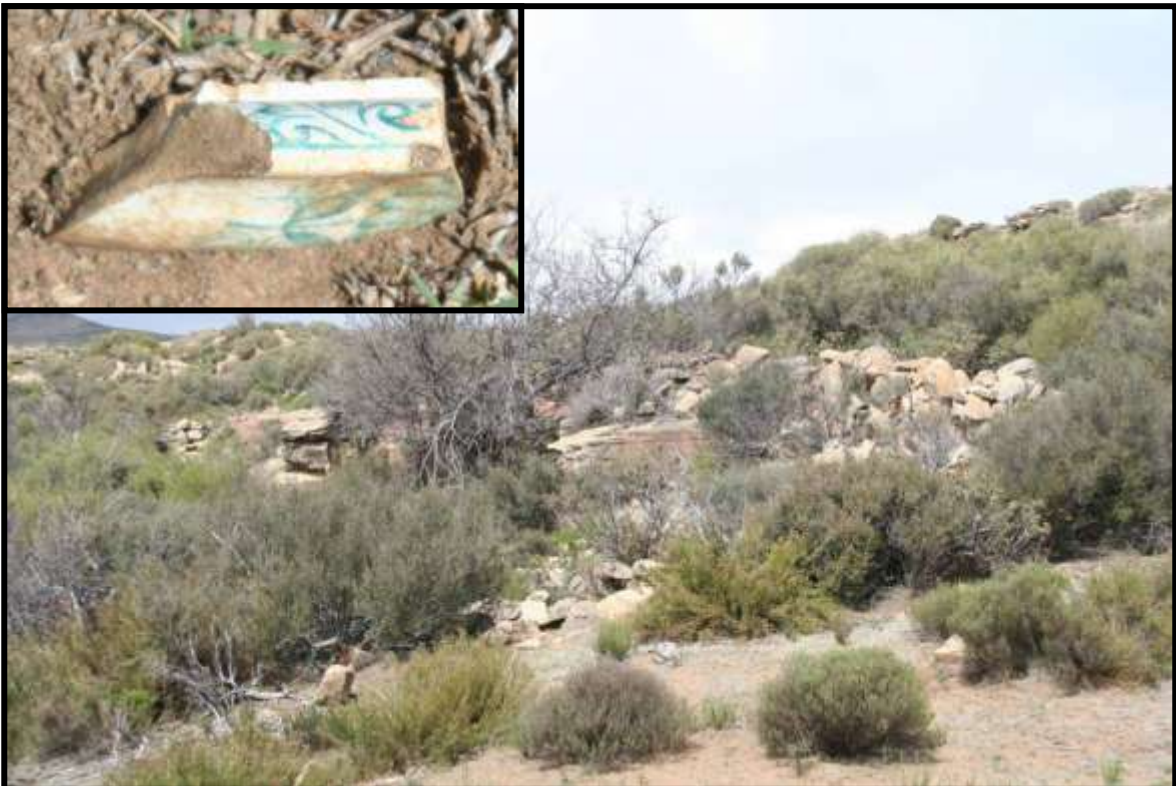
FIG. 33: STONE WALLING AND ARTEFACTS AT UMZ017

The site is located at the base of a koppie and ~ 100m south of UMZ016. The site consists of two rectangular stone walled features in front of a line of boulders that form a natural wall (fig. 33). Both kraals are 2m x 4m in size. Unlike UMZ017, there are several artefacts in front of the features including early 19th century (green) transfer print ceramics. Artefacts up to the 1970s were also observed.

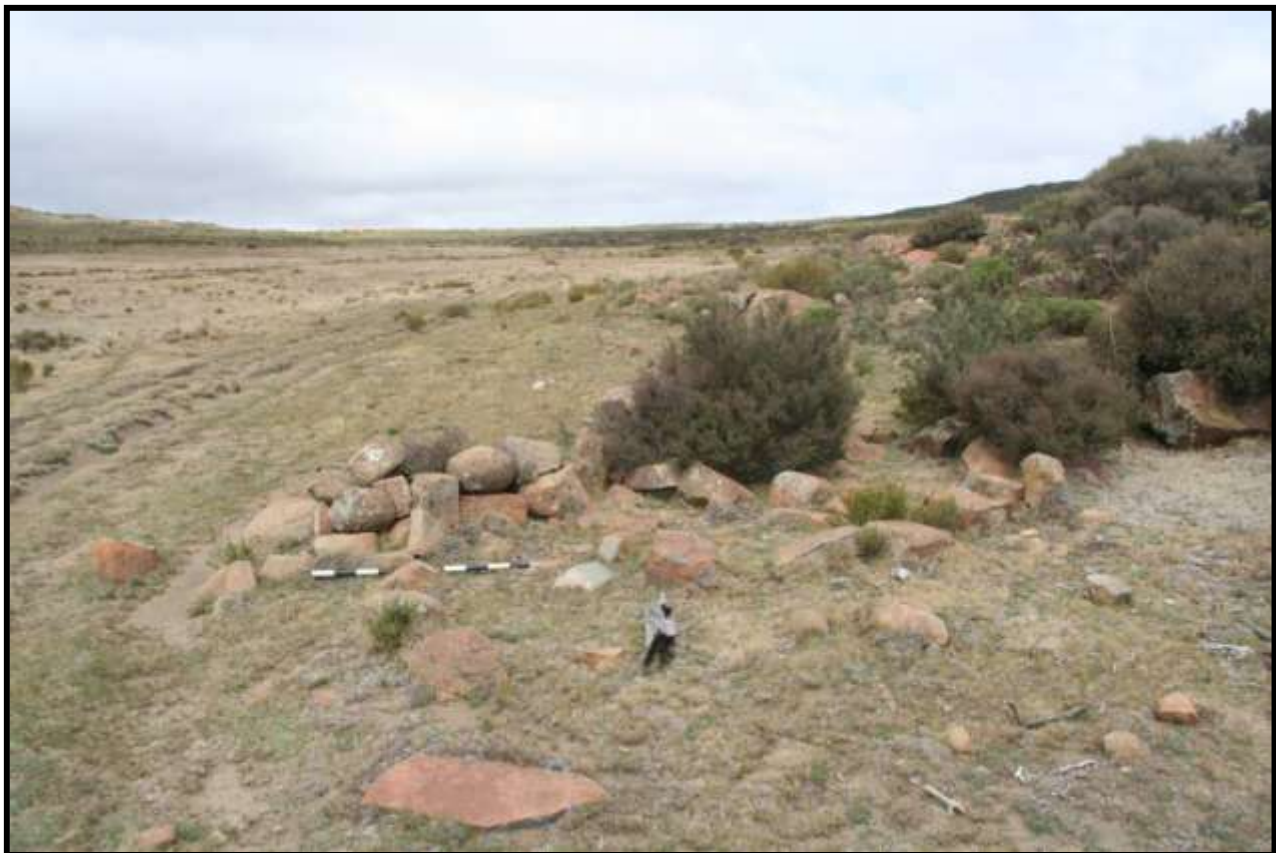
FIG. 34: STONE WALL REMAINS AT UMZ019

UMZ019 is located near the top of the mountain beside and existing track. The site consists of the remains of a stone wall that would have abutted the small rock outcrop (fig. 34). Only a few meters of the wall remain

SAHRA Rating: 3C

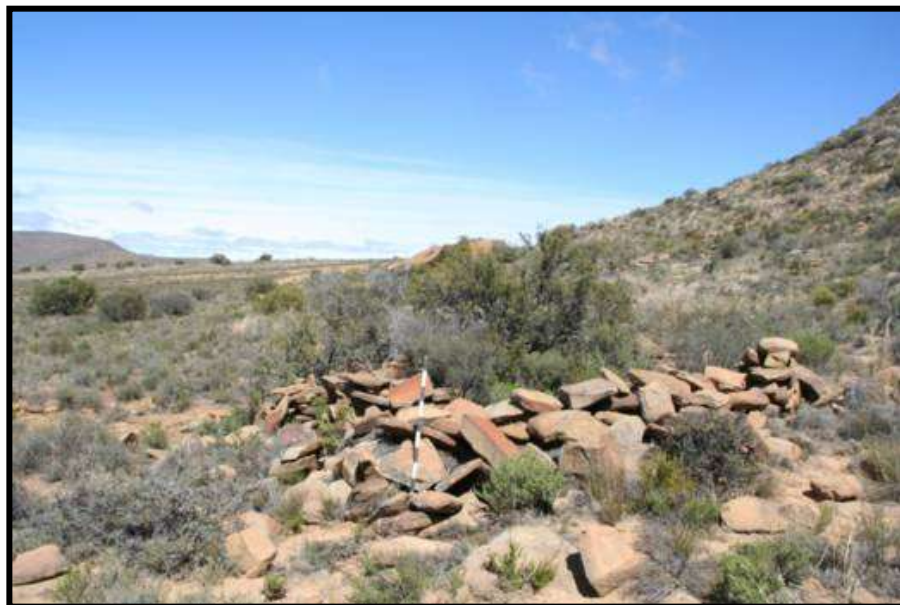
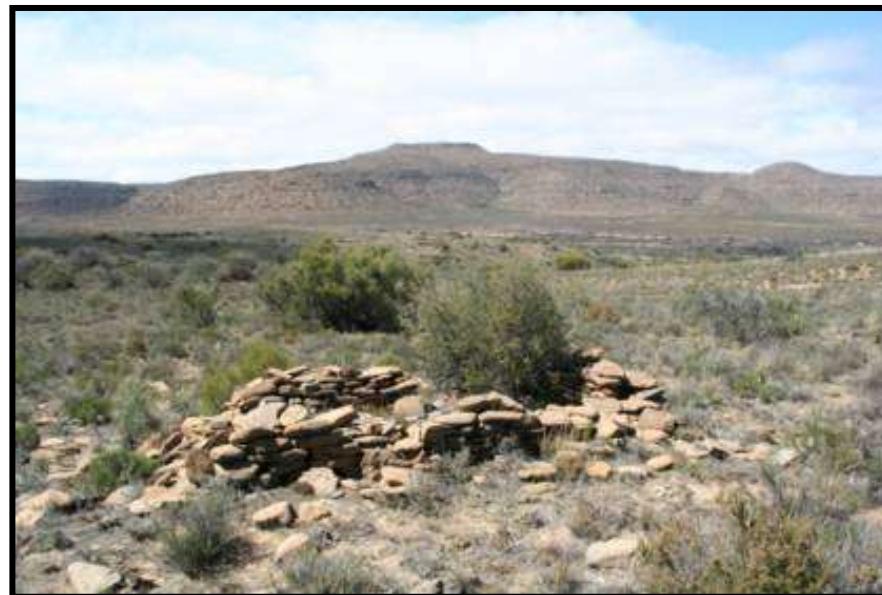
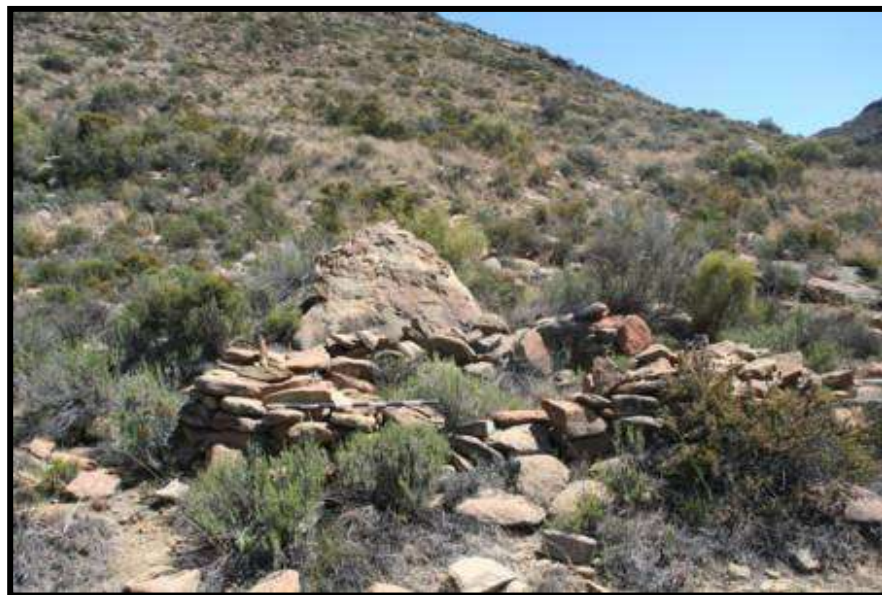
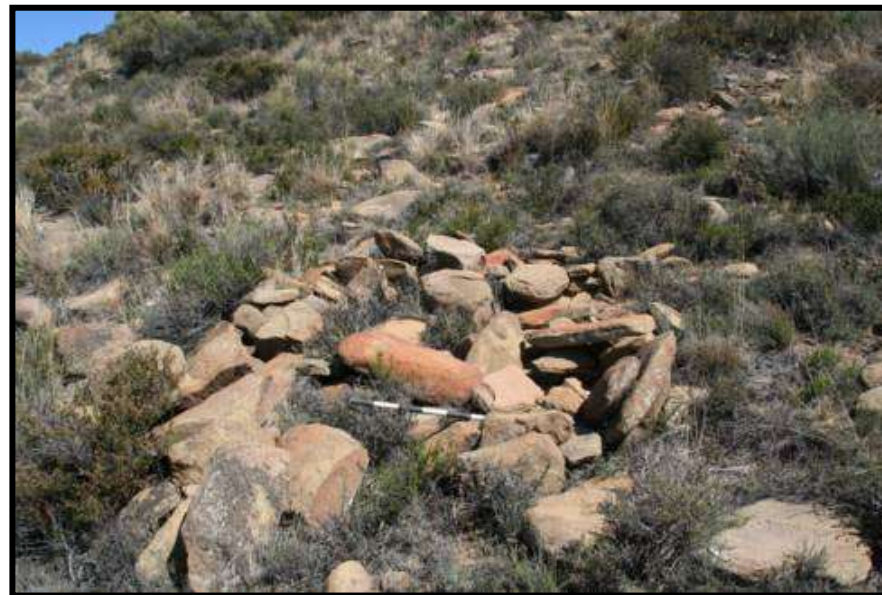
FIG. 35: STONE WALLED KRAALS AT UMZ020

The site is located at the base of a kloof that leads to UMZ018. The site consists of four stone walled kraals within a 50m radius of each other. The kraals vary in size and range from 2m radius, 2m x 2m, and two of 2m x 3m (fig. 35). These features were probably used for sheep. These kraals may or may not be related to the farm Boshhoek; however, their architecture appears to predate this farm (1950) as it is similar to several other pre-19th century stone walled features in the area.

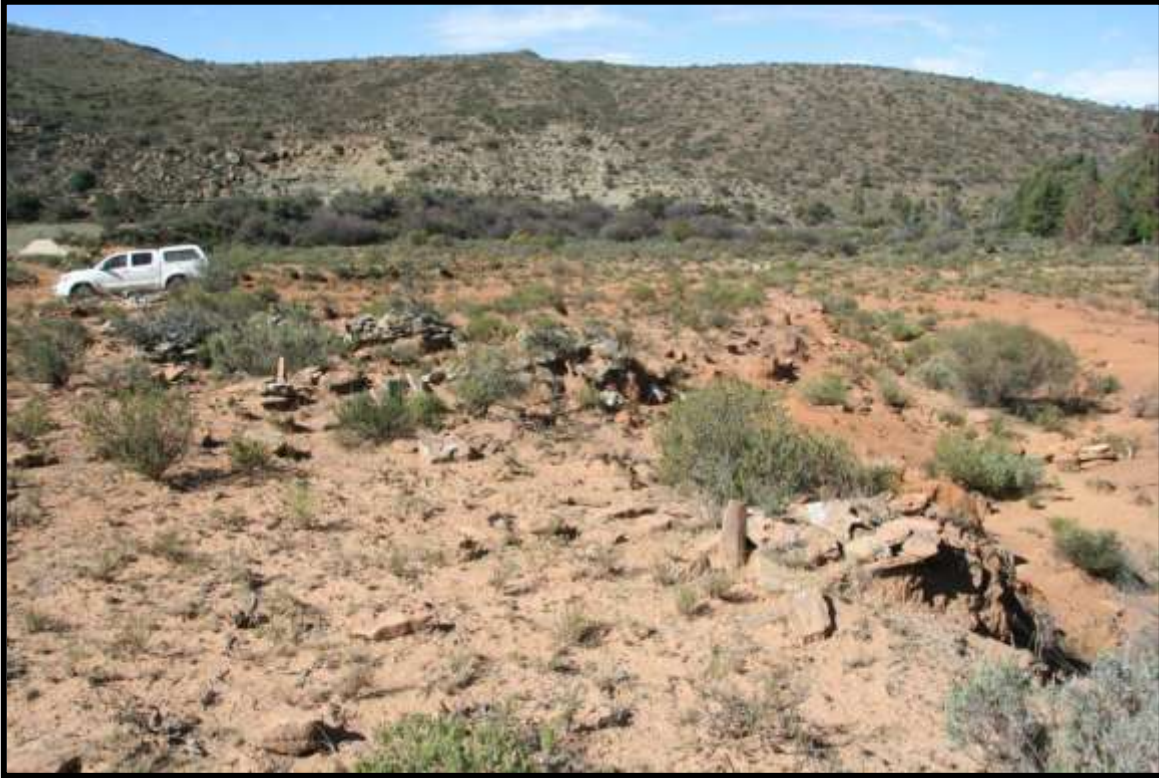
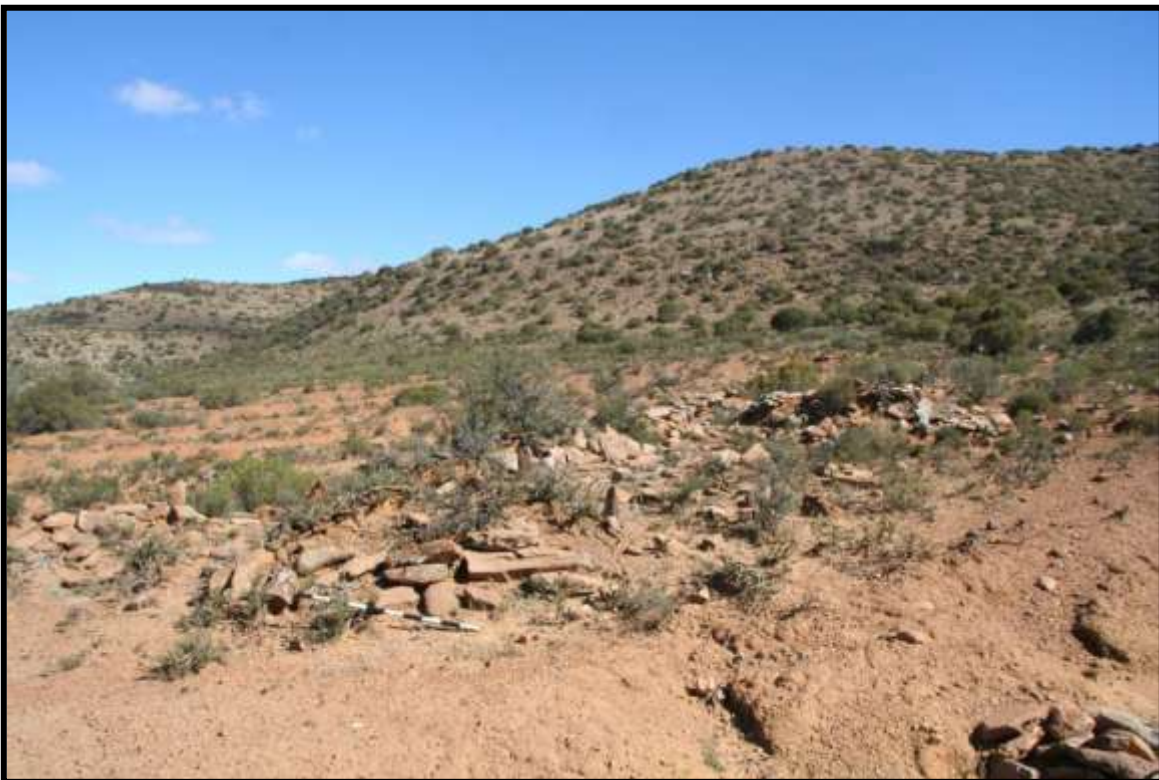
FIG. 36: GRAVES AT UMZ021

The site is located beside an erosion gully and dam, 350m northwest of the main farm buildings of Driekop. UMZ021 consists of thirteen graves. The graves consist of stone cairns with unmarked headstones that have been placed mainly on the (south) western side of the grave (fig. 36). The graves are in a poor condition and will be undercut by erosion in the near future. These graves are probably the graves of farm labourers from the original Driekop farm and are older than 60 years in age. There is an existing track is within 5m of the easternmost grave. This site is a red flag.

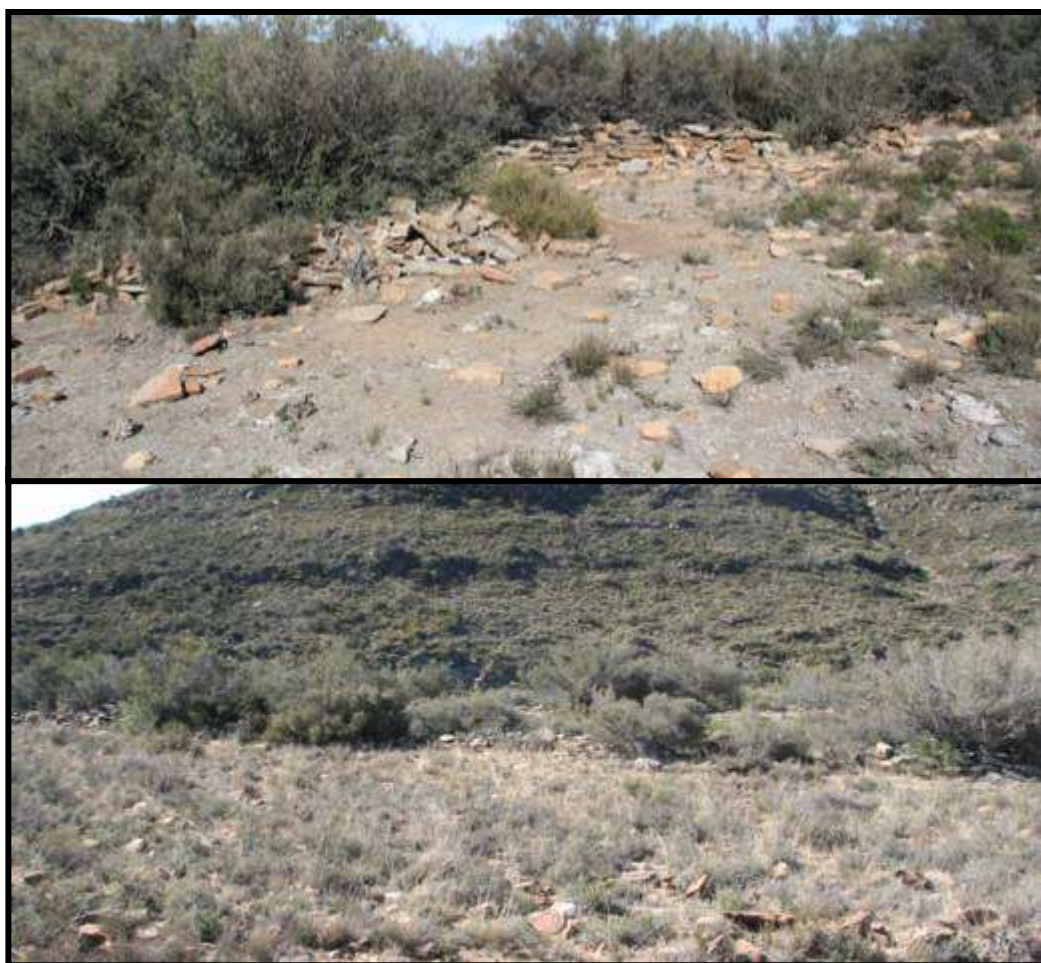
FIG. 37: STONE WALLED KRAALS AT UMZ022

The site is located halfway up the mountain in a flat area. UMZ022 consists of two stone walled kraals that are no longer in use (fig. 37). The first kraal is 30m x 20m in size while the second kraal is 30m x 30m in size and has an inner secondary wall. There is an existing track between the two kraals.

SAHRA Rating: 3C

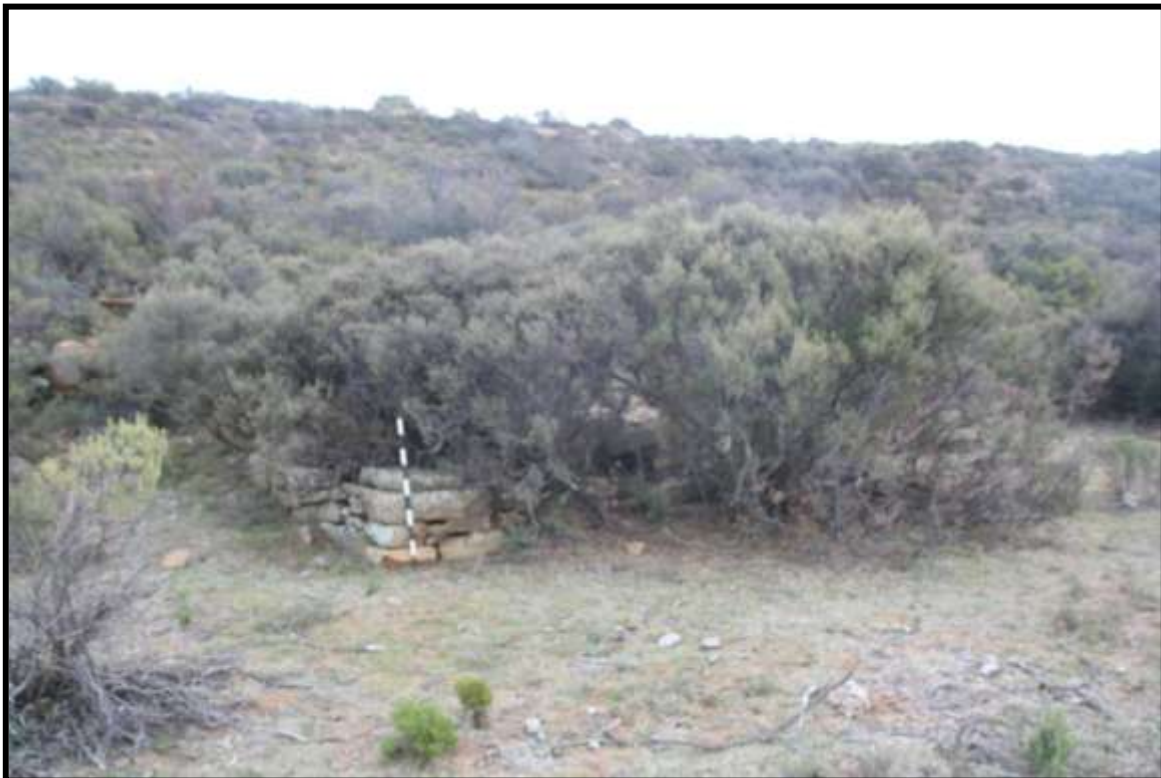
FIG. 38: STONE WALLED KRAAL AT UMZ023

The site is located at the base of a small hill. UMZ023 consists of a single stone walled kraal 3m x 4m in size (fig. 38). The kraal is no longer in use.

SAHRA Rating: 3C

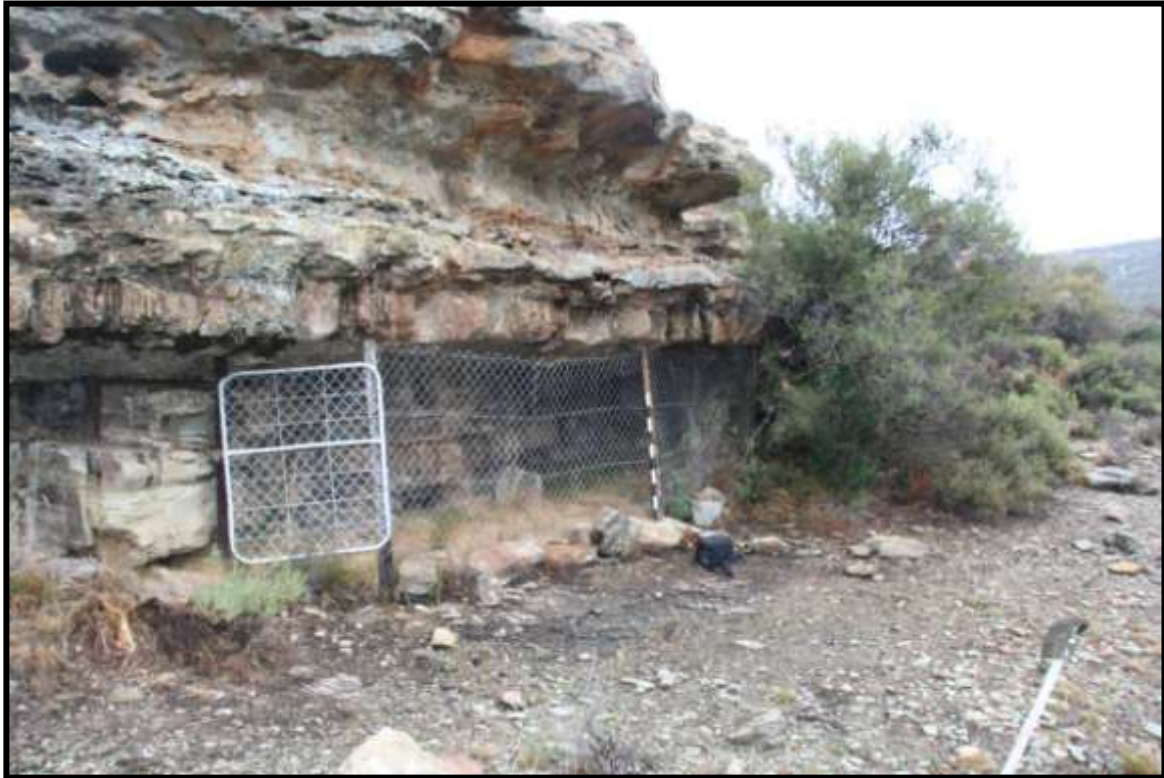
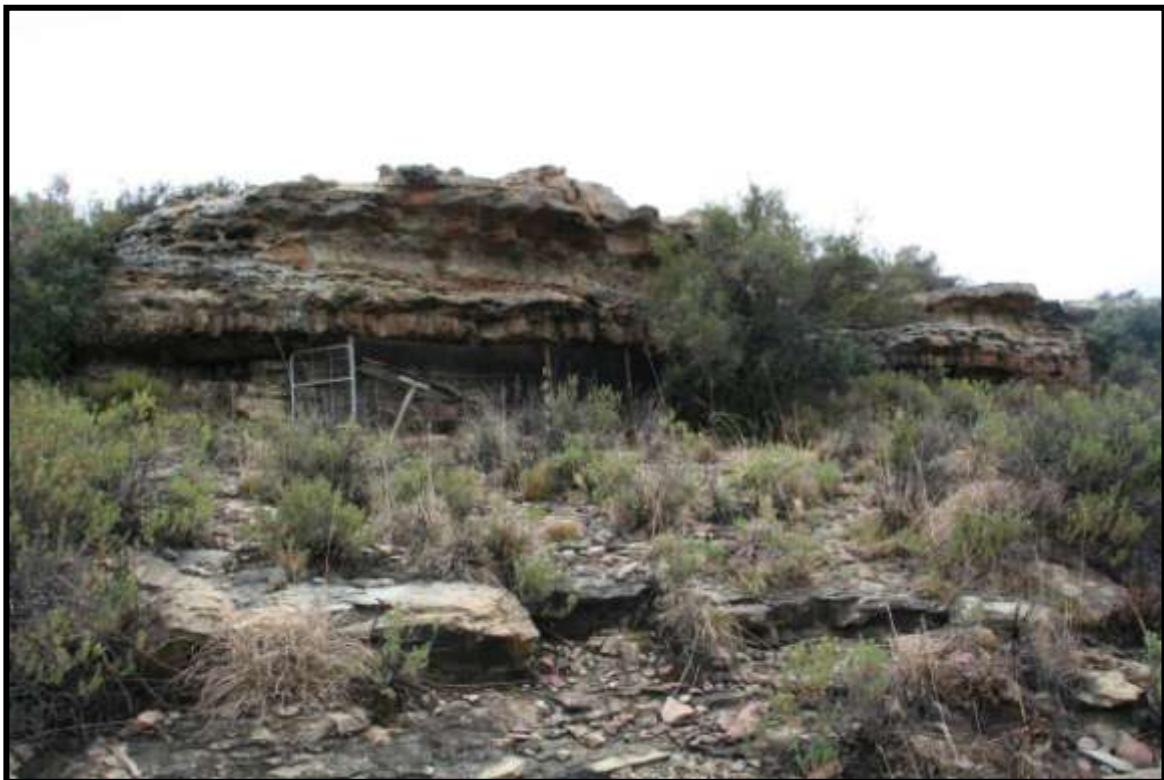
FIG. 39: SHELTER AND TALUS SLOPE AT UMZ024

The site is located below the top of the mountain overlooking the valley. The shelter is on a sandstone ridge and is 7m wide, 1.5m deep and 1.5m high (fig. 39). There is a small talus slope in front of the shelter that extends for ~10m. The shelter has a deposit. There is a high density of stone tools on the talus slope. The tools are predominantly made from hornfels, although a few silcrete artefacts occur. The tools are typical of a Wilton and post-Wilton complex:

SAHRA Rating: 3B

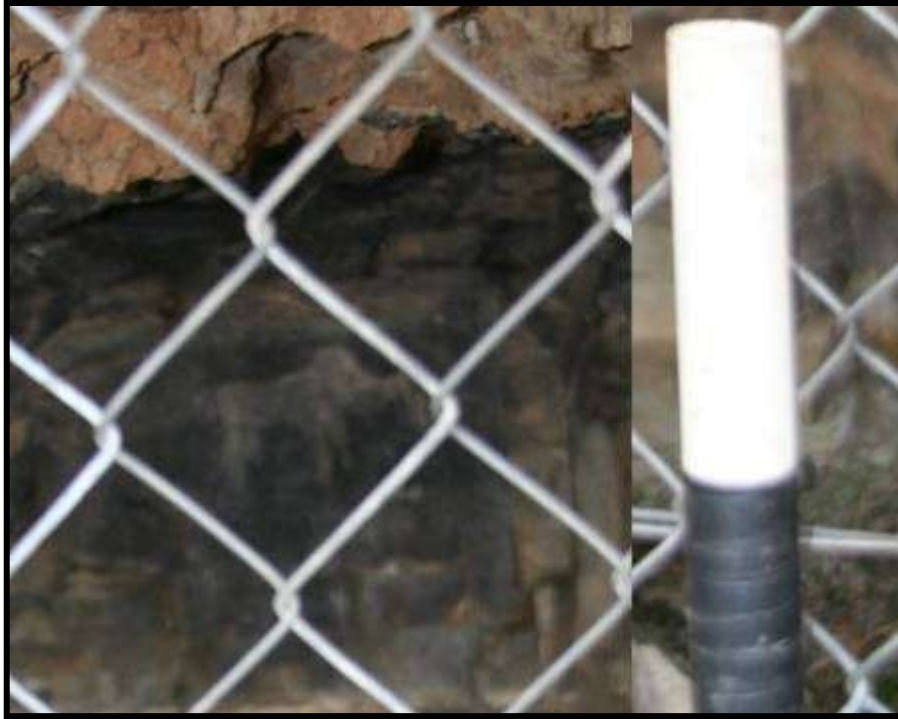
FIG. 40: WHITE ELAND AT UMZ024

Three paintings occur at the shelter. The main painting is a 'late white' eland that appears to be more finger-painted than in the fine line tradition (fig. 40). To the right are two faint red antelope that are in the fine line tradition.

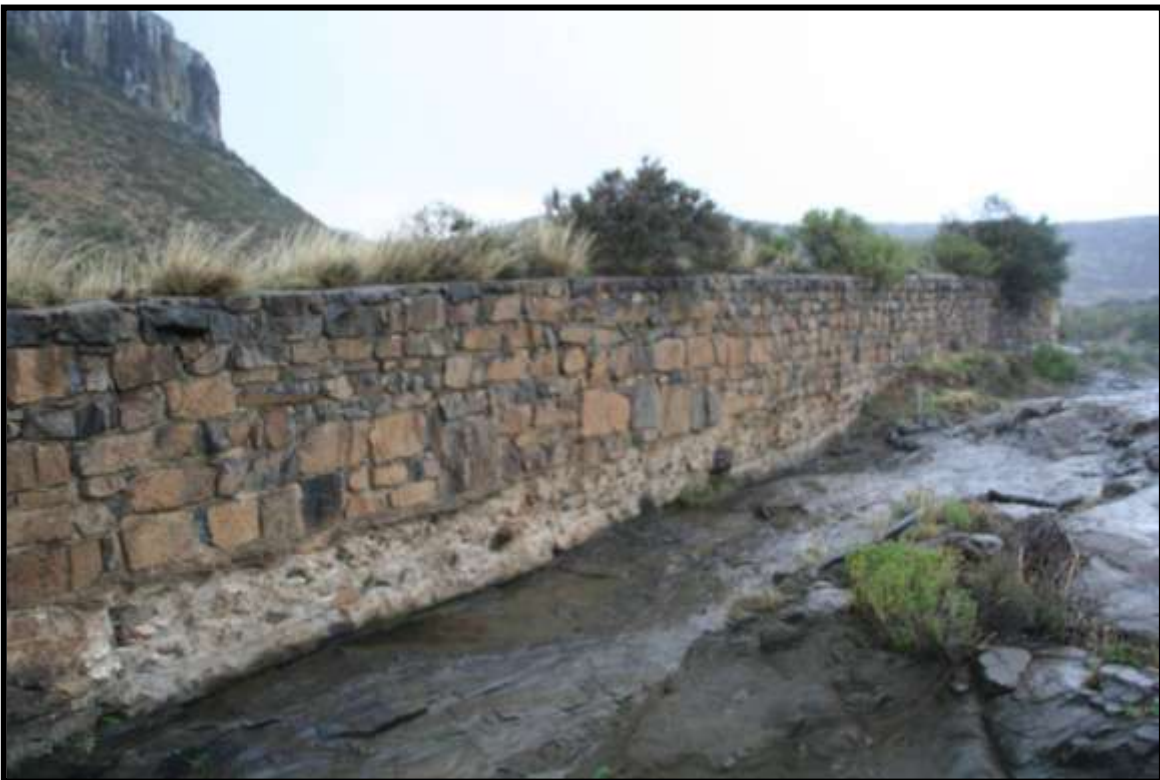
FIG. 41: RETAINING WALL AT UMZ025

The site is located in a river valley on the side of the river. UMZ025 consists of a single retaining wall that appears to be attached to a dam (fig. 41). Many of these types of walls occur in the study area, none of which will be affected.

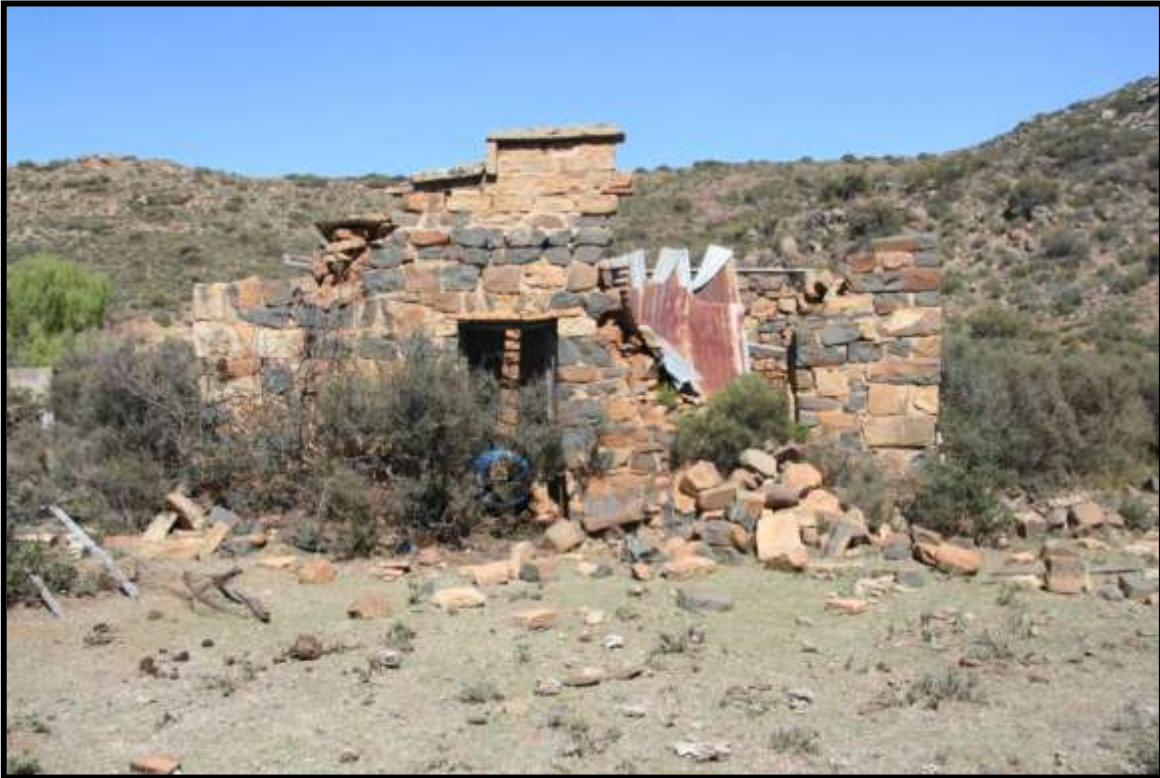
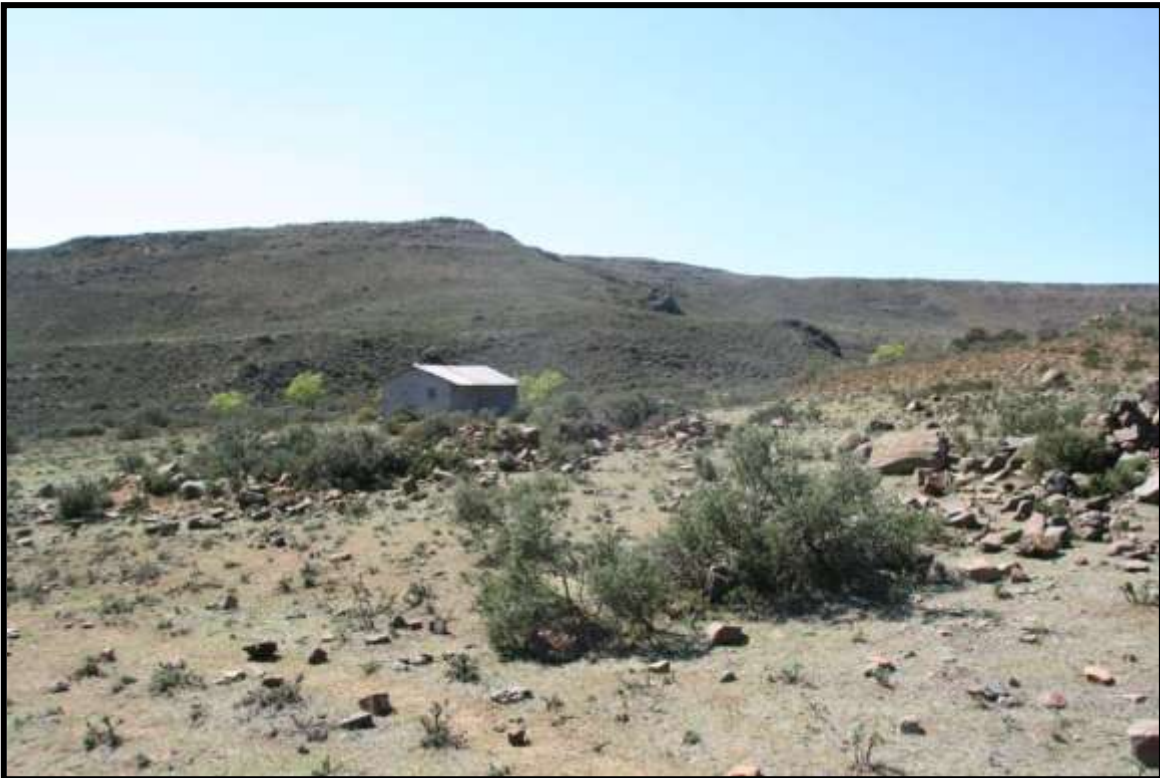
FIG. 44: ORIGINAL BERGPLAAS FARM AND KRAALS

Bergplaas is located on the Erf Elands Kloof 135. It was first surveyed in 1827 (SG F265/1827; fig. 42) and by 1926 the farm is noted on the SGD (FB50/1926; fig. 43). Since then one additional building has been erected on the farm. The site consists of farmhouse, several kraals and stone walls (fig. 44). The farmhouse itself is very small and consists of 2 – 3 rooms. The stone walled kraals vary in size and age, but are ~50m x 20m in size. Artefacts occur on the surface throughout the site.

SAHRA Rating: 3B

Mitigation: If the perimeter walls are affected by the access road then mitigation is required. The walling should be surveyed and replaced/rebuilt after the project is completed. No structures should be damaged. ECPHRA should be contacted if any middens are exposed

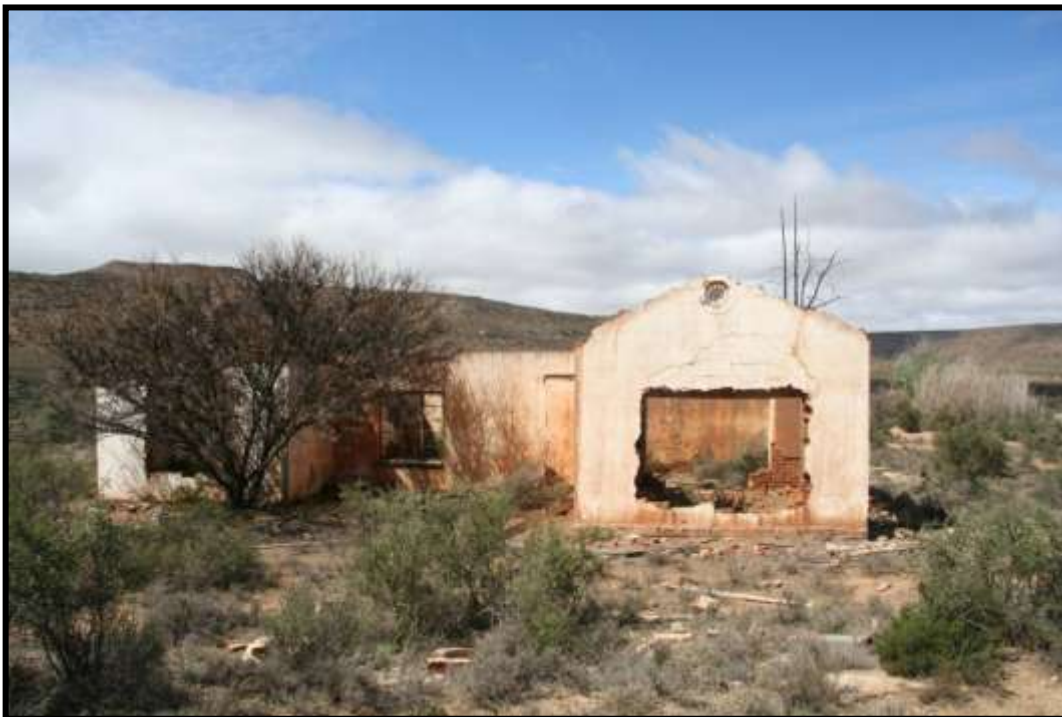
FIG. 45: FARM HOUSE DATING TO 1950

Boshoek is located on the Erf Leeuw Hoek 61. The one building is dated to 1950; however, other buildings occur on the 1945 aerial map. The farm consists of three buildings made from clay bricks with a plaster, one stone walled main kraal, and two labourers houses (fig. 45). There is an intact 'donkey' (oil/diesel fire fuelled geyser) near the main house. The labourers' houses occur ~170m northwest of the main house. One of these houses is in ruin, and one is in good condition (fig. 46). There are smaller features in the general area relating to the farm complex. An old Chevrolet bonnet occurs outside the one house. The design probably dates to a 1950 – 1952 Chevrolet truck. The SGD are not available online for this Erf. Some of the buildings are older than 60 years and are thus protected by the NHRA.

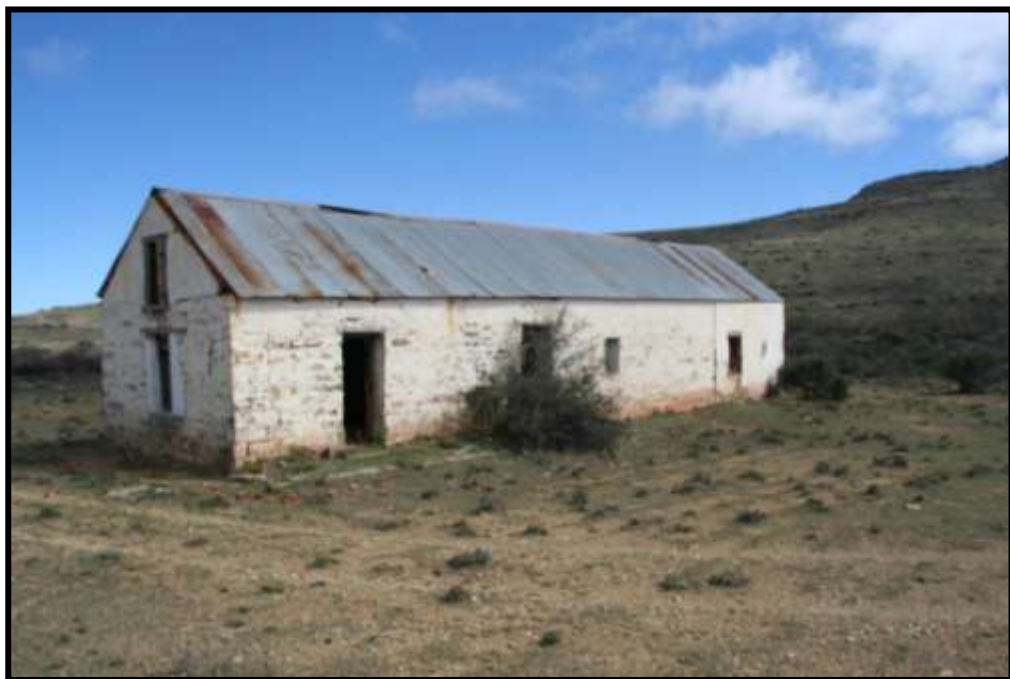
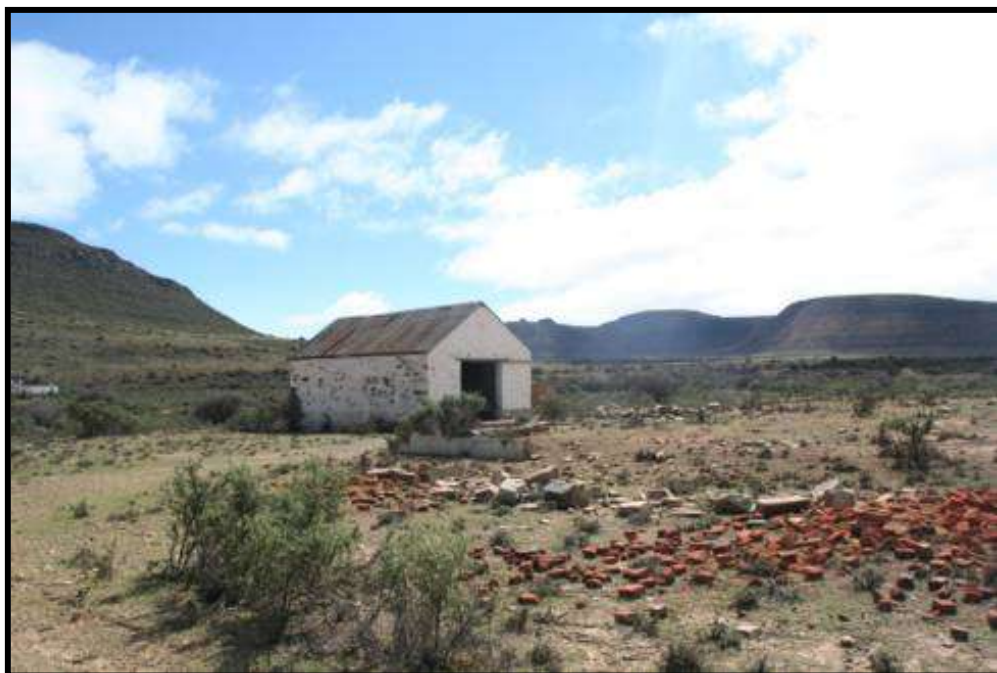
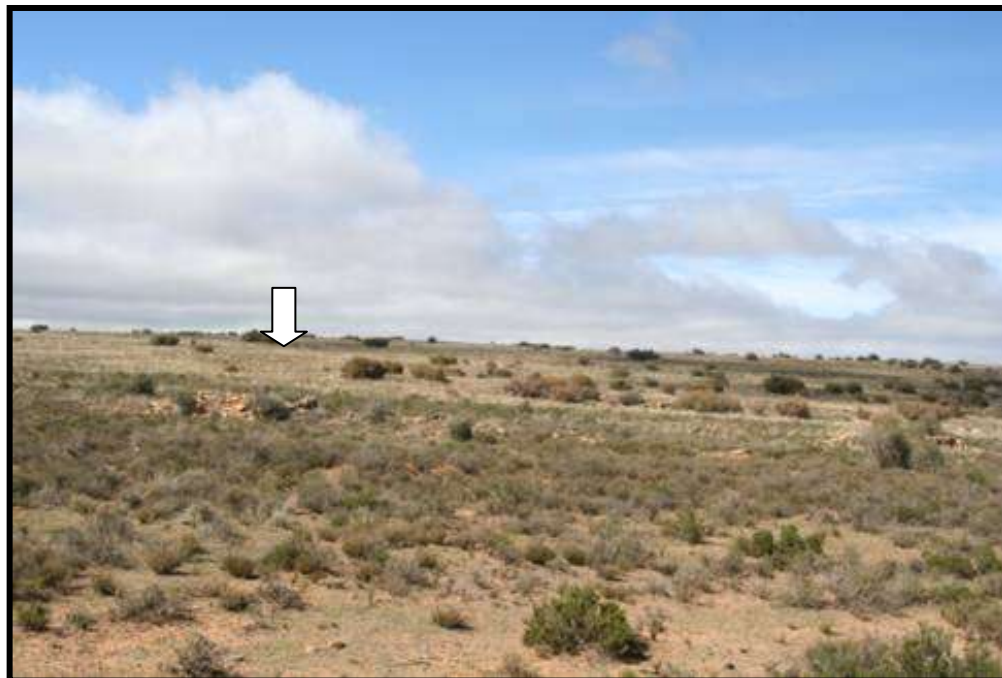
FIG. 47: BUILDINGS AT LEEUHOEK

Leeuhoek is located on the Erf Leeuw Hoek 61. The SGD are not available online for this Erf. I presume this is the original farmhouse as it is named after the Erf. The site consists of several buildings over an area of 400m x 500m, with outlying kraals, and ploughed lands with terracing. The buildings have been built at various times: some are from local sandstone with little, if any, plaster (i.e. the older buildings), while others have been built from bricks and cement). The buildings include the main farmhouse, labourers' houses, kraals, general walling, sheds and smaller built features (fig. 47). The buildings are in various stages of ruin.

SAHRA Rating: 3B and to be determined by an historical architect.

Mitigation: The access road should not damage any existing built features, regardless of the stage of ruin. It would be best for the road to bypass the site in general. IF this is not possible, the features will need to be assessed by an architect historian to determine what may and may not be damaged. Furthermore, the site will need to be mapped and photographed if affected in any manner. Older rubbish middens may be sampled and/or excavated if exposed.

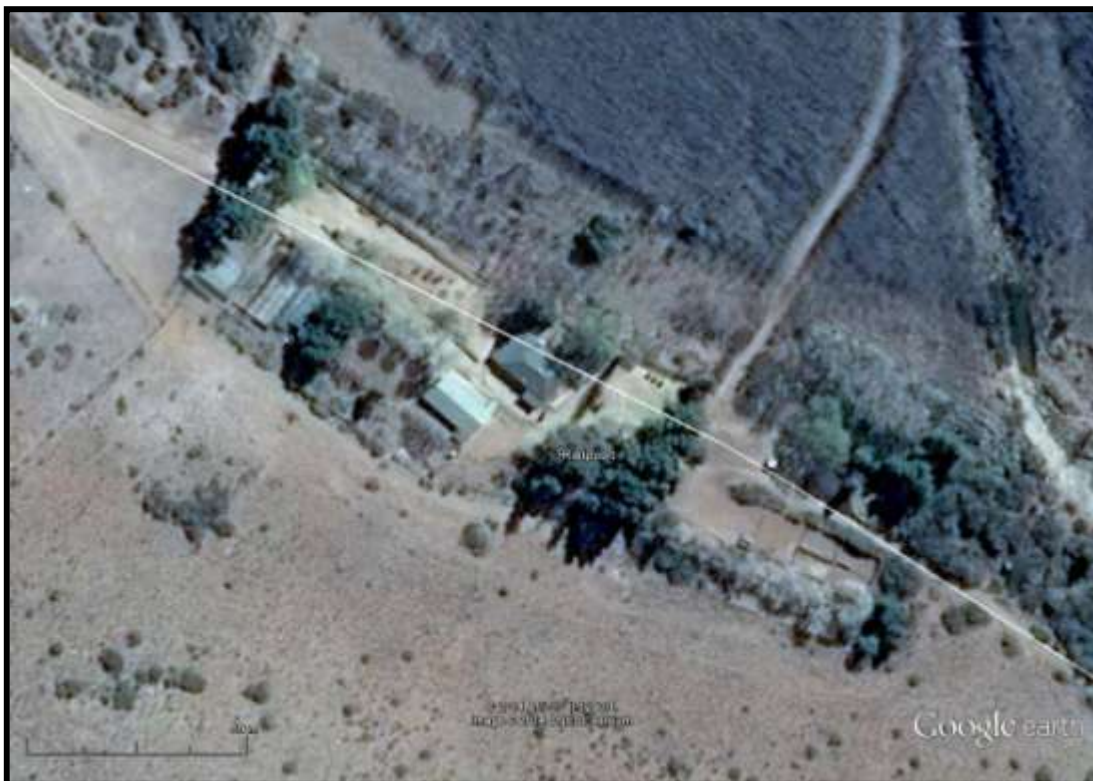
FIG. 48: AERIAL VIEW OF RIETFONTEIN

Rietfontein is located on the Erf Leuwe Kop 120. The SGD are not currently available online. The farm consists of a main farmhouse, with a shed and large stone walled kraal, with the farm labourers houses ~90m to the west (fig. 48). Some of the buildings are in the same architectural style as at Winterhoek, while others appear to be more recent. The buildings are surrounded by blue gum trees, of which some form a windbreak and a field boundary marker. Some of the buildings are older than 60 years in age.
