**HERITAGE SURVEY OF THE UMSOBOMVU WIND
ENERGY FACILITY, EASTERN AND NORTHERN CAPE**

**FOR EOH COASTAL AND ENVIRONMENTAL
SERVICES**

DATE: 27 OCTOBER 2013

**Umlando: Archaeological Surveys and Heritage
Management**

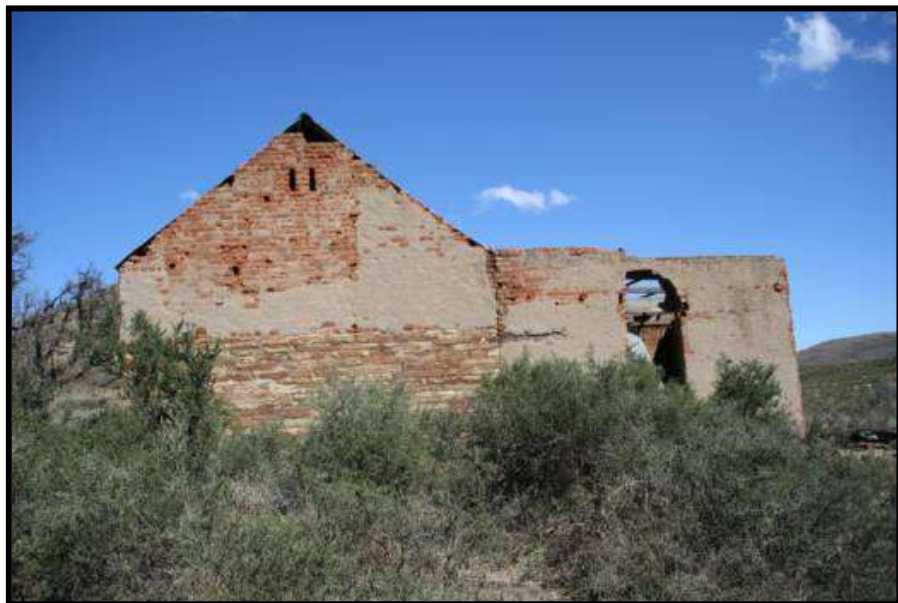
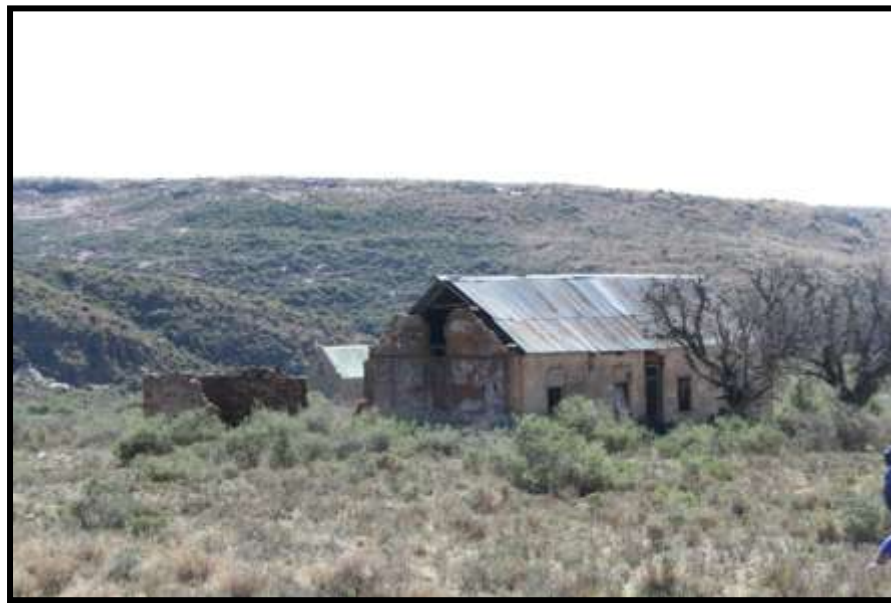
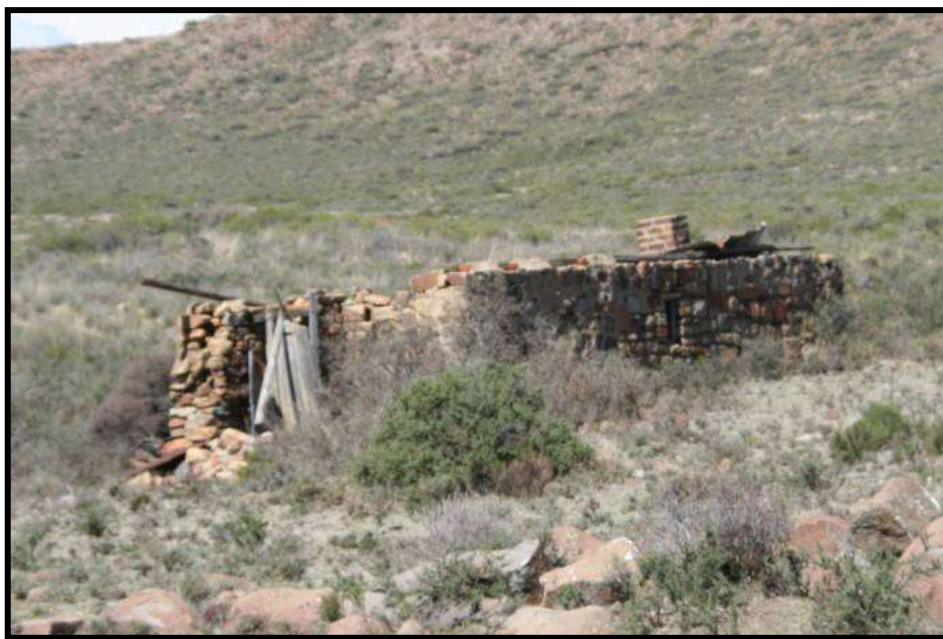
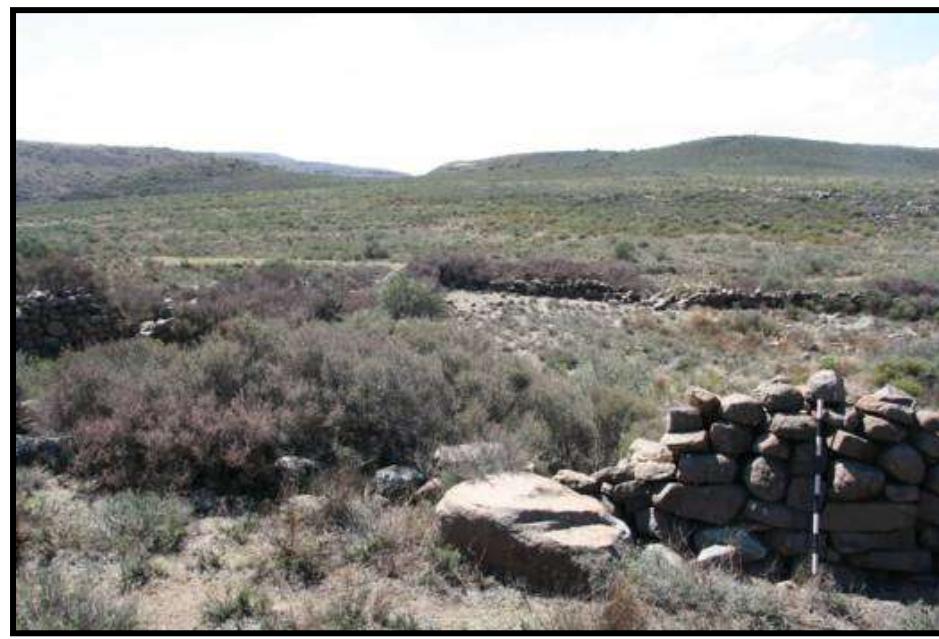
FIG. 49: ORIGINAL BUILDINGS AT UITZICHT

The farm is located on the Erf Uitzicht 3. The SGD maps are not available online for this farm, although it appears on the 1829 SGD diagrams on the adjacent farm. This is one of the first registered farms in the area. The farm complex occurs over an area ~500m x 150m wide, with a cemetery located 250m northeast of the main house. The farm complex consists of four areas with built structures. All built structures are form local sandstone. From east to west, they are (fig. 49):

Significance: The farm complex dates to 1853 and is in relative good condition, besides falling into ruin. The farm can give insight into early farming life in the area. The farm complex is thus of high significance.

Mitigation: The area should not be affected. Stelae may be affected but need to be removed before construction and replaced in the same place thereafter by a heritage practitioner.

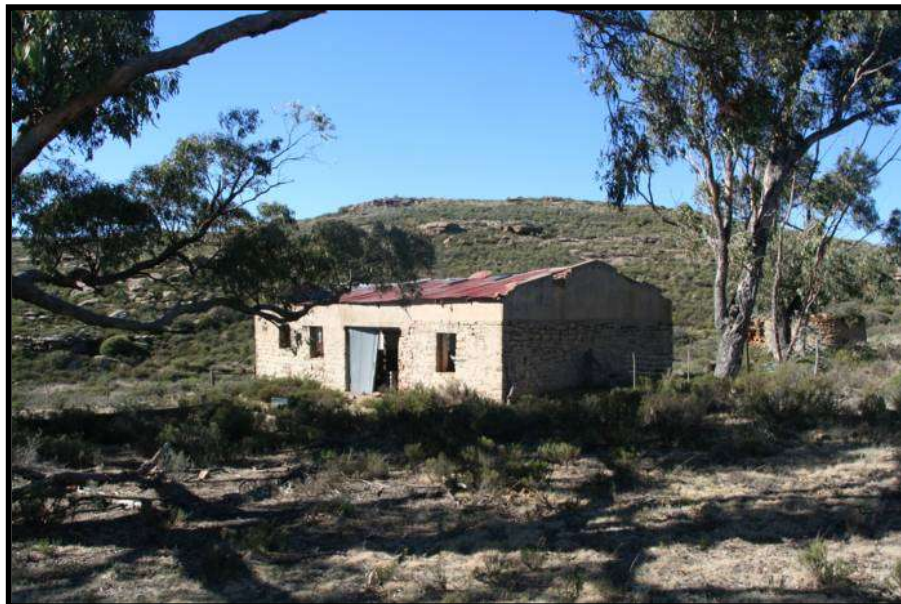
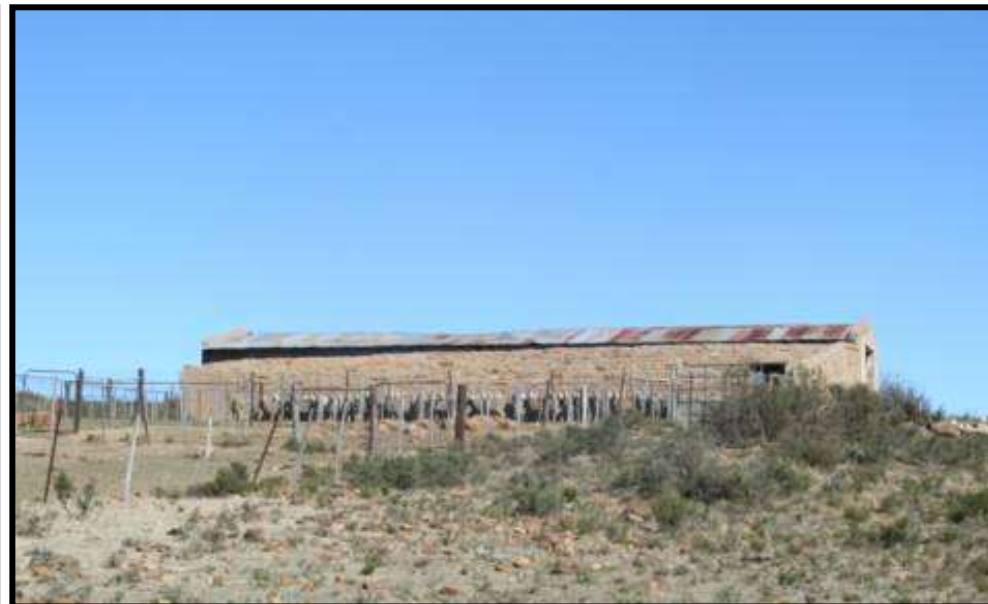
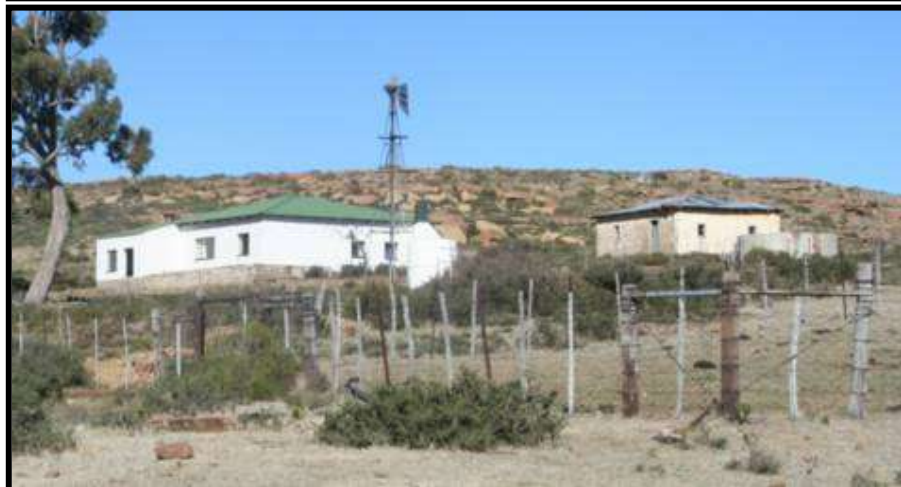
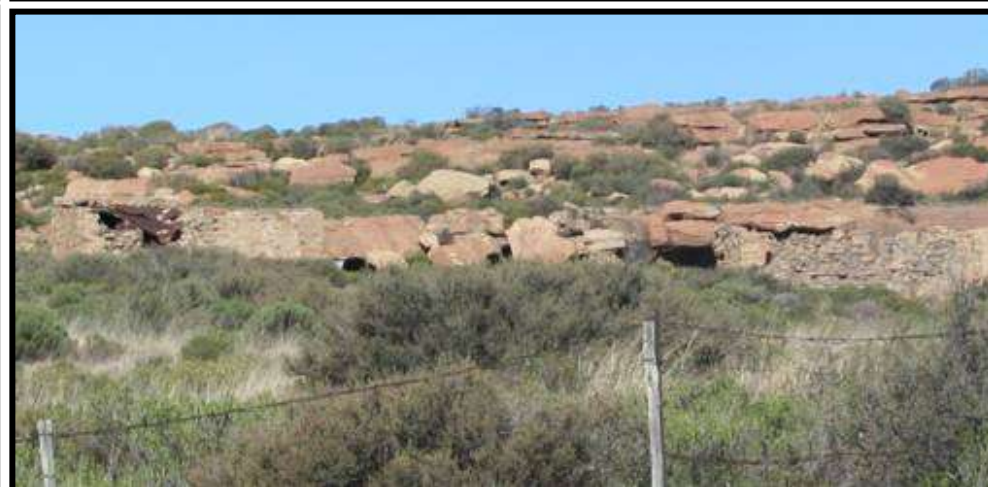
FIG. 53: BUILDINGS AT WELTEVREDEN

The farm is located on the Erf Uitzicht 3. The SGD maps are not available online for this farm, although it appears on the 1829 SGD diagrams on the adjacent farm. The farm consists of two main farmhouses, a shed, kraals and labourers' houses (fig. 53). The original farmhouse is no longer in use, and a 20th century house has been built nearby. The main buildings appear to date to the 19th century. The labourers' houses are ~150m to the east of the main house. It appears that these have been in use up to the recent past.

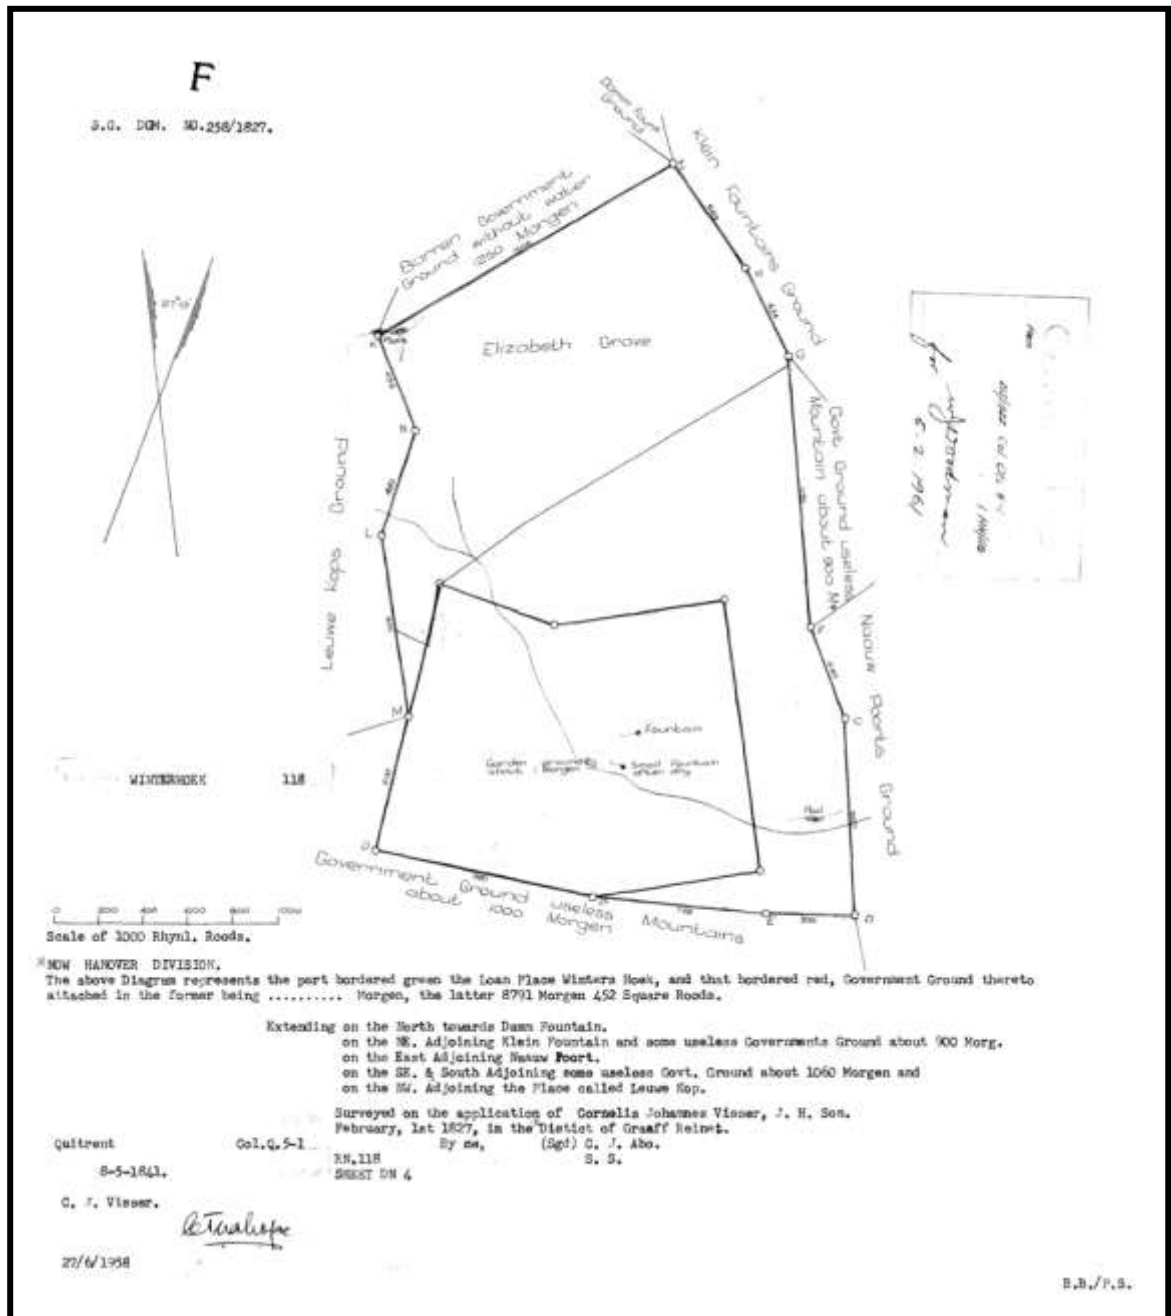
FIG. 54: SGD DRAWING OF WINTERHOEK AT 1827

The Farm Winterhoek is located on the Erf Winterhoek 118. The SGD indicates that the farm was first surveyed in 1827, where one morgen of garden ground is noted but no buildings (F258/1827; fig. 54). The farm was surveyed again in 1893 for an Annex. On the northern part of the farm (F393/1893; fig. 55). In 1922, the SGD survey notes (F217/1922; fig. 56) buildings on the farm in the same location where the existing buildings occur, and the garden ground from 1827. The built structures on the farm thus predate 1929, and are automatically protected by the NHRA.

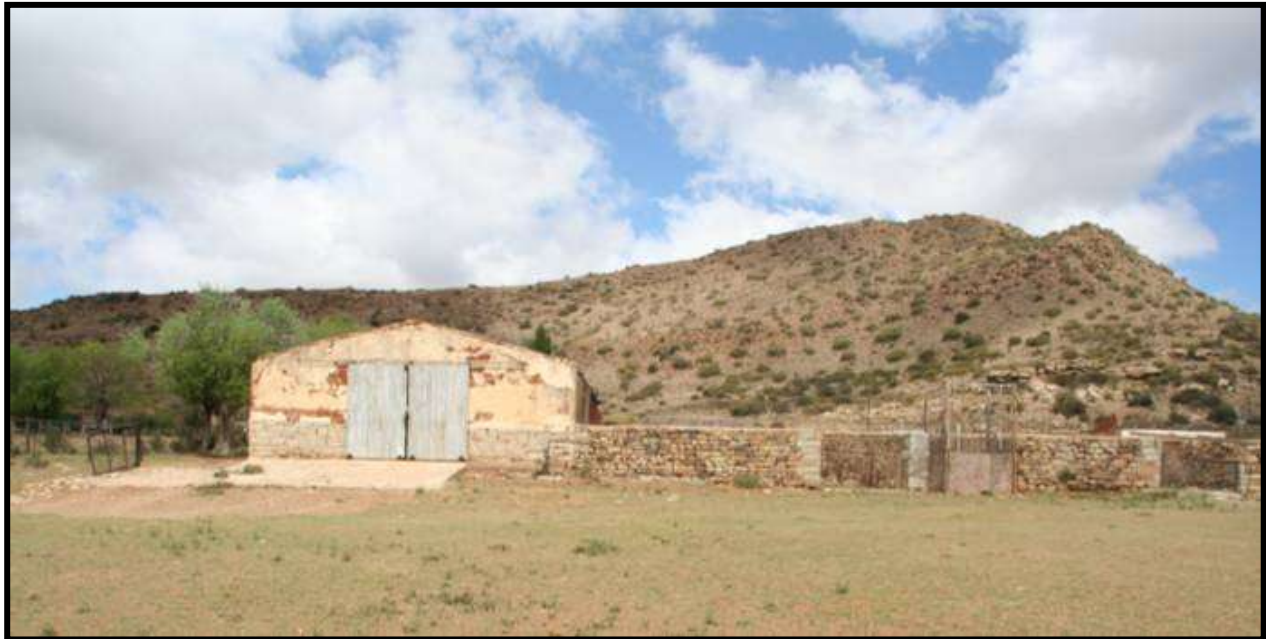
FIG. 57: SHED AND KRAAL WALLING AT WINTERHOEK

The existing farm consists of a farmhouse, a shed, and some stone walling for kraals and farm labourers' houses (fig. 57). The farm buildings are located near an existing track into the valley that goes towards Bergplaas.

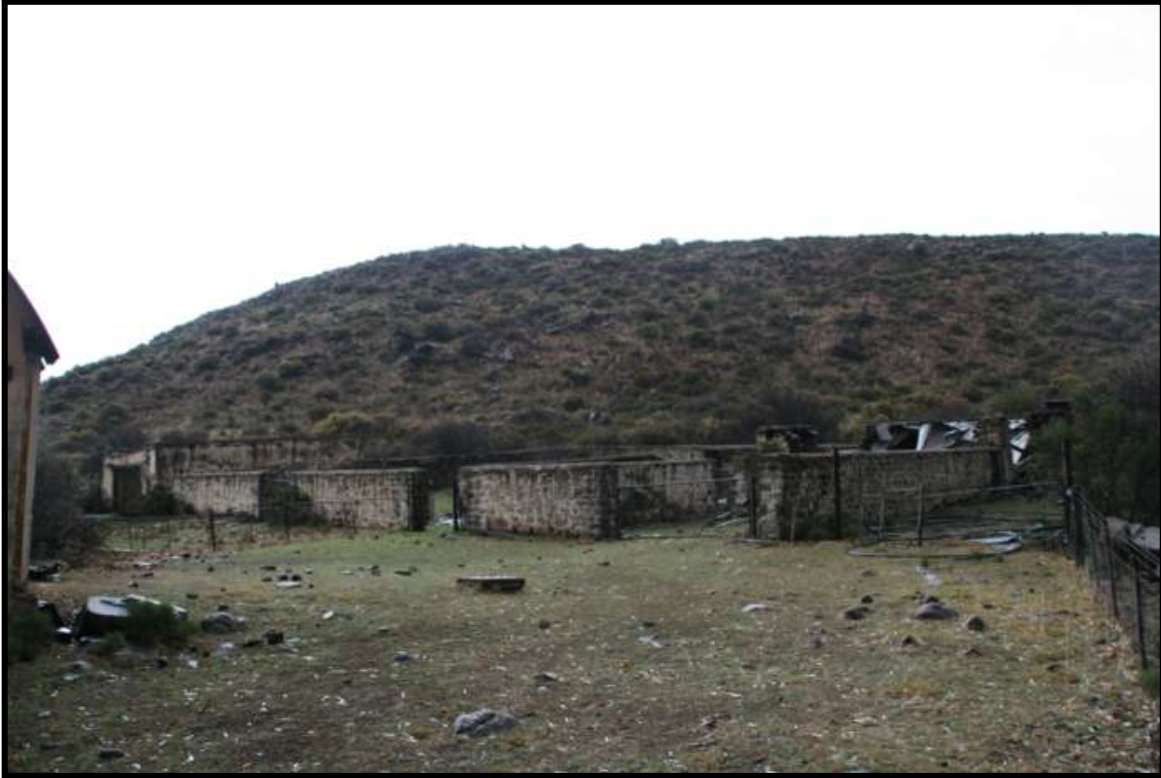
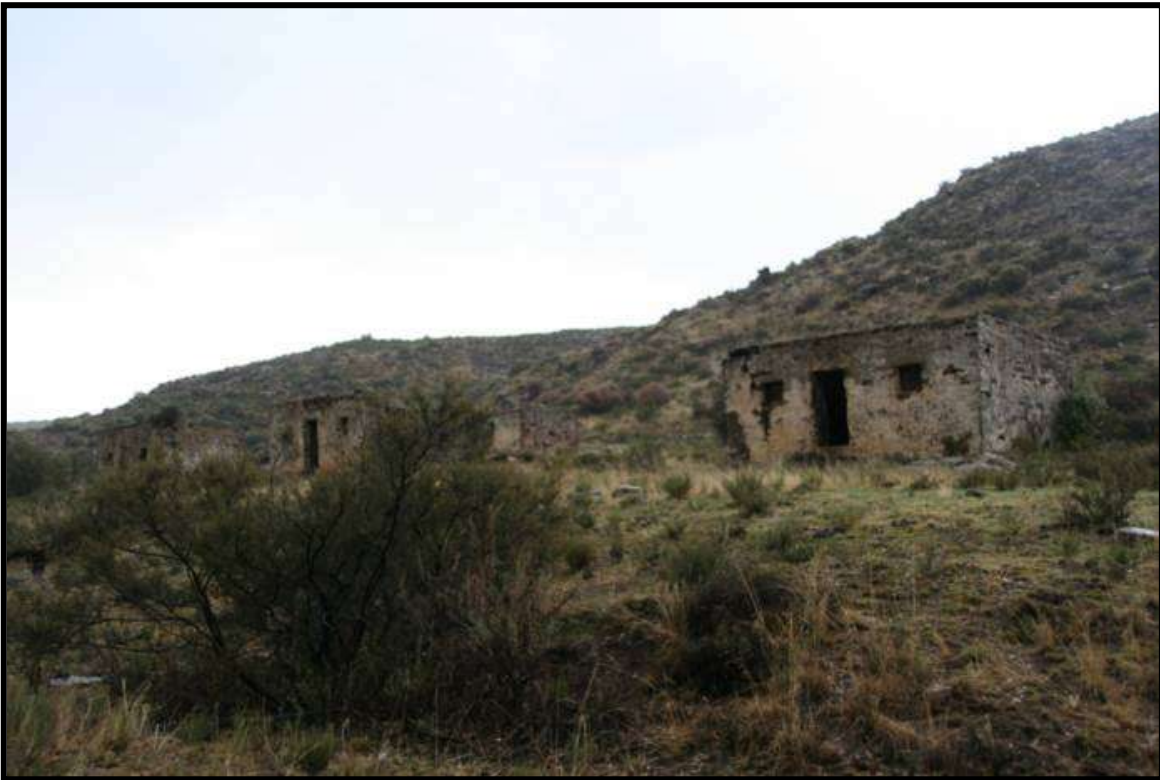
FIG. 58: BUILDINGS AT WILGEFONTEIN

Wilgefontein is located on the Erf Leuwe Kop 120. The SGD are not currently available online. The farm consists of a main farmhouse, with a shed and large stone walled kraal, with the farm labourers houses ~90m to the east. The farmhouse is in the same architectural style as at Winterhoek, and are thus probably of similar age (fig. 58). The buildings are surrounded by blue gum trees, of which some form a windbreak and a field boundary marker.

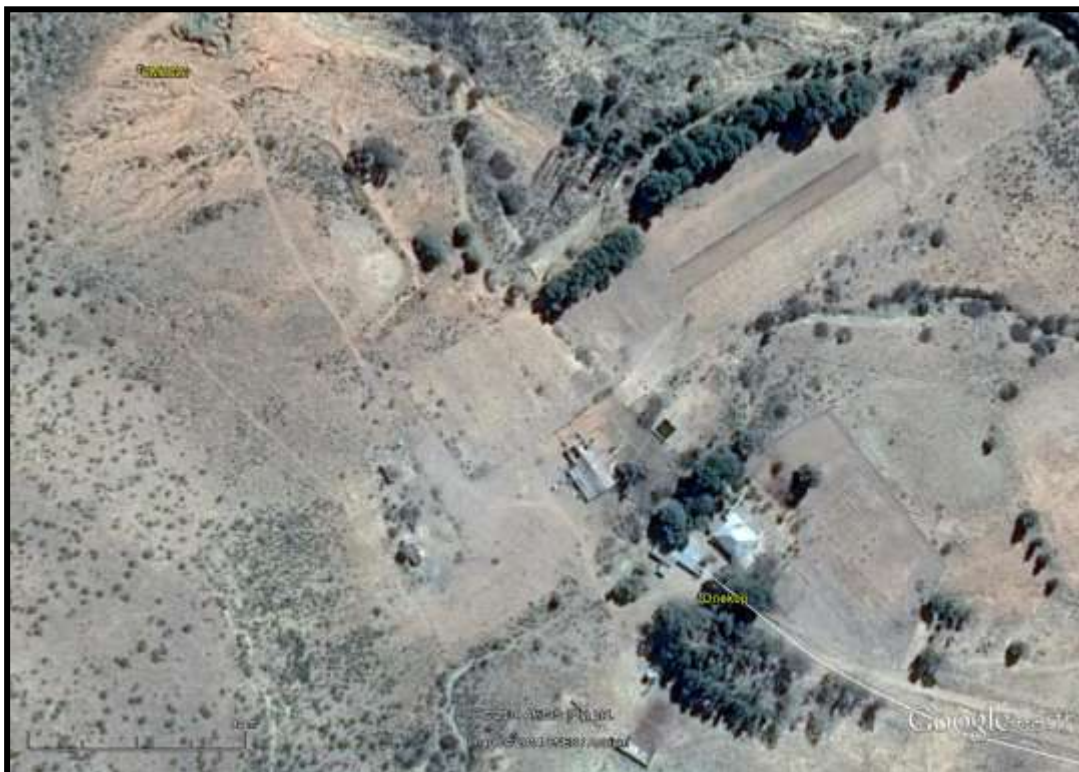
FIG. 59: LAYOUT OF DRIEKOP

Driekop is located on the Erf Klip Krands 60. The SGD are not currently available online. The farm consists of a main farmhouse, with a shed and large stone walled kraal, with the farm labourers houses ~120m to the west. The farmhouse is in the same architectural style as at Winterhoek, and is thus probably of similar age. The layout is shown in fig. 59. The farm buildings occur on the 1945 aerial photograph and thus it is protected.
