**PROPOSED UMZIMKHULU BULK WATER PIPELINE,
KWAZULU-NATAL**

Phase 1 Heritage Assessment

22 March 2019

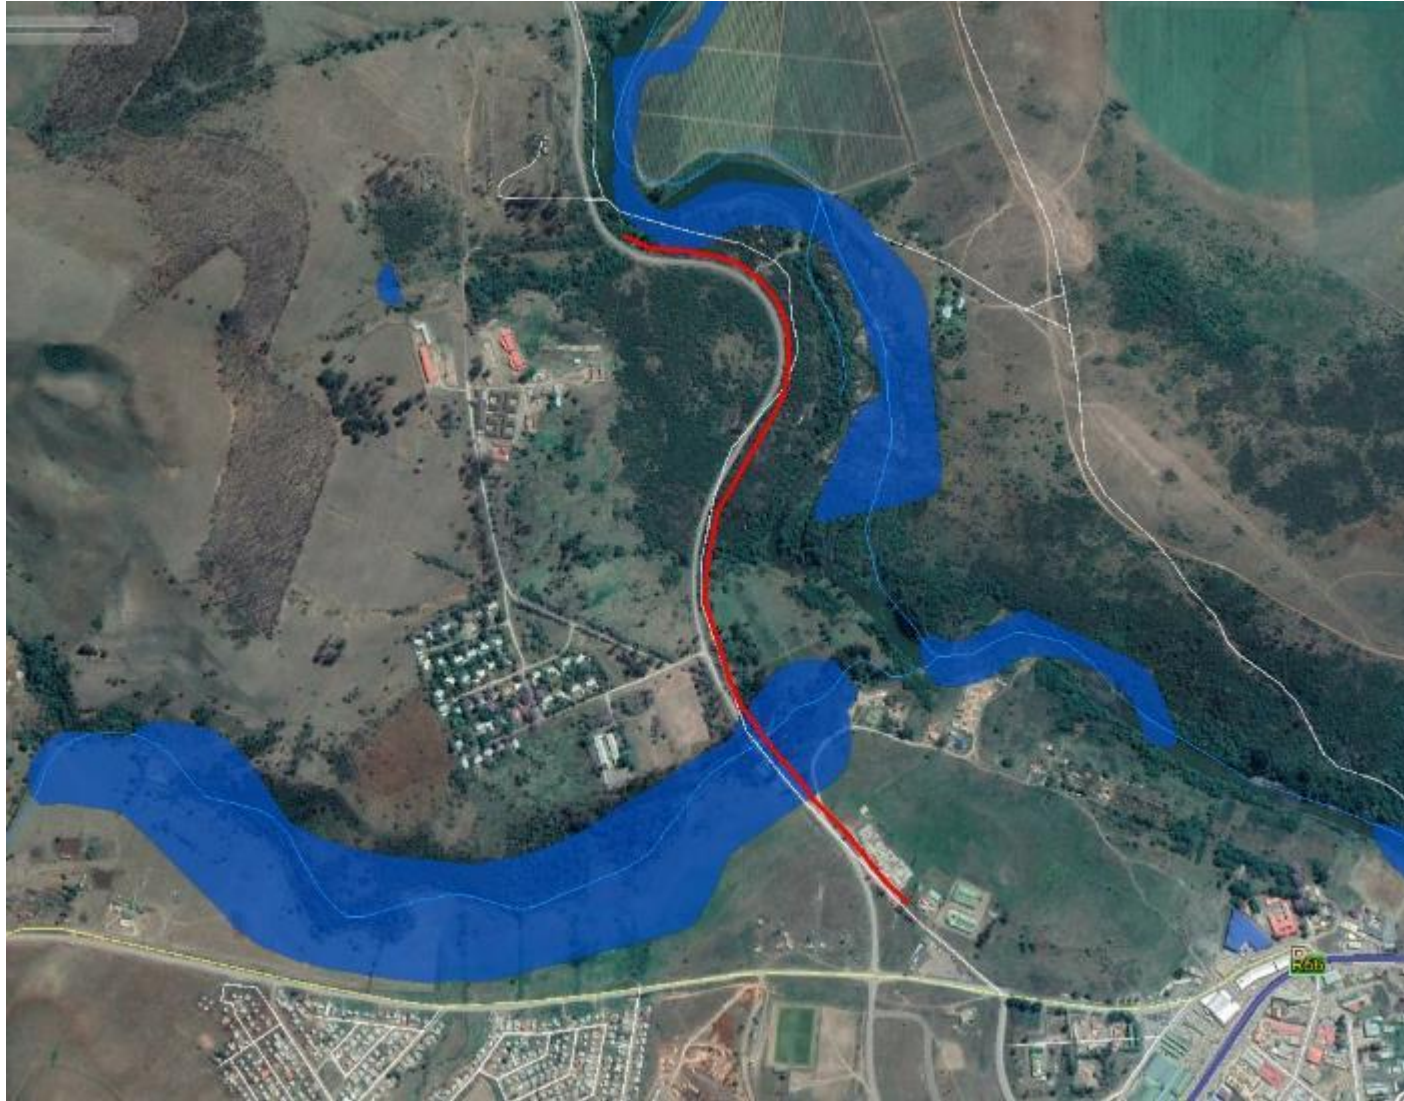
Figure 1: Pipeline indicated in red with blue indicating watercourse restrictions

The town of Umzimkhulu is situated in southern KwaZulu-Natal and inland and north-west of the coastal town of Port Shepstone. The proposed pipeline is situated on the northern outskirts of the town and to the west of the Umzimkhulu River (see **Figures 1** and **2** below).

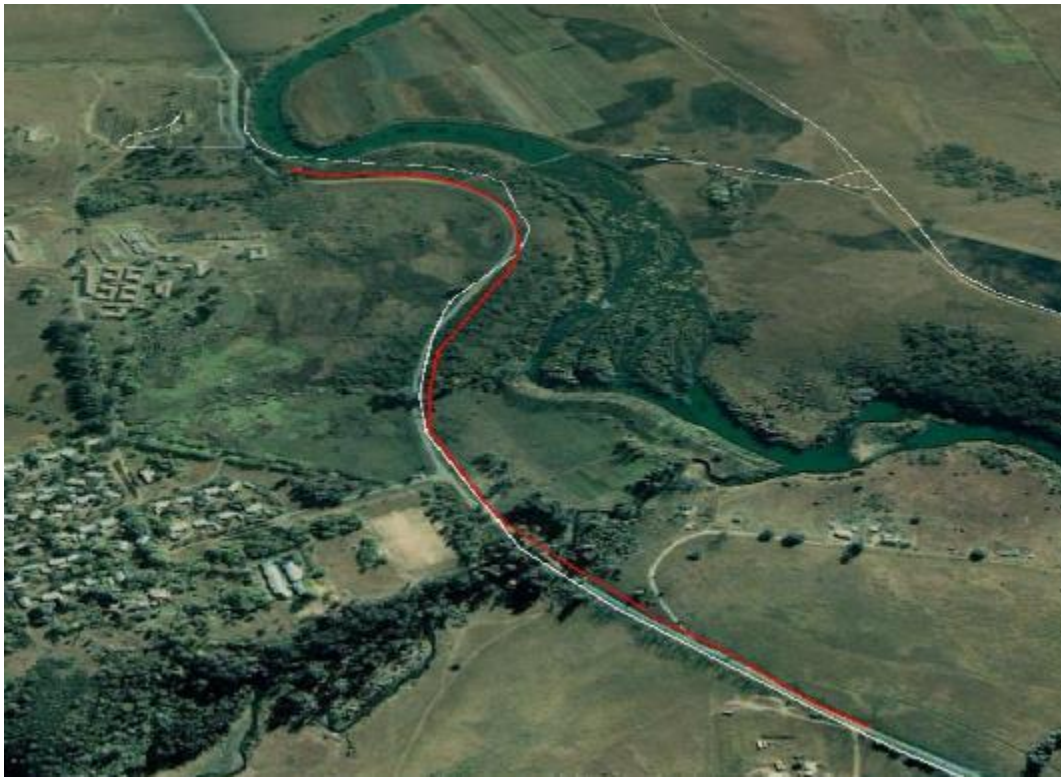
Figure 3: 2001 Google Earth image of pipeline and surrounds

A Google Earth image from 2001 (**Figure 3**) of the pipeline route shows that the land immediately north of the Mvubukazi River was cultivated whereas today it is no longer cultivated nor are there any buildings at the south-east start/end point of the pipeline. This had, however, changed by 2010 when several buildings are clearly visible at this start/end point (see **Figure 4**).

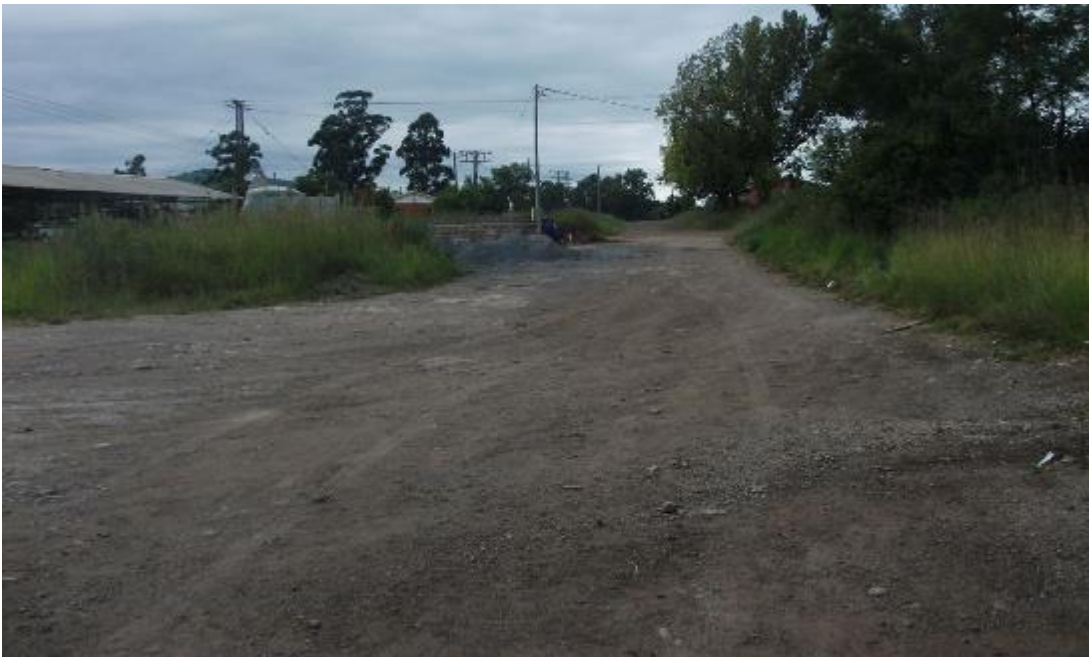
Figure 5: South-eastern start/end point of pipeline

The site inspection started at the pipeline's south-east start/end position where it is situated between the tar road and a business (Conrite Walls Pty Ltd) that makes precast walls. This area is highly disturbed with a gravel access road and buildings.

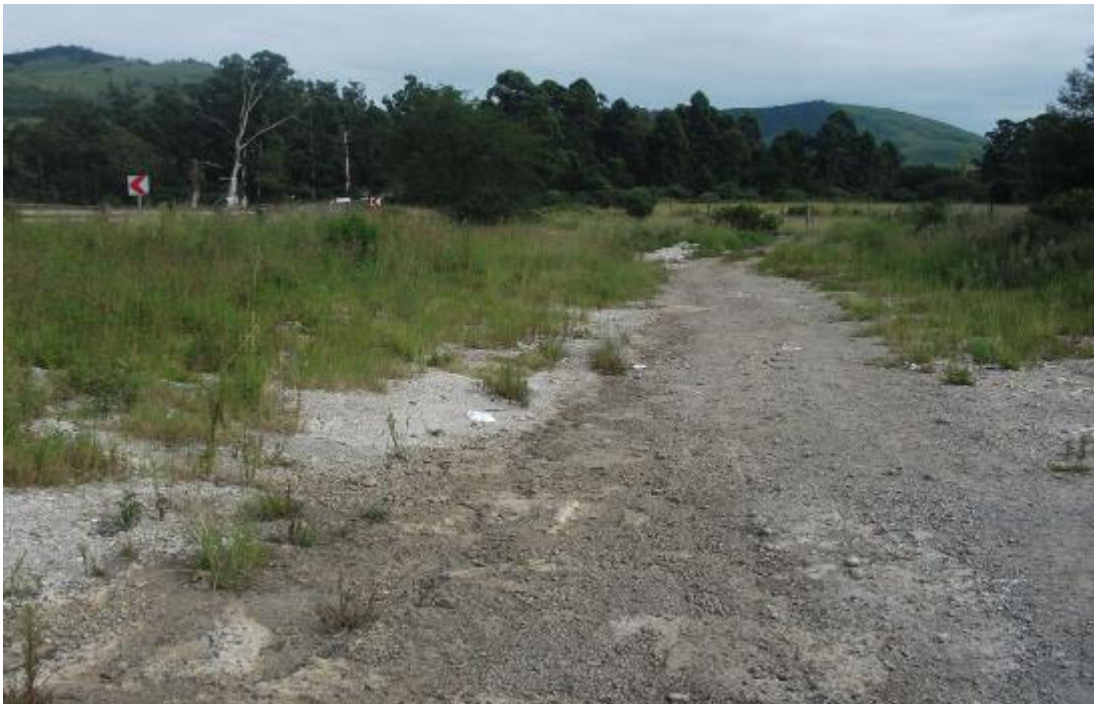
Figure 6: Looking northwards along pipeline route

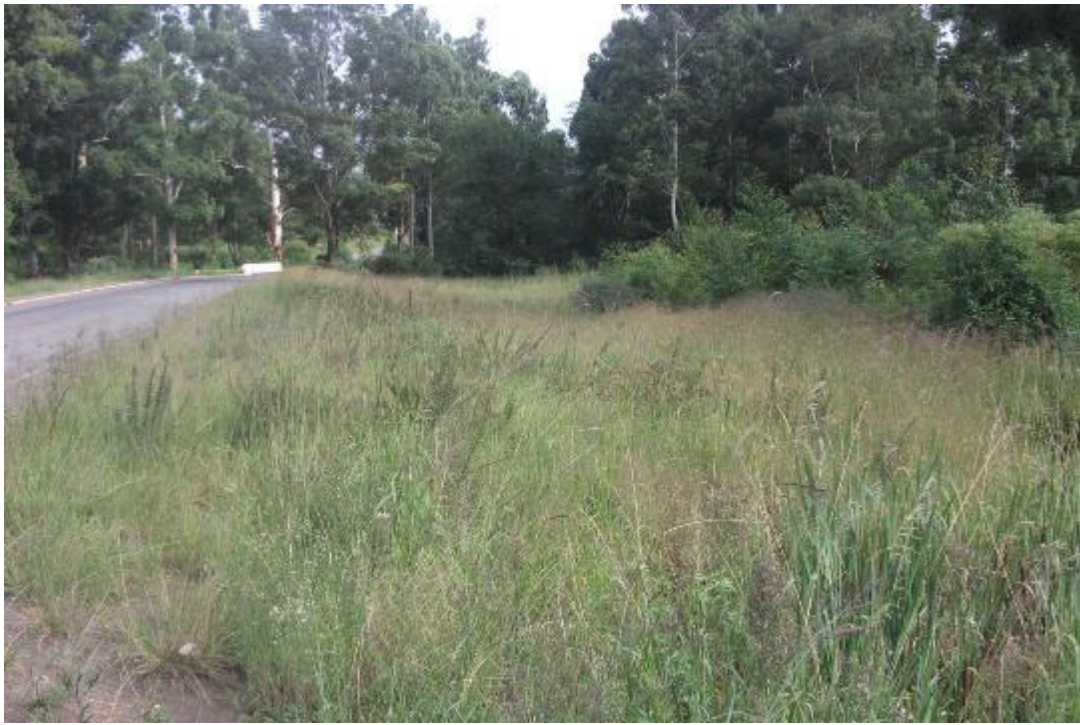
Figure 7: Pipeline route showing bridge crossing Mvubukazi River

From here, the pipeline runs on the eastern side of the tarred road that goes to the settlements of Nguse, Dryhoek and Sicelweni that are situated to the north-west of Umzimkhulu. It also crosses the Mvubukazi River which is a tributary of the Umzimkhulu River.

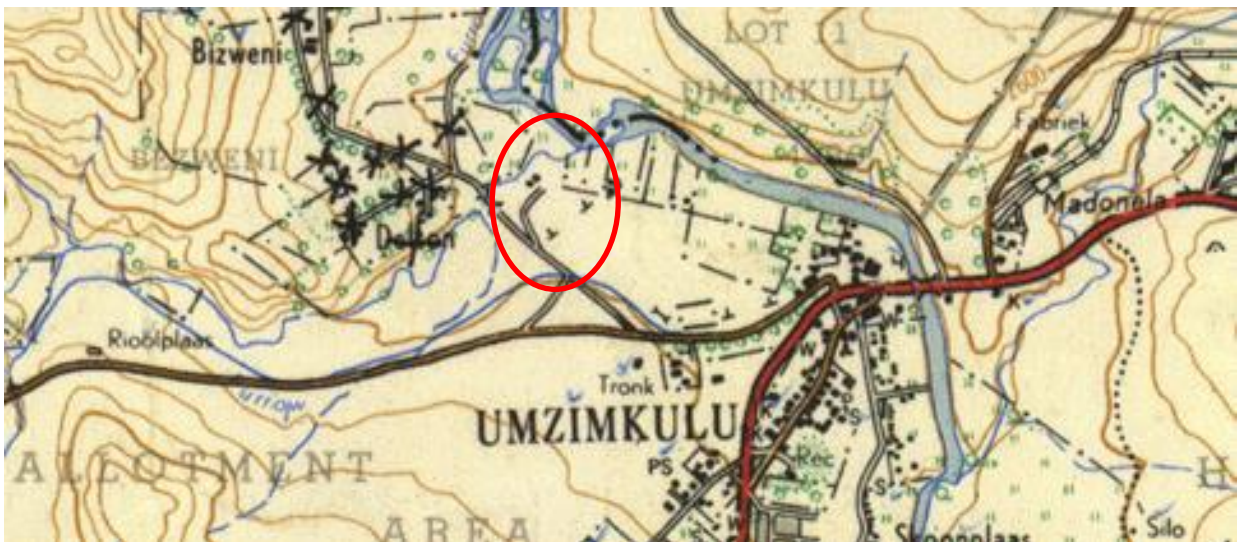
Figure 8: Section of topographical map showing structures

The 1: 50 000 topographical map (3029BD) that was surveyed in 1965 with aerial photography taken in 1958 of this section of the pipeline route shows the existence of several structures near the Mvubukazi River as well as cultivated land near the Umzimkhulu River. From the reference table of the map, the two structures closest to Umzimkhulu were telephone and telegraph lines. The round dots are not referenced but it is assumed that they were houses or farm buildings.

Today, the telephone lines are gone. No other remains were found and it should be noted that the round dots/structures are situated some distance from the route of the proposed pipeline and remains (if any) should not be impacted by the construction of the pipeline.

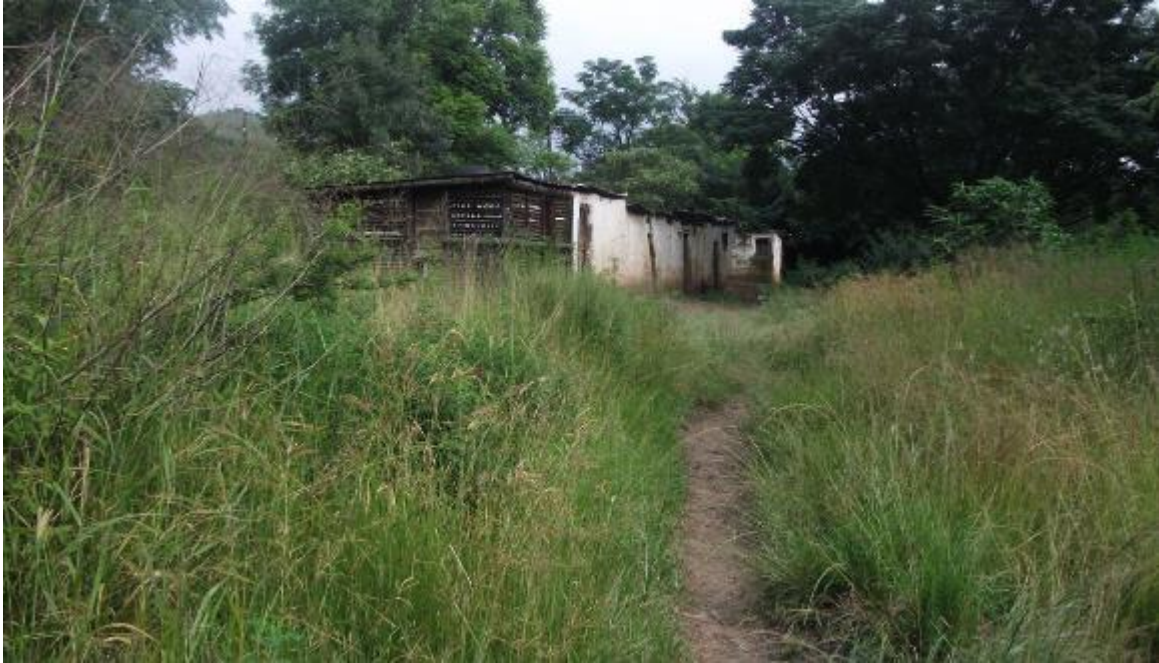
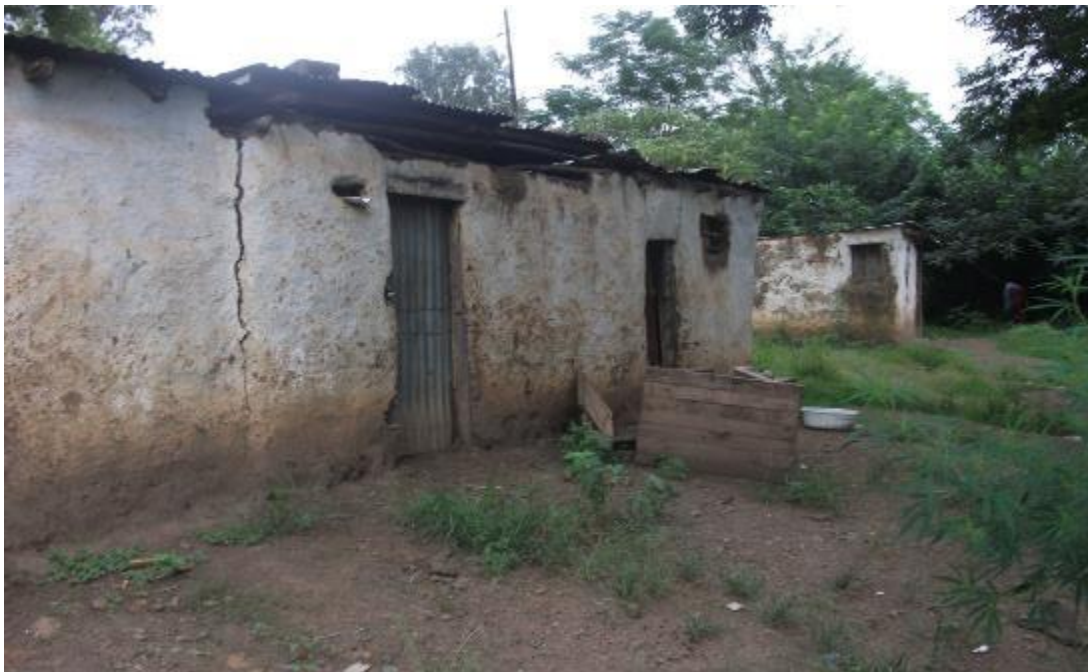
Approximately 130 m north-west of the Mvubukazi River, several structures were found that are located at 30°15'18.6"S 29°55'42.9"E. One of the structures has been subdivided into individual rooms. All the structures appear to be quite old and are run-down. Their actual age could, however, not be determined.

Figure 9: Buildings close to pipeline route

Figure 10: Section of building close to pipeline route

The specialist spoke to three people who live in the structures, namely, Messrs Andries Dzanibe, Linda Ngubane and Maneni Dzanbie. They said that there were no graves in the area. They asked that they be given employment with the construction of the pipeline. It is recommended that the structures are not impacted by the proposed pipeline.

COORDINATES	DESCRIPTION	Significance	MITIGATION
30°15'18.6"S 29°55'42.9"E	Structures	Possibly > 60 years; even if not >60 years the structures are occupied hence of high social significance	5 m buffer around all structures in which no construction activity may take place
30°15'16.6"S 29°55'41.7"E	Concrete floor	Low significance	Can be altered, destroyed or removed

It is recommended that the structures found along the pipeline route are left intact as they could potentially be older than 60 years and are occupied by several individual who would lose their place of residence if the buildings were destroyed. This would have a high negative socio-economic impact on the individuals occupying the structures.

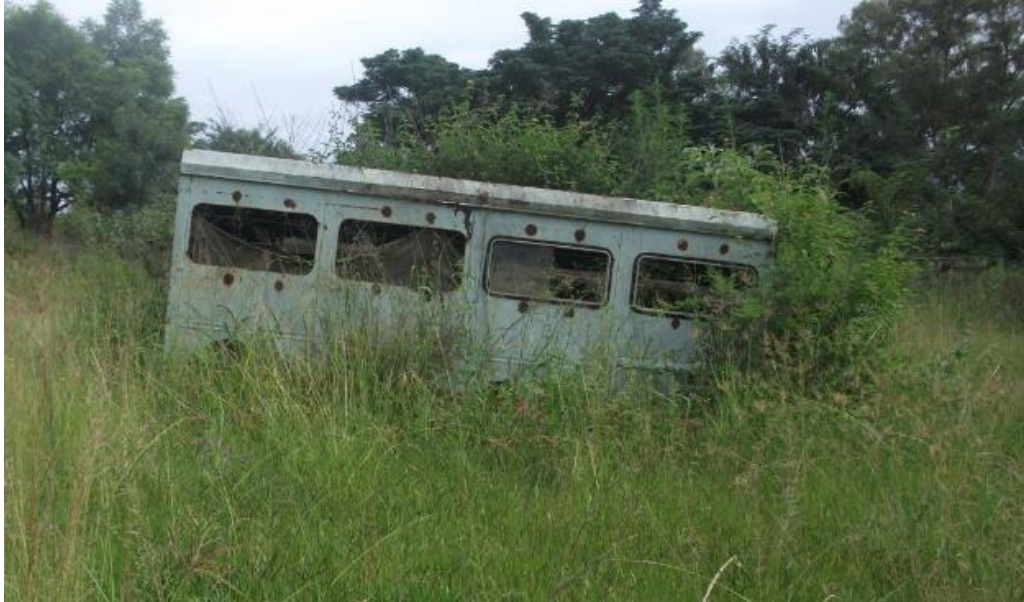
A section of a bus or of a train (see below) was found close to the above structures. It is of no significance and can be removed.

Figure 11: Undetermined vehicle

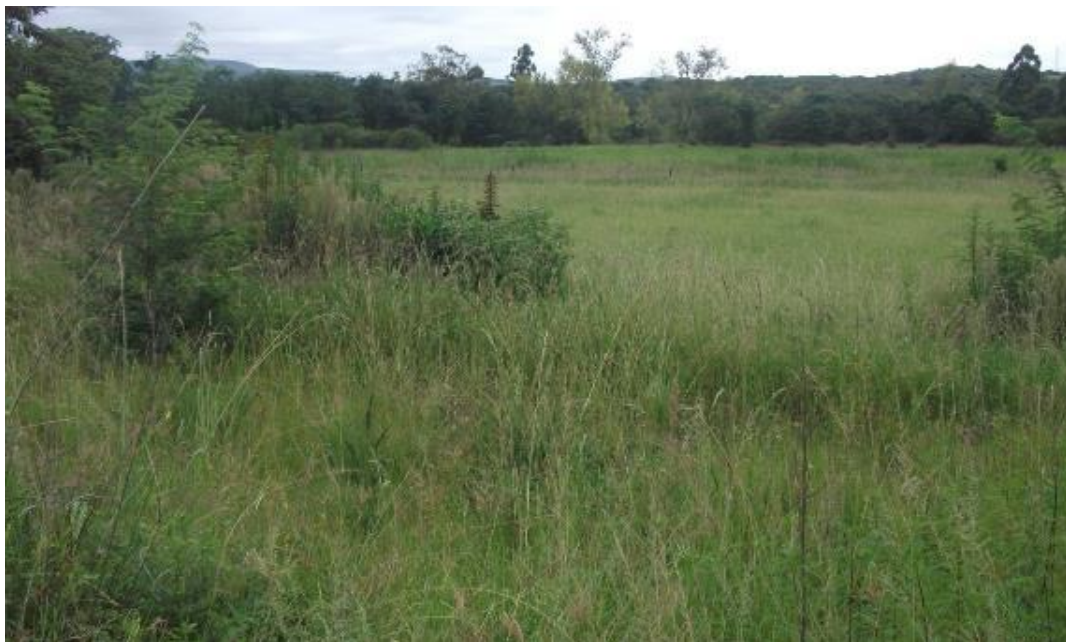
Further north, fallow land was observed between the proposed pipeline and Umzimkhulu River. The cultivation of this area is visible on **Figures 2 and 3** above and in **Figure 11** below.

Figure 12: Fallow land lying east of pipeline route

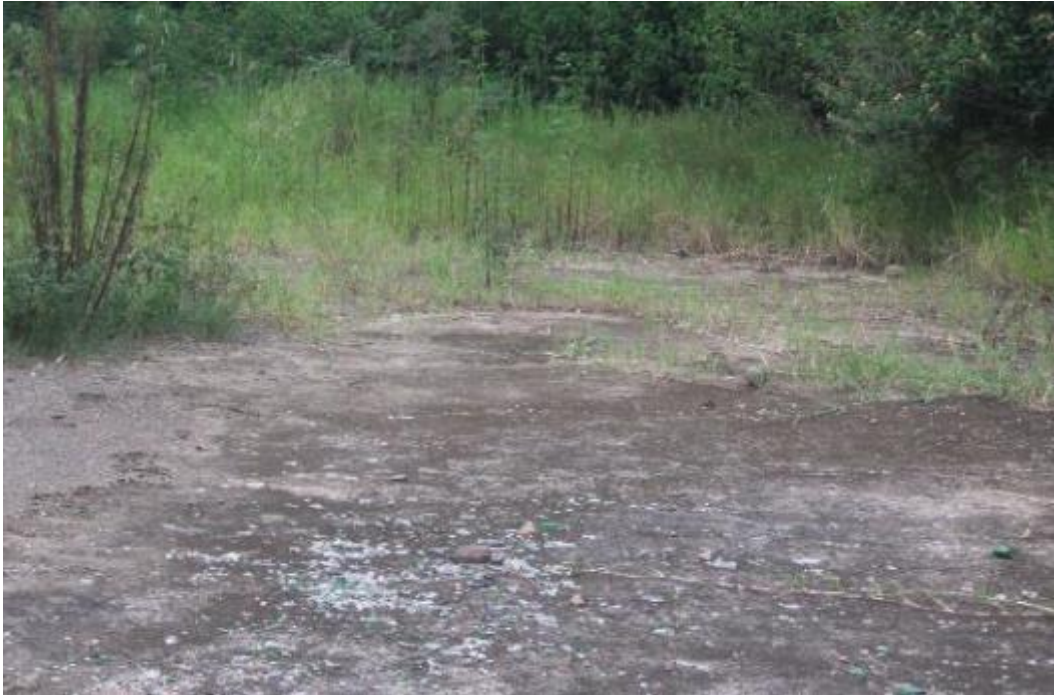
The remains of a concrete floor were found at 30°15'16.6"S 29°55'41.7"E. No other remains associated with the floor were found during the inspection. It is deemed to be of low to negligible heritage significance as only the floor of the structure that used stand there remains.

Figure 13: Remains of concrete floor

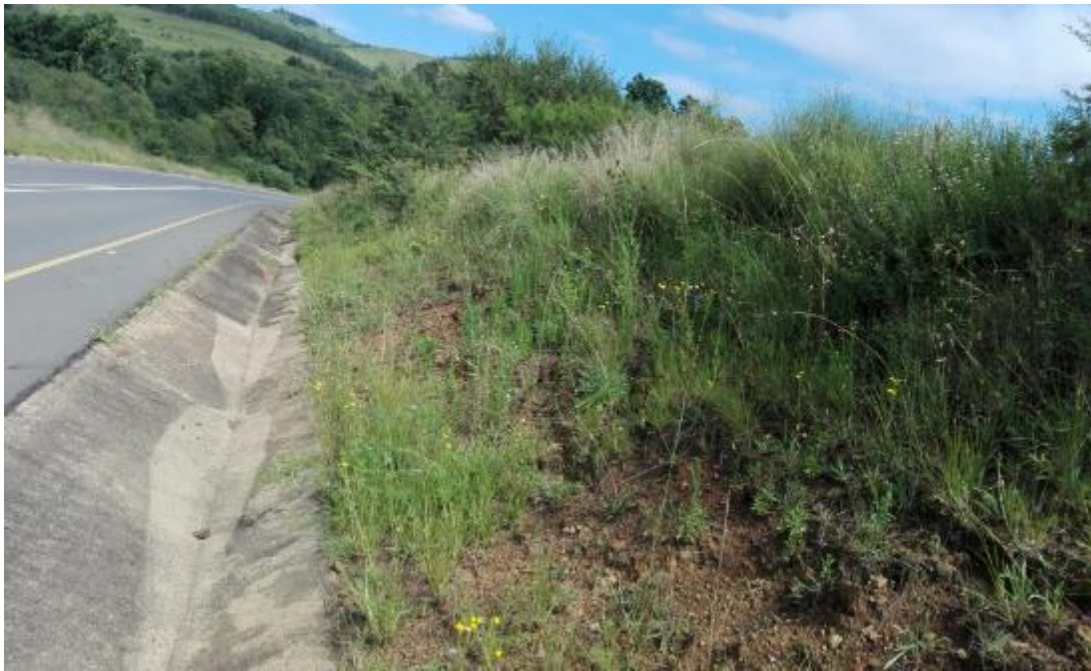
Figure 14: Vegetation along pipeline route

From this point onwards no further structures or sites of interest were discovered. Areas that could be accessed were inspected and close observation of overgrown areas was undertaken.
