## **MANAGEMENT, MONITORING AND EVALUATION OF THE CRADLE OF HUMANKIND FOSSIL SITES**

**UPDATED FOSSIL SITE MANAGEMENT PLAN  
FOR**

**WONDER CAVE**

**2009 - 2013**

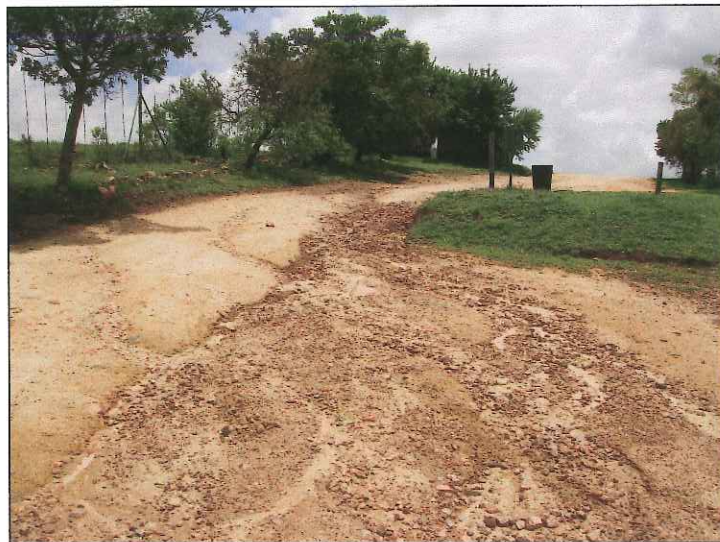
*Fig 3: Erosion of the Wonder cave driveway, 2008*

- Erosion has affected the car park area (Fig 3) as well as the entrance pathway and its steps (Figs. 4 and 5). This will continue to deteriorate unless anti-erosion interventions are put in place.

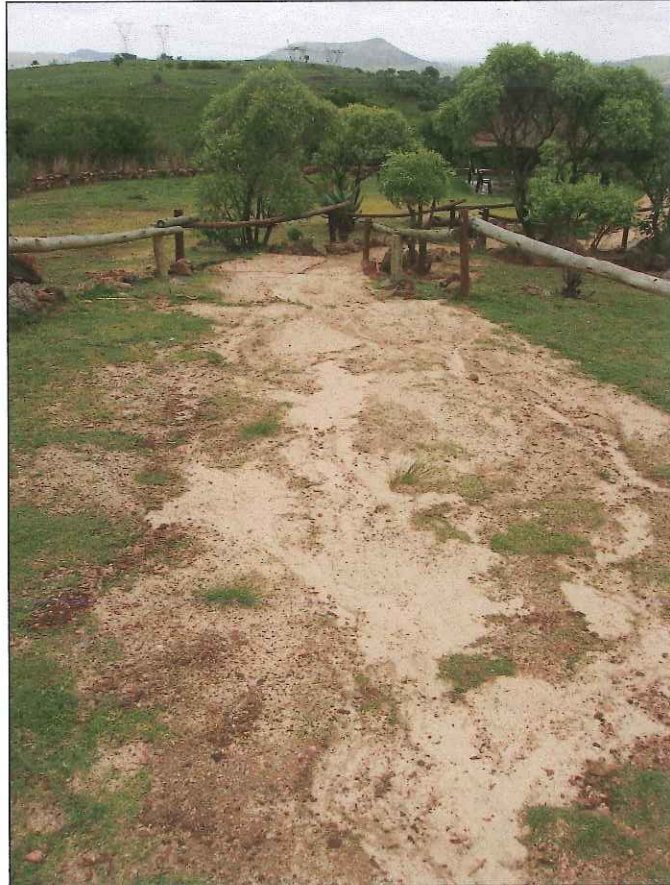
A partially-cemented pathway with a low, bricked parapet on either side leads visitors to the gated cave entrance. The sloping entrance driveway and path creates an automatic channel for water (Figs 3,4 and 5), which would normally be directed into the cave during rainstorms, but the flow has been deflected away from the visitor entrance. Water abstraction combined with redirection of rainwater which would normally enter the cave, is contributing to the desiccation of the cave.

*Fig 4: Erosion of the entrance pathway, Wonder cave, 2008*

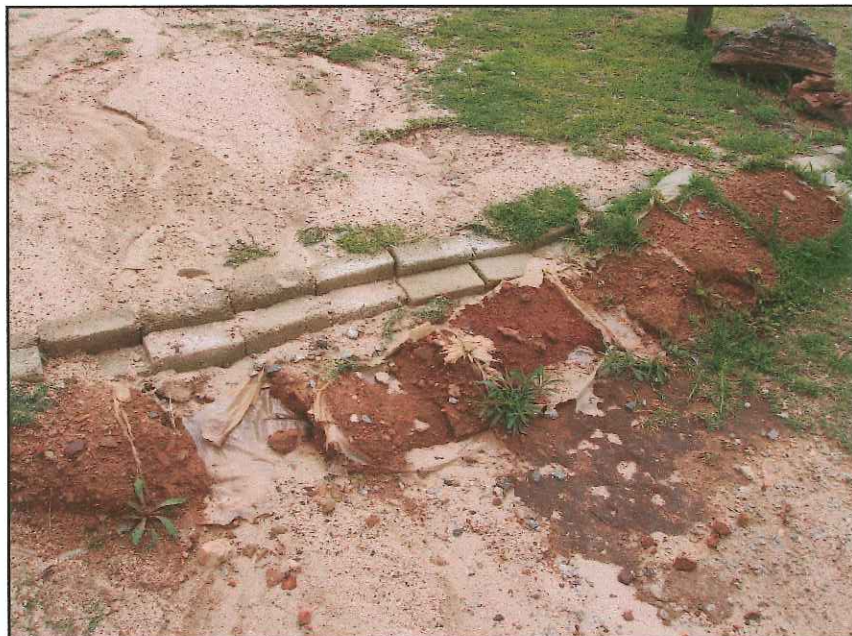
*Fig. 5: Ruptured sandbagging on entrance pathway, Wonder Cave*

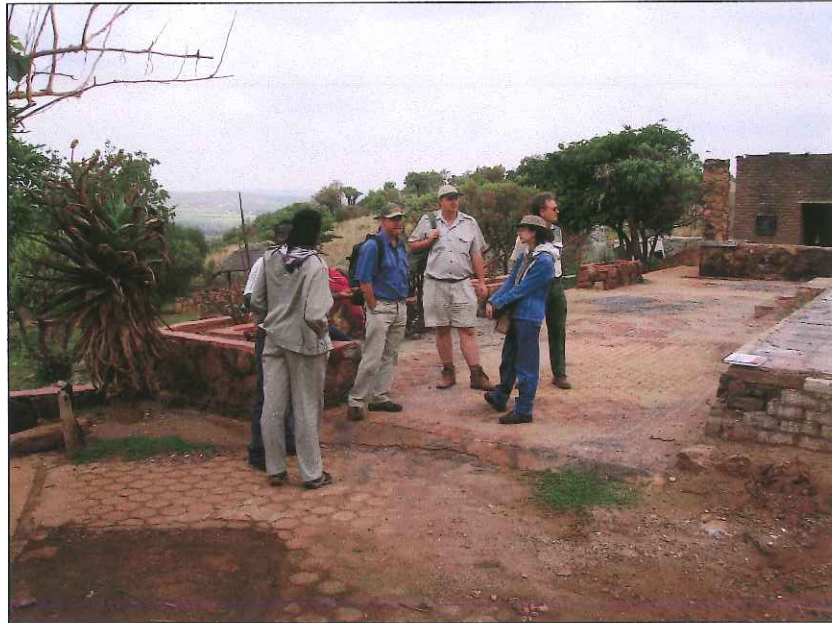
*Fig 6 Ruin of restaurant after the fire, 2007*

- Management of fire is highly significant in the adjacent reserve and it is supposed that the landowner has his own or a communal fire management policy in place.
- The thatched roof restaurant burned to the ground some months ago (although in this case, the cause was uncontrolled domestic fire)
- Because of the danger of drawing smoke and ash into the cave, firebreaks should be slashed or mown, and not burnt. Ash and smoke settled on rock formations and discolours them

- The thatched restaurant burnt down, highlighting the risk of domestically started fires and the need for fire-fighting equipment and staff training in such situations
- Grass fires in the vicinity can cause smoke and soot to be drawn into the cave where it would discolour speleothems

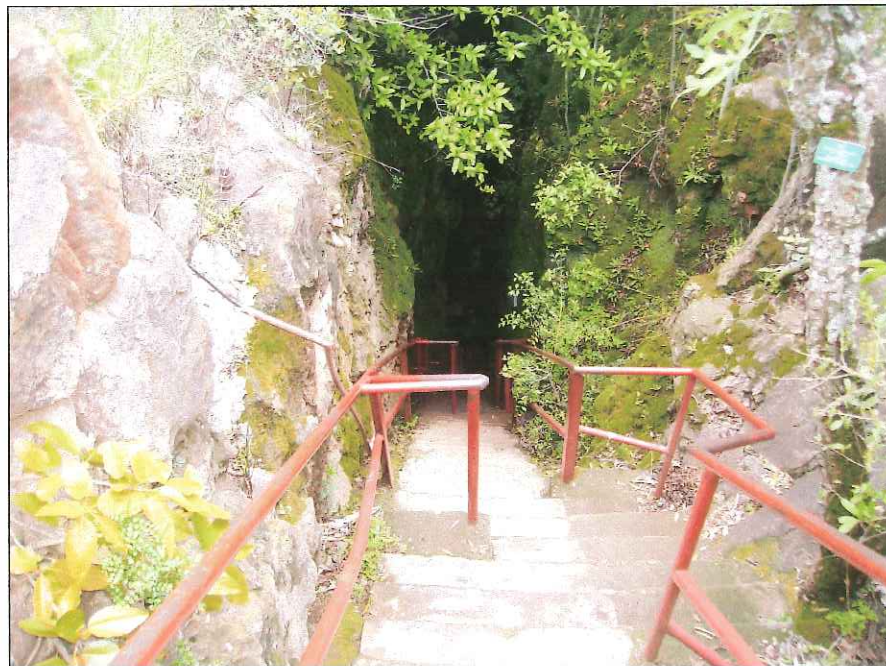
*Fig 7: The narrow shaft-like aven providing access into the Wonder Cave. From the bottom of the steps, an electric lift takes visitors down to the top of the debris cone which formed beneath the aven, which is still many metres above the true cavern floor.*

The cave is accessed through a vertical shaft with a very steep and long staircase (Fig 7) and an electric elevator or lift. The shaft opens into a large cavern about 125 x 50 m with a ceiling height of up to 40 m. It is artificially lit with electric lighting. There are several deposition cones below avens that are now choked with surface-derived material. One is partly calcified and fossilized primate remains and other small mammals can be seen on the surface at the apex. Another is unconsolidated and appears to be stable with a slope of about 70 degrees.
