**A REPORT ON A CULTURAL HERITAGE IMPACT ASSESSMENT FOR THE
PROPOSED PROSPECTING OF THE GLOSAM MINE CLOSE TO
POSTMASBURG, NORTHERN CAPE PROVINCE**

REPORT NO.: AE01802V

19 January 2018

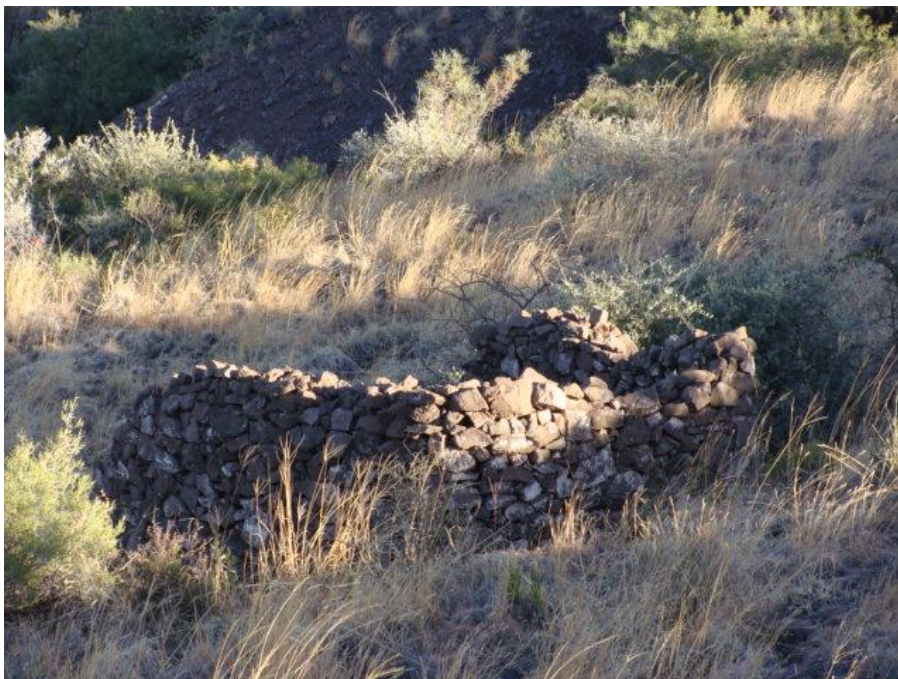
Site 1 - GPS: 28°03'54.2"S; 23°02'43.7"E (Figure 18-19)

Here are two such Miners boxes, a few meters from each other. The first is approximately 3 x 3 m in size with stone walling of 1,5 m high. The second is larger, having measurements of 7 x 4 m and also is approximately 1,5 m high. This one may even have more than one room, but the fallen stones make it difficult to determine this precisely.

FIGURE 18: REMAINS OF A MINERS BOX AT SITE NO. 1.

FIGURE 19: REMAINS OF THE SECOND MINERS BOX AT SITE NO. 1.

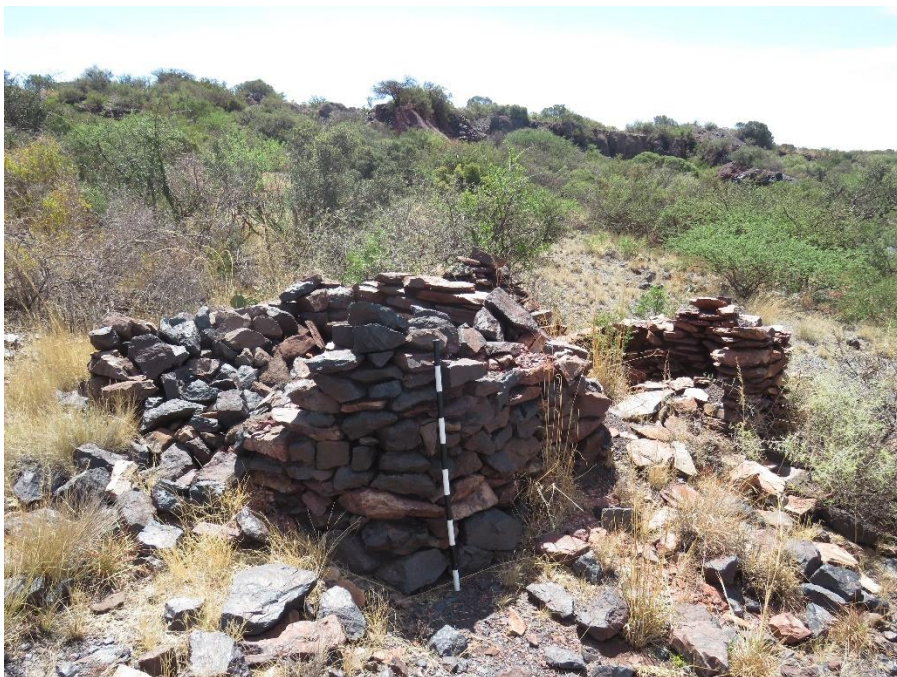
Site 13 - GPS: 28°04'02.6"S; 23°02'17.1"E (Figure 20)

This one has measurements of 4 x 3 m and the stone walls are approximately 1 m high. It also has at least two rooms, indicated by a dividing wall.

FIGURE 20: REMAINS OF THE MINERS BOX AT SITE NO. 13.

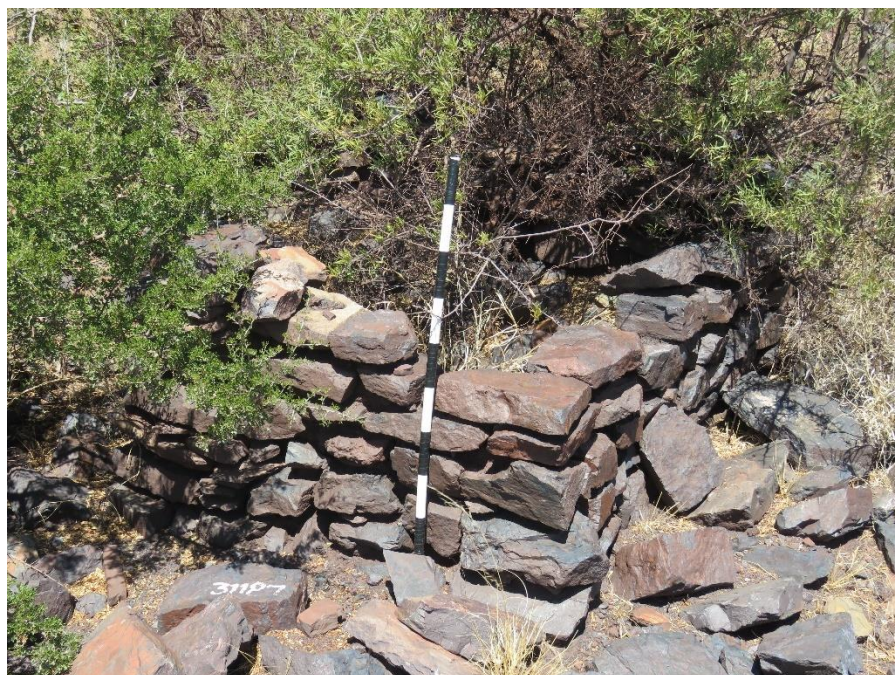
Site 17 - GPS: 28°04'03.8"S; 23°01'51.4"E (Figure 21)

This one has measurements of 3 x 2 m and the stone walls are approximately 3 m high. In front (at the entrance?) it has a stone with a number (311P7) painted thereon.

FIGURE 21: REMAINS OF THE MINERS BOX AT SITE NO. 17.

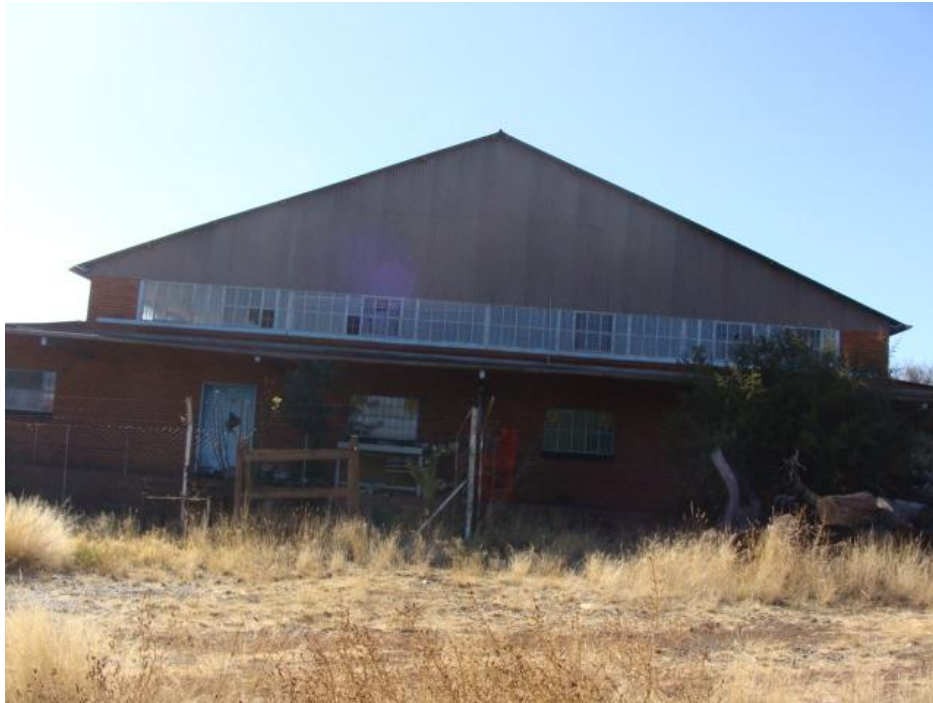
Next to this the old recreation hall which currently is used as a store room (Figure 23). It also is not older than 60 years.

FIGURE 23: OLD RECREATION HALL CLOSE TO THE HOSTEL AREA.

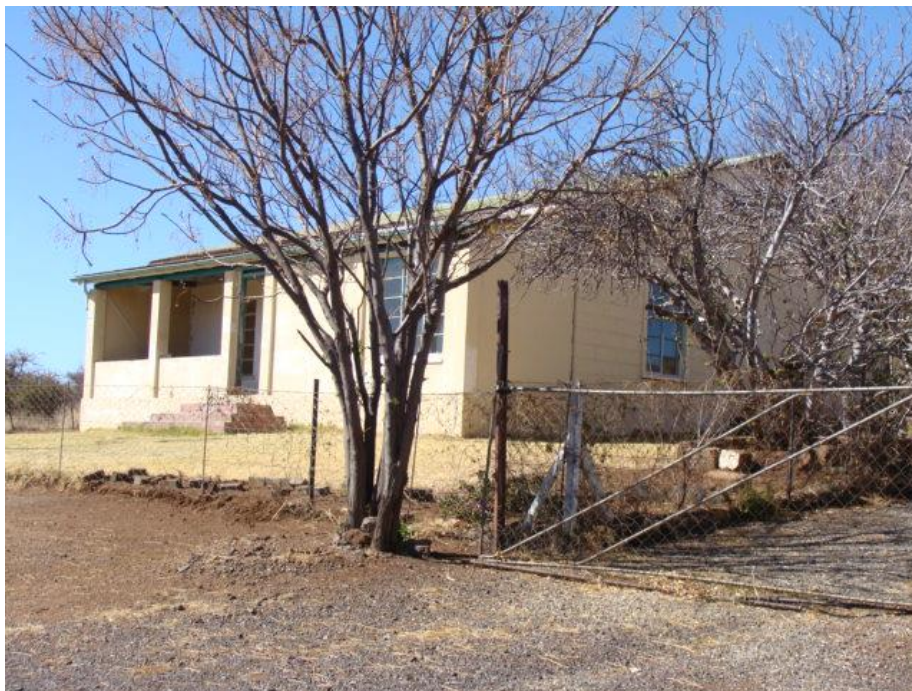
This is three mine houses at the top of a hill to the south-west of the village (Figure 31-32). These also are not older than 60 years (probably younger than those in the centre of the village) and therefore do not need to be preserved. It however is in a good condition and may be utilized with those in the village.

FIGURE 32: HOUSE NUMBER 1 AT SITE NUMBER 4.

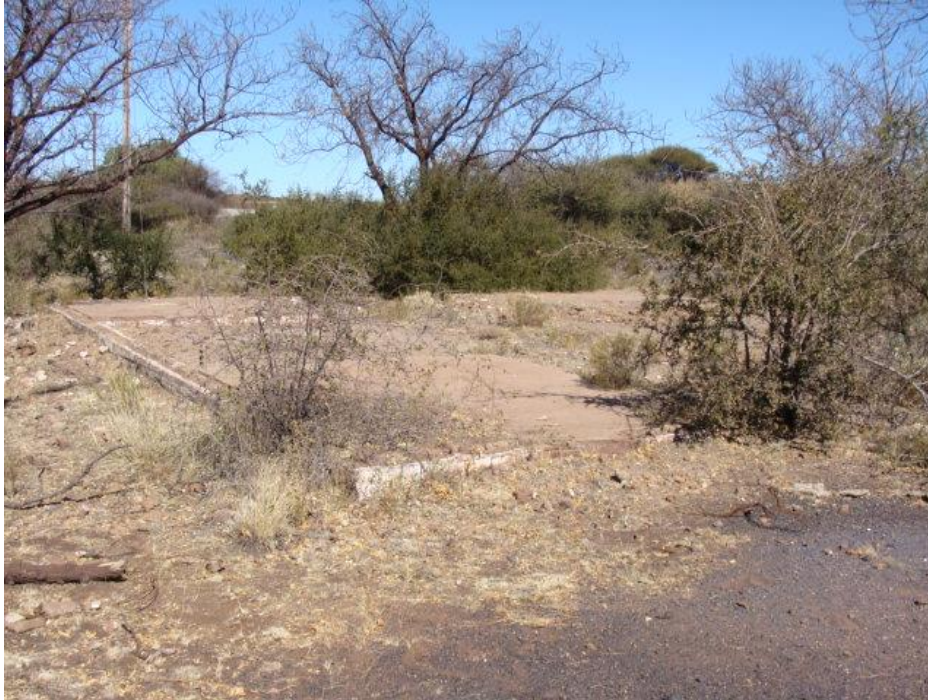
Foundation - Site no 5:

This is the foundation of a house or office building (Figure 34). Nothing of the walls or roof remained, but it probably is older than 60 years.

Figure 34: Foundation of a building less than 60 years old.

- The foundation (site 5), concrete building remains (site 16) and metal framework of an industrial building (site 21) has no cultural heritage value and may therefore be demolished. Since it is older than 60 years, a permit would be required from the SAHRA.

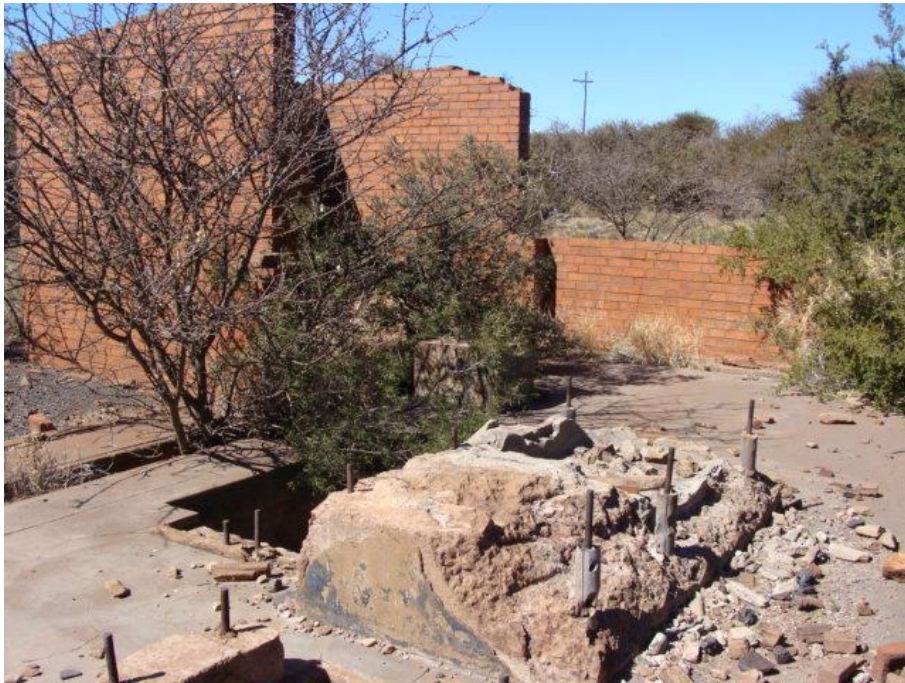
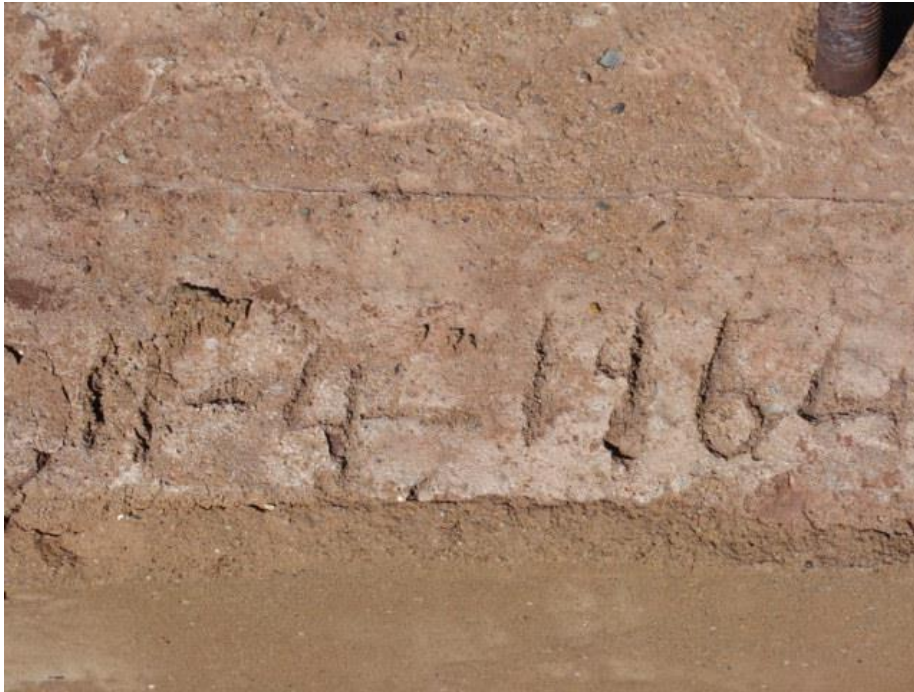
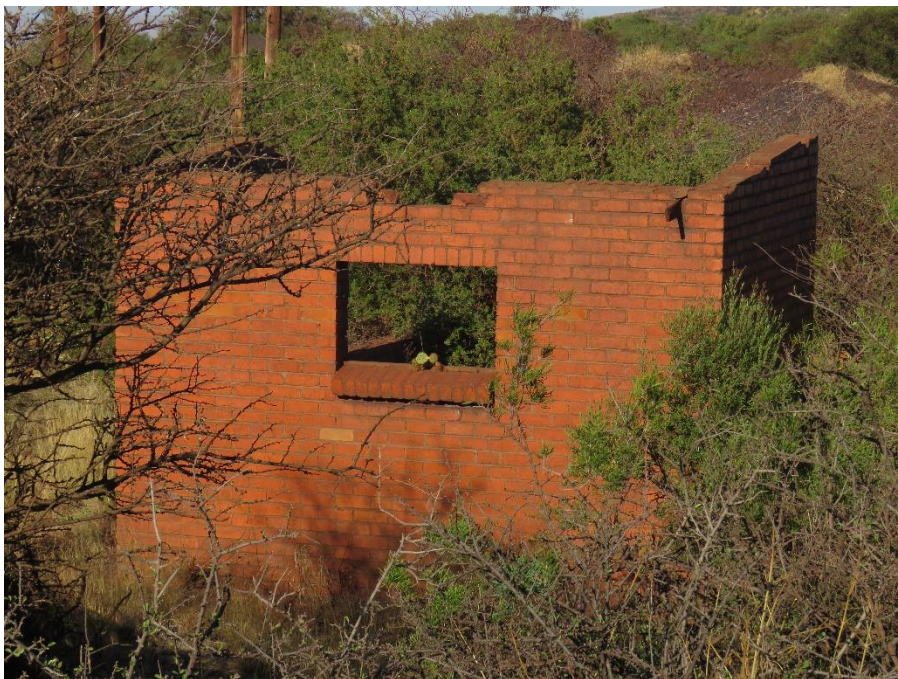
This is the remains of two associated industrial buildings within the mining area. The first has dimensions of 6 x 4 m and have concrete 9 pillars, approximately 2 m high. The second is a small brick building with walls of about 3 x 3 m and 2 m high. It was built in 1964, as indicated in an inscription in the cement (Figure 35-37).

FIGURE 35: REMAINS OF AN INDUSTRIAL BUILDING IN THE MINING AREA.

FIGURE 36: (11-4-1964) INDICATED ON THE BUILDING.

FIGURE 37: SECOND BUILDING ASSOCIATED WITH THE FIRST.

The site has no cultural heritage value and may therefore be demolished. This report is seen as ample mitigation. The structure is younger than 60 years and in a very poor condition. It may be demolished without a permit from SAHRA.

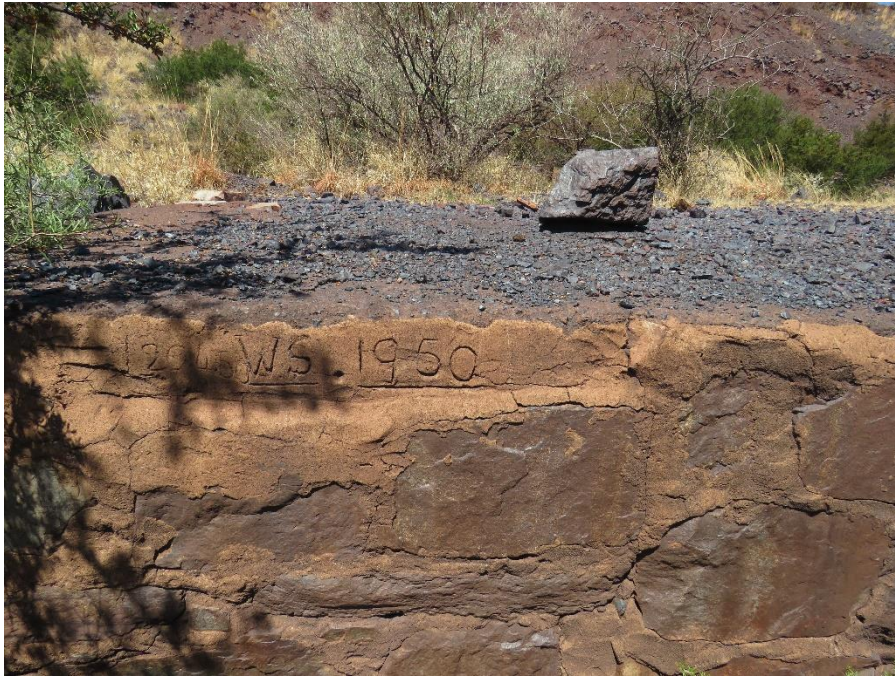
This is a loading platform, built from stone and cement from where ore was loaded onto trucks or carriages. The date, 1950, is scratched into the cement (Figure 41-42). The structure therefore is older than 60 years old.

FIGURE 41: DATE (1950) SCRATCHED INTO THE CEMENT OF THE LOADING PLATFORM.

FIGURE 42: THE LOADING PLATFORM.

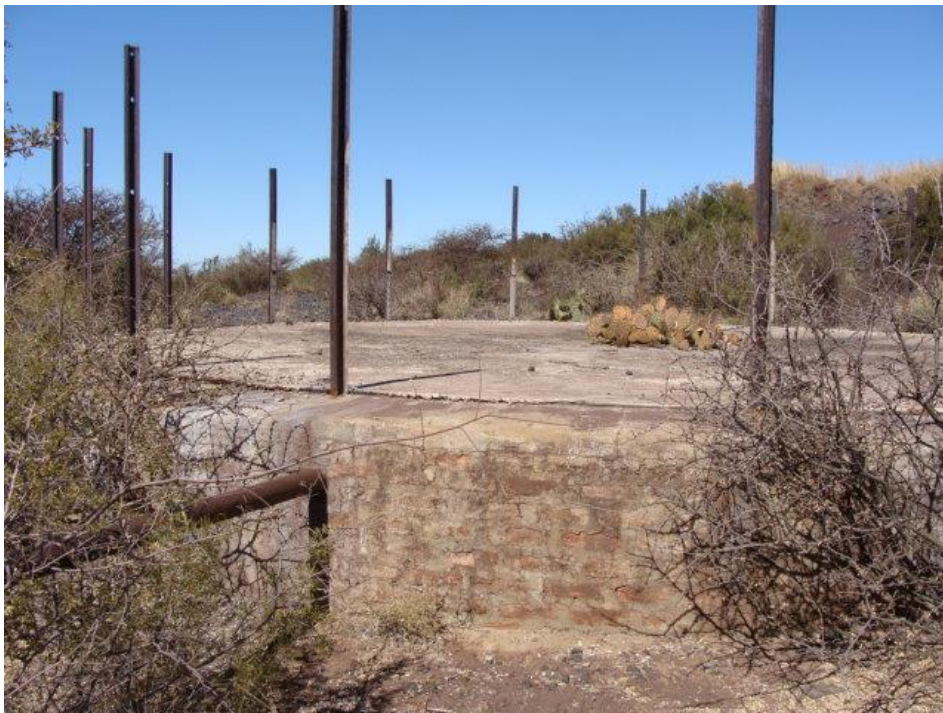
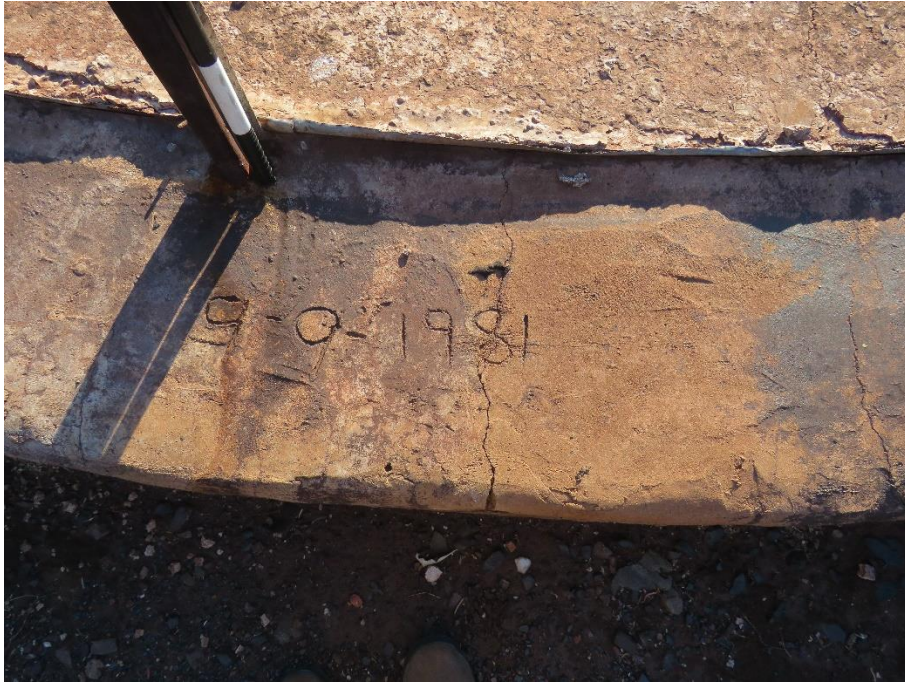
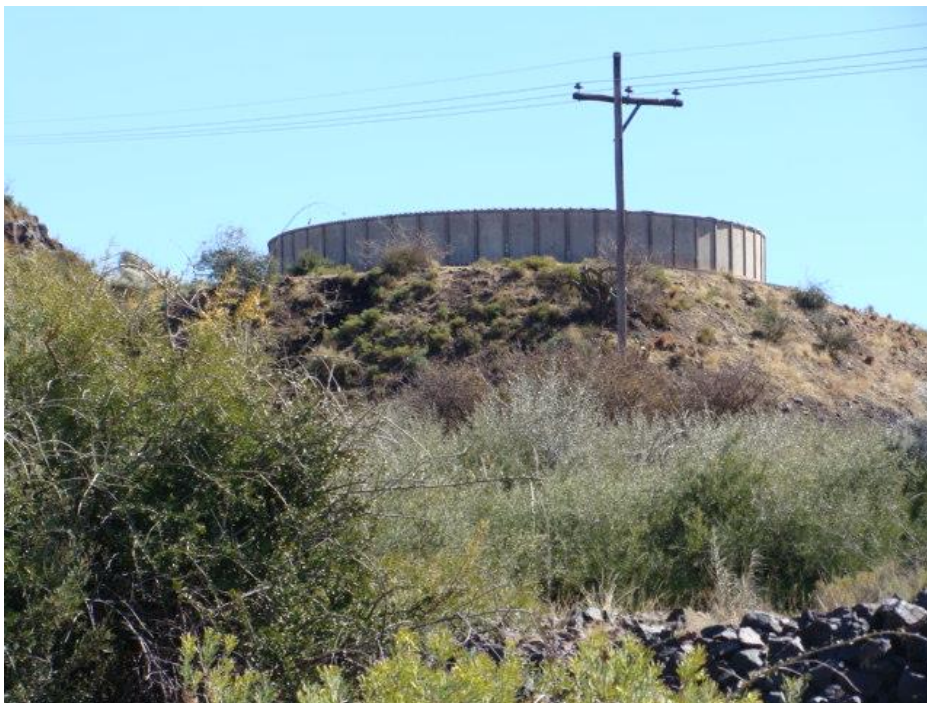
This is the base for a water reservoir which is younger than 60 years as the date 1981 is inscribed in the concrete (Figure 43-44). It has a diameter of 10 m. A second, complete reservoir (Figure 45) was identified closer to the village.

FIGURE 43: REMAINS OF A WATER RESERVOIR.

FIGURE 44: DATE INSCRIBED IN THE CONCRETE.

FIGURE 45: RESERVOIR CLOSE TO THE VILLAGE.

The site has no cultural heritage value and may therefore be demolished. This report is seen as ample mitigation. The structure is younger than 60 years and in a very poor condition. It may be demolished without a permit from SAHRA.

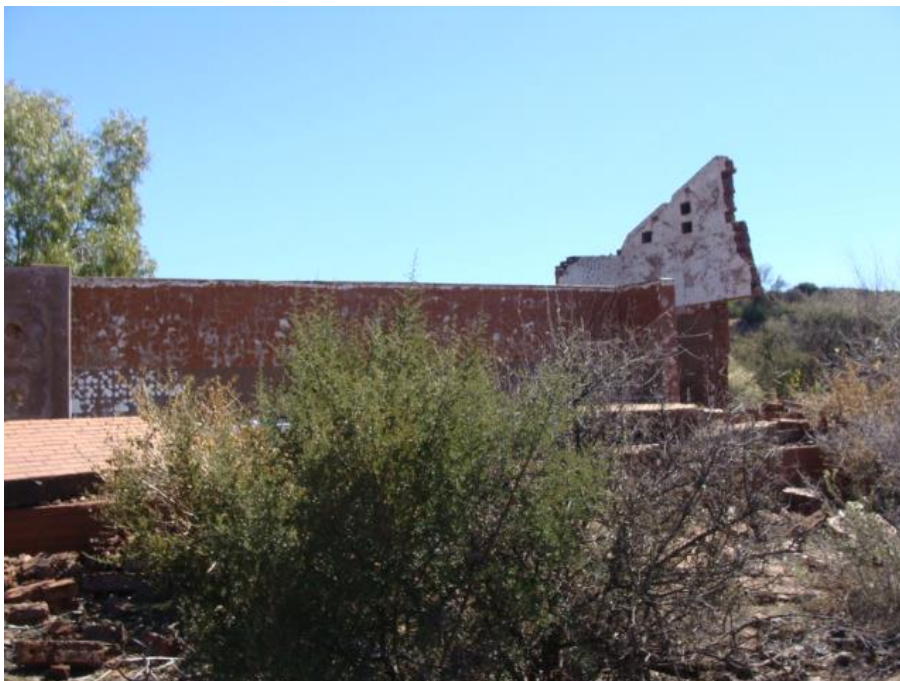
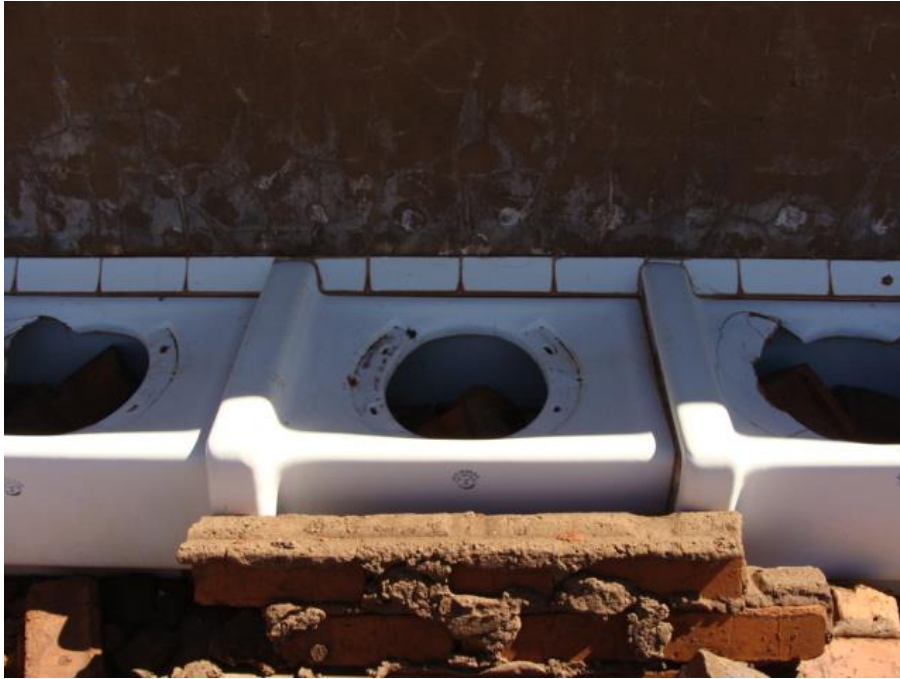
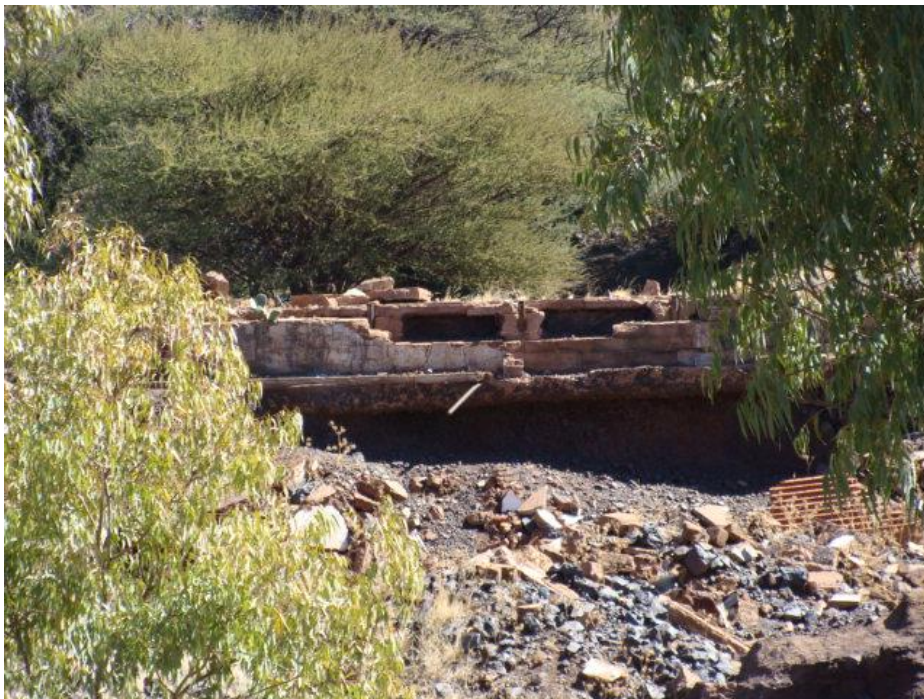
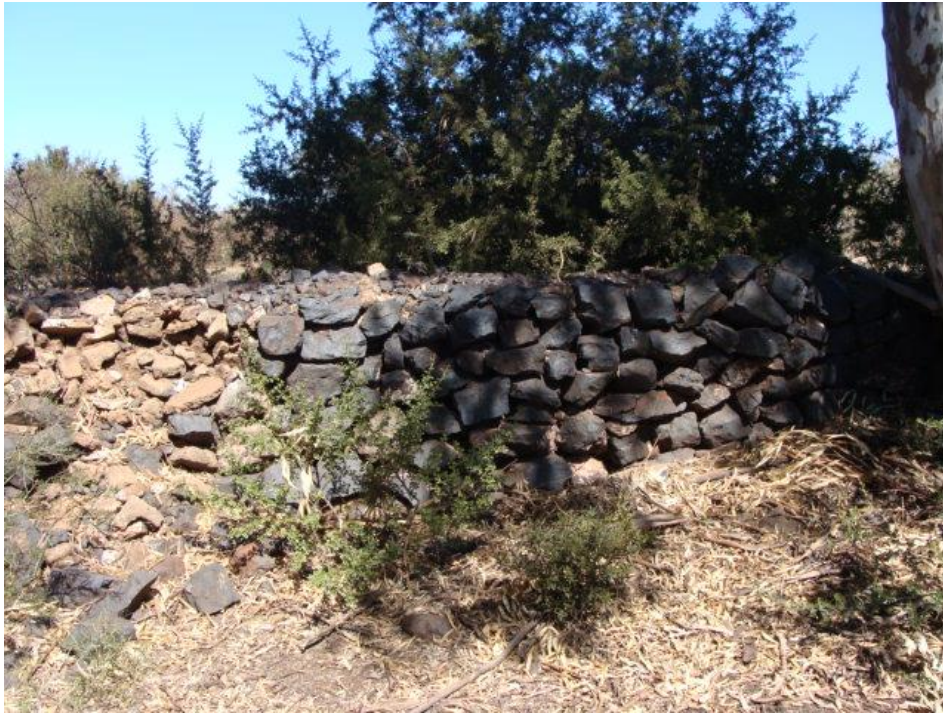
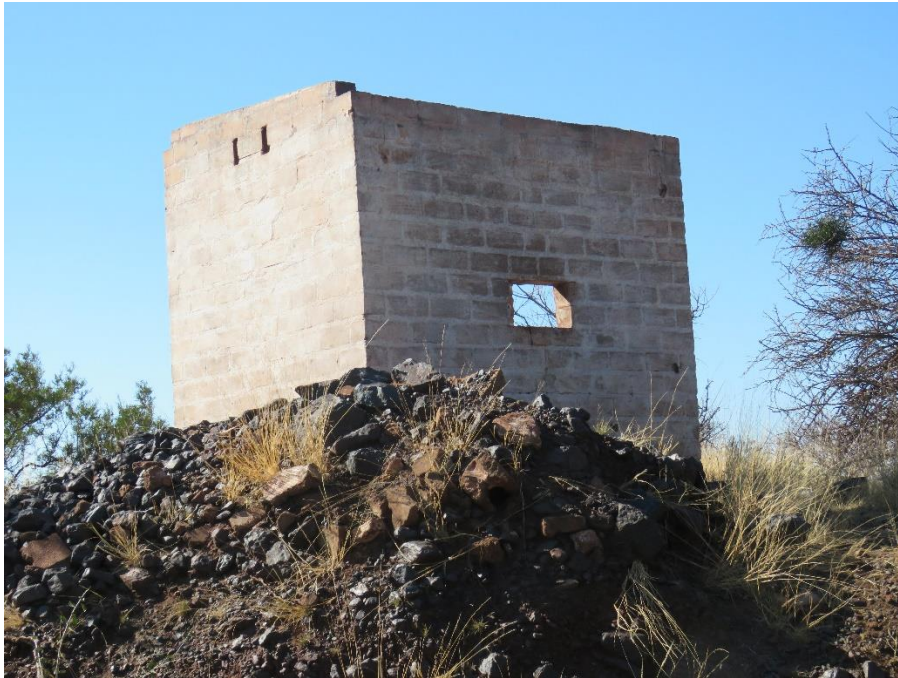
From the bad state of the site it seems it was deliberately demolished.

FIGURE 46: REMAINS OF THE TOILET BUILDING.

FIGURE 47: PART OF THE ROW OF TOILETS INSIDE OF THE BUILDING.

FIGURE 48: REMAINS OF ONE OF THE OTHER BUILDINGS IN THE AREA.

FIGURE 49: STONE WALL IN THE AREA.

FIGURE 50: FOUNDATION OF ANOTHER BUILDING IN THE AREA.

FIGURE 51: ANOTHER ASSOCIATED BUILDING.

The site has no cultural heritage value and may therefore be demolished. This report is seen as ample mitigation. The structures are younger than 60 years and in a very poor condition. It may be demolished without a permit from SAHRA.

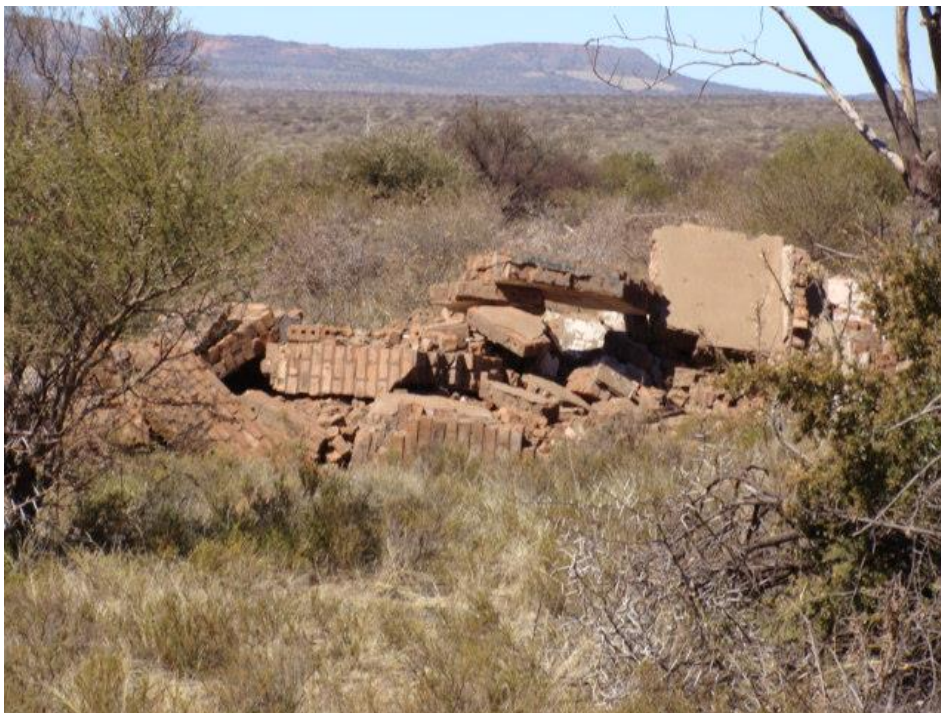
It probably also was part of the industrial or office setup at the mine, or it may have been residential. It is younger than 60 years.

FIGURE 52: REMAINS OF ONE OF THE BUILDINGS AT SITE NUMBER 11.

FIGURE 53: REMAINS OF ANOTHER BUILDING IN THE AREA.

The site has no cultural heritage value and may therefore be demolished. This report is seen as ample mitigation. The structures are younger than 60 years and in a very poor condition. It may be demolished without a permit from SAHRA.

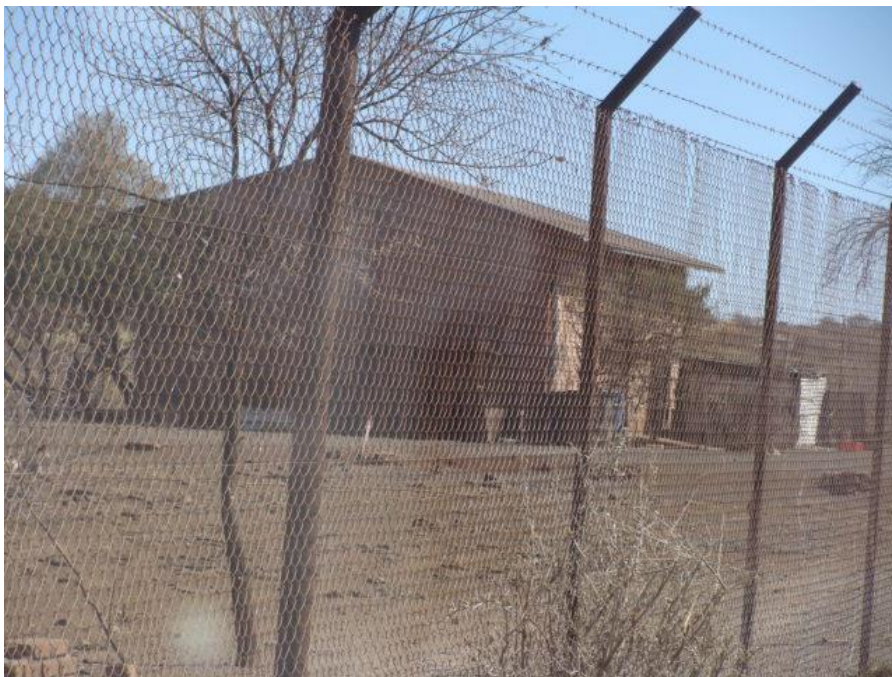
It is a camp, probably for cattle, with a few old and one new building inside (Figure 54). It seems to be used as stores or livestock enclosures. Some small dams are also found in the vicinity as well as a cattle dip and feeding area somewhat to the east.

FIGURE 54: ONE OF THE BUILDINGS INSIDE OF A FENCED IN CATTLE CAMP.

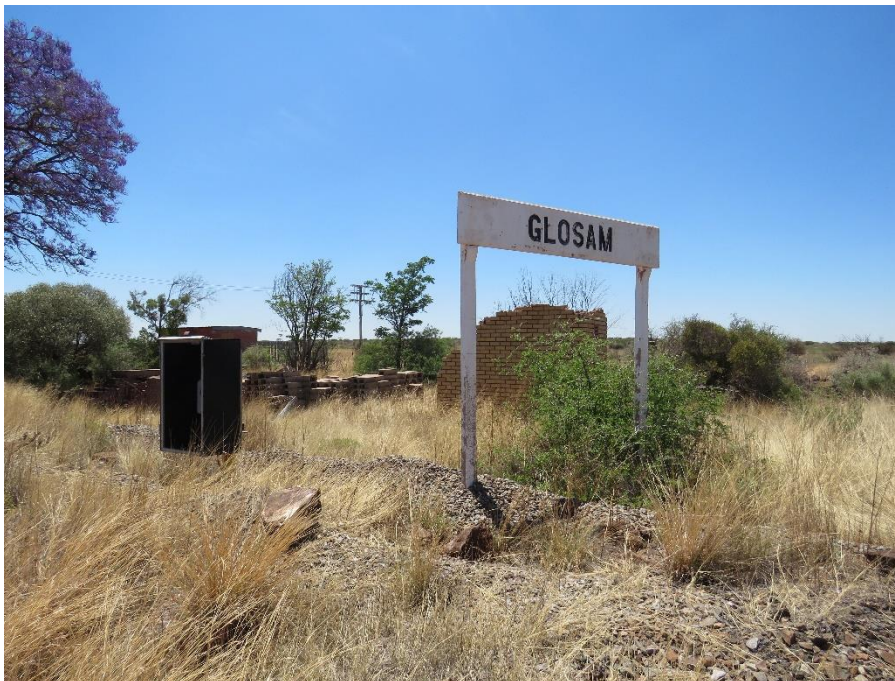
At Ertsrand siding there are no building remains left and one can only see the signage. At Glosam siding the ruins of some buildings are visible. These are however in a very bad state of decay. It seems everything may be just older than 60 years.

FIGURE 55: THE ERTSRAND SIDING.

FIGURE 56: THE GLOSAM SIDING.

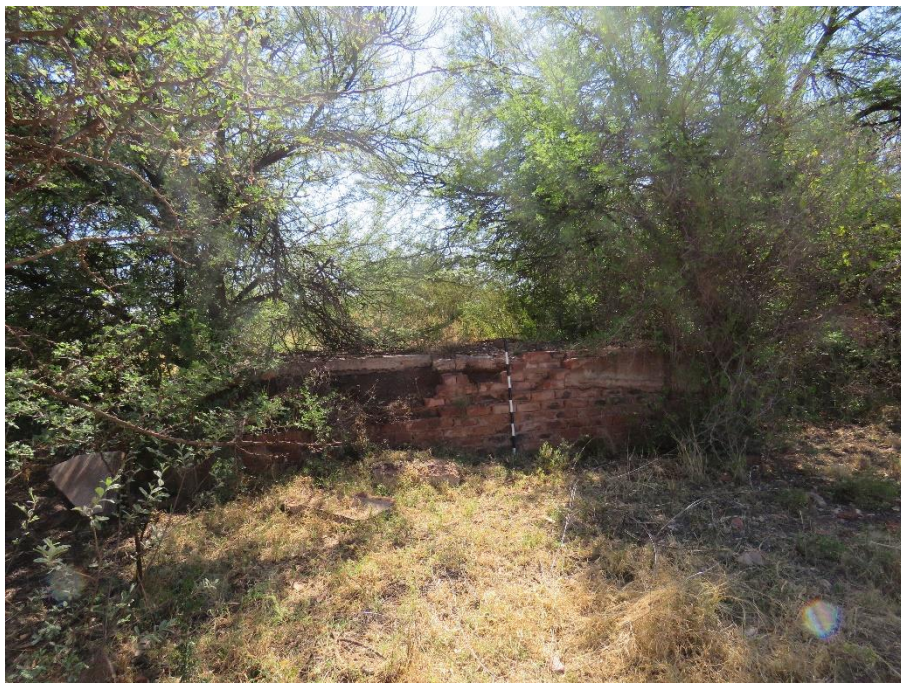
This is an abandoned farm yard consisting of the remains of a house (without walling), other concrete floors, a dam, fences etc. The house floor has a size of 18 x 11 m (Figure 58). It likely dates to the 1960's.

FIGURE 58: HOUSE REMAINS AT FARM YARD.

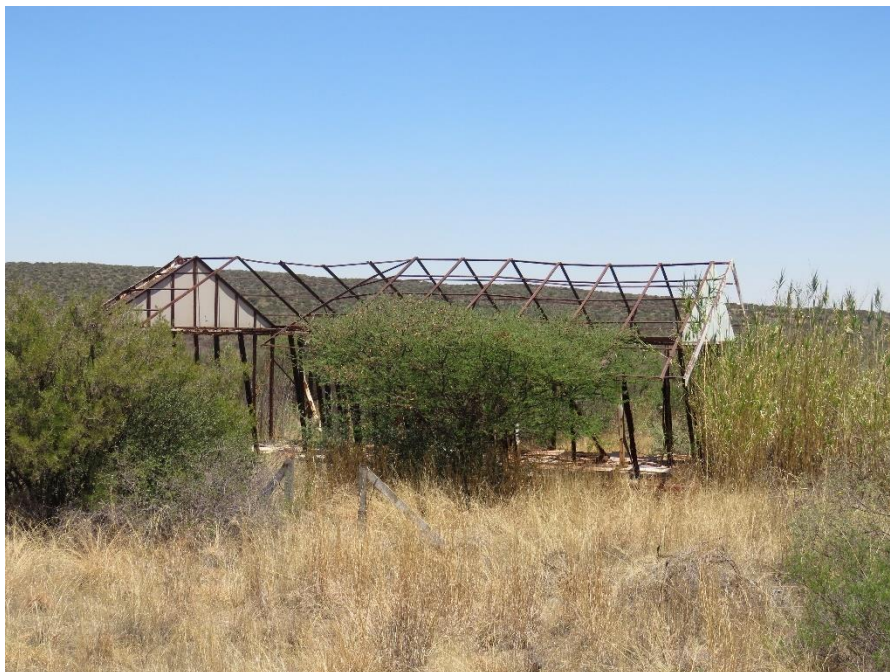
The building is probably related to the railways as it is located directly adjacent to the railway track. It consists of steel poles forming a frame and a concrete floor (Figure 59).

FIGURE 59: STEEL FRAME OF A RAILWAY BUILDING.

- The foundation (site 5), concrete building remains (site 16) and metal framework of an industrial building (site 21) has no cultural heritage value and may therefore be demolished. Since it is older than 60 years, a permit would be required from the SAHRA.
