# PROPOSED UPGRADE AND REALIGNMENT OF THE UMBUMBULU M30 ROAD, ETHEKWINI METROPOLITAN MUNICIPALITY, KWAZULU-NATAL

# **Phase 1 Heritage Impact Assessment**

# August 2017

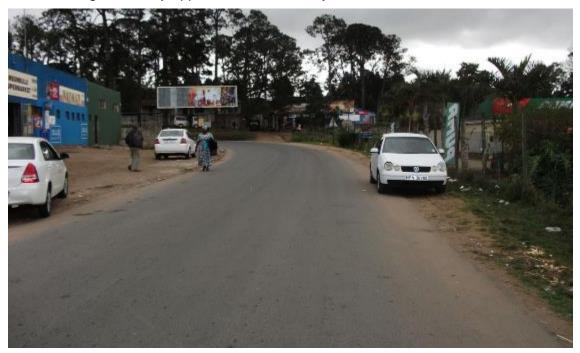
Figure 3: Entrance to Umbumbulu from R603

From the R603, the M30 has a Puma service station on one side and businesses (including the Mbumbulu Supermarket and Zama Zama supermarket) on the other side. The structures appear to be fairly recent developments and less than 60 years of age.

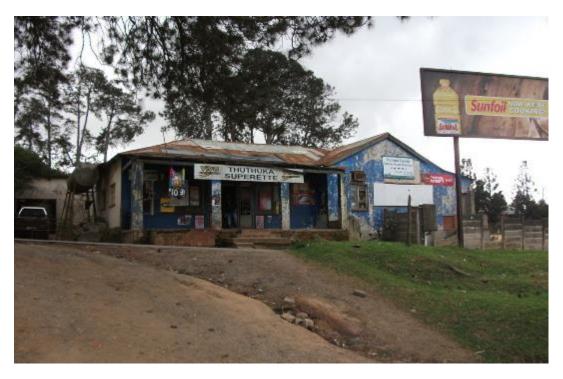
Figure 4: Thuthuka Superette

However, when the road bends towards the north-west, four structures on its north-eastern side (along 300006 Street) are well over 60 years old. One structure serves as the Thuthuka Superette, the second as Umbumbulu's post office, the third structure is dilapidated and unused and the fourth structure is used as a business and possibly as a residence as well. Although these structures are neglected they appear to be structurally sound.

Speaking to residents did not evince any information regarding the history nor the age of the buildings. The use of red brick and corrugated roofing indicates structures that could reasonably be expected to be over 60 years ago.

It is the understanding of the specialist that the area in which these buildings are located will not be affected by the proposed upgrade of the M30. However, construction / upgrade activities must not impact on these buildings as they are protected in terms of section 33 (1) (a) of the KwaZulu-Natal Heritage Act (KZNHA) (2008) that states that: no structure which is, or which may reasonably be expected to be older than 60 years, may be demolished, altered or added to without

the prior written approval of the (Amafa) Council having been obtained on written application to the Council. The demolition or alteration of these buildings is not recommended.

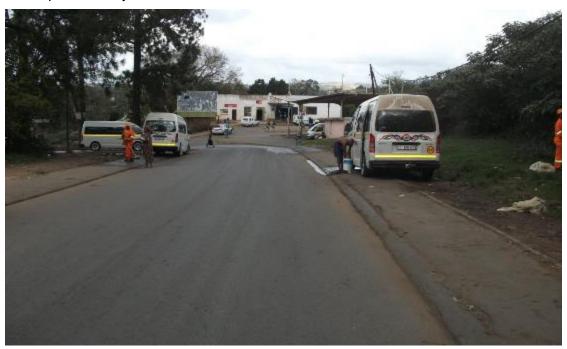
Figure 8: View of M30 looking south-west with open area on right

As the M30 heads northwards, the buildings on either side of the road are a mix of old and new. North of the taxi rank there is an open space which was being cleared of litter by workers during the site inspection. Residents indicated that to their knowledge, there were no graves or other heritage sites in this overgrown open area.

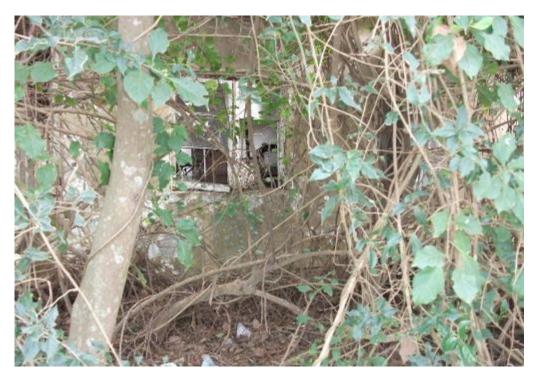
Figure 10: Building on M30 situated behind dense vegetation

Buildings next to and opposite the open area appear to be less than 60 years apart from one structure which is situated behind very dense vegetation that could be over 60 years of age. It is in a depilated condition but appears to be occupied. It is located approx. at 29°59'09.10"S 30°42'10.18"E and it is recommended that the structure is not impacted by the proposed upgrade as it is also protected by section 33 of the KZNHA.

- A buffer zone of 3 m must be placed around all structures along the M30 road to avoid damage
  to the structures during the upgrading process. The material used for the buffer must be highly
  visible to all construction workers.

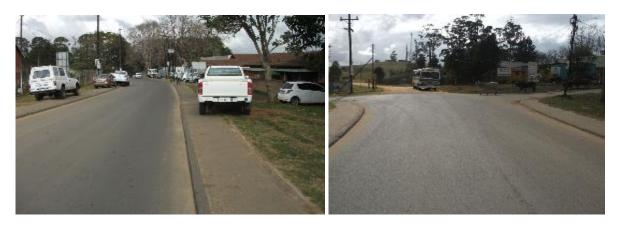
Figure 11: View of M30 to the south and to the north

There is a very new magistrate's court. Next to the magistrate's court is the social grants (SASSA) offices. The building behind the vehicular entrance could be over 60 years old and should not be impacted by the proposed upgrade of the M30.

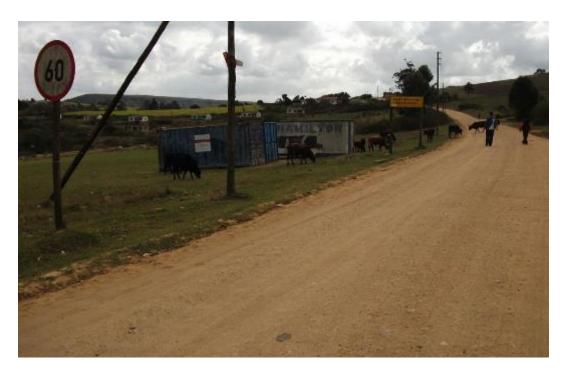
Figure 13: Open area alongside gravel road

The section of gravel road that may be tarred was inspected. On the north-western side of the road is an open field used as a soccer field and grazing for cattle. No heritage sites were found. On the south eastern side is the recently built Umbumbulu community hall and house.

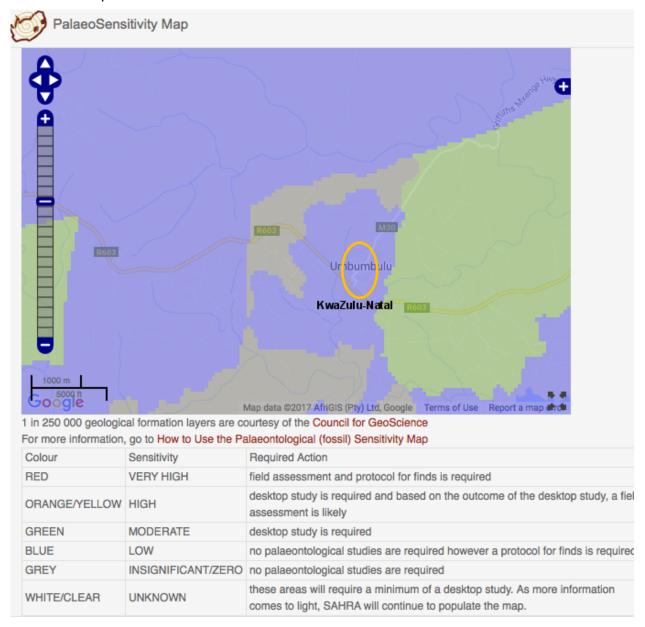
Figure 15: Fossil sensitivity of project area (indicated with orange oval)

The South African Heritage Resources Agency's (SAHRA) Fossil Sensitivity Map revealed that the project area is situated in an area of low fossil sensitivity as indicated by the blue colour in **Figure 15** below. This means that no additional studies are required but that a protocol must be

in place in the event of chance finds of fossils during the upgrade of the road. See Chapter 9 below for this protocol.

- If there are chance finds of fossils during construction, a palaeontologist must be called to the site in order to assess the fossils and rescue them if necessary (with an Amafa / SAHRA permit). The fossils must then be housed in a suitable, recognized institute
