**UPGRADE OF DISTRICT ROAD D1252 SITUATED IN
WARDS 3 & 4 OF IMBAMBAZA LOCAL MUNICIPALITY,
KWAZULU-NATAL**

Phase 1 Heritage Impact Assessment

29 July 2019

**AUTHOR: JLB Consulting
Jean Beater**

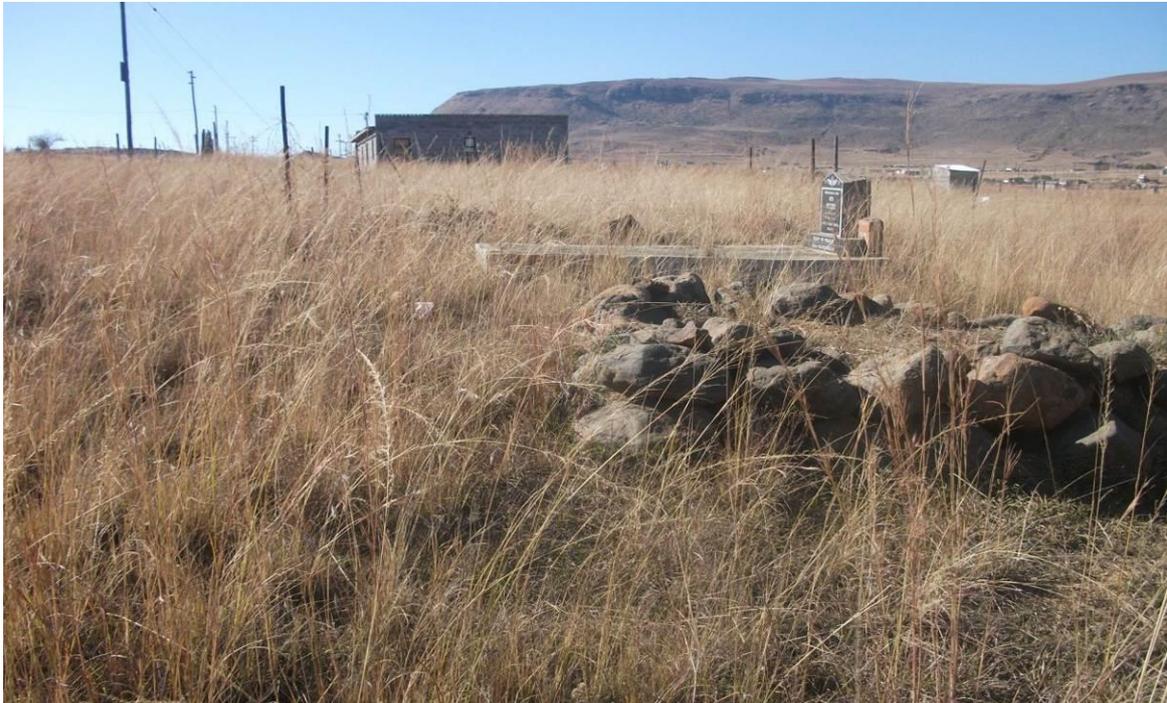
Figure 5: Fenced graves

At least five graves were found situated 20 m south of the D1252 road at 28° 56' 09.1" S, 29° 35' 19.1" E. The graves are made from packed rock and two of the graves have inscribed headstones. The graves are fenced with barb wire and this area is about 35 m in length. The graves are situated some distance from the road and should not be impacted by the upgrade of the road.

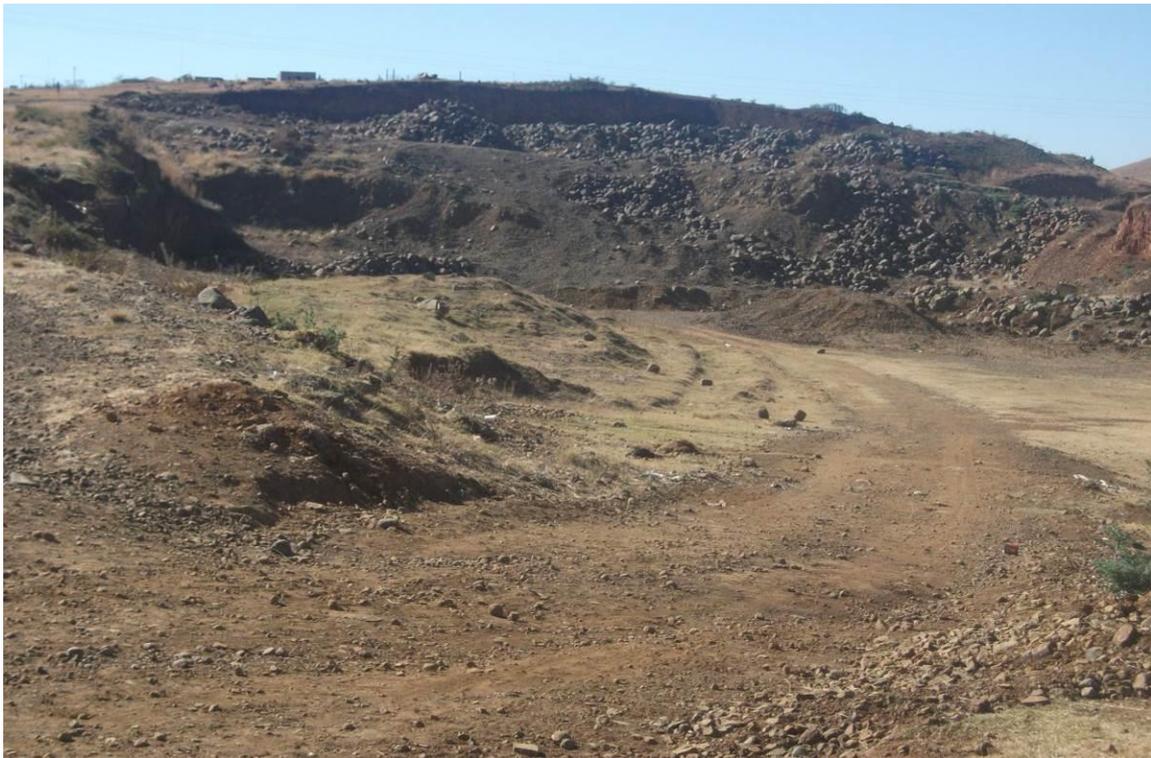
Figure 6: Existing borrow pit

An existing borrow pit, which is currently being mined, will be used to source material for the upgrade of road. The area is very disturbed as can be seen in **Figure 6** below. The area and surrounds were inspected and a fenced circular Shembe temple made from white-painted stones is located 14 m north of and above the borrow pit (see **Figure 7** below). If the borrow pit is to be mined northwards, then the temple will most likely be impacted. Although of no heritage significance, it may be of importance to those members of the Shembe religion that worship at the temple.

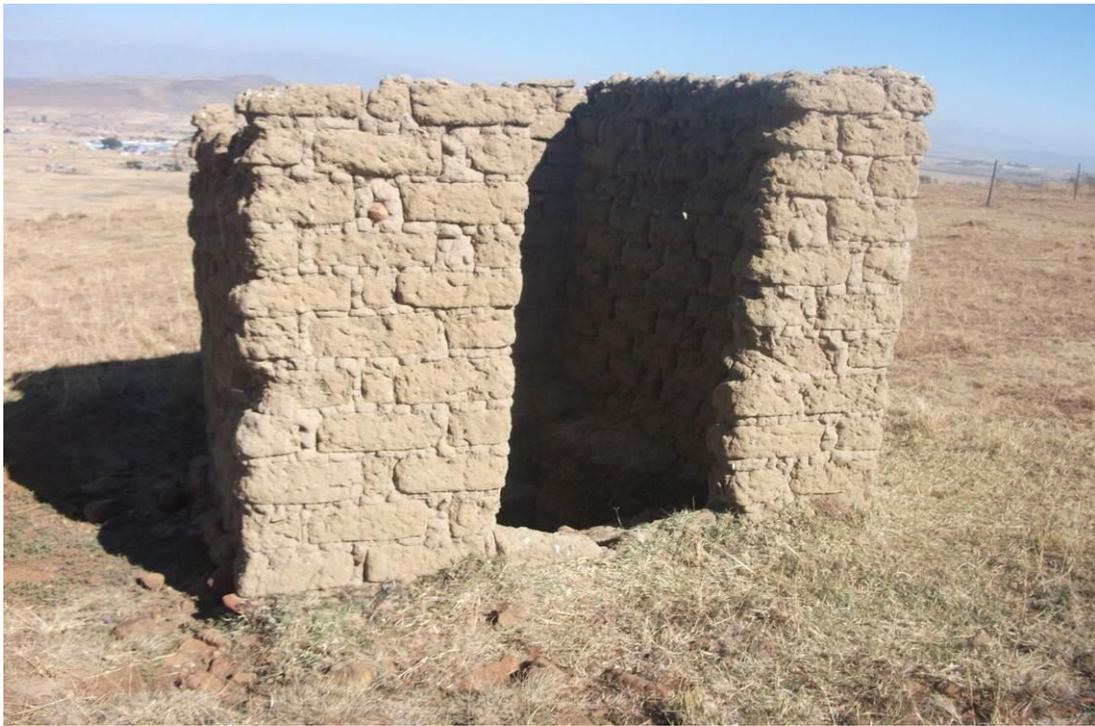
Figure 8: Structure near Shembe temple

About 25m south-east of the temple, a mud brick structure was found that could be used by those worshipping at the temple for their ablutions. It is of no heritage significance, It could also be impacted if the borrow pit expands northwards.

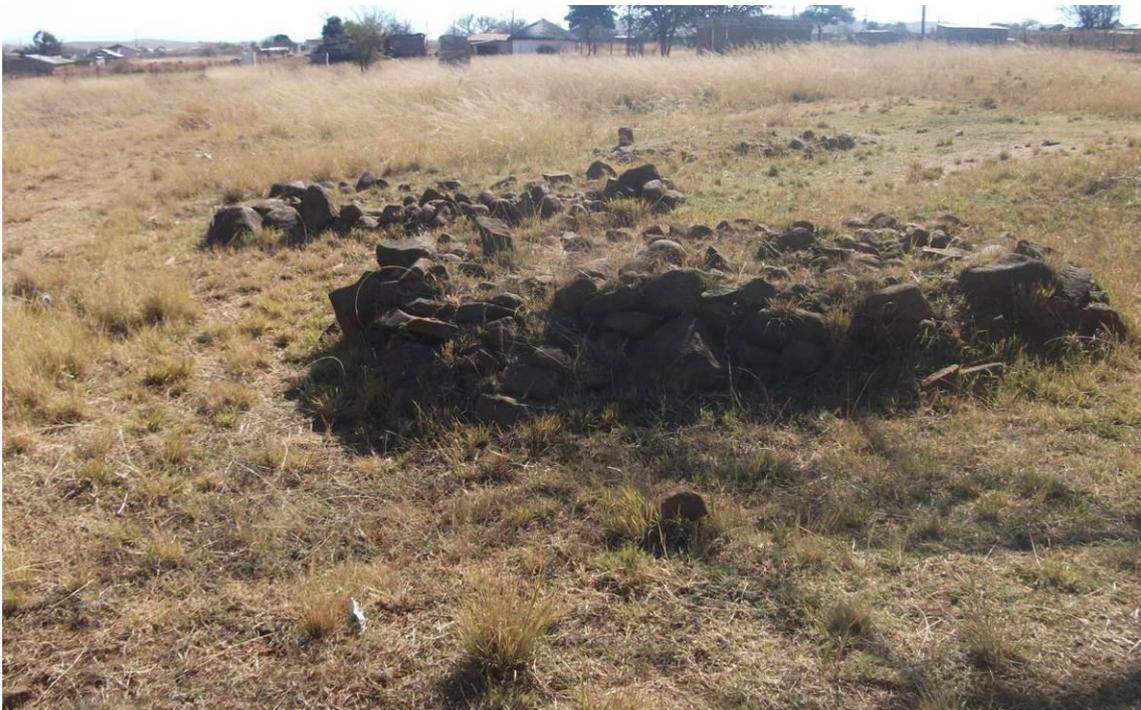
Figure 9: Three graves

Three graves were found on the opposite of the road to the borrow pit underneath trees at position 28° 55' 59.6" S, 29° 36' 00.7" E. The graves are made from packed rock and are situated 35 m north of the D1252 and should not be impacted by the proposed upgrade.

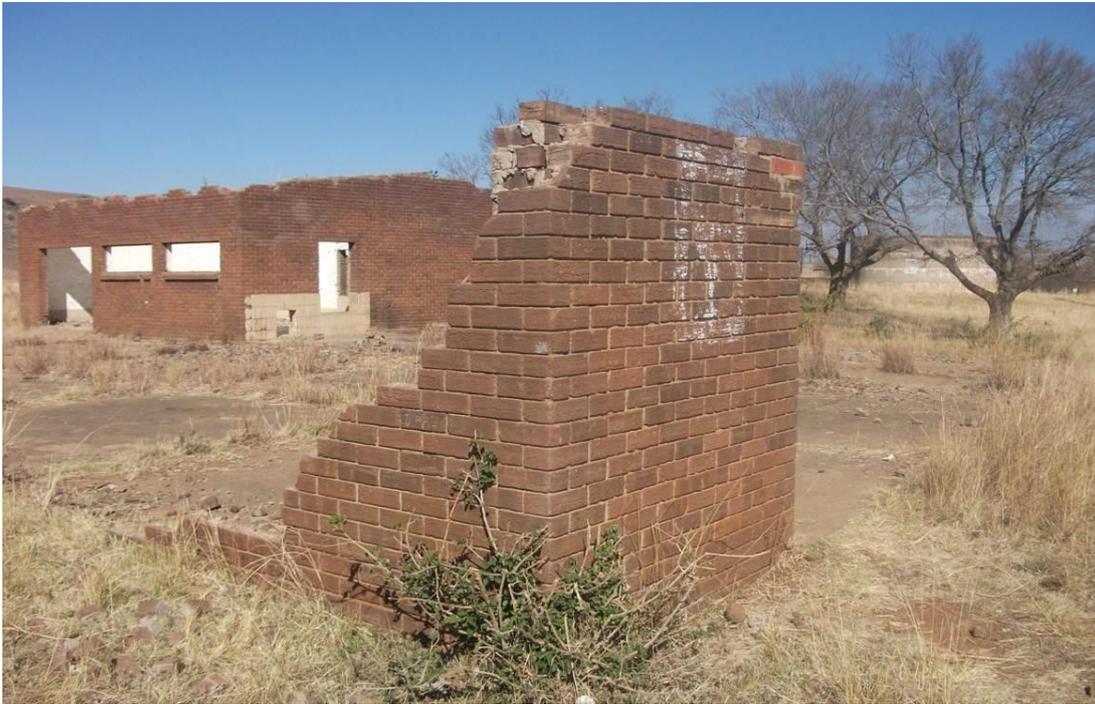
Figure 10: Partially demolished structure

The remains of a brick building were found close to the road. It is unclear what the building was used for and it could have been a municipal or government office or community hall. The boundary of the structure is about 5 m south of the road. It does not appear to be older than 60 years and is of low heritage significance.

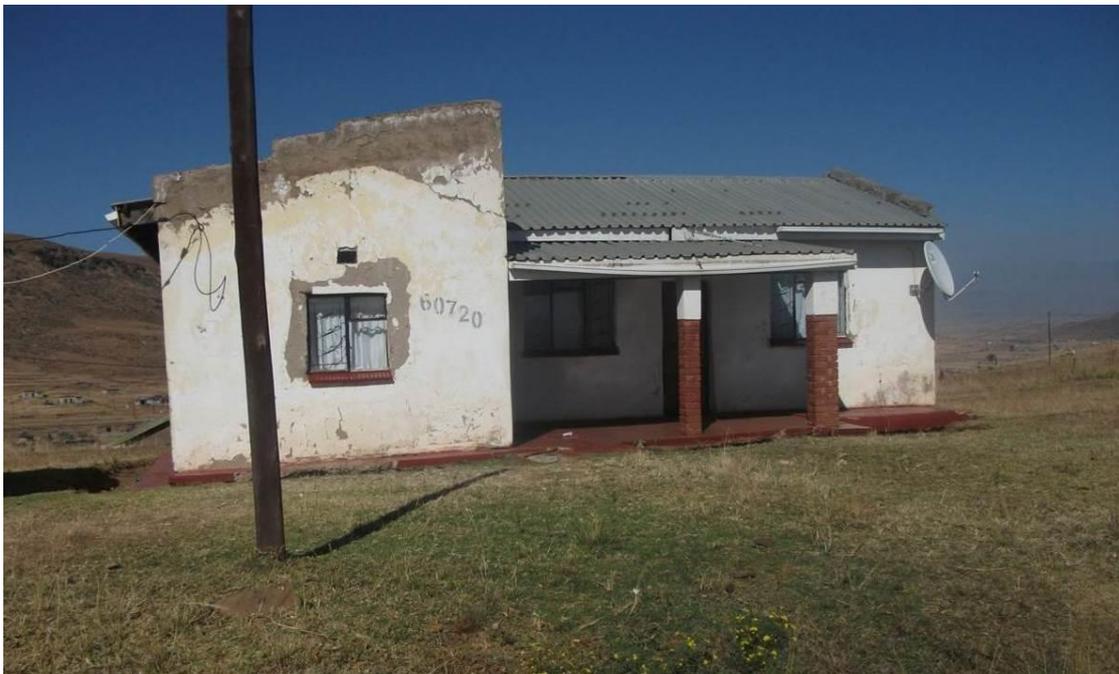
Figure 11: Potential protected structure

A dwelling that could be older than 60 years was found about 10 m south of the road. As the road is not going to be widened, it should and must not be impacted by the road upgrade.

Nature: Damage or destruction of protected structure		
	Without mitigation	With mitigation
Extent	Local (2)	Local (2)
Duration	Long-term (4)	Long-term (4)
Magnitude	Moderate (6)	Low (4)
Probability	Probable (3)	Improbable (2)
Significance	36 (Medium)	20 (Low)
Status (positive or negative)	Negative	Negative
Reversibility	Low	Low
Irreplaceable loss of resources	No	No
Can impacts be mitigated?	Yes	
<i>Mitigation: The structure is protected by heritage legislation; in addition, it is someone's home and should be respected accordingly.</i>		
<i>Mitigation Measures: (1) A buffer of 3m must be placed between the structure and the road works to avoid damage to it during the upgrade; (2) construction workers to respect the significance of the structure to the homeowner/s</i>		
Cumulative impacts: None		
Residual Impacts: None

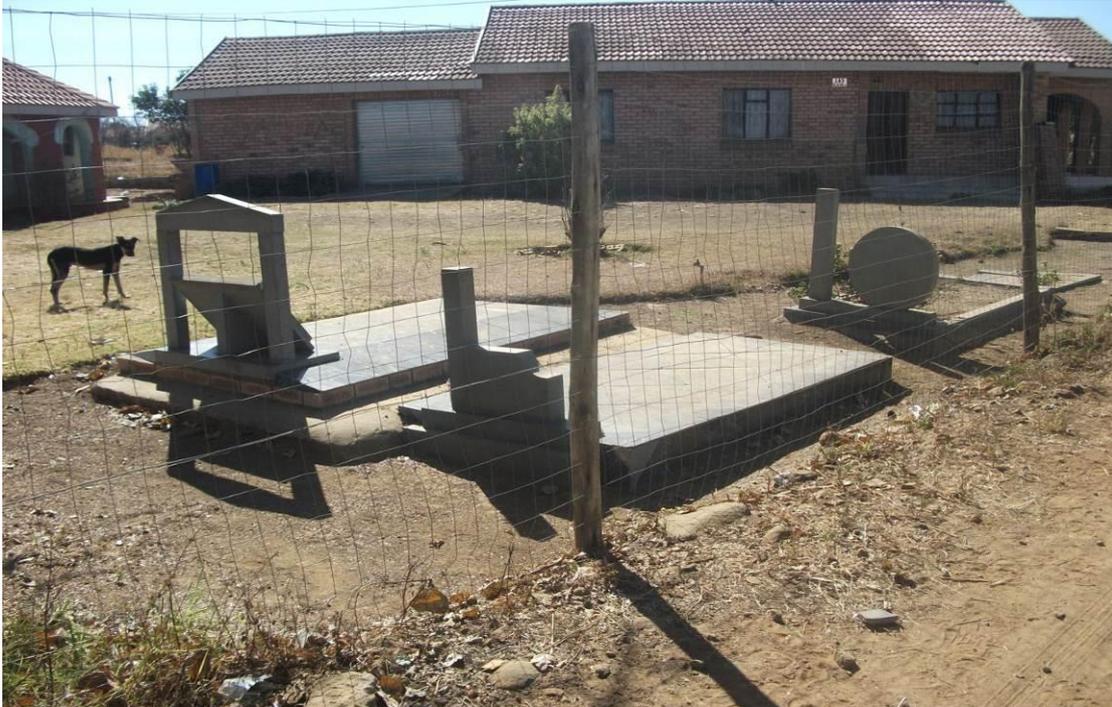
Figure 12: Graves located close to the road

Several graves were found within the fenced boundary of a homestead about 8 m south of road at 28° 55' 55.2" S, 29° 36' 25.0" E. The graves should not be impacted by the road upgrade. However, diagonally opposite this site four graves were found located on the boundary of the road and homestead at 28° 55' 54.5" S, 29° 36' 25.5" E. Only a fence separates the road and the graves. The upgrade of the road could impact on these graves. They are all fairly recent graves with granite headstones and tombstones.

The relocation of graves is not recommended as graves are highly significant to people and there are many traditional, cultural and personal sensitivities and norms concerning the removal of graves. The four graves situated alongside the road should be protected from activities resulting from the upgrade of the D1252 either by sandbagging or by other means (as agreed with the homeowner) that will prevent damage to the graves.

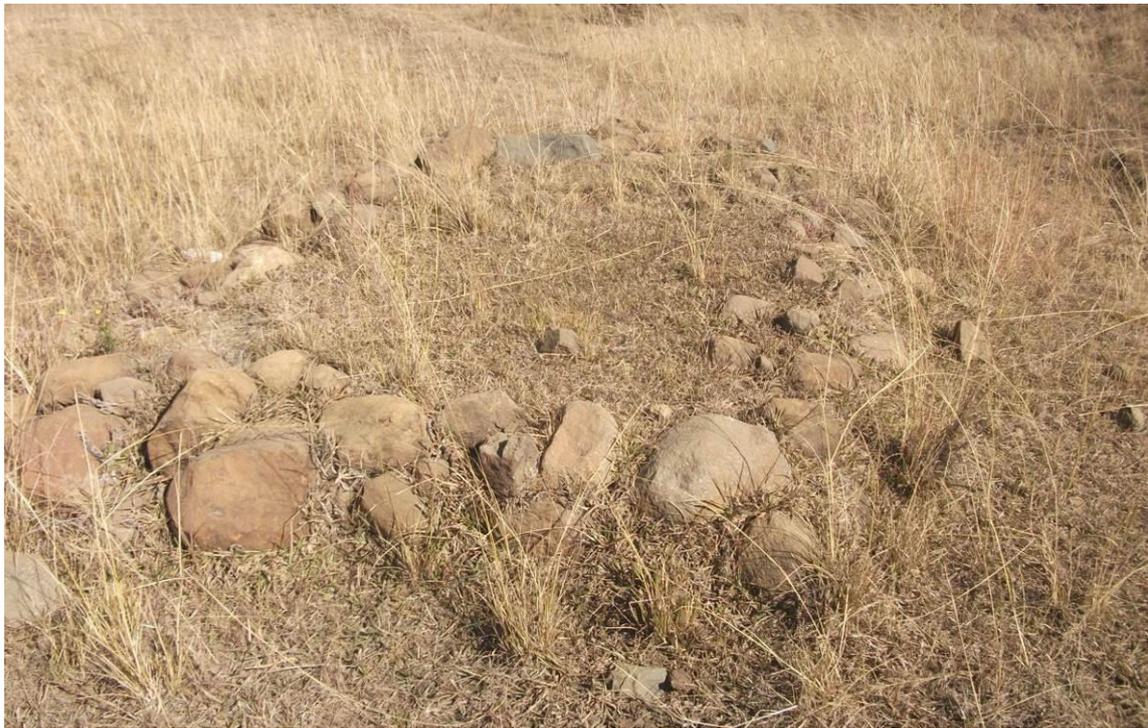
Figure 13: Single grave

Two graves made from packed rock were found situated respectively 14 m and 30 m south of the D1252 road in an open area. The foundations of a structure were found close to these graves and it is surmised that the graves could be linked to the structure. The graves are situated some distance from the road and should not be impacted by the upgrade.
