**PROPOSED UPGRADE OF ROAD D954, MNAMFU,  
UGU DISTRICT MUNICIPALITY, KWAZULU-NATAL**

**Phase 1 Heritage Impact Assessment**

**15 March 2021**

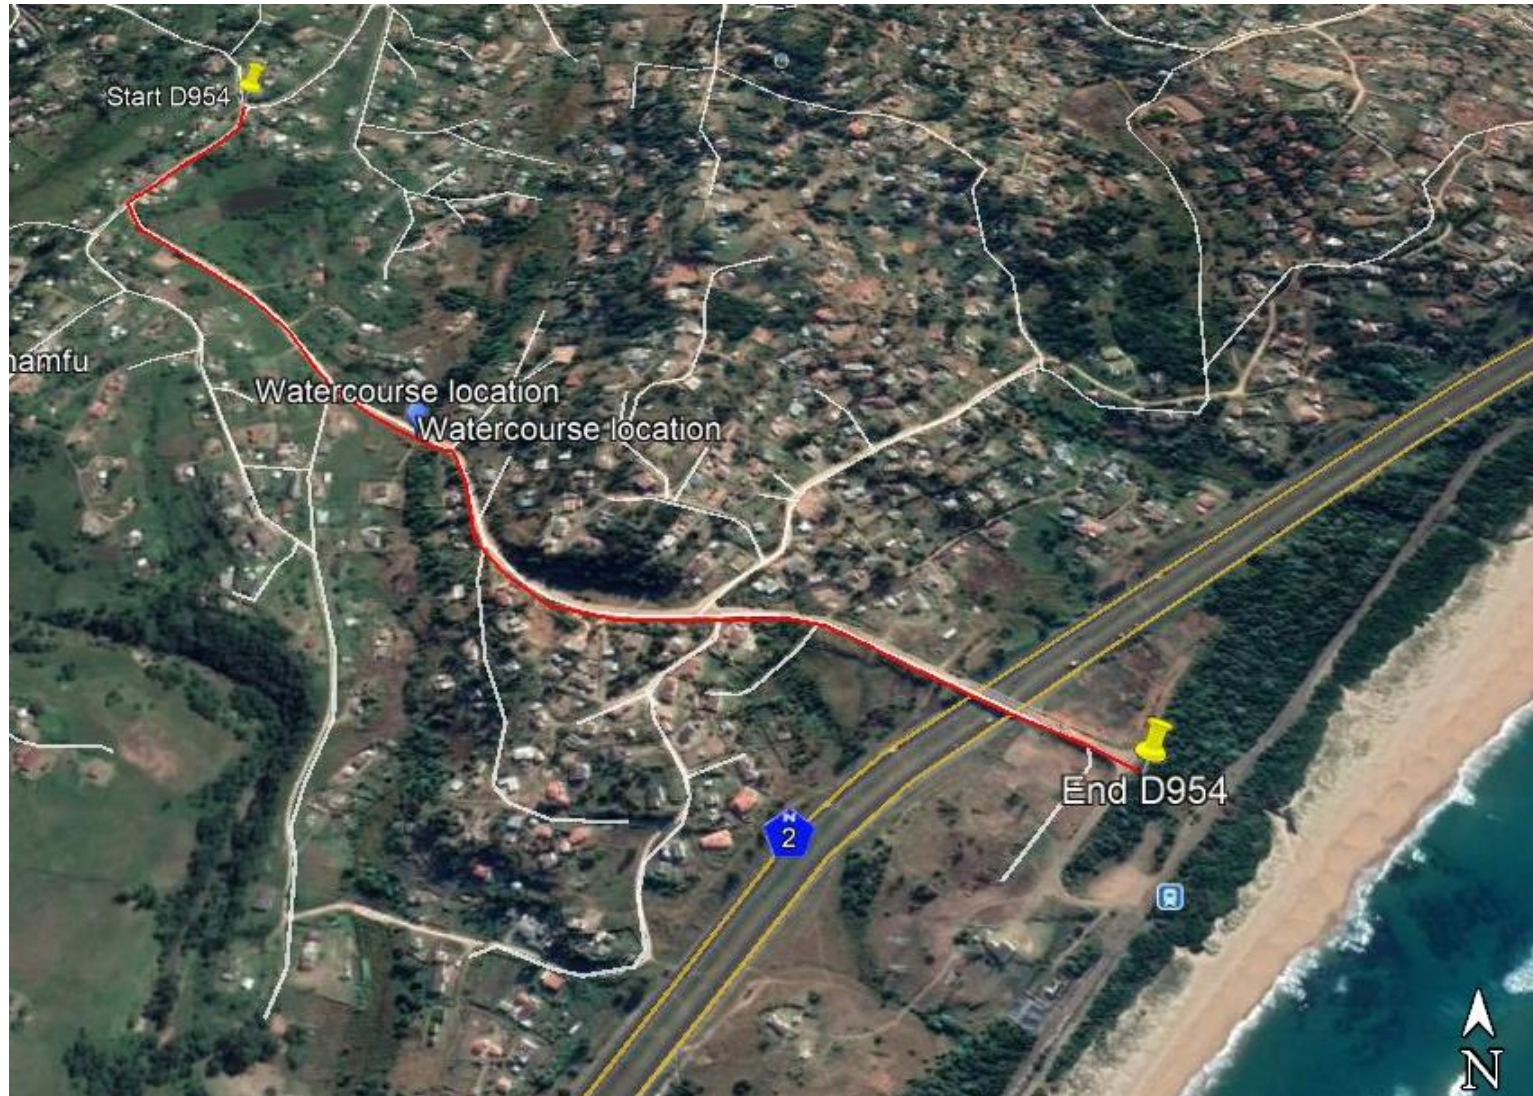
**Figure 1: Aerial view of road to be upgraded indicated in red**

The start and end coordinates of the road are as follows: Start: 30°30'39.98"S; 30°36'14.76"E and End 30°31'11.31"S; 30°36'46.11"E respectively. See **Figure 1** below.

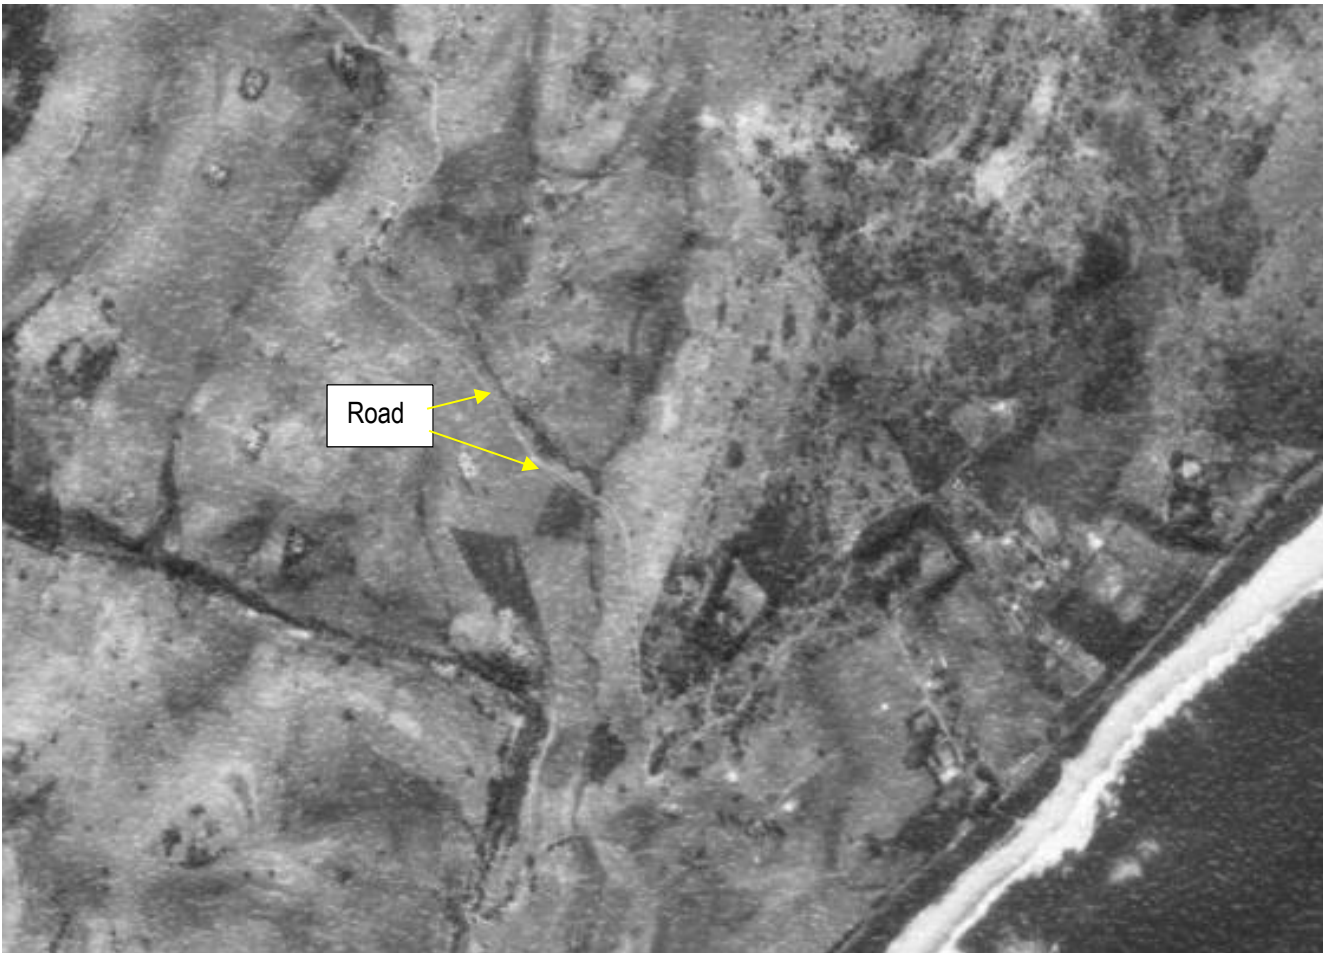
The 1955 aerial photography image of the project area (**Figure 2**) shows residences along the alignment of the road since that time. No structures (dwellings, general dealerships/stores, etc.) situated close to the road should be impacted by the road upgrade (including the general store depicted in **Figure 4**) below as this structure could be older than 60 years therefore protected by section 37 (1)(a) of the KwaZulu-Natal Amafa and Research Institute Act, 2018, which refers to the protection of structures older or reasonably expected to be older than 60 years. No structure >than 60 years can be altered, demolished, damaged without prior approval of the Institute.

Figure 2: Aerial photograph of road showing a few residences close to D954 road

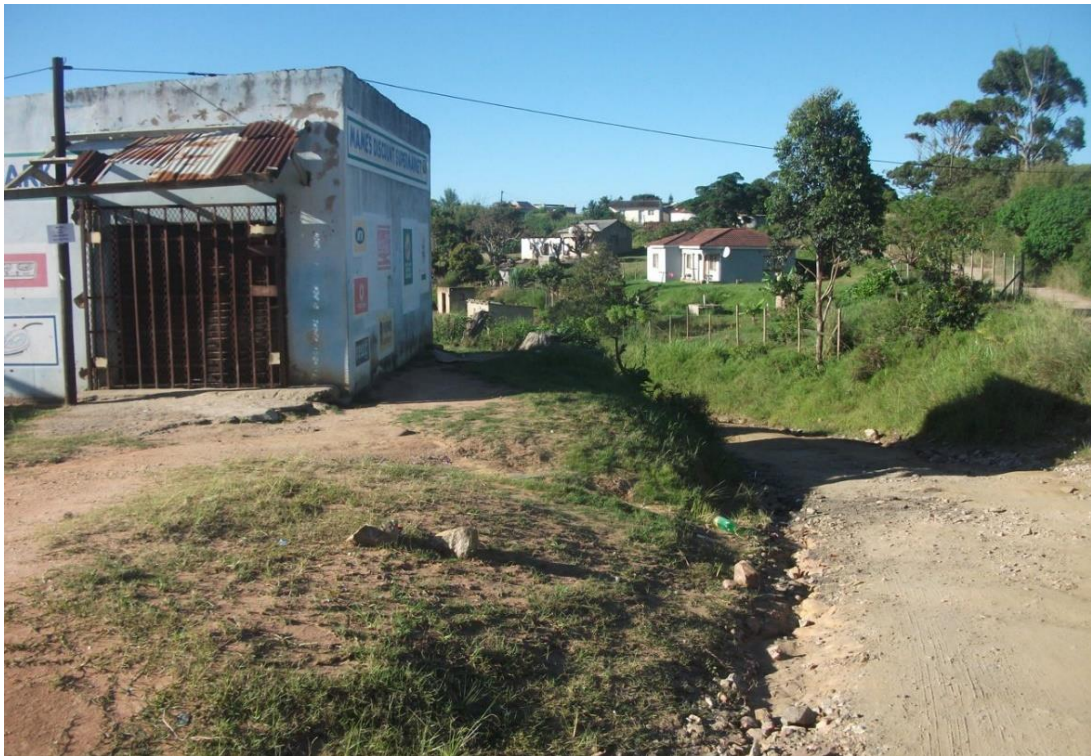
**Figure 4: General store in close proximity to D954 road**

COORDINATES	HERITAGE RESOURCE	SIGNIFICANCE + MITIGATION MEASURES
30°30'47.31" S 30°36'11.80" E	General store / structure that could be older than 60 years.	Low heritage significance as there are many such structures in KZN; however, it is recommended that the structure is not impacted by road upgrade and that a 5 m buffer is placed between the store & upgrade activities

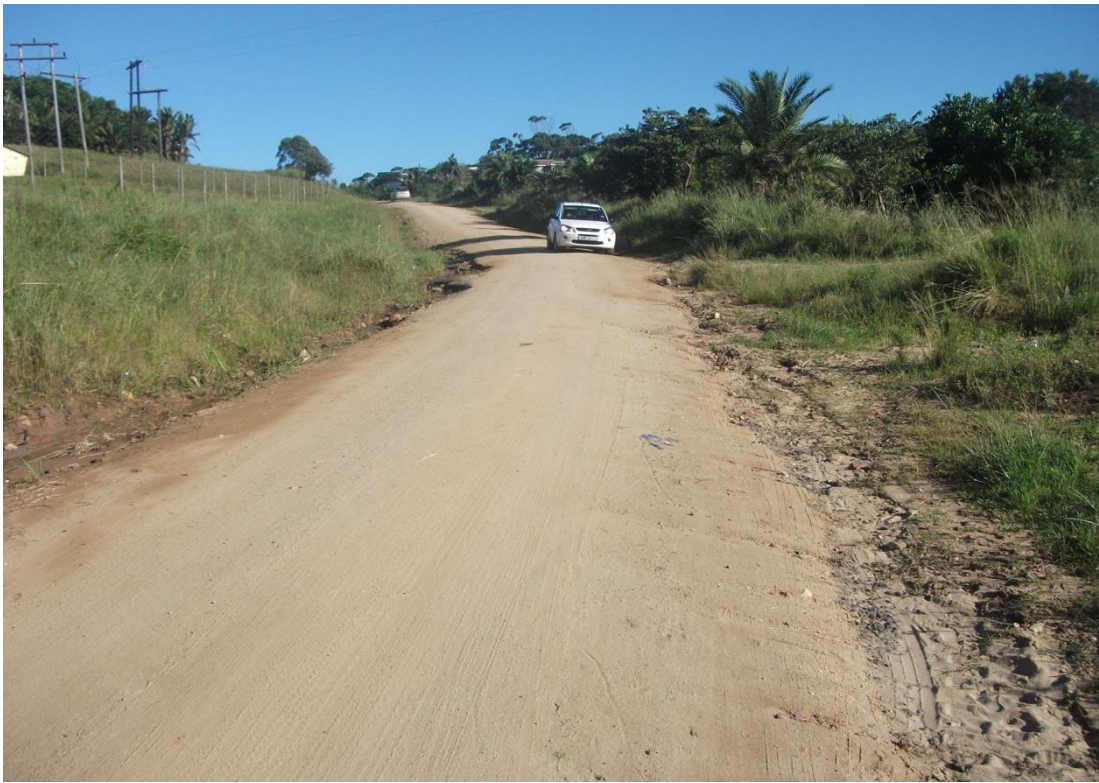
**Figure 6: View northwards of condition of road**

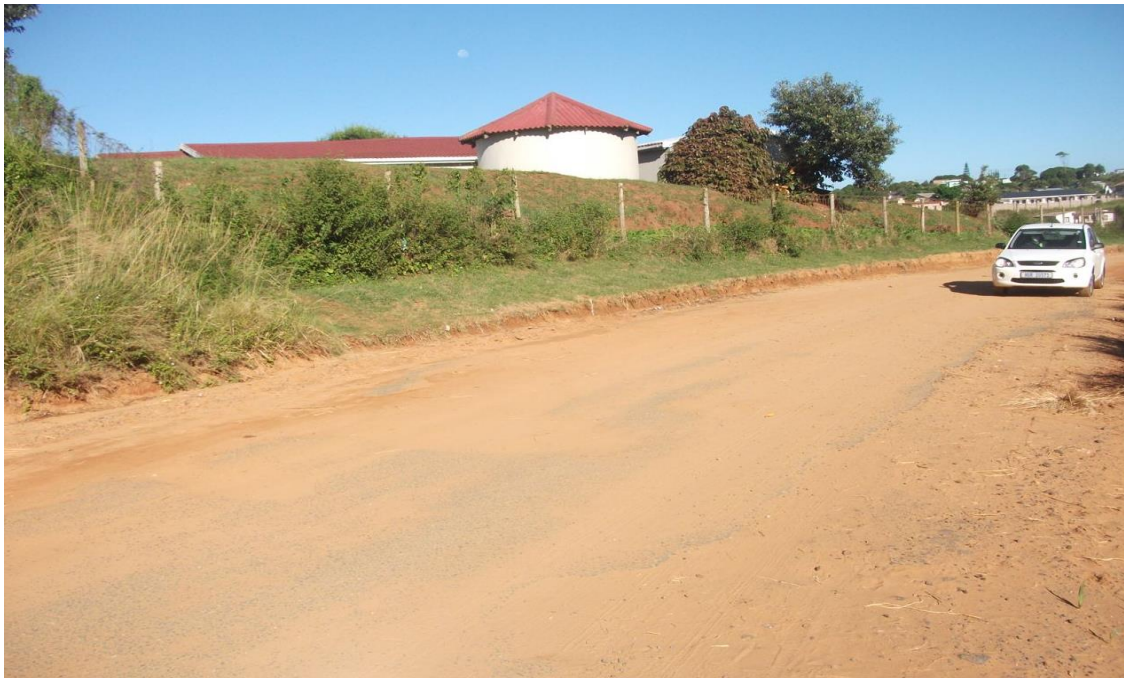
**Figure 8: Section of tarred road and dwellings**

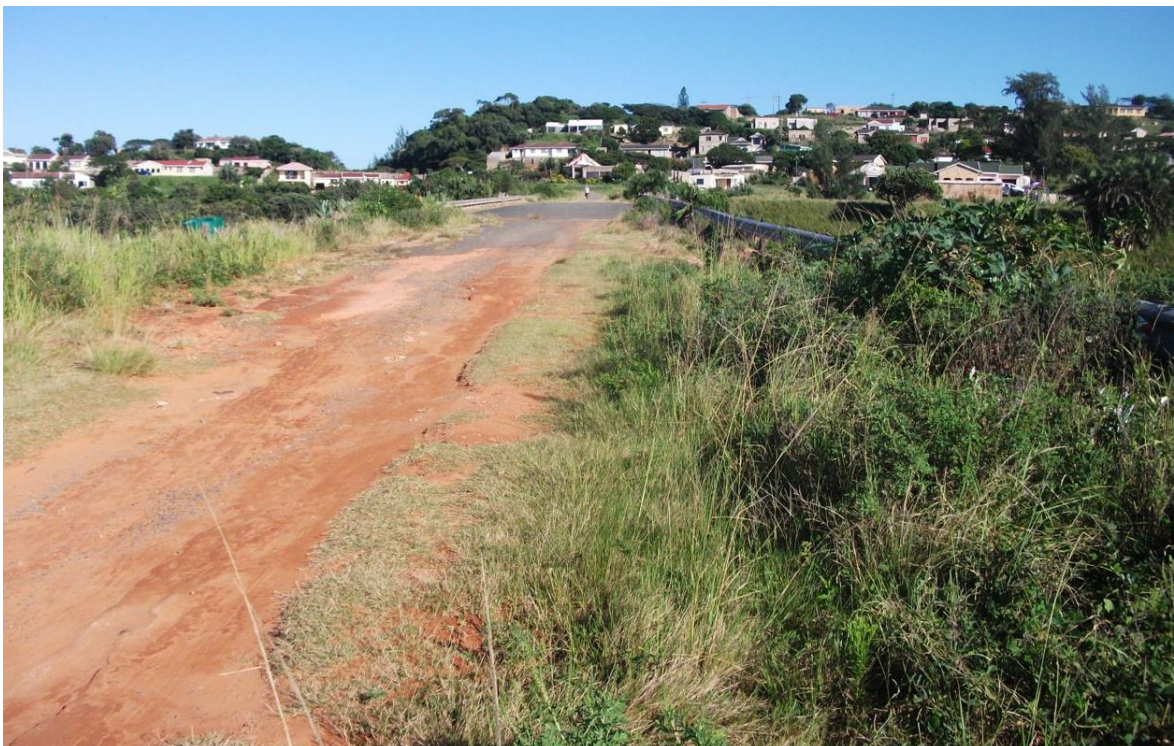
About 300m of the south-eastern section of the road close to the ocean and which crosses the N2 highway used to be tarred and sections of this are still visible but the tarred section has deteriorated over time as can be seen in **Figure 9** below.

**Figure 9: South-eastern end of road upgrade**
