# VISUAL IMPACT ASSESSMENT

## PROPOSED SAND MINE ON BLAAUWBERG FARM (CAPE FARM 88 AND CAPE FARM 91, MELKBOSSTRAND), CITY OF CAPE TOWN

PHS Consulting

March 2012

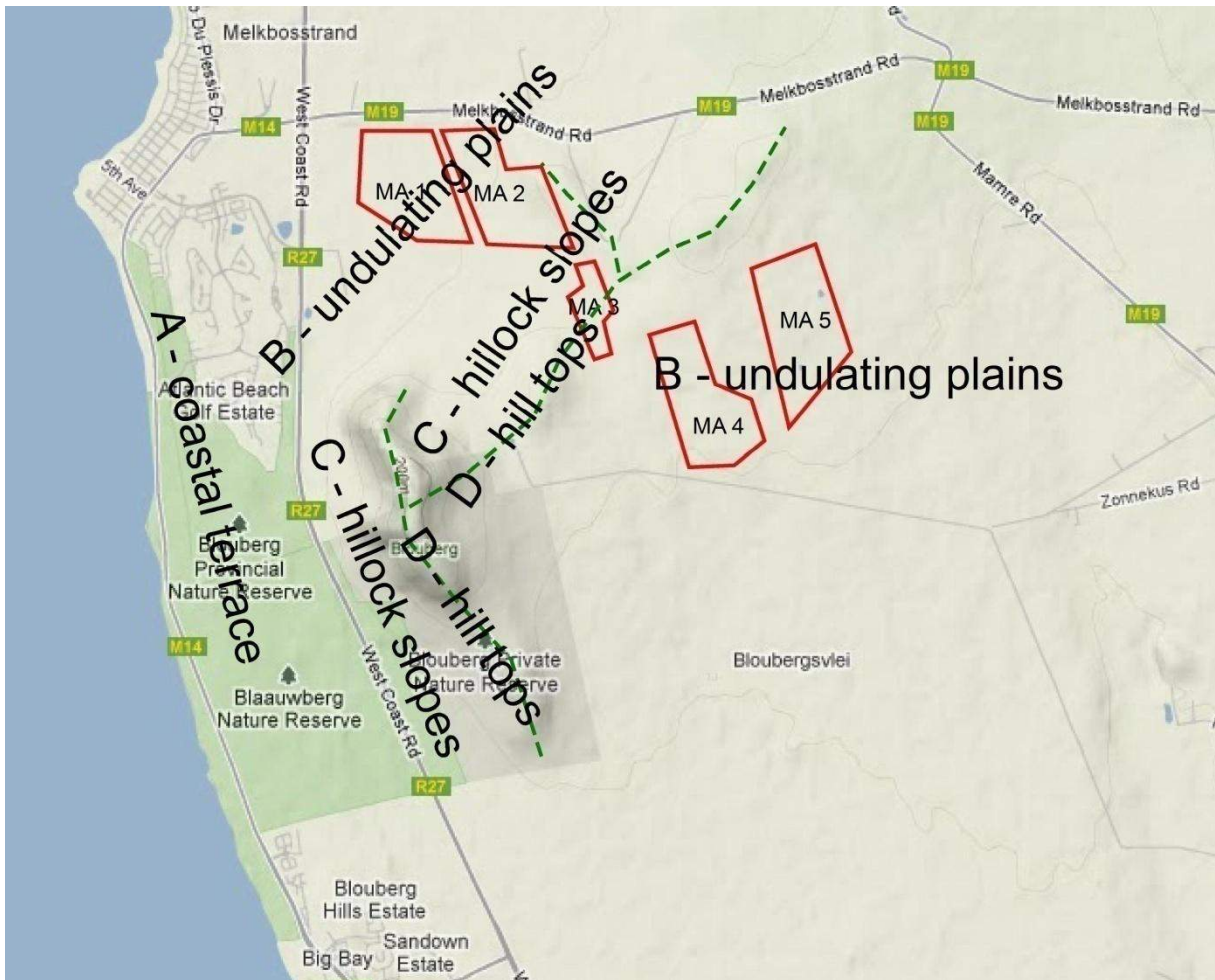
Figure 4: Terrain map

The area is characterised by 4 major landscape types, namely the Coastal terrace (A), undulating plains (D), hillock slopes (C) and the hill tops (D).

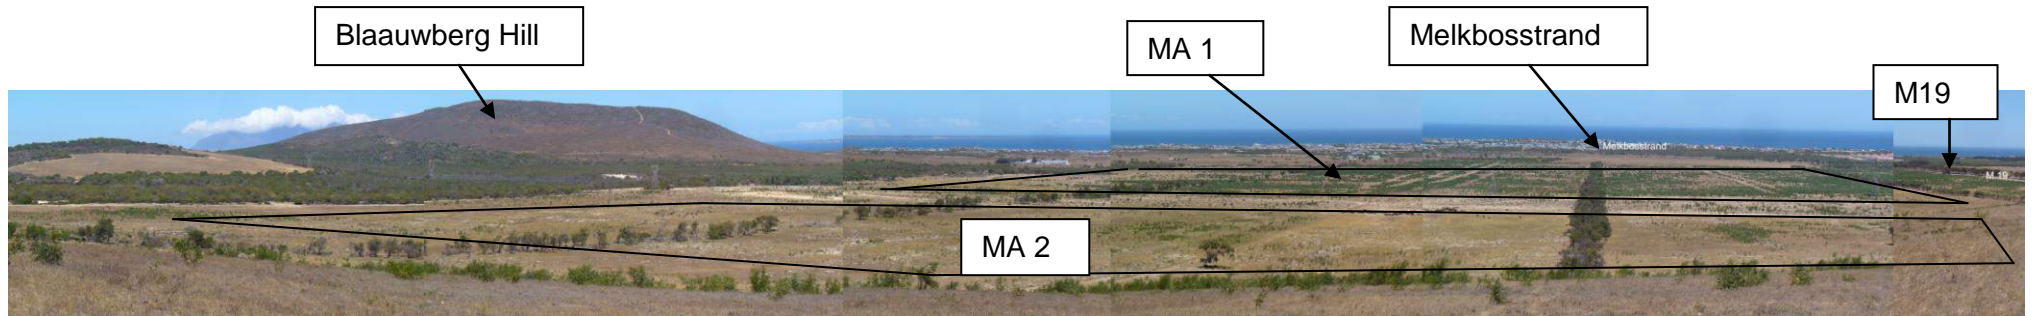
Photo 1: Taken from the viewshed towards the west, separating the application area in a distinct western and eastern area. MA 1 & MA 2 is located on the western side of the viewshed, closest to Melkbosstrand of the proposed mining areas.

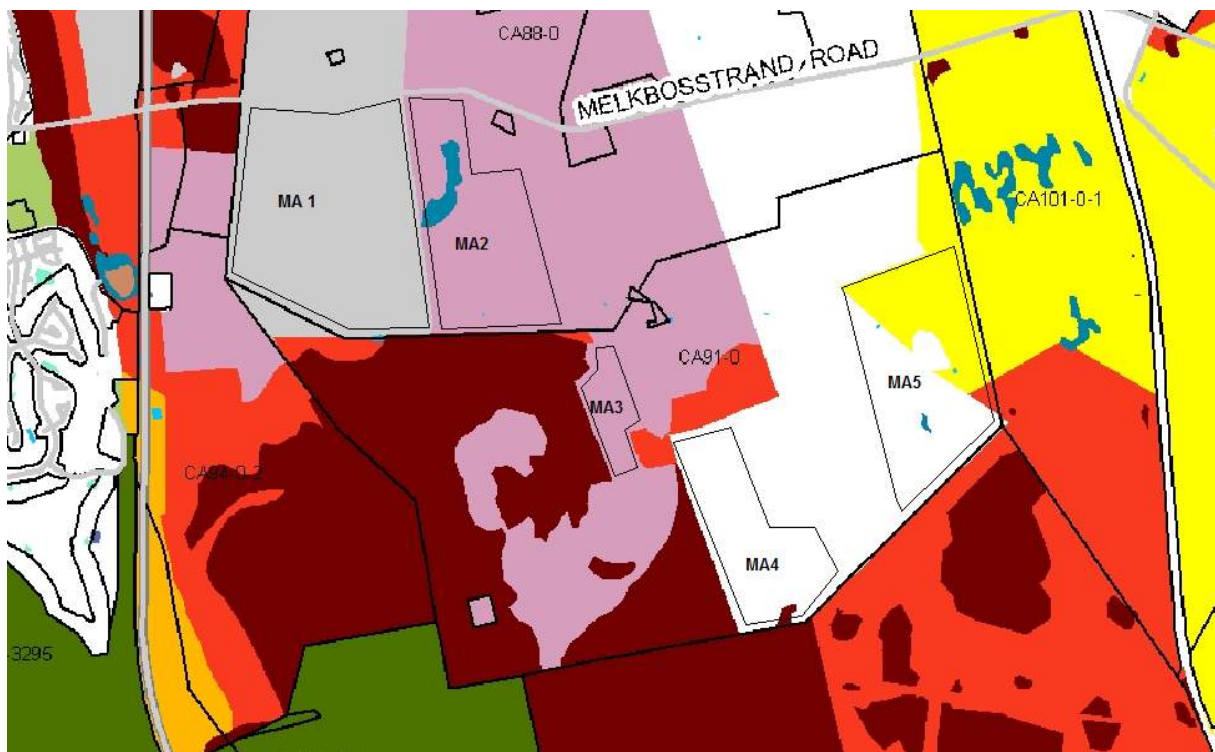
**Figure 7: Proposed Mining Areas MA1 to MA5 in relation to City of Cape Town's Biodiversity Network (map and legend provided by the City of Cape Town)**

The City of Cape Town's comments relate to the above map as follow:

Mining Area MA2 to MA5 impact on the City of Cape Town: Biodiversity Network in the following manner:

- MA2 - The possible presence of a wetland entity.
- MA3 - Located between a CBA 1b and a CBA 1d Irreplaceable site that forms part of land that the City of Cape Town has been attempting to acquire for inclusion to the Blaauwberg Conservation Area (BCA). As such the opinion is held that mining of MA3 and its potential detrimental associated edge effect of the CBA sites warrant this area to be excluded from mining activity.
- MA4 - The southern section impacts a CBA 1b remnant.
- MA5 - The north-eastern half of MA5 impacts a CBA 1d and CBA 2 remnant.

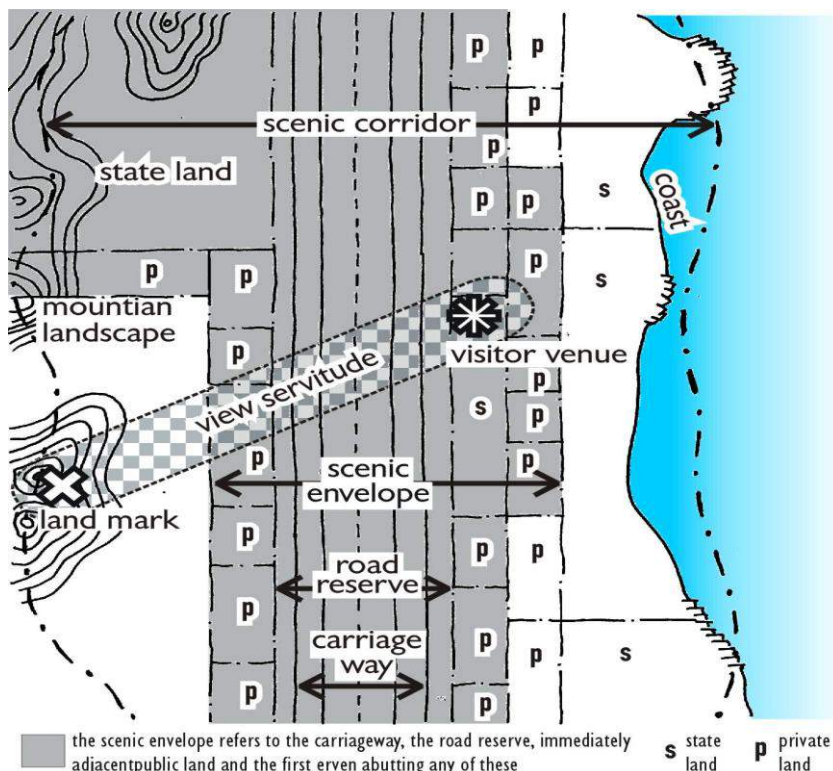
Figure 8: Scenic Corridor vs Scenic Envelope

The Scenic Drive Study defines a **Scenic Corridor** as “The unfolding area defined by a major edge condition such as ridge lines and coastlines which constitute a visual entity”. **Scenic Road Envelope** is defined as “the carriageway, the road reserve, immediately adjacent public land and the first erven abutting any of these”. (Refer to Fig 5 below)

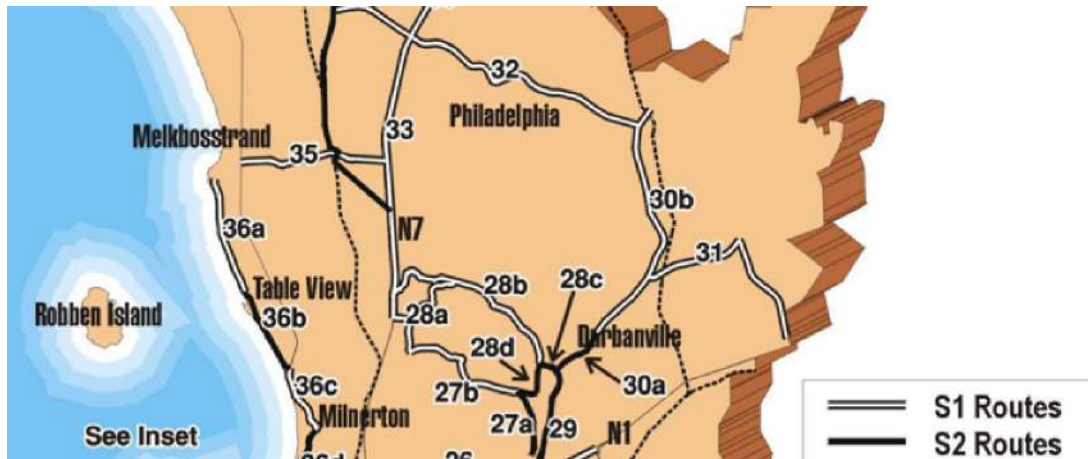
**Figure 9: The M19 is indicated as Route 35 on the above map**

This route provides **representative scenic views** of the Atlantic Ocean. An avenue of gum trees lined the route.
