**ANNUAL PALAEOONTOLOGICAL
MONITORING REPORT
(SEPTEMBER 2022) ON VAALBULT
COLLIERY LOCATED ON
PORTIONS 1, 9 AND 10 OF THE
FARM VAALBULT 3 IT,
MPUMALANGA PROVINCE**

Prepared for:
Vaalbult Mining Company (Pty) Ltd

Prepared by:
Dr B D Millstead

9 September 2022

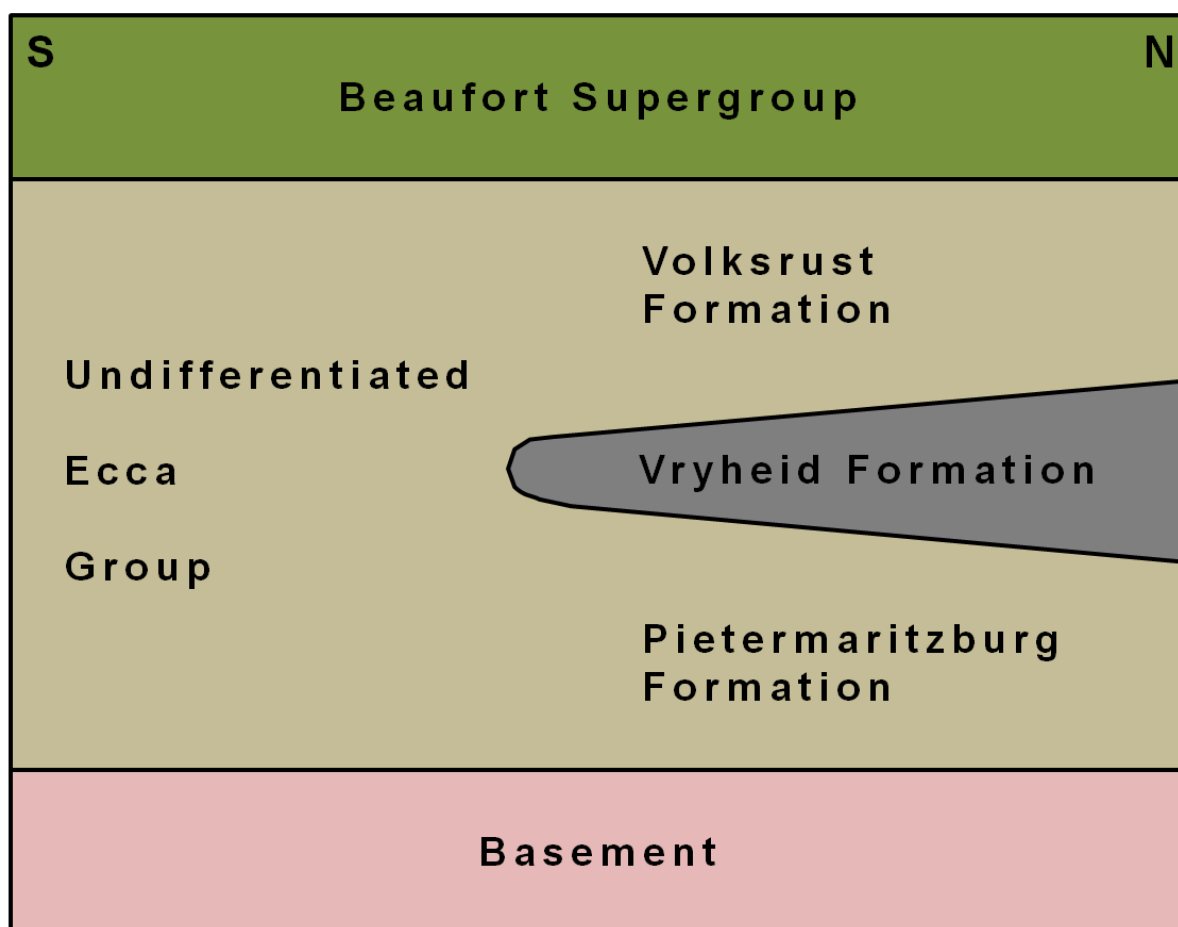
Figure 5: Schematic north-south oriented stratigraphic section of the Ecca Group in the northeast corner of the Karoo Basin. The Volksrust and Pietermaritzburg Formations can only be recognised when the Vryheid Formation forms part of the vertical sequence. In the north and north-western portions of the basin the Pietermaritzburg Formation was not deposited. In these areas the coal-bearing strata of the Vryheid Formation rest directly upon the basement.

In the Main Karoo Basin, of South Africa the Vryheid Formation is a sandstone and coal-rich stratigraphic unit that interfingers with (i.e., is transitional with and partially time equivalent to) the overlying Volksrust and underlying Pietermaritzburg Formations; both of which are both predominantly argillaceous (Figure 5). In terms of environment of deposition, the formation can be divided into a lower fluvial-dominated deltaic interval, a middle fluvial interval (the coal-bearing zone) and an upper fluvial-dominated deltaic interval (Johnson *et al.*, 2006). The thickness and frequency of the sandstone units increases from the base of the formation, reaching their maximum in the middle fluvial interval and then decrease again towards the overlying Volksrust Formation. To the south and southeast, the Vryheid Formation grades laterally into undifferentiated, deep-water argillites of the Ecca Group (Figure 5).

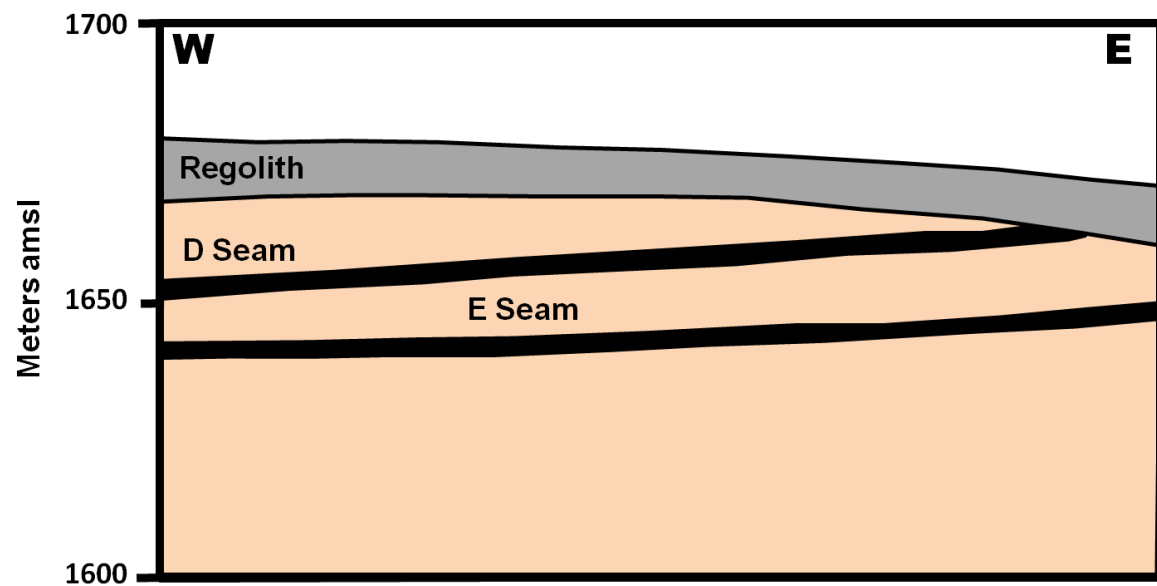
Figure 6: Schematic E-W oriented geological cross section across the central western section of the Mining Right area, and approximately in the same location as the mine pit (data obtained from the client). The location of this cross-section is provided in Figure 9.

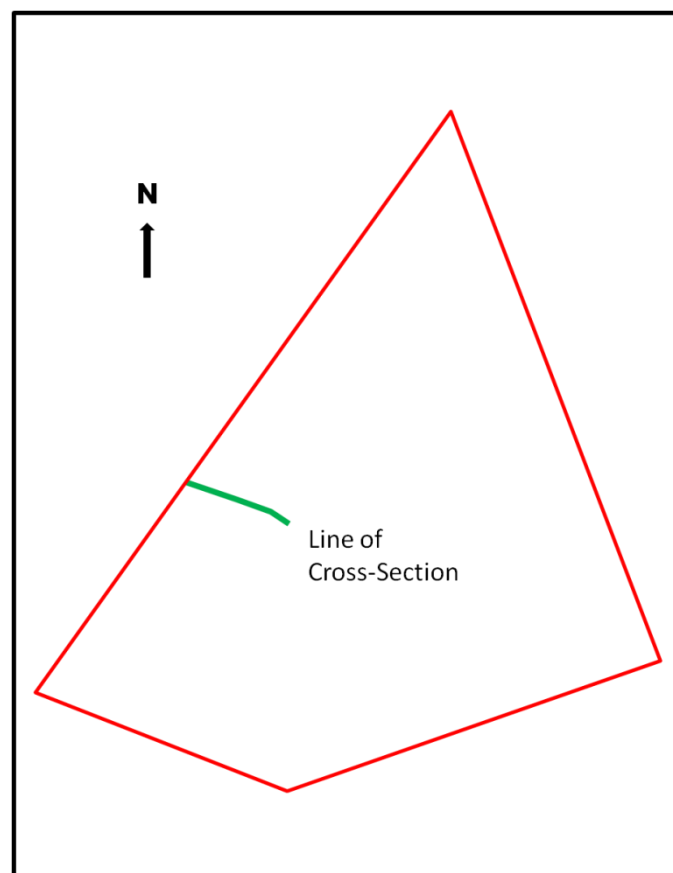
Figure 7: Map showing the location of the geological cross-section shown in Figure 8.

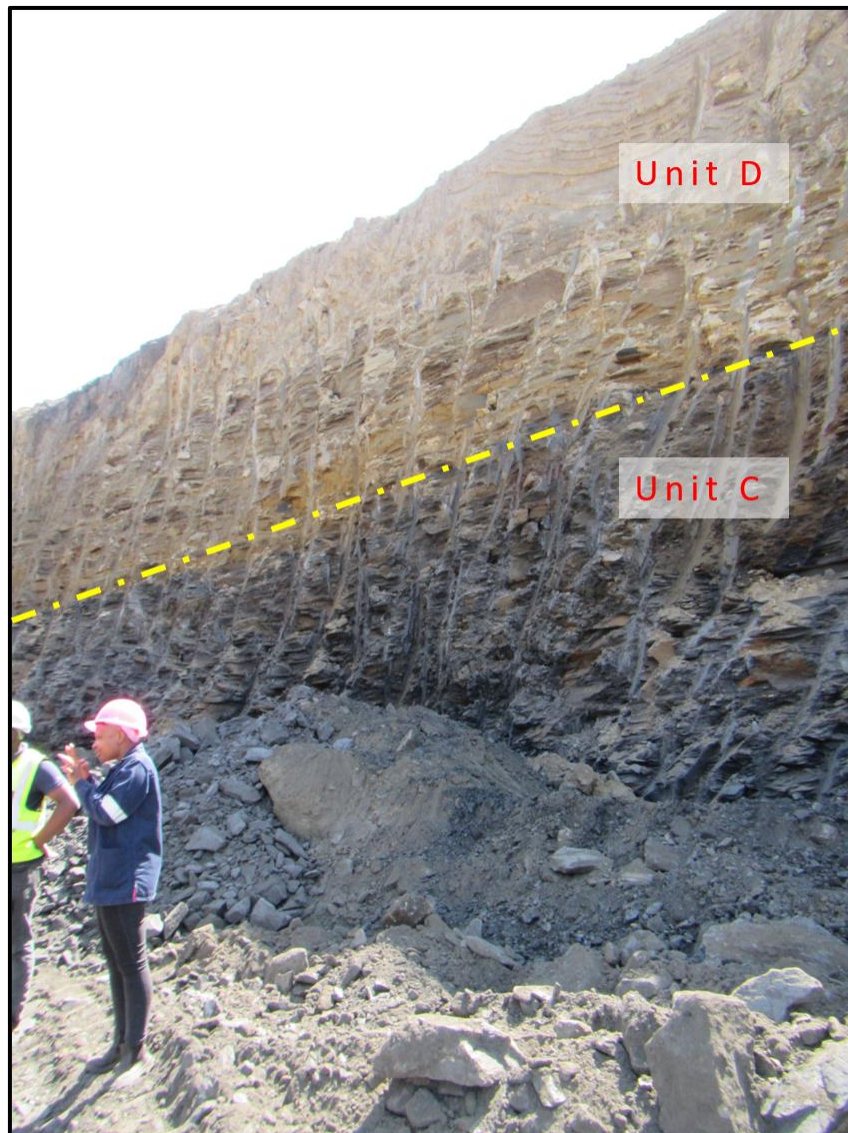
Figure 8: View of the eastern end of the northern highwall in the mine void containing both Cuts 2,5 and 3,5 (waypoint VB5; see Figure 3). Visible in the photograph is that the lowermost unit C is ca. 6 m thick. It is stratigraphically overlain by the ca. 6m thick succession of unit D. A sharp, seemingly conformable contact separates the two units. Unit B lies just below the floor of the open pit.

The sedimentary sequence separating the two seams varies between 11.5 m and 12.5 m in thickness (the thickness decreases towards the west; Figure 8). The inter-seam lithostratigraphic succession within the colliery is as follows. Immediately overlying the E seam is a highly variable sandstone unit (unit B) which is termed “the parting” in the mine’s terminology. Unit B has been observed to be a 30 cm thick, buff coloured

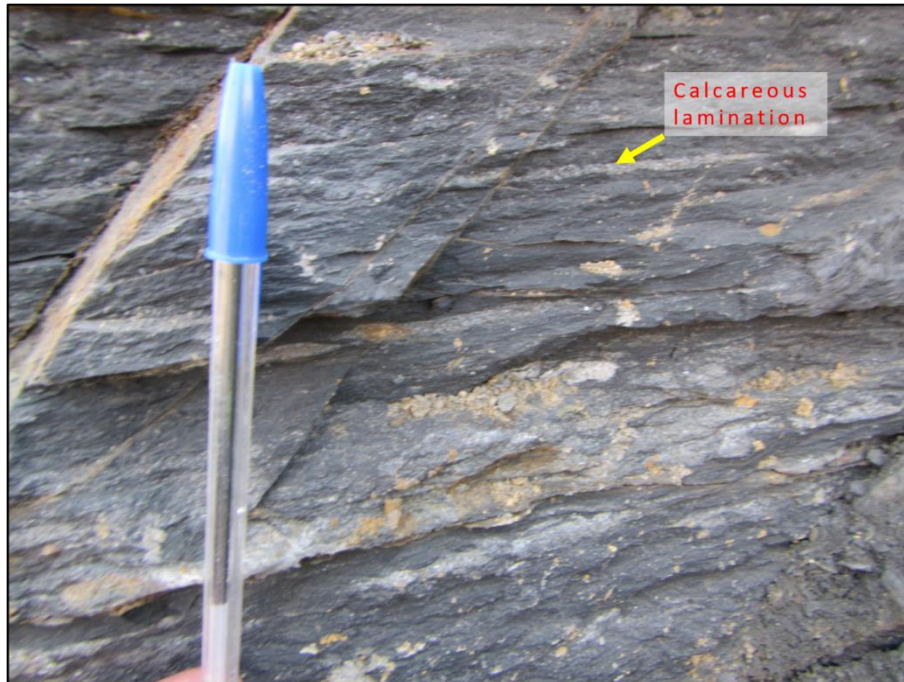
Figure 9: Rocks of unit C located at waypoint VB5. The finely laminated, dark grey, carbonaceous mudstones of the unit occasionally exhibit thin (mm scale) calcareous laminations.

The strata cropping out at waypoints VB5-VB7 are the finely laminated, dark grey unit C, which are stratigraphically overlain by buff sandstones of unit D (Figures 10-12).

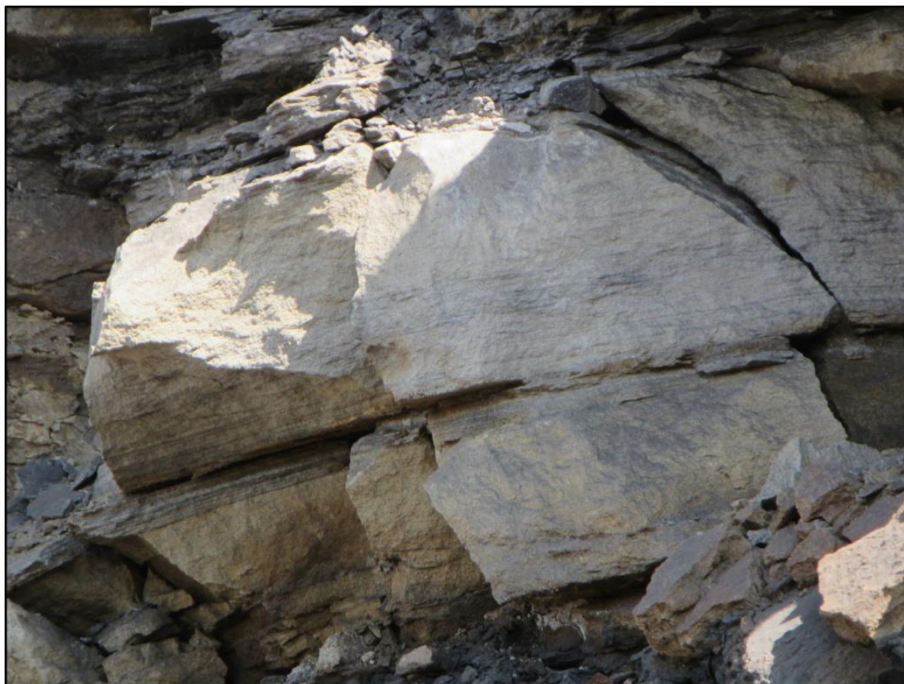
Figure 10: Thinly bedded to massive, buff-coloured sandstones of unit D (waypoint VB5, see Figure 3).
