GIJIMA – ARBOR RAILWAY SIDING – BASIC ASSESSMENT REPORT

**ARBOR RAILWAY SIDING BASIC ASSESSMENT REPORT FOR PROPOSED OPERATIONS
OF A RAIL SIDING TO STORE, HANDLE AND RAIL COAL, MPUMALANGA PROVINCE**

Document Name: GAB – R – Updated BAR

Volume 3 of 3 – Specialist Reports

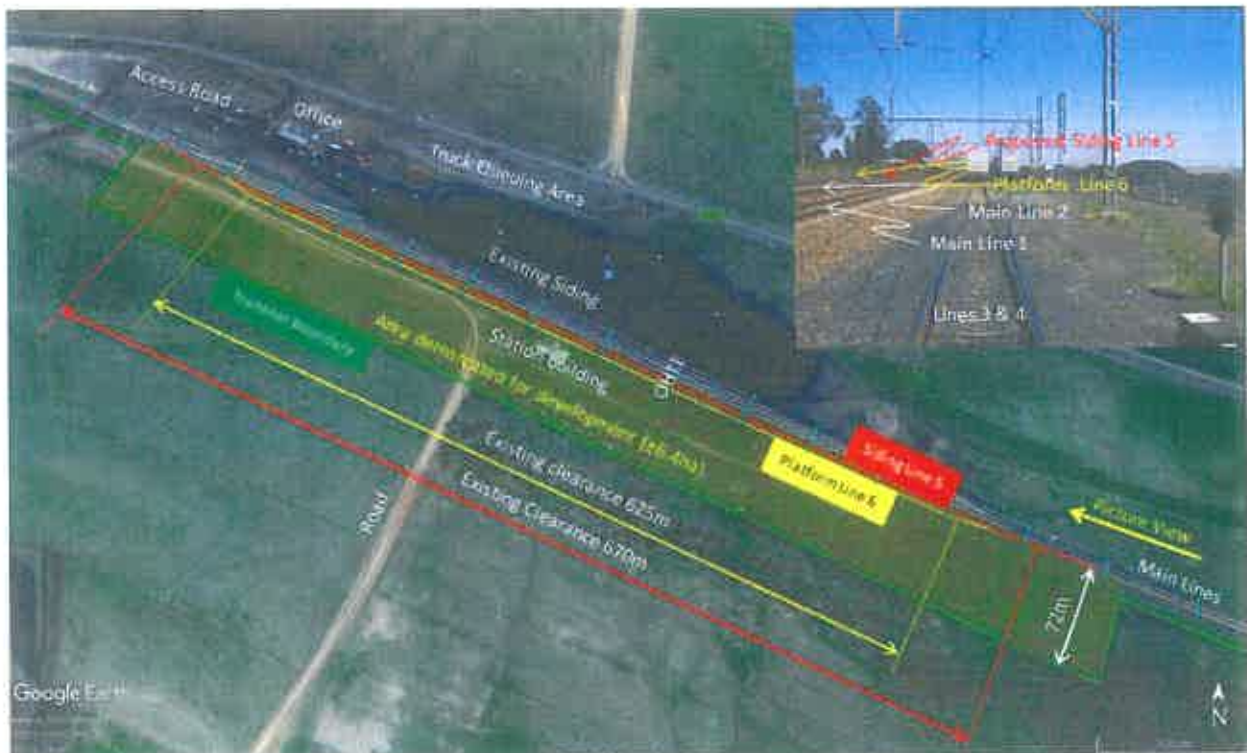
It is the intention to utilize the two lines next to the existing platform (indicated as red and yellow lines on the drawings) as the future loading lines. All the other infrastructure required to comply with the various regulations will eventually be placed within the existing Transnet boundary as shown in yellow shading on Figure 1.

Figure 1: Proposed site for the future expansion of the existing facility

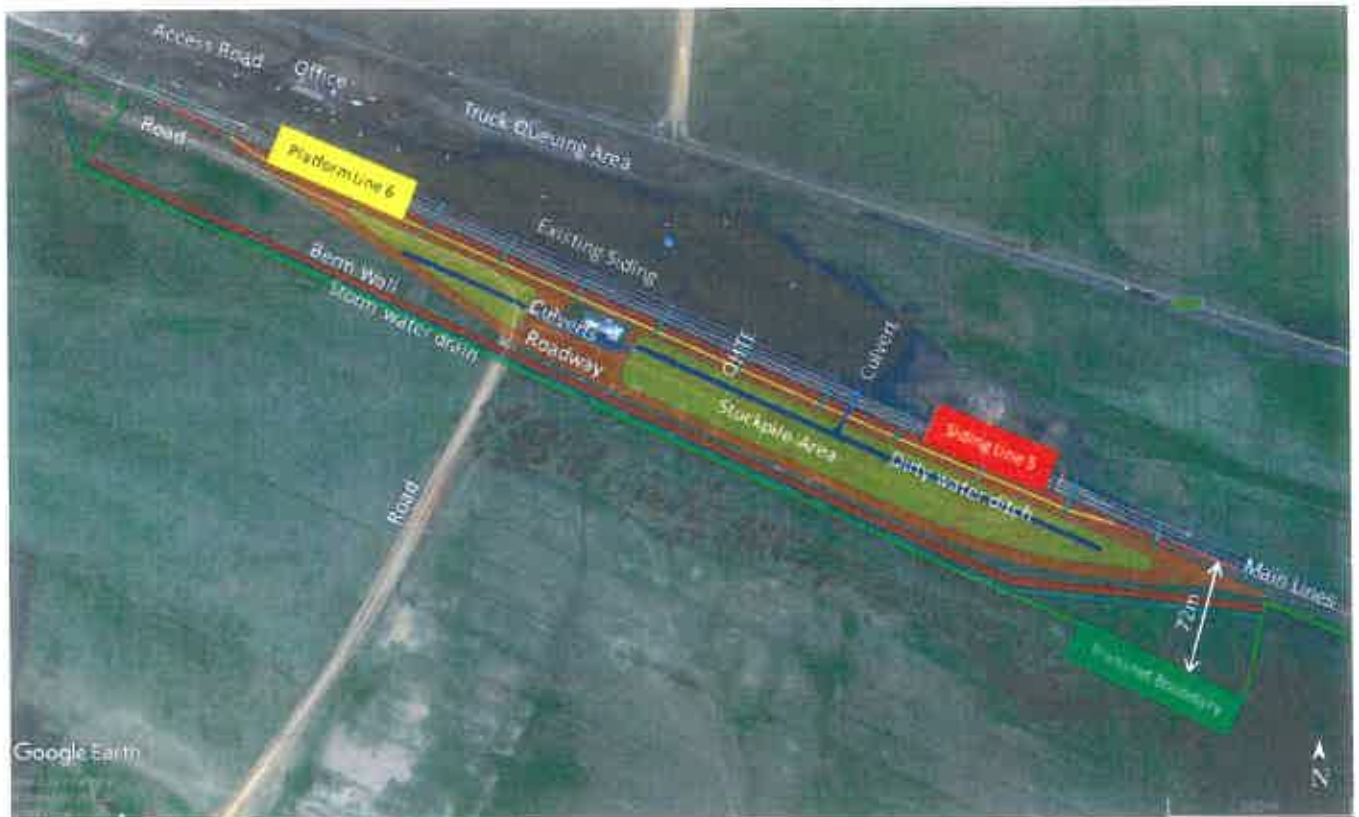
A storm water drain and berm wall will also be installed on the TFR boundary line to divert the runoff storm water away from the siding in order to separate the clean and dirty water systems.

Figure 3: Layout for Phase 1

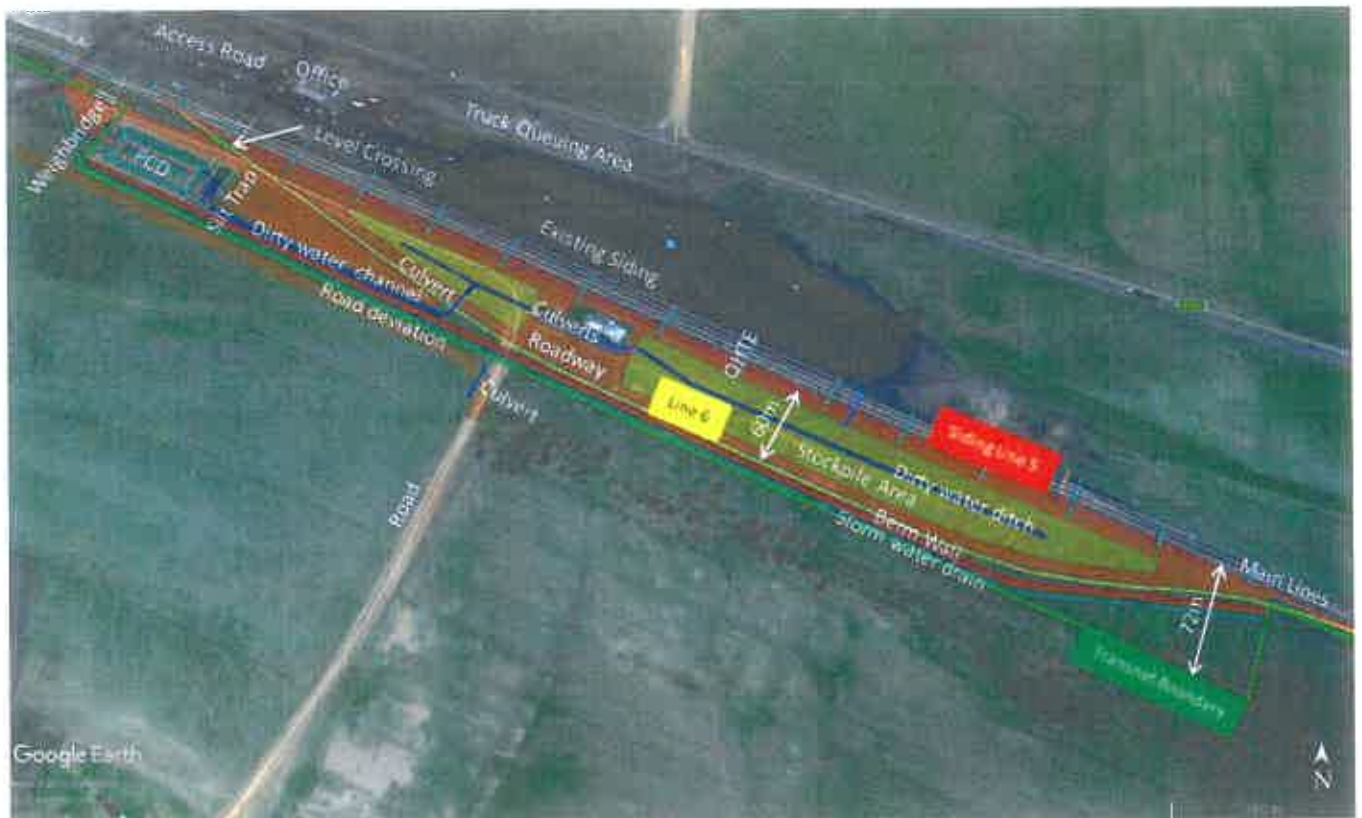
- Redirecting the contaminated water flow
- Adding a silt trap
- Adding a Pollution Control Dam (PCD)

Figure 5: Layout for Phase 2

According to the “Class C” specification for landfills subsurface drains have to be installed below the floor of the PCD for monitoring purposes. Due to the relatively small size of the PCD a single ring drain at the floor edges will suffice. Although the final ground levels for phase 2 are yet unknown it will be assumed that the outlet of the ring drain will daylight inside the storm water channel. These drains are indicated on Figure 5 by the red lines.

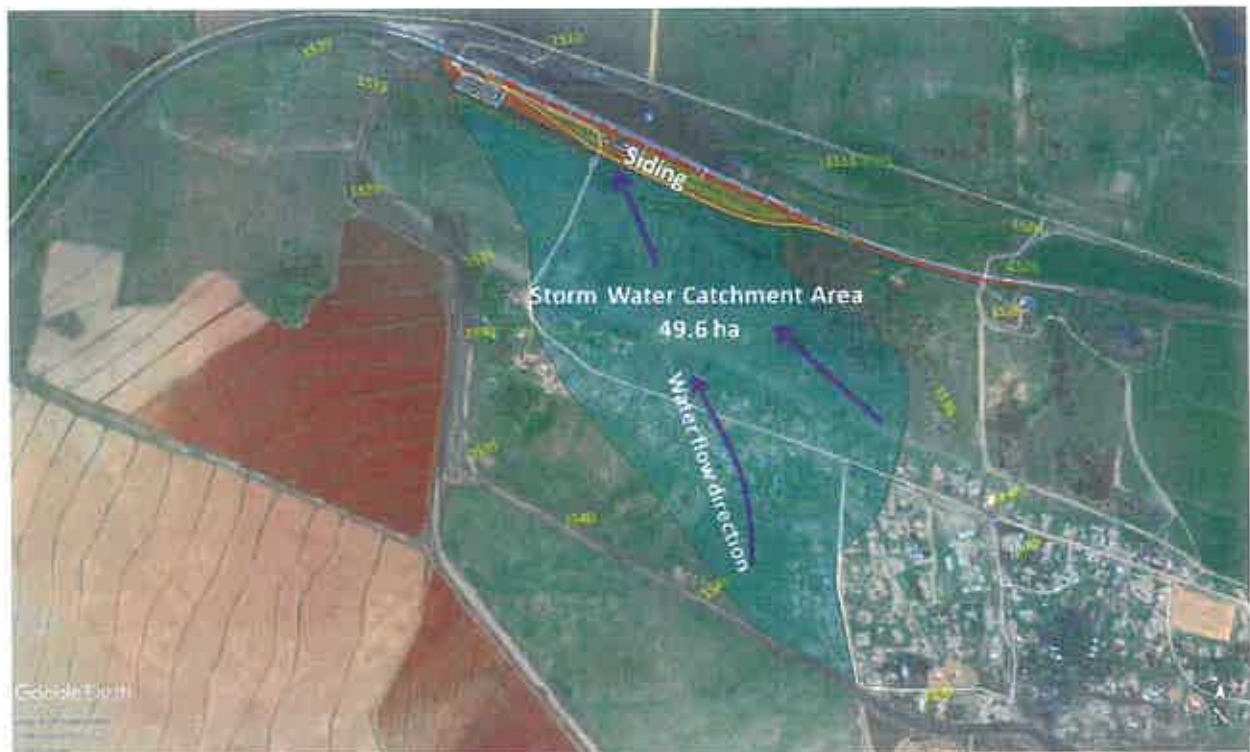
The size of the catchment area according to Google Earth is about 49.6ha – see the blue shaded area on Figure 14.

Figure 14: Storm water catchment area

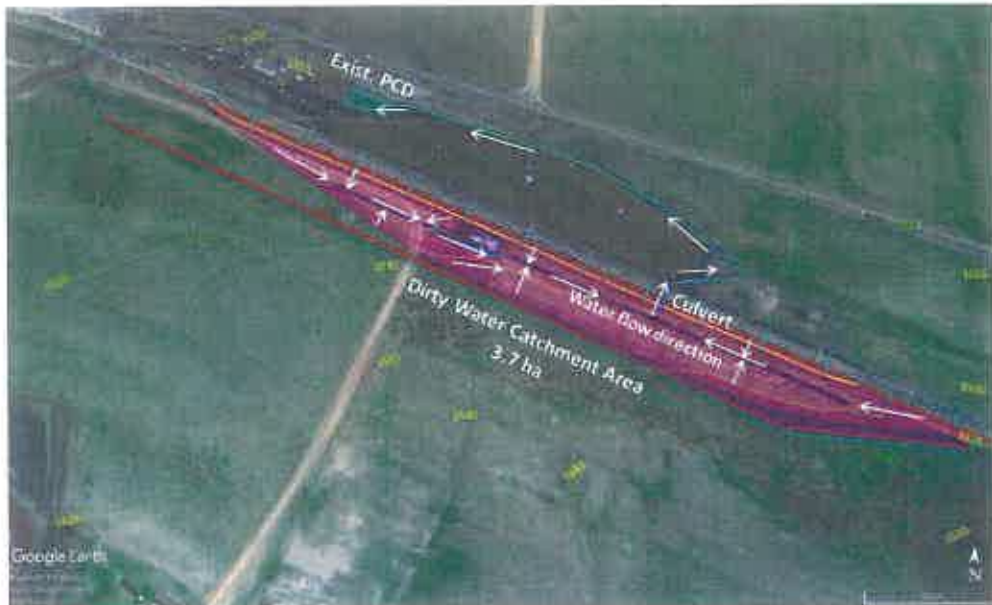
The size of the polluted area will be about 3.8ha – see purple shaded area on Figure 15.

Figure 15: Polluted area for phase 1

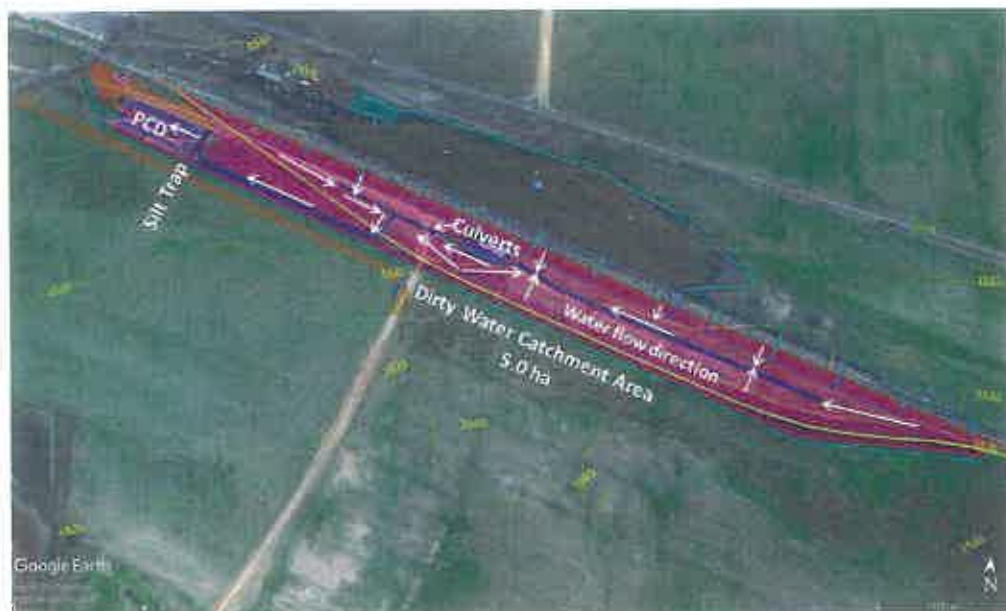
The size of the polluted area will be about 5.0ha – see purple shaded area on Figure 16.

Figure 16: Polluted area for phase 2

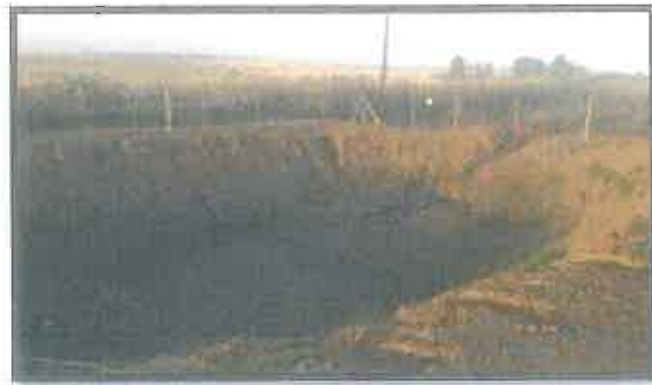
Figure 10: Control dam in site (Image ©MYEZO)

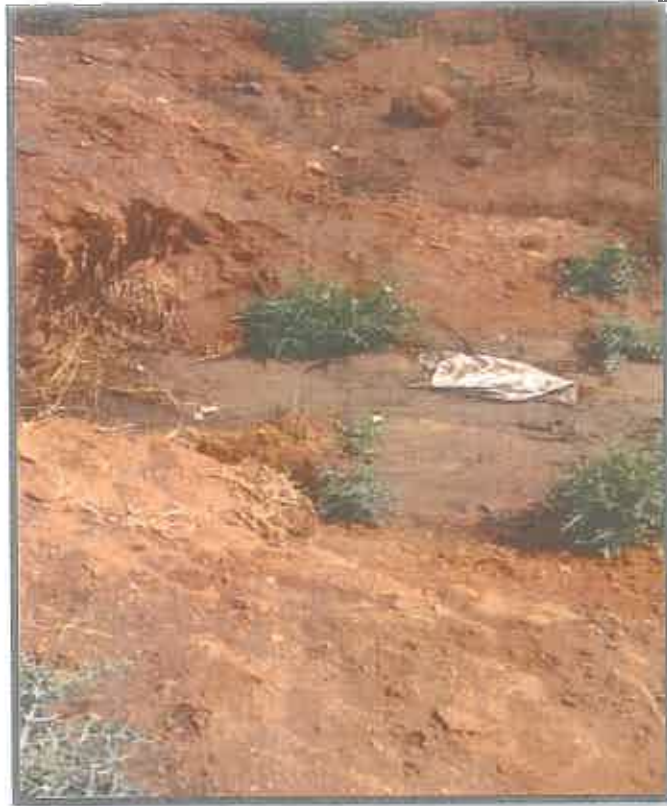
Figure 13: Stormwater colbet from R555 used to drain stormwater.

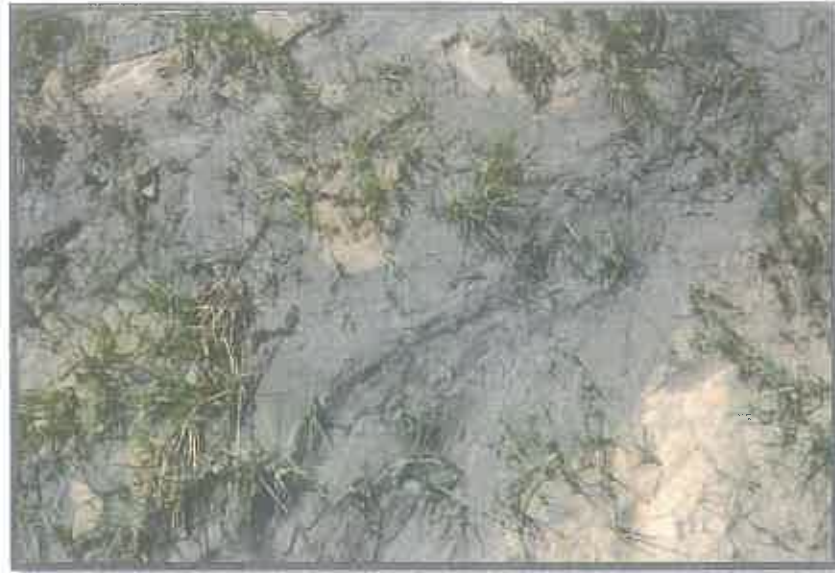
Figure 15: Coal dust residue observed in stormwater drained on the area towards NFEPA recognised ecosystem in the area.
