HERITAGE IMPACT ASSESSMENT: PROPOSED WIND FARM AT KLAWER, VREDENDAL DISTRICT, WESTERN CAPE

(Assessment conducted under Section 38 (8) of the National Heritage Resources Act as part of an EIA.)

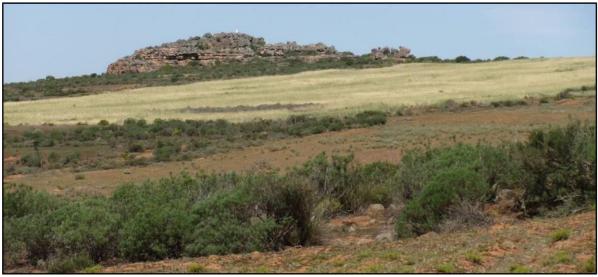
Plate 1: General view of landscape, showing Hottentotskop which is the most prominent feature in the Study Area; oats fields and patches of indigenous vegetation.

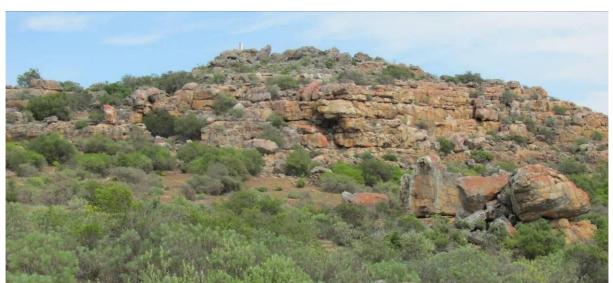
Plate 1: View of Hottentotskop from the east. There are archaeological sites around the hill.

The landscape of the farms Bird Field and Klipheuwel consists of rolling hills, covered in cereal crops, rising to the granite kopje of Hottentotskop (Plate 1). The only historic buildings on Klipheuwel are situated 2.5 km to the west of the proposed facility. The cultural landscape, as defined in Section 3.1 above, is considered to be of low significance. The only exception is Hottentotskop which could be considered to represent an archaeological landscape of moderate significance in terms of prehistoric inhabitants.

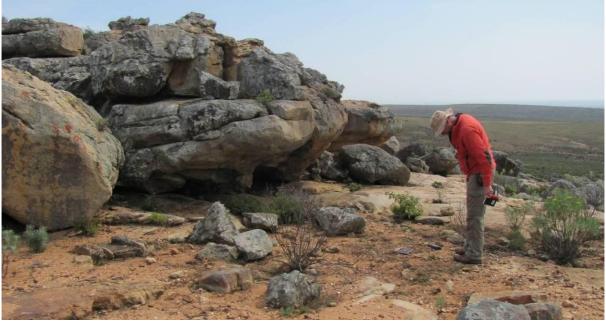
Plate 2: Site 34 comprising a scatter of stone tools lying on a rocky platform near the kopje.

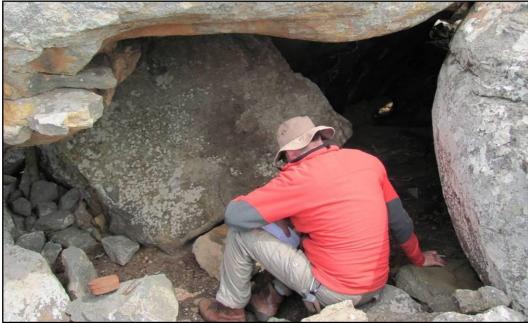
Plate 3: Site 37 is a small shelter under the beacon with evidence of pre-colonial settlement.

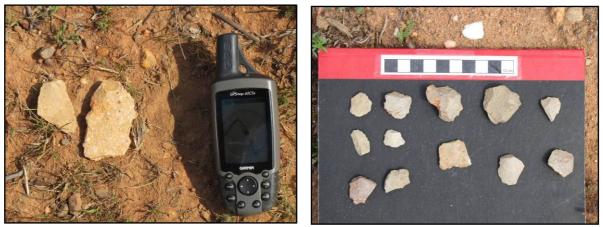
Plate 4: Stone artefacts on coarse-grained silcrete from Site 42; Plate 5: Stone artefacts from Site 34.

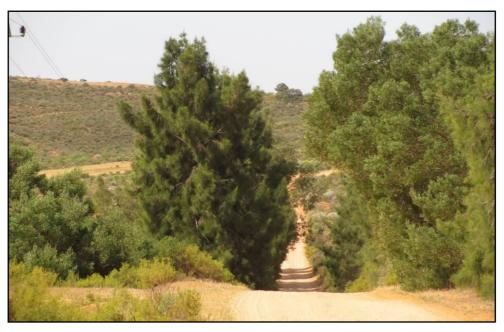
Plate 8:

Short avenue of trees along the Western Access Road.

There is also a short avenue of pine trees (scenic but of no specific heritage value) along the Western Access Road which may be potentially negatively impacted if the road is widened for trucks. This makes the Eastern Access Road preferable.

Access Road East and Access Road West are alternate public roads (Figure 2). No preference is expressed for either route, they are both acceptable. However, there is a short avenue of pine trees along Access Road West which may be impacted if the road is widened to accommodate larger trucks (Plate 8). The avenue does not appear to be 60 years old, but is nevertheless of interest as a feature on the landscape.

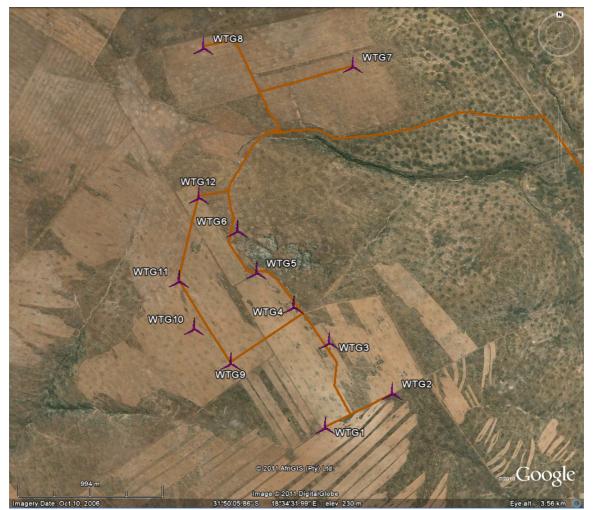
Figure 3. Revised layout plan with turbine 5 situated off Hottentotskop reduces heritage

impacts.

A revised layout plan proposed by G7 in response to the preliminary findings of specialists will effectively eliminate impacts to archaeological material Turbine 5 has been moved from the outcrop known as Hottentotskop where most archaeological material was concentrated resulting in a low impact to heritage.
