**ARCHAEOLOGICAL MONITORING: DEVELOPMENT ON ERF 16044  
(ADJOINING D'OUWE WERF), CHURCH STREET, STELLENBOSCH,  
WESTERN CAPE**

(Archaeological Monitoring conducted in terms of the requirements of  
Permit Number 2011/06/001).

August 2011

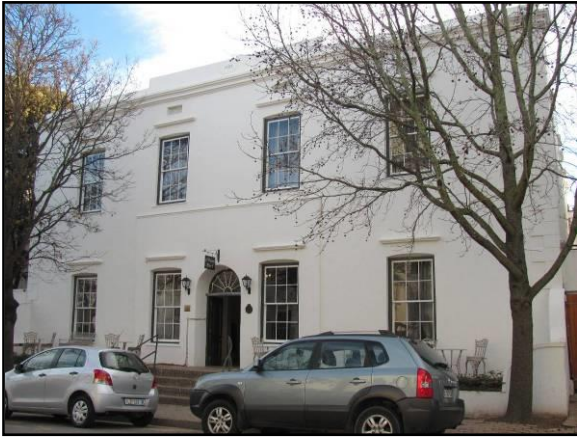
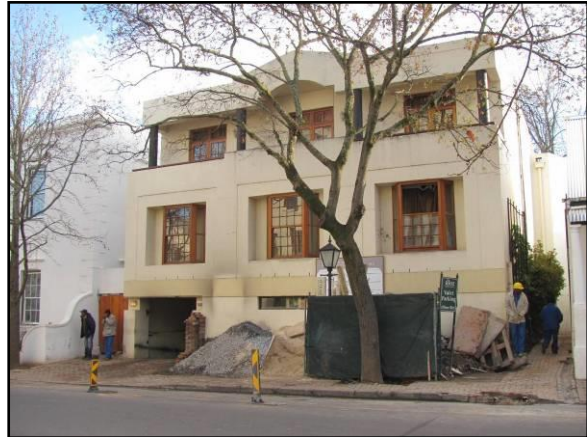
**Plate 1:** View of D' Ouwe Werf, No 30 Church Street. **Plate 2:** View of the more recently constructed annex to the hotel termed the "Columbo Building" (No 32 Church Street). The development is taking place in the garden behind the annex, with the access through the garage.

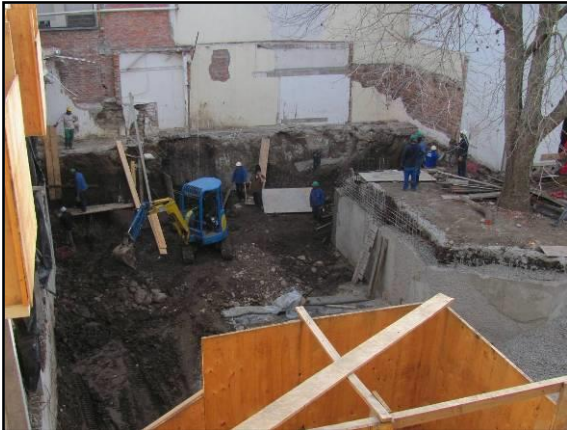
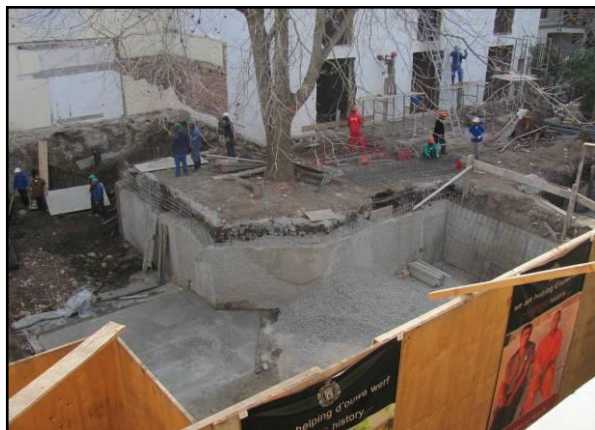
**Plate 3:** View from the Columbo Building northward across Erf 1261, with D'Ouwe Werf building to the left. **Plate 4:** View from the Columbo Building north-east toward Erf 1262, note the excavation for the swimming pool on the far right, and the tree which has been retained in the centre of the property.

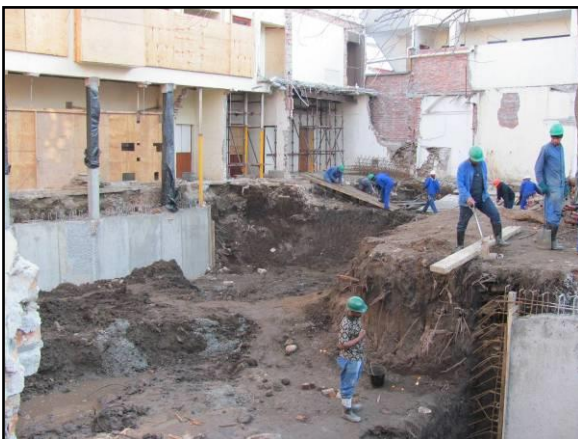
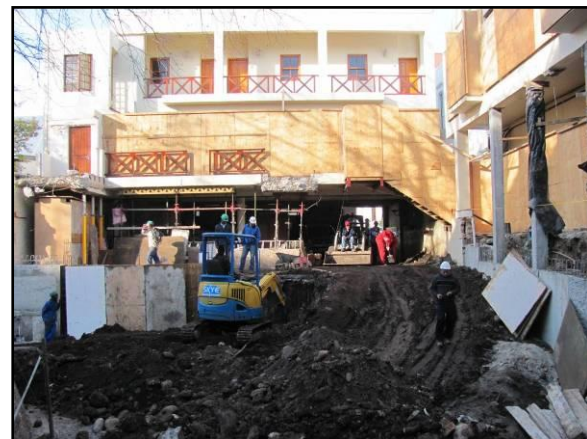
**Plate 5:** View northward, with the boarded doors and windows of D'Ouwe Werf on the left, and the plastered, red brick walling of Erf 1258 at the back of the property. **Plate 6:** View southward, to the rear of the Columbo Building. Plates 3 & 4 were taken from the top verandah.

No sub-surface features were found but a single section of above ground stone walling was found along the northern edge of the development, abutting Erf 1258.

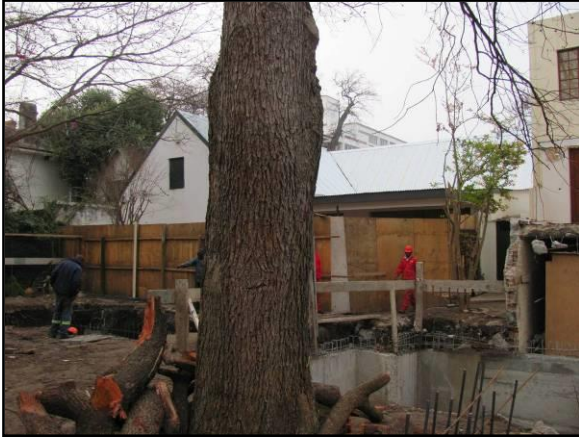
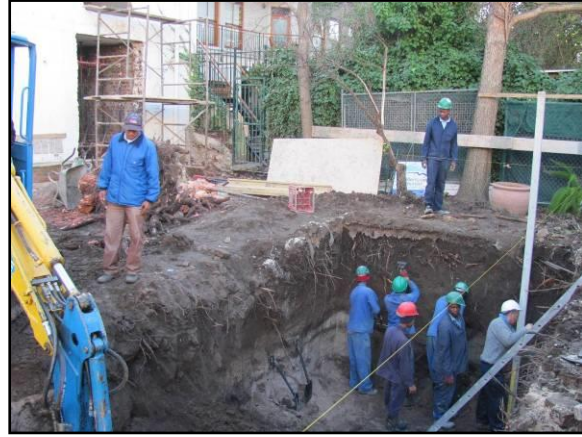
**Plate 7:** View south-eastward towards the back of the Spice Café, only the roof is visible behind the boarding. **Plate 8:** View eastward, excavations for the swimming pool behind the Spice Café on Erf 1262.

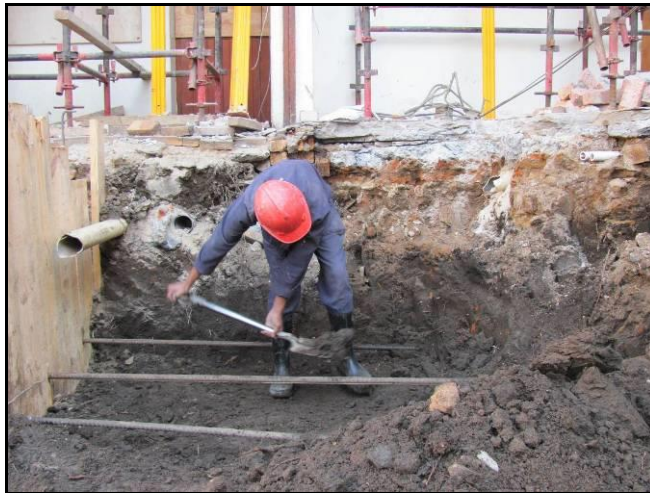
**Plate 10:** Steel rods were hammered into the deposit to prevent soil collapse.

The soil in the north-west corner was very wet and because it was stabilised with steel rods prior to removal (Plate 10), it was difficult to follow the stratigraphic sequence in this corner (Plate 17). Where the disturbed soil with red brick extended down to 70cm in the site, in this corner the soil was disturbed to a depth of 1.5m.

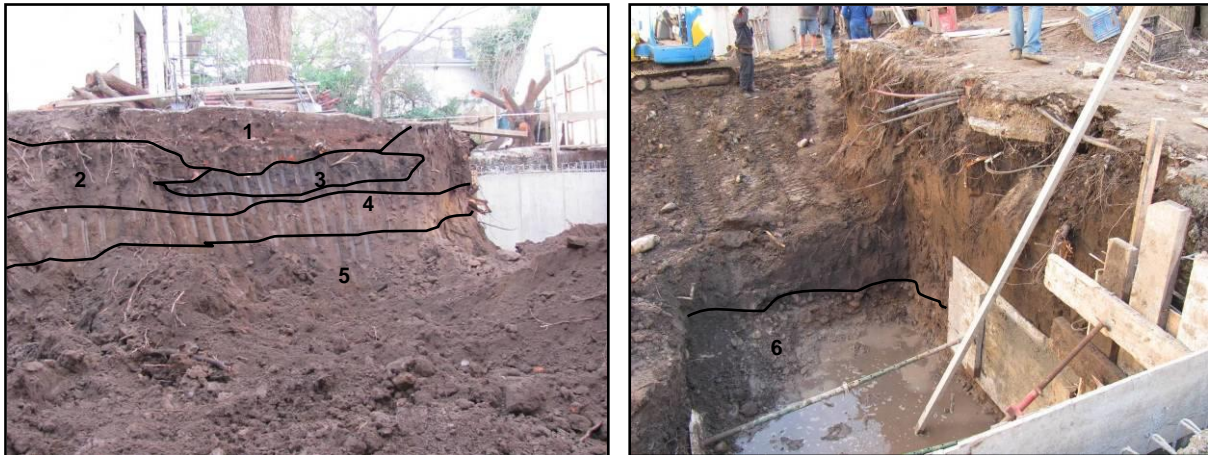
The excavations reached a level of approximately 3m, terminating in rounded river cobbles (Layer 6) which appear to represent an earlier course of the Eerste River (Plate 12).

**Plate 11:** View of the east wall of the excavations for the parking garage; **Plate 12:** View of the excavation some 3m from the surface, showing the river cobbles and water table.

- 1) The top (Layer 1) approximately 70cm of deposit consists of builder's rubble such as red brick and old tiles, as well as bone, iron and ceramics;
- 2) Below this was Layer 2 consisting of brown sterile soil, with roots;
- 3) Beneath this was Layer 3, which consisted of a lens of rich dark, loam, also sterile;
- 4) Below this was Layer 4, which was a hard pale brown layer, also sterile;
- 5) Below this was Layer 5, a hard brown loam, sterile.
- 6) Excavations at 3 metres uncovered a dense layer (Layer 6) of river cobbles in a pale sandy matrix. It appeared that this represented an old river channel/old river terrace? Groundwater seepage occurred at this horizon.

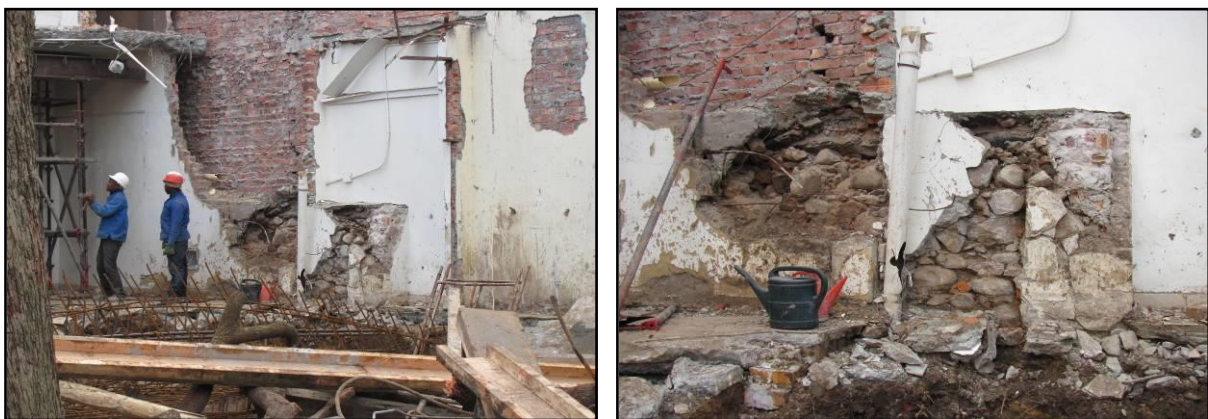
**Plate 13:** View of the north boundary of Erf 1261 and the southern boundary of Erf 1258. Note the section of stone walling abutting the red brick wall. **Plate 14:** Close up of the stone walling.

The purpose of this small section of roughly packed stone walling is unclear. It seems wedged in between the basement of the adjoining Erf 1258, and the demolished building on Erf 1261 (Figure 3). It could relate to the structures observed by Clift (2004) during her excavations on Erf 1258.

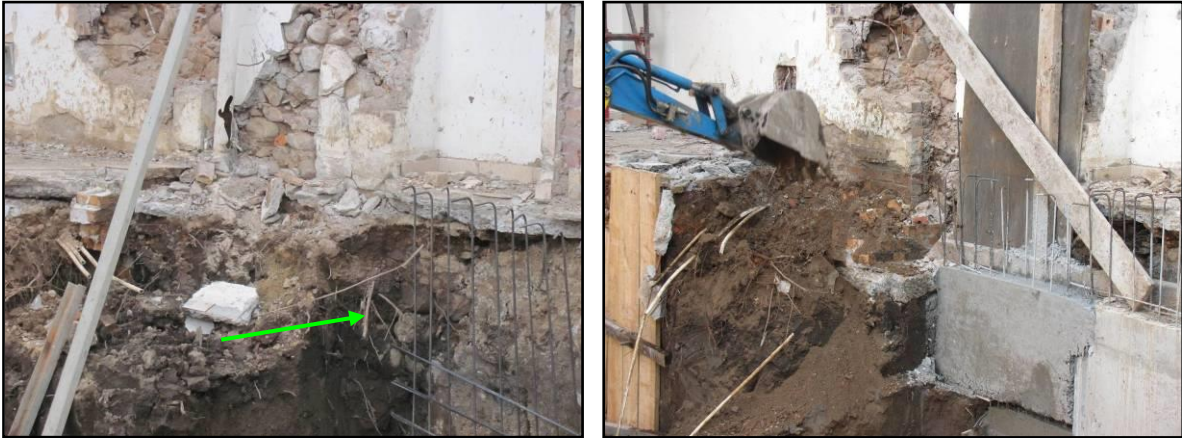
**Plate 15:** Note the stone walling continues below ground level for a further 1.5m. **Plate 16:** After the wall started to collapse, a portion of concrete had to be cast to retain the lower section.

The owner of the property indicated an interest in retaining a portion of the stone walling for the benefit of visitors and efforts were therefore made to shore up the wall with boards. Further conservation of the stone wall lies outside the scope of the monitoring work.

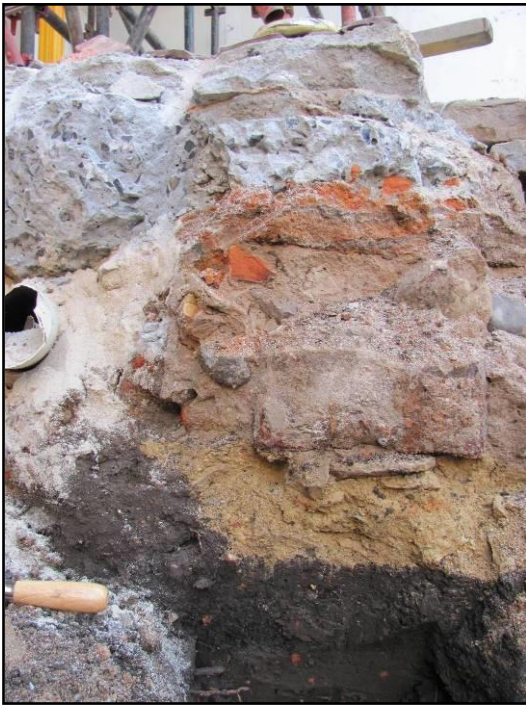
**Plate 17:** View of the section under D'Ouwe Werf hotel in the north-west corner. The black soil with red brick rubble extends down to at least 1.5m, suggesting that there had been considerable re-working of the deposit prior to the construction of the new annex at the back of the hotel in the 1980s.

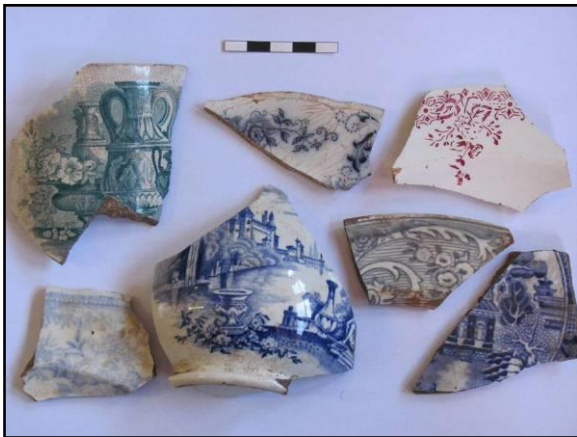
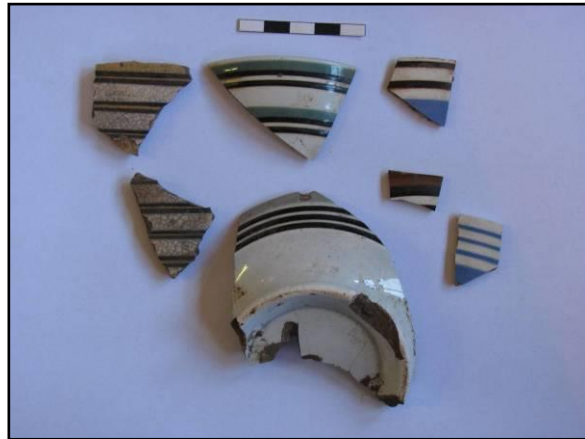
- A selection of cream coloured whiteware, some could be creamware but it was not possible to be confident on this identification;
- A number of fragments of industrial slipware (whiteware with a banded slip decorated or “annular ware”), comprising of regular horizontal bands of clay slip, were recovered. Some of the earliest examples of annular ware are on pearlware. One fragment of a bowl, with bands of black and olive green, contains some blue pooling in the basin rim. Annular ware dates from the early 1790s to late middle 19<sup>th</sup> century;

- Transfer printing in underglaze blue and white on refined earthenware started after the 1780s, and mass produced refined earthenwares start being exported after 1815. A number of examples of blue-&-white underglaze transfer printed table ware were recovered. The most common pattern is Willow with examples of Asiatic pheasant and Rhine pattern also present.

Plate 14: Blue-&-white, green and mulberry underglaze transfer printed table ware; Plate 15: Industrial slipware.

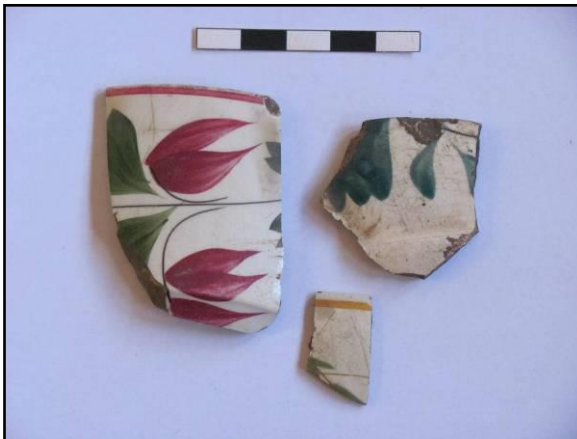
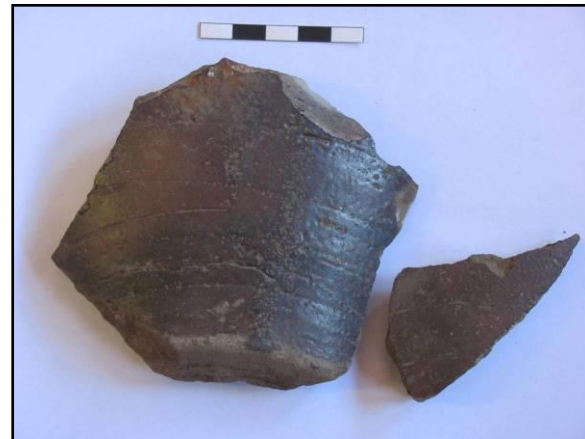
- There is only a single example of a moulded, shell-edged border to a vessel;
- A single fragment of spongeware with a blue design;
- Some examples of hand painted whiteware with bright floral decorations;

- Stoneware examples included a stoneware ginger beer bottle neck and small fragment of stoneware, from a very large jar, possibly a Martevan.

Plate 16: Hand painted whiteware with bright floral decorations; Plate 17: Stoneware fragment possibly from a Martevan.

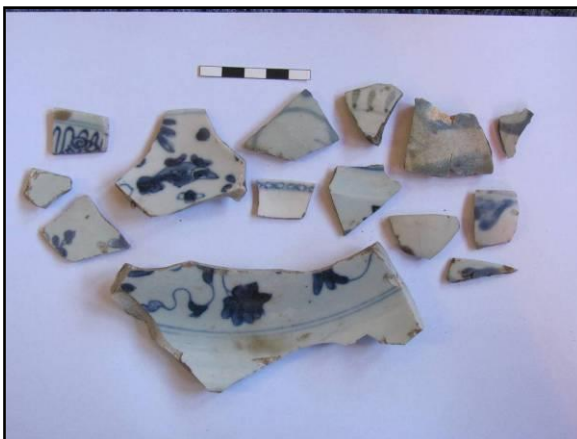
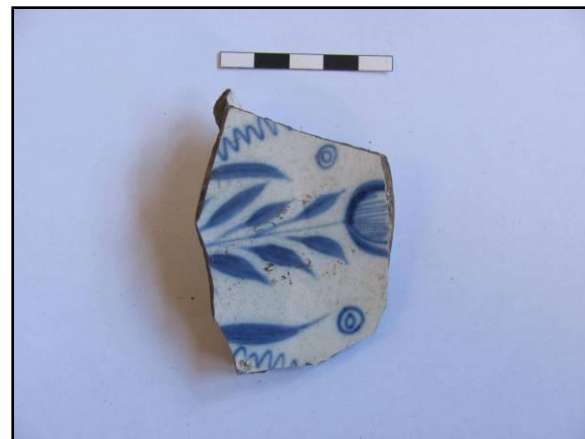
- A relatively small collection of Chinese export porcelain on underglaze blue, probably late 18<sup>th</sup> to early 19<sup>th</sup> century;
- A single fragment of Chinese export porcelain with brown glaze on the outside and underglaze blue on the inside of the sherd, dating to the mid 18<sup>th</sup> century;

- A selection of undecorated European porcelain, including British bone china, as well as fragments with moulding and gilt;
- A single fragment of hand painted pearlware with blue glaze puddling or “gather” (Klose & Malan 2000). It dates to between the 1790s and 1820s;

Plate 18: Both Chinese export porcelain and coarse, low-fired Asian ware on underglaze blue; Plate 19: Hand-painted pearlware.
