**ARCHAEOLOGICAL IMPACT ASSESSMENT  
WRENCHVILLE PHASE 2 LOW COST HOUSING  
DEVELOPMENT, REM. ERF1, KURUMAN  
NORTHERN CAPE**

SAHRA CASE Id: 14281

**OCTOBER  
2019**

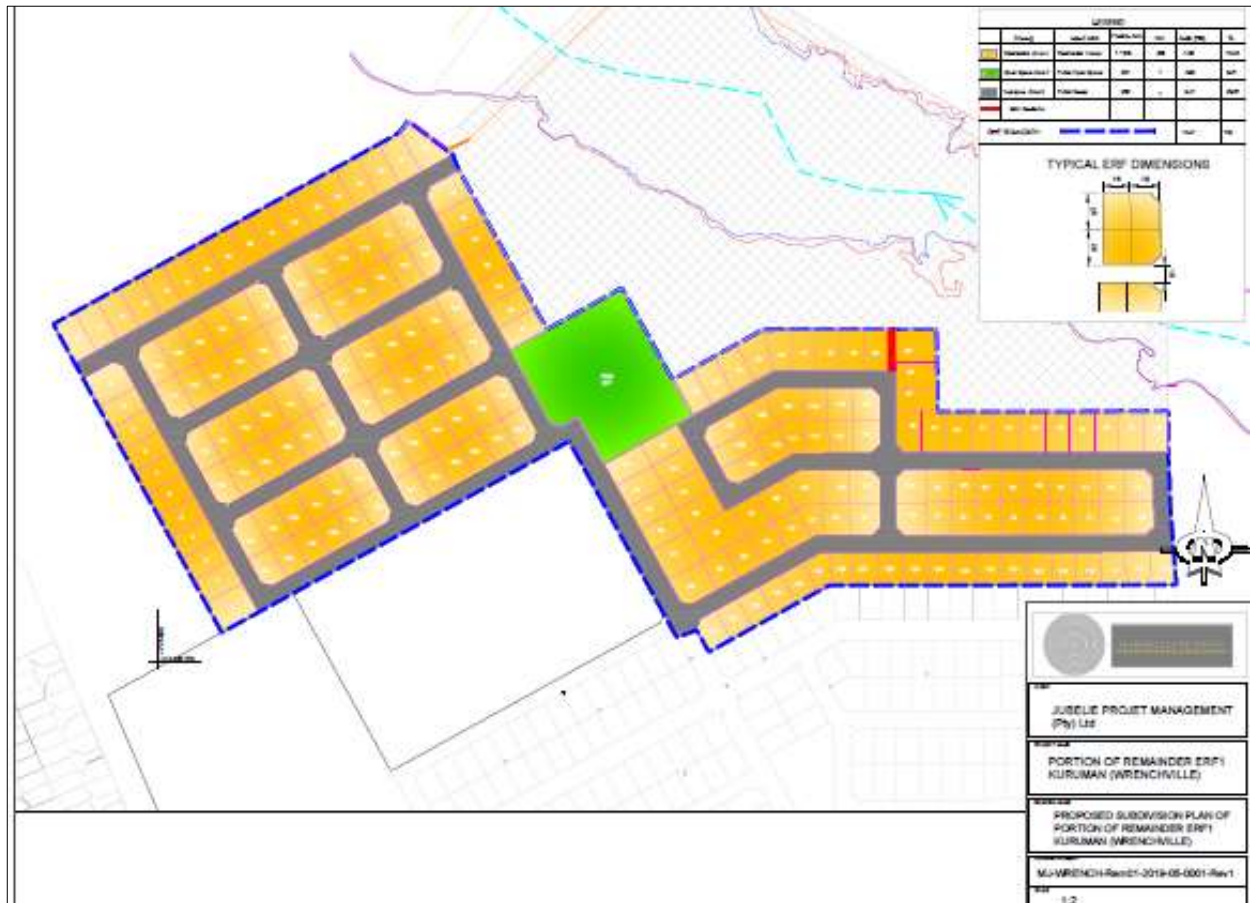
Figure 3. Wrenchville Phase 2 housing development: Proposed site layout plan

The proposed Wrenchville Phase 2 low cost development will consist of approximately 200 residential units, including internal streets and engineering services (Figure 3). Access to the property will be taken off the existing Buitekant Street within the existing residential neighbourhood of Wrenchville, located approximately 150m from the proposed development site. The total extent of the property is about 10ha. The reason for the proposed development is to alleviate the current housing shortage/backlog within the Ga-Segonyana Local Municipality and improve the quality of life of the surrounding community.

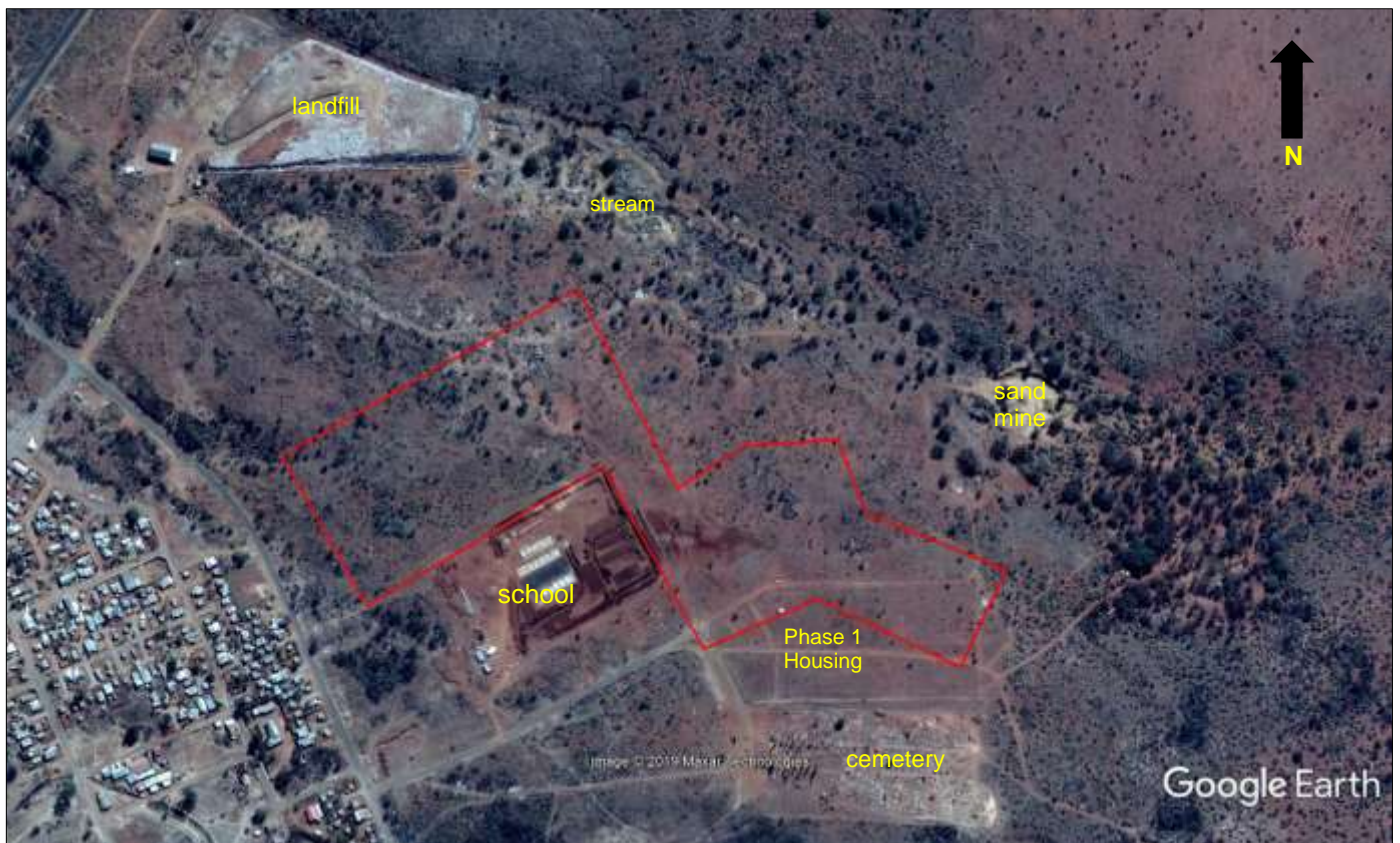
Figure 4. Google aerial map of the proposed Wrenchville Phase 2 housing site (red polygon) & surrounding land use

The proposed ± 10ha development site is situated in Wrenchville, which is about 3.5kms south east of Kuruman/town centre (Figure 4). Almost the entire proposed housing site, on a substrate of sand and banded ironstone gravels is severely degraded, mainly due to mining of gravel deposits, and extensive dumping of rubble, domestic and industrial waste (Figures 5-12). Wide gravel roads used by landfill and construction trucks, pedestrian footpaths and overgrazing contribute to the overall degraded character of the site. There are no significant landscape features on the property. The northern portion of the site slopes gently down towards a semi-natural stream channel situated along the northern edge of the property, and is also very severely degraded. Surrounding land use is residential, including the Wrenchville Phase 1 housing project, Wrenchville School (currently under construction), Wrenchville Cemetery, the Kuruman Formal Landfill Site, and illegal sand mining (now abandoned).

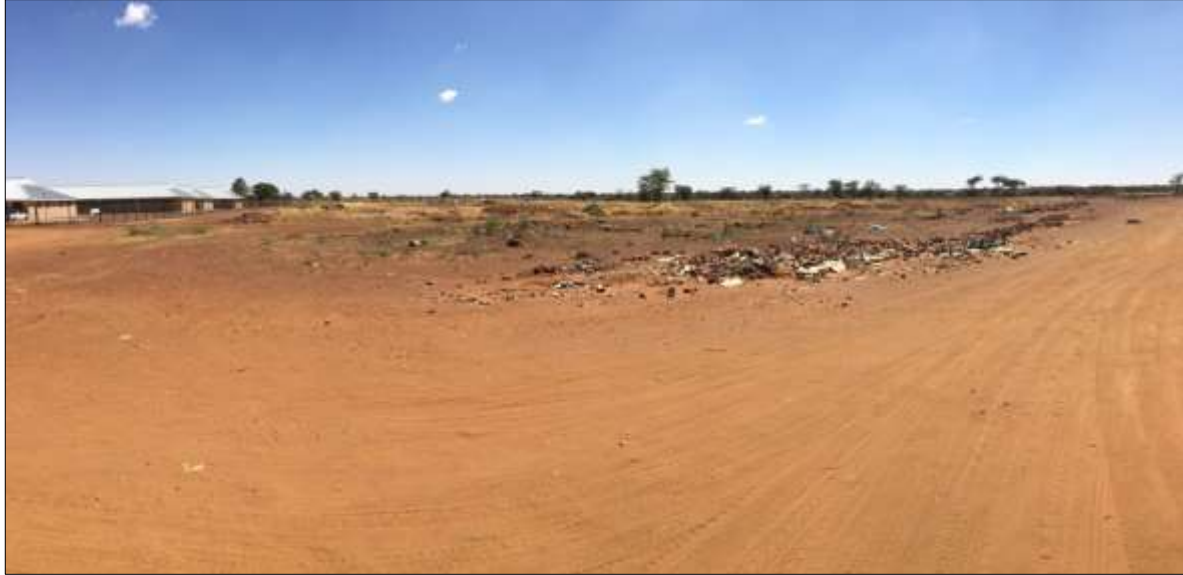
Figure 5. View of the development site facing north. Wrenchville School is to the left of the plate

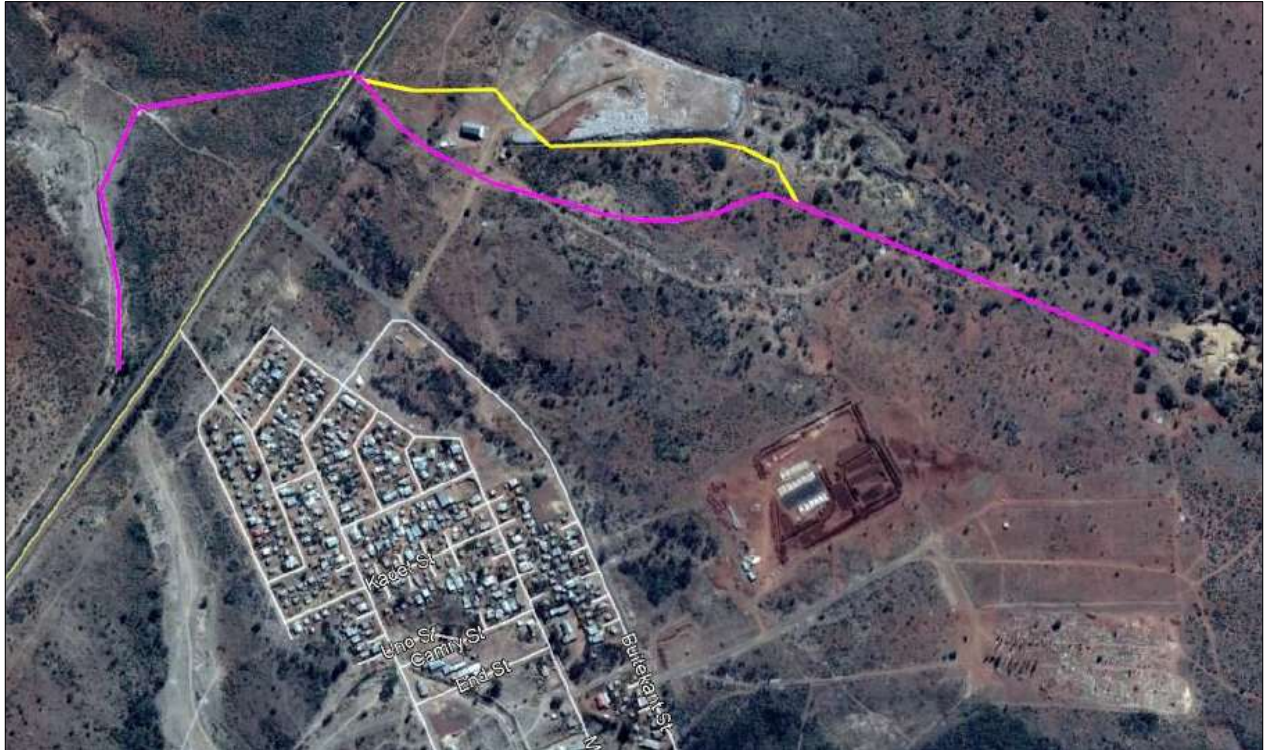
Figure 13. Wrenchville Phase 2 Housing Development. Proposed sewer routes. The yellow route alongside the Kuruman Landfill Site is the preferred route alternative

It is proposed to locate the bulk sewer pipeline below the 1:100 year flood line of the degraded stream channel (Figures 13-28). Two layout alternatives for the bulk sewer are proposed, with the yellow route diversion being the preferred alternative. The proposed sewer line will pass underneath Buitekant Street through an existing culvert, and run alongside the Kuruman River in a southern direction before connecting to the existing pump station situated adjacent to the bridge crossing on Buitekant St (Figures 29-37).

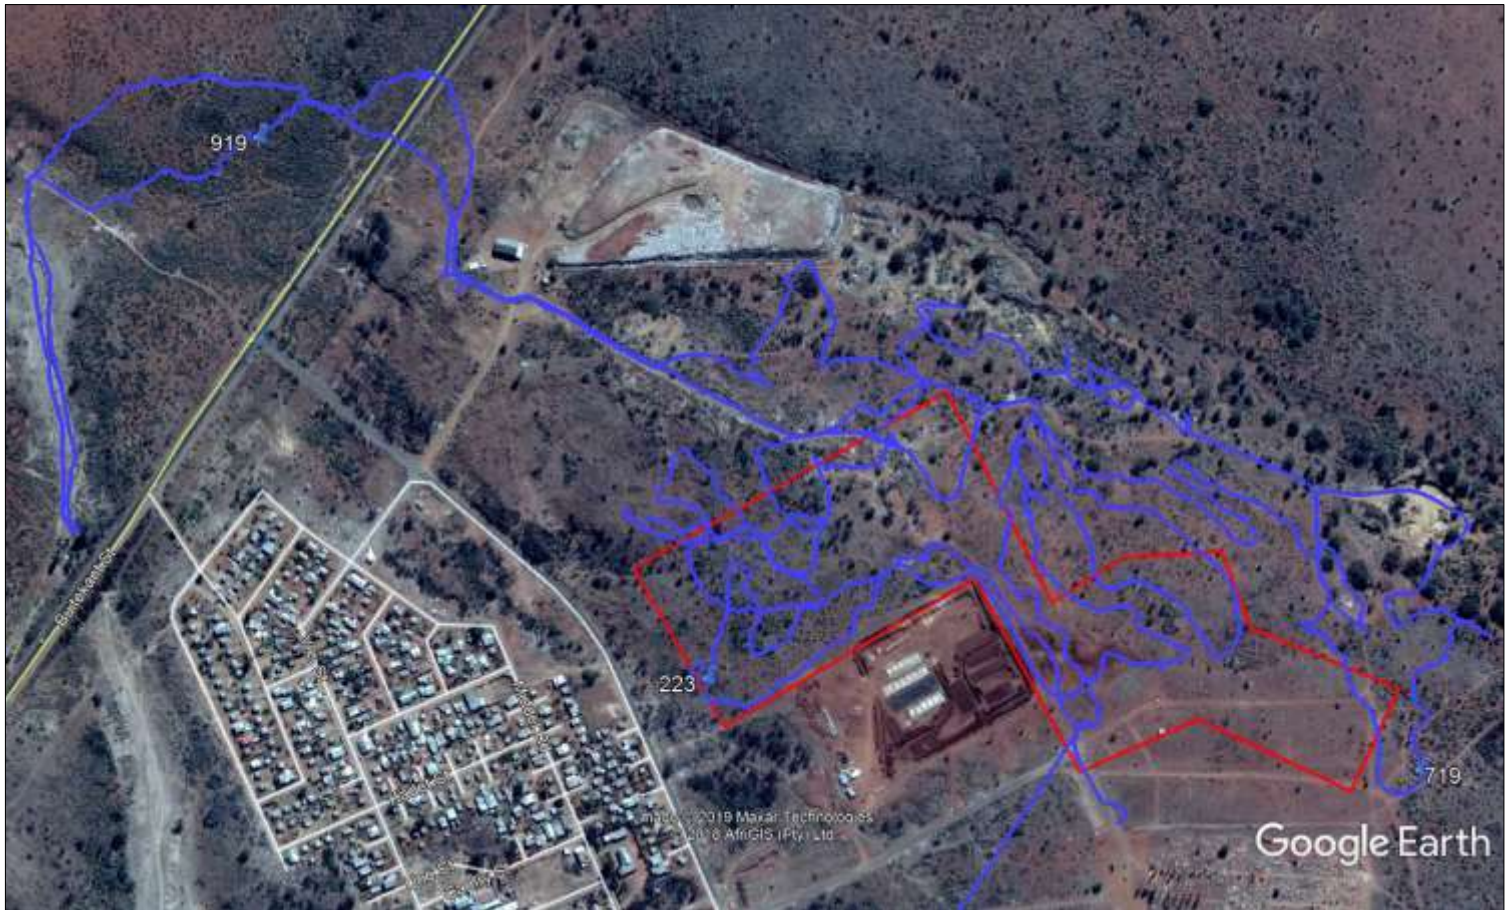
Figure 38. Track paths (in blue) and waypoints of archaeological finds

Trackpaths and waypoints of archaeological finds are illustrated in Figure 39.

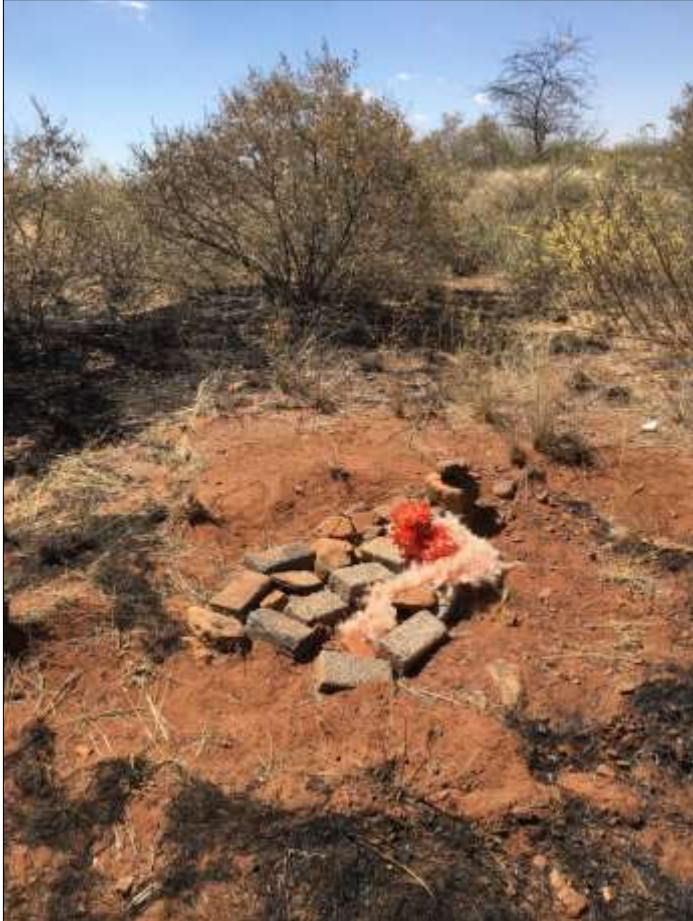
Figure 39. Grave (Point 223)

The grave (Point 223) of a possible child was recorded about 200m from the boundary fence of the new Wrenchville School, on the edge of the proposed footprint area (Figure 40). The grave is clearly quite recent and was reported to the Contractor, who in turn reported the find to the South African Police Services in Kuruman for further investigation.

Point	Name of farm	Lat/long	Finds	Grading	Mitigation
	Rem. Erf 1, Kuruman				
223		S27° 26.522' E23° 27.321'	Grave, possibly of a small child (recent)	High 3A	Reported to SAPS Kuruman
719		S27° 26.578' E23° 27.810'	ESA banded ironstone handaxe	NCW <sup>1</sup>	None required
919		S27° 26.353' E23° 27.447'	MSA chalcedony flake	NCW	None required
		GPS reading not captured	Utilized/retouched LSA flake	NCW	None required

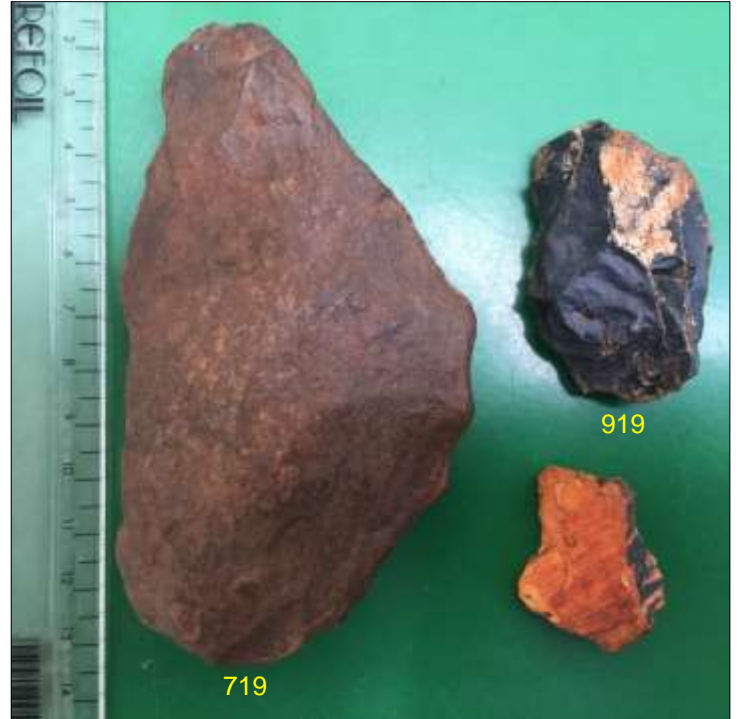
Figure 40. Stone tools. Scale is in cm

Only two, isolated stone tools were recorded in the proposed housing development site (Table 1 & Figure 40). These include a small, burnished, Early Stone Age banded ironstone biface/handaxe (Point 917) and a Later Stone Age utilized/miscellaneous retouched banded jasperlite flake (GPS reading not captured).

An isolated Middle Stone Age retouched chalcedony flake (Point 919) was found on a patch of surface gravel of banded ironstone in the surrounding area.

Only three Stone Age implements, of low archaeological significance were recorded, in a severely transformed and degraded context.
