Heritage Impact Assessment of the complex making up Zithulele Hospital, Mqanduli district, Eastern Cape

Prepared for: **Mr. Eddie Goosen**
Regional Director
Transport and Infrastructure
AfricaWSP
August 2017

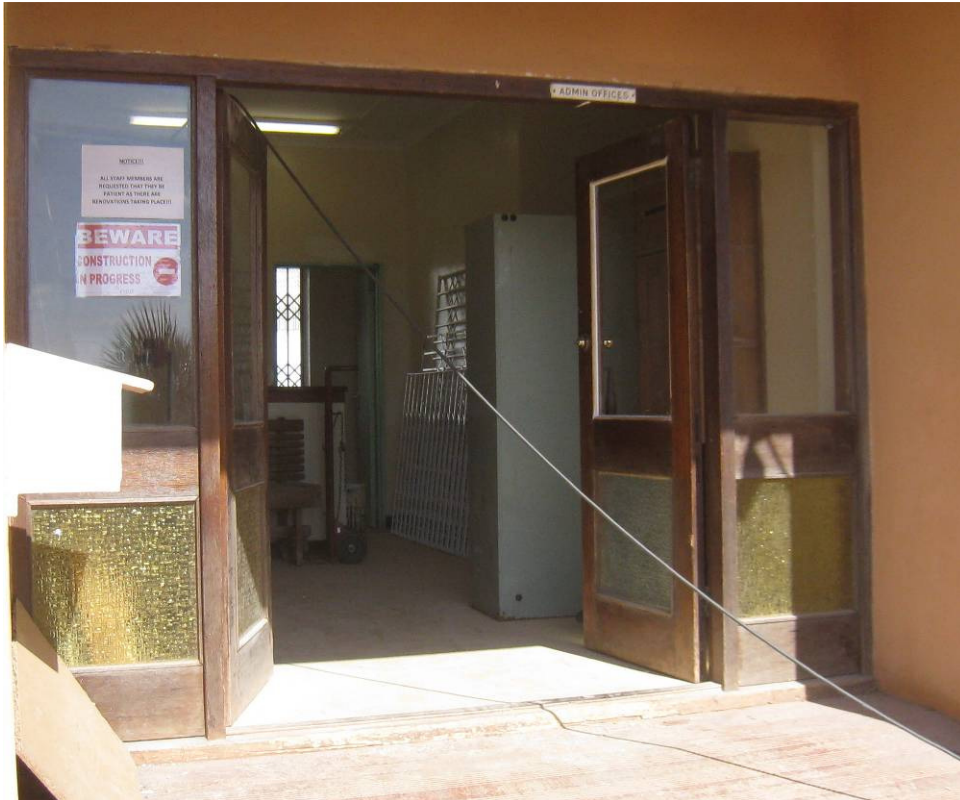
The Administration Block is ostensibly the oldest structure on the site. It is of conventional construction and plastered and painted, under a hipped roof of corrugated sheeting and with steel standard section openings. The front entrance doors point to its vintage. It is north facing with a deepened veranda along the western end. It is currently undergoing significant refurbishment, largely of a cosmetic nature.

Fig 17: Front entrance doors to the Administration Block

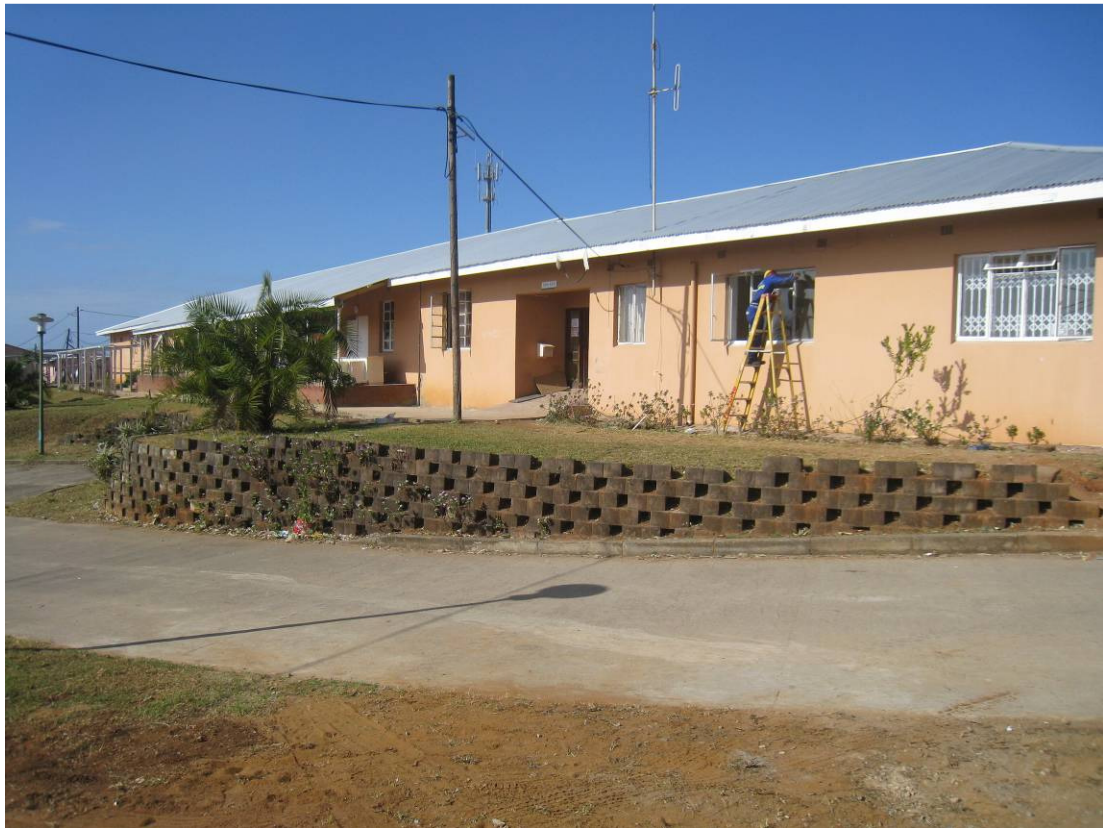
Fig 18: The administration Block from the car park in front

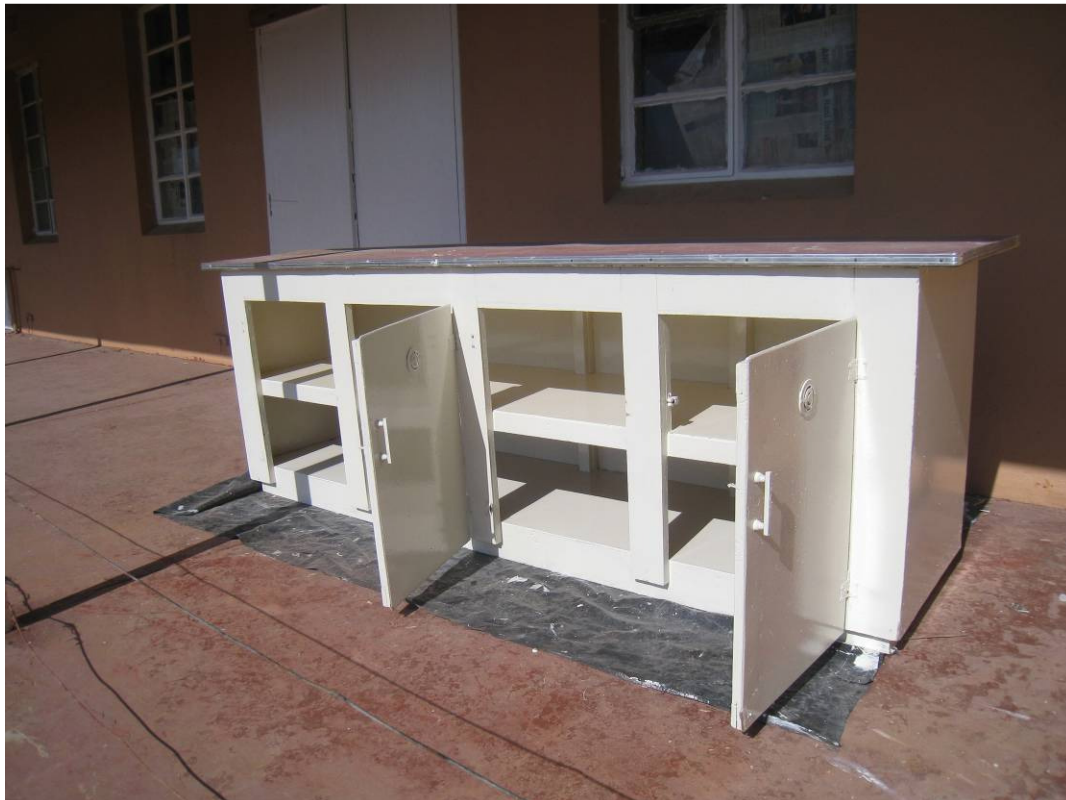
Fig 20: Front veranda of the Administration Block, showing old furniture being refurbished

The building has been significantly overhauled for reuse. The nature of the structure, as built in the 1960s means that there is little of any major architectural, technical, historical or scientific material that is being altered. Items of significance are the Matrons plaque which will be removed for display in contextualized setting, and the plaque at the entrance indicating its position as a Mission Hospital of the Nederduitse Gereformeerde Sendings Kerk with support from the Cape Government.

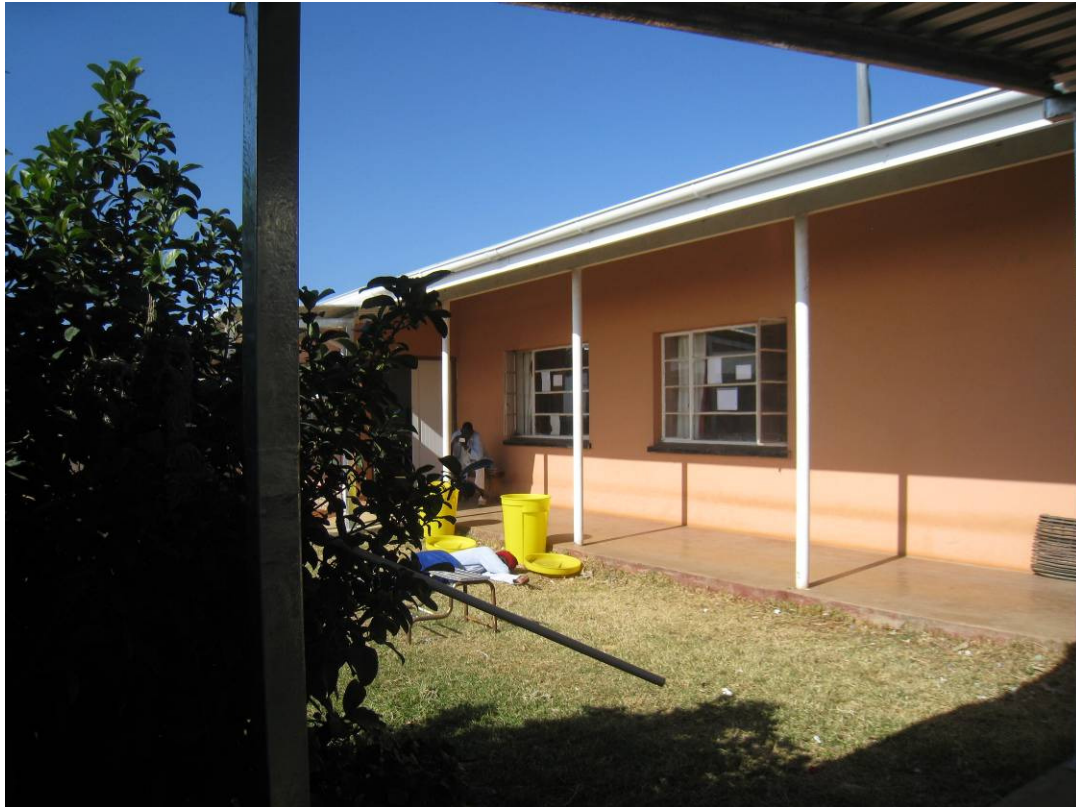
Fig 21: Front veranda, recently refurbished

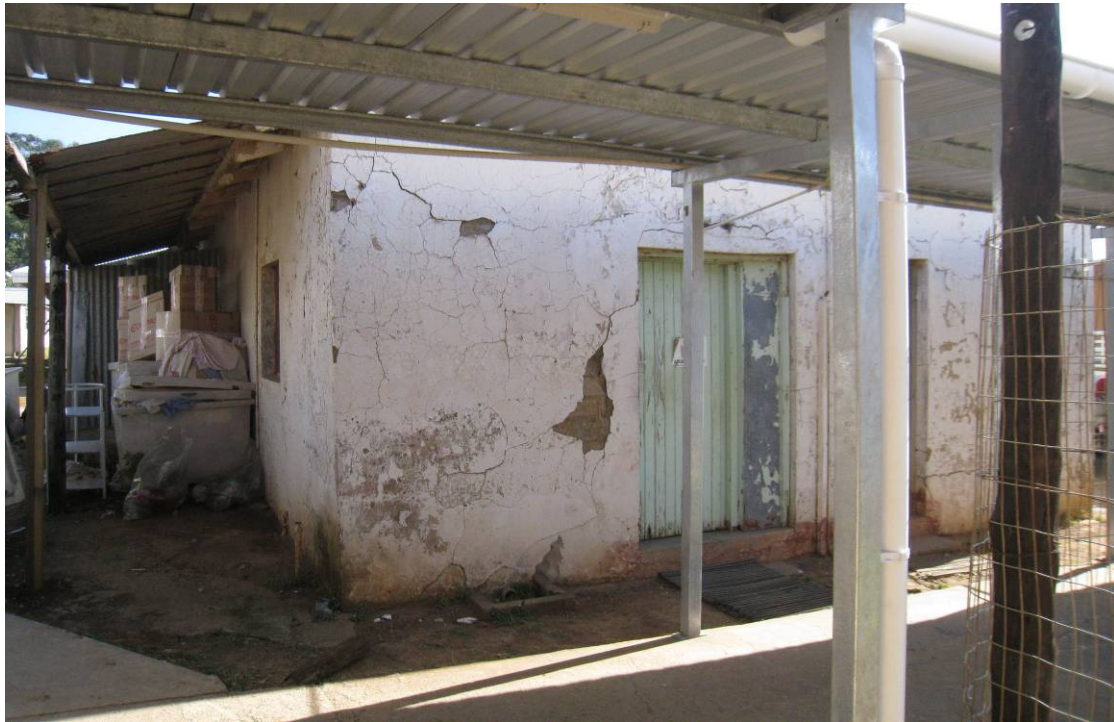
This is an earth brick building resting on a low dado of fired brick, under a double pitched corrugated sheeting roof. The southern edge has a deep veranda which, it is understood, acted for a time as the laundry. The doors are of timber and the windows standard steel section. It has been ill-maintained; part of the current degradation due to the attempted repair of areas in need of patching with cement plaster, leading to spalling after water incursion.

Fig 24: The Old Stores from the Kitchen Block

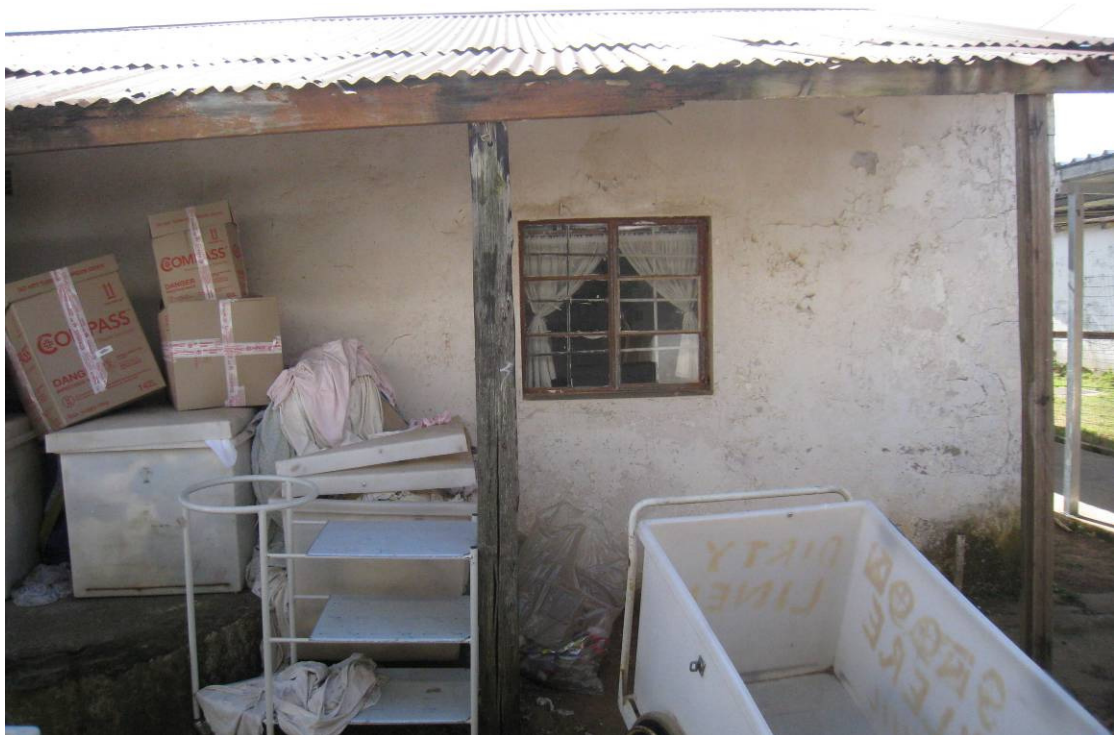
Fig 25: The Old Stores from the Laundry Block

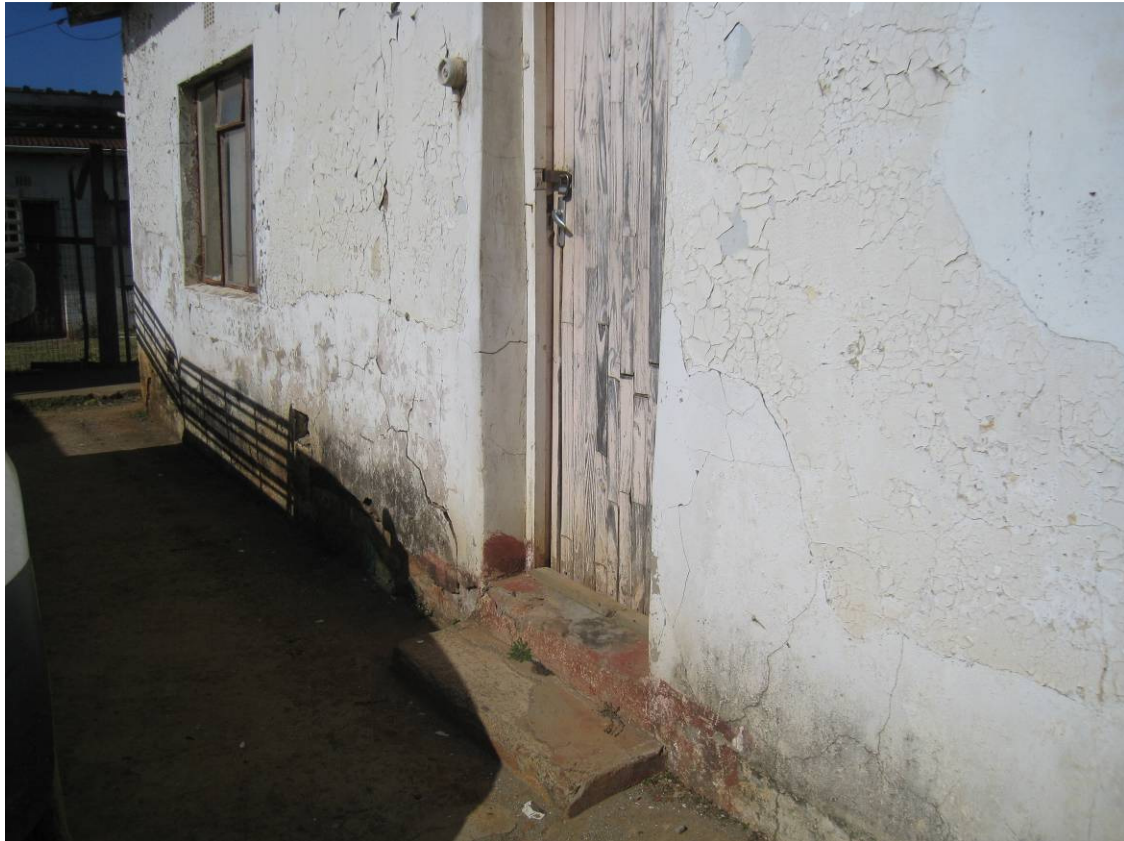
Fig 26: The Old Stores building showing the condition at ground level as well as the general wall condition

This building is under the age of 60 years and thus has no protection under the South African Heritage Resources Act. It has medium social significance being constructed out of earth brick as part of the hospital during the Transkei era.

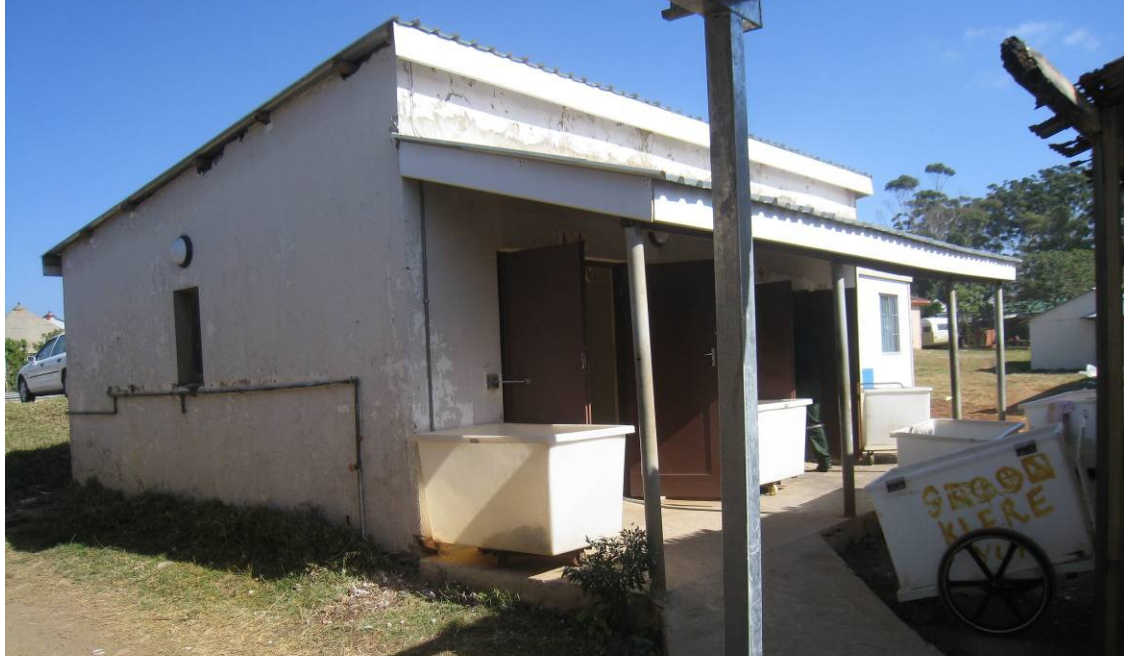
The laundry is of more recent construction, being of mixed materials under a corrugated sheeting monopitch roof, and with a parapet wall above a veranda to the north side. The windows are steel, and the sets of double timber doors open to the north veranda.

Fig 27: The Laundry Block from the north east

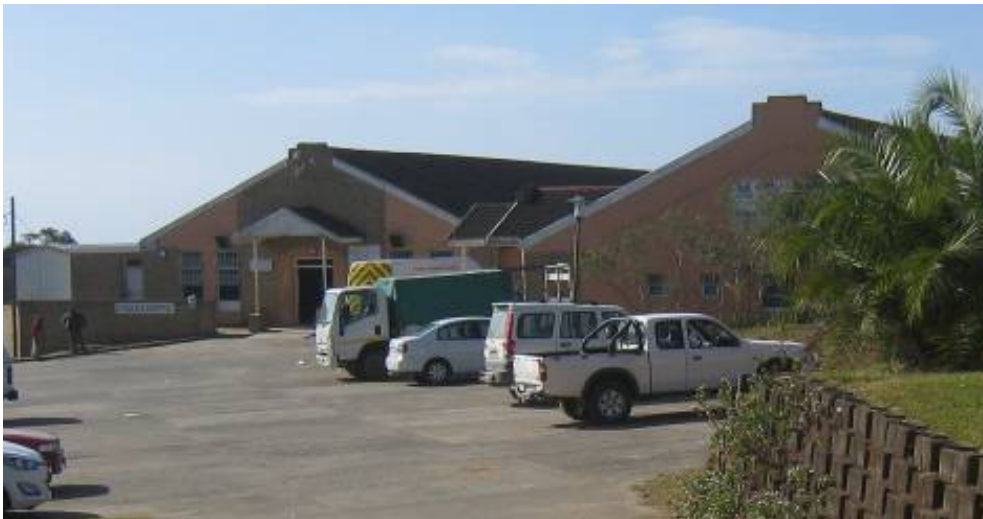
This is an architecturally monolithic block connected to the Physiotherapy Department and constructed both below it and to the north of it. It is of conventional construction, plastered and painted with a double pitched concrete tiled roof, asbestos / fibre cement fascias and bargeboards, and a post-modern expression of the ridge which is carried down the wall in facebrick, and carried out with same to the edges of the building. The windows are of standard steel sections, pivot hung. It has not been maintained well over the years, and suffers badly, particularly on the east elevations which are well shaded, from water incursion from both ground water and drainage issues, as well as badly maintained rainwater goods.

Fig 29: Front view of the Outpatients Department with the Physiotherapy Block (right)

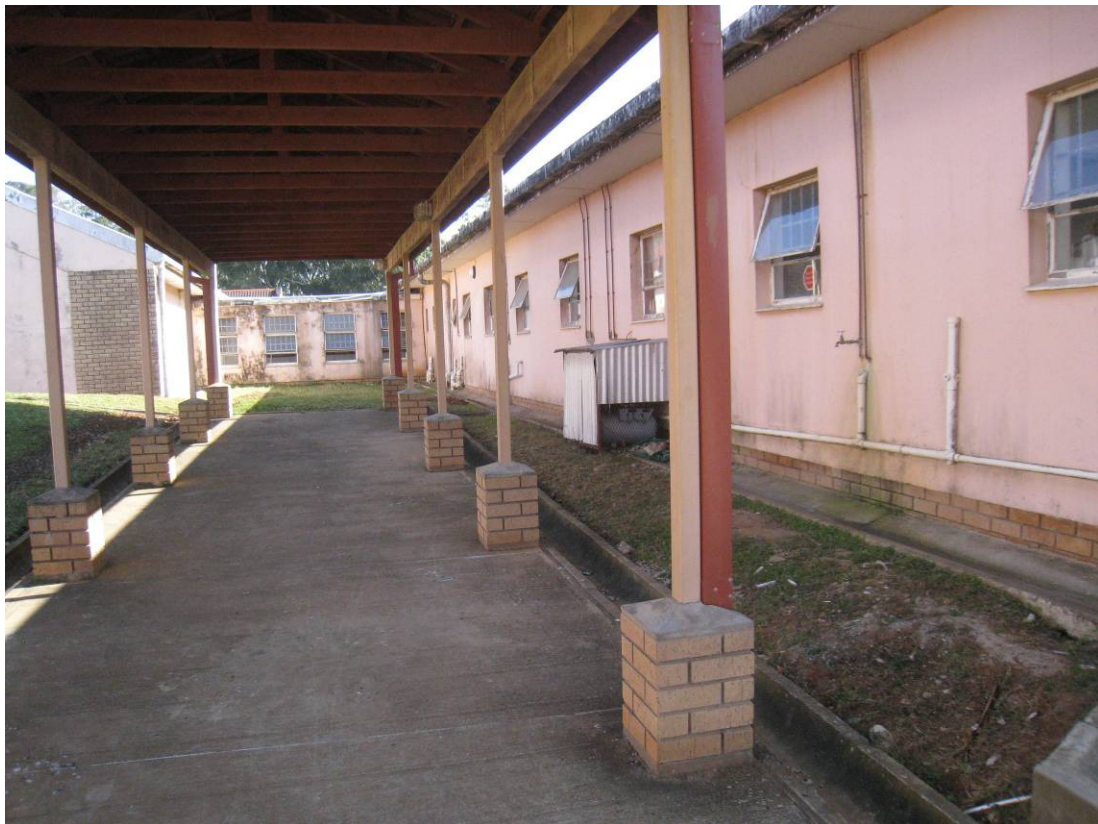
Fig 32: Rear of the junction of the Outpatients Block (right) and junction with the Physiotherapy Block (centre)

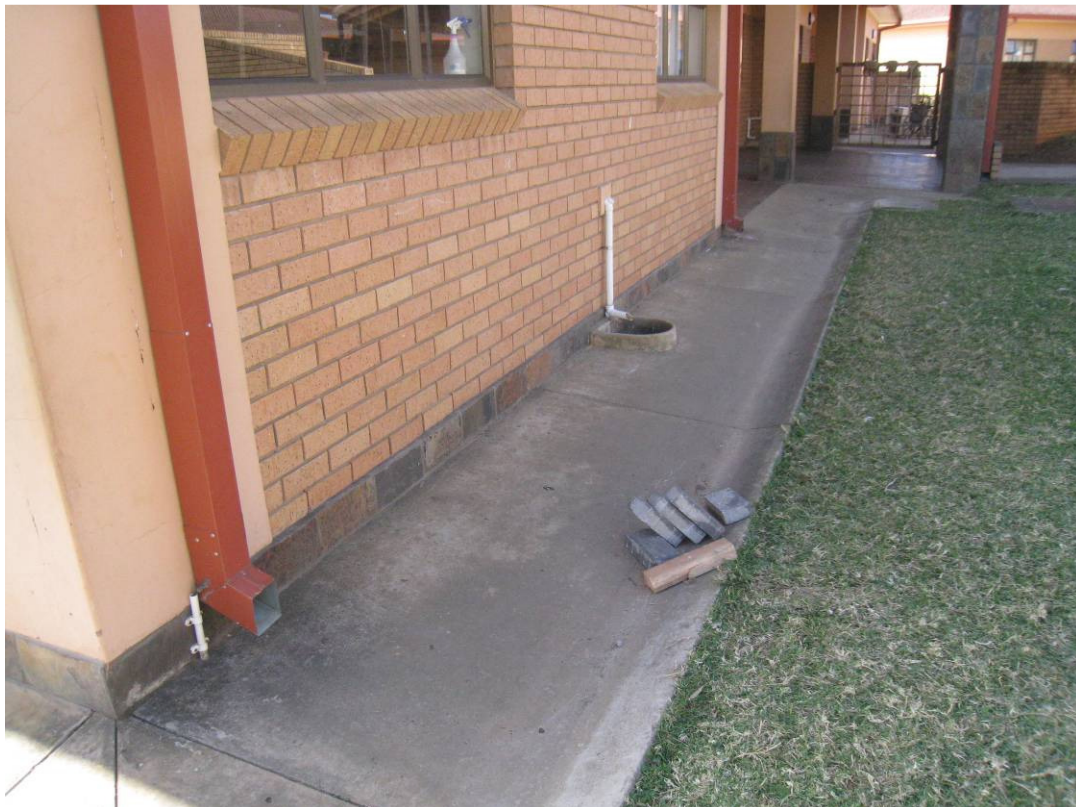
The Paediatric Department is situated on the north of the site, to the north east of the Outpatients Department. It was completed and then opened in 2006. It is constructed using a pale facebrick in stretcher bond, with similar brick-on-edge cills, and a hipped and gambreled concrete tiled roof with standard steel windows and plastered corners and eaves bands. It forms part of a similar complex with the General Wards, and connected with walkways of a similar era.

Fig 35: Detail showing material construction and condition of Paediatric Department

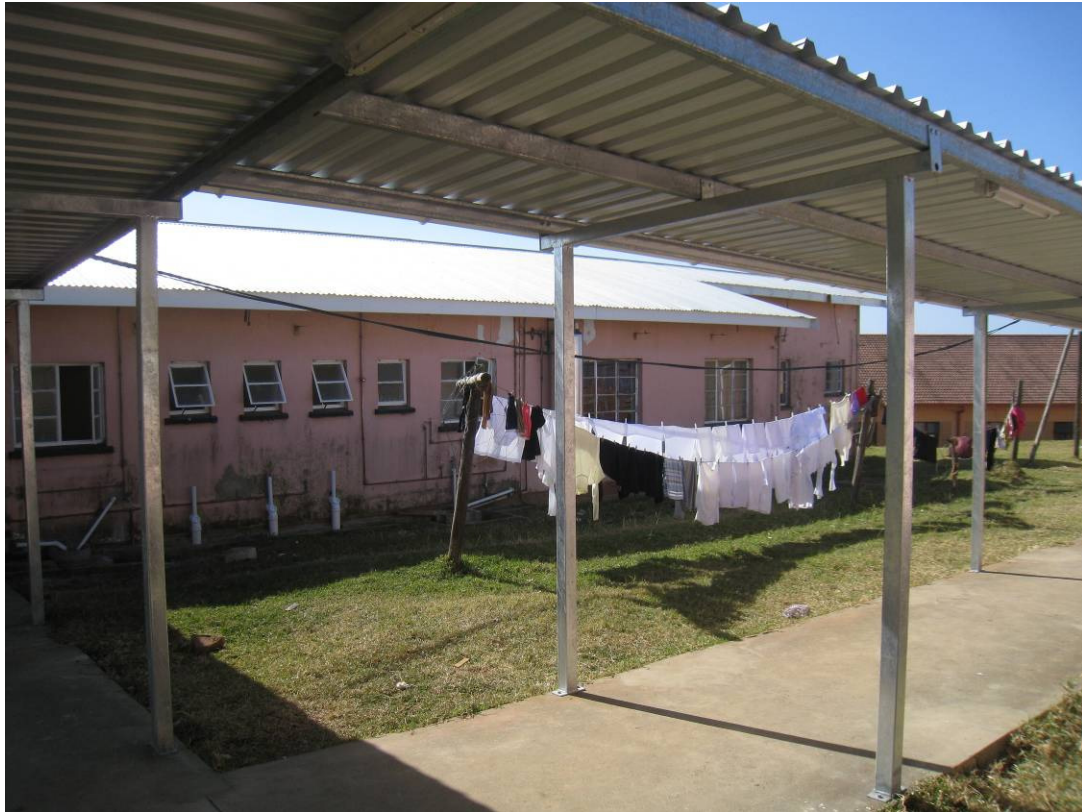
The staff accommodation at Zithulele Hospital consists of a series of long buildings situated on the contour, constructed of standard construction, on fired brick dados, with standard steel section windows under a double pitched corrugated sheeting roof. The walls are plastered and painted.

Fig 37: Staff Accommodation, lower level

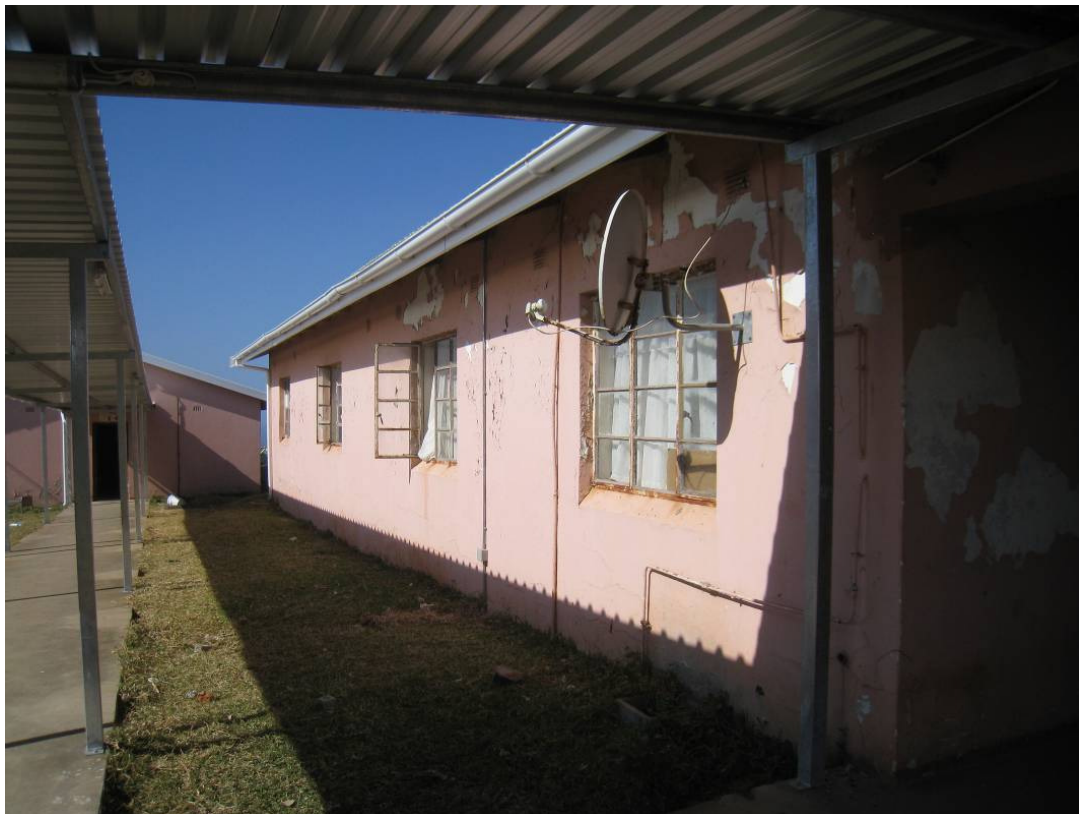
Fig 38: Staff accommodation showing condition of building as a result of lack of maintenance and damp.

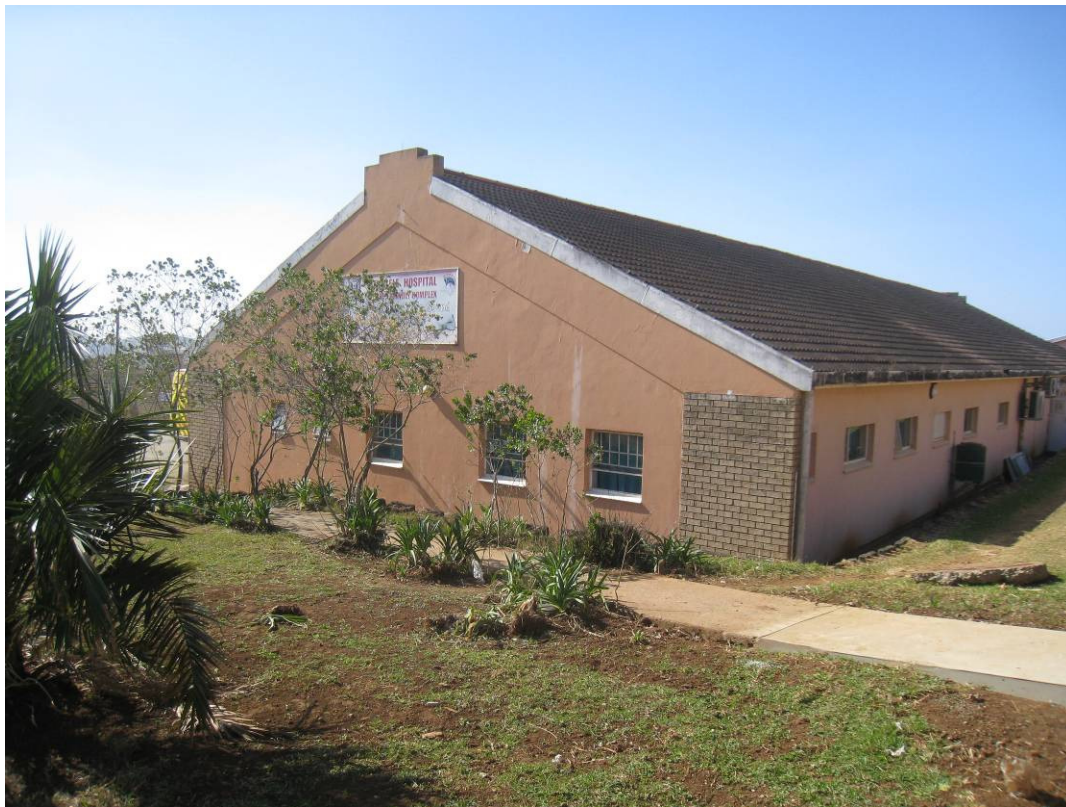
This is an architecturally monolithic block connected to the Outpatients Department and constructed both above it and to the South of it. It is of conventional construction, plastered and painted with a double pitched concrete tiled roof, asbestos / fibre cement fascias and bargeboards, and a post-modern expression of the ridge which is carried down the pitch in a raised plaster, and then accentuated on the edges of the building with a deep, pale facebrick. The windows are of standard steel sections. It has not been maintained well over the years, and suffers badly, particularly on the east elevations which are well shaded, from water incursion from both ground water and drainage issues, as well as badly maintained rainwater goods.

Fig 41: The Physiotherapy Block from the west

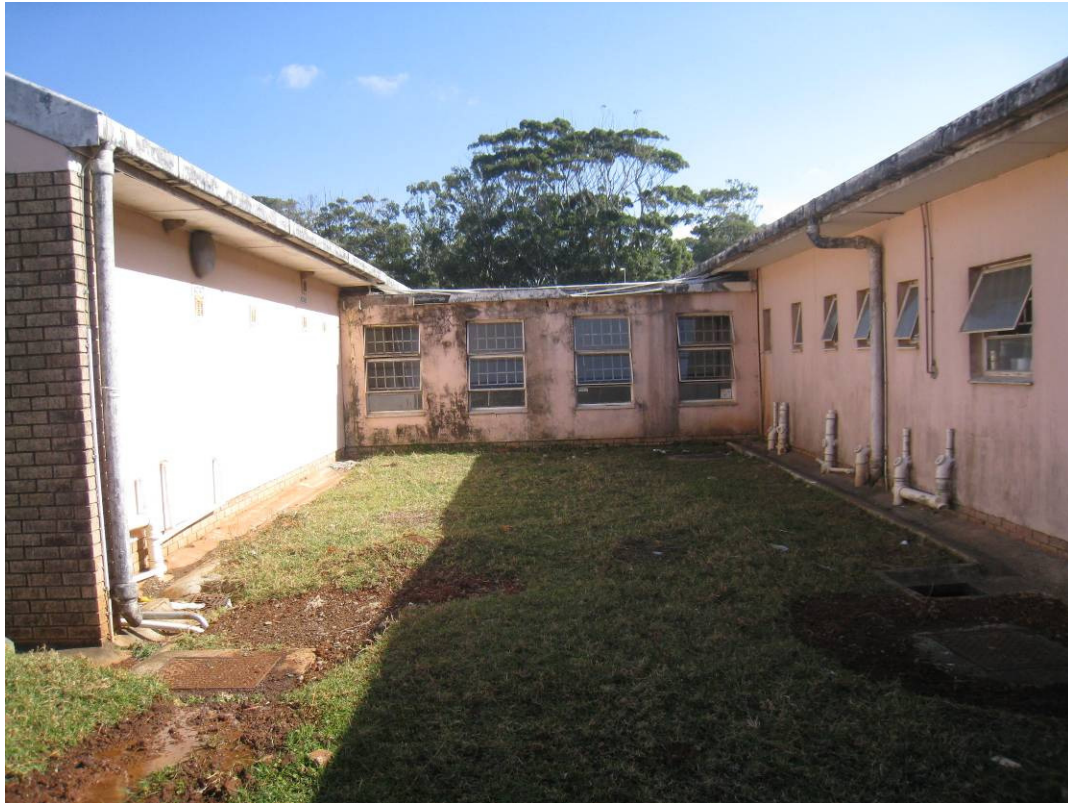
Fig 42: View of connecting passage between Outpatients Department on the right and the Physiotherapy Block on the left. Note damp issues on all three structures.

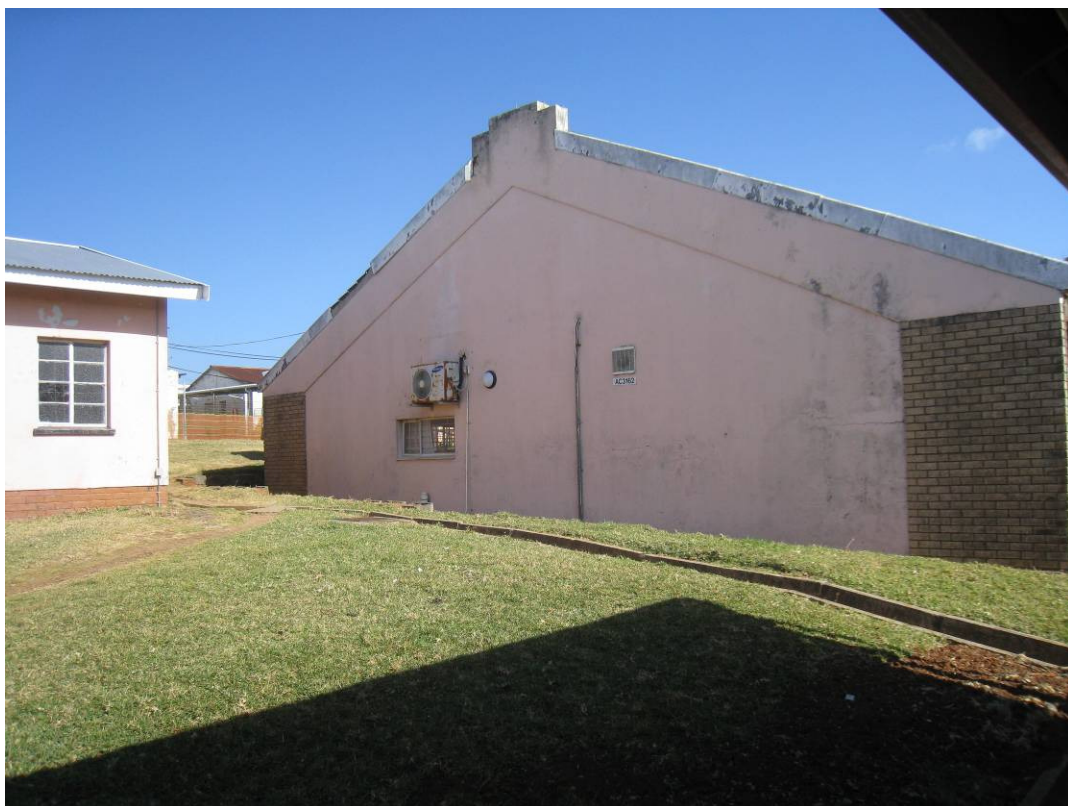
Fig 43: View of Physiotherapy Block from the north east with the end of one of the Nurses Accommodation buildings to the left. Note water incursion both from above and below.

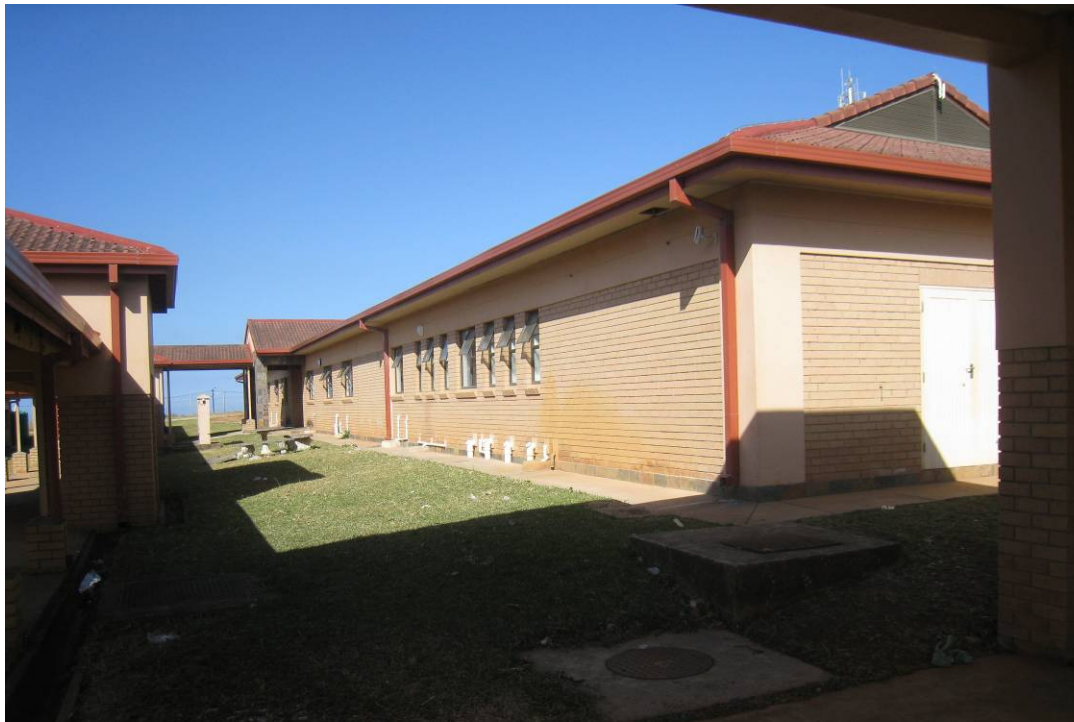
As with the Paediatric Department, the General Wards are constructed using a pale facebrick in stretcher bond, with similar brick-on-edge cills, and a hipped and gambreled concrete tiled roof with standard steel windows and plastered corners and eaves bands. They forms part of the similar complex with the Paediatric Department, and are connected with walkways of a similar era.

Fig 44: View of General wards

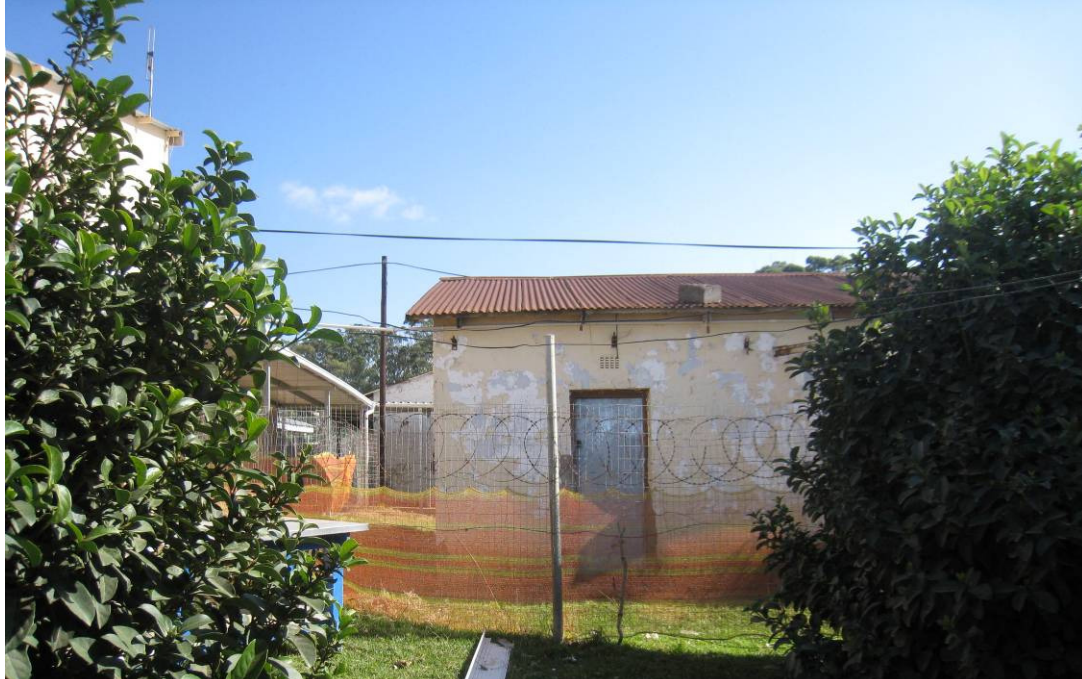
As with the Stores building, the 'Old Physiotherapy Block' is an earth brick building resting on a low dado of fired brick, under a double pitched corrugated sheeting roof. The doors are of timber and the windows standard steel section. It has been ill-maintained; part of the current degradation due to the attempted repair of areas in need of patching with cement plaster, leading to spalling after water incursion. Whilst having been in use relatively recently, it is now fenced off due to its condition, and potential hazard to users.

Fig 45: 'Old Physiotherapy Block' from the Kitchen

For the buildings themselves, given their differing histories of recent construction, demolition, should it be required, is an option.

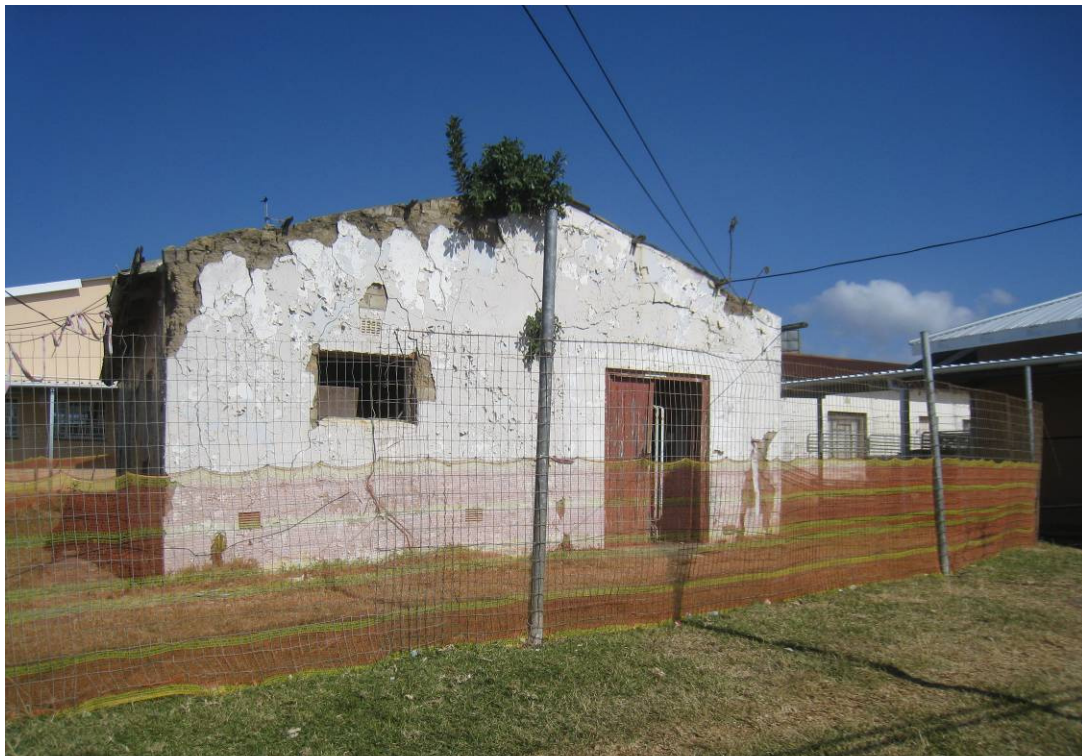
Fig 46: 'Old Physiotherapy Block' from below with the kitchen in the background to the left

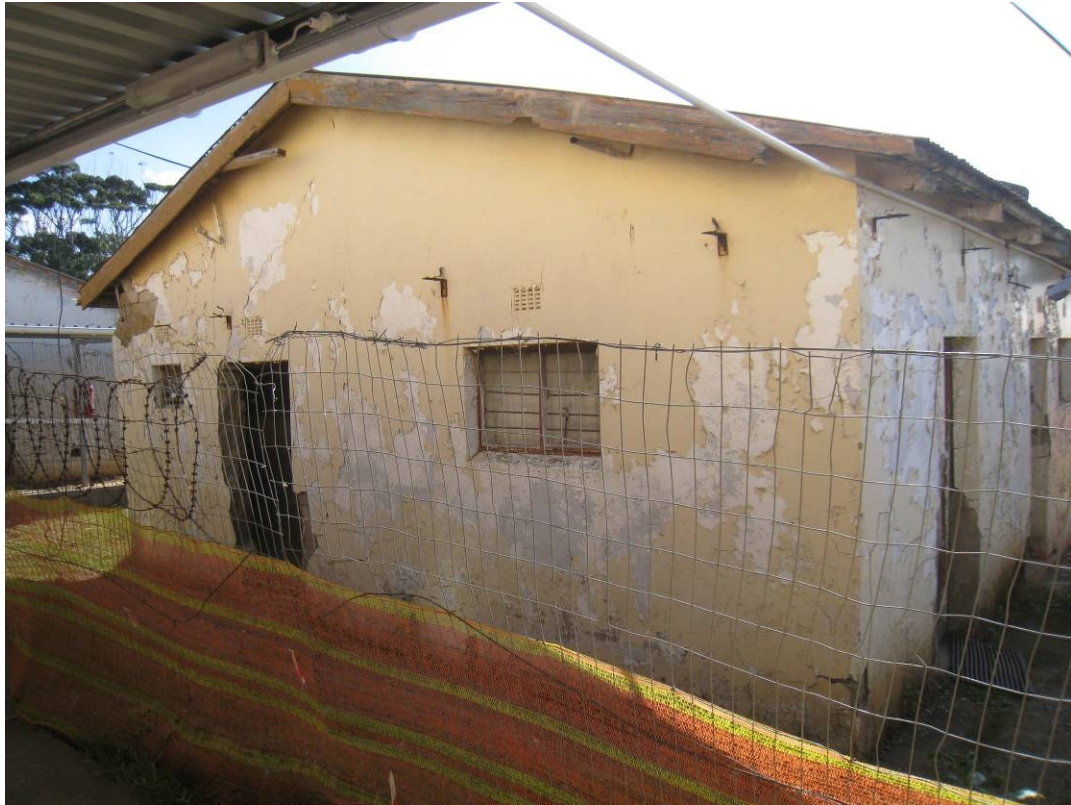
Fig 47: The Old Physiotherapy Block from the Kitchen building above it

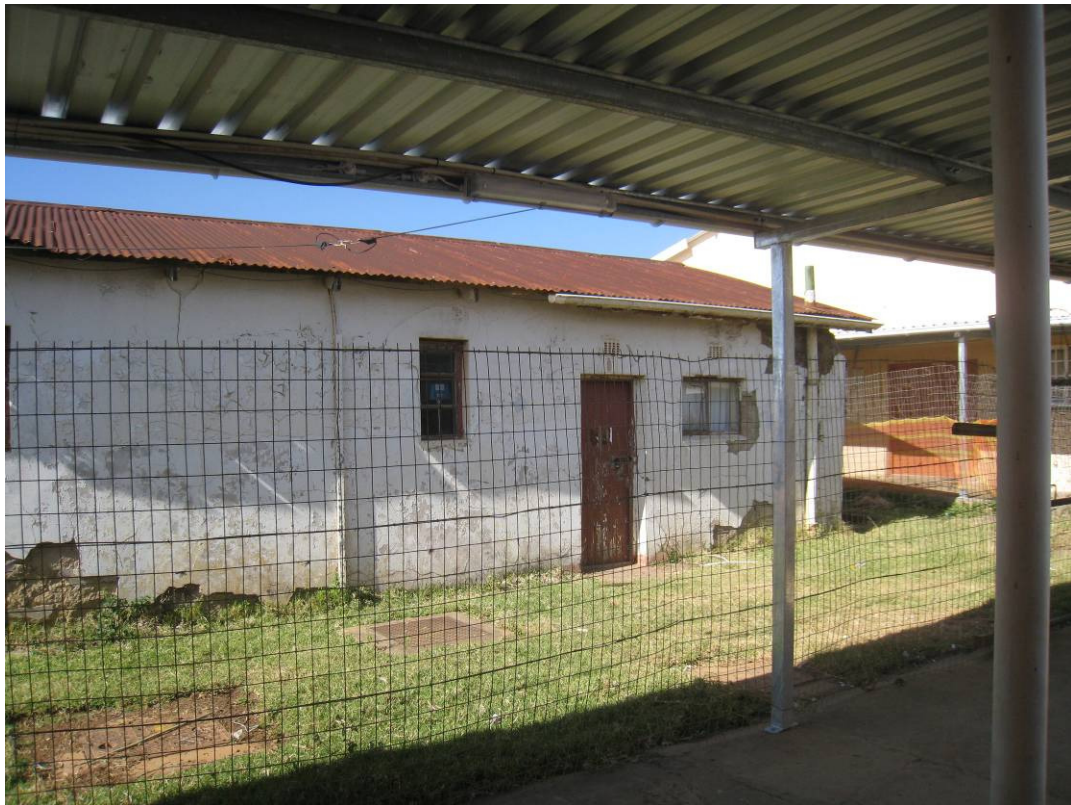
Fig 48: The Old Physiotherapy Block from the Old Stores with the Kitchen in the background

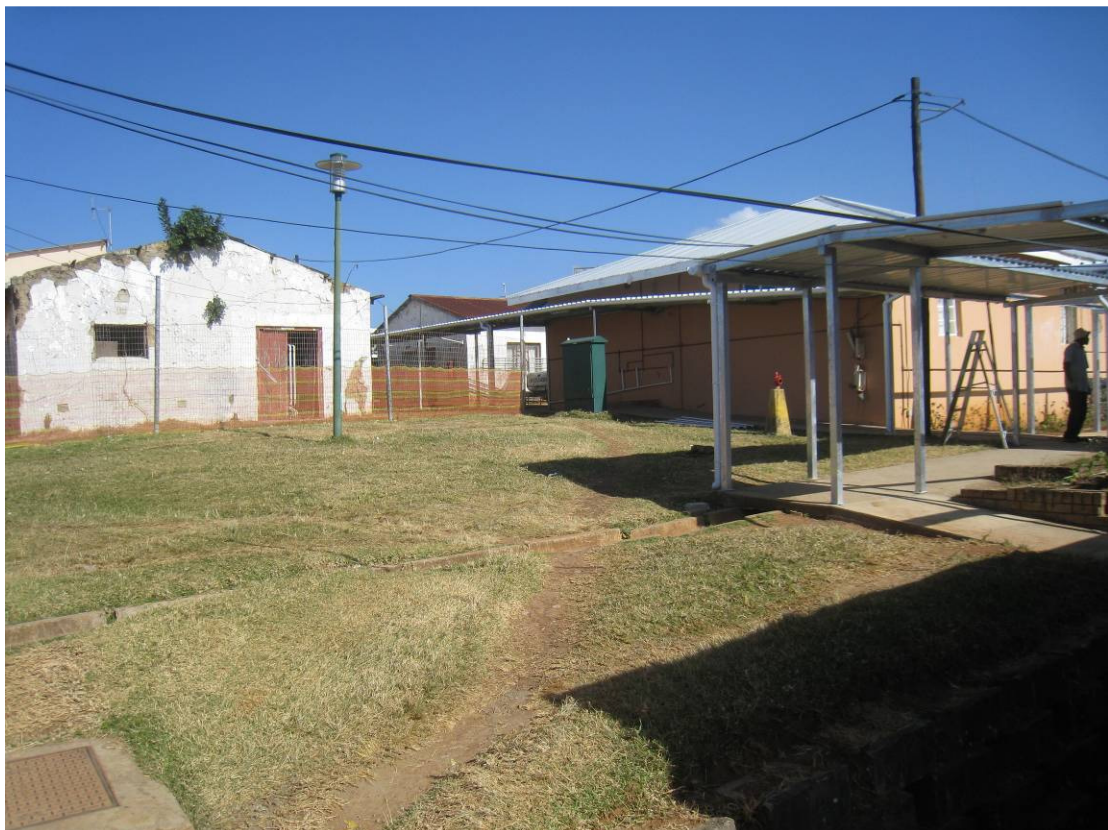
Fig 50: Old Physiotherapy Block from the north east with the Old Stores directly behind it and the end of the Administration Building to the right
