**HERITAGE IMPACT ASSESSMENT:
PROPOSED GRID CONNECTION INFRASTRUCTURE
FOR THE ZONNEQUA WIND FARM, NAMAKWALAND
MAGISTERIAL, NORTHERN CAPE**

Required under Section 38 (8) of the National Heritage Resources Act (No. 25 of 1999).

SAHRA Case No.: 13833

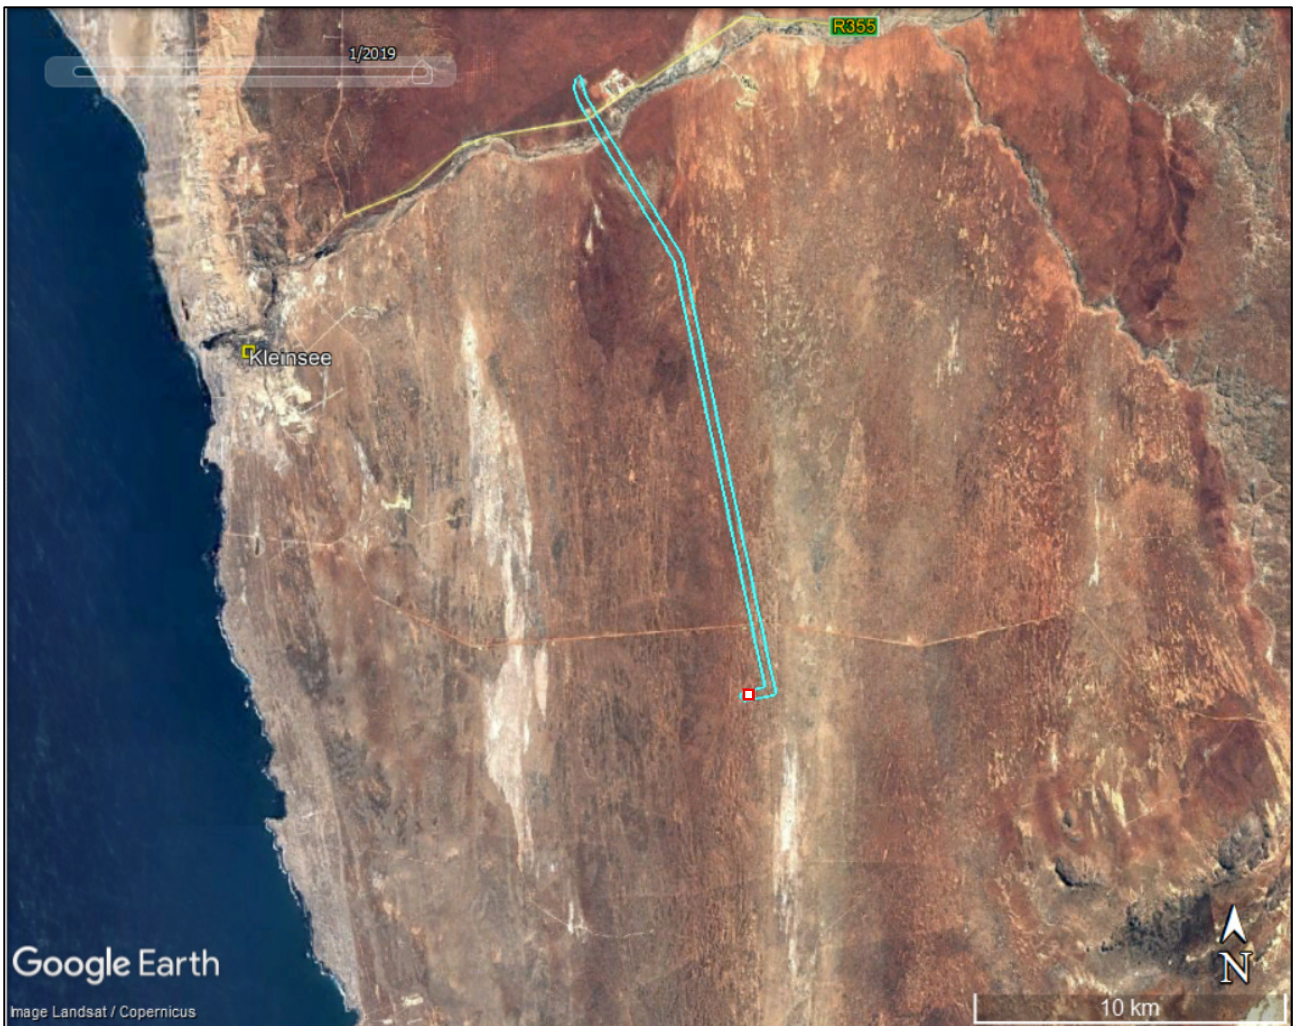
Figure 2: Aerial view of the study area showing the 300m corridor footprint (turquoise) and the collector substation location (red square) located within the corridor.

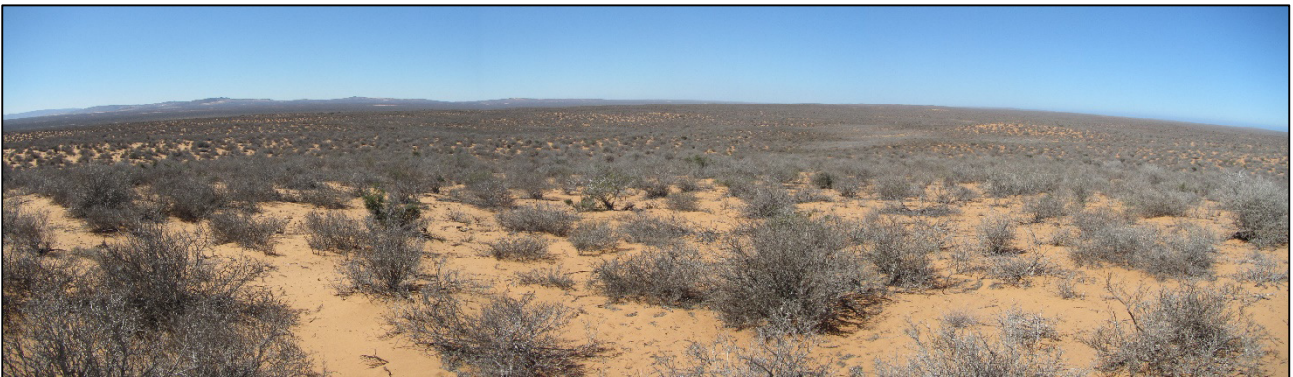
Figure 3: View towards the northeast across the dune cordon in the southern part of the 300m corridor.

In the south the 300m corridor largely traverses a belt of tall red dunes (Figure 3) and in the far north crosses an area where many open deflation hollows occur (Figure 4). Hereafter it crosses an area of exposed *heuweltjies*, passes over the Buffels River then runs a short distance up the slope to the existing Gromis Substation (although the substation is not visible, its access road can be seen in Figure 5). The vicinity of the Buffels River is the only place in the entire 300m corridor that rock outcrops occur but these are very low (Figure 5) with the exception of some bedrock in the river bed.

In the south the 300m corridor begins on a belt of red sand dunes with many archaeological sites in them. A considerably higher density of sites was noted to the south of the 300m corridor and it seems that far fewer are located in the portion of this dune cordon traversed by the proposed double-circuit 132kV power line. It was noticeable that marine shell was largely absent, with ostrich eggshell fragments and stone artefacts dominating the scatters. The sites tended to be located on dune tops with the artefacts visible in deflated areas. These areas varied from lightly deflated and slightly less vegetated than the surrounding areas to proper deflation hollows, although the latter were by far in the minority and tended to be quite small compared to the deflation hollows located further north. These location types are shown in Figures 3 and 4.

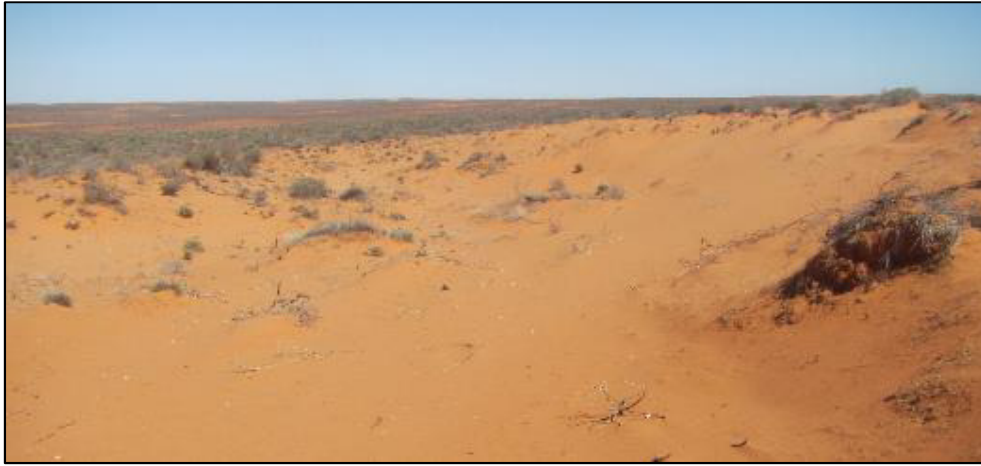
Figure 4: View across a deflation hollow with other similar hollows in the background marked by orange sandy patches on the landscape. This is at site MV2018/026 (waypoint 089).

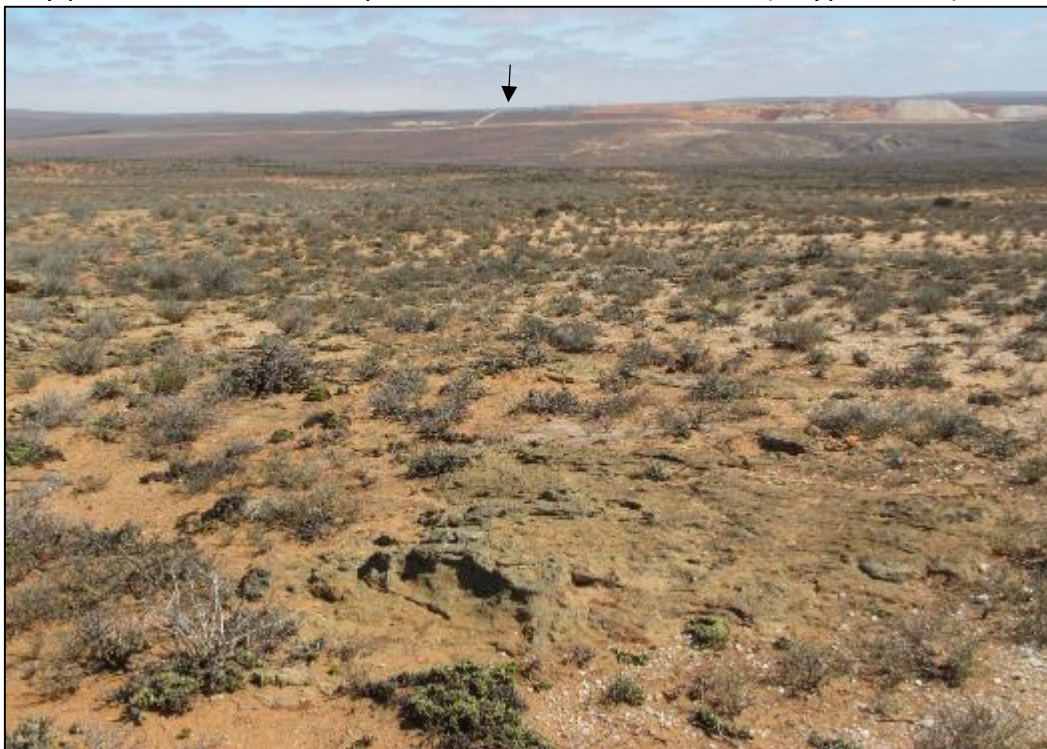
Figure 5: View along the 300m corridor over the Buffels River valley towards the existing Gromis Substation (arrowed). An abandoned mining area lies to the right (east) of the Substation. A low bedrock exposure is visible in the foreground.

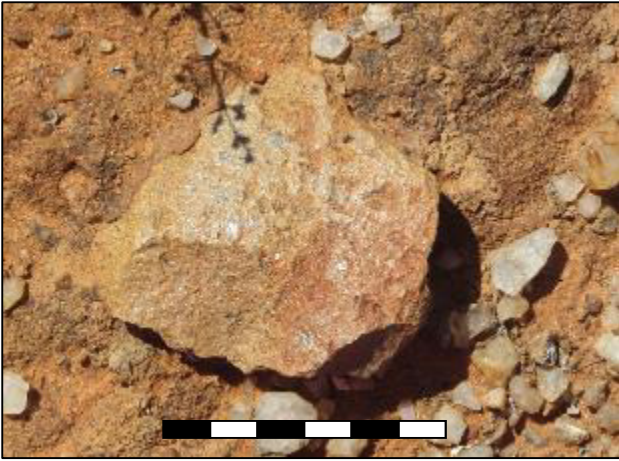
Figure 16: A large flake trapped in the dorbank to the south of the Buffels River. Scale in cm.

In the far north, on either side of the Buffels River, there were places where the dorbank was exposed at the surface. In these areas MSA and ESA artefacts were seen. An example of an artefact stuck into the dorbank was noted to the south of the river (Figure 16), while to the north an area stripped of topsoil during mining activities displays an extensive scatter of Pleistocene-aged material, including handaxes (Figures 17 to 19). Within a few hundred metres on either side of the Buffels River there were a few light shell scatters. It was not possible to tell whether there were stone artefacts associated with them because of both the natural quartz gravel and the low density background scatter of quartz artefacts present. Figure 19 shows an example of one such scatter which also had pottery on it (MV2018/034; waypoint 97). Two small quartz outcrops displaying flaking were also noted to the south of the river.

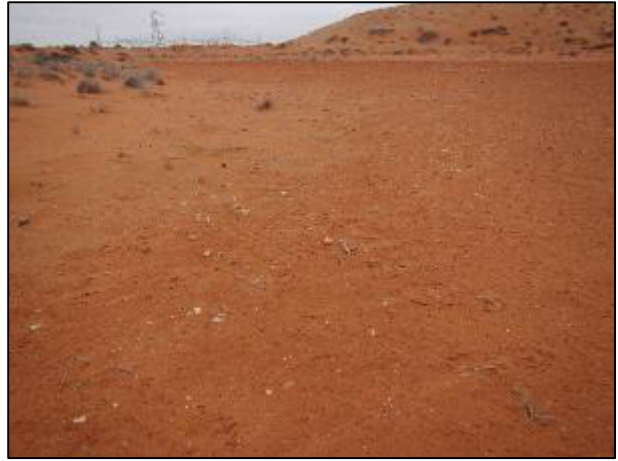
Figure 17: The dorbank surface at waypoint 059 with artefacts scattered over it.

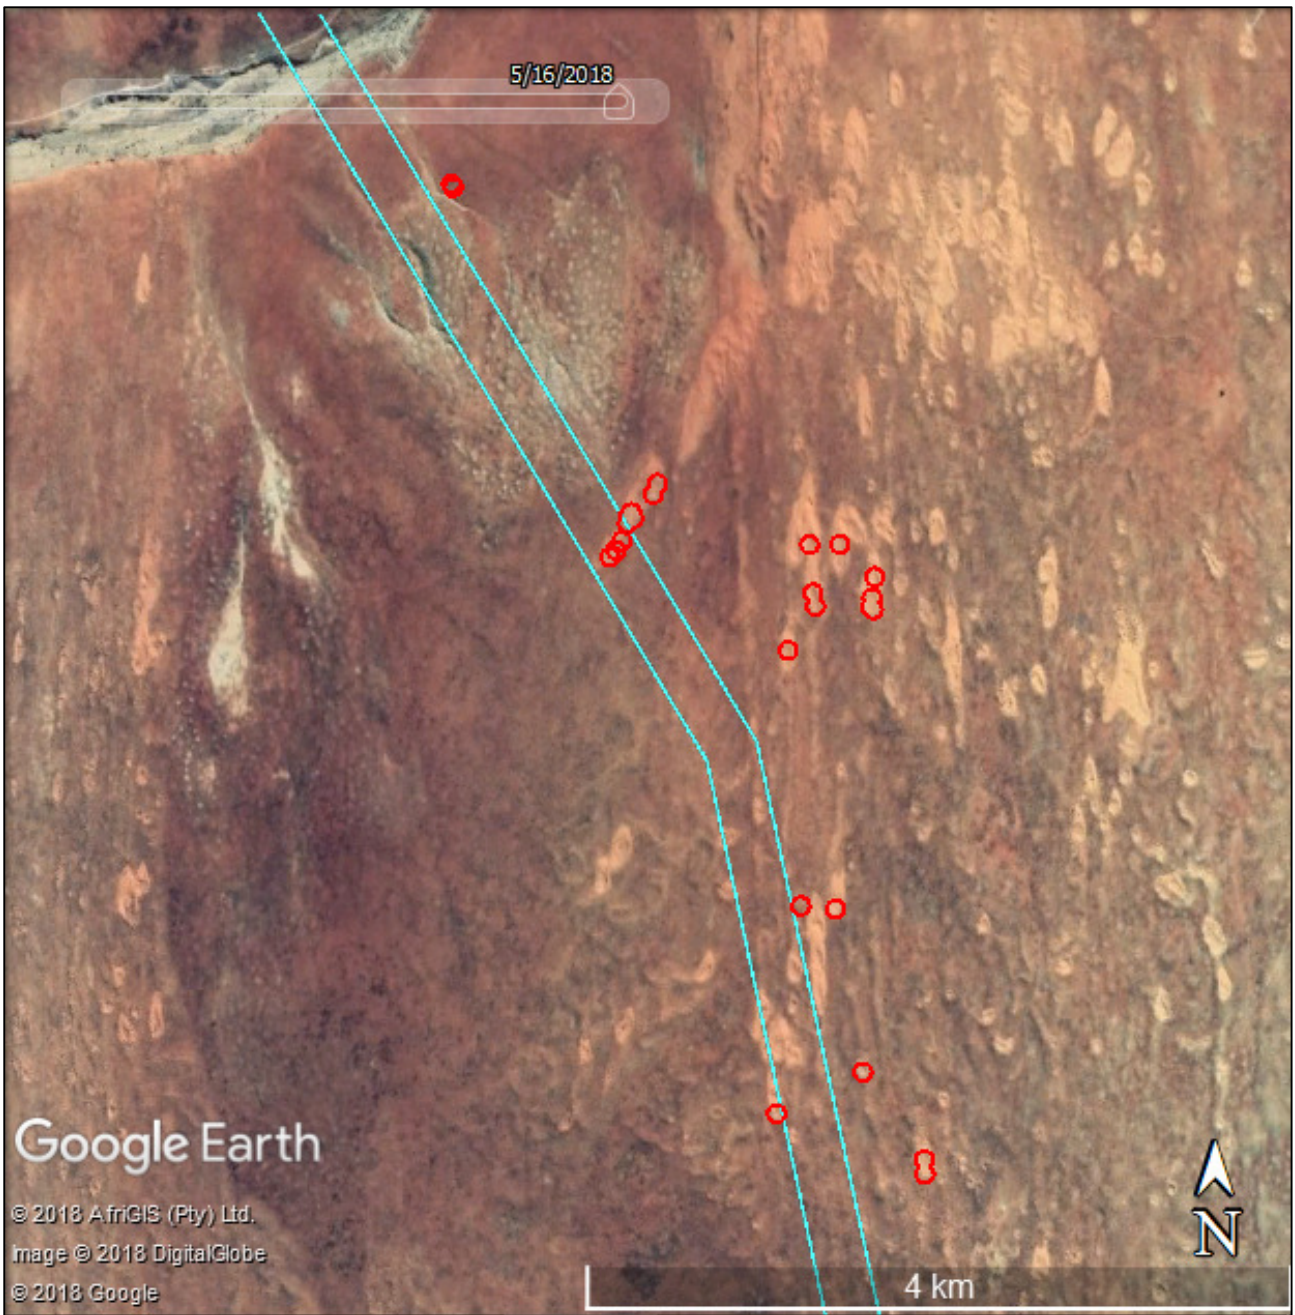
Figure A3.5: Map showing 50 m buffers from the centre point of all significant archaeological sites (red circles) relative to the northern section of the 300m corridor.

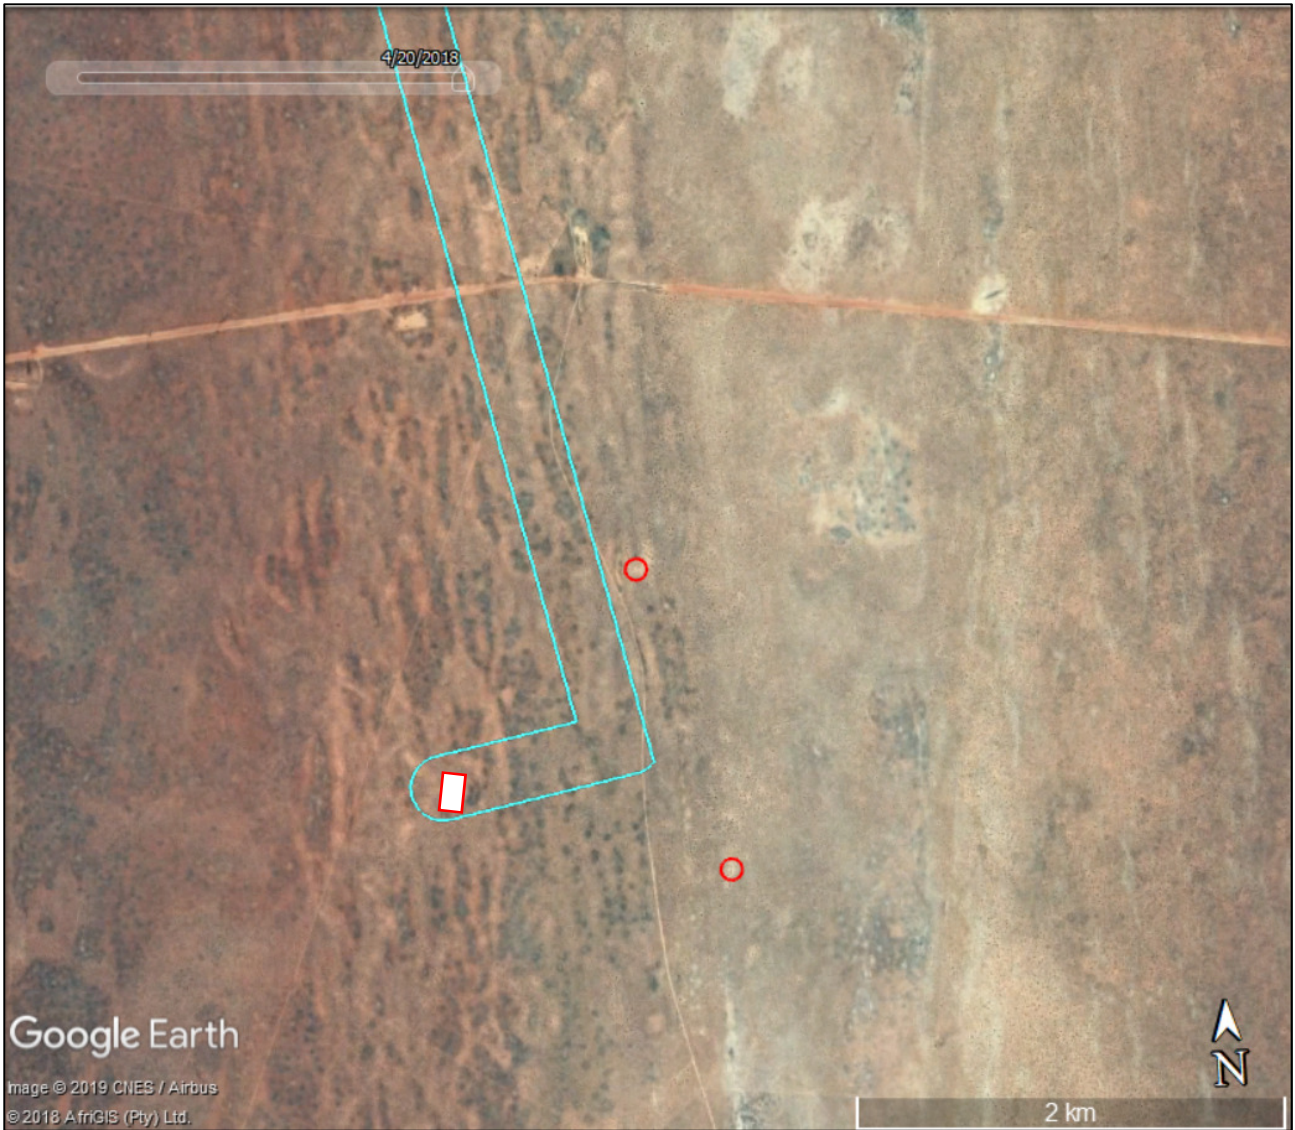
Figure A3.6: Map showing 50 m buffers from the centre point of all significant archaeological sites (red circles) relative to the southern section of the 300m corridor and collector substation (red polygon).
