**PROPOSED ZUKA VALLEY RESIDENTIAL ESTATE,  
SEAWARD, BALLITO, KWAZULU-NATAL**

**Phase 1 Heritage Impact Assessment**

**15 March 2019**

**AUTHOR: JLB Consulting  
Jean Beater**

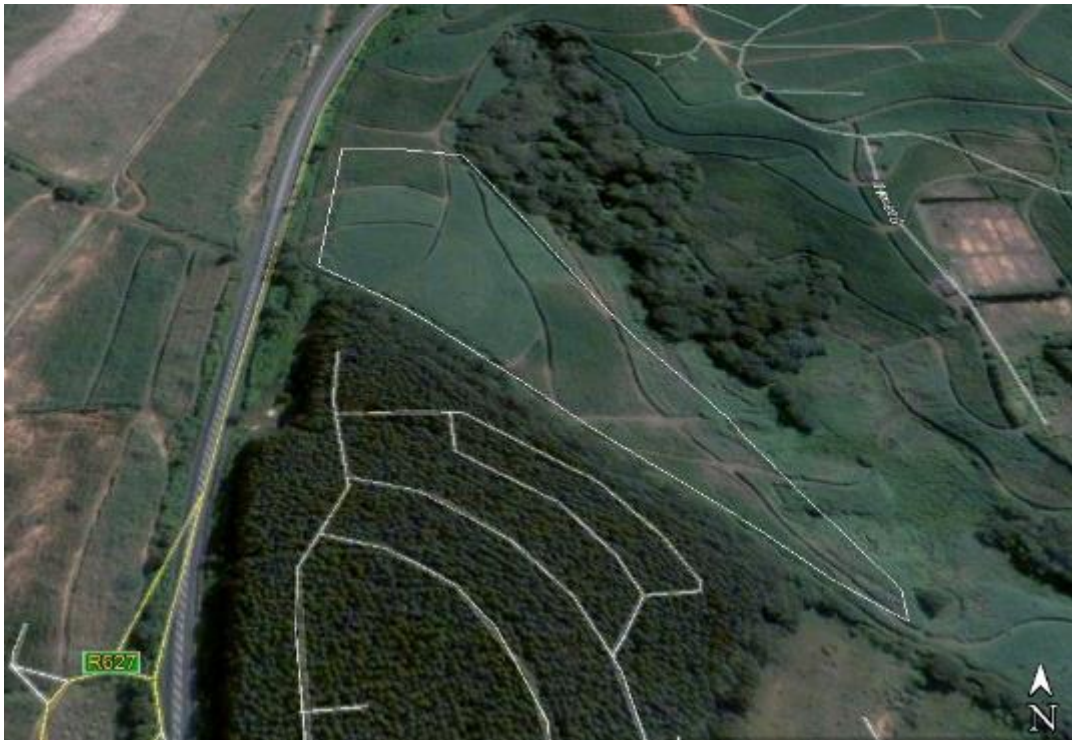
**Figure 3: 2002 Google Earth image of project site**

The site of the proposed development was used for the cultivation of sugar cane at the turn of this century apart from the drainage line and wetland. The Google Earth image from 2002 provided below clearly depicts this.

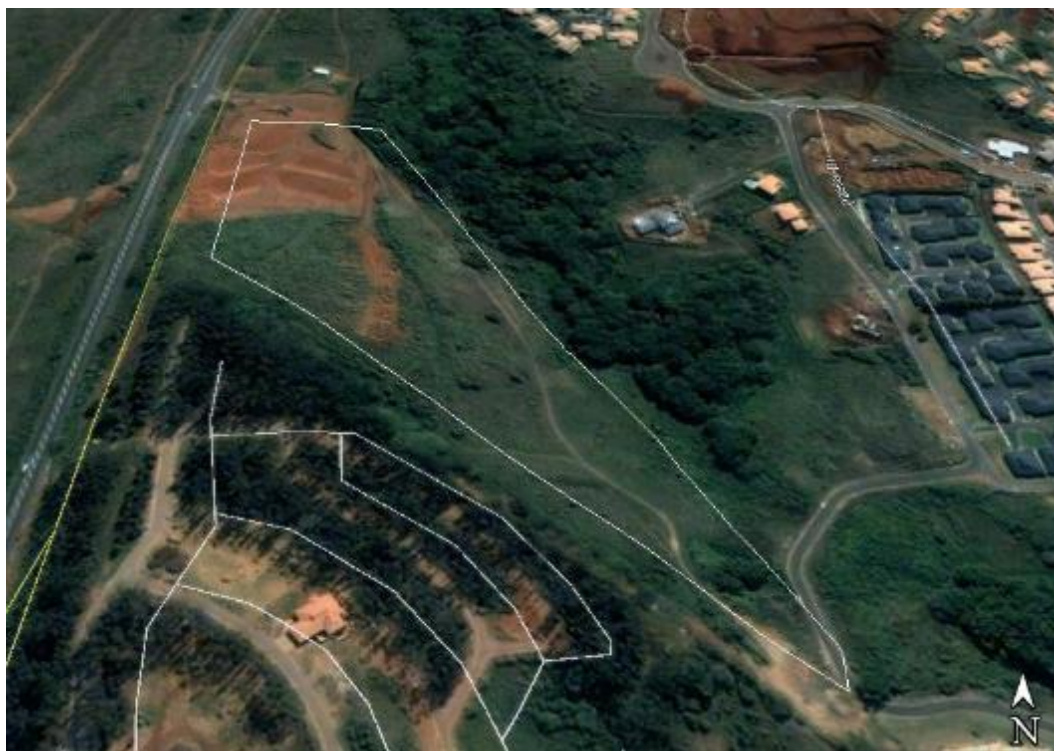
**Figure 4: 2006 Google Earth image of project site**

By 2006, sugar cane farming had stopped, and residential development had started in earnest in the surrounding area. In addition, the western end of the project area abutting the R627 road shows evidence of terracing (see **Figure 4** below) presumably for residential development (which did not take place) whilst the rest of the site reverted to a mixture of indigenous and alien vegetation.

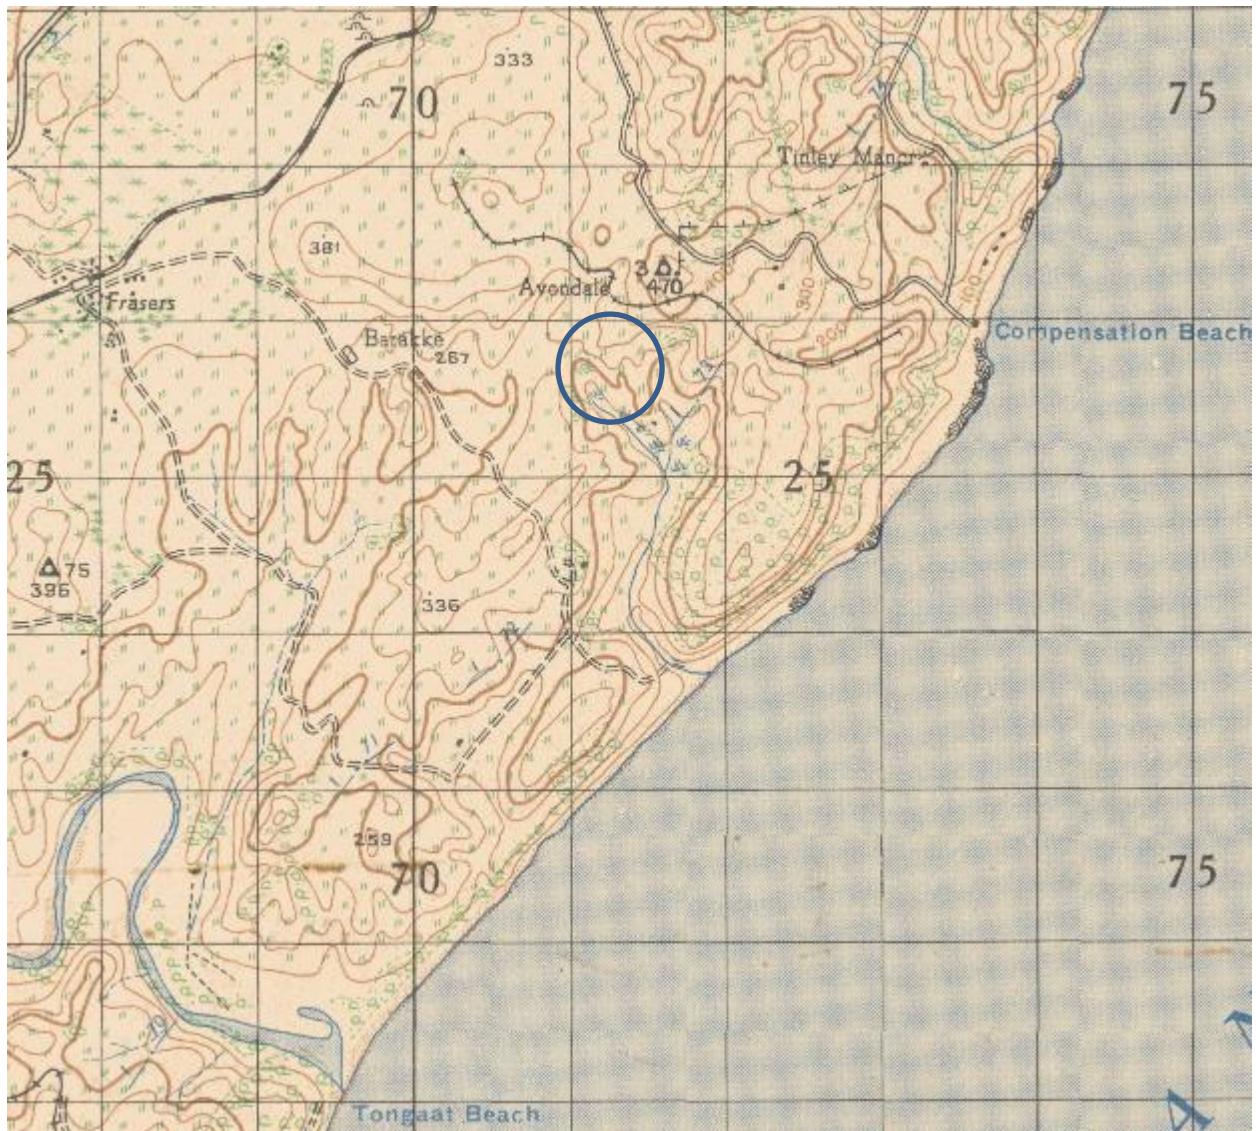
**Figure 5: 1942 topographical map (2931CA) with approximate position of site outlined in blue**

The 1942 1:50000 topographical map (below) of the area shows that the project site and surrounds was under cultivation interspersed with trees and bushes.

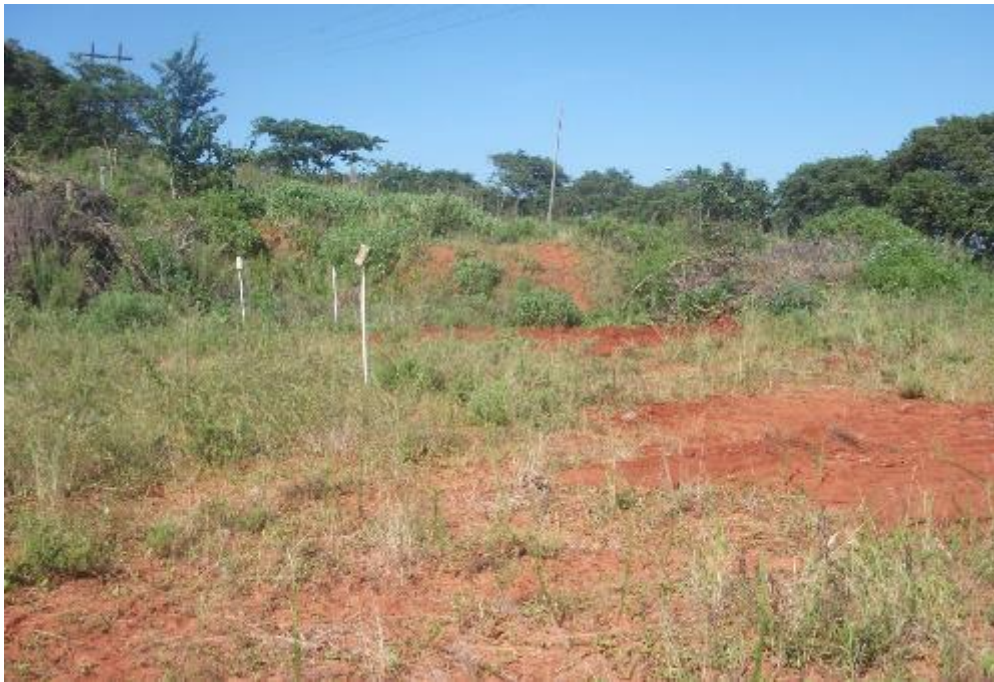
The project area nearest to the R627 was found to be disturbed by previous and current terracing of the site in preparation for development. This is understood to be Phase 1 of the proposed development. A few pathways had been cleared for access by prospective buyers. Vegetation was dense in uncleared areas. This area was inspected on foot and no heritage resources were found during the inspection including in the cleared areas.

**Figure 6: Terraced area in western half of project site**

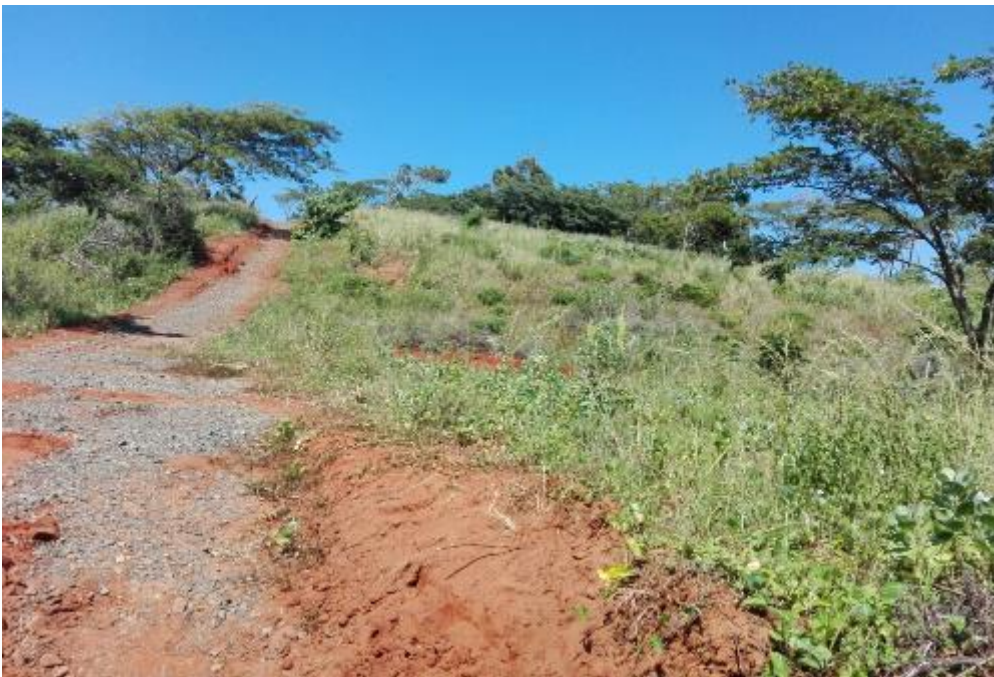
**Figure 7: Cleared pathways and vegetation on site**

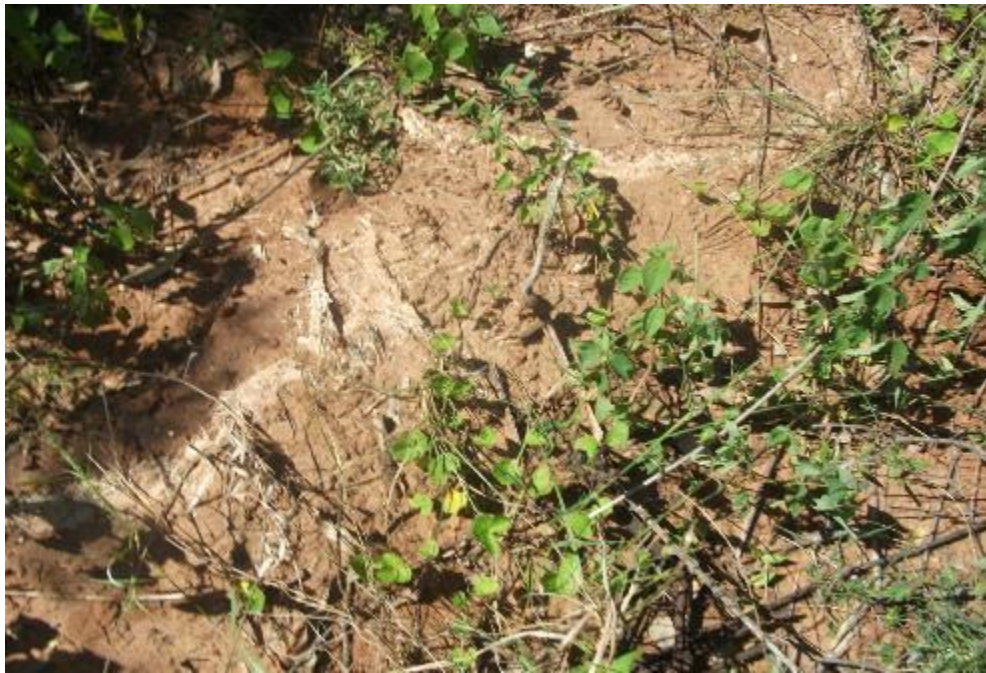
Remains of a section of bagging which was presumably used either for erosion control or for the terracing of the site in the early 2000s was found during the inspection as can be seen in **Figure 10** below.

**Figure 10: Remains of bagging used for terracing**

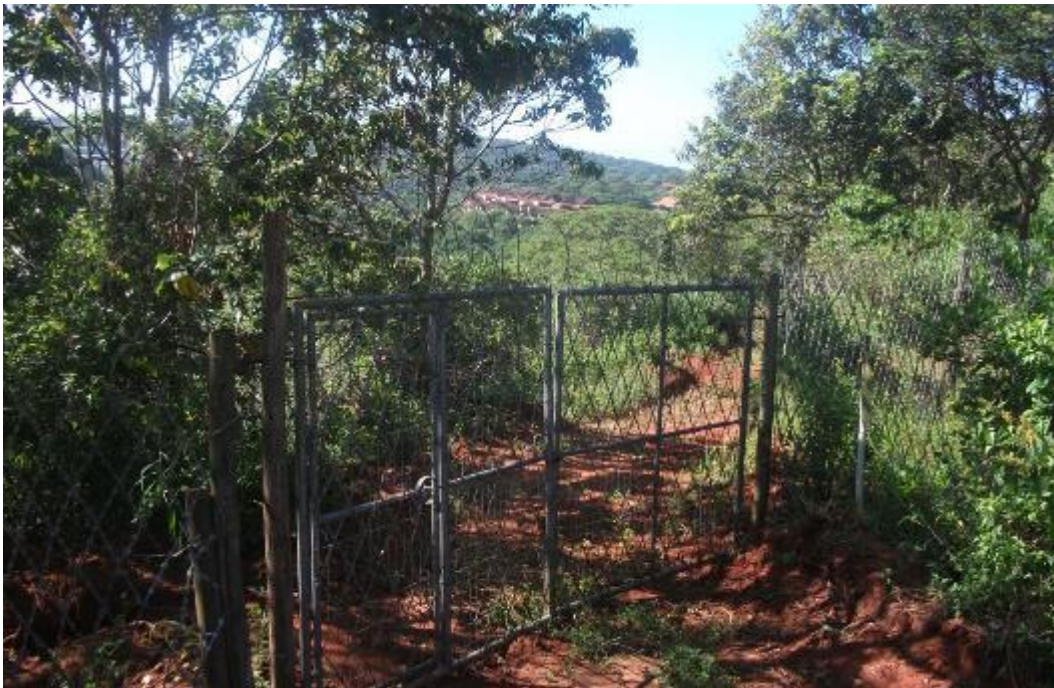
Phases 1 and 2 are separated by an existing security fence. The topography of the area south-east of the fence is steep and very overgrown with trees, bushes and undergrowth as it extends into the valley. Fortunately, there were cleared areas along the boundary fence lines of the project site that were used to access the site as well as existing pathways west of the drainage line on the north eastern side of the site. The path appears to have been part of walking route which possibly formed part of the Seaward Estate's Private Open Space system. Phase 2 of the development was inspected on foot and no heritage resources were found.

**Figure 11: Fencing separating Phases 1 and 2 of development**

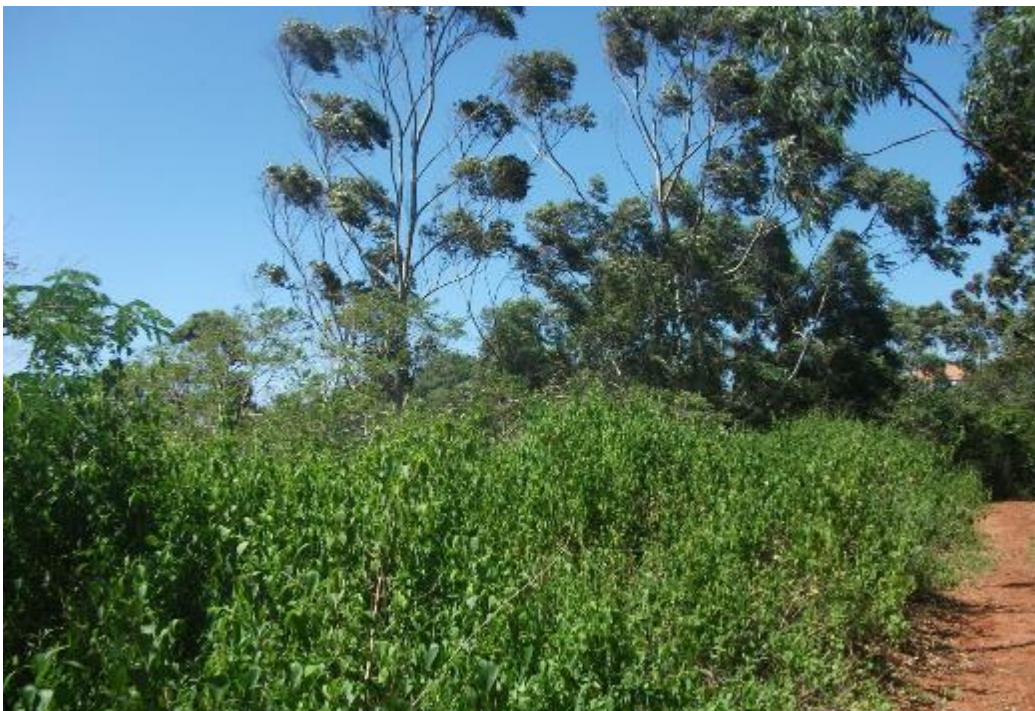
**Figure 13: Stand of gum trees**

Stands of gum trees occurring on the south-western boundary of the site were inspected but no heritage resources found. The specialist spoke to a security guard patrolling the fence line about potential heritage sites in the project site. The guard stated that he was unaware of any graves on the site.

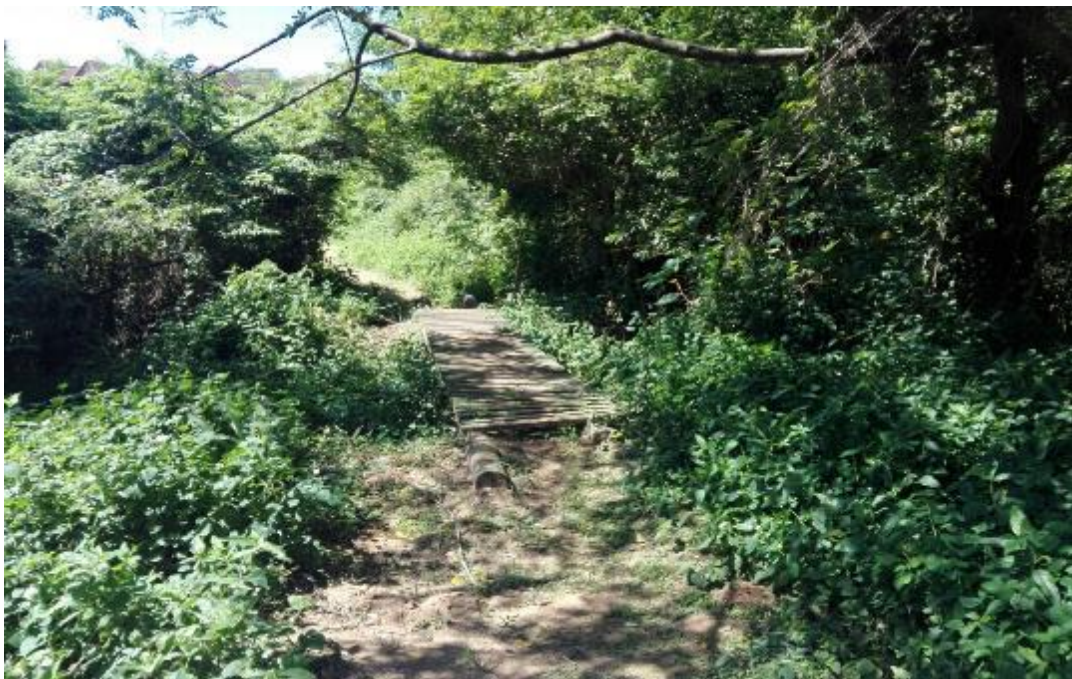
A wooden bridge located towards the eastern end of the project site was found that crosses the drainage line mentioned above (see **Figure 15** below).

**Figure 15: Wooden bridge over drainage line**
