**ZWELIBOMVU 2 RESERVOIR INLET PROJECT,
ETHEKWINI MUNICIPALITY, KWAZULU-NATAL**

Phase 1 Heritage Impact Assessment

28 June 2019

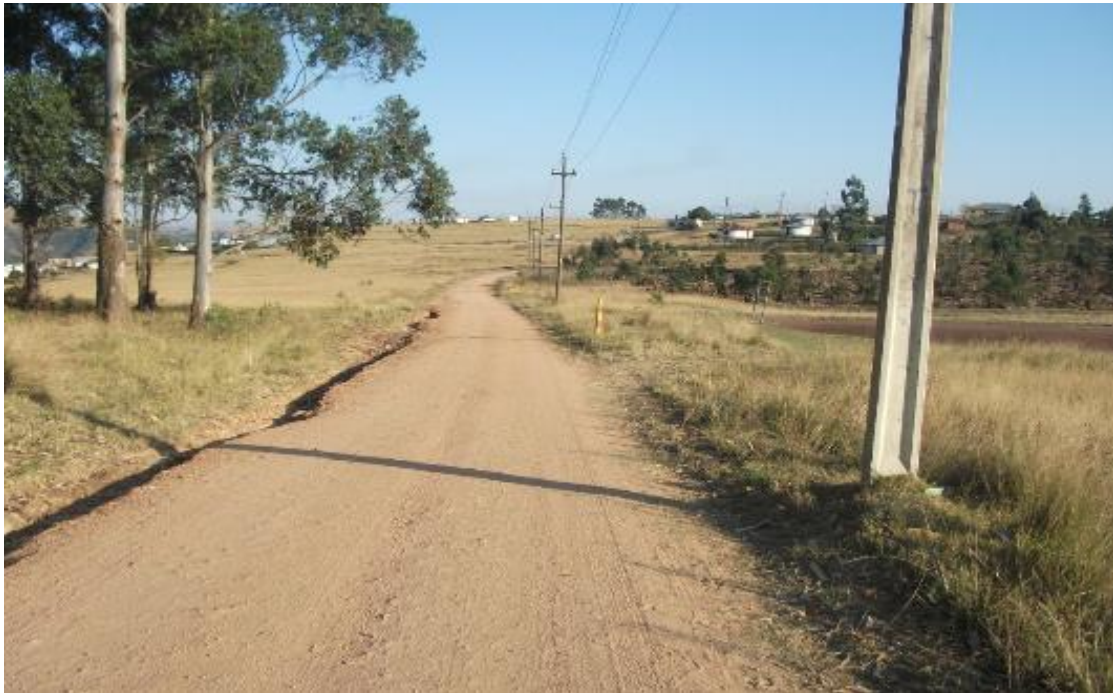
Figure 2: View along road and pipeline route

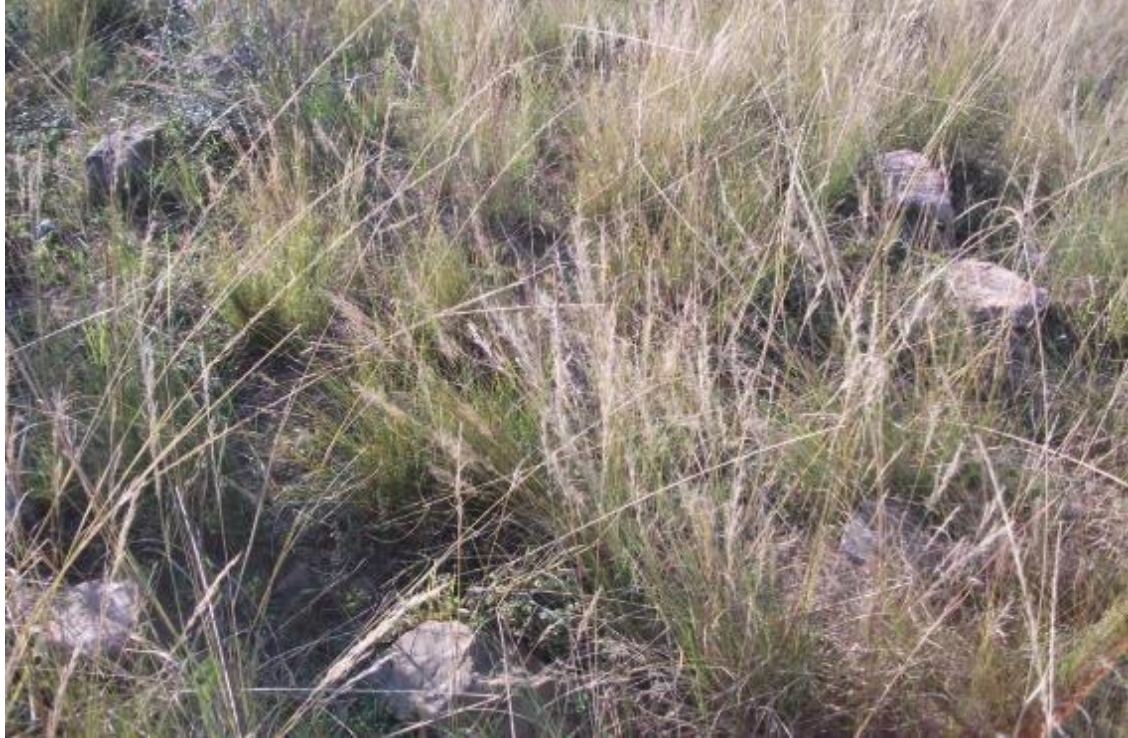
Residents pointed out several graves that are situated near the replacement pipeline route between the Zwelibomvu 2 Reservoir and edge of the valley. One of the grave sites was found along an old vehicle track which was, according to residents, moved to the current road in order to avoid the graves.

Figure 4: Rock outline of grave/s

COORDINATES	HERITAGE RESOURCE	PROXIMITY TO PIPELINE; MITIGATION MEASURES
29°53'15.1"S 30°42'29.7"E	± 6 graves	9m north east of pipeline; no construction within 5 m of graves, buffer to be demarcated with visible danger tape
29°52'25.0"S 30°41'57.0"E	>2 graves in old road track (Figure 4)	9m east of pipeline on other side of road; no mitigation necessary as long as pipeline is situated on the other side of the road
29°52'24.4"S 30°41'57.9"E	2 graves amongst bushes (Figure 5)	22m east of pipeline on other side of road; no mitigation necessary
29°52'23.1"S 30°41'58.0"E	>2 graves situated south of residence	10m east of pipeline on other side of road; no mitigation necessary as long as pipeline is situated on far side of road
29°50'21.4"S 30°40'33.3"E	Remains of old structure; use and age is unclear (Figure 6)	3m north-east of pipeline; avoid impacting on structure if possible. If impacted, then age and heritage significance must be determined prior to any action taking place.

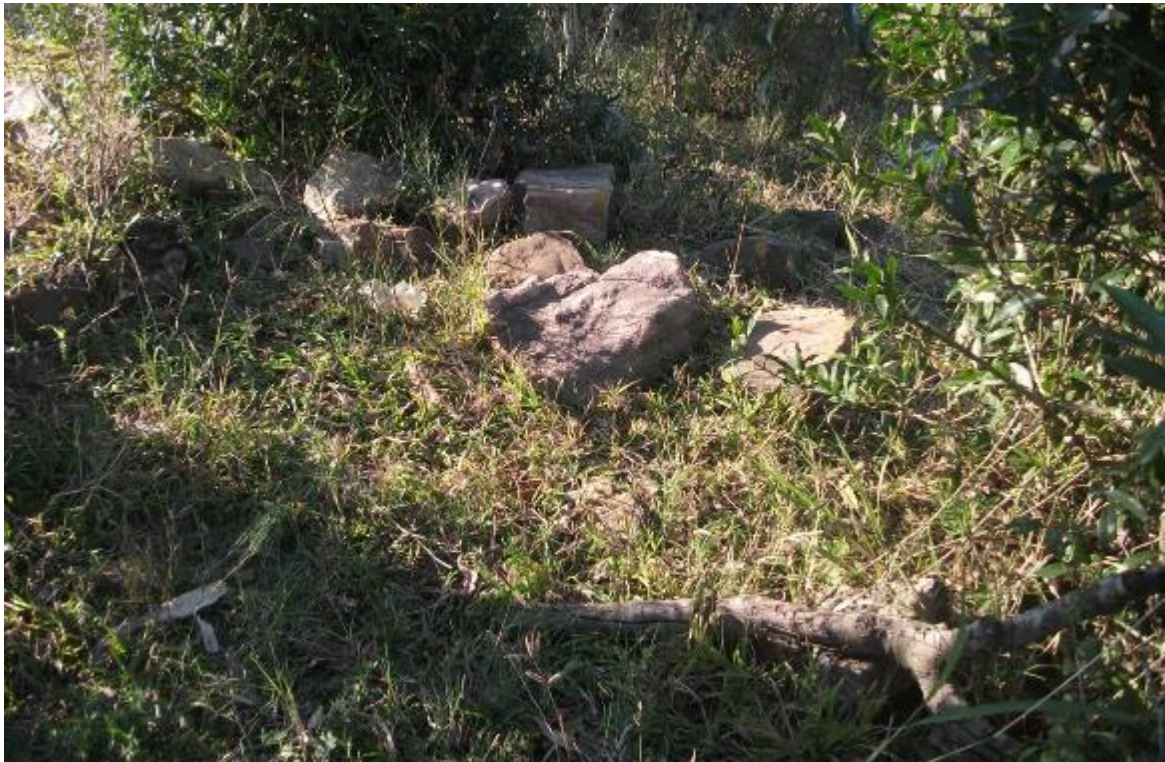
Figure 5: Graves amongst bushes

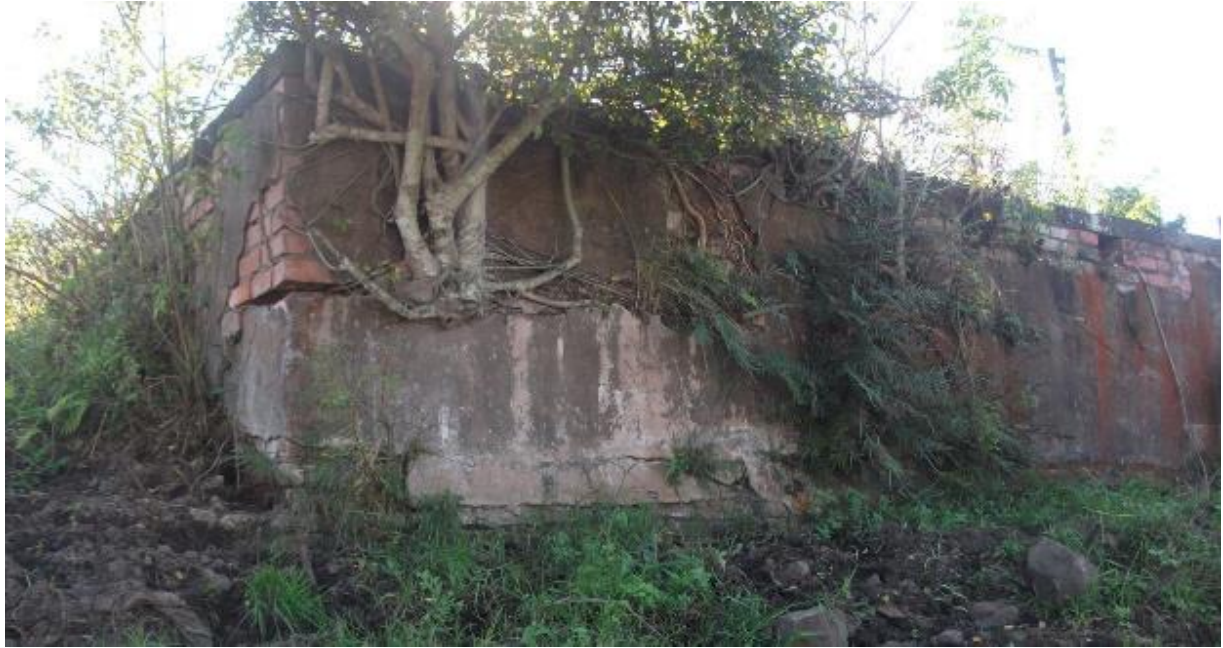
On the Shongweni Reservoir side of the valley, several heritage resources were found close to the pipeline route. The remains of a structure were found very close to the route along Wathanga Road (see **Figure 6** below). It is recommended that the pipeline avoid the structure as the age and use of the structure could not be determined. If it is to be impacted, then a built heritage specialist would need to be consulted to determine if the building is older than 60 years and if it is of any heritage significance.

**Figure 6: Remains of structure**

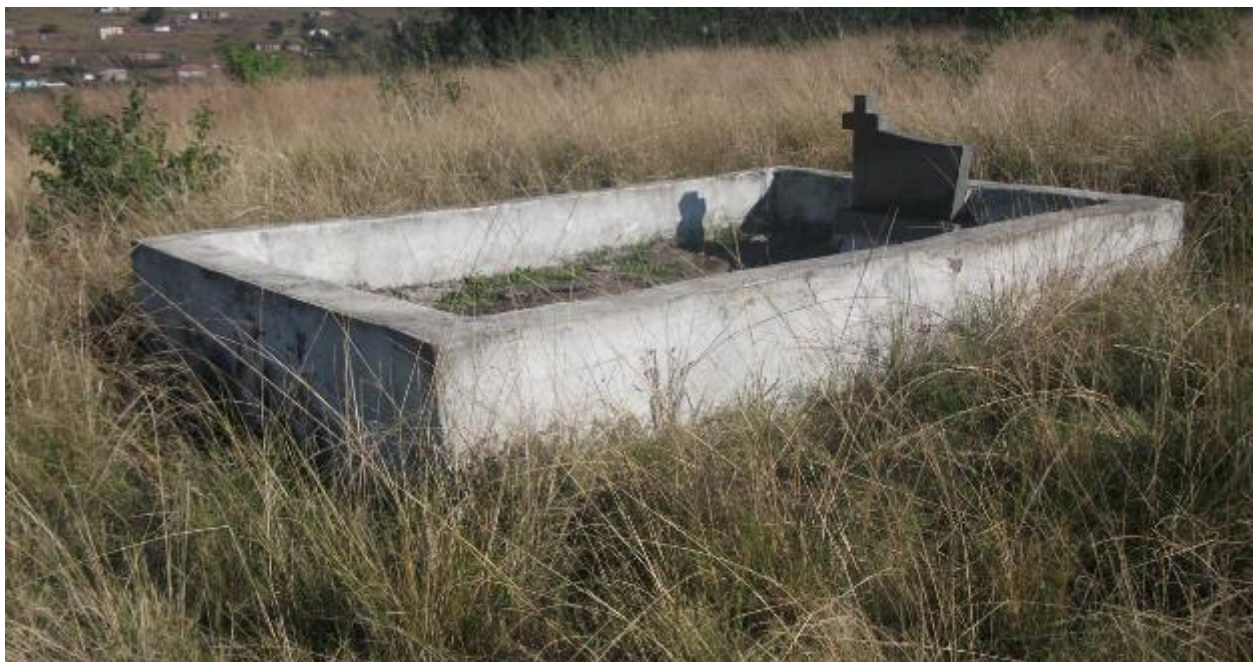
Several grave sites were found along Wathanga Road including a large burial site where at least 10 graves were found.

Figure 7: Single grave

29°50'31.9"S 30°40'48.3"E	Single grave (Figure 7)	11m south-west of pipeline; no mitigation necessary
29°50'31.8"S 30°40'49.4"E	>7 graves (Figures 8 and 9)	6 m north-east of pipeline. Ensure that pipeline alignment is within road reserve. Graves on same side of road as pipeline hence graves should be fenced with danger tape to avoid damage during laying of pipeline
29°50'33.4"S 30°40'51.8"E 29°50'33.7"S 30°40'52.4"E	±10 graves	6m north-east of edge of pipeline; site should be demarcated by danger tape to prevent damage to the graves
29°50'33.9"S 30°40'52.9"E	1 grave	10m east of pipeline, could be part of large burial site referred to above; no mitigation necessary
29°50'38.4"S 30°40'54.3"E	Remains of structure; no graves found in vicinity of remains	3m north-west of pipeline; appears to be a recent structure; no mitigation measures necessary as it is of no heritage significance
29°50'47.7"S 30°40'55.4"E	Grave/s situated above road on cutting	5m north-east of pipeline; ensure that laying of pipeline does not lead to collapse of side of cutting above which the grave/s are located

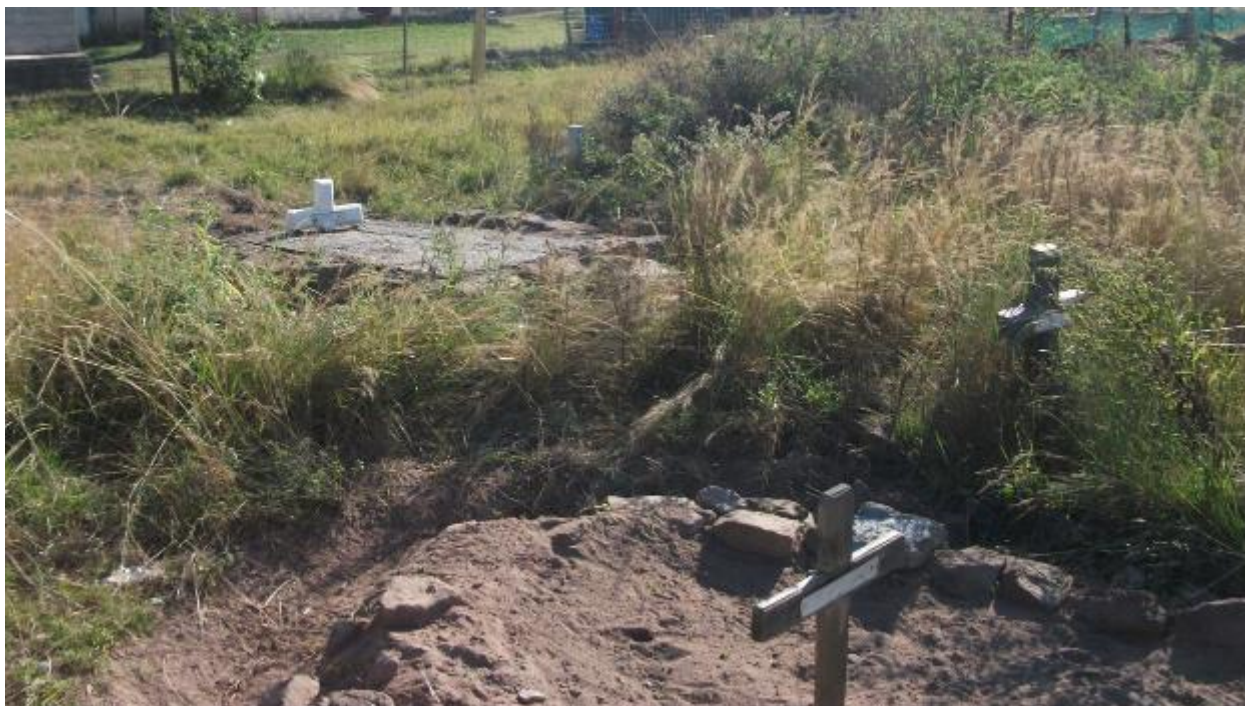
Figure 8: Several graves in one area

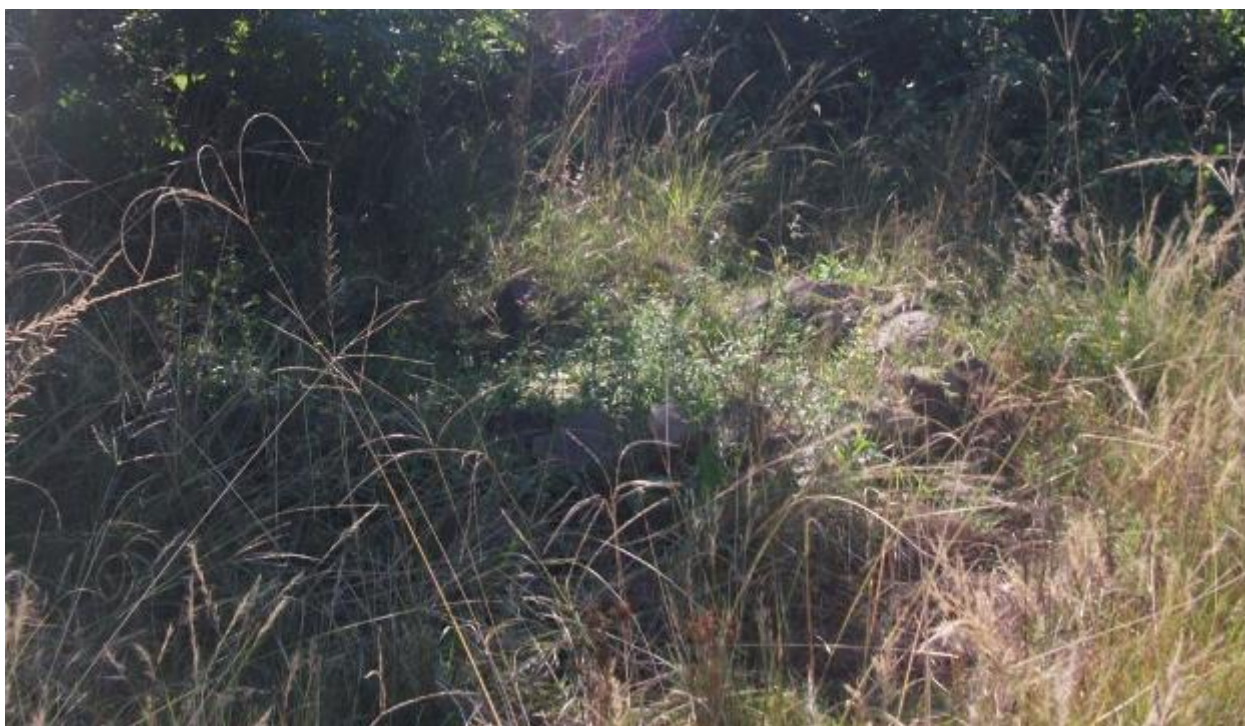
Figure 9: Outline of grave amongst bushes

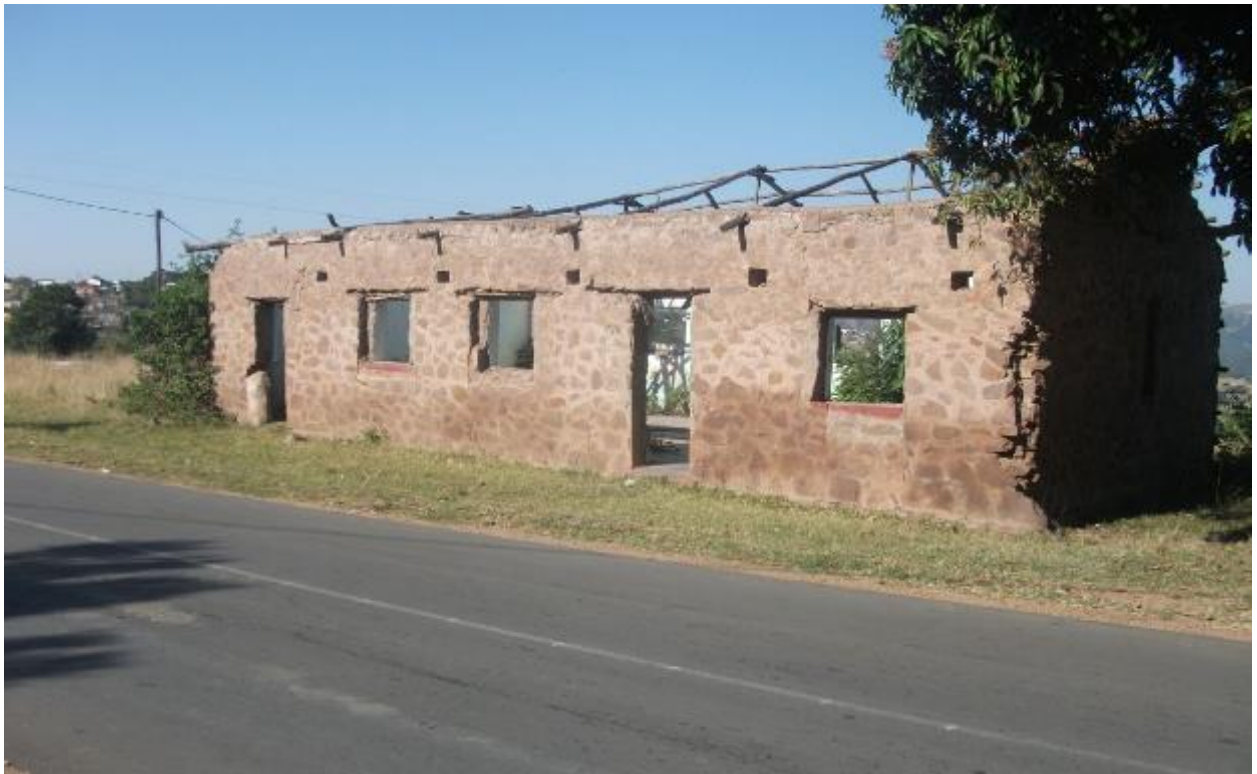
Figure 10: Abandoned structure

The age of the abandoned structure shown below in **Figure 10** is unknown. It is recommended that the pipeline be placed on the opposite of the road so that the structure is not impacted by the pipeline.

29°50'49.6"S 30°40'58.6"E	Abandoned structure; age could not be determined (Figure 9)	6m south of pipeline; ensure laying of pipeline does not impact on structure
29°51'06.5"S 30°41'16.3"E	Several groups of fenced graves in open area	16m north-west of pipeline; no mitigation necessary
29°51'35.2"S 30°41'20.5"E	Many graves within homestead (Figure 10)	9m west of pipeline; no mitigation necessary as long as pipeline remains in road reserve and on other side of road

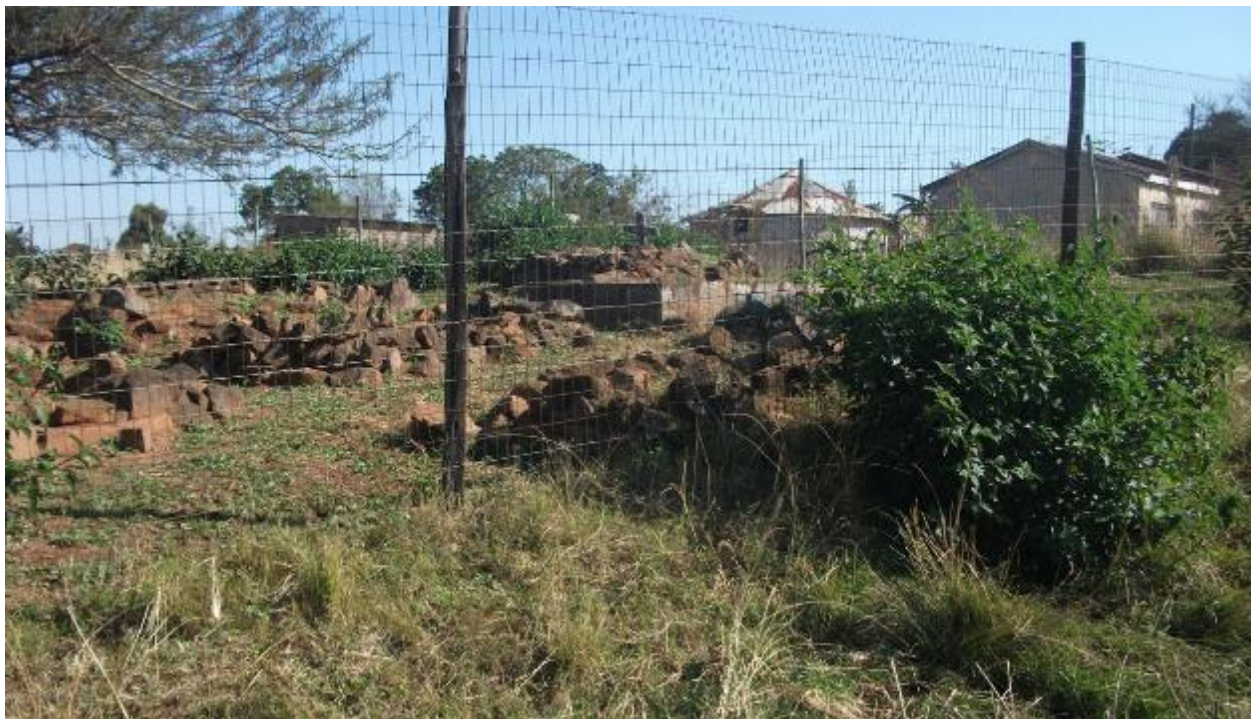
Figure 11: Graves within boundary of homestead
