3.6.11. ORWRDP II Proposed Borrow Pit 11

4. SURVEY METHODOLOGY

5. DESCRIPTION OF SITES

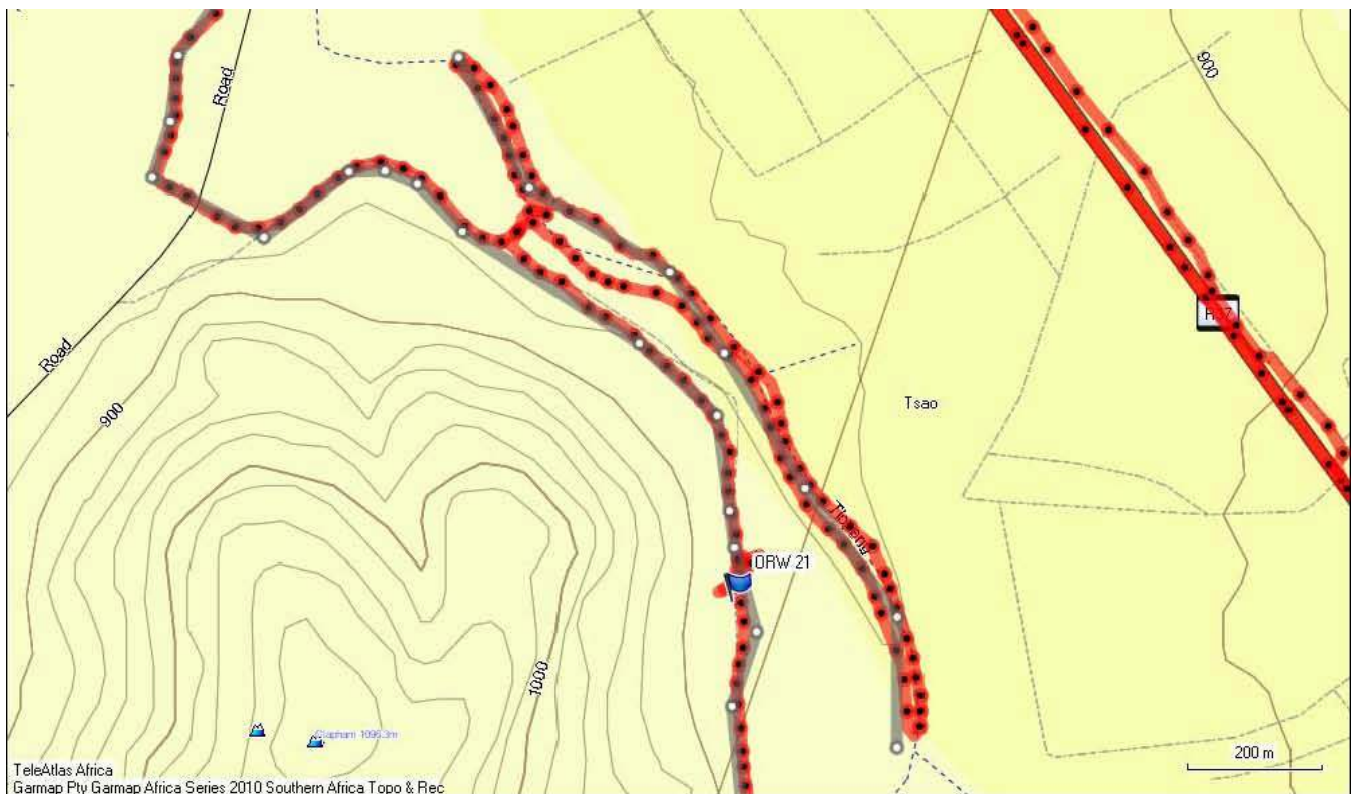
Figure 27. Transect log plot indicating the survey.

The area surveyed corresponds directly with the indicated proposed borrow pit area. Refer Figure 27 for a transect log plot indicating the survey.

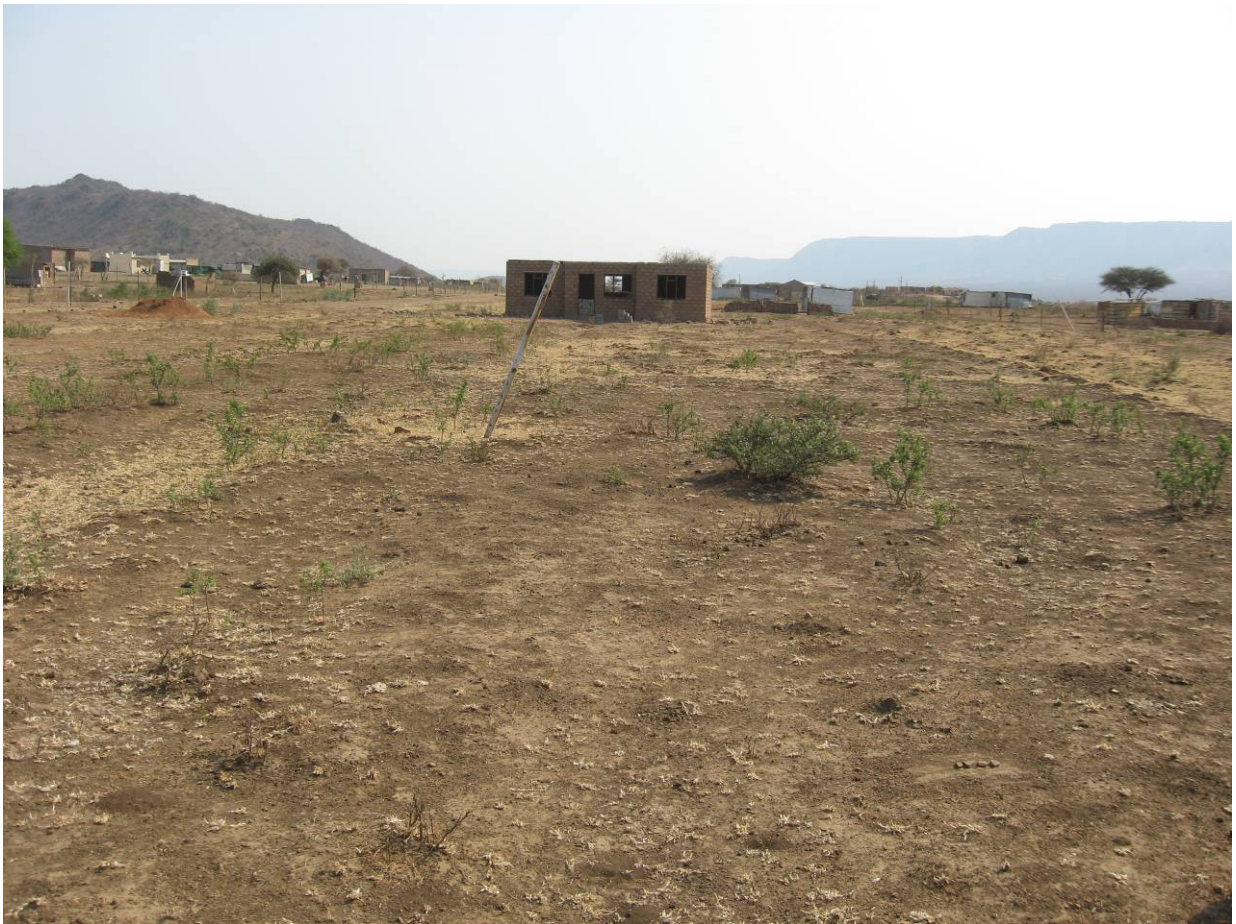
Figure 29. Site ORW 1.

- Potshard scatter

- Late Iron Age

- Disturbed

- Approximately 30m in diameter, no directional alignment.

- Surface scatter only, no associated deposits

- Due to disturbed context and non-diagnostic ceramics the site has no heritage value.

- Generally Protected C (Field Rating IV C): this site has been sufficiently recorded (in the Phase 1). It requires no further recording before destruction (generally Low significance).

- None

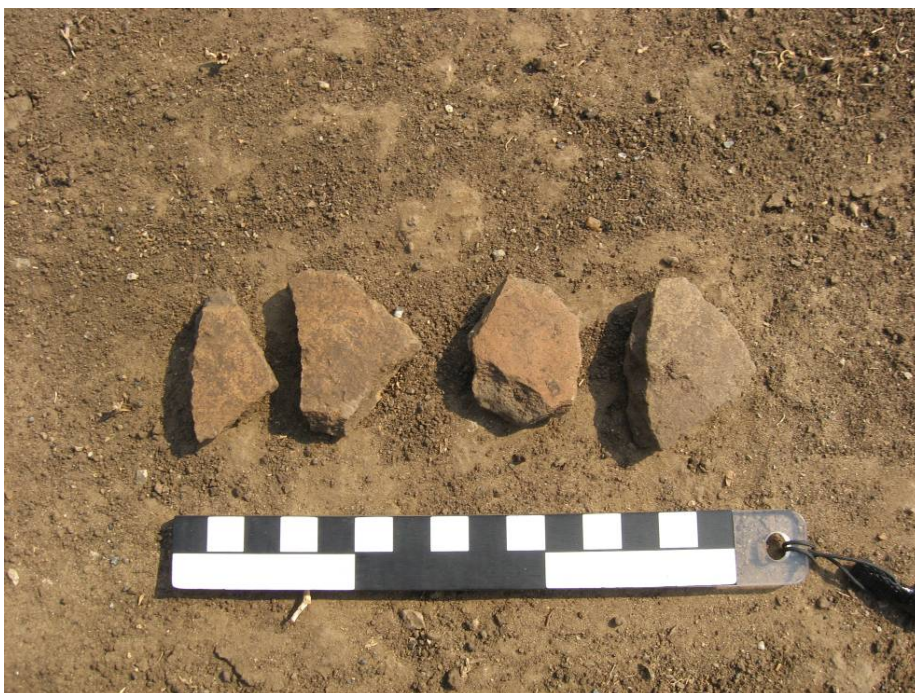
Figure 30. Artifacts at Site ORW 1.

- Non diagnostic potsherds were found at the site (Fig. 30).

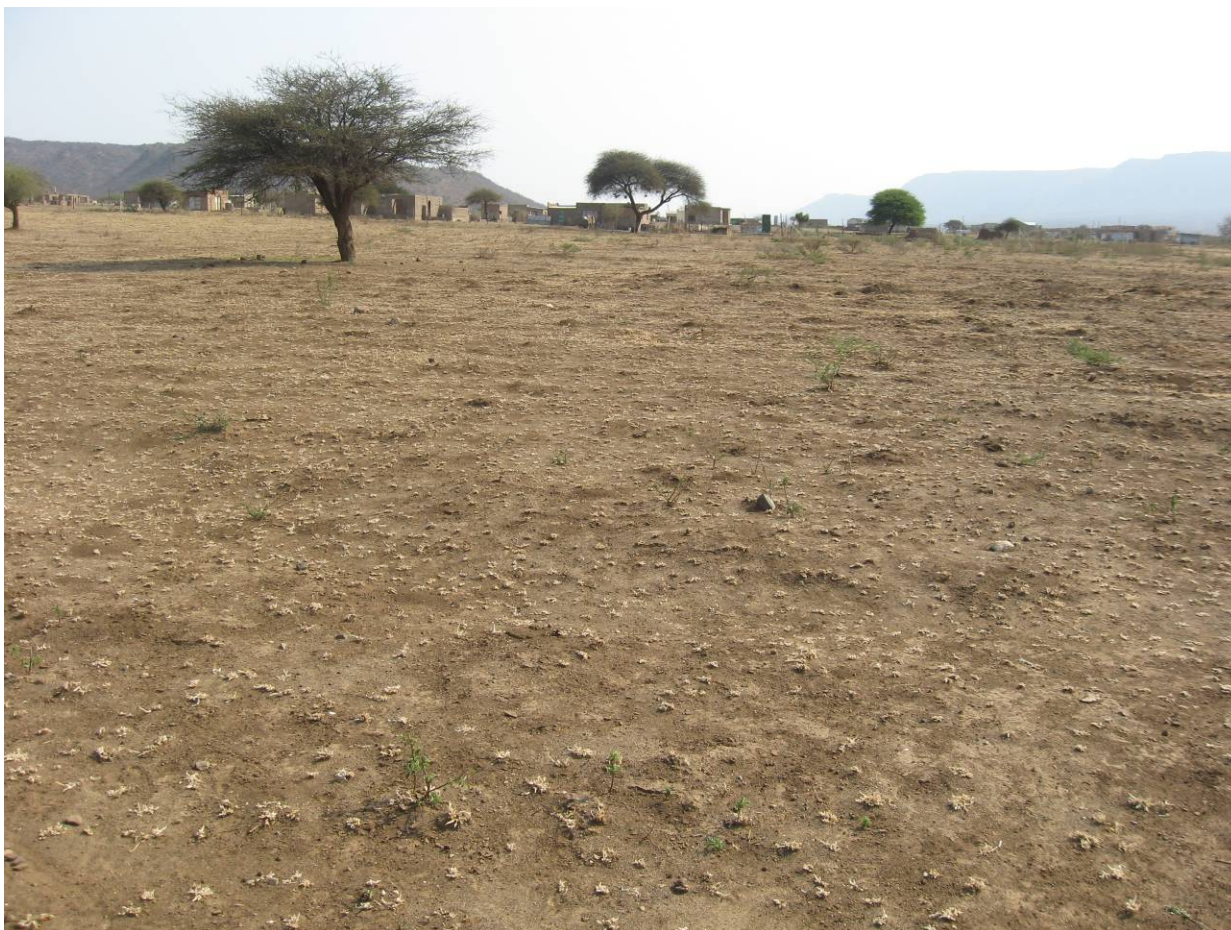
Figure 32. Site ORW 2.

- Potshard scatter.

- Late Iron Age

- Disturbed.

- Approximately 30m in diameter.

- Surface occurrence only, no evidence for any deposits.

- Due to disturbed context and non-diagnostic ceramics the site has no heritage value.

- Generally Protected C (Field Rating IV C): this site has been sufficiently recorded (in the Phase 1). It requires no further recording before destruction (generally Low significance).

- None

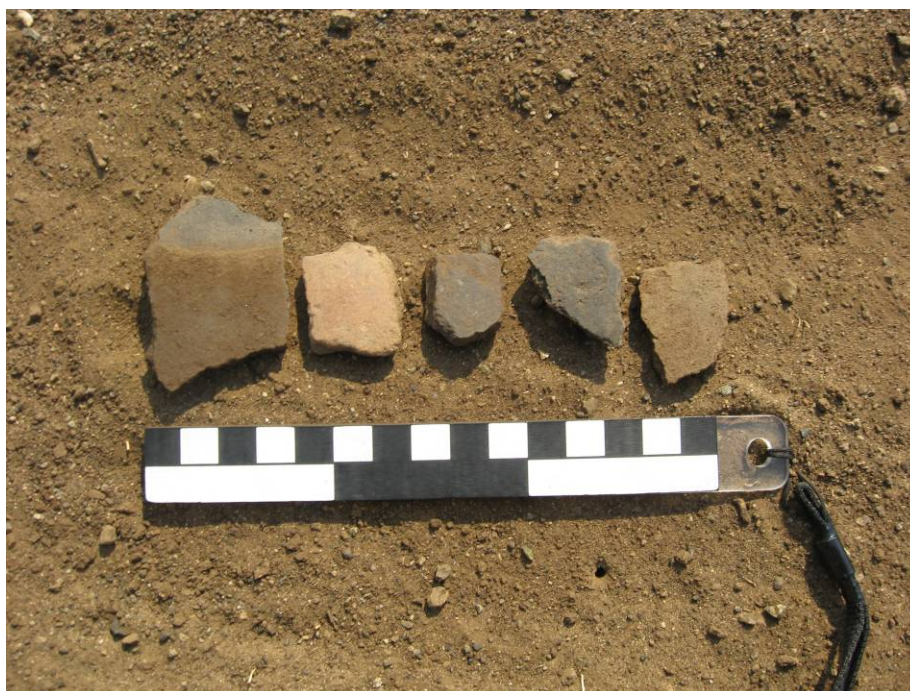
Figure 33. Artifacts at Site ORW 2.

- Non-diagnostic potsherds were found at the site (Fig. 33).

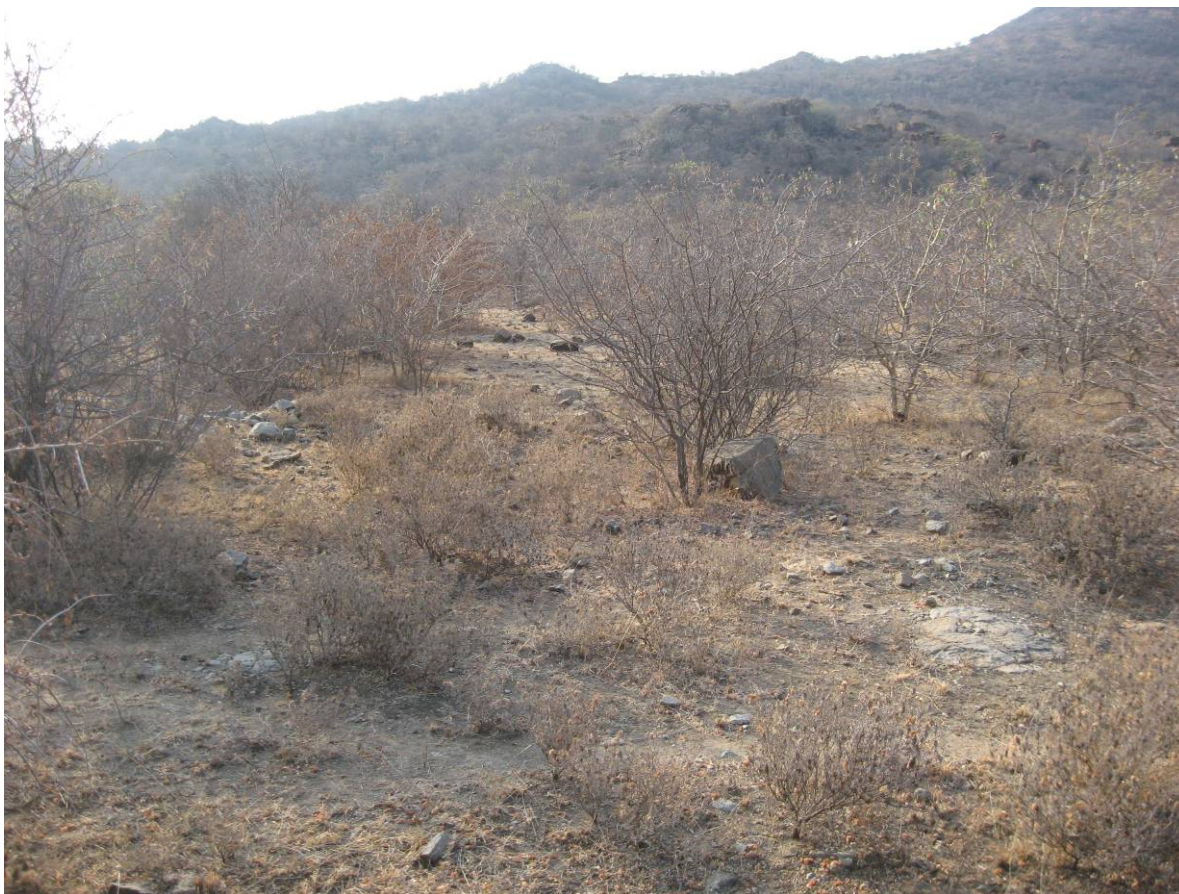
Figure 34. Site ORW 4.

- Potshard scatter.

- Late Iron Age.

- Primary but severely weathered.

- Low density scatter over an area of approximately 30m in circumference.

- Surface indications only, no indications of deposits of any depth.

- Due to disturbed context and non-diagnostic ceramics the site has no heritage value.

- Generally Protected C (Field Rating IV C): this site has been sufficiently recorded (in the Phase 1). It requires no further recording before destruction (generally Low significance).

- None

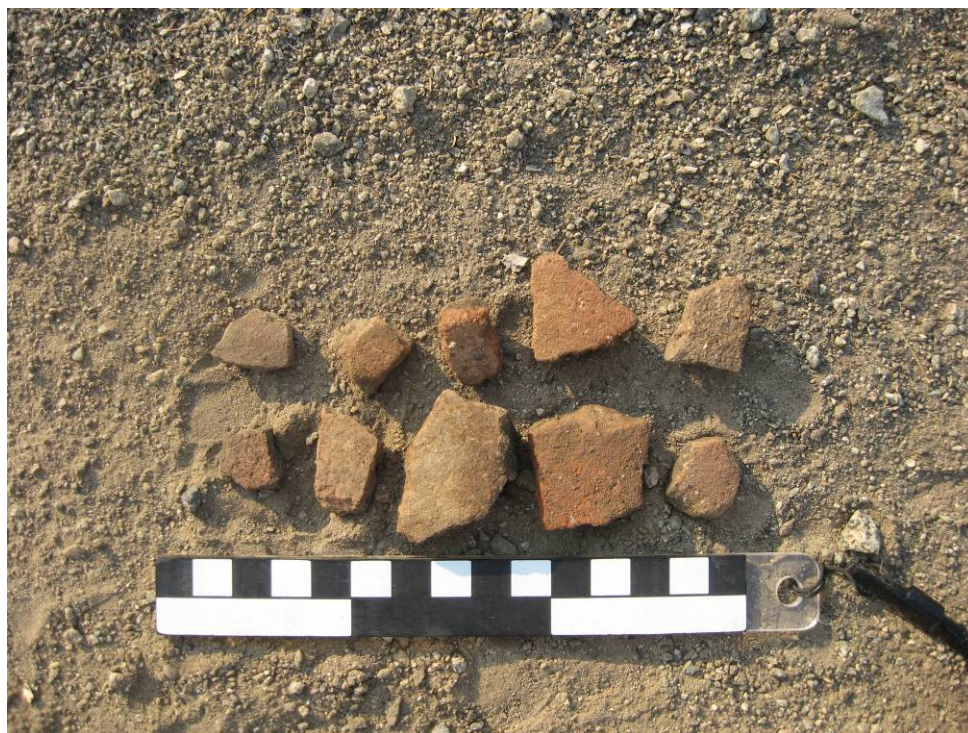
Figure 35. Artefacts at site ORW4.

- Non-diagnostic ceramics (Fig. 35).

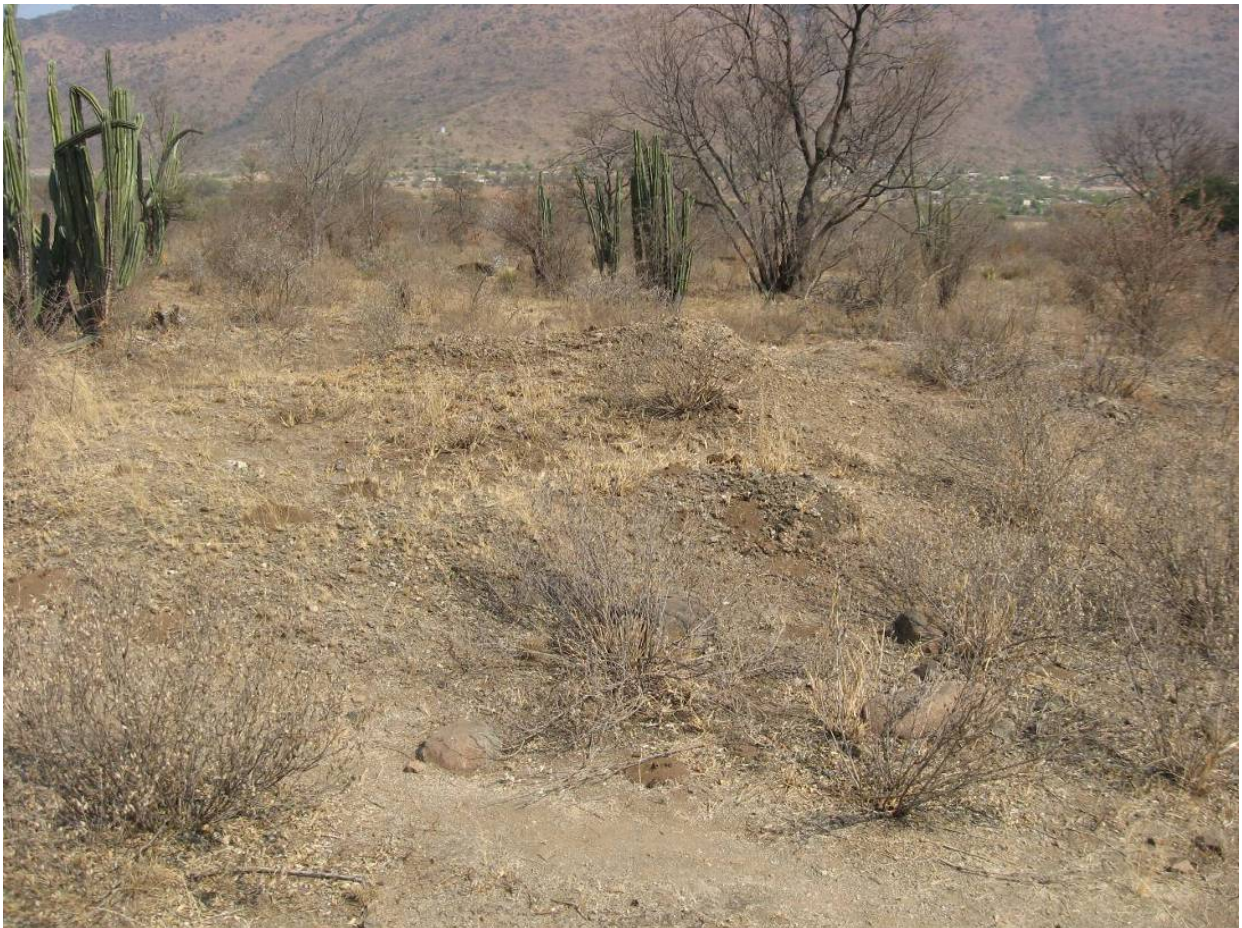
Figure 37. General photograph of Site ORW 5.

The remains and the foundations of a cluster of dilapidated structures were identified at this location. The remains consisted basically of packed lines of rocks which were used in the foundations of these structures on which mud-brick walls were built. These structures were predominantly square or rectangular in shape and the rooms measured approximately 5m x 5m. A few metal artefacts such as wire and cans were observed amongst the remains of the structures.

- Recent modern.

- In total an area of approximately 40x40m is covered by the ruined homestead.

- Single phase habitation with very sub-surface features.

Through experience of similar sites and a knowledge of cultural customs and traditions it is known that stillborn babies and deceased infants occasionally were being buried within the occupational settlement. These children were sometimes buried underneath the floors and walls of houses and huts. These burials were not marked, but were known to the immediate family.

Customs and traditions like these were common in the rural African communities even up to the later parts of the 20th century. It is therefore not only possible, but rather likely that some of these structures may be on top of some of these infant remains.

Significance: Moderate significance. The structures themselves have little or no heritage value or significance due to their relevant recent origins from within the last 60 years. The structures, however should be avoided, but if this deems not to be possible, a watching brief is recommended due to the possibility of infant human remains underneath the remains of the structures.

- Generally Protected A (Field Rating IV A): this site should be mitigated before destruction (generally High/Medium significance);

- If the structures can not be avoided during construction a suitably accredited archaeologist should be present when they are destroyed to ensure that no human remains are inadvertently discovered.

- Appoint a suitably accredited archaeologist on a watching brief to monitor construction activities.

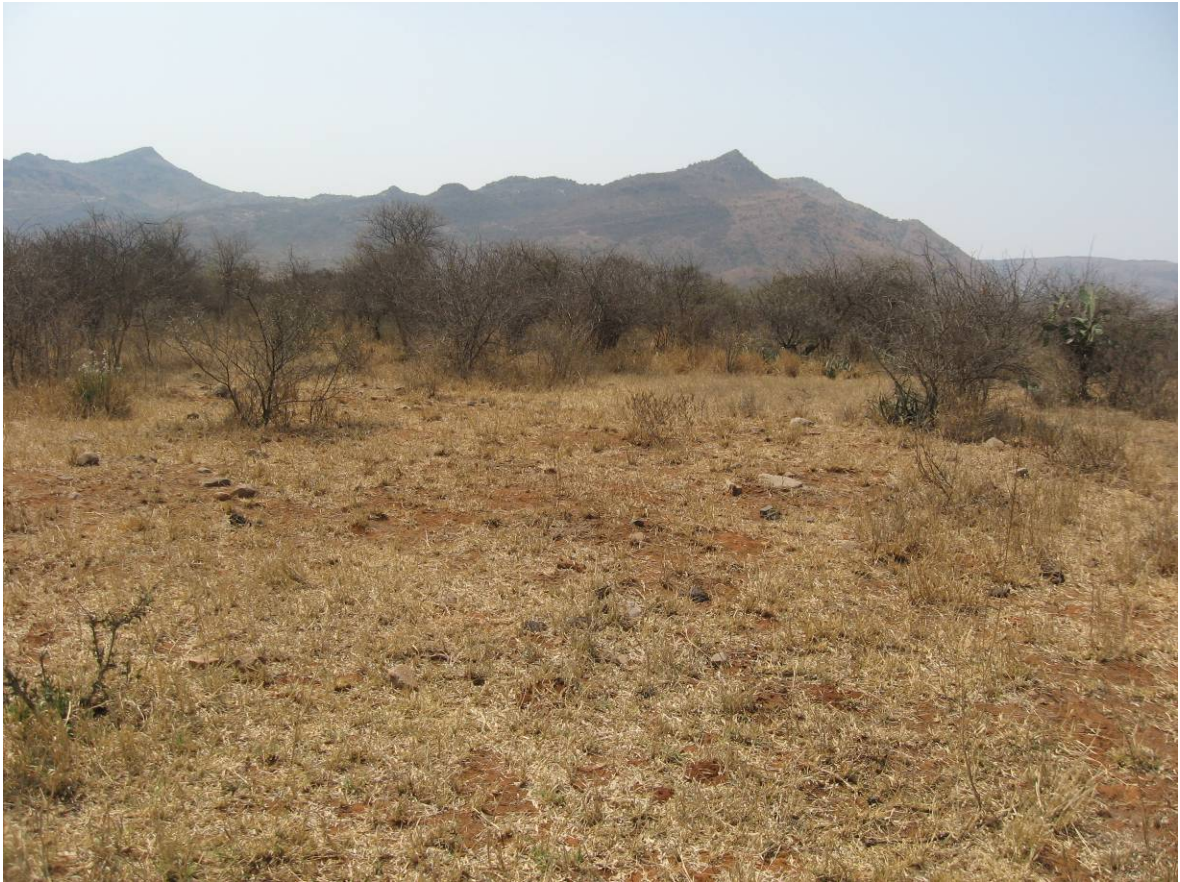
Figure 39. Site ORW 10.

- Potshard scatter

- Late Iron Age

- Disturbed

- Approximately 80m in diameter, no directional alignment.

- Due to the disturbance by previous ploughing the sub-terranean features of the site has been destroyed. Some indications of possible grain bin foundations and habitational structures were observed, but none are intact.

- Due to disturbed context and non-diagnostic ceramics the site has no heritage value.

- Generally Protected C (Field Rating IV C): this site has been sufficiently recorded (in the Phase 1). It requires no further recording before destruction (generally Low significance).

- None

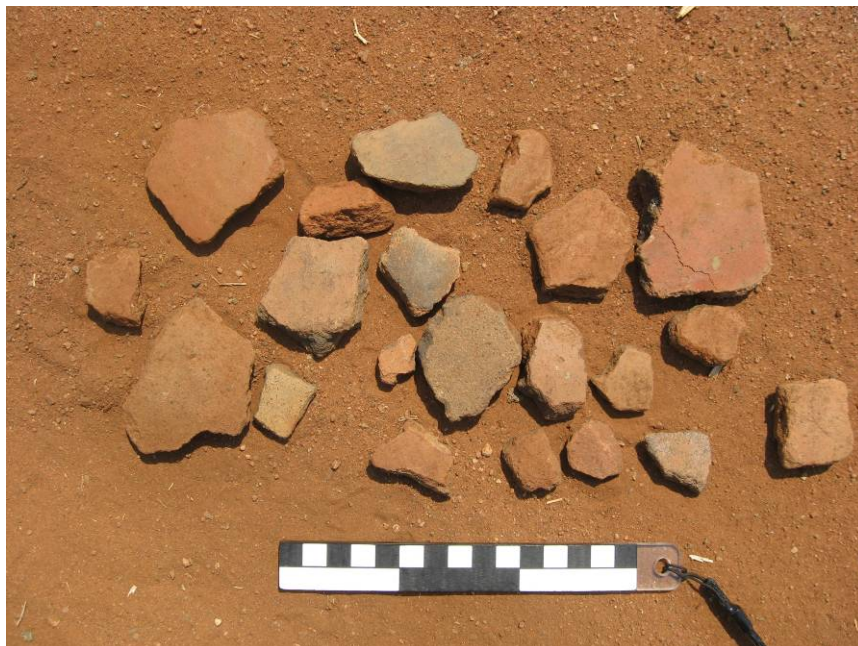
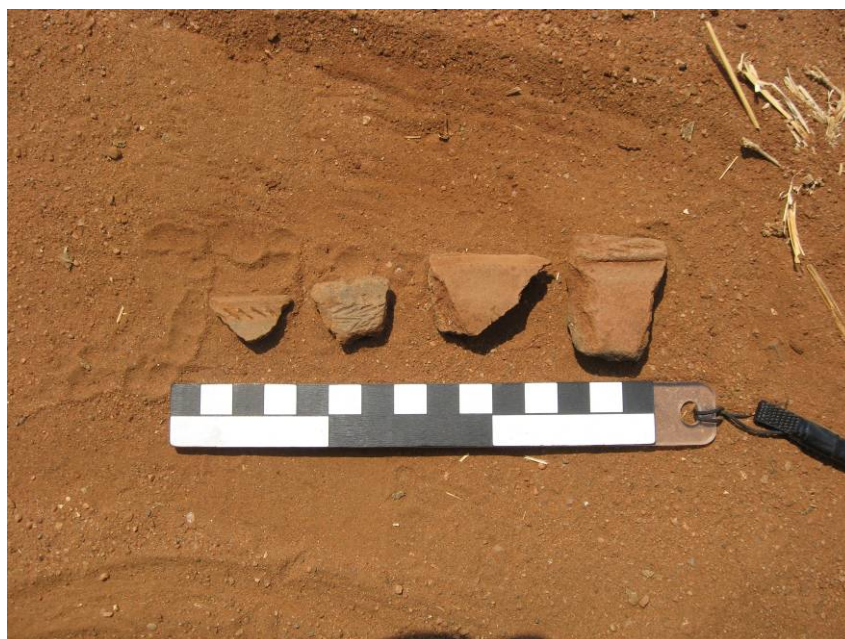
- Non- diagnostic potsherds were found at the site (Fig. 40). Although some fragments showed possible decoration, this was not sufficient to ascribe the site to a particular ceramic facies or tradition.

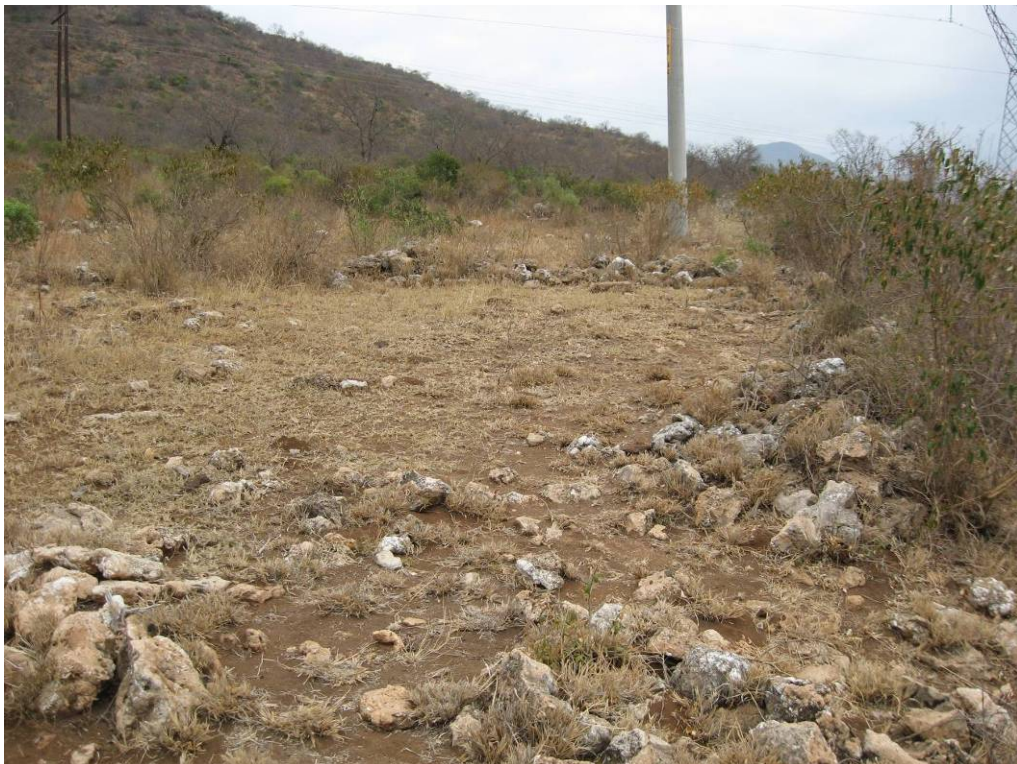
Figure 41. General photograph of Site ORW 11.

The remains and the foundations of a cluster of dilapidated structures were identified at this location. The remains consisted basically of packed lines of rocks which were used in the foundations of these structures on which mud-brick walls were built. These structures were predominantly square or rectangular in shape and the rooms measured approximately 5m x 5m. A few metal artefacts such as wire and cans were observed amongst the remains of the structures.

- Recent modern.

- In total an area of approximately 50 m in diameter is covered by the ruined homestead.

- Single phase habitation with very sub-surface features.

Significance: Moderate significance. The structures themselves have little or no heritage value or significance due to their relevant recent origins from within the last 60 years. The structures, however should be avoided, but if this deems not to be possible, a watching brief is recommended due to the possibility of infant human remains underneath the remains of the structures.

- For human remains inadvertently discovered in other situations, the legal requirement is that all activities affecting the burial must be stopped and that the discovery must be reported to the SAPS and SAHRA. The status of the remains is then ascertained. If it is found to be forensic in nature (nominally younger than 60 years and perceived to be the victim of crime or a person that have died of unnatural causes) recovery by the Provincial Forensic Pathology Services in conjunction with the SAPS is mandated. If the remains are of cultural, historical or archaeological origin recovery is usually facilitated by SAHRA by means of a Rescue Permit.

- Appoint a suitably accredited archaeologist on a watching brief to monitor construction activities.

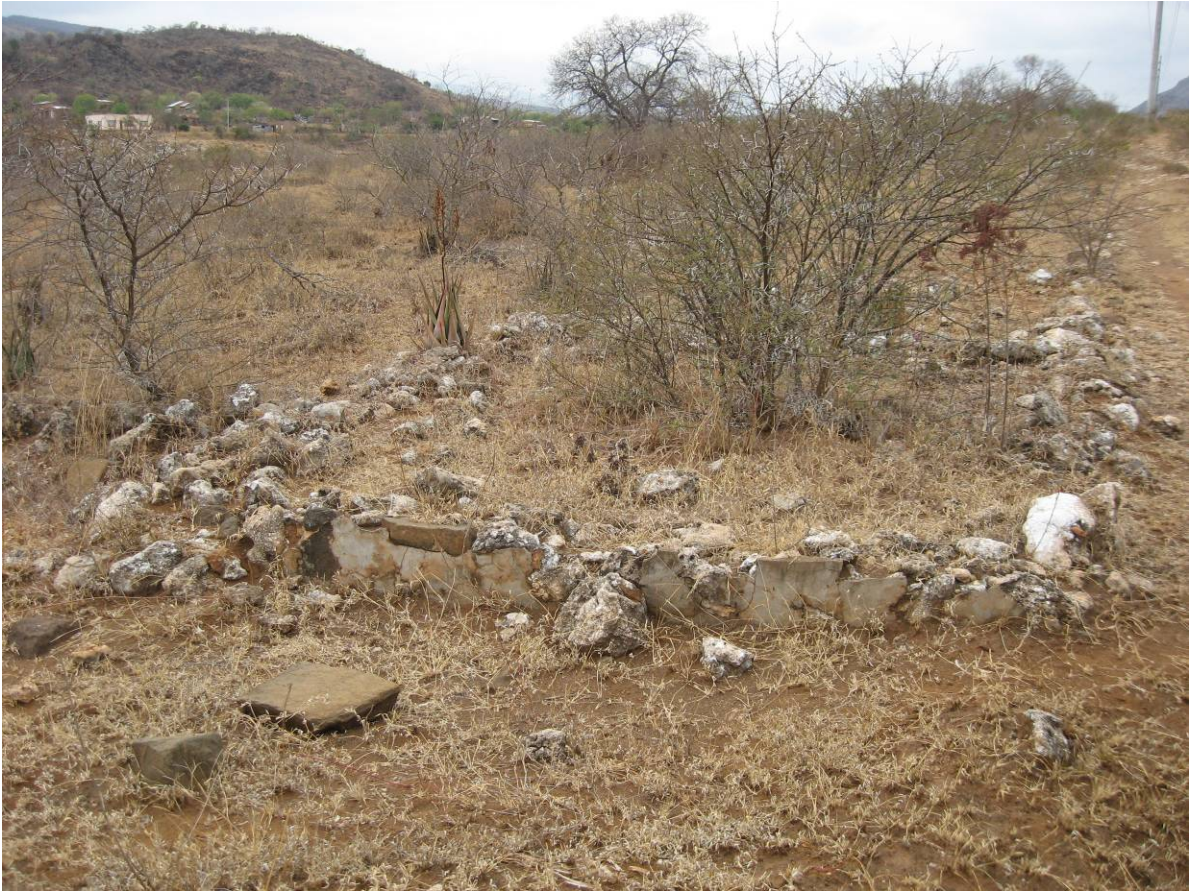
Figure 43. General photograph of Site ORW 12.

The remains and the foundations of a cluster of dilapidated structures were identified at this location. The remains consisted basically of packed lines of rocks which were used in the foundations of these structures on which mud-brick walls were built. These structures were predominantly square or rectangular in shape and the rooms measured approximately 5m x 5m. A few metal artefacts such as wire and cans were observed amongst the remains of the structures.

Significance: Moderate significance. The structures themselves have little or no heritage value or significance due to their relevant recent origins from within the last 60 years. The structures, however should be avoided, but if this deems not to be possible, a watching brief is recommended due to the possibility of infant human remains underneath the remains of the structures.

- For human remains inadvertently discovered in other situations, the legal requirement is that all activities affecting the burial must be stopped and that the discovery must be reported to the SAPS and SAHRA. The status of the remains is then ascertained. If it is found to be forensic in nature (nominally younger than 60 years and perceived to be the victim of crime or a person that have died of unnatural causes) recovery by the Provincial Forensic Pathology Services in conjunction with the SAPS is mandated. If the remains are of cultural, historical or archaeological origin recovery is usually facilitated by SAHRA by means of a Rescue Permit.

- Appoint a suitably accredited archaeologist on a watching brief to monitor construction activities.

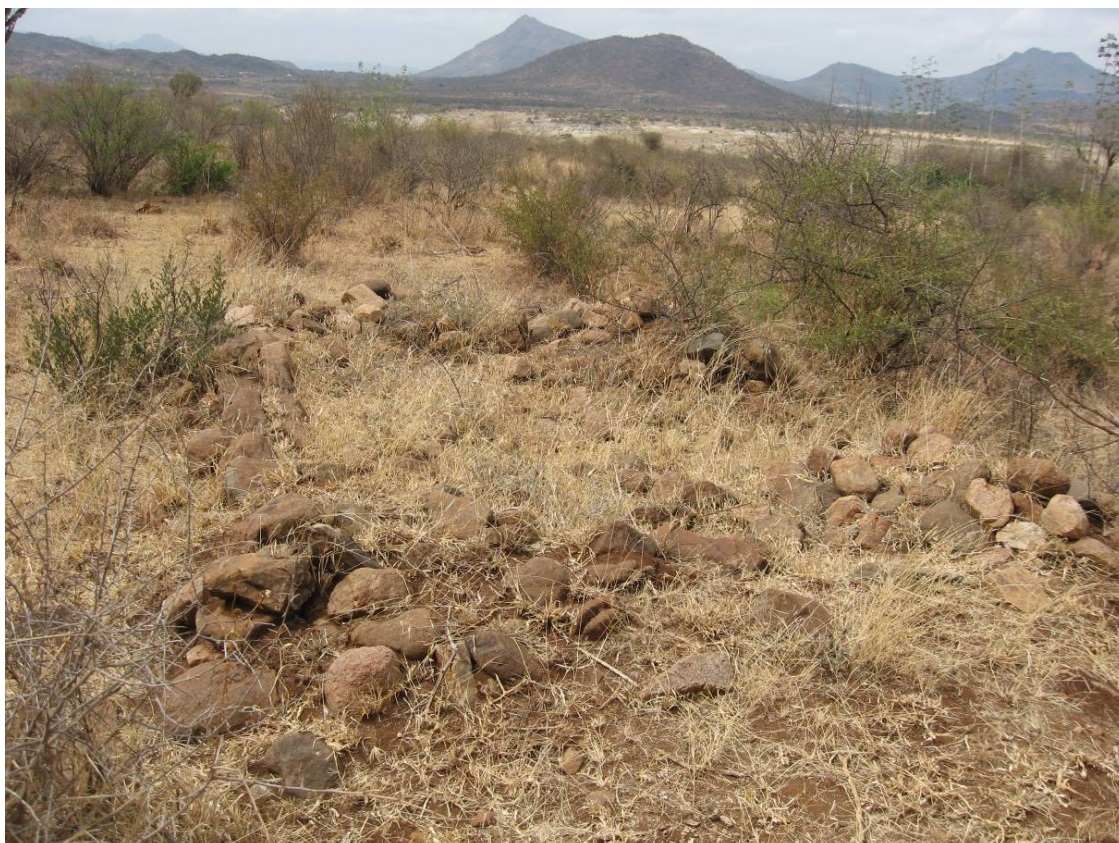
Figure 45. General photograph of Site ORW 14.

The remains and the foundations of a cluster of dilapidated structures were identified at this location. The remains consisted basically of packed lines of rocks which were used in the foundations of these structures on which mud-brick walls were built. These structures were predominantly square or rectangular in shape and the rooms measured approximately 5m x 5m. A few metal artefacts such as wire and cans were observed amongst the remains of the structures.

Significance: Moderate significance. The structures themselves have little or no heritage value or significance due to their relevant recent origins from within the last 60 years. The structures, however should be avoided, but if this deems not to be possible, a watching brief is recommended due to the possibility of infant human remains underneath the remains of the structures.

- For human remains inadvertently discovered in other situations, the legal requirement is that all activities affecting the burial must be stopped and that the discovery must be reported to the SAPS and SAHRA. The status of the remains is then ascertained. If it is found to be forensic in nature (nominally younger than 60 years and perceived to be the victim of crime or a person that have died of unnatural causes) recovery by the Provincial Forensic Pathology Services in conjunction with the SAPS is mandated. If the remains are of cultural, historical or archaeological origin recovery is usually facilitated by SAHRA by means of a Rescue Permit.

- Appoint a suitably accredited archaeologist on a watching brief to monitor construction activities.

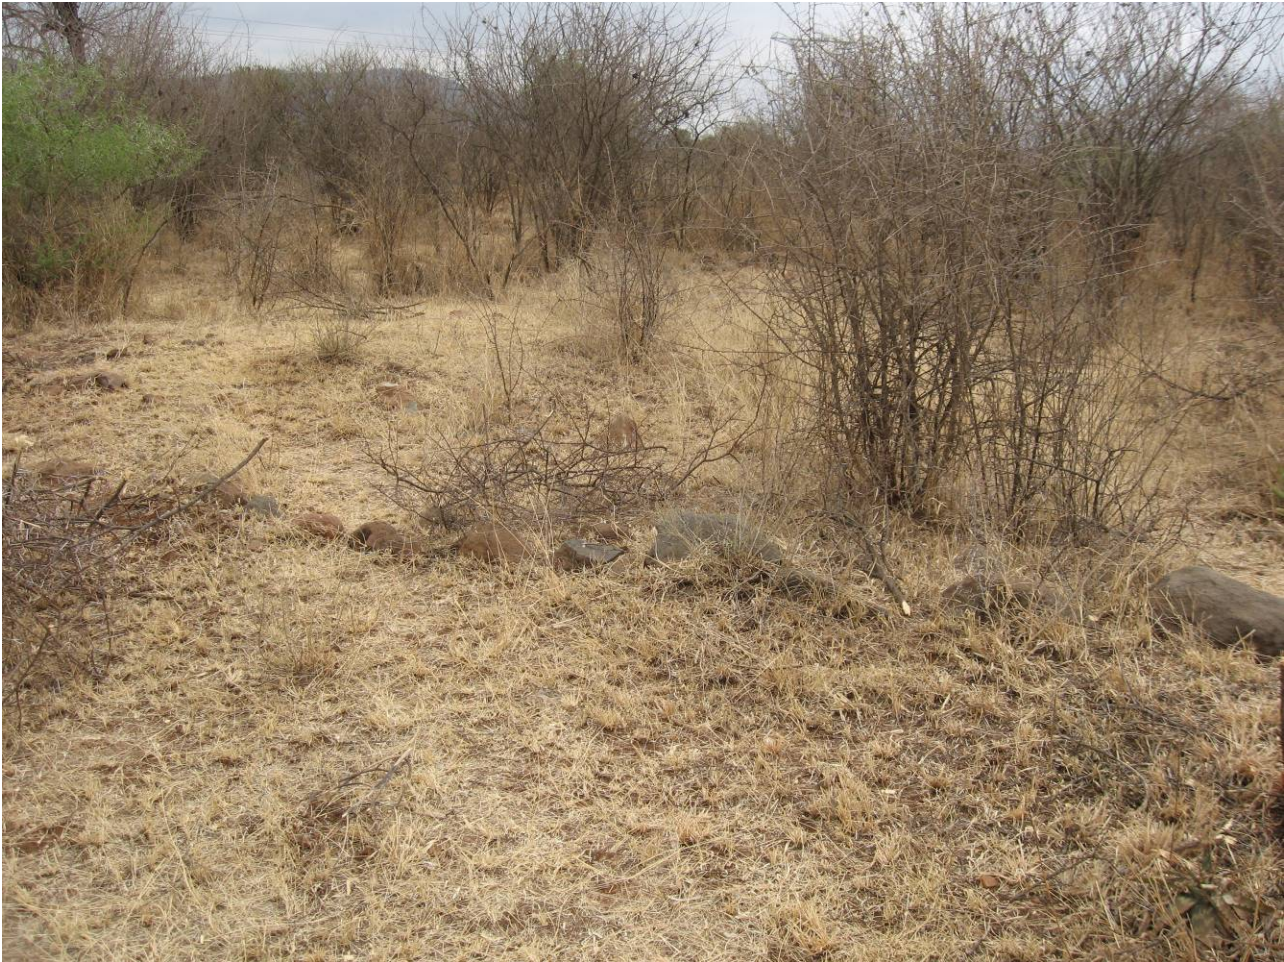
Figure 46. General photograph of Site ORW 15.

The remains and the foundations of a cluster of dilapidated structures were identified at this location. The remains consisted basically of packed lines of rocks which were used in the foundations of these structures on which mud-brick walls were built. These structures were predominantly square or rectangular in shape and the rooms measured approximately 5m x 5m. A few metal artefacts such as wire and cans were observed amongst the remains of the structures.

Significance: Moderate significance. The structures themselves have little or no heritage value or significance due to their relevant recent origins from within the last 60 years. The structures, however should be avoided, but if this deems not to be possible, a watching brief is recommended due to the possibility of infant human remains underneath the remains of the structures.

- For human remains inadvertently discovered in other situations, the legal requirement is that all activities affecting the burial must be stopped and that the discovery must be reported to the SAPS and SAHRA. The status of the remains is then ascertained. If it is found to be forensic in nature (nominally younger than 60 years and perceived to be the victim of crime or a person that have died of unnatural causes) recovery by the Provincial Forensic Pathology Services in conjunction with the SAPS is mandated. If the remains are of cultural, historical or archaeological origin recovery is usually facilitated by SAHRA by means of a Rescue Permit.

- Appoint a suitably accredited archaeologist on a watching brief to monitor construction activities.

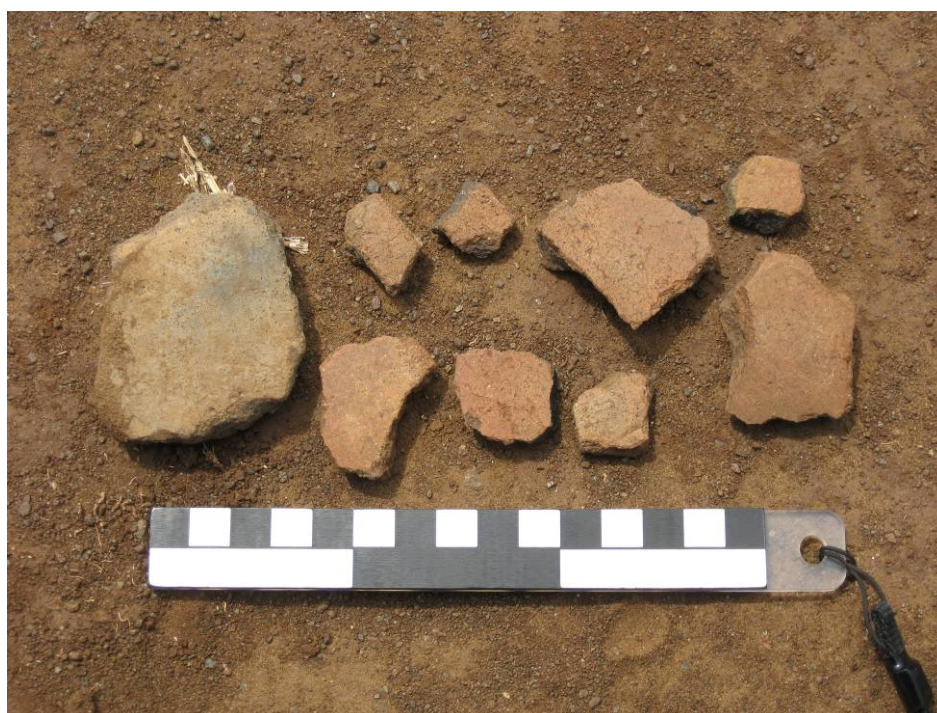
Figure 49. Artefacts at site ORW18.

- Non-diagnostic ceramics (Fig. 49).

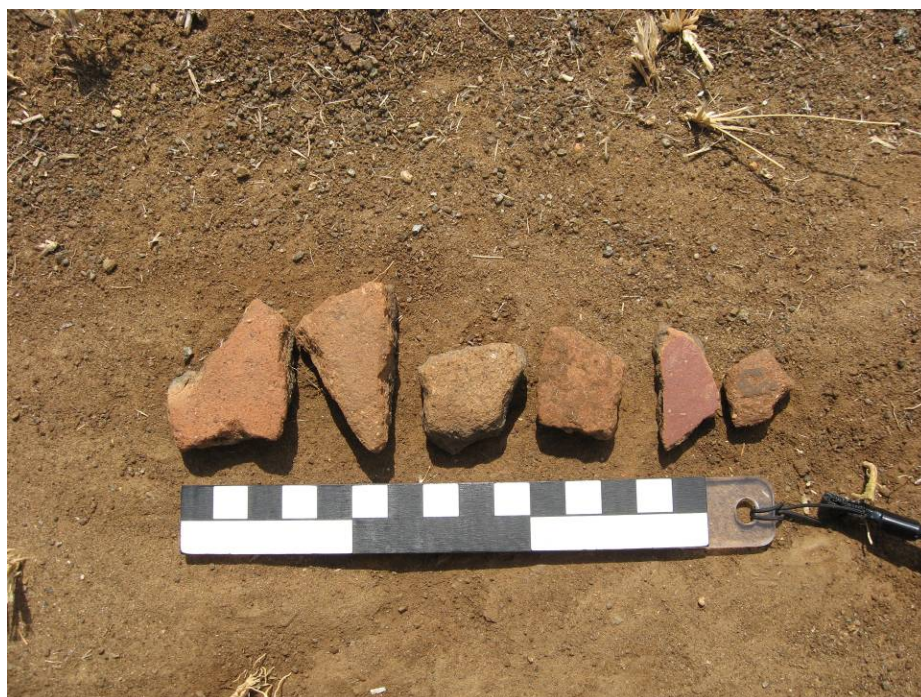
Figure 51. Artefacts at site ORW 19.

- Non-diagnostic ceramics (Fig. 51). Some fragments of ceramic display graphite burnishing which might indicate an affinity with the Marateng facies.
