**A LETTER OF RECOMMENDATION FOR  
EXEMPTION FOR DORDRECHT SPORTS FIELD  
UPGRADE**

**FOR INDWE ENVIRONMENTAL CONSULTING**

**HERITAGE SURVEY OF THE DORDRECHT WATER &  
SANITATION SERVICES UPGRADES; DORDRECHT,  
EASTERN CAPE**

**FOR AURECON (PTY) LTD**

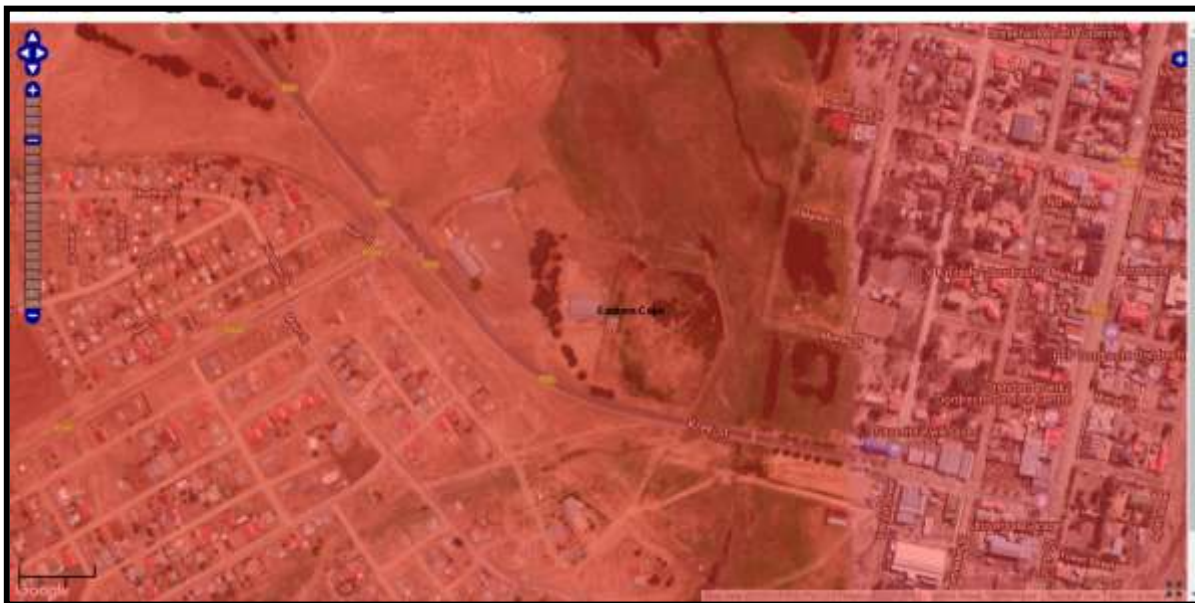
**FIG. 6: PALAEOONTOLOGICAL SENSITIVITY MAP**

COLOUR	SENSITIVITY	REQUIRED ACTION
RED	VERY HIGH	field assessment and protocol for finds is required
ORANGE/YELLOW	HIGH	desktop study is required and based on the outcome of the desktop study, a field assessment is likely
GREEN	MODERATE	desktop study is required
BLUE	LOW	no palaeontological studies are required however a protocol for finds is required
GREY	INSIGNIFICANT/ZERO	no palaeontological studies are required
WHITE/CLEAR	UNKNOWN	these areas will require a minimum of a desktop study. As more information comes to light, SAHRA will continue to populate the map.

According to the PIA desktop (Appendix A), the town of Dordrecht is in the Molteno Formation (fig. 6). If deep excavations (>2m) are planned within the study area, then they should be inspected by a palaeontologist.

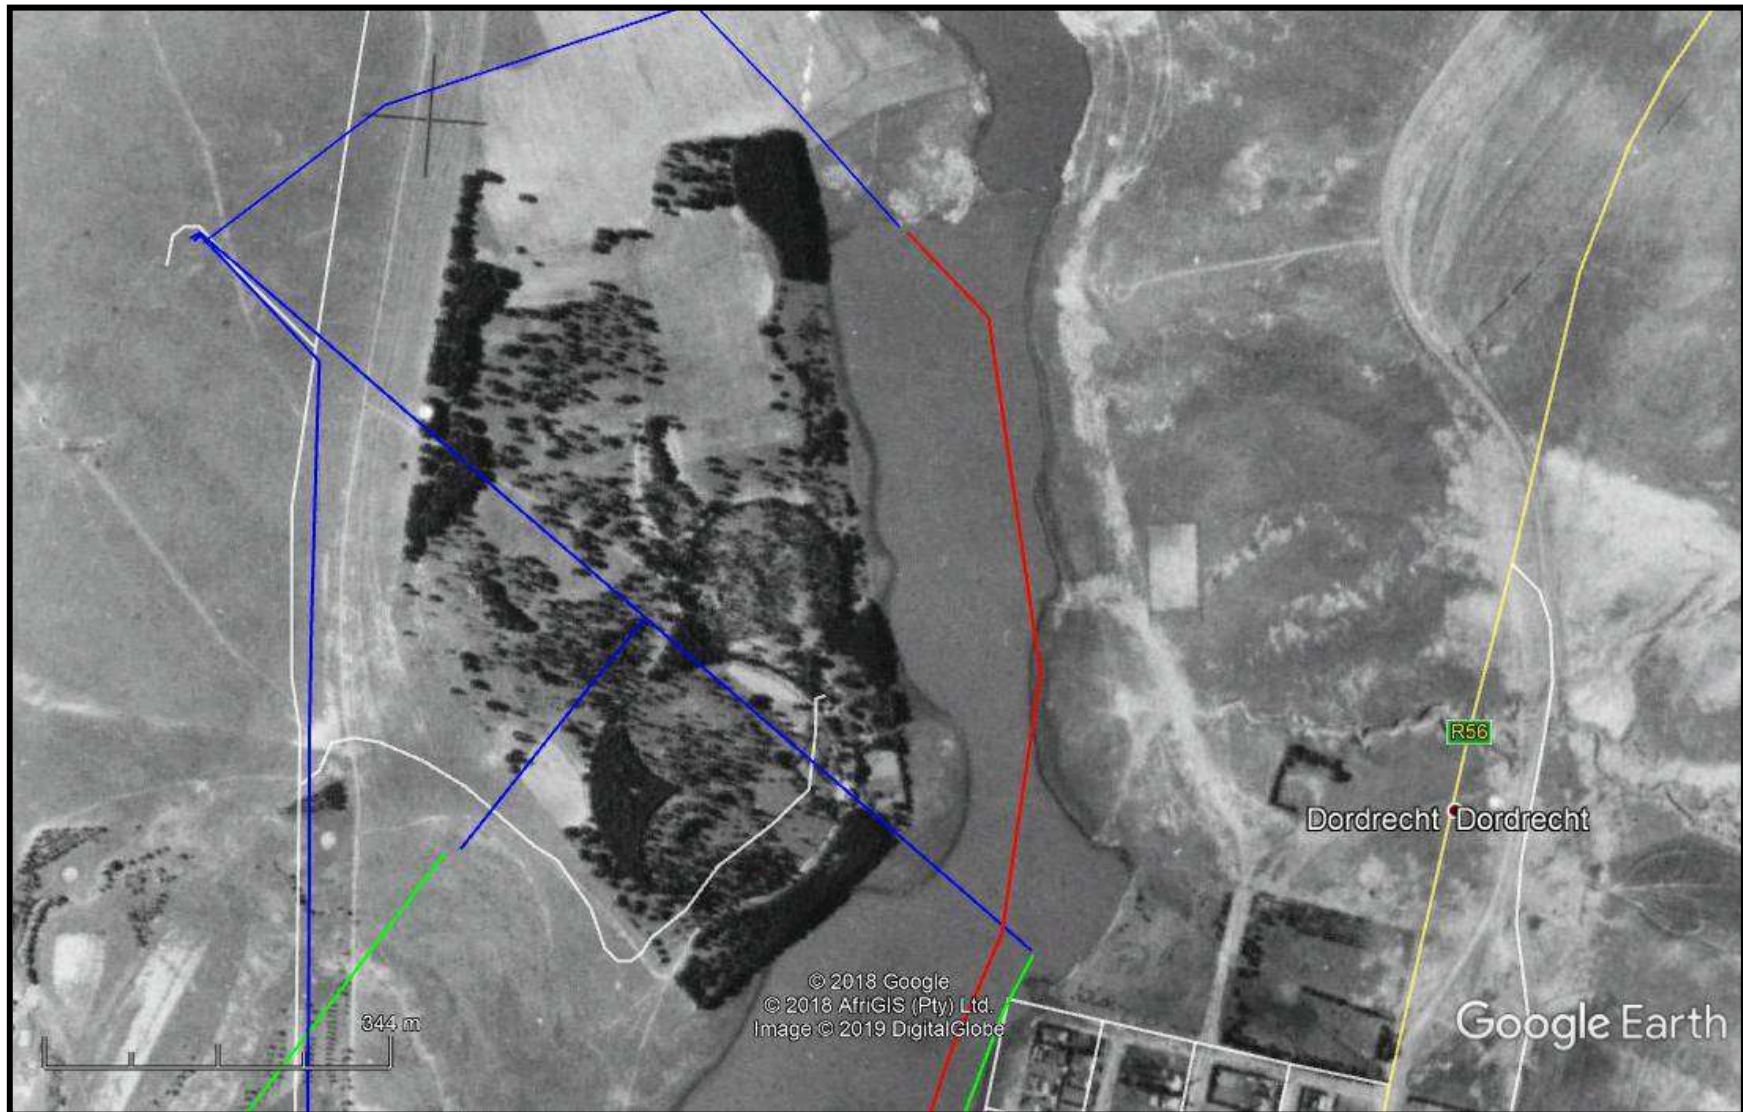
FIG.6b: STUDY AREA IN 1945

The Munnik Dam post-dates 1966 and is not protected by heritage legislation. The dam wall will be raised resulting in an approximate 50m extension to the dam in places. The backwater flow will affect an historical railway bridge (fig. 14). This bridge predates 1945: fig. 6b indicates that the railway was already in disuse and had been moved further north to its current position. The highwater mark will not negatively affect the bridge more than the existing stream does.

The pipeline will be placed in the Dordrecht Commonage, and specifically in an area that has been demarcated with alien trees (fig. 16). These trees were in existence before 1945, and fig. 6b shows that they were planted in two circles within a polygon. There are a few buildings on the eastern side. The purpose for the trees is currently unknown, but they could have been used as an 'afsaal', or outspan outside of the town. The Surveyor General does not have the title deeds and surveys for this section uploaded yet. The trees could be viewed as part of a cultural landscape, however it is unlikely that the pipeline will damage the overall landscape. No mitigation is required for the trees.

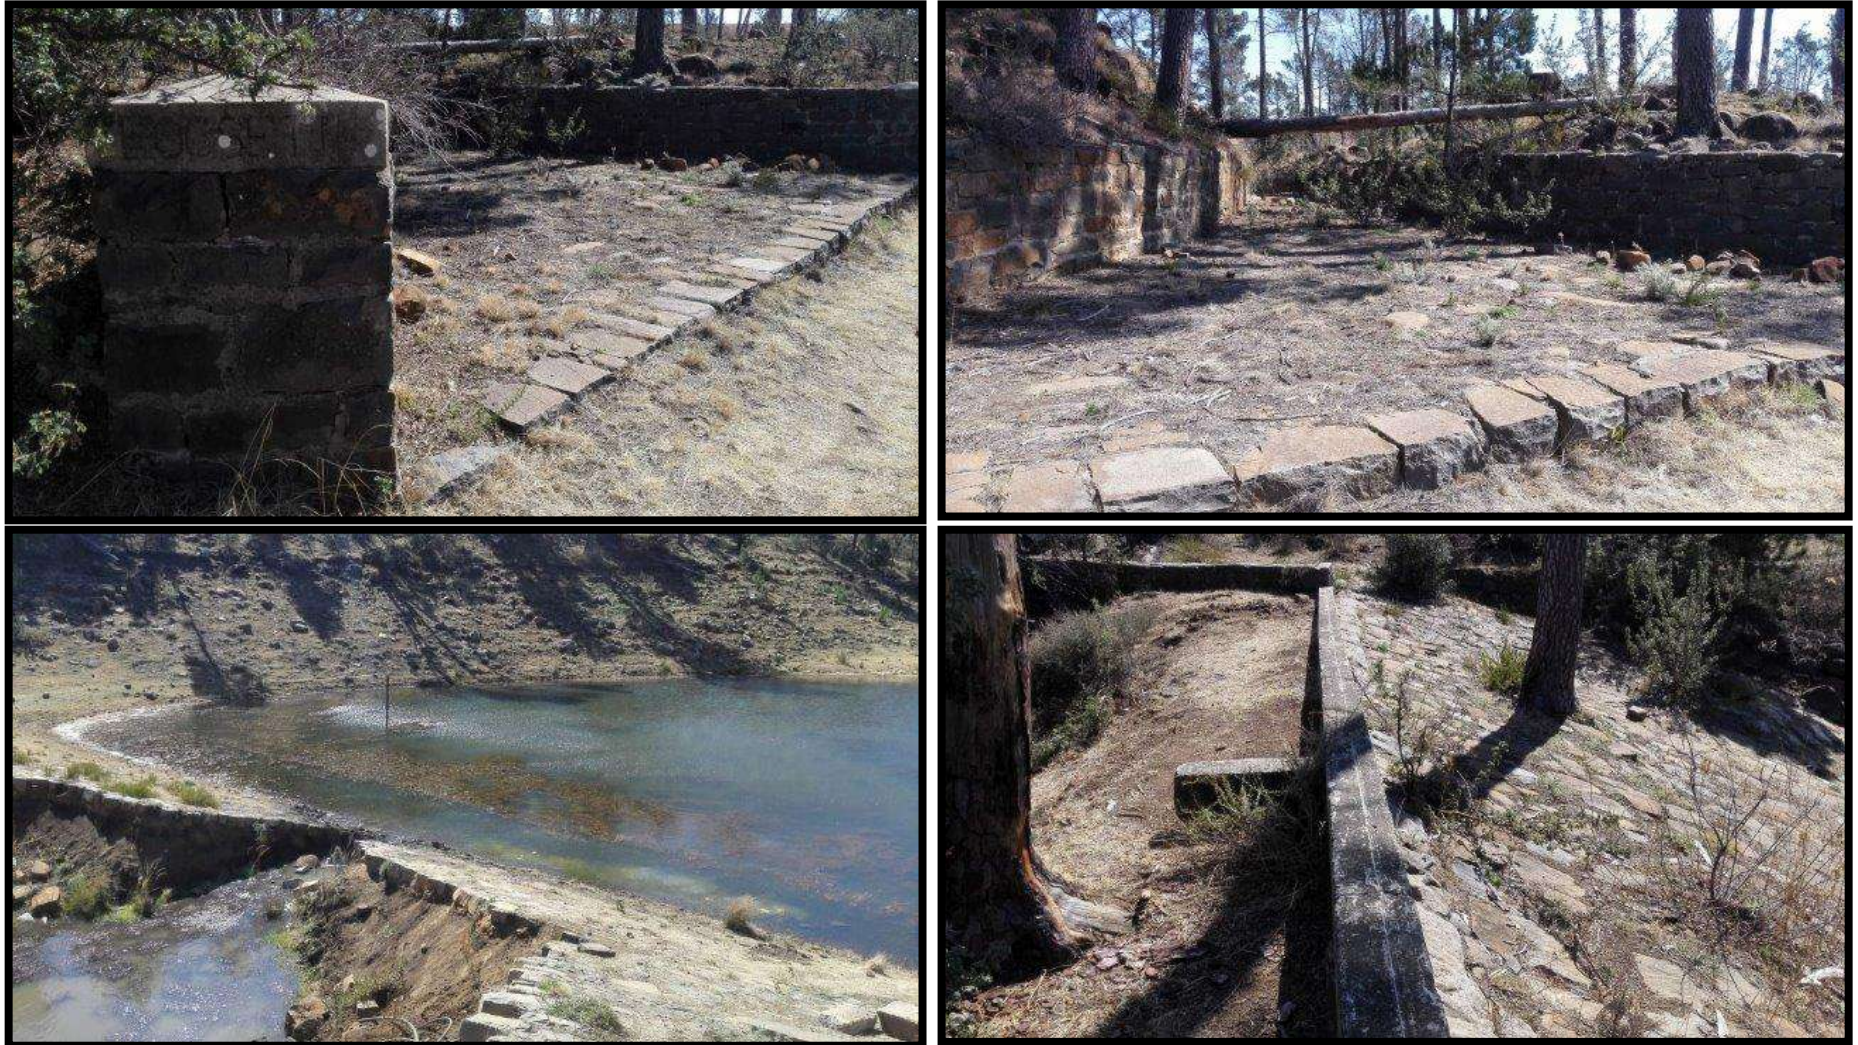
**FIG. 8a: BUILT STRUCTURES AT THE HOGSETT DAM**

The Hogsett Dam was originally built in 1932. The cobbled spillway was added either at the time of building or at a later stage. This needs to be verified. The spillway and dam wall need to be removed in order to update the entire dam. The dam burst in 2011 as the original spillway was apparently too narrow to cope with the amount of water, which contributed to the dam collapsing. The proposal is to follow the line of the spillway, but it will be made deeper and wider, so the original one would need to be replaced. The dam wall will also be replaced in its entirety. Fig. 8a-b shows some of the built features. These features appear to be in various stages of disrepair.

All built structures older than 60 years in age are automatically protected by the heritage legislation. A permit will be required for the destruction of any of these features. ECHPRA may require an assessment by a professional architect/historian. It is highly unlikely that permission will not be granted for the built structures to be destroyed. The proposal should include setting the material aside as part of a materials bank. ECHPRA will need to decide where the material is to be stored.

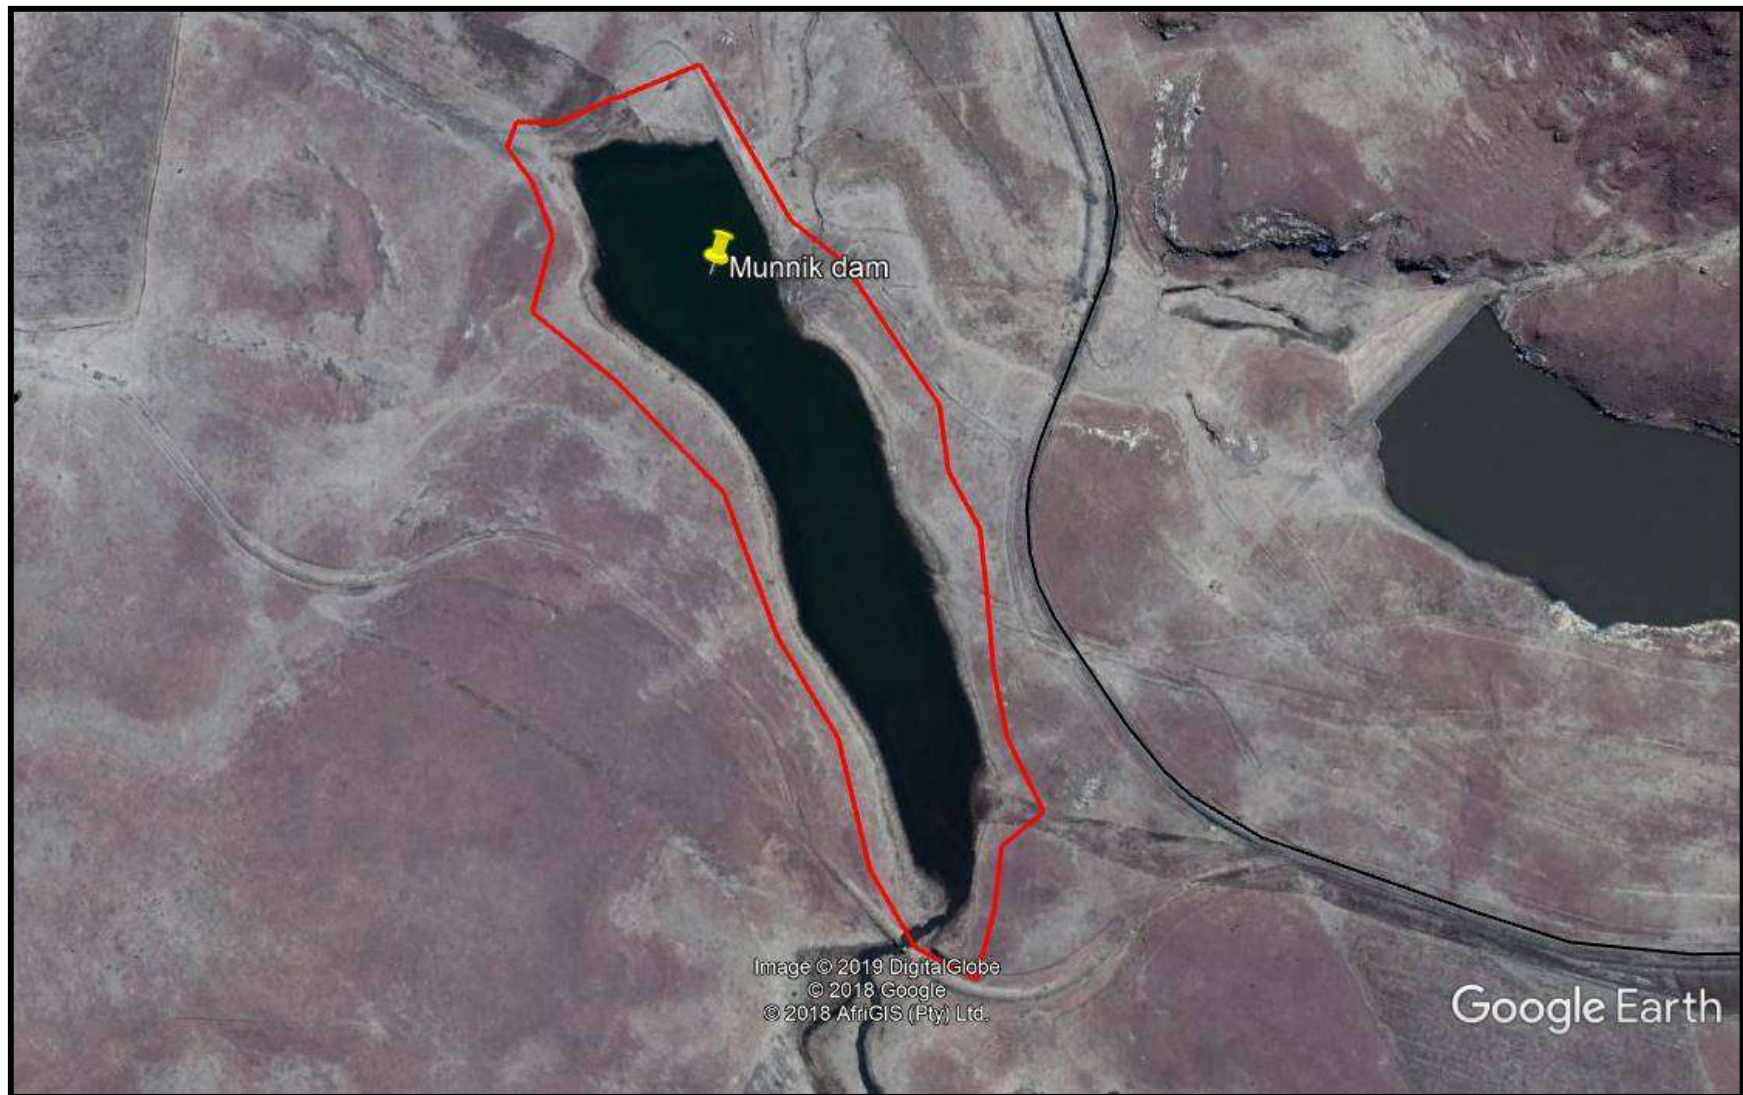
FIG. 10: MUNNIK DAM

The Munnik Dam post-dates 1966 and is not protected by heritage legislation (fig. 10). The dam wall will be raised resulting in an approximate 50m extension to the dam in places. There are no known buildings in the new affected area; however, a survey would be required for potential archaeological material. If the dam wall will result in new excavations, then a palaeontological survey might be required. This is discussed below.

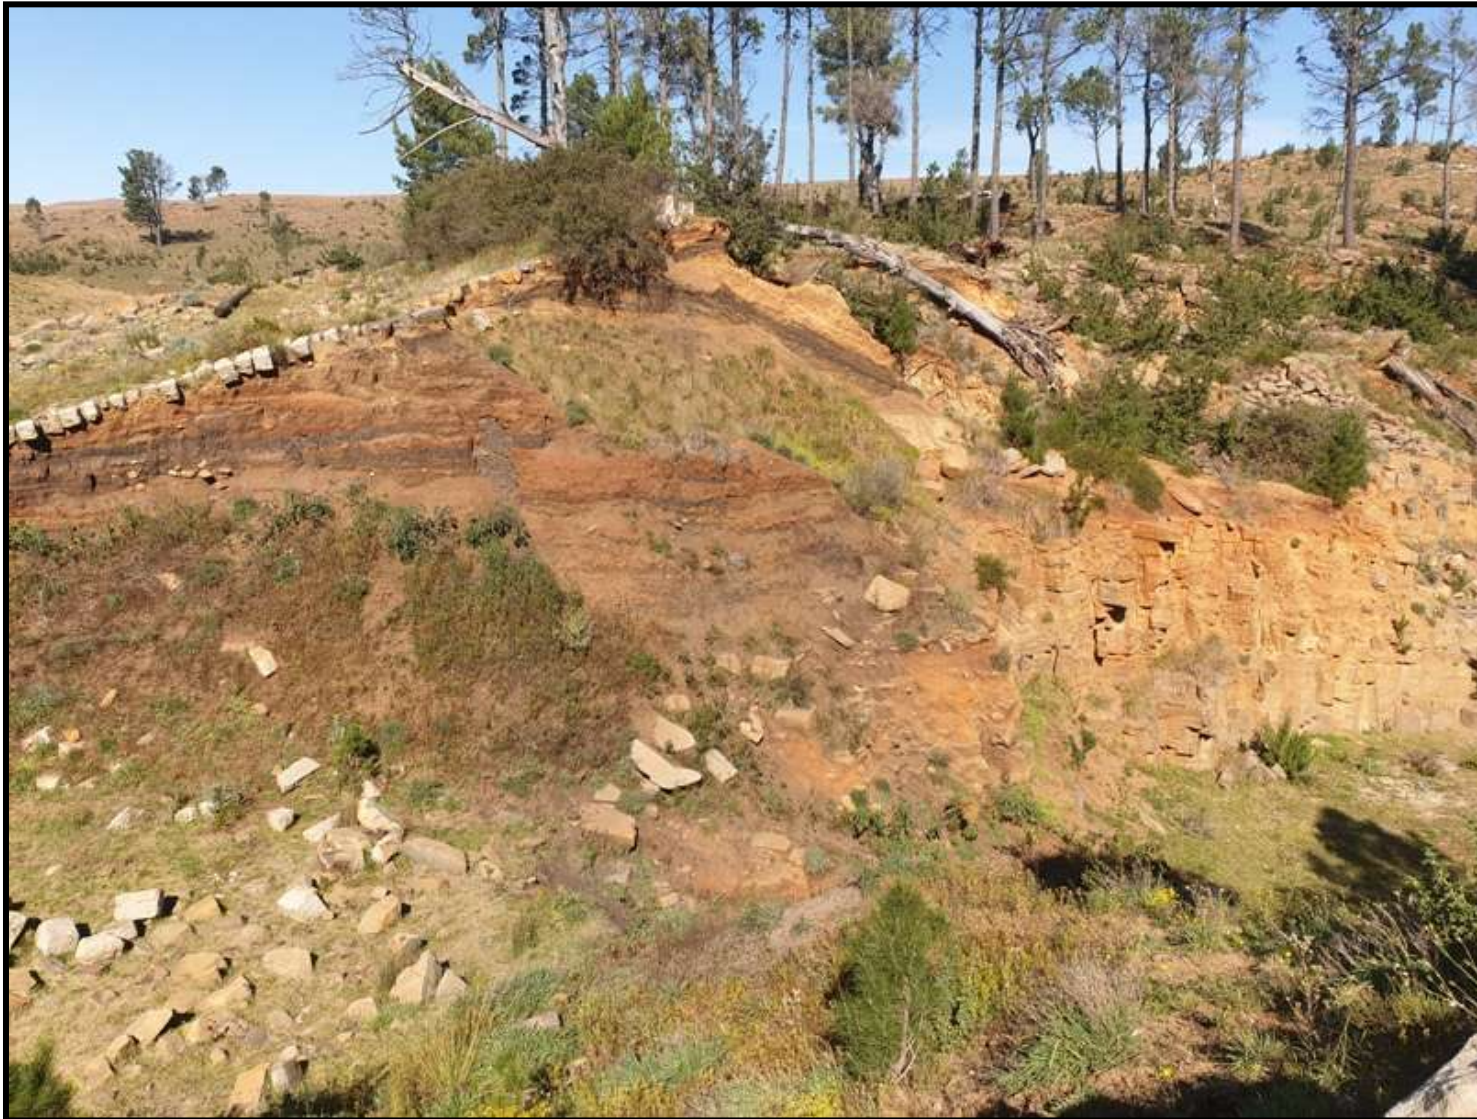
**FIG. 13: CROSS-SECTION OF THE BROKEN HOGSETT DAM WALL**

As noted above, the Hogsett Dam wall collapsed (fig. 13) in 2011 and the spillway was extensively damaged at the same time. The original dam wall is unstable as is the spillway and is a safety hazard. The proposal is to rebuild the dam wall and spill way. The spill way will be widened and made higher. The proposal is to use some of the original material at the face of the spillway. This will include the pillars with the Hogsett Reservoir' cornerstones. However, the rest of the spillway will require new materials. The client is prepared to store the materials in an agreed upon location for other buildings in Dordrecht and surrounds. Samples of the various grouting will be retained as well. Most of the grouting was removed during the flood.

An application to have the Hogsett Dam demolished and replaced has been undertaken.

The desktop noted that the Hogsett Dam is older than 60 years in age. There are several built features at the dam that probably related to the original dam. These features may need to be assessed by a qualified historical architect if ECHPRA requires it. The features will need to be destroyed as the dam wall needs to be rebuilt after it collapsed in 2011. The spillway is too small to handle the proposed volume of water and will need to be removed.

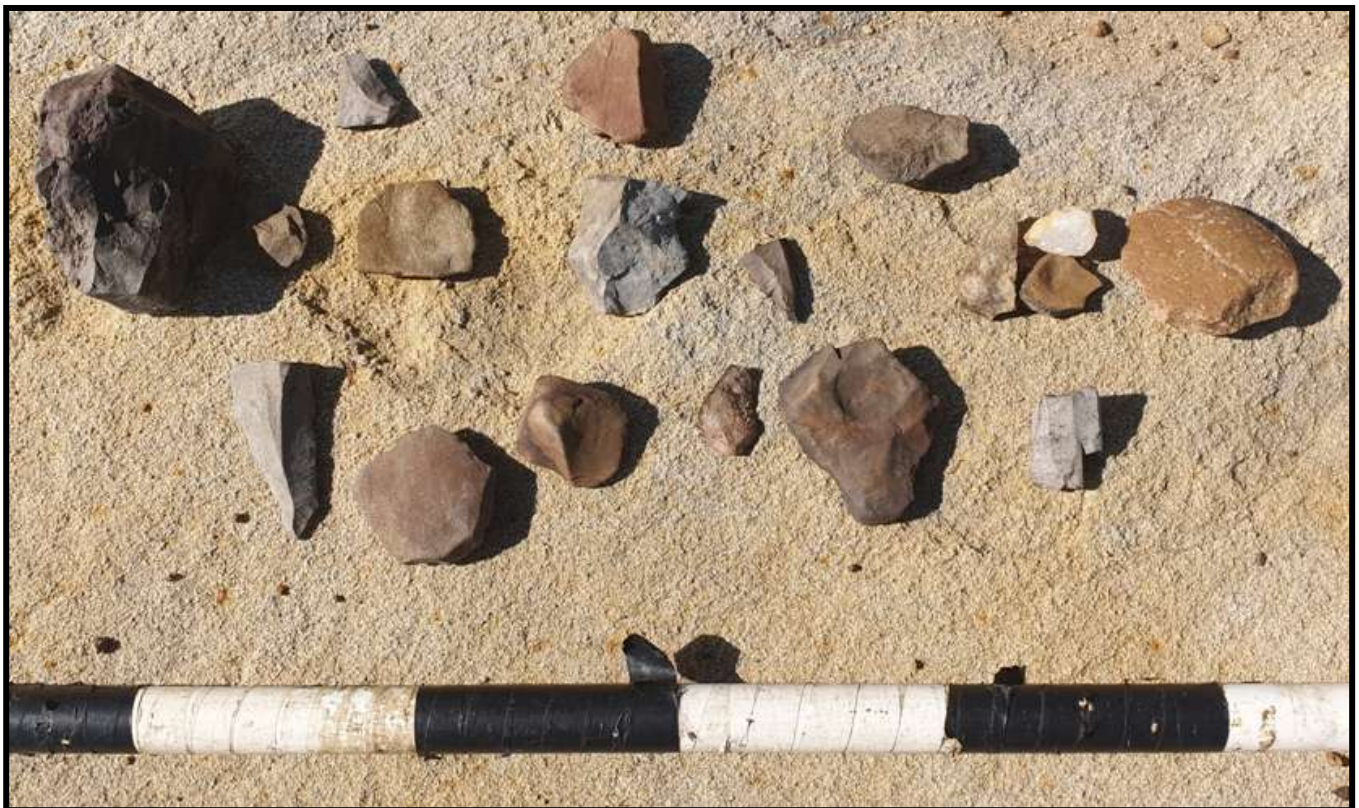
**FIG. 15: STONE TOOLS AT MUNNIK DAM**

The survey noted an extensive scatter of Early, Middle, and Late Stone Age stone tools within the existing dam levels (fig. 15). These were exposed on the sandstone floor as the Munnik Dam dried up. They include:

- ❖ ESA
  - Quartzite chopper
- ❖ MSA
  - 2 x complete unifacial points on hornfels
  - Several demineralised hornfels (utilised) flakes
- ❖ LSA
  - Hornfels bladelet core
  - Quartz irregular core
  - General flakes on quartzite, quartz and hornfels
- ❖ ISA
  - Irregular cores on hornfels
  - ochre

**Significance:** Both the bridge and stone tools are of low significance.

**Mitigation:** No further mitigation is required.

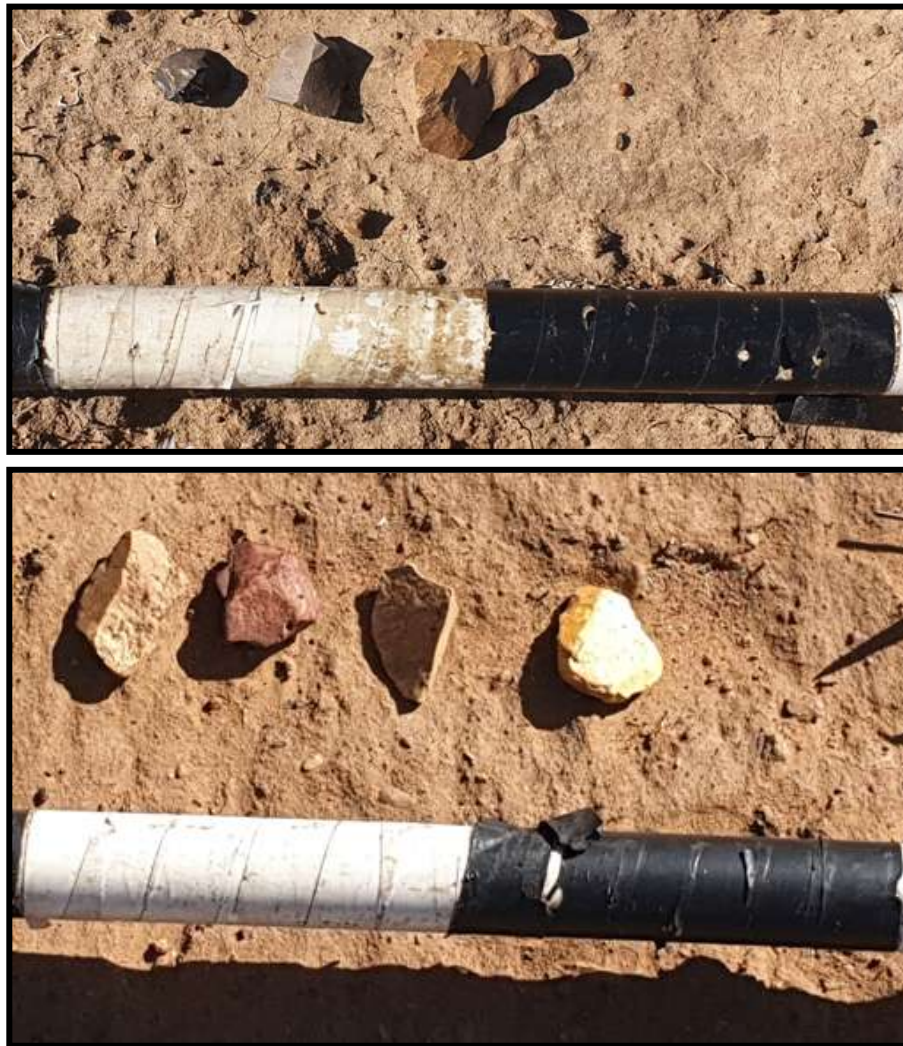
**FIG. 17: STONE TOOLS NEAR THE WWTW**

The WWTW might be expanded in the future. For this reason, I surveyed a 100m radius around the existing structures and north of the golf club. Occasional LSA and MSA stone tools were noted: these are generic stone tools similar to those at Munnik Dam (fig. 17). These are in a secondary context and have no significance.

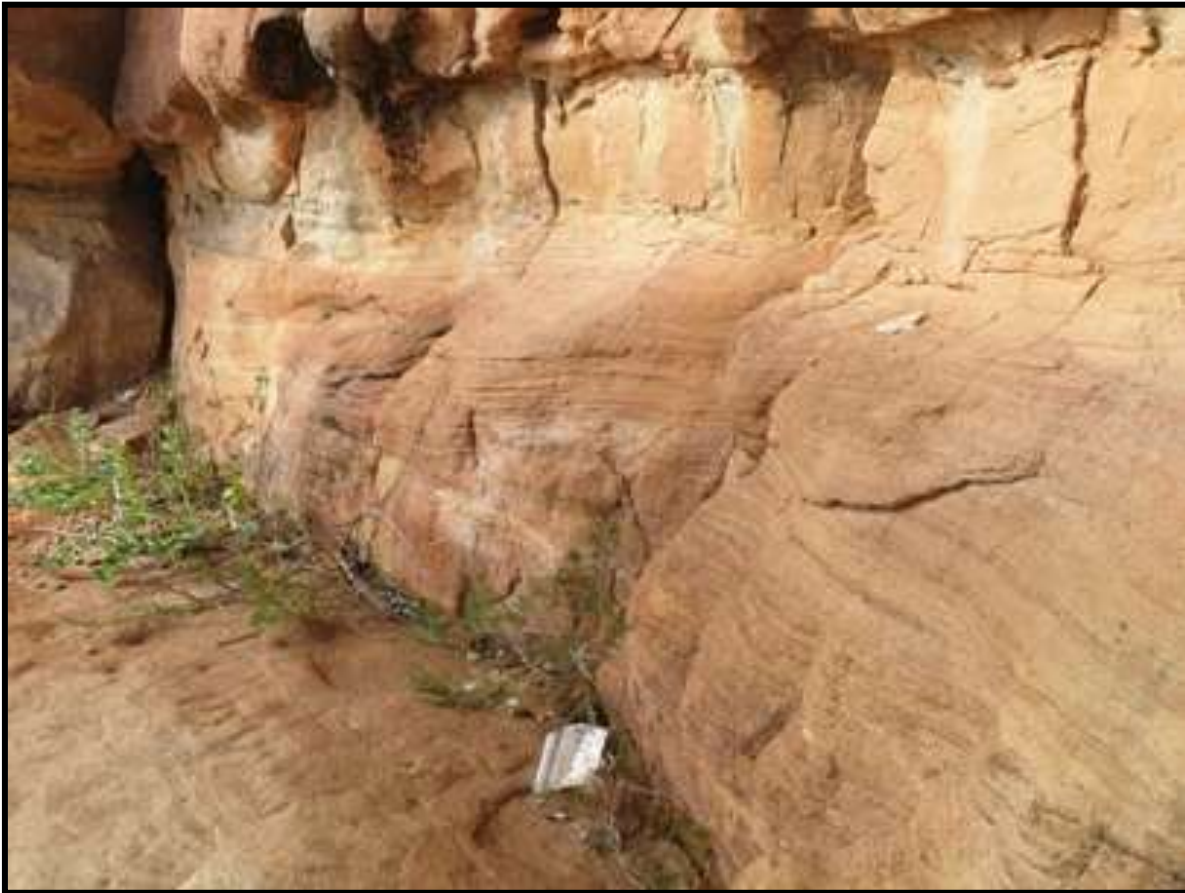
**FIG. 18: OVERHANGS ALONG THE SANDSTONE ABOVE WATER WORKS**

A pipeline from the Hogsett Dam to the existing water treatment works will be replaced. A smaller reservoir is planned just above the facility. The area is above a sandstone ridge that was potentially sensitive for rock art (fig. 18). The overhangs were very weathered and no paintings were observed. There were a few names engraved and/or painted at some overhangs. One shelter had a broken sherry bottle above the ground on a ledge. This would normally be considered an ancestral offering site; however, given the amount of broken bottles along this area, it is probably litter.

**Significance:** The overhangs are of low significance

**Mitigation:** No further mitigation is required.

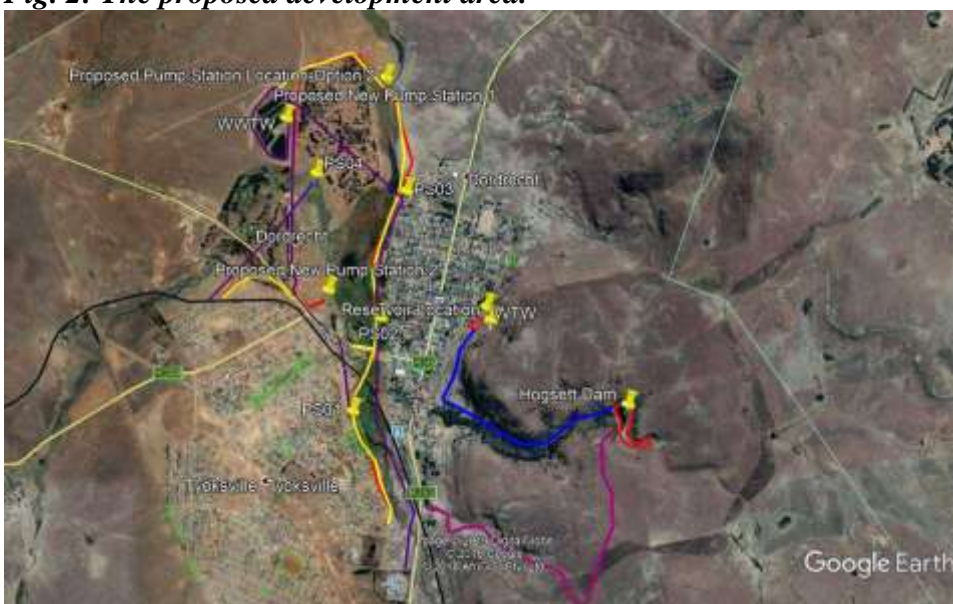
**Fig. 3: Pipeline options: Option 1 (purple), Option 2 (yellow) and Option 3 ( red). Image source Umlando.**

There are three options for the pipelines, each with pump stations (Fig. 3). Option 1 (purple on map) uses an existing system. Option 2 (yellow on map) and 3 (red on map) are partly aligned with Option 1, but also occur as new lines. Changes and renovations will also be done to the Hogsett and Munnick Dams.

Option 1 (purple on map: Fig. 3) uses an existing footprint and no further palaeontological work will be required provided that it does not break new ground.
